Fatal accident during cargo discharge of the bulk carrier *Graig Rotterdam* Alexandria Port, Egypt 18 December 2016

SUMMARY

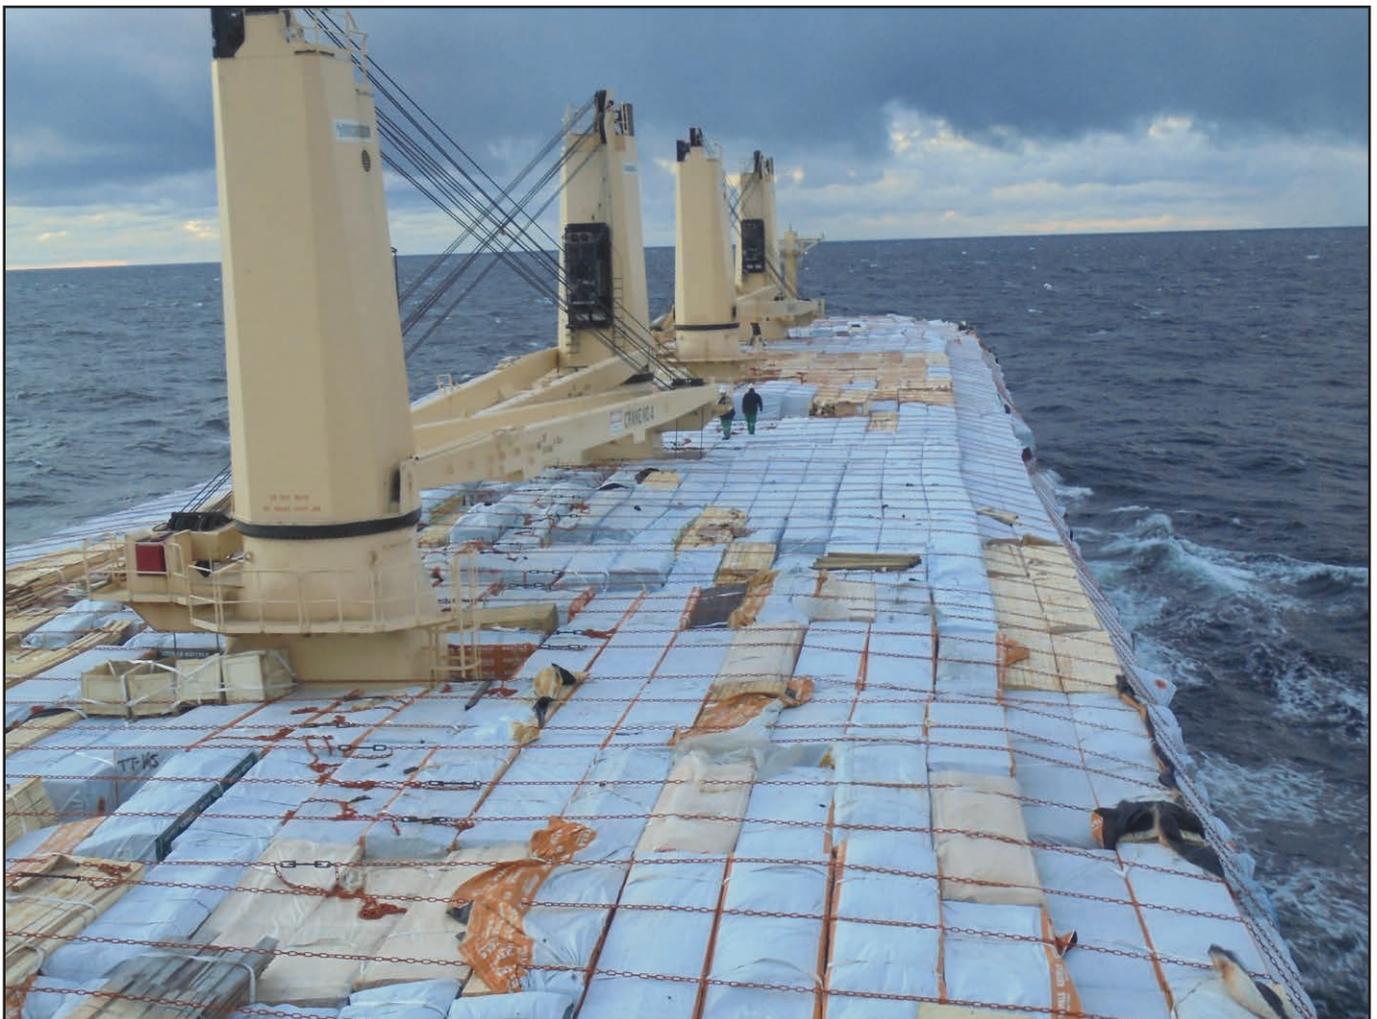
The deck cargo was stacked four packages high on top of the hatch covers and six high on deck. Following the supercargo's instruction, the ship's crew secured the deck cargo by means of top-over lashings³ using chains and turnbuckles supplied by the charterer (**Figure 2**).

Figure 2: *Graig Rotterdam* at sea with timber deck cargo secured by top-over lashings

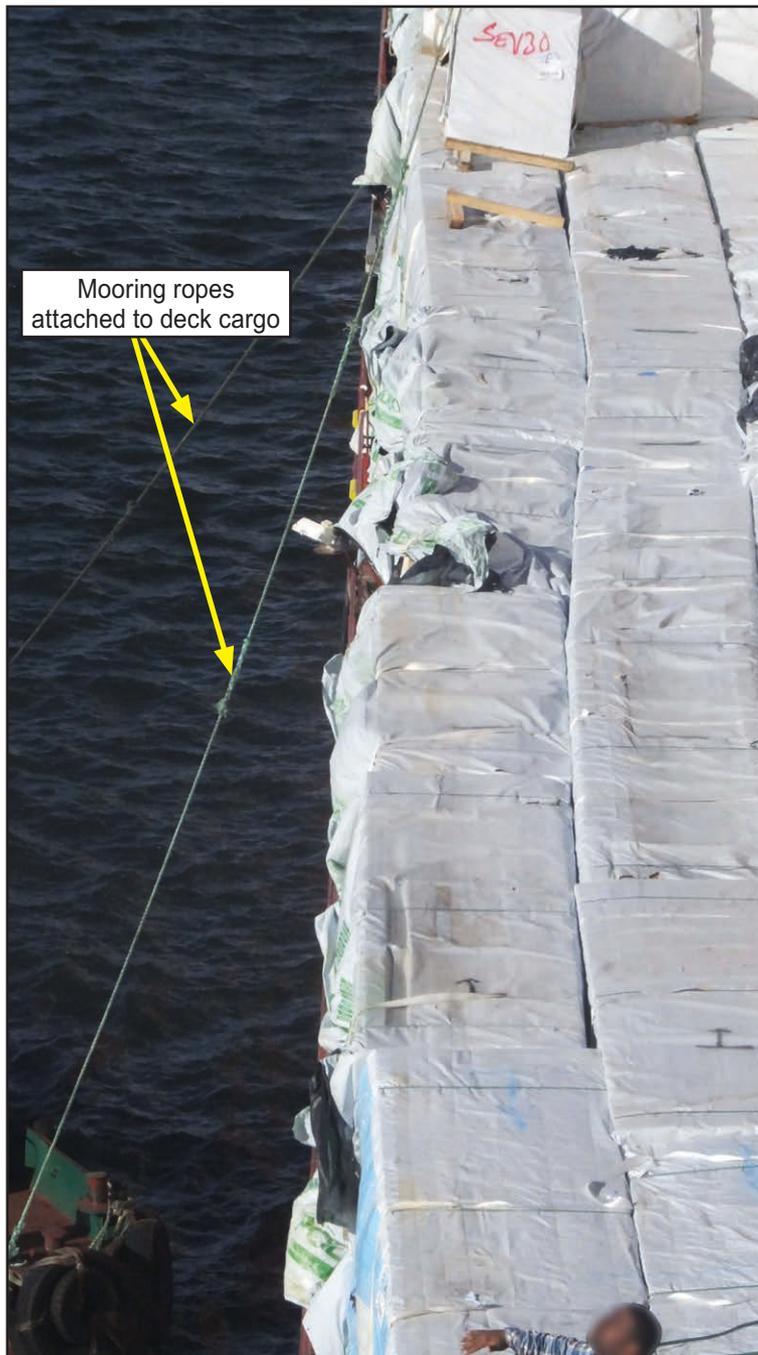
Two barges were located on *Graig Rotterdam's* starboard side, and one barge was positioned on its port side forward. The barges were secured with mooring ropes attached to the deck cargo packages (**Figure 3**). Deck cargo was being discharged from the stacks on top of numbers 2 and 3 hatch covers into the two barges located on the ship's starboard side using two of the ship's cranes.

Figure 3: Cargo barges secured to deck cargo packages

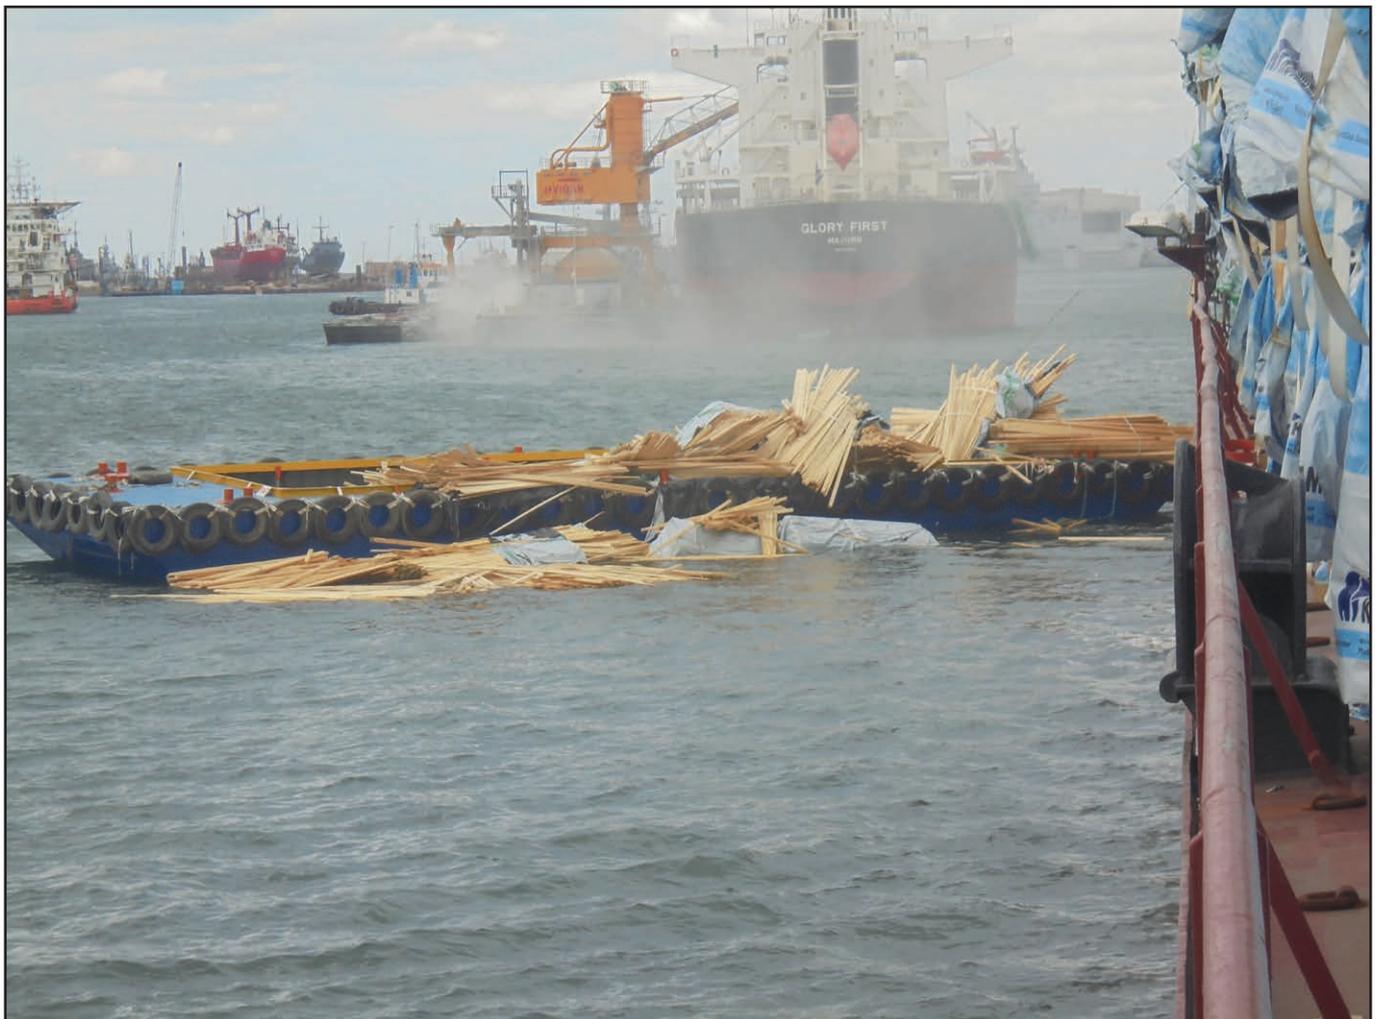
Approximately 20 packages of timber fell from the port side of the stack on top of number 1 hatch cover. Some of the packages fell into the water and the remainder fell into the barge that was secured on *Graig Rotterdam*'s port side forward (**Figure 4**).

The barge was unmanned at the time of the accident and already contained some packages.

Figure 4: Port side cargo barge, immediately after cargo collapse

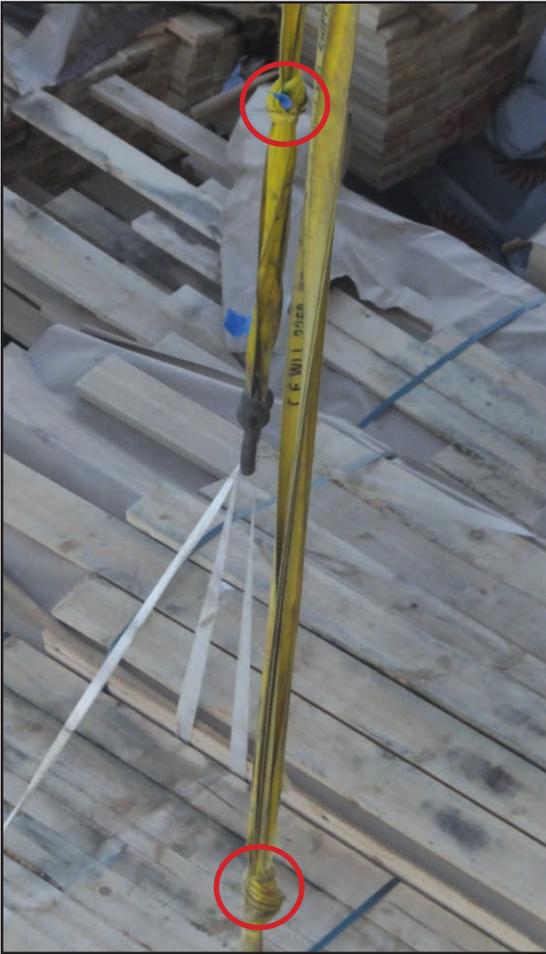
- Knotted cargo slings (**Figure 5**) and open shackles being used as hooks (**Figure 6**) to lift cargo.
- Walking on the edge of deck cargo stacks (**Figure 7**).

Figure 5: Knotted cargo slings

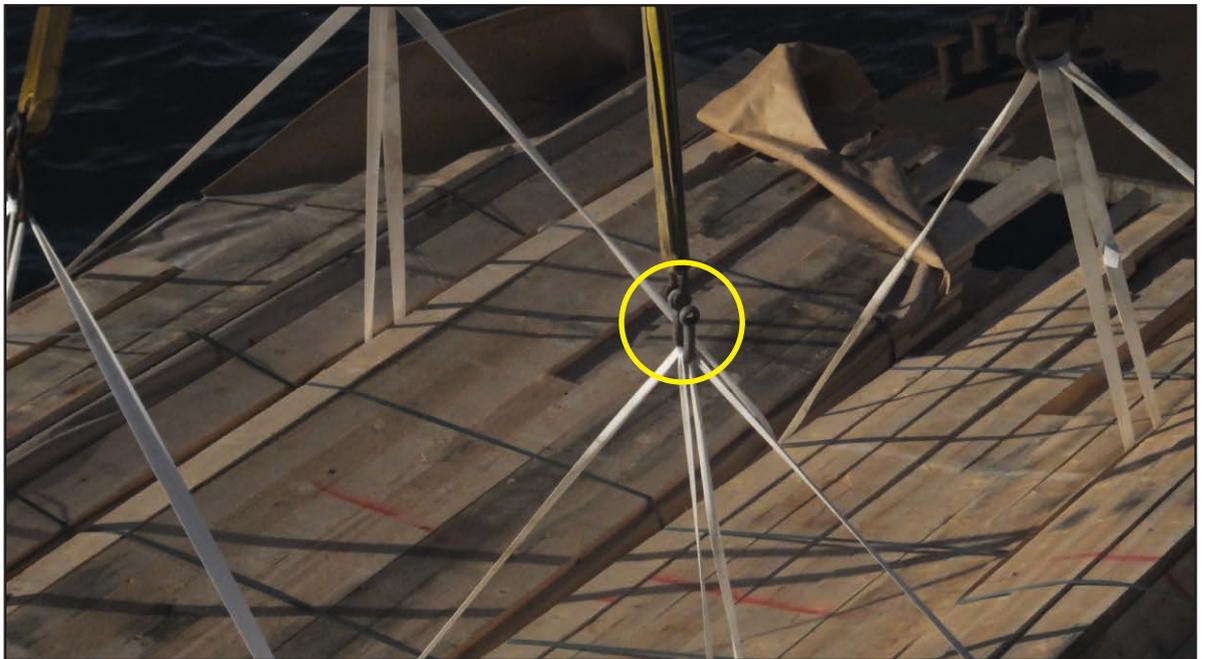
Figure 6: Open shackles used as cargo hooks

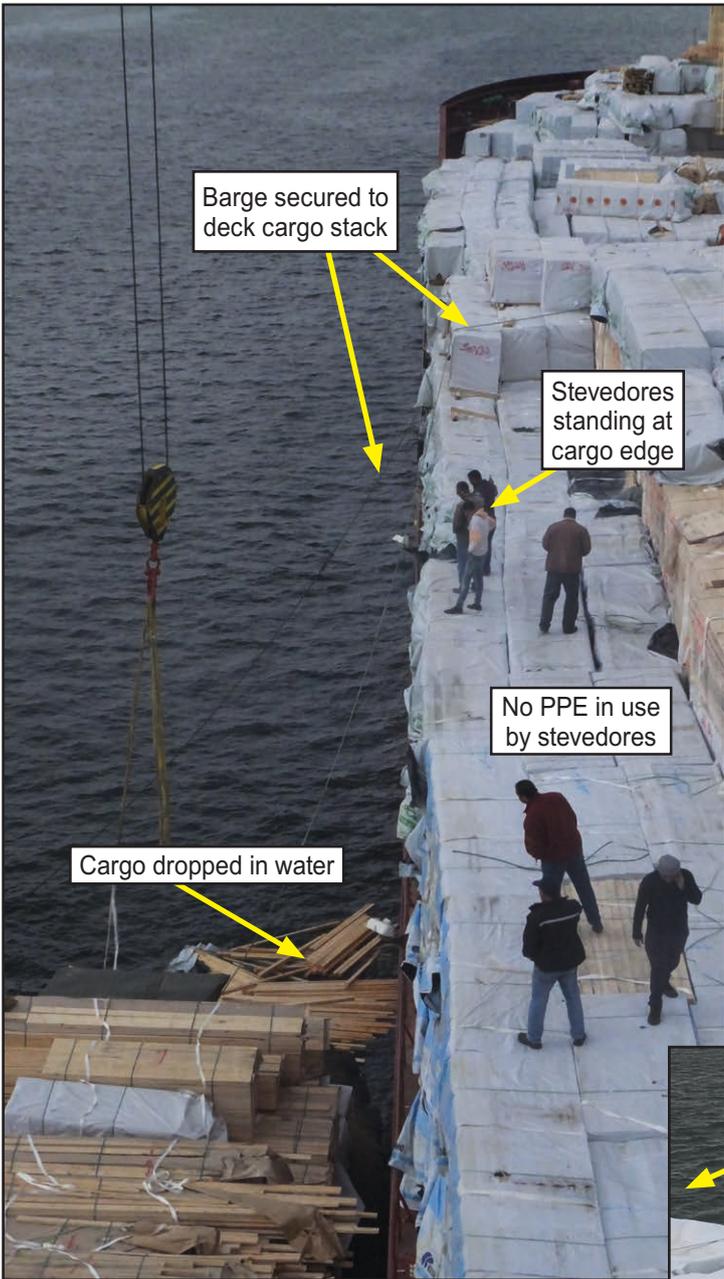
- Personal protective equipment (PPE) not being worn (**Figure 7**).
- Cargo packages being dropped onto the deck or into the water (**Figure 7**).
- Barges being secured to deck cargo stacks (**Figures 7, 8 and 9**).
- Smoking while on the deck cargo stacks.
- Climbing and being lifted by crane from barges to the ship.

Figure 7: Poor stevedoring practices

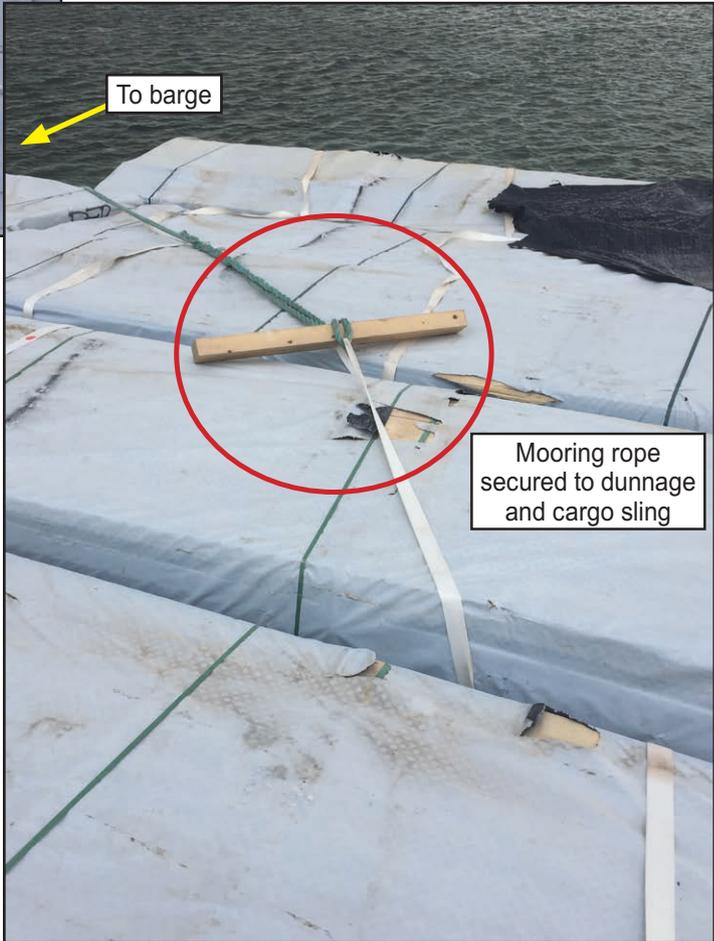
Figure 8: Barge mooring rope attached to deck cargo stack

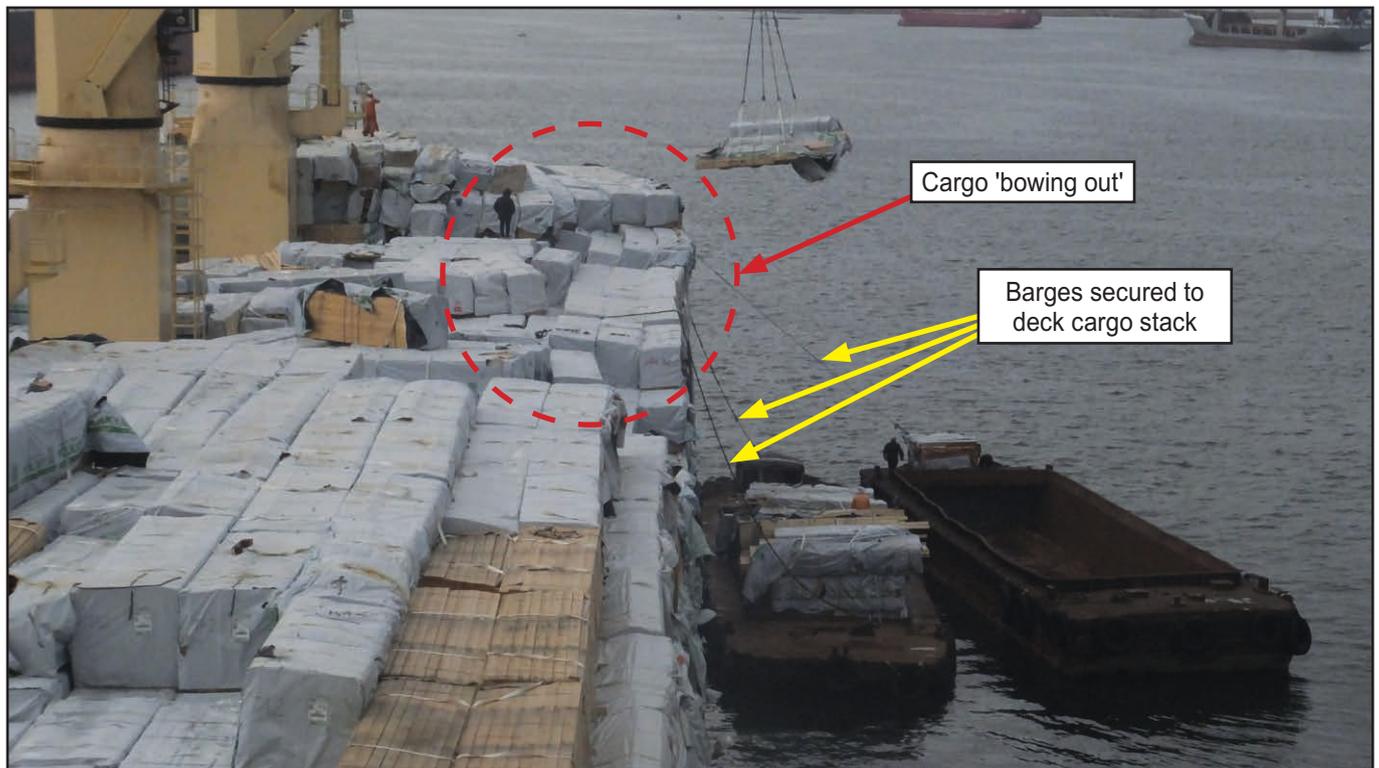
Figure 9: Cargo 'bowing out' in fore part of vessel

The deck cargo had been secured for passage in accordance with the ship's CSM, which assumed the packages had sufficient racking strength so as not to require the use of uprights. Consequently, when all cargo lashings were removed prior to commencing cargo discharge, nothing other than friction and the strength of the metal banded package construction was left to hold the timber deck cargo in place. While the stability of the deck cargo stow when secured with top-over lashings on passage was sufficient, the stability of the stow once the lashings had been removed was insufficient to counter the effects of ship movement, cargo repositioning, dunnage displacement, barges securing to deck cargo stacks, and cargo discharge operations over a prolonged period. In this regard, there was evidence that the cargo was 'bowing out' after the securing lashings had been removed, particularly in the fore part of the vessel (**Figure 9**).

The rigidity of timber packages is of great importance for the stability of the deck cargo and the racking strength of the timber packages should be taken into consideration when securing systems are designed. *Graig Rotterdam's* master was not advised of the cargo package racking strength prior to the cargo being loaded in Finland.

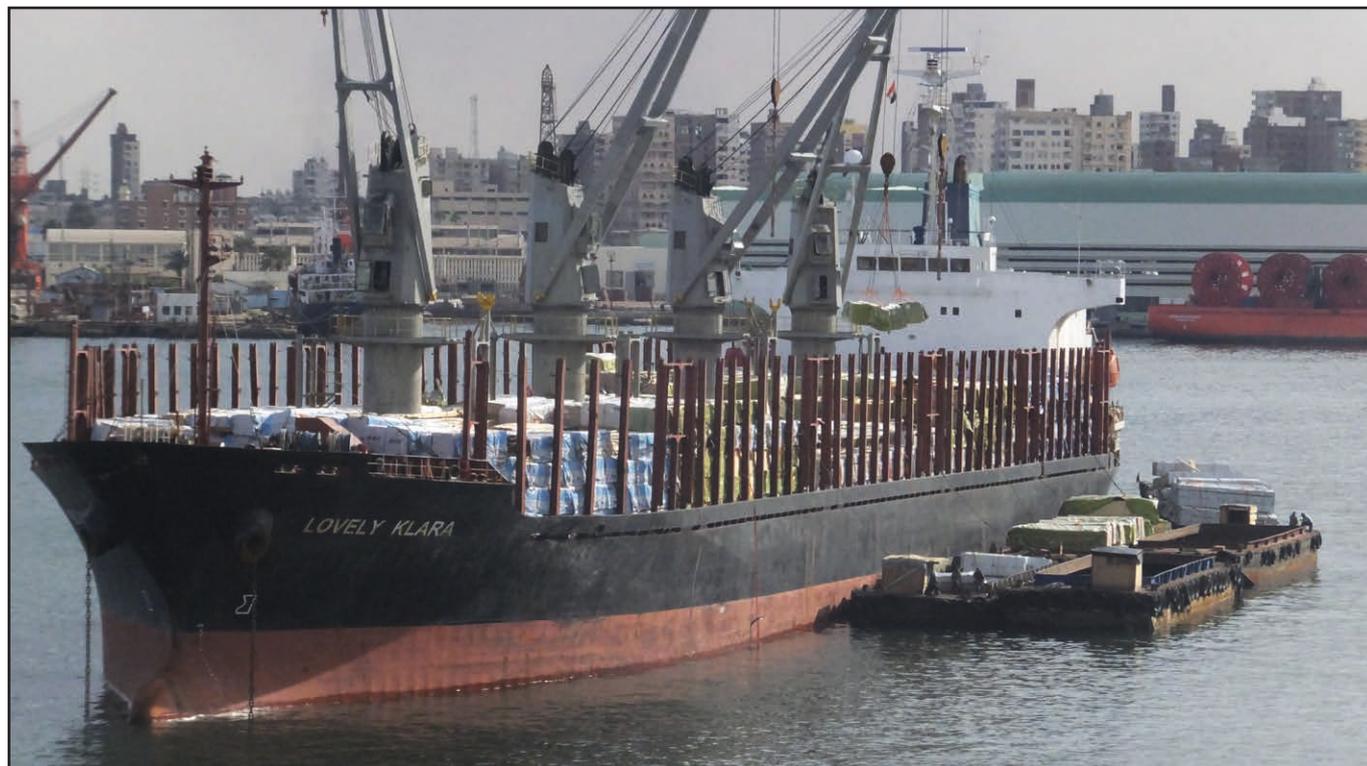
Uprights provide an additional means of securing timber deck cargo packages with limited racking strength for passage, in accordance with the TDC Code. There is no evidence that the cargo packages carried on *Graig Rotterdam* had insufficient racking strength so as to require them to be supported by uprights while on passage. However, provision of uprights would have helped prevent a deck cargo stack from collapsing once the securing lashings had been removed in circumstances such as those faced by *Graig Rotterdam* in Alexandria Port, Egypt. There were two other ships discharging packaged timber cargoes to the same terminal in Alexandria at the time of the accident. Both ships were fitted with steel uprights (**Figure 10**).

Figure 10: A vessel, with steel uprights, discharging a timber deck cargo at the same anchorage
