Report on the investigation of the
explosion of gas released from a cargo
of unprocessed incinerator bottom ash on

Nortrader

at anchorage in Plymouth Sound

on 13 January 2017

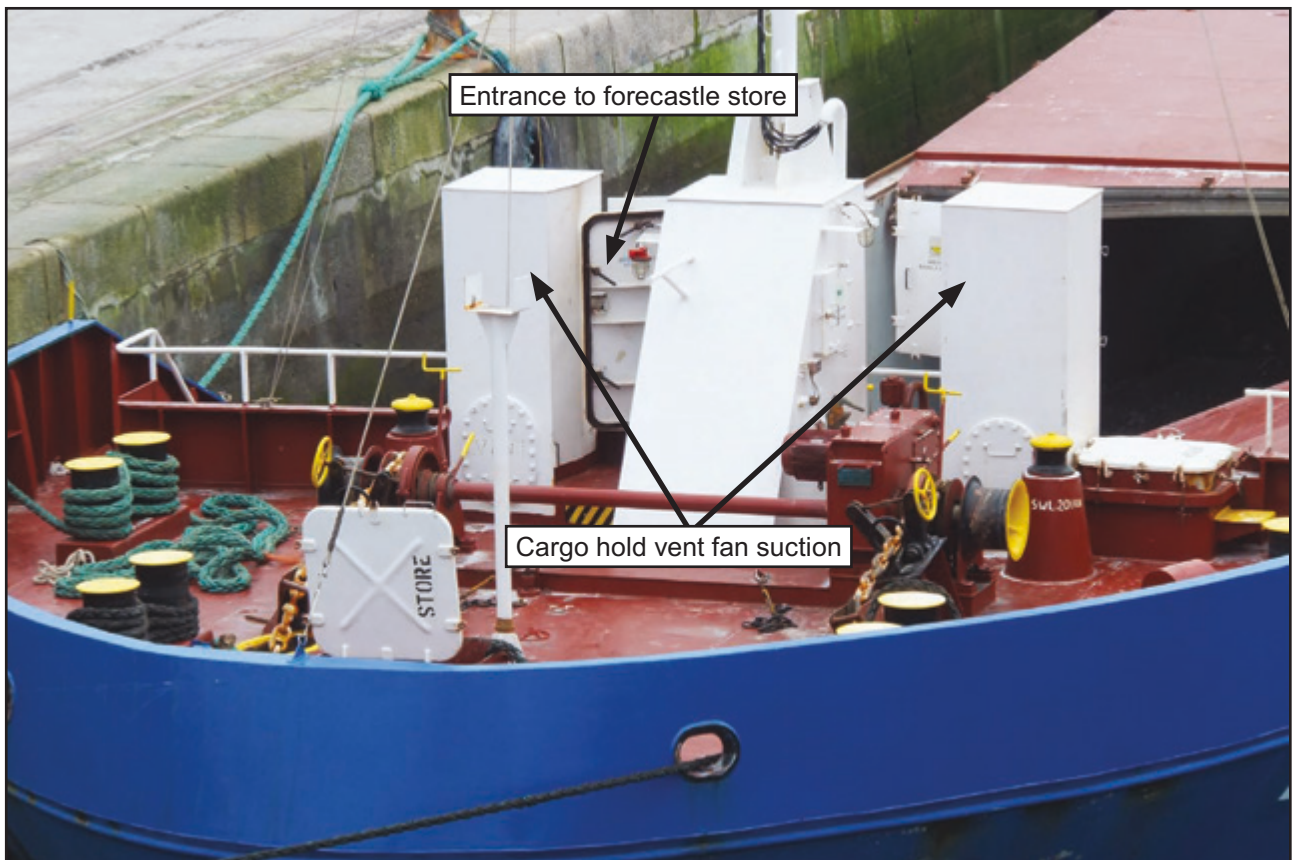
Figure 3: Forecandle deck and entrance to forecandle store

At approximately 1440, the chief engineer went to the forecandle store (**Figure 3**) where the emergency fire pump main starter panel was located. He opened the door to enter the store and used the hook on its outside to secure the door in the open position. He then went down the ladder into the store and started the emergency fire pump. From the sound of its operation he suspected that the pump was running dry and so he returned to the forecandle and opened a fire hydrant, to confirm that no water was being pumped. He then returned to the store and stopped the emergency fire pump using the stop button on the starter panel (**Figure 4**).

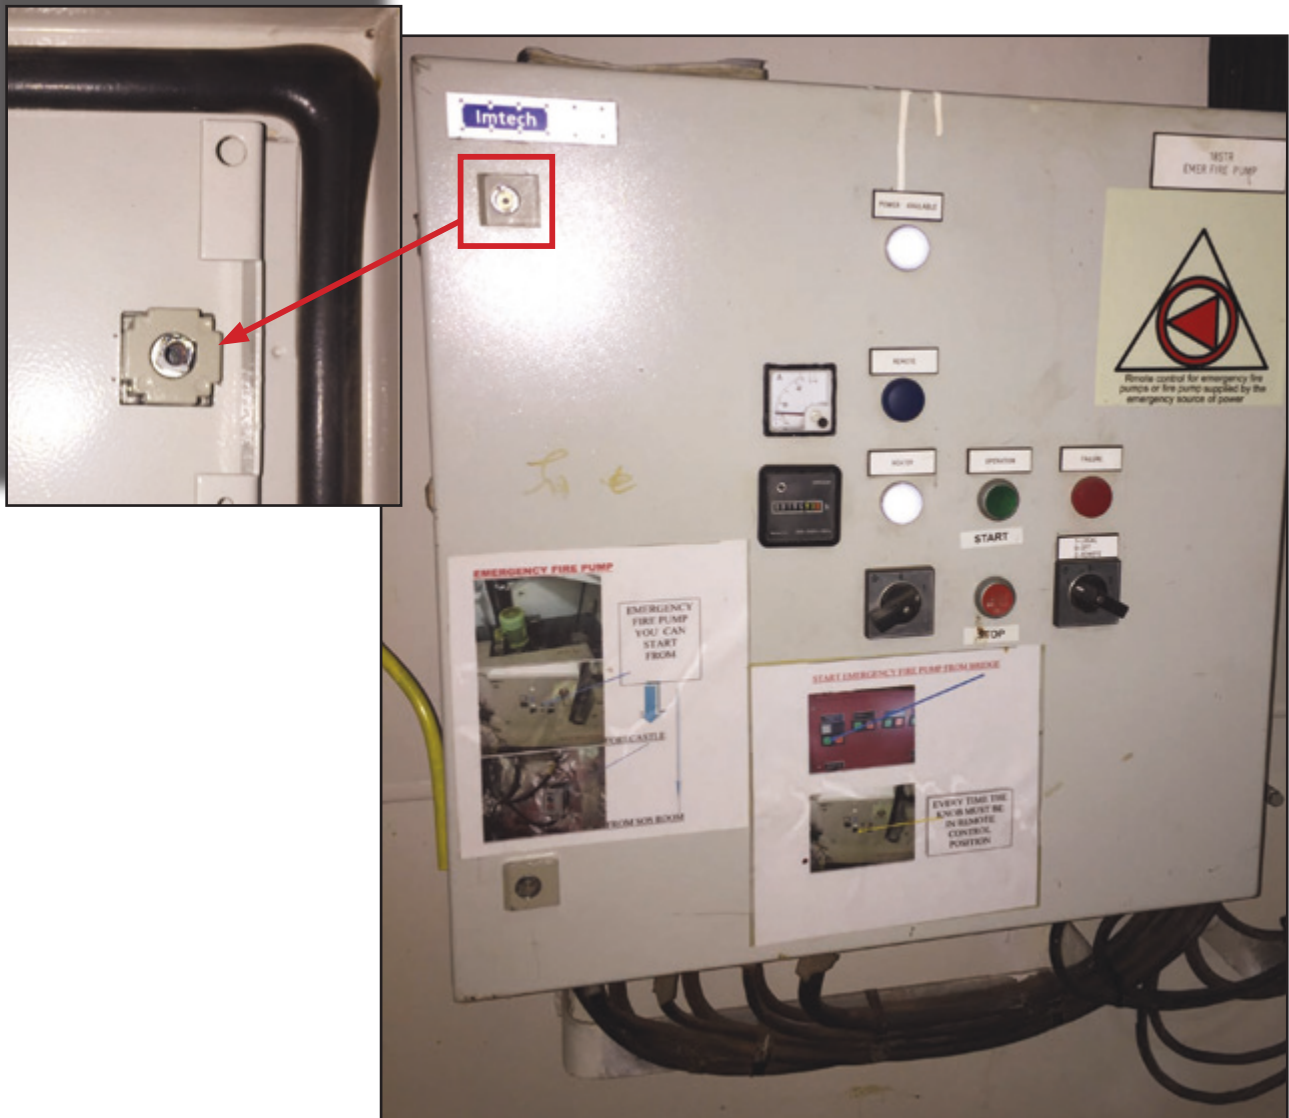
Figure 4: Emergency fire pump starter panel (**inset:** reverse of door, showing broken door lug)

The forecastle store was located in a compartment forward of the hold. It was accessed via a door on the forecastle deck and down a short stairway. The starter panels for various equipment, including the emergency fire pump and cargo hold ventilation fans, were located in the forecastle store. The emergency fire pump and bow thruster were located at the bottom of the compartment and were accessed by a vertical ladder from the store. At the time of the accident, the emergency fire pump starter panel door was not properly closed as one of its two fastening lugs was broken.

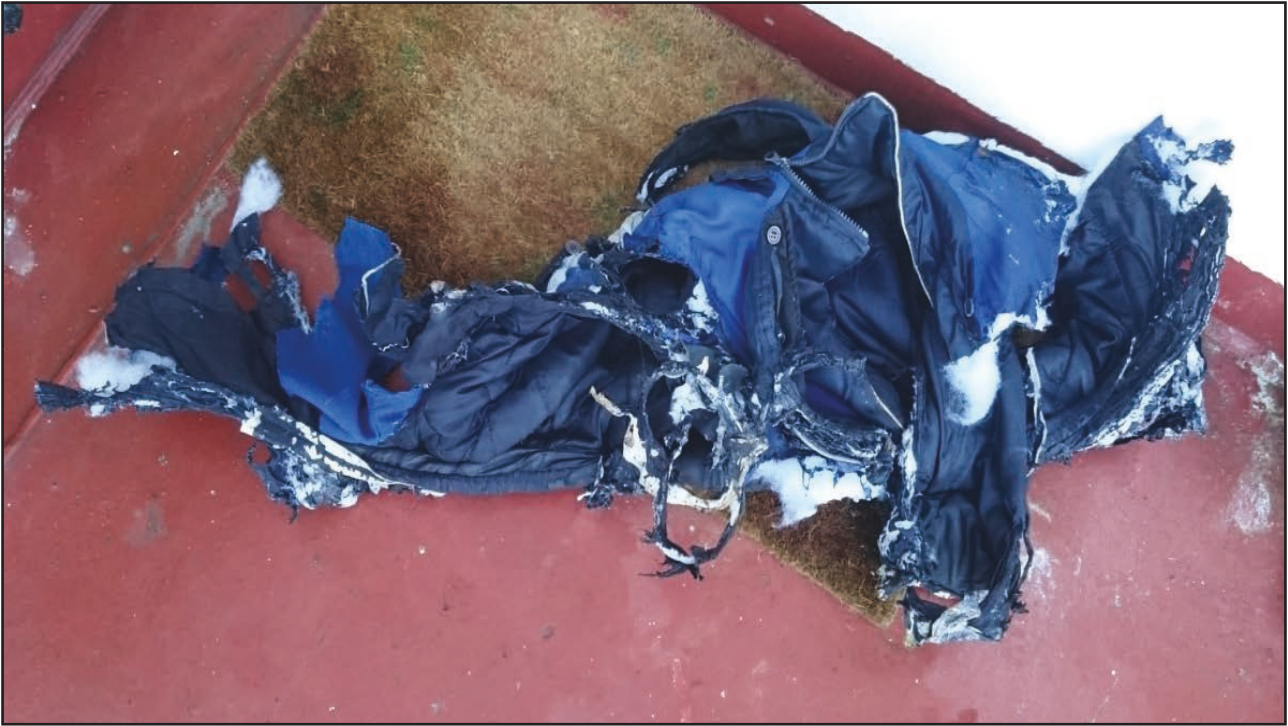
At the time of the accident, the third officer was on watch. On hearing the explosions, the master and the rest of the crew immediately came to the bridge. They saw the chief engineer staggering along the starboard side of the main deck between the cargo holds and shipside protective railing. The bosun met him halfway between the forecabin and the accommodation, and escorted him to the mess room. The synthetic fibre-filled parka¹ coat that the chief engineer had been wearing had melted onto his body and head. He was conscious and complained of being in extreme pain. Once in the mess room, the chief officer cut the chief engineer's coat off him (**Figure 5**) and attempted to make him comfortable.

Figure 5: The chief engineer's burnt parka coat

HHU estimated the flame front temperature to have been 1000°C. However, the passage of the flame front would have been very quick as the accumulated hydrogen burned. The chief engineer appeared to have suffered the full brunt of the first explosion, causing the synthetic fibre-filled coat he was wearing to melt onto his body.

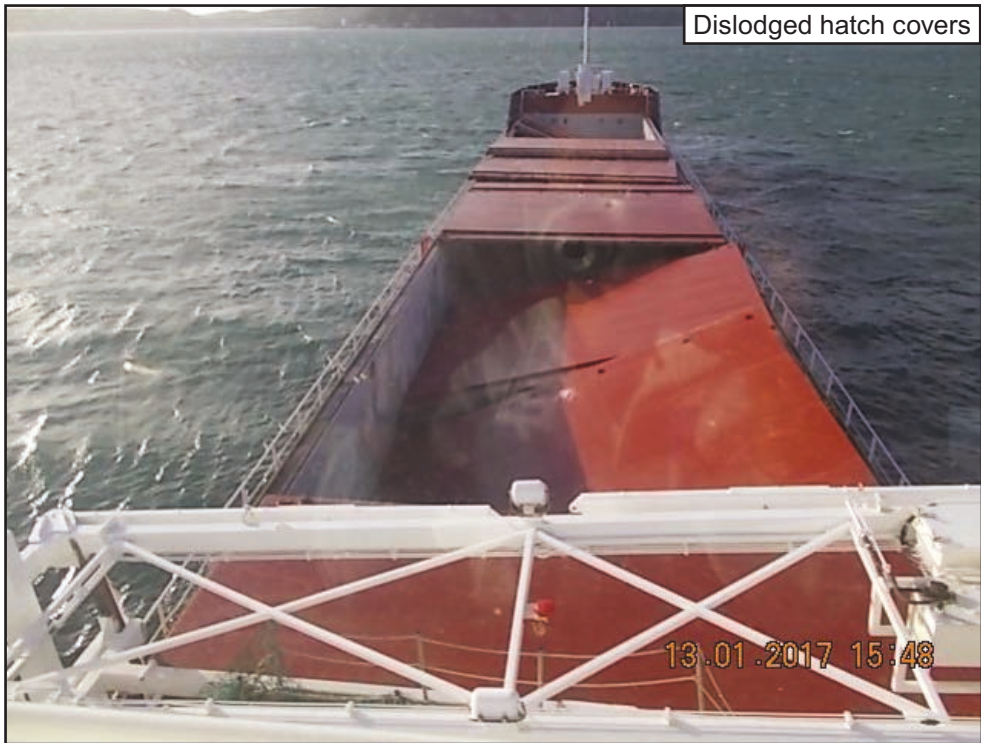
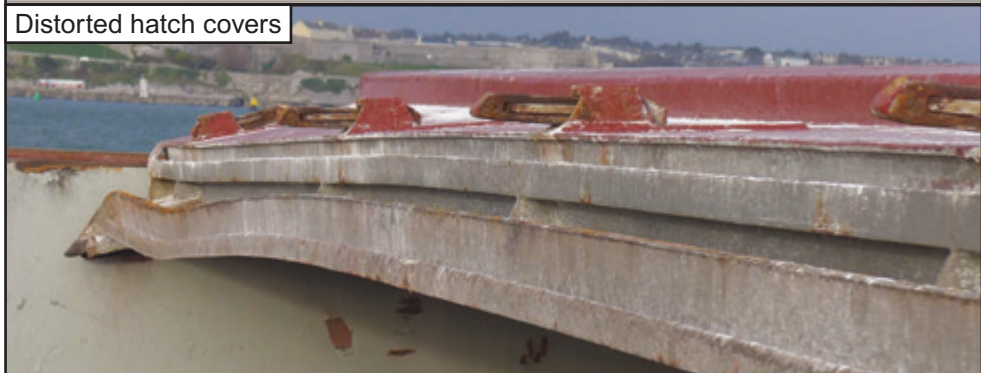
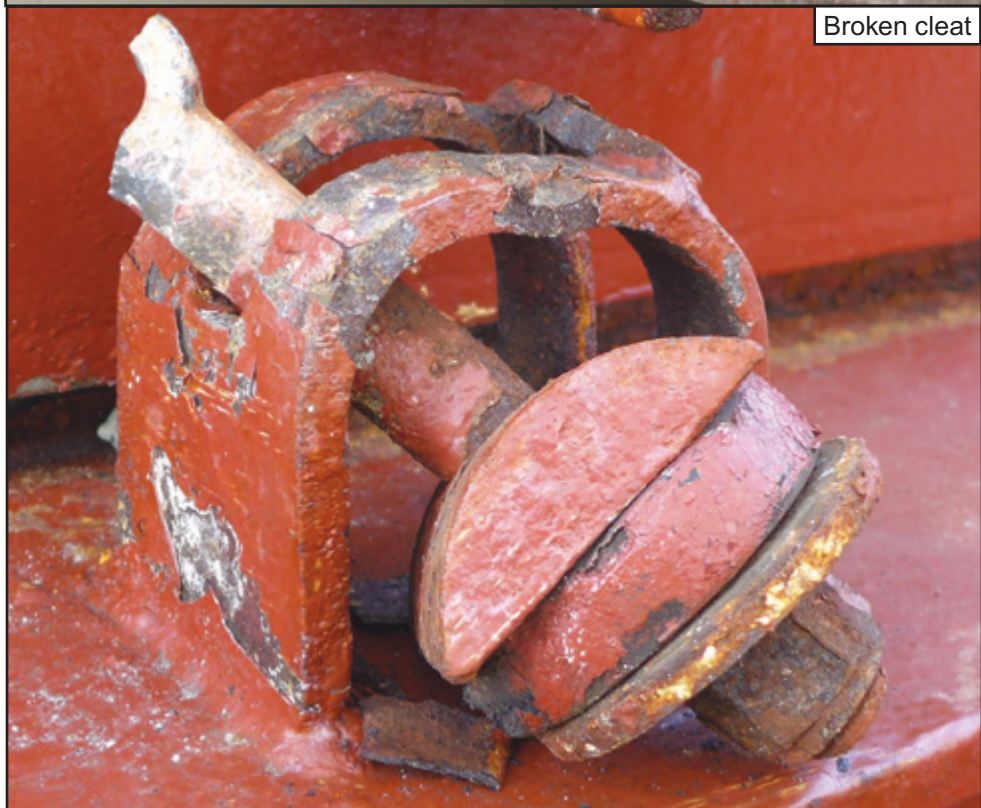
The explosions dislodged and distorted all nine of the vessel's steel hatch covers, breaking all but one of the 66 hatch cleats in the process (**Figure 6**). Some of the hatch covers dropped into the cargo hold and were found resting on top of the cargo. The cargo hold coaming bar was also damaged in several locations and the cargo ventilation trunking tower flaps were deformed.

Figure 6: Damage caused by the explosion

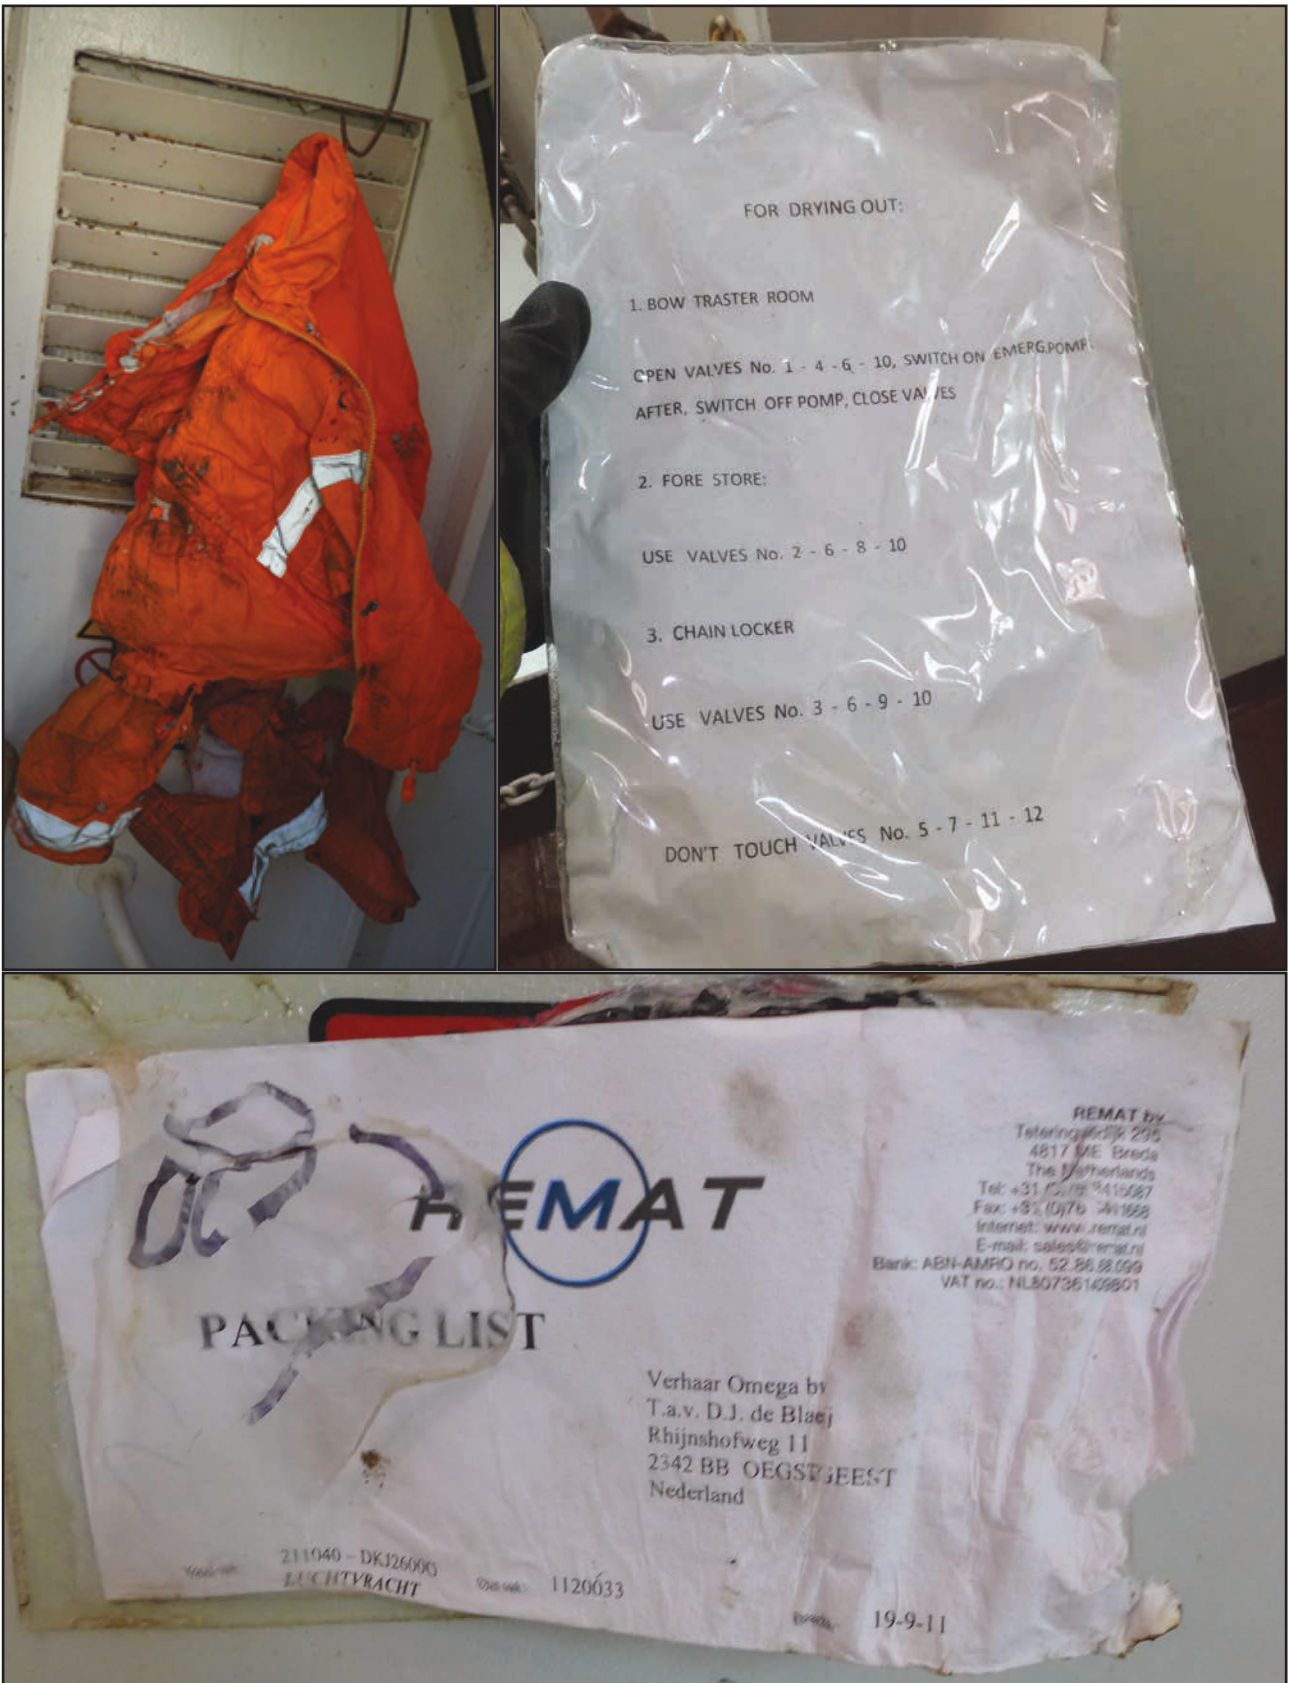
There was no fire damage, although there was evidence of intense heat within the forecastle store. A parka coat, like that worn by the chief engineer, which had been hung at the entrance to the forecastle store, had been severely melted and several laminated sheets and plastic document wallets were heat damaged (**Figure 7**).

Figure 7: Evidence of short-lived heat damage

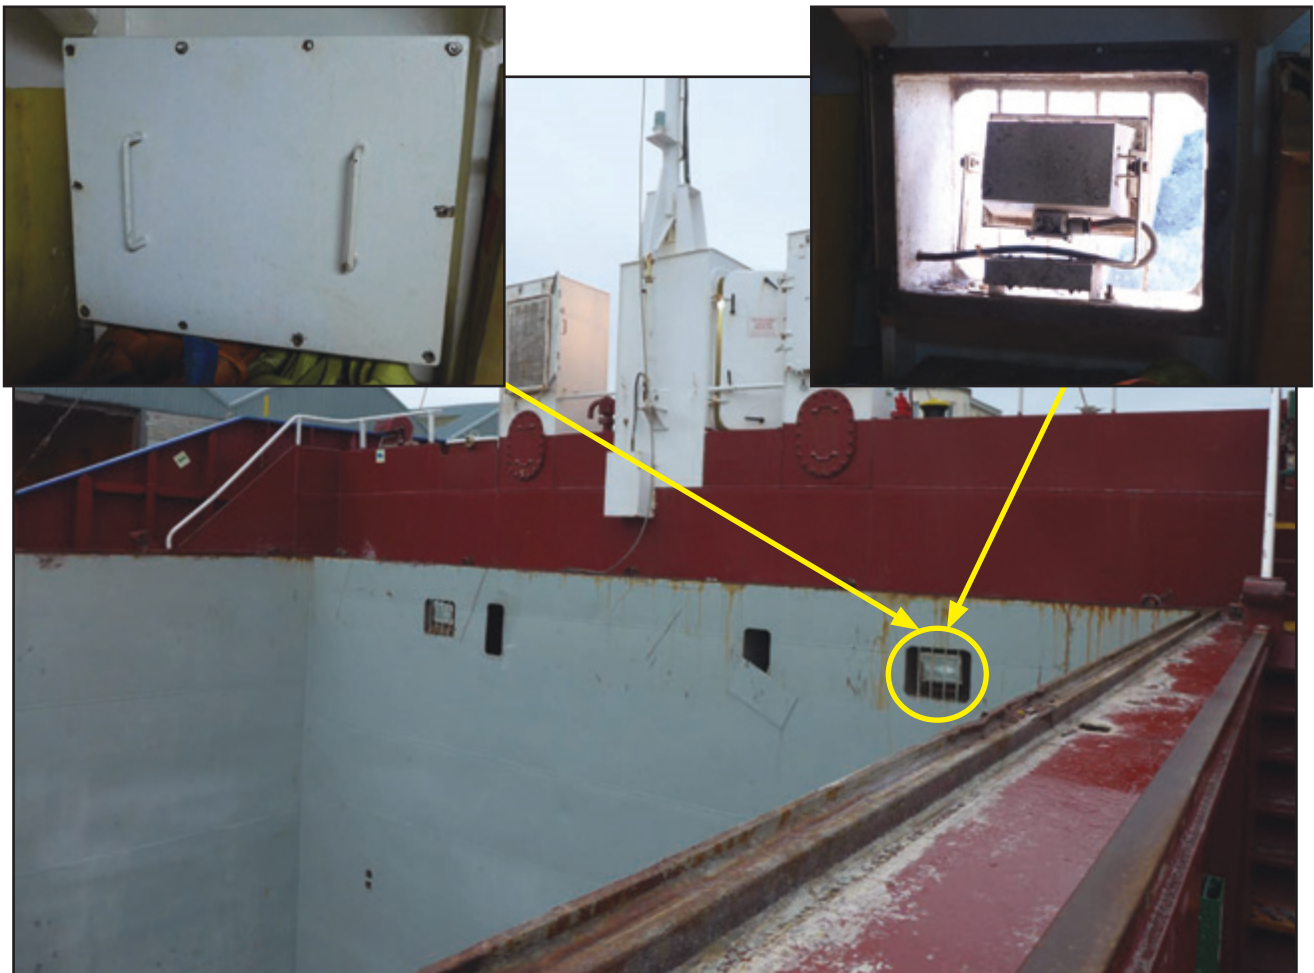
There were two cargo lamps at the forward end of the hold. The access to the starboard lamp was from within the forecandle store. The access plate for this was found loosely fitted using two of ten bolts, and the sealing gasket was missing (**Figure 8**).

Figure 8: Cargo hold lamp access
(insets: views from forecandle store with maintenance hatch closed and removed)

The access plate for the starboard cargo hold lamp fitting had been left loosely secured by two bolts with no gasket. It is likely that the bulb in this fitting was prone to regular failure, due to the vibration generated in the area during the bow thruster operation, resulting in a need for frequent access. However, leaving the access plate slack and unsealed effectively connected the cargo hold with the forecastle store, allowing the atmosphere of both spaces to equalise. Had *Nortrader* been certified to carry dangerous goods, the access to the cargo lamps might have been better designed and more strictly controlled.

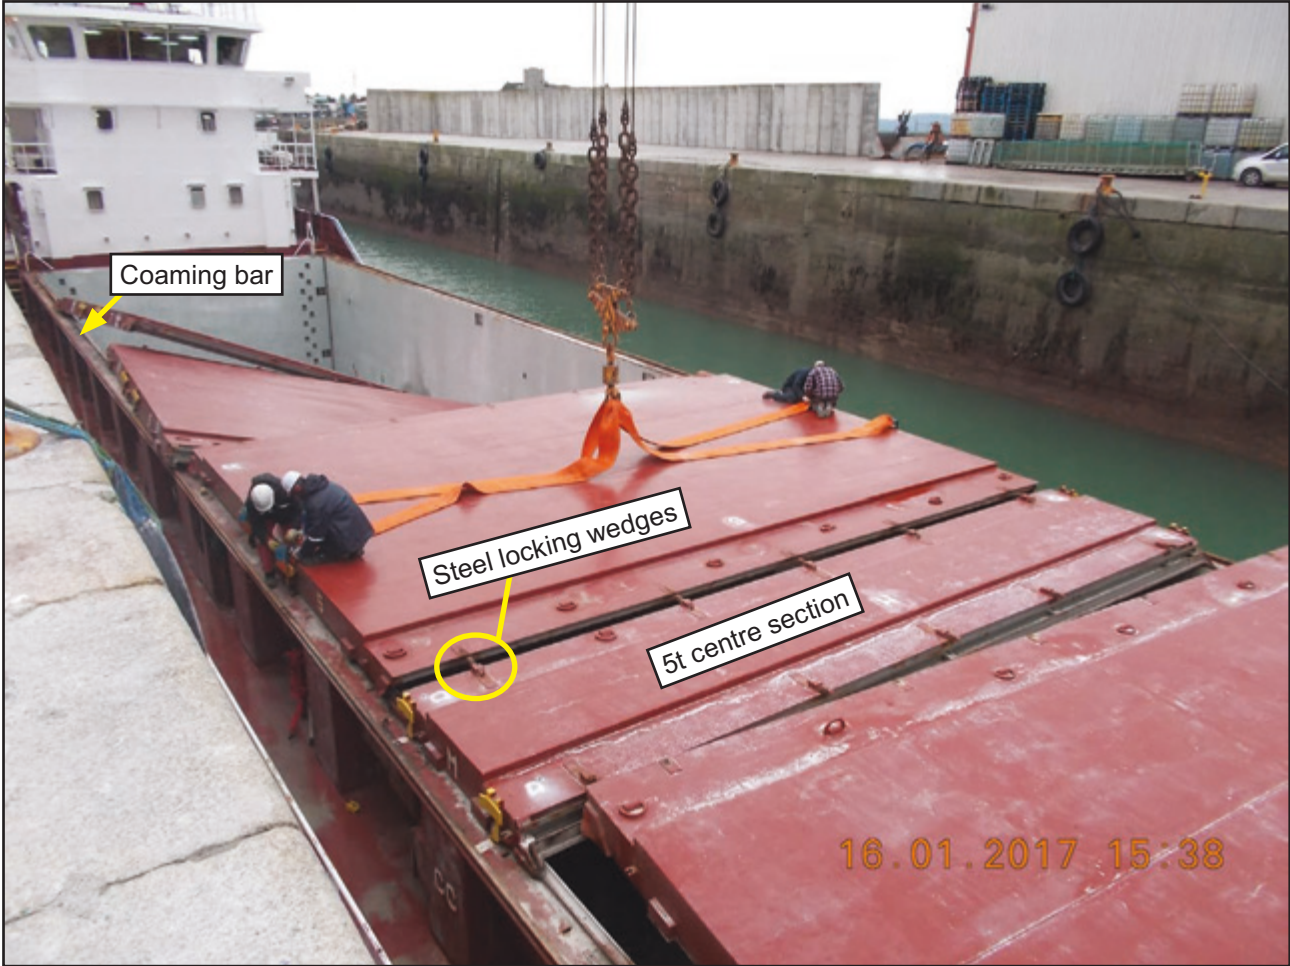
Figure 9b: Hatch covers undergoing temporary repairs

Nortrader's Classification Society, Bureau Veritas, carried out a damage assessment survey, which concluded that the vessel had not sustained any structural damage, and it was granted a dispensation to sail to Rotterdam for repair. Five of the nine hatch covers were replaced along with all of the hatch cleats and the cargo hold coaming bar. The cargo ventilation trunking tower flaps were repaired. The vessel returned to service on 20 April.

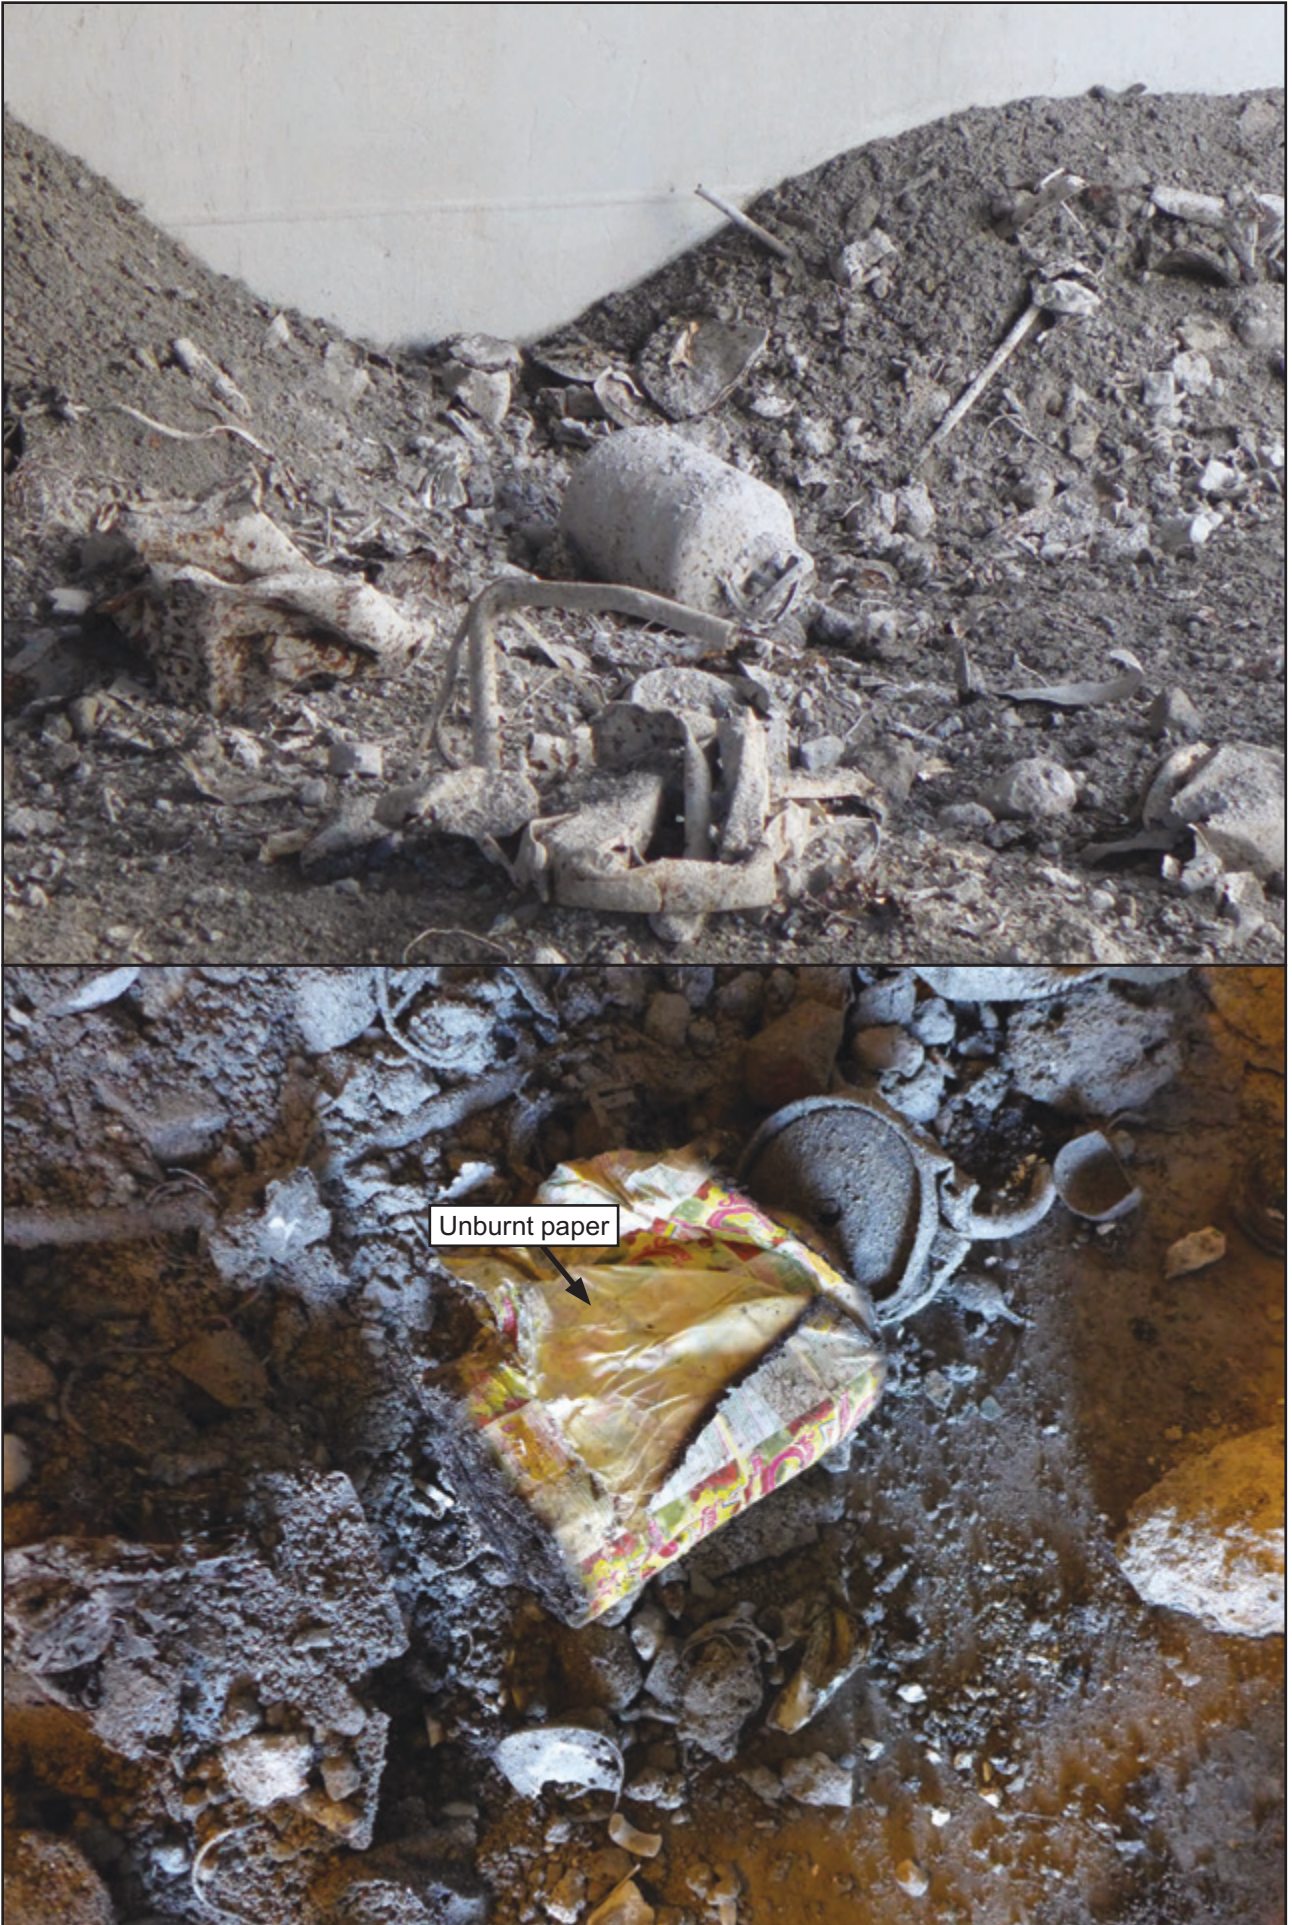
Figure 10: U-IBA from *Nortrader* after the explosion
