## MARINE TRANSPORTATION SAFETY INVESTIGATION REPORT M18A0001

### **BOTTOM CONTACT**

Passenger ferry *Deer Island Princess II*  
Little Letete Passage, New Brunswick  
02 February 2018

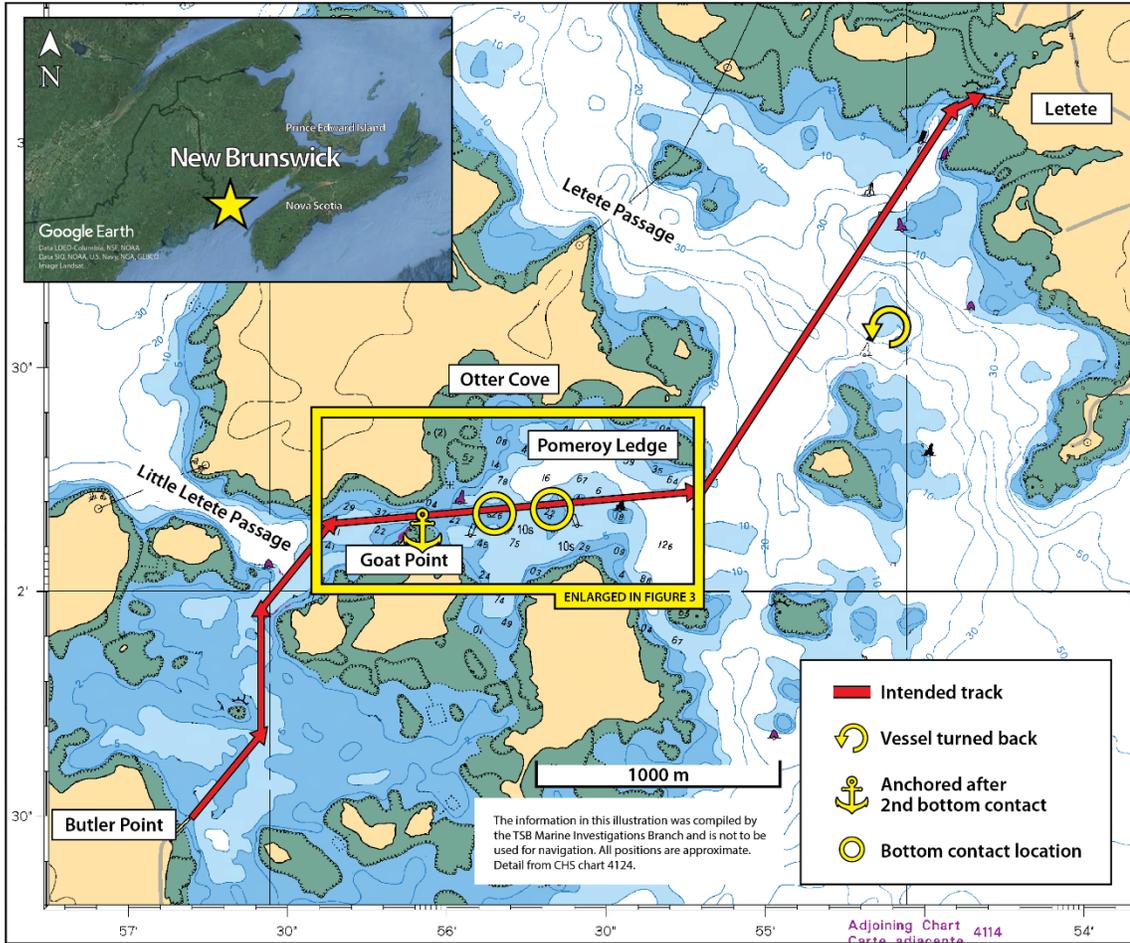
Figure 2. Nautical chart showing the *Deer Island Princess II*'s intended track and the location of the bottom contacts. The inset image shows the general location of the occurrence. The fourth leg of the voyage (outlined) is enlarged in Figure 3 (Source of main image: Canadian Hydrographic Service, Chart 4124: Letete Passage, Letang Harbour and/et Blacks Harbour, with TSB annotations; source of inset image: Google Earth, with TSB annotations)

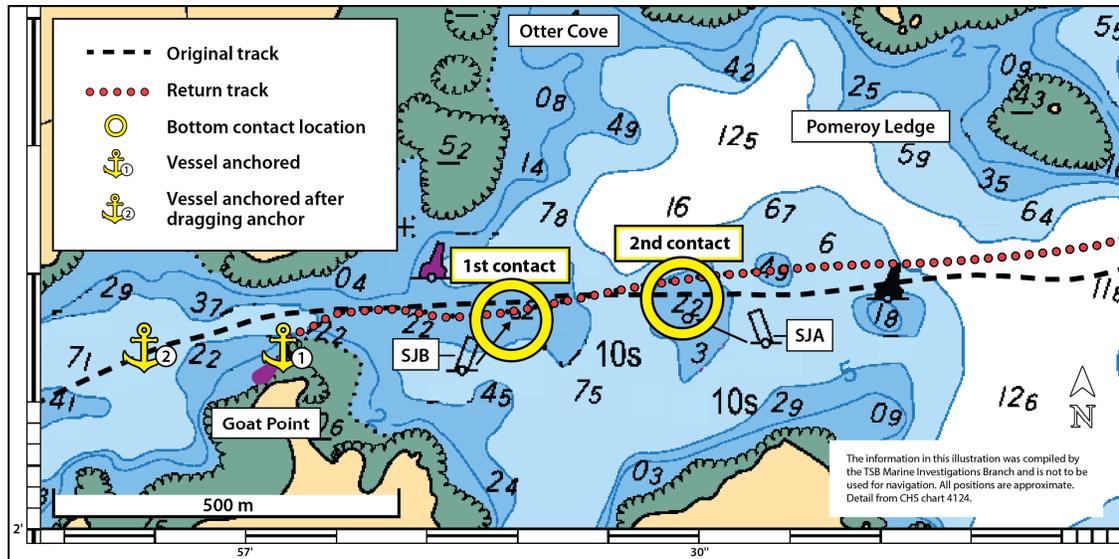
Figure 3. Close-up of the fourth leg of the route depicted in Figure 2, showing the normal location of buoys SJA and SJB; the *Deer Island Princess II*'s actual original track and actual return track; the locations of the bottom contacts; and the location where the vessel was anchored. (Source: Canadian Hydrographic Service, Chart 4124 Letete Passage, Letang Harbour, and/et Blacks Harbour, with TSB annotations)

The shoal where the *Deer Island Princess II* made contact the second time was ordinarily marked by isolated danger buoy SJB. However, the buoy was missing from its charted position<sup>45</sup> and had been for some time, without it being reported to the CCG.

A strong northwesterly wind was blowing out of Passamaquoddy Bay at the time of the occurrence. This likely created a negative surge that further lowered the water level at the occurrence site below predicted levels, allowing the vessel to make contact with the 2.6 m shoal normally marked by missing isolated danger buoy SJB.
