Foundering of leisure boat *Globetrotter* with the loss of one life off Fleetwood, England 31 May 2020

SUMMARY

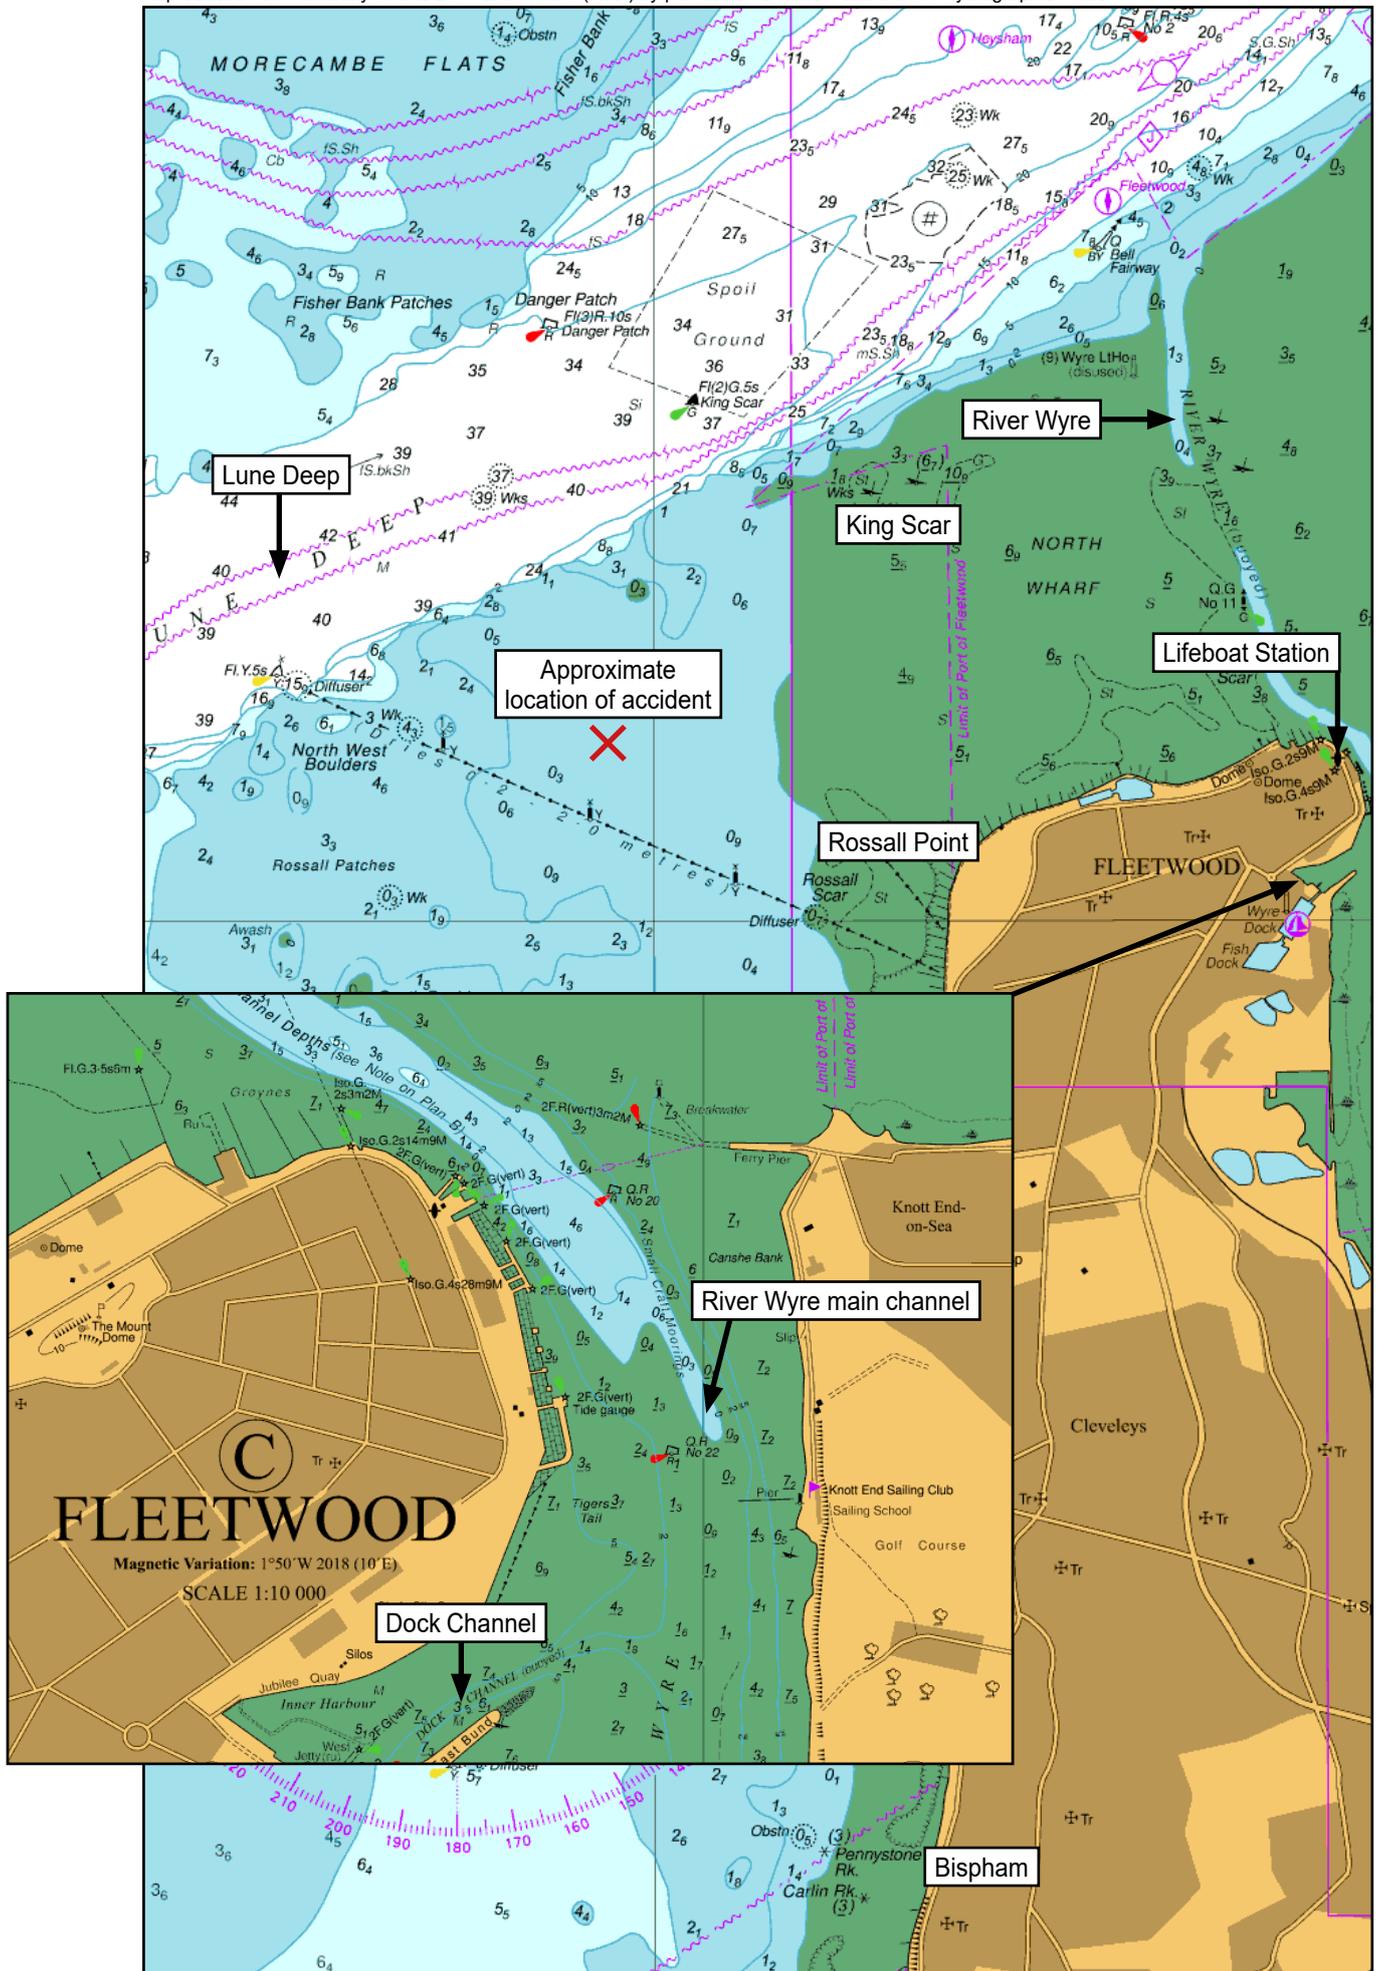
Figure 1: Extract of BA Chart 2010 and inset shows approaches to Fleetwood

As the two pleasure boats motored from Jubilee Quay into the buoyed Dock Channel (**Figure 1 inset**) they were followed by *Pisces*, a commercial fishing boat, which was heading out for a day's fishing. *Globetrotter*'s course alteration through the first set of Dock Channel buoys was executed later than *Fivebuoys* (**Figures 2a and 2b**), and *Globetrotter* stopped briefly, then sheered to port before continuing its passage towards the River Wyre main channel (**Figure 1 inset**). Those on board *Fivebuoys* saw *Globetrotter*'s sheer and it was captured on Fleetwood Harbour Authority's CCTV system¹ (**Figures 2a and 2b**).

Fivebuoys was the faster of the two pleasure boats, and by the time *Globetrotter* had reached the main channel (**Figure 1 inset**), *Fivebuoys* was almost out of sight of *Globetrotter*'s owner. At 0724, *Globetrotter*'s owner contacted *Fivebuoys*' skipper by mobile telephone and told him that he was having problems with the boat's steering. After discussing the issue, *Globetrotter*'s owner decided to continue with the trip.

At 0752, Holyhead Coastguard transmitted a ‘Mayday Relay’, which included *Globetrotter*’s last reported position off Fleetwood lifeboat station. Many boats in the vicinity responded, including *Pisces*, which was in sight of *Globetrotter*. *Pisces* immediately made its way towards the sinking boat. At 0757, the RNLI inshore lifeboat crew reported that nothing could be seen off the lifeboat station, but that there appeared to be a boat in trouble near Rossall Point (**Figure 1**).

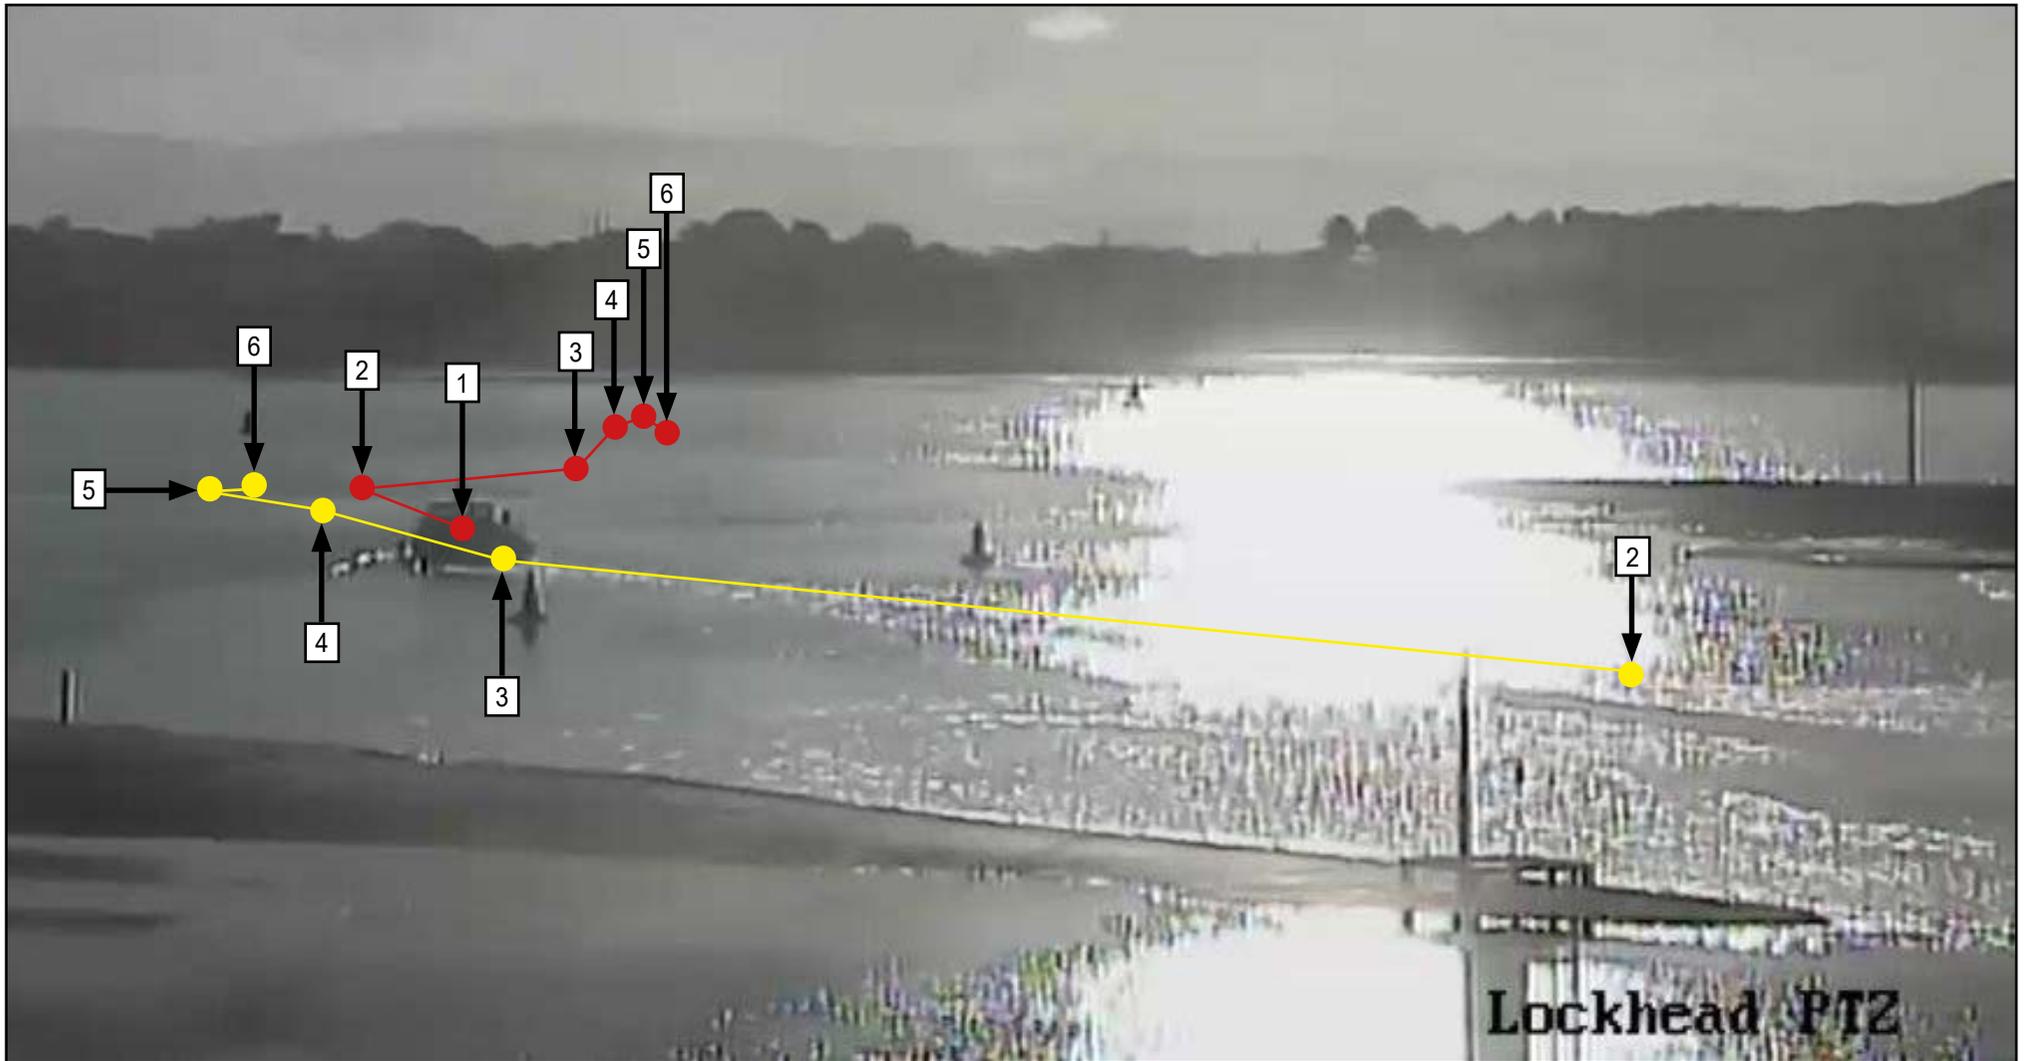
Figure 2b: Reconstruction of *Globetrotter's* and *Fivebuoys'* tracks through the Dock Channel

The investigation was unable to establish the exact cause of the water ingress that led to the foundering of *Globetrotter* and the subsequent loss of one life. However, it is likely that the brief grounding observed during the departure from Jubilee Quay led to a catastrophic failure of the boat's hull. This is further supported by the steering problems encountered immediately after the grounding. It is also possible that the wave action resulting in slamming of the boat's hull exacerbated the damage and increased the rate of water ingress.

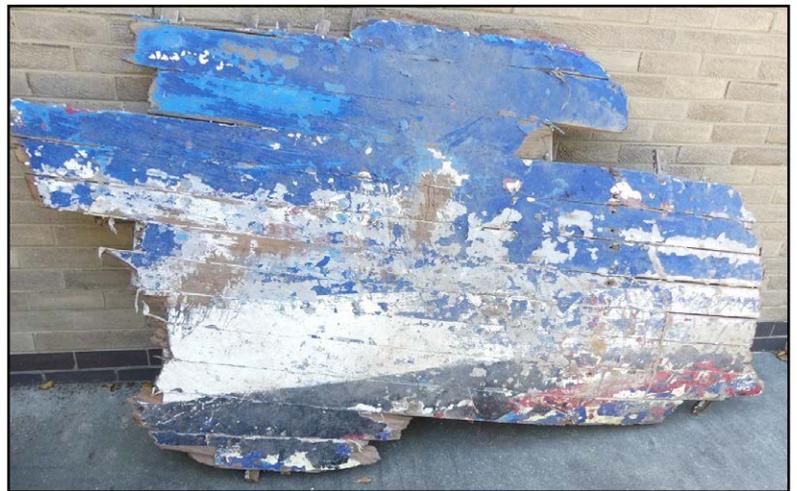
Figure 3: Recovered wreckage section

Following the accident, a member of the public retrieved a section of *Globetrotter's* wreckage (**Figure 3**) from the shoreline at Rossall Point. The section, which measured approximately 1320mm x 2300mm, was sent to an expert in wooden boatbuilding for examination. The conclusions reached by the expert were that:

- The boat was of traditional build used for centuries, but the use of Iroko planking dated the construction after the 1940s.
- The wreckage section was from the port side of the boat and would have been above the waterline.
- Some of the planking in the wreckage section was in poor condition.
- It was likely that the hull sections under the waterline were in a similar, if not worse, condition.

Globetrotter quickly broke up after foundering, with its wheelhouse floating free while the search for the casualty was still ongoing. This, and the findings of an expert in wooden boatbuilding, strongly suggested that *Globetrotter's* material state was poor, and that the maintenance completed by the various owners did little to enhance the boat's hull integrity.

Globetrotter was not in a seaworthy condition, its hull was not watertight, and the condition of its planks and their fastenings was unknown. Old wooden hulled boats will be susceptible to plank failures and leakage through joints and fastenings if they are not regularly and properly maintained. Hull plank and fastening damage can sometimes be difficult to identify and therefore the importance of regular out of water inspections and surveys cannot be emphasised enough.
