# SAFER SEAS Digest 2020

Lessons Learned from  
Marine Accident Investigations

NTSB/SPC-21-01

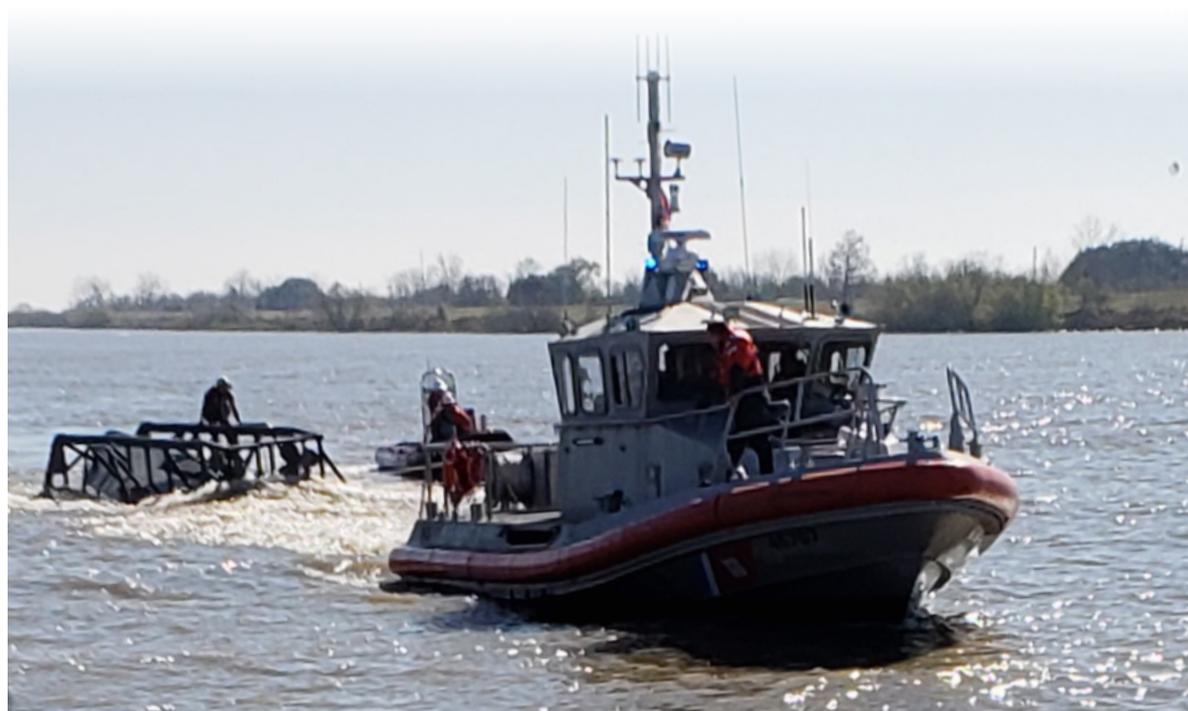
Figure 3. CG 45707 tows the overturned *MSRC 8-1*. SOURCE: BSEE.

The probable cause of the capsizing of the workboat *MSRC 8-1* was the boat becoming perpendicular to a strong river current, for an undetermined reason, while tethered to the oil spill response vessel *Louisiana Responder*. Contributing to the accident was the unforeseen risk associated with conducting the exercise in a strong current, which also contributed to the severity of the outcome by hampering rescue efforts.

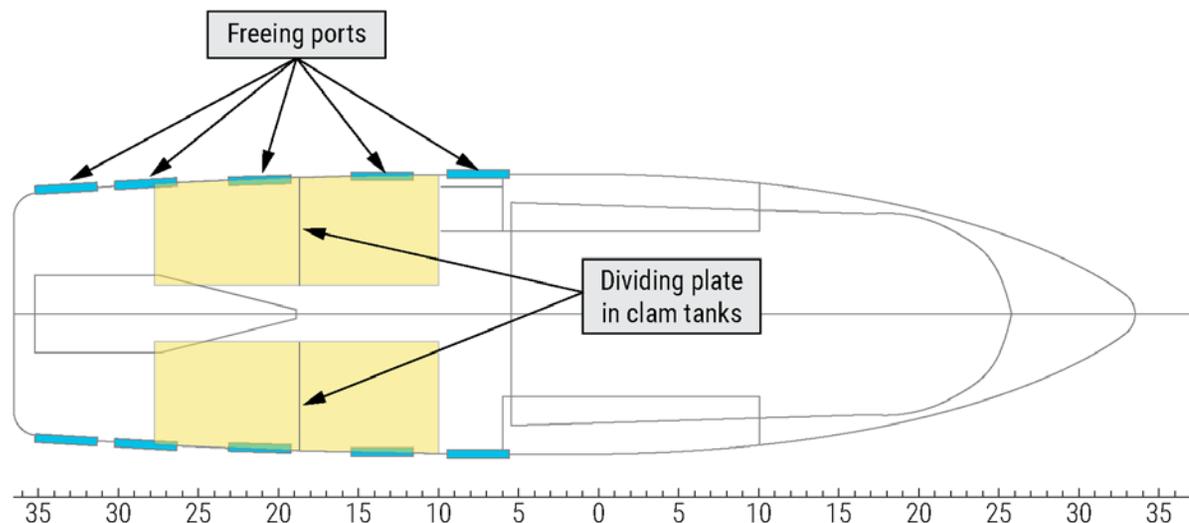
The probable cause of the capsizing and sinking of fishing vessel *Misty Blue* was flooding of the port clam tank from an undetermined point of ingress, which led to a decreased freeboard and a list allowing boarding seas to be trapped on deck, thereby decreasing the vessel's stability. Contributing to the sinking was the relatively small freeing port area of the vessel, which likely increased water accumulation on deck.

**Figure 9.** Plan view of *Misty Blue*'s tank layout and freeing port locations. The clam tanks are highlighted in yellow.

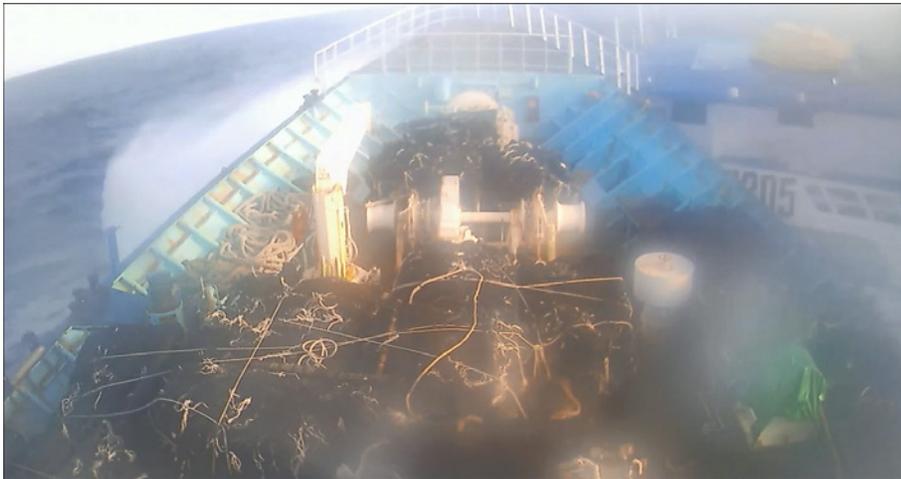
**Figure 11.** Damage sustained to both vessels. Bow of *American Eagle* (left) and *Koorale* (right). SOURCE: AMERICAN EAGLE FISHING, LLC.

The probable cause of the collision between the fishing vessels *American Eagle* and *Koorale* was both vessels' captains and fishmasters not following international collision regulations or communicating to make arrangements while pursuing the same school of fish.

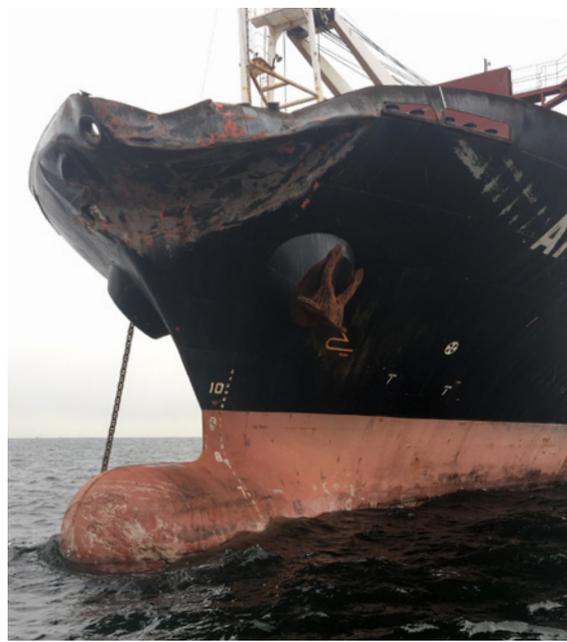
Figure 15. Damage to *APL Guam*. SOURCE: COAST GUARD.

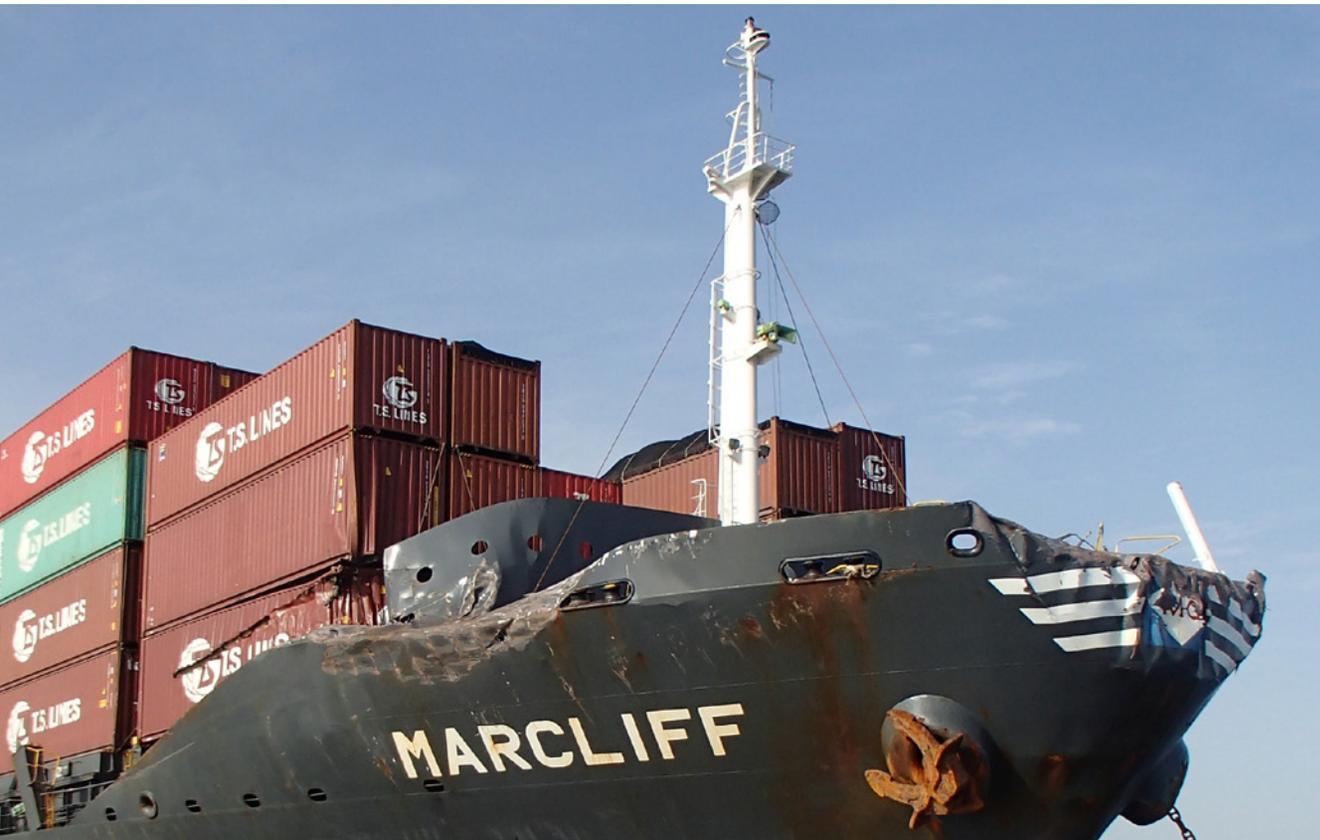
Figure 16. Below: Damage to *Marcliff* bow, starboard side, and container. SOURCE: COAST GUARD.

The probable cause of the collision between the containerships *Marcliff* and *APL Guam* was the *Marcliff* master's attempt to pass between the *APL Guam* and the anchored *Hansa Steinburg* with insufficient safe maneuvering room. Contributing to the accident was a lack of communication between the *Marcliff* bridge team and the *APL Guam* pilot and bridge team to establish their maneuvering intentions.

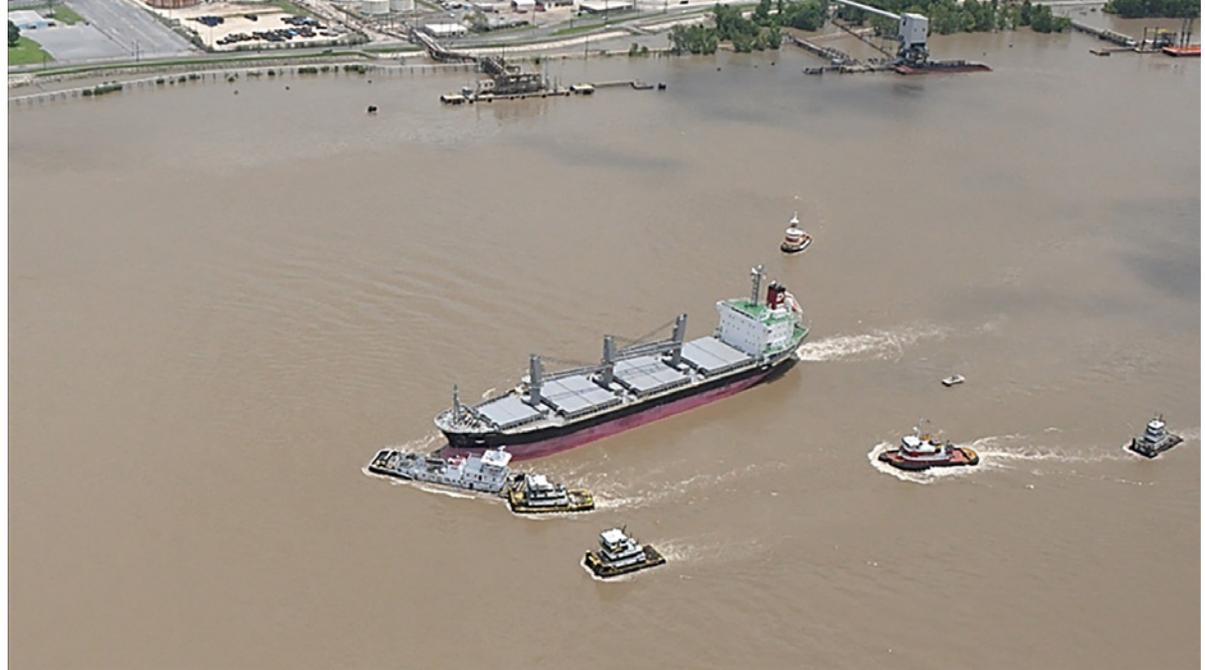
Figure 21. Both vessels shortly after the collision. SOURCE: COAST GUARD.

At 1215:08, the *Century Queen*'s bulbous bow struck the *Kaytlin Marie* amidships at about a 90-degree angle, and the towboat was pushed sideways up-current. The bulker's bow was torn open for about 6 feet, and the void space was filled with some of the diesel fuel released from the towboat's punctured fuel tanks. The *Kaytlin Marie*'s pilot was pinned by furniture that had come loose, and refrigerators in the galley that broke free pinned two deckhands, one of whom suffered internal injuries; the other had a minor injury.

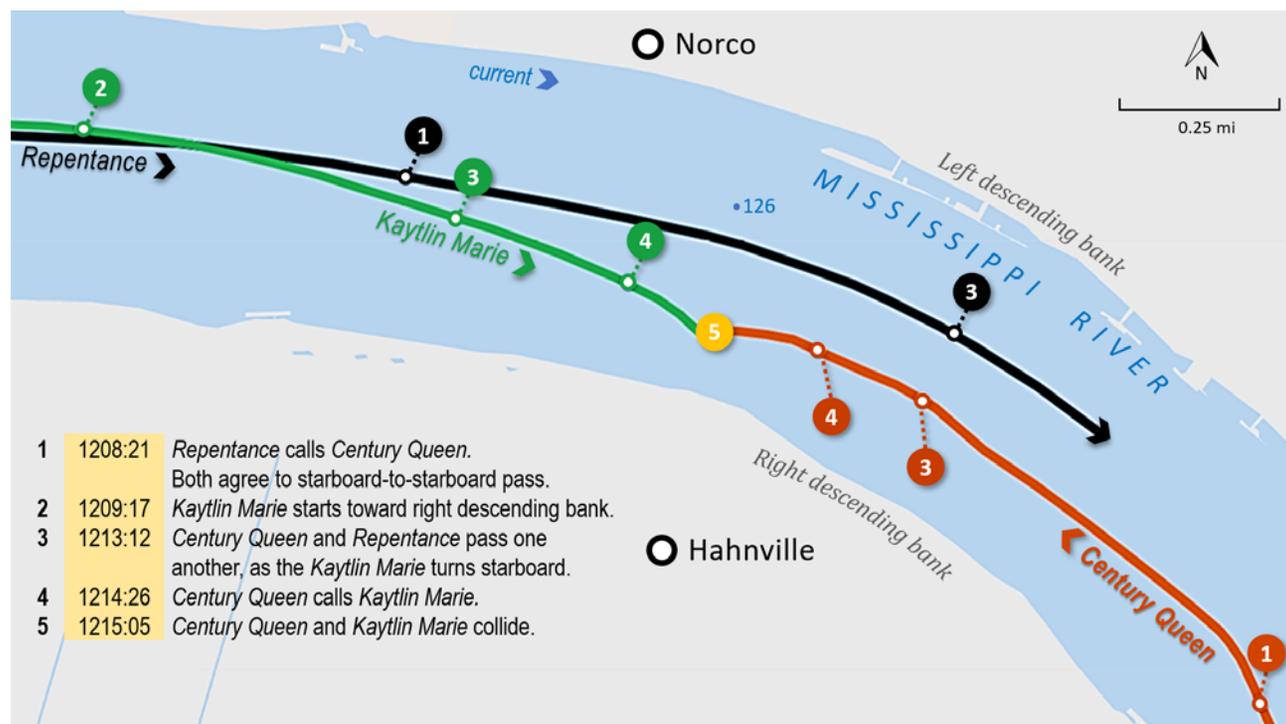
The probable cause of the collision between the bulk carrier *Century Queen* and the towing vessel *Kaytlin Marie* was the lack of early and effective communications to confirm a passing arrangement between the two vessels.

**Figure 23.** Tracklines of the vessels during the last 7 minutes prior to the collision. The *Century Queen* is represented in red, the *Kaytlin Marie* in green, and the *Repentance* in black. BACKGROUND SOURCE: GOOGLE MAPS.

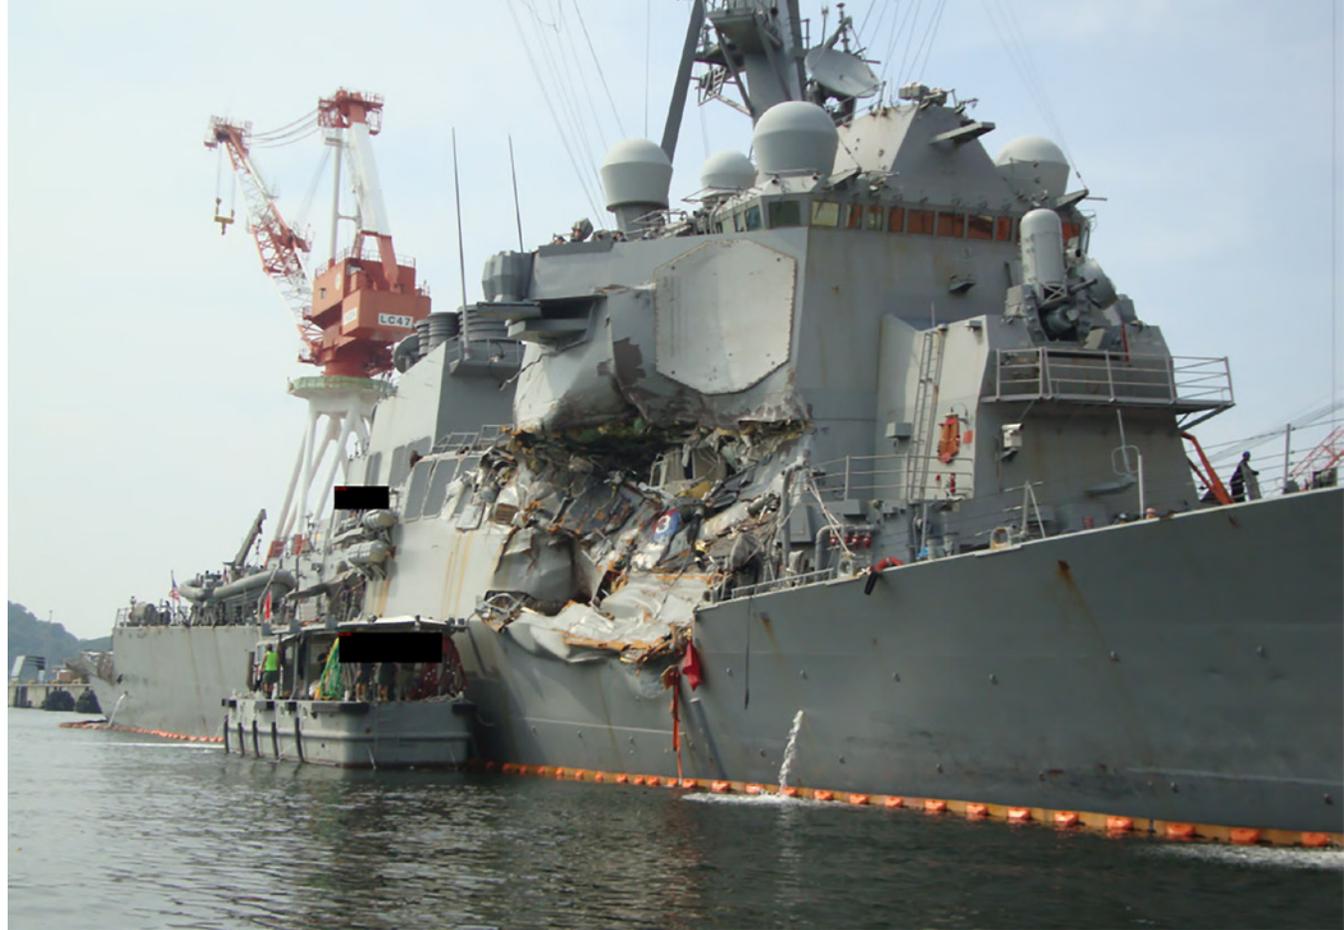
Figure 29. Post-collision damage to the *Fitzgerald*'s starboard side. SOURCE: US NAVY.

The *ACX Crystal's* bow penetrated the *Fitzgerald's* hull and superstructure, trapping numerous crewmembers aboard the destroyer, and the vessel took on a 7-degree starboard list. Seven crewmembers, trapped in their berthing compartment, perished. The destroyer sustained damage in excess of \$300 million. No one was injured on board the *ACX Crystal*, but the container ship sustained damage to its bow and forward compartments. The cost to repair the *ACX Crystal* was not reported to investigators.

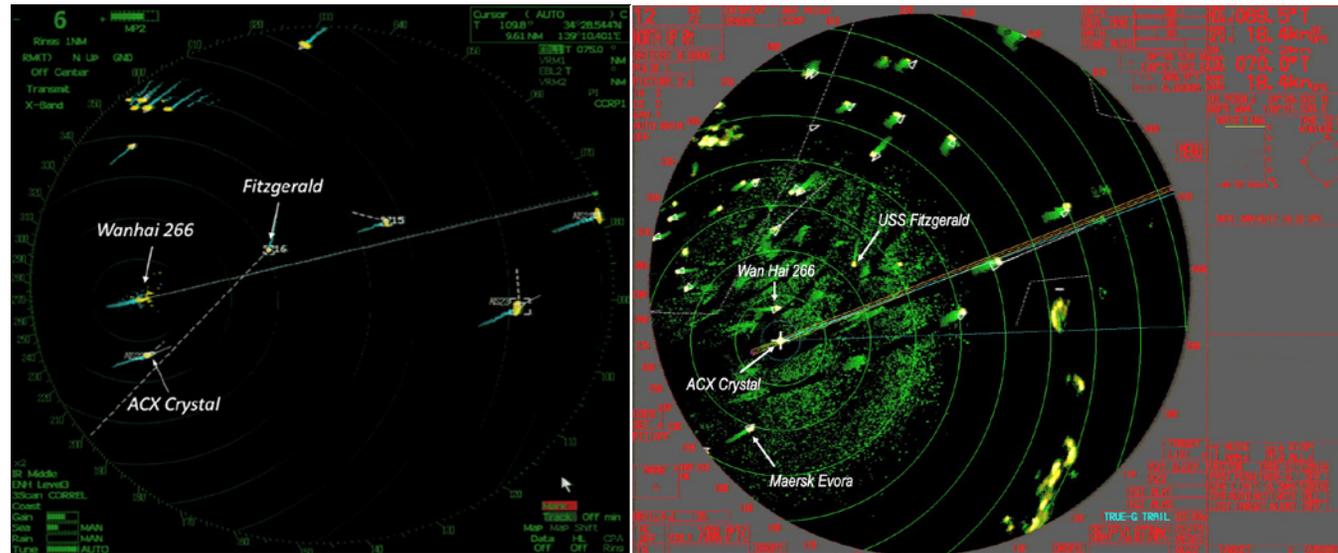
**Figure 32.** A comparison of radar screens from different vessels before the collision. **Left:** Screen capture from the *Wan Hai 266* electronic navigation software, about 6 minutes before the collision. **Right:** Screen capture from the *ACX Crystal* electronic navigation software (radar and ARPA), at the same time. (Vessel names have been added to screen images.)

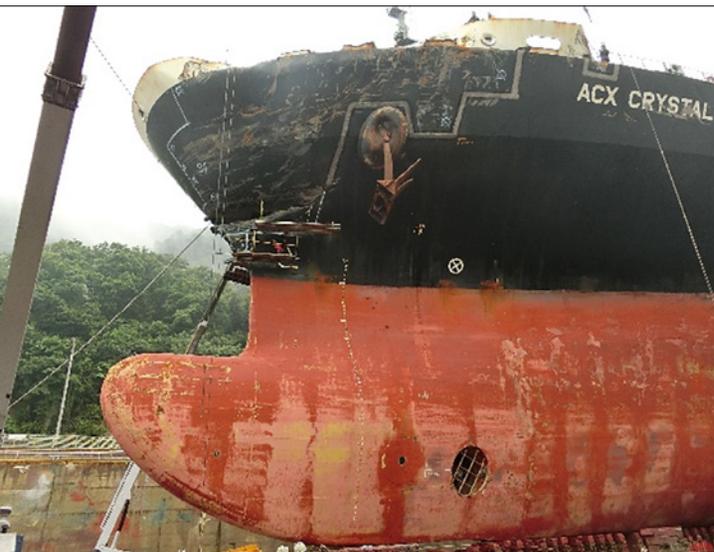
**Figure 33.** Postaccident damage to the *ACX Crystal*'s bow.  
SOURCE: JAPAN TRANSPORT SAFETY BOARD.

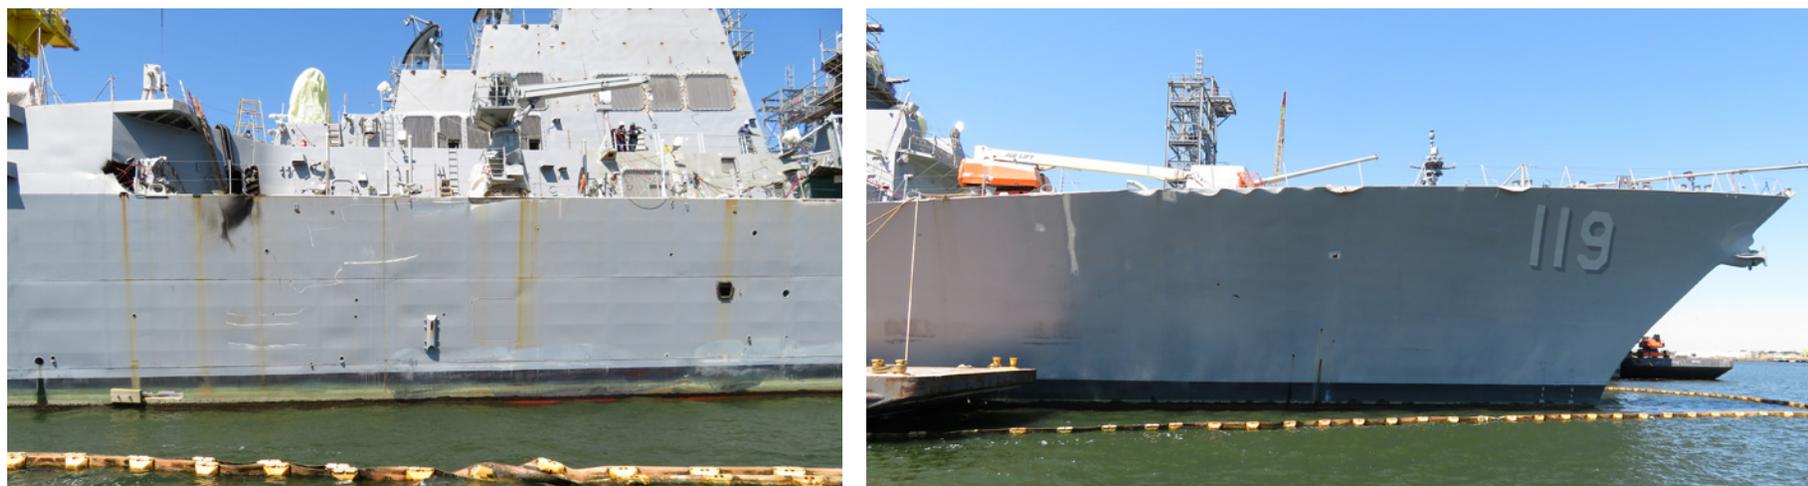
The probable cause of the collision of the heavy lift vessel *Hawk* with a docked barge and the destroyer *Delbert D Black* was the speed at which the conning pilot was operating the *Hawk* while attempting to turn and anchor in a shipyard basin.

**Figure 36. Below:** Damage to the *Delbert D Black*'s starboard hull (left) and bow (right).

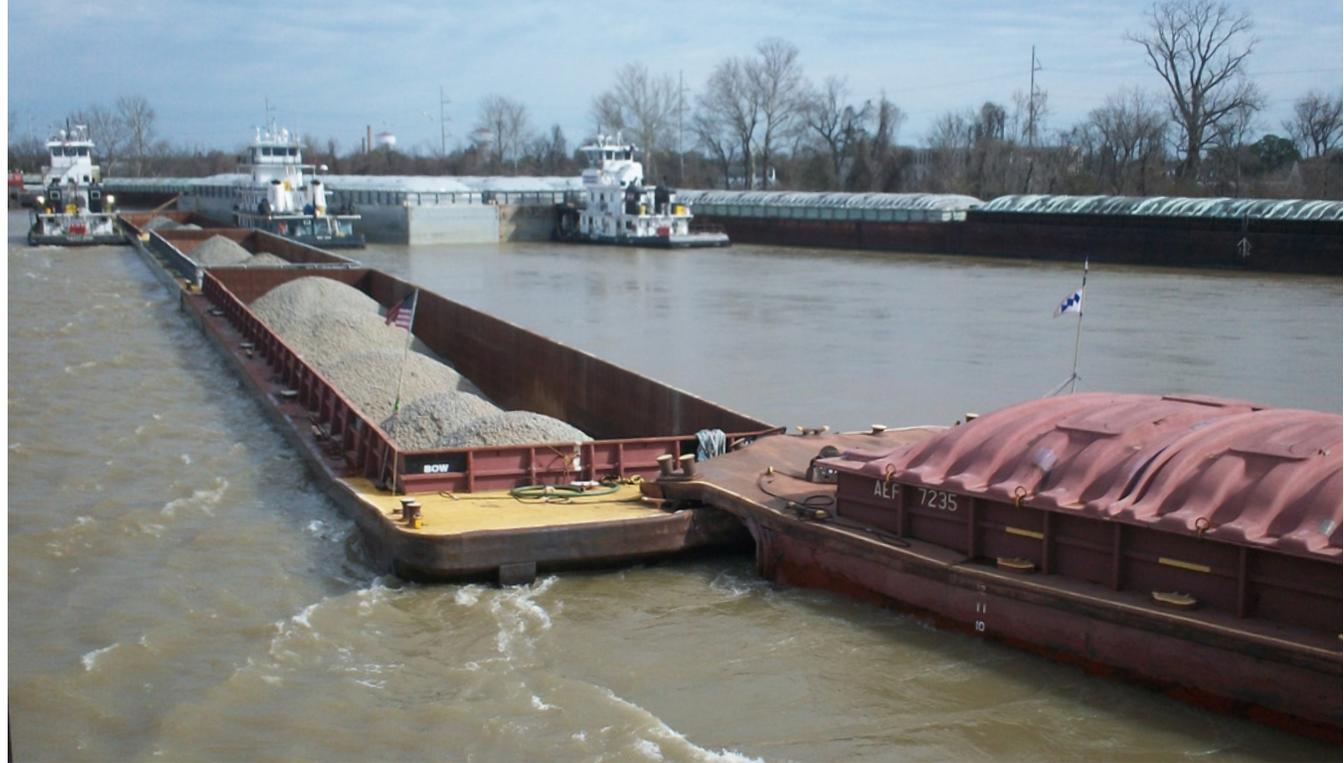
**Figure 38.** The AEP 7235 lying across the 005492 after the collision.

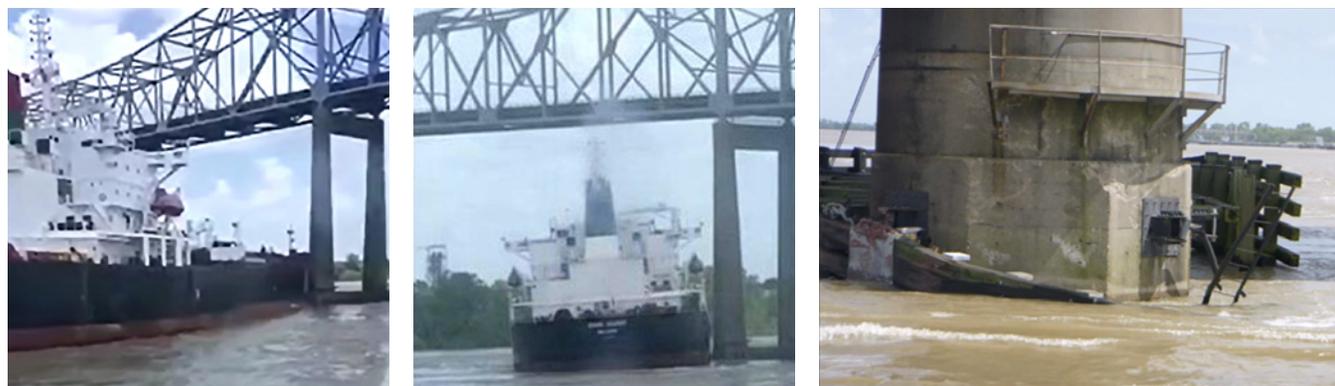
Figure 65. Left and middle: Two photos showing the *Dank Silver* striking the Sunshine Bridge. SOURCE: CRESCENT TOWING. Right: Damage to the fendering system for the western pier of the Sunshine Bridge, from the north. SOURCE: LOUISIANA DEPARTMENT OF TRANSPORTATION AND DEVELOPMENT.

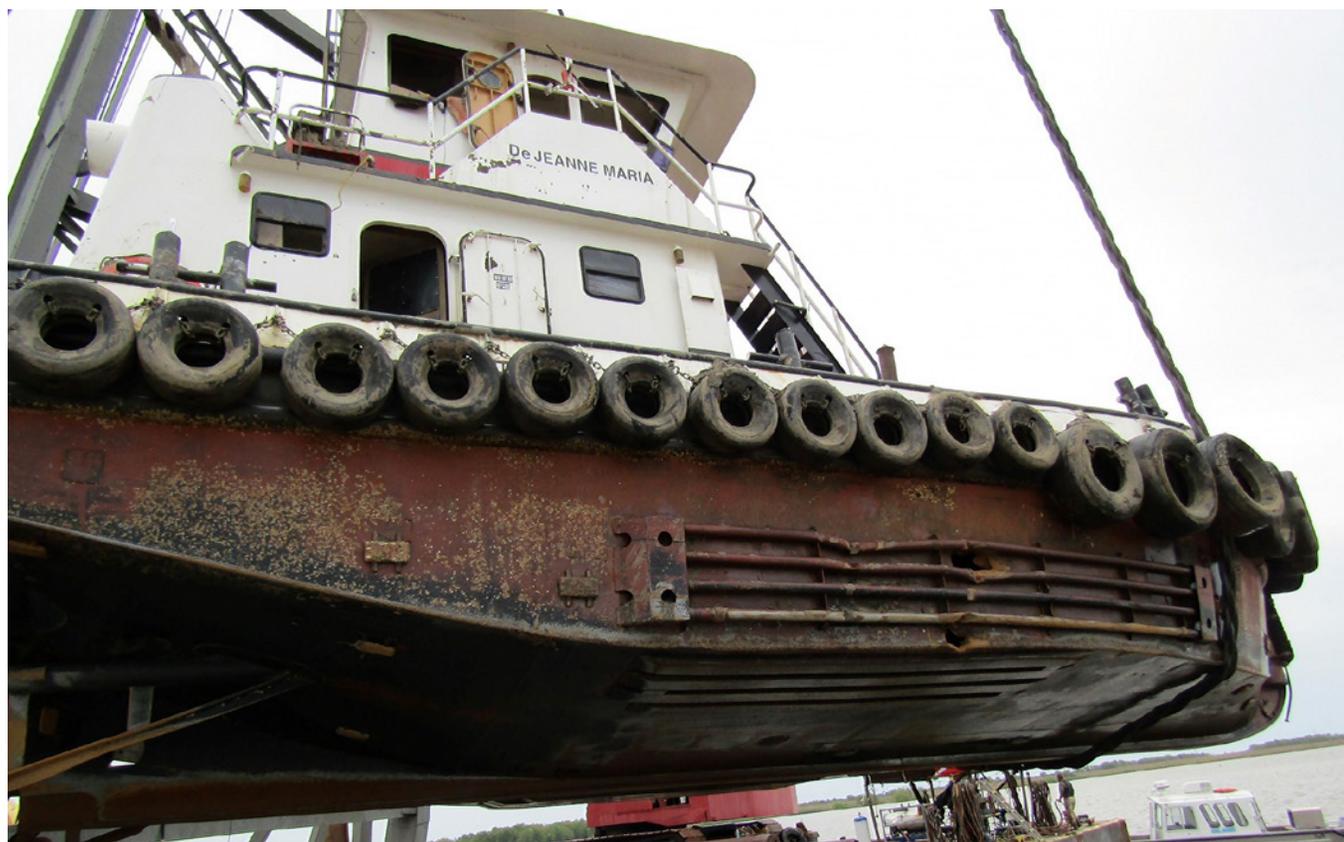
**Figure 67.** *DeJeanne Maria* during recovery. Punctures to the vessel's hull are visible. SOURCE: CENTRAL MARITIME, L.L.C.

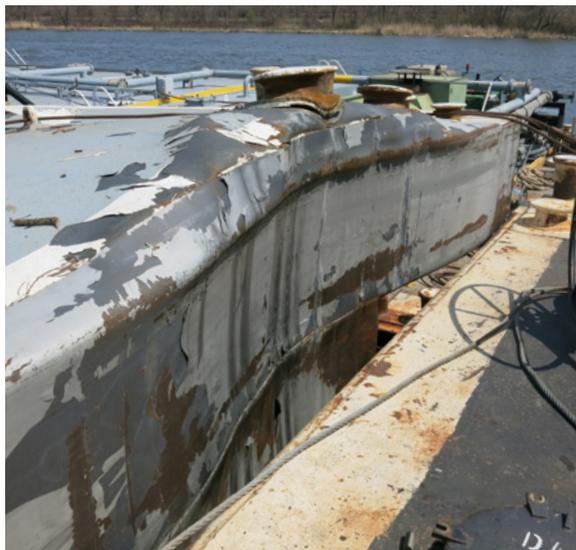
**Figure 72.** Damage to tank barge ATC 3404.

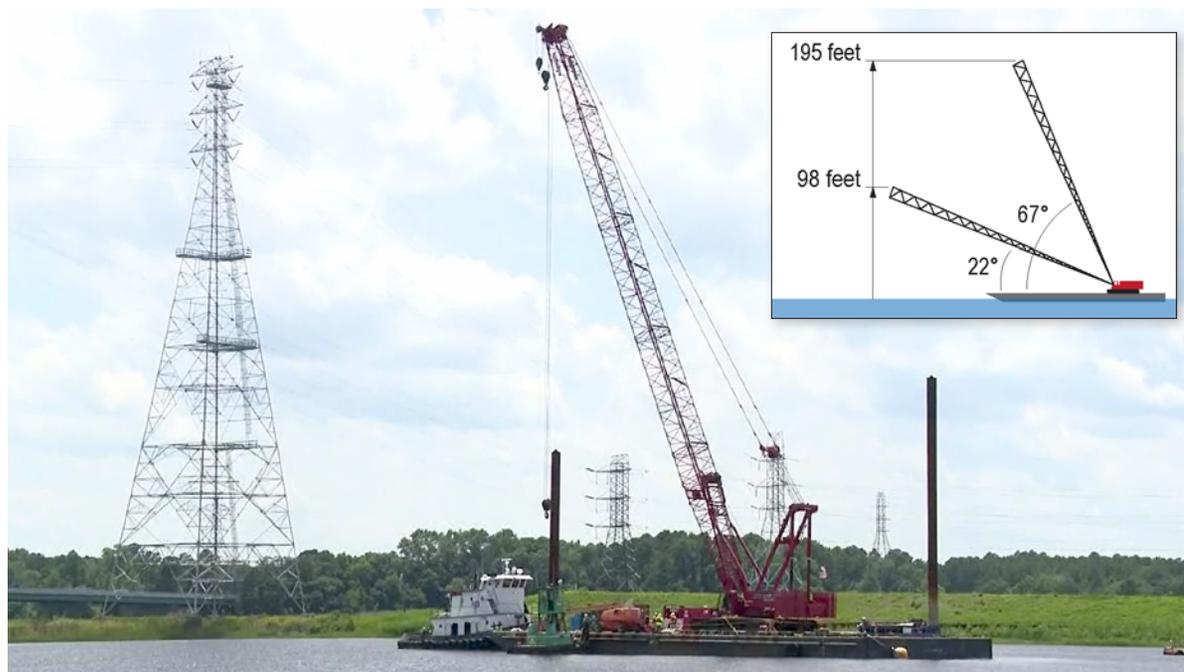
**Figure 86.** Towing vessel *Goose Creek* and crane barge *U1510* spudded down in Chesapeake, Virginia, after the accident. Inset (not to scale) depicts the crane boom elevation when stowed at 22° and as determined after the accident with an angle of 67°. SOURCE: COAST GUARD; ILLUSTRATION BY NTSB.

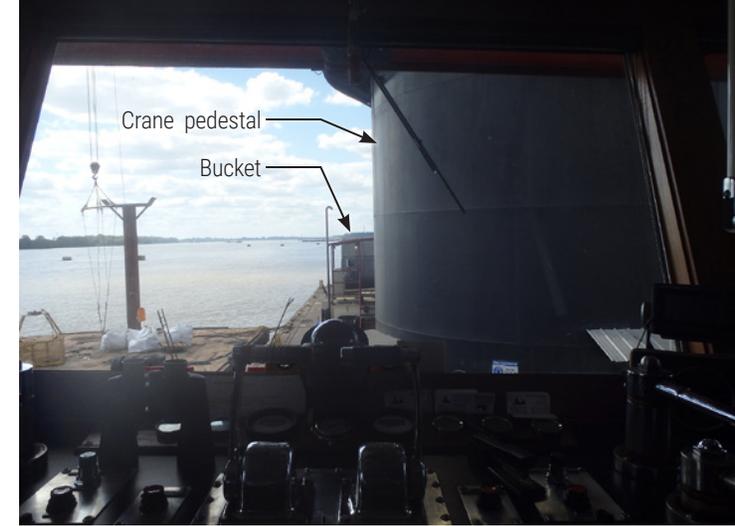
**Figure 92.** Forward view from the *Kristin Alexis*' wheelhouse. The crane's pedestal blocks most of the starboard view, while the crane bucket blocks a portion of the forward view ahead.

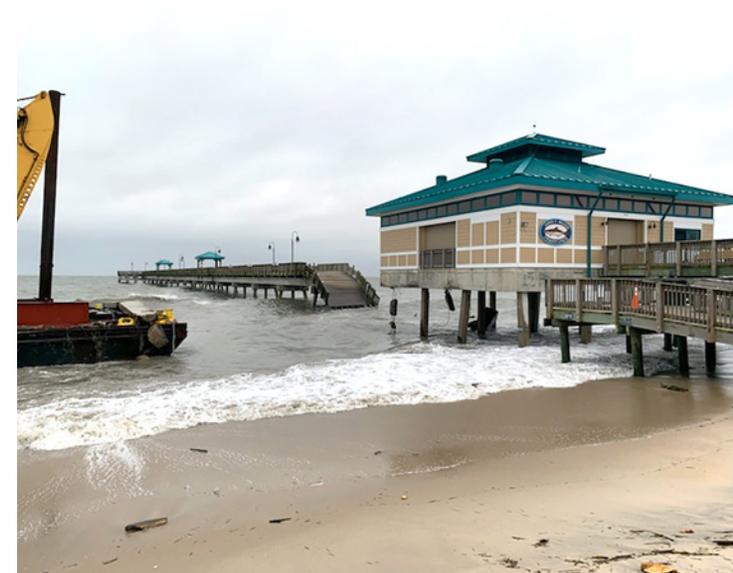
**Figure 124.** The damaged fishing pier with debris on the deck of the *YD 71*.

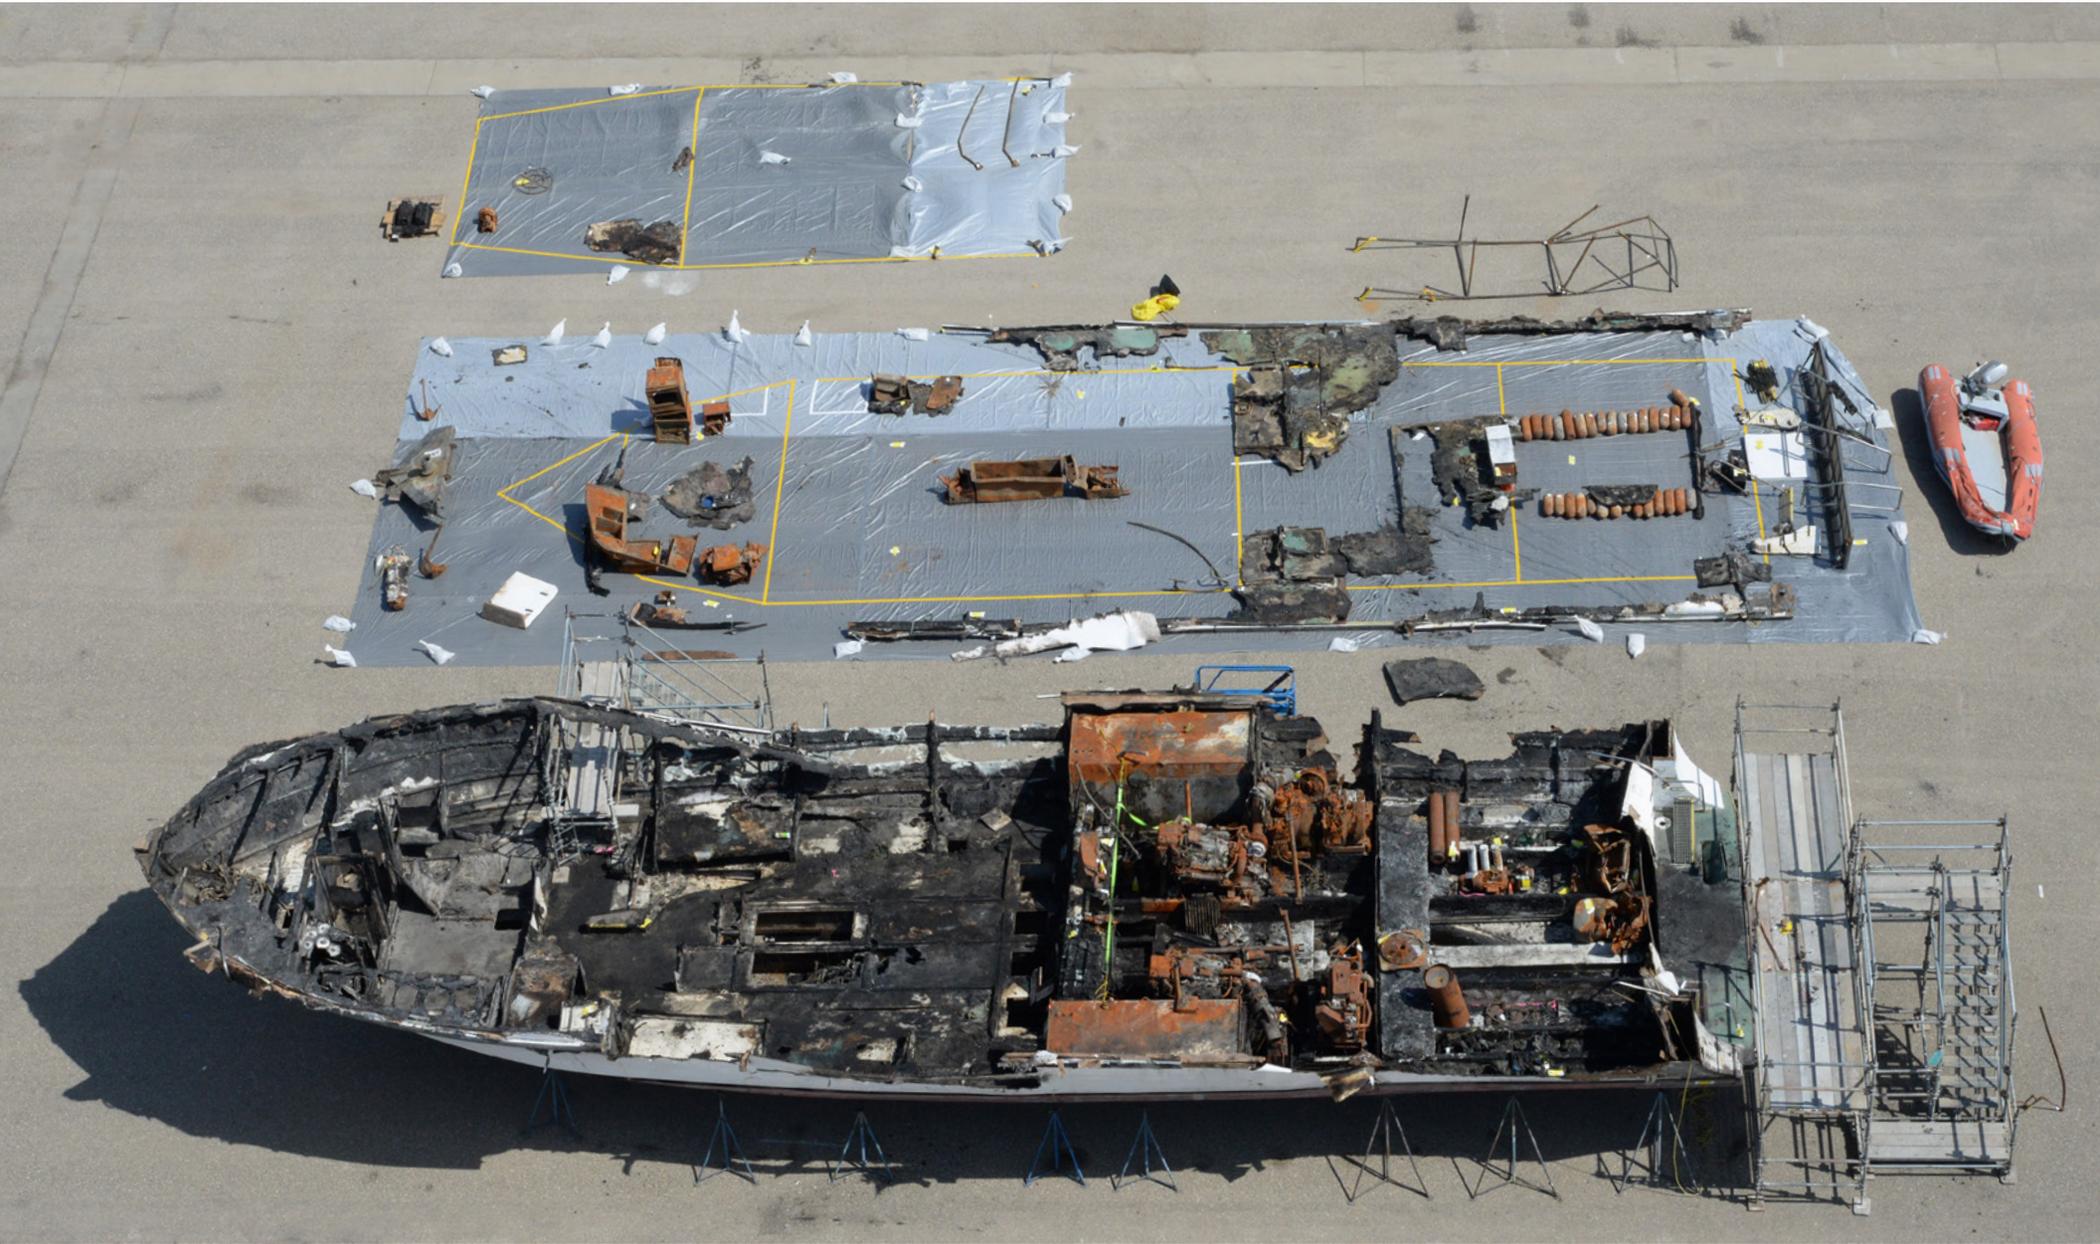
The wreckage and debris of the *Conception* was later salvaged and examined by investigators. Very little material remained from the upper deck and main deck. Examination of the recovered wreckage and debris did not yield any physical evidence relevant to the cause and origin of the fire. Although a definitive ignition source could not be determined, the most likely ignition sources include the electrical distribution of the vessel, unattended batteries being charged, improperly discarded smoking materials, or another undetermined ignition source. (PHOTO SOURCE: FEDERAL BUREAU OF INVESTIGATION.)

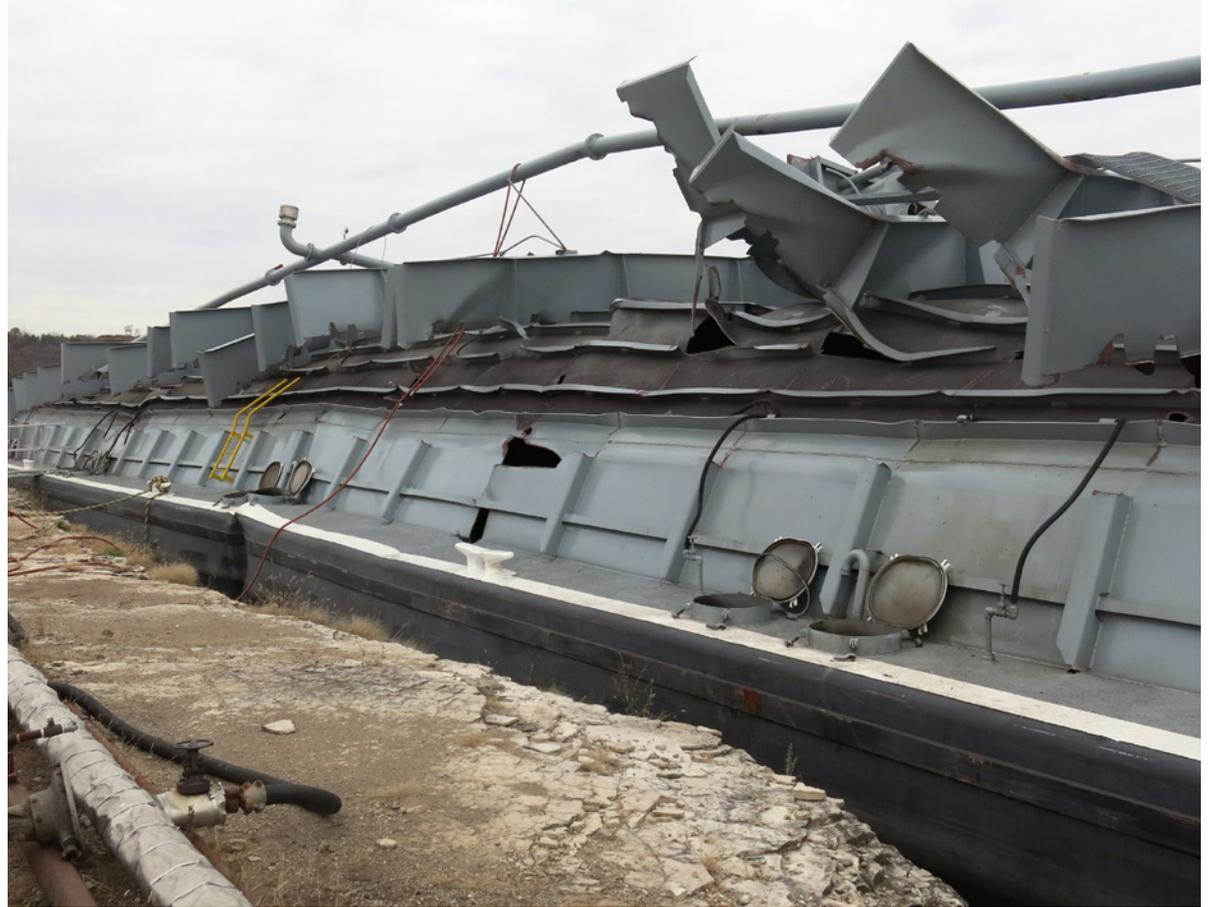
**Figure 150.** Damage of the *IB1940* after the explosion shows a distorted portside tank bulkhead and raised tank-top.

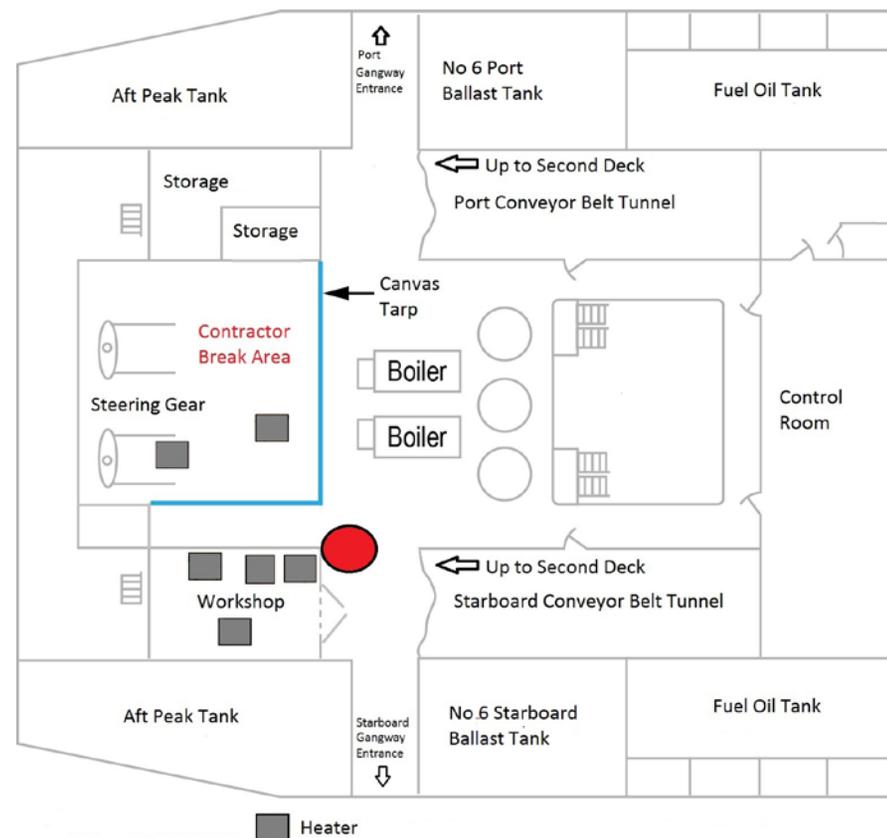
**Figure 156.** Drawing (not to scale) of third deck, showing location of heaters and tarp in the engine room. A red circle identifies the structural fire damage on the third deck.
