Capsizing of Roll-on/Roll-off
Vehicle Carrier *Golden Ray*
St. Simons Sound, Brunswick River,
near Brunswick, Georgia
September 8, 2019

Marine Accident Report

NTSB/MAR-21/03
PB2021-100930

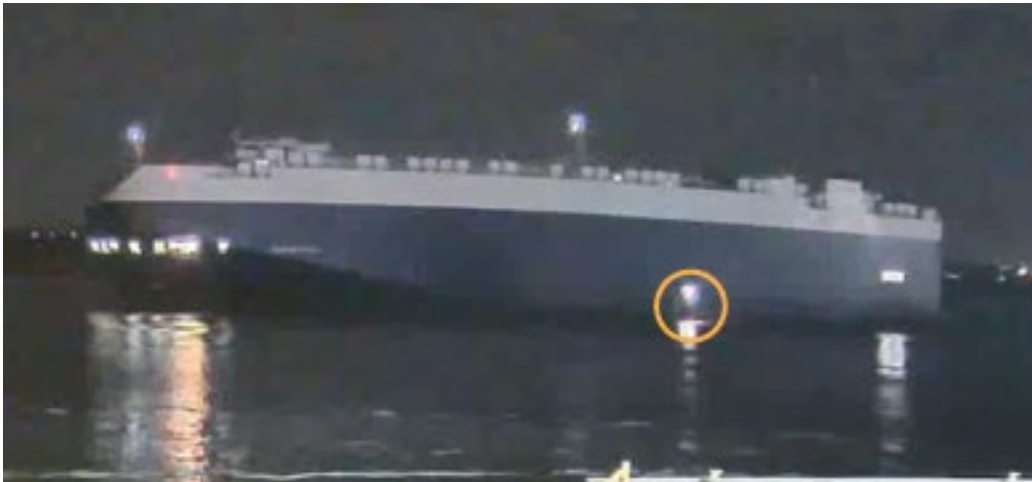
About the same time, the master ordered the crew to open the portside pilot door (side port), located on deck 5, in preparation for the pilot's planned departure just outside of the Port of Brunswick at the sea buoy (see figure 3). The pilot door was a watertight hatch in the side shell that opened and closed locally by an electronic/hydraulic system; the door was 7 feet (2.1 meters) high and 7 feet (2.1 meters) wide. After supervising the opening of the portside pilot door, the chief officer went to his stateroom. The crewmembers left to conduct other duties, and no one remained at the open door as the vessel proceeded outbound.

Figure 3. The *Golden Ray* departing Jacksonville, Florida, about 0130 on September 7. The light amidship is the open portside pilot door. (The lights on the blue hull at the bow and stern are mooring line stations.)

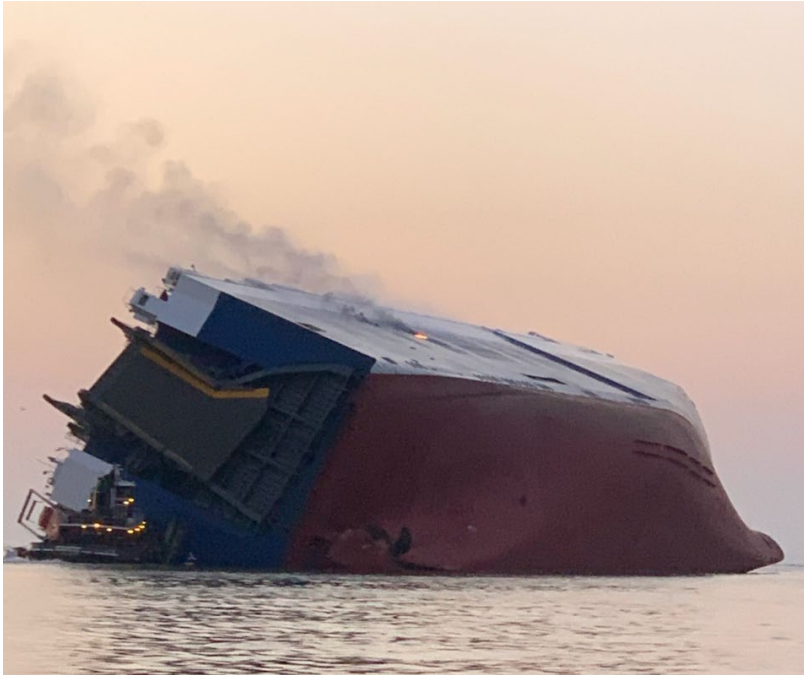
About 0430, first responders noticed smoke and flames on the starboard side of the *Golden Ray* in the area of the vehicle decks (see figure 5). The cargo hold contained combustible materials, including tires and plastic components in the vehicles. Because of the reported thick, black smoke

Figure 5. Stern view of the grounded *Golden Ray* after the heeling event. Flame and smoke emanate from the starboard side in the area of the cargo decks. Photo taken 6 hours after the heeling event.

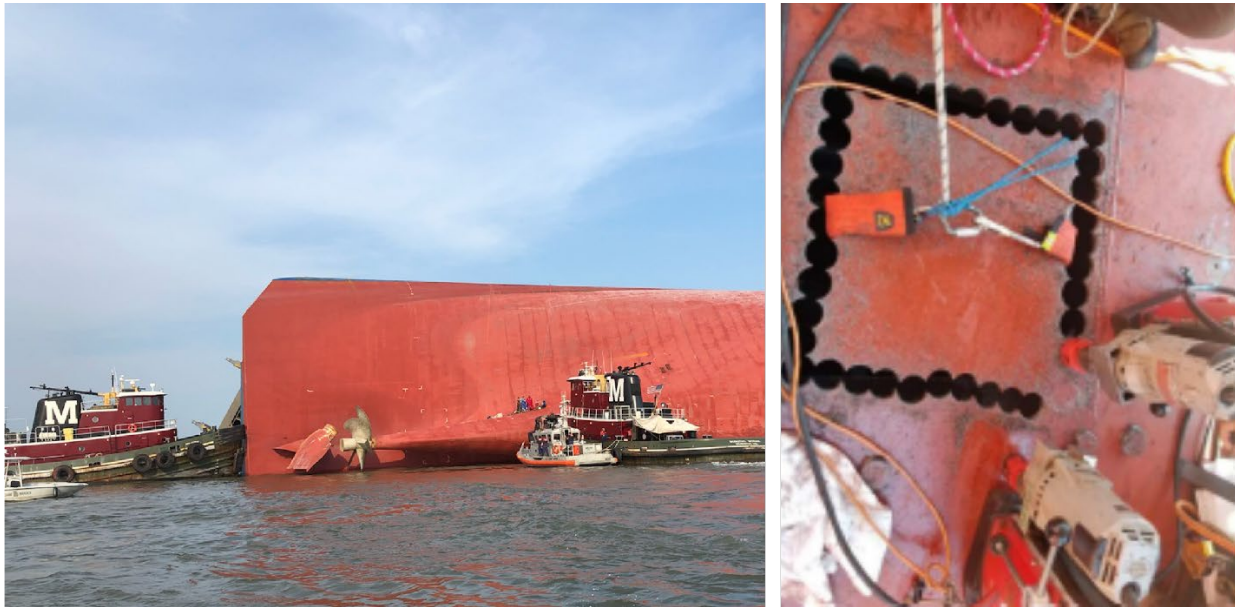
contact with the engineers (see figure 7). An atmosphere reading of the engine room showed its temperature was as high as 155°F. Realizing that the internal atmosphere was extremely hazardous to the engineers, the rescuers continued drilling holes to create a square access opening into the hull rather than wait for the requested cold cutting equipment to arrive.

Figure 7. Emergency responders attempt to rescue the trapped engineers and cadet (left). Responders drilled holes into the hull to access the engineers (right).

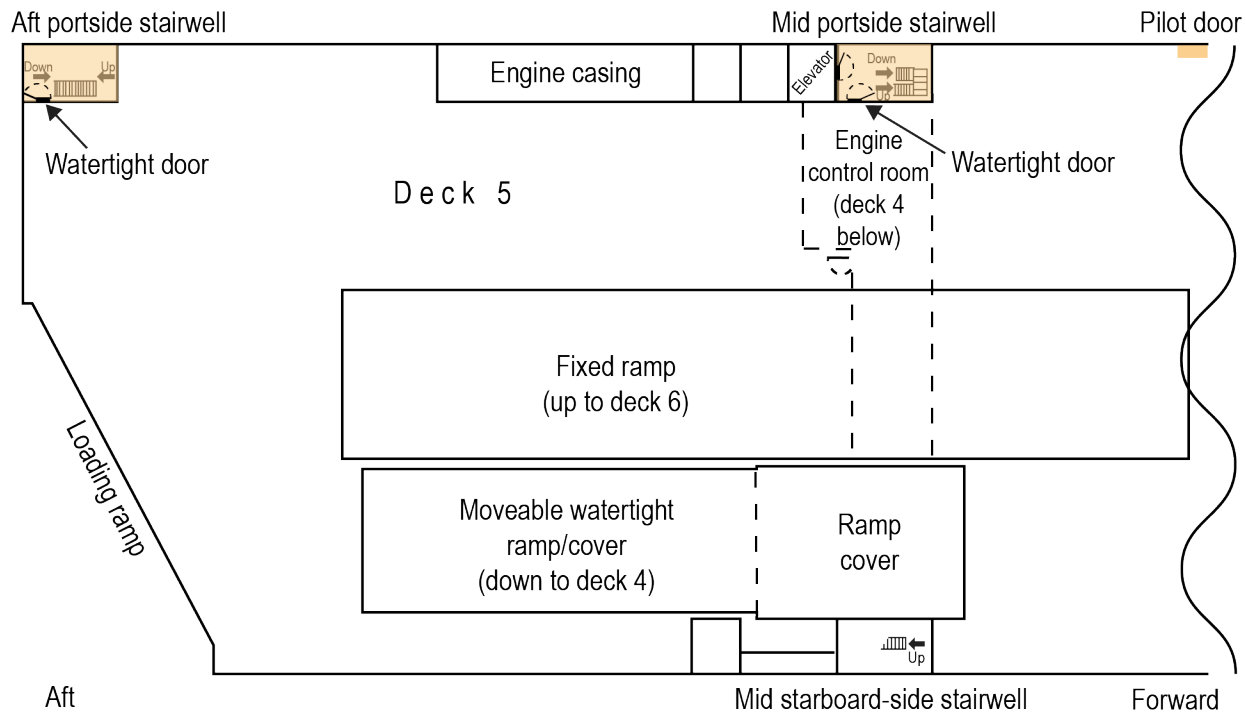
The IMACS data showed that in addition to the portside pilot door, the watertight doors to both the aft and mid portside deck 5 stairwells were open at the time of the accident and had been open since 2341 on September 7 before the vessel departed the Colonel’s Island Terminal. The mid portside stairwell, about 75 feet (22.9 feet) aft of the pilot door, served as the primary access to the engine room and the engine control room on deck 4; the escape trunk stairwell serving the lower engine room exited to this stairwell at deck 4 (see figure 11).

Figure 11. Simplified overhead plan of the aft portion of deck 5. The stairwells with open watertight doors and the pilot door are highlighted. Dashed lines indicate spaces on deck 4 below.

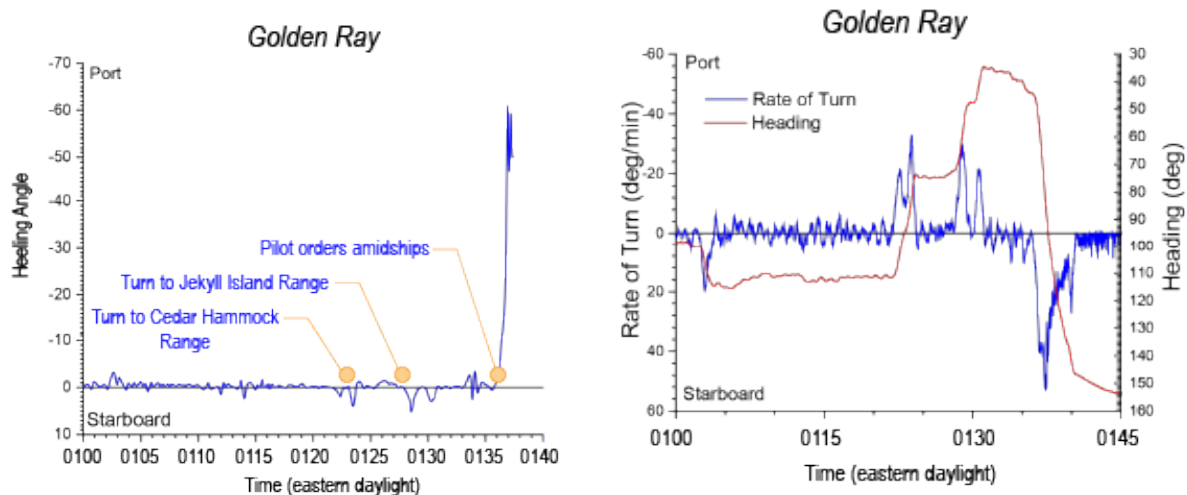
After the accident, the NTSB used data from the *Golden Ray*'s VDR and IMACS to determine the forces acting on and their effect on the vessel at the time of the accident. The study showed that from an initial heel of about 8° at 0136:00, the vessel heeled past 50° in about 50 seconds (by 0136:50) and reached over 60° in less than a minute, while its starboard rate of turn increased from about 2° per minute to over 40° per minute (see figure 14).

Figure 14. Graphs from the *Golden Ray* performance study by the NTSB. Left: heeling angle through the transit, including previous two left turns. Right: heading and rate of turn through the transit.

According to the study, the heeling of the vessel was driven by a moment created by hydrodynamic side force on the hull at a distance below the center of gravity during a starboard turn at 12–13 knots. The hydrostatic stability (buoyancy) resisting the heel was much less than would be expected for the reported GM of 2.45 meters (8 feet) and instead was consistent with a GM of approximately 0.45 meters (1.5 feet). The study also found that although the effect of wind could not be calculated precisely, the low magnitude of the heeling moment from wind relative to other sources of heeling moment was not significant. The study found that the vessel's center of gravity was significantly higher than reported, leading to the lack of roll resistance.

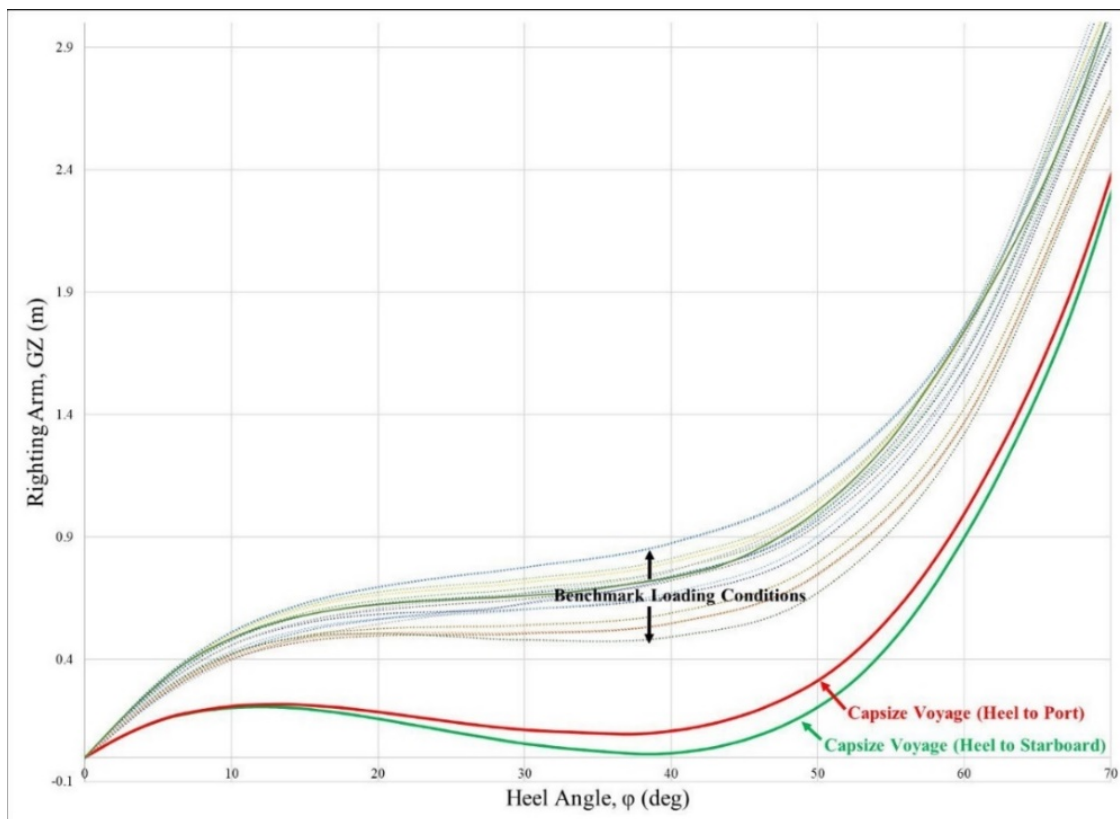
IS Code criteria were applied to these righting arm curves, the MSC found that with the vessel's loading condition, the area under the vessel's righting arm curve between 30° and 40° was particularly limited, and it failed to meet the 2008 IS Code (see figure 16). Because there was limited area under the righting arm curve, the MSC determined that the vessel did not meet the area ratio criteria of the 2008 IS Code's severe wind and rolling criteria. The MSC concluded that the vessel, as loaded, had an extremely low righting energy, which prevented it from withstanding further adverse static or dynamic heeling effects and enabled the vessel to capsize due to the centrifugal force experienced by the vessel throughout the starboard turn.

Figure 16. Righting arm curves generated from the MSC analysis of the *Golden Ray* during the accident voyage compared with benchmark righting arm curves chosen from the vessel's T&S Booklet loading conditions.

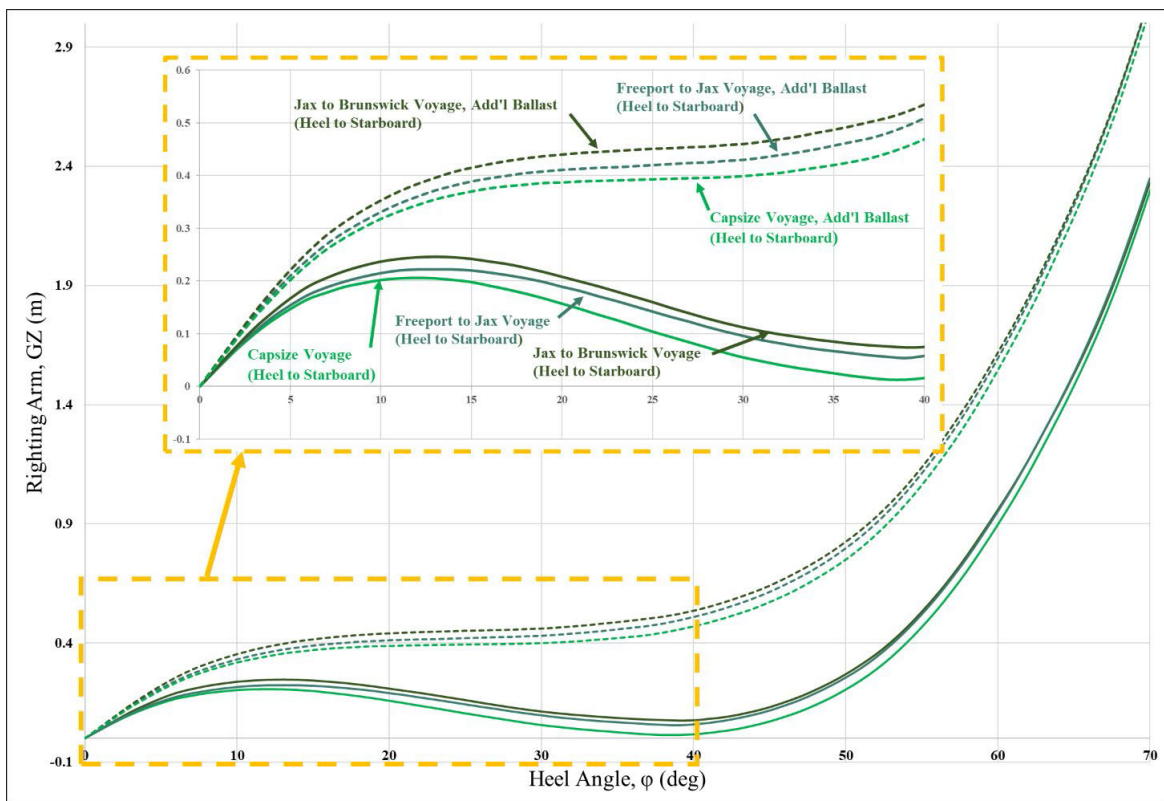
The MSC report also stated that if the *Golden Ray* had maintained an additional 1,492 MT of ballast (1,500 MT was loaded after departure from Freeport and then discharged before the vessel arrived in Jacksonville in order to meet the port’s draft requirements), the vessel would have been in compliance with the 2008 IS Code during both previous voyages and the accident voyage (see figure 17). The MSC also noted that, with the additional ballast, the vessel’s theoretical initial GM for those voyages would have been 2.25 meters (7.4 feet) for the accident voyage, 2.4 meters (7.9 feet) for the voyage from Freeport, and 2.47 meters (8.1 feet) for the voyage from Jacksonville. (For comparison, the MSC calculated the initial GM for the representative loading condition to be 1.76 meters (5.8 feet) for the accident voyage, 1.84 meters (6 feet) for the voyage from Freeport, and 1.91 meters (6.3 feet) for the voyage from Jacksonville.)

Figure 17. Theoretical righting arm curves (dashed green lines) generated from the MSC analysis of the *Golden Ray* during the accident voyage and previous two voyages with an additional 1,492 MT of ballast. The righting arm curves (solid green lines) generated from the MSC analysis for the vessel in the representative loading condition for each voyage are shown for comparison.

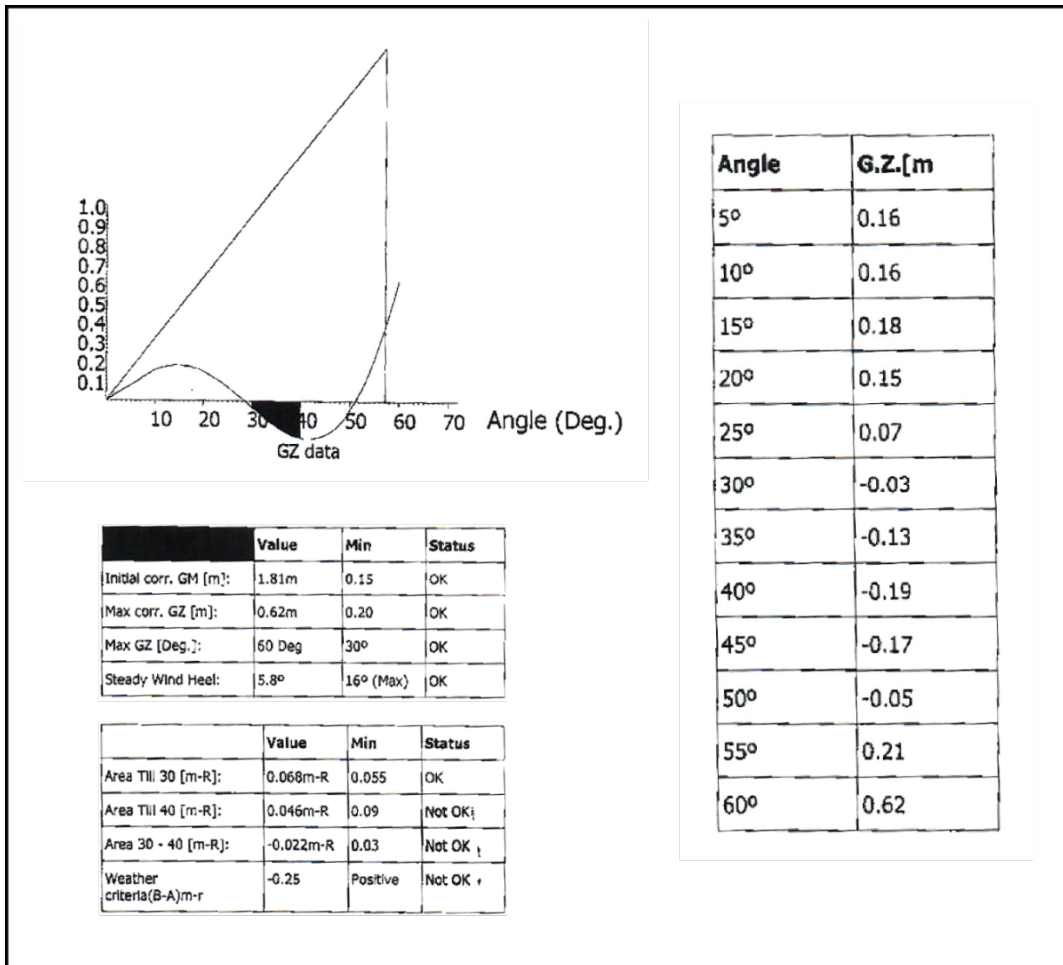
Hyundai Glovis. The charterer conducted a simulated stability analysis of the *Golden Ray* using the LOADCOM computer on board the *Silver Ray*, a vessel of the same class as the *Golden Ray* (Hyundai Glovis Co. Ltd. 2020). This simulation used vessel data and conditions collected by the charterer and was not observed by the Coast Guard or the NTSB. The simulation calculated that the GM of the *Golden Ray* was 1.8 meters (5.9 feet), indicated that the righting arm curve for the *Golden Ray* at the time of the accident was extremely low, and showed a LOADCOM status of “Not OK” for three stability requirements (see figure 18). Additionally, the righting arm curve showed negative stability after a heel of about 25°.

Figure 18. Righting arm curve calculated on the *Silver Ray*'s LOADCOM stability computer based on the *Golden Ray*'s vessel data from the accident. Note that three of the stability requirements have a status of “Not OK” and the righting arm (GZ) is negative beyond 25°.
