Fire aboard Roll-on/Roll-off Vehicle Carrier *Höegh Xiamen*

Pier 20, Blount Island

Jacksonville, Florida

June 4, 2020

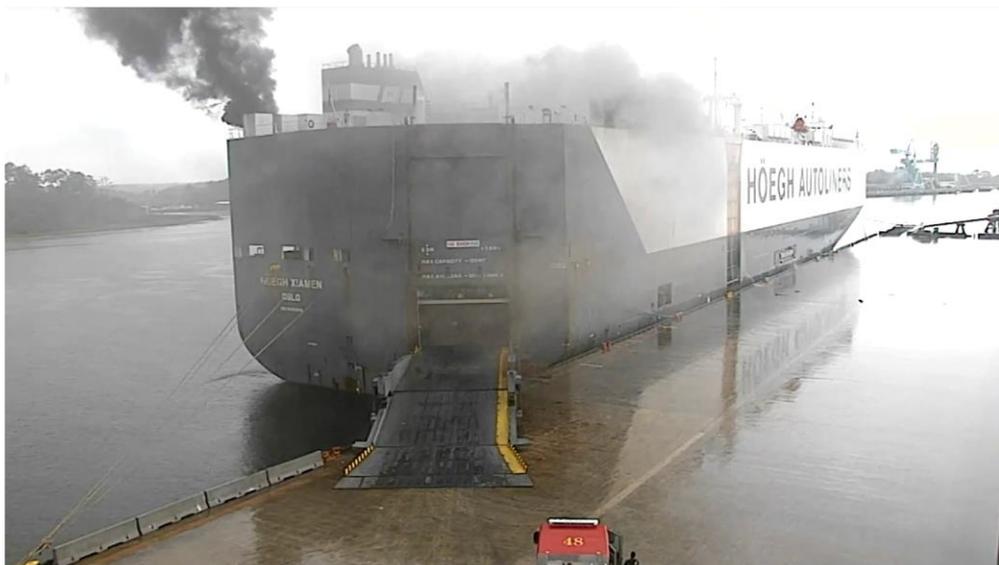
Figure 4. Smoke coming from aft cargo deck ventilation housing exhausts about 1603.

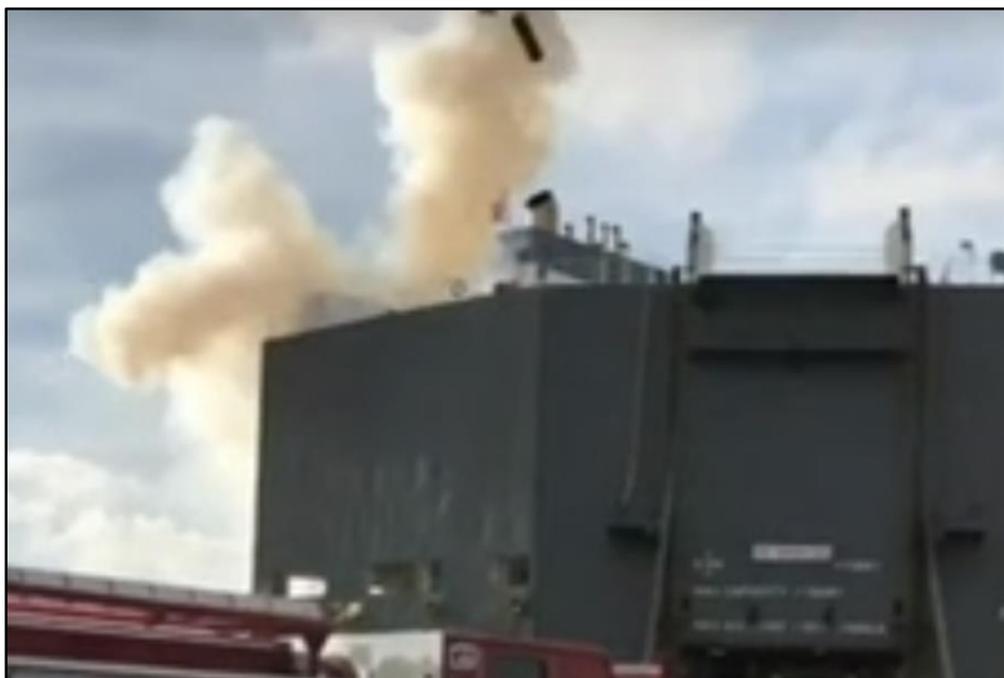
Upon opening the access door to the portside exhaust ventilation housing for deck 9, firefighters on deck 12 heard “a loud roar that sounded like a jet engine” as the exhaust housing “exploded” (see figure 5). The ventilation housing threw debris in the air. From the exterior of the ship, firefighters witnessed a tall column of grey-white smoke projecting from the stern on the weather deck and debris flying. According to firefighters, there may have been multiple explosions of varying magnitude. Firefighters in the port aft stairwell and on deck 5 described feeling intense heat and hearing a “roaring sound of rushing air.” Nine firefighters who were working in the stairwell or who had been staged on deck 5 were burned, five of them seriously, by the superheated air that rushed down the stairwell. Firefighters working on decks 7, 8, and 12 were unharmed.

Figure 5. Explosion of deck 9 ventilation exhaust housing. Note debris in air at top center of image. (Source: WJXT)

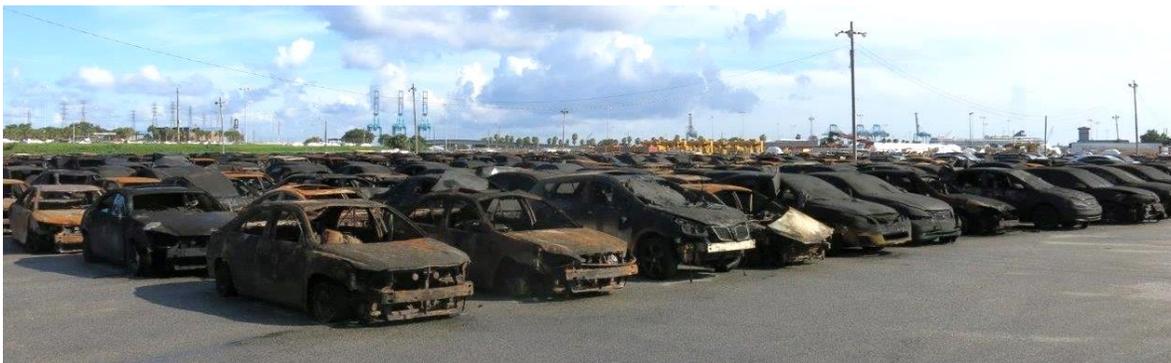
The *Höegh Xiamen* and its cargo of 2,420 used vehicles were declared a total loss valued at \$40 million (see figure 7). Salvage operations began on July 9, 2020. On August 30, after salvage operations were completed, the anchor-handling tug, *Alp Striker*, towed the ship from Jacksonville to Aliaga, Turkey, where the *Höegh Xiamen* was recycled.

Figure 7. Thermally damaged vehicles after removal from the *Höegh Xiamen*, Blount Island, Jacksonville, Florida, July 23, 2020.

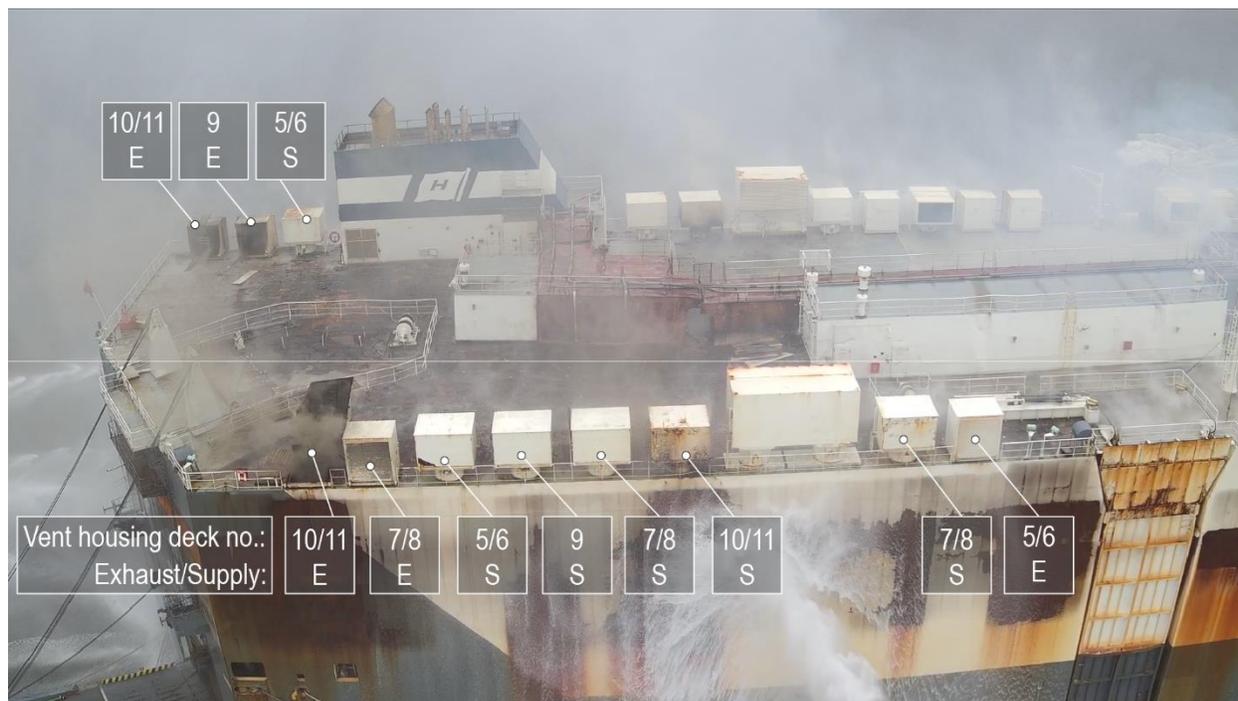
After the accident, the JFRD and the Coast Guard examined the vessel's ventilation housings during walkarounds of deck 12. (Figure 11 shows the damaged aft housings.) The condition of the housings fell into three categories: 43 had no signs of external sooting or mechanical damage; 8 exhibited external sooting but no mechanical damage; and 7 exhibited both external sooting and mechanical damage.

Figure 11. Damaged aft ventilation housings after the reported explosion of portside vent housing for deck 9 (9E in the photo). (Background source: JFRD)

The ventilation housings associated with decks 7/8, 9, and 10/11 exhibited sooting, and the housings associated with decks 9 and 10/11 exhibited mechanical damage. The ventilation housings for deck 10/11 exhibited greater levels of mechanical damage than those of deck 9.

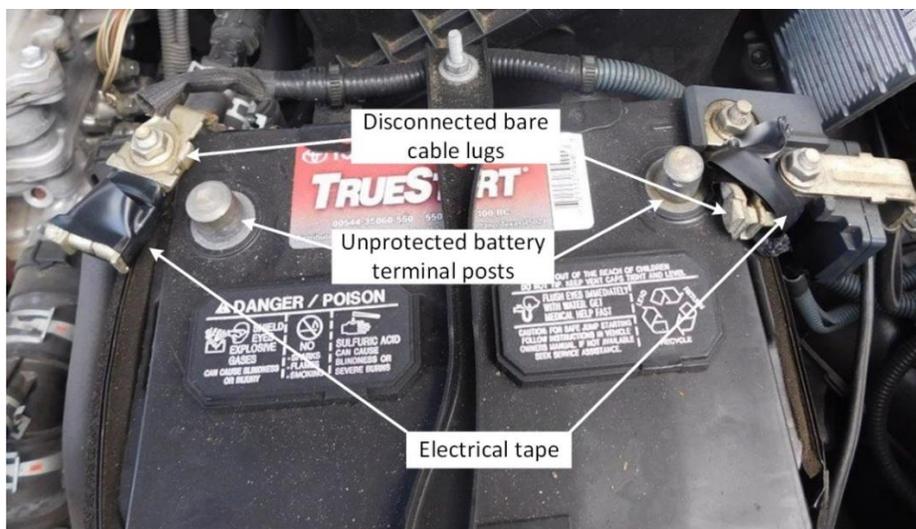
The sample of 39 forklift vehicles loaded in Jacksonville included 12 vehicles that did not have batteries and 3 vehicles with battery cables that had not been disconnected from the battery terminal posts. Of the 24 remaining vehicles, 22 had exposed battery terminal posts; none of these were protected with plastic caps. Instead, the battery cable lugs were partially wrapped with electrical tape, leaving exposed metal on the lug (see figure 14). Investigators also found 14 instances of disconnected and exposed battery cable lugs resting above or on top of the vehicle battery and touching or nearly touching the exposed battery terminal posts. All of the forklift vehicles examined (except those without batteries) were found to have batteries not secured in accordance with Grimaldi's procedures.

Figure 14. Battery in forklift vehicle removed from deck 5. The disconnected battery cable lugs were located near terminal posts, and the battery terminal posts were unprotected. (Source: Coast Guard)

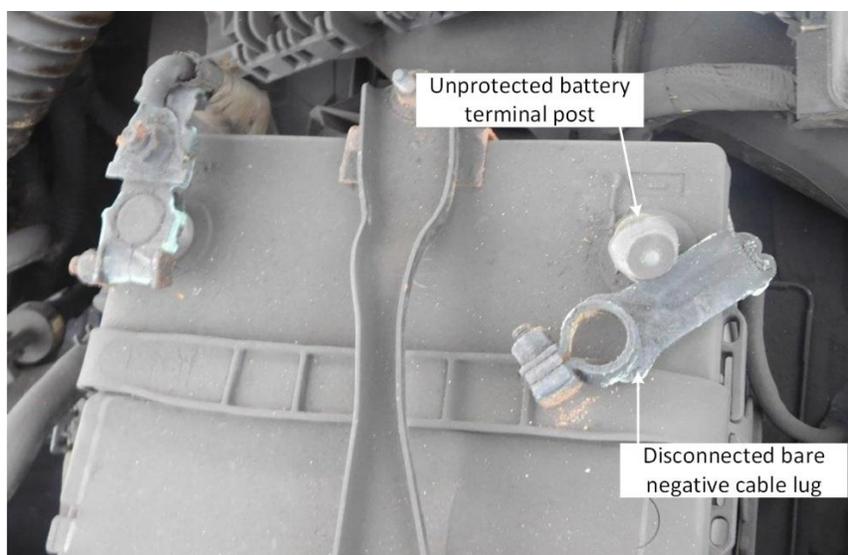
The sample of 20 towed vehicles loaded in Jacksonville included one vehicle that did not have any battery in the engine compartment and two vehicles with battery cables that had not been disconnected from the negative battery terminal posts. Sixteen of the remaining 17 vehicles were found with visibly exposed battery terminal posts that were not protected with plastic caps. Investigators also found 13 instances of disconnected and exposed battery cable lugs resting above or on top of the vehicle battery and touching or nearly touching the exposed battery terminal posts (see figure 15). All the towed vehicles examined (except the one without a battery) were found to have batteries not secured in accordance with Grimaldi’s procedures. Table 4 summarizes the towed vehicle examination.

Figure 15. Battery in towed vehicle removed from deck 7. The disconnected bare cable lug was in physical contact with unprotected battery terminal post. (Source: Coast Guard)

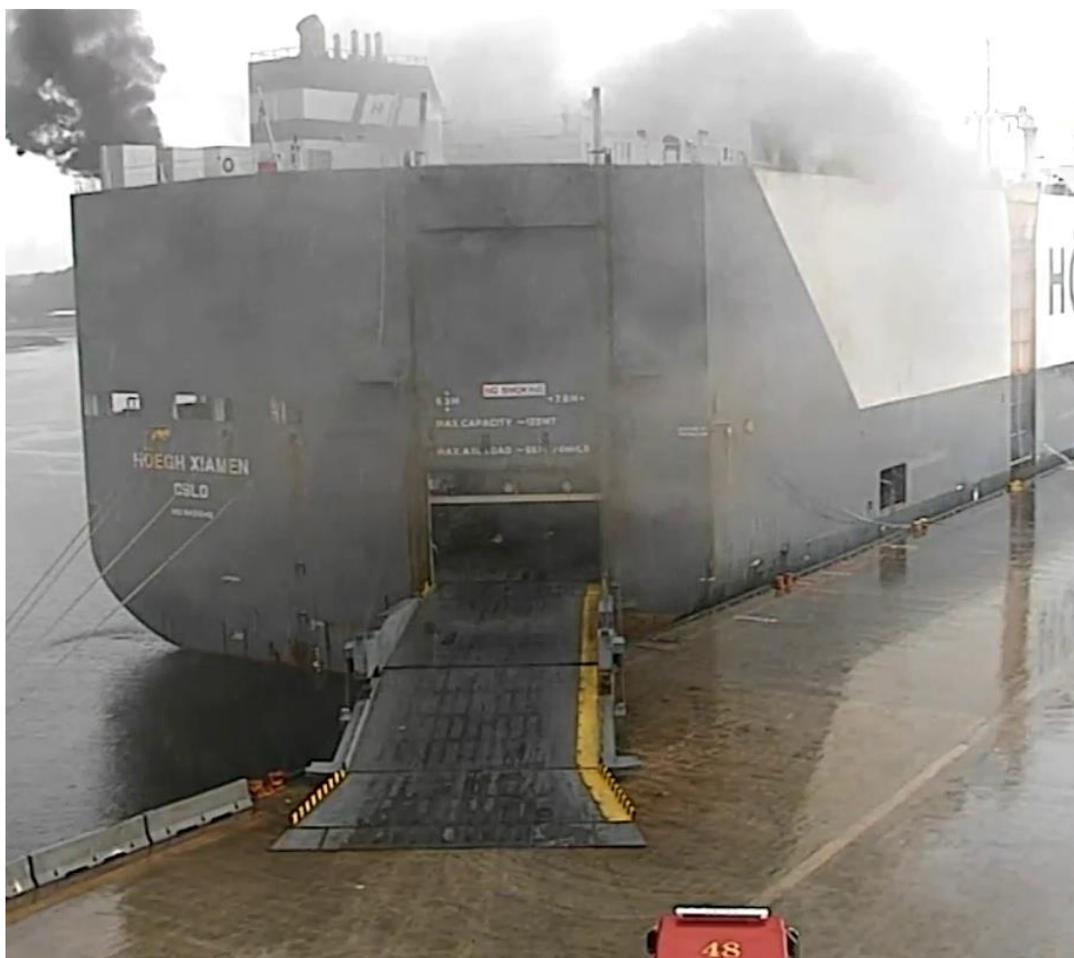
The video showed that when Engine 48 arrived, there was smoke flowing from the two aftmost exhaust vents on the port side (corresponding to decks 9 and 10/11) and the two aftmost exhaust vents on the starboard side (corresponding to decks 10/11 and 7/8) (see figure 16). At the time of Engine 48's arrival, the white paint on the starboard side of the *Höegh Xiamen* did not appear to have any thermal discoloration.

Figure 16. Engine 48 arriving on scene about 1603. Starboard vents 10/11E and 7/8E and port vents 10/11E and 9E exhibit smoke flow. (Source: Jacksonville Port Authority)

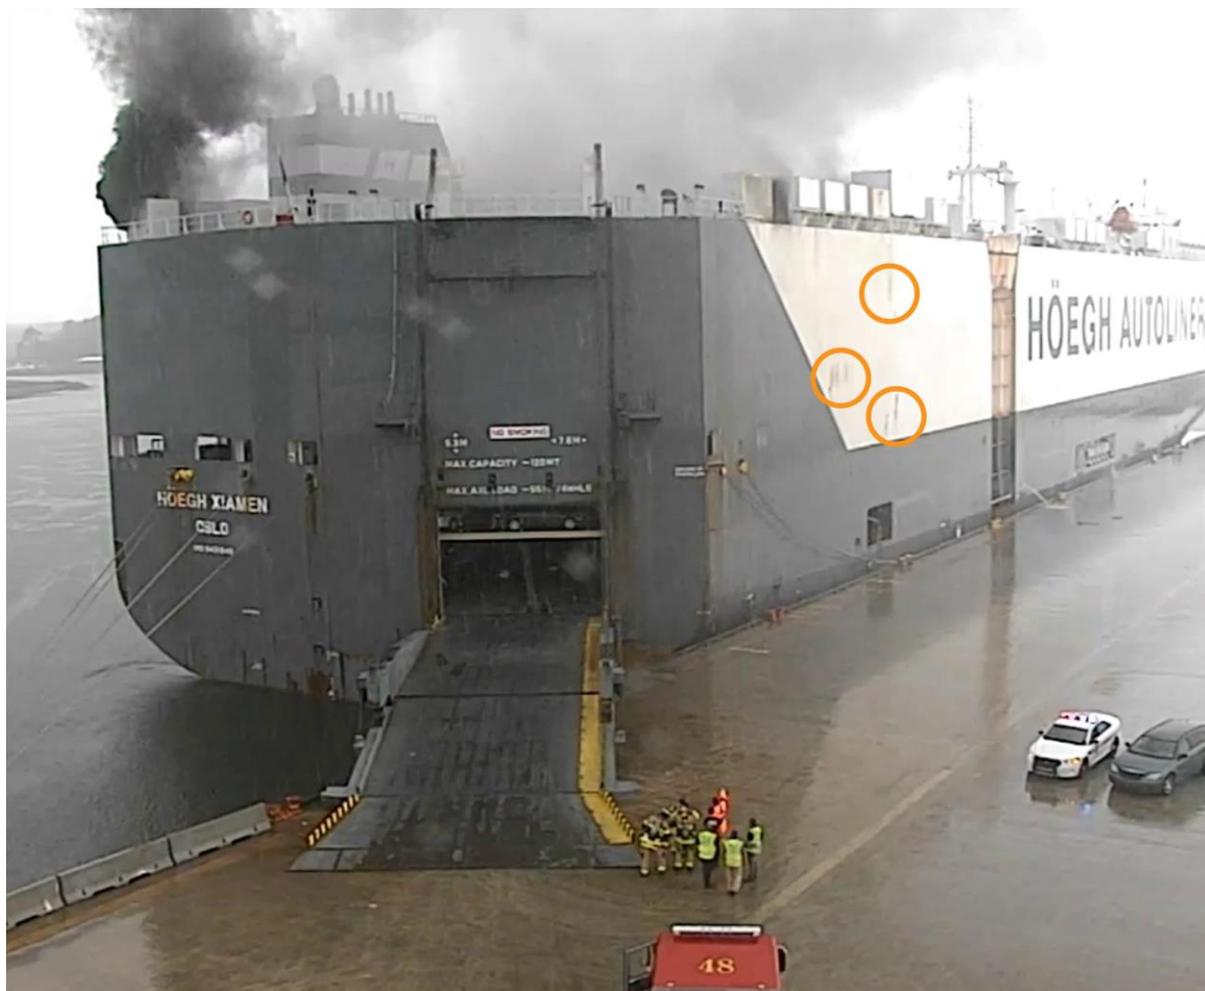
About 5 minutes after the fire department first arrived on scene, the video showed firefighters and one crewmember at the edge of the vessel's stern ramp. Smoke continued to rise from the vents on the ship's stern, with a much darker, thicker plume emitting from the port side. The video showed that, at this time, the white paint on the vessel's starboard side was beginning to exhibit thermal discoloration in areas corresponding to the fire zones associated with decks 7/8 and 10/11 (see figure 17). About 5 minutes later, the discoloration became more pronounced, and the discoloration continued to darken over the next 15 minutes.

Figure 17. About 1608, 5 minutes after Engine 48's arrival, the white paint on the starboard side of the vessel exhibits thermal discoloration (circled in orange). Starboard vents 10/11E and 7/8E and port vents 10/11E and 9E exhibit smoke flow. (Source: Jacksonville Port Authority)
