# **SAFETY DIGEST**

**Lessons from Marine  
Accident Reports  
2/2020**

**SAFETY DIGEST**  
**Lessons from Marine Accident Reports**  
**No 2/2020**

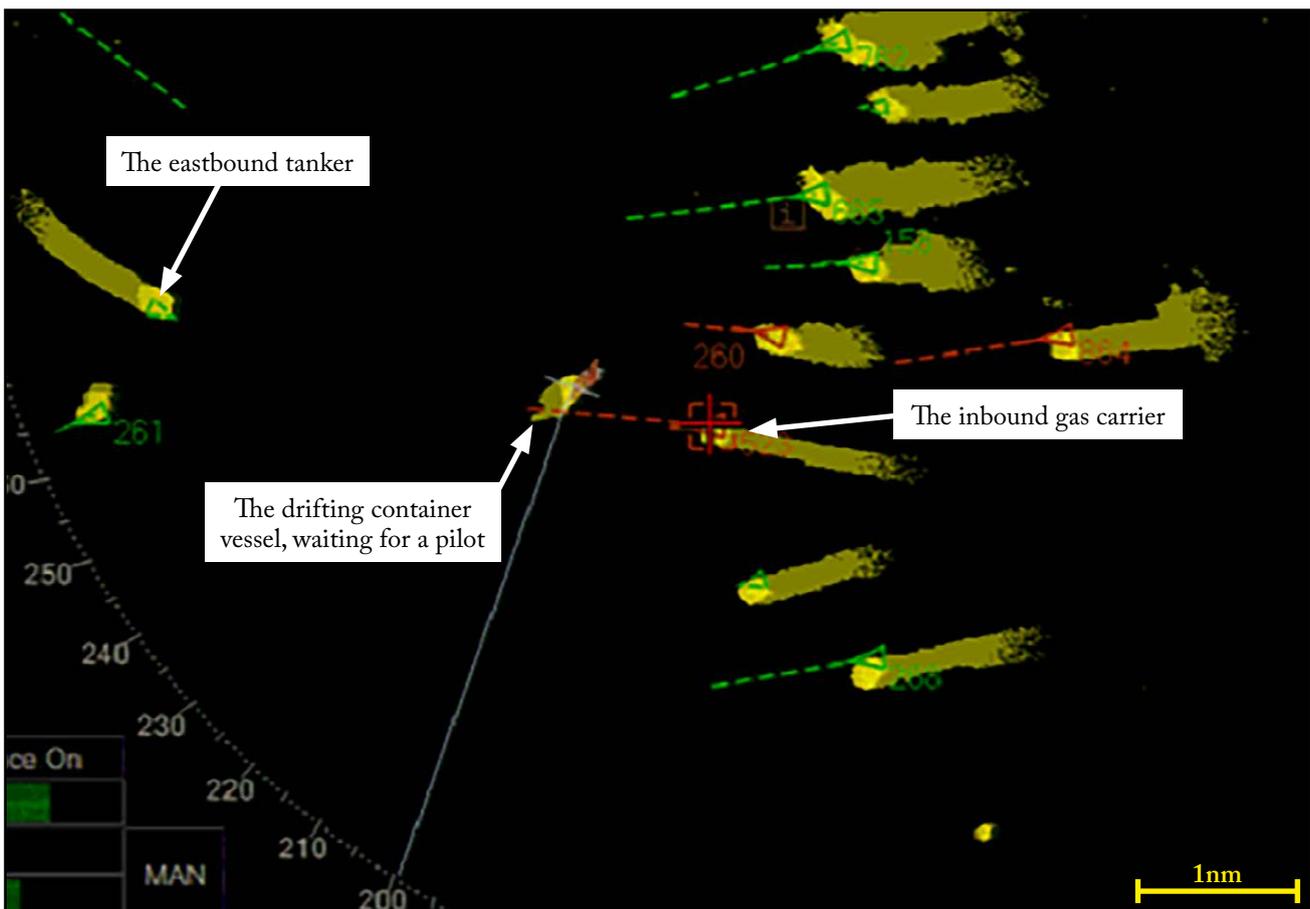
An inbound container vessel had been instructed by the port authority to wait outside the port until conditions improved (Figure 1). At the same time, a gas carrier was proceeding at about 13kts towards a boat transfer rendezvous position near the port's entrance. In the same vicinity, there were eight other vessels heading west towards the traffic separation scheme (Figure 1).

Figure 1: Extract of the container vessel's radar picture 4 minutes prior to collision

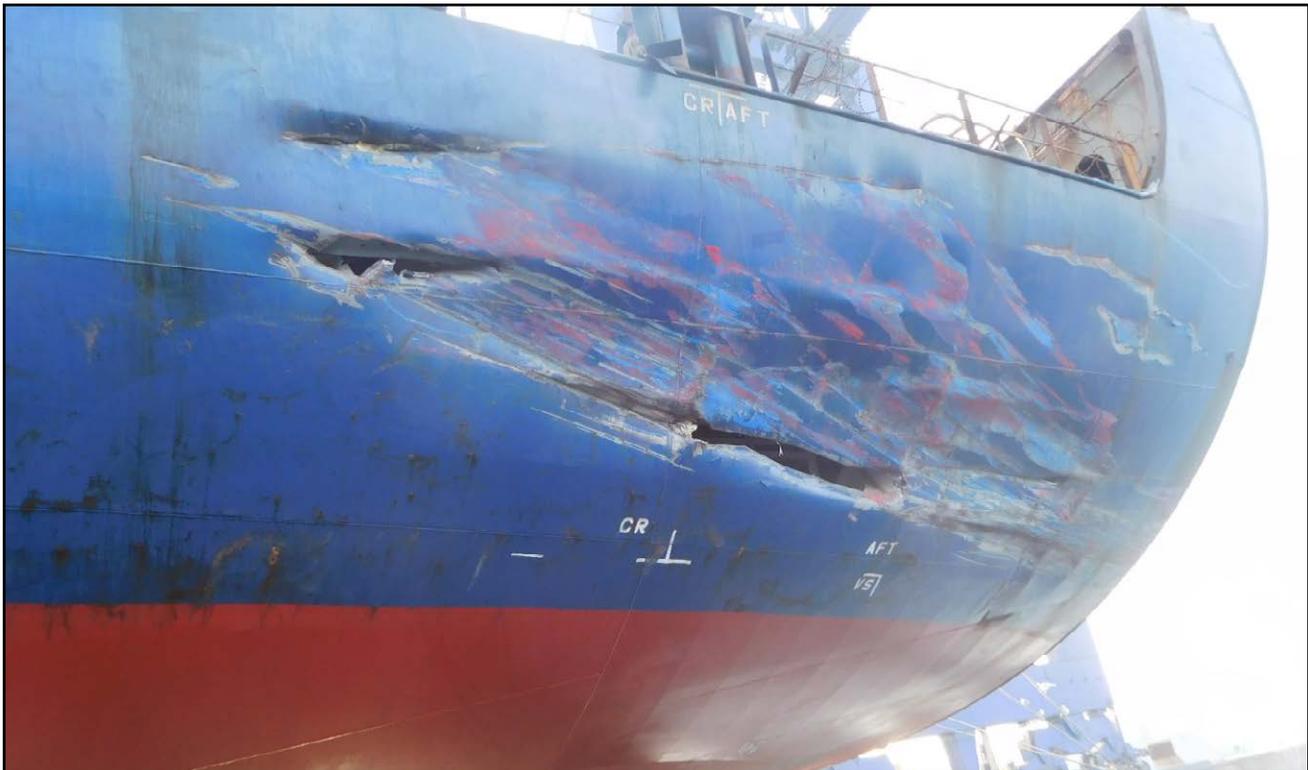
On the bridge of the gas carrier, the master was conning and was aware of the container vessel ahead from radar and AIS data. As the range reduced, the master made an alteration of course to starboard to avoid the container vessel. Realising that this alteration of course had not delivered the anticipated separation, the gas carrier's master applied full starboard rudder; however, this was insufficient to avoid collision. Figure 2 shows the damage to the container vessel's port quarter.

Figure 2: Detail of damage to the container vessel's port quarter

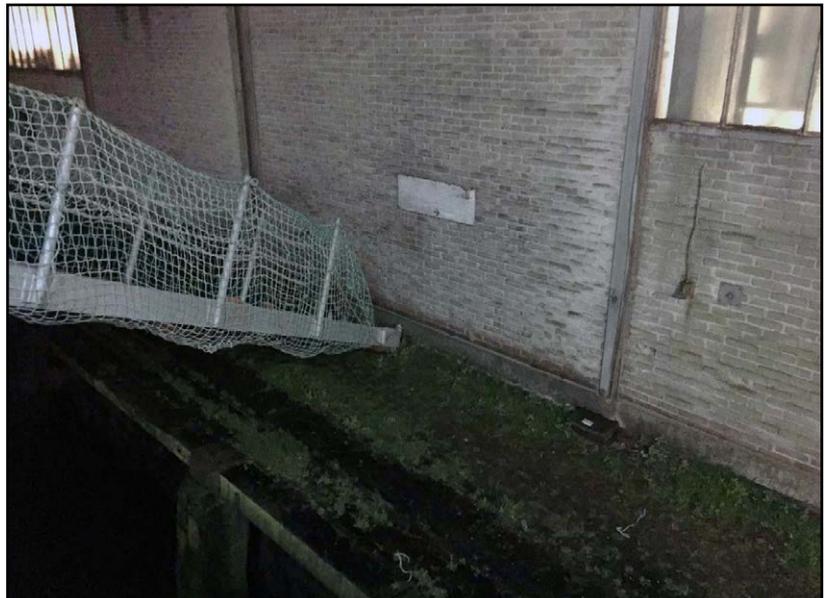
Figure: Ship's gangway on the narrow quayside

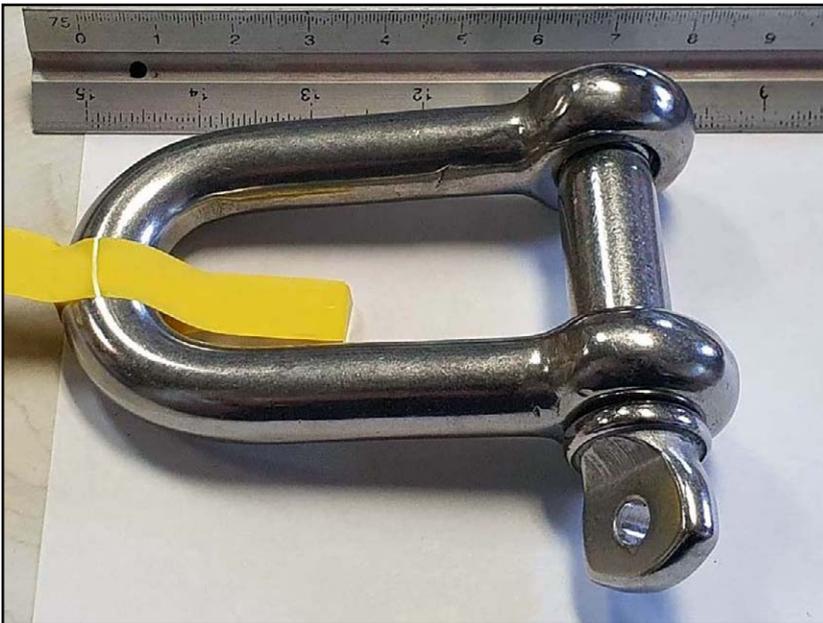
Figure 1: Steel shackle used as heaving line weight

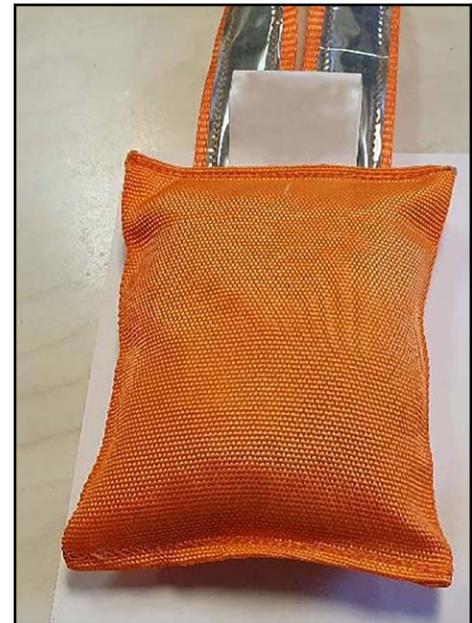
Figure 2: Bean bag supplied by tug company as a safe alternative heaving line weight

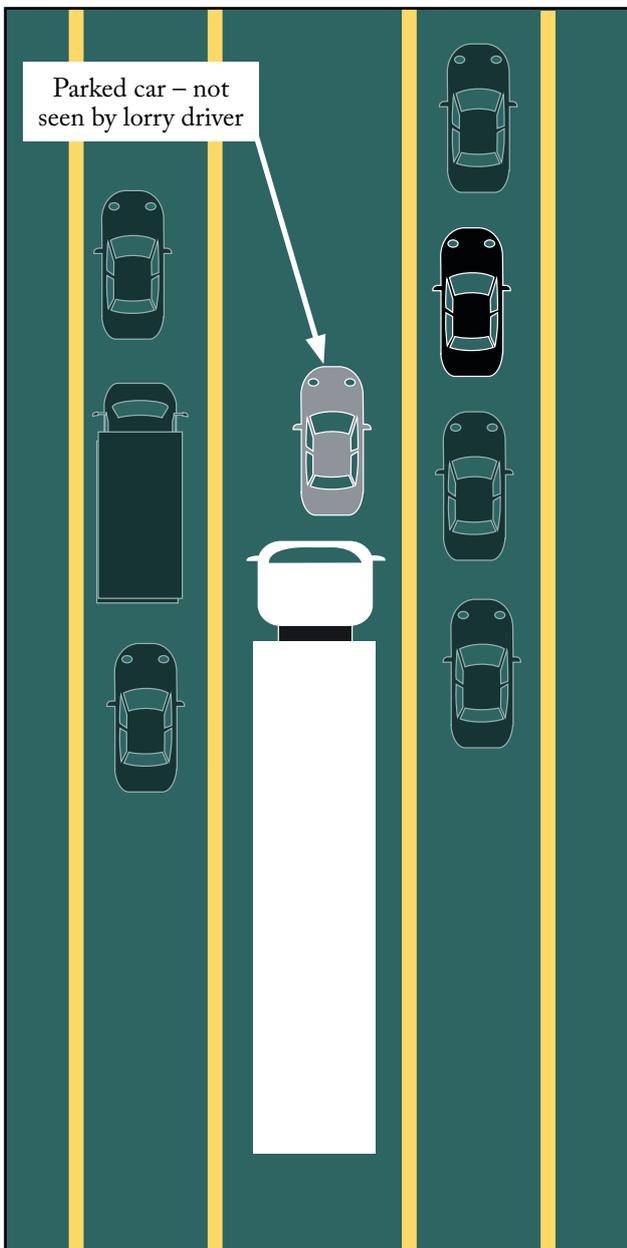
Figure 1a: Location of vehicles on the car deck

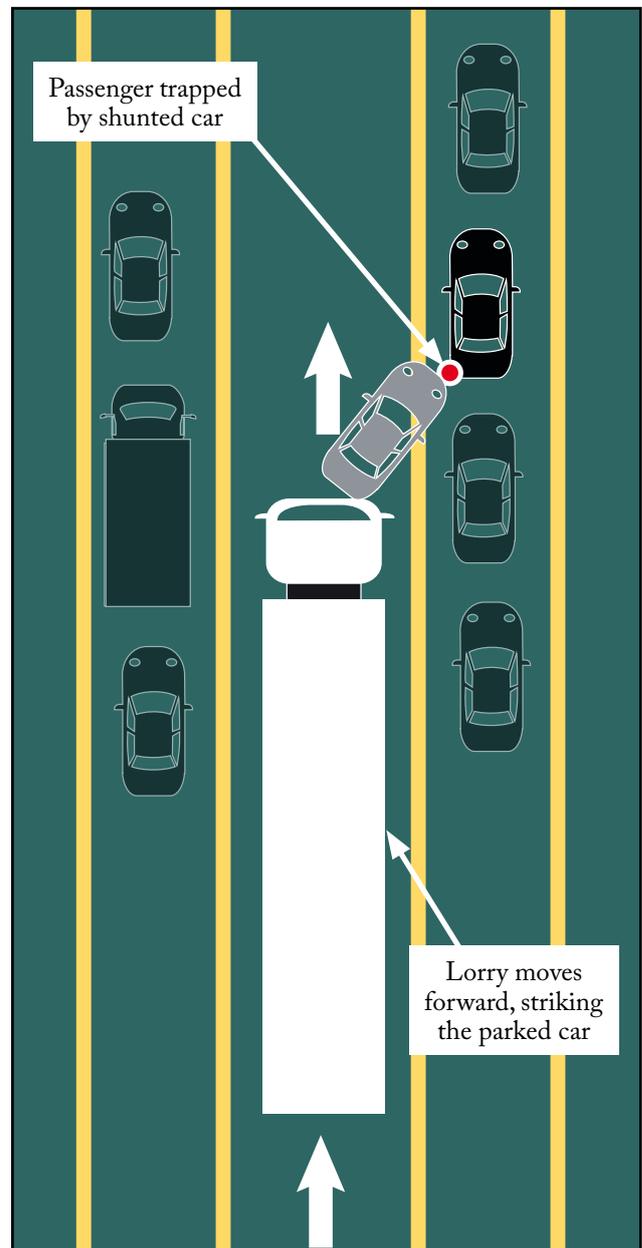
Figure 1b: Position of vehicles after shunt

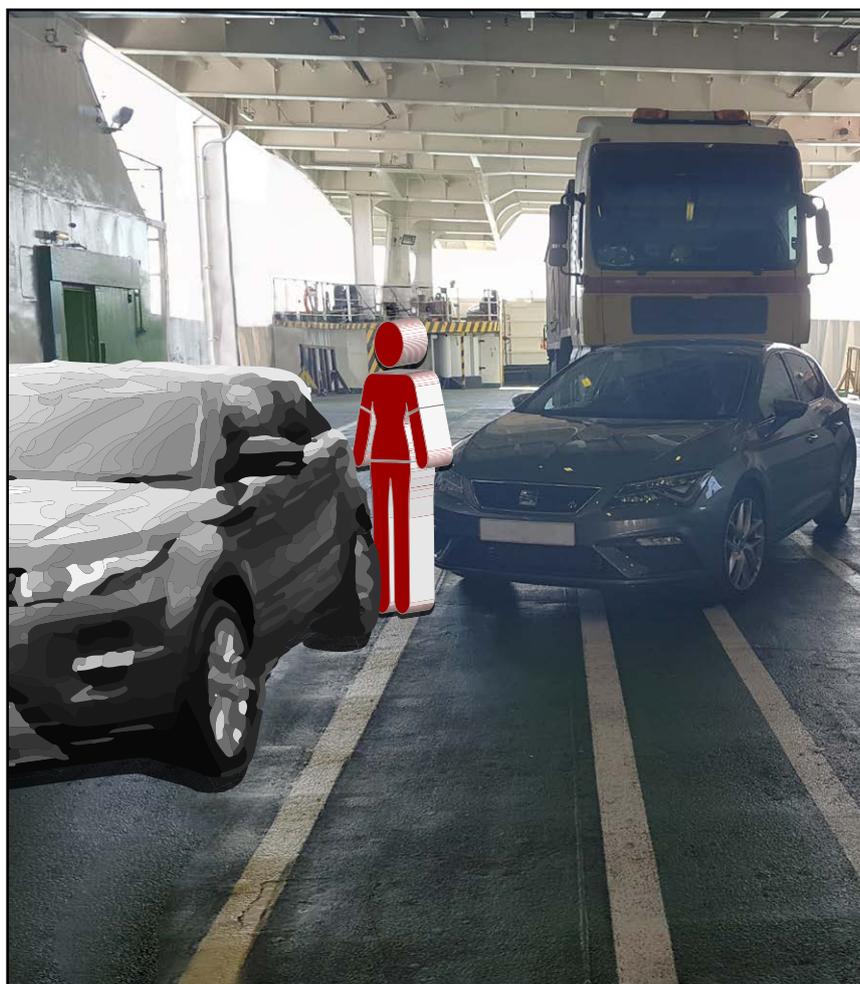
Figure 2: View of vehicle deck showing how car driver was trapped

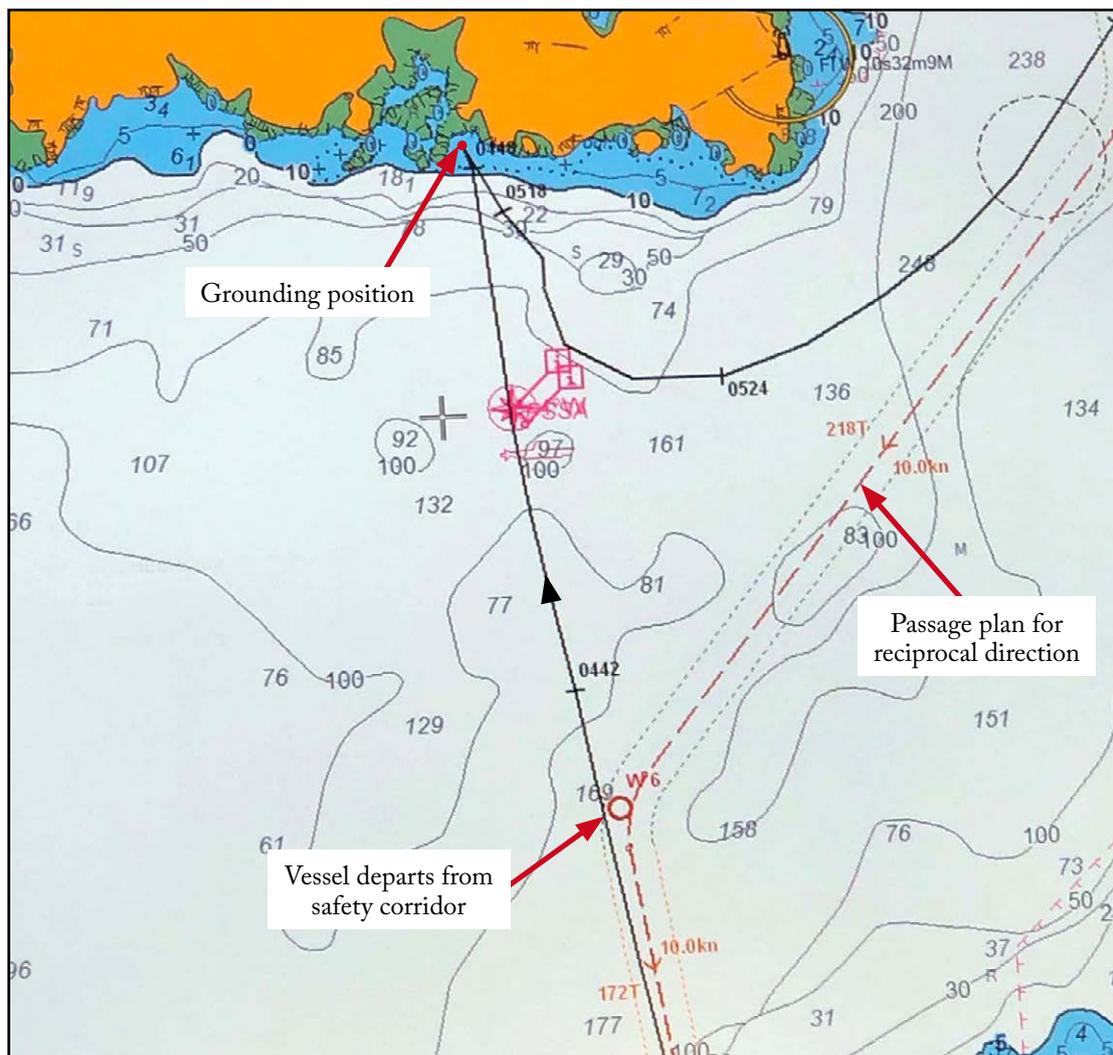
The master was called to the bridge, and an initial assessment found no internal damage. The crew refloated the vessel using its own power around 30 minutes after the grounding and headed for harbour. Once the vessel was within mobile phone range, the coastguard was informed. An inspection by divers found some minor damage and the vessel proceeded to dry dock for repairs.

Figure: Planned ECDIS track and actual track showing position of grounding

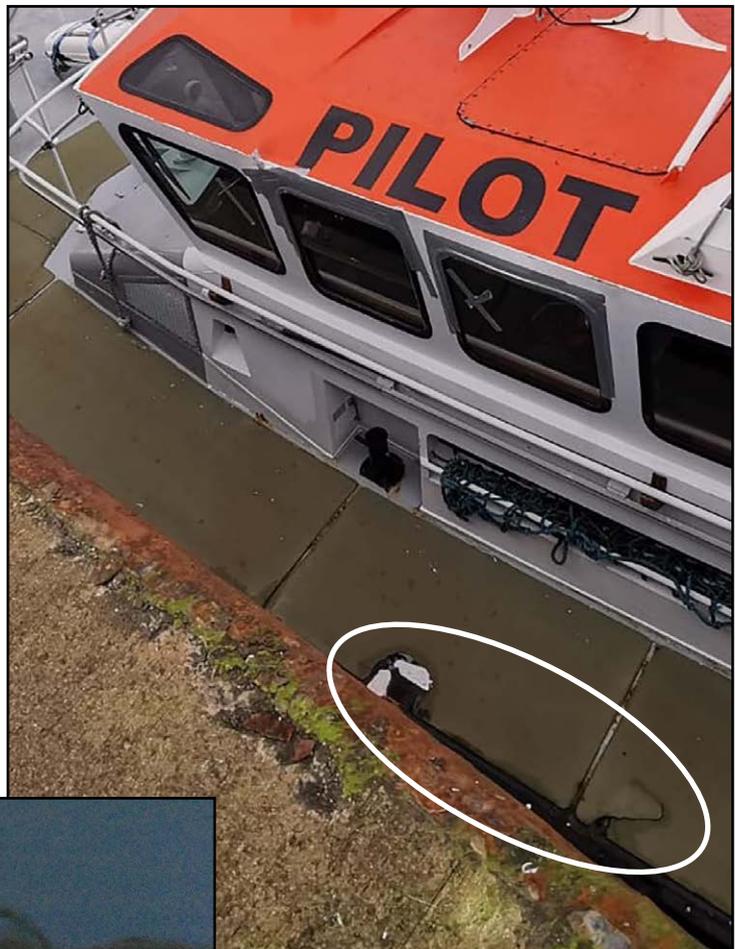
When the research vessel then rolled back to starboard, its diagonal side fendering struck and punctured the deck edge of the pilot boat (Figure 1). Further contact damaged the research vessel's fendering (Figure 2) and the pilot boat's wheelhouse.

Figure 1: Puncture damage to the pilot boat's deck

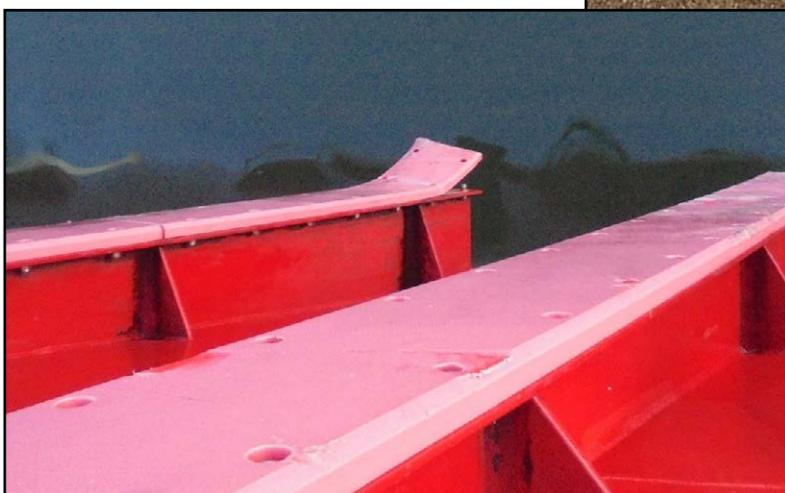
Figure 2: Damage to the research vessel's fendering and the unprotected fender ends

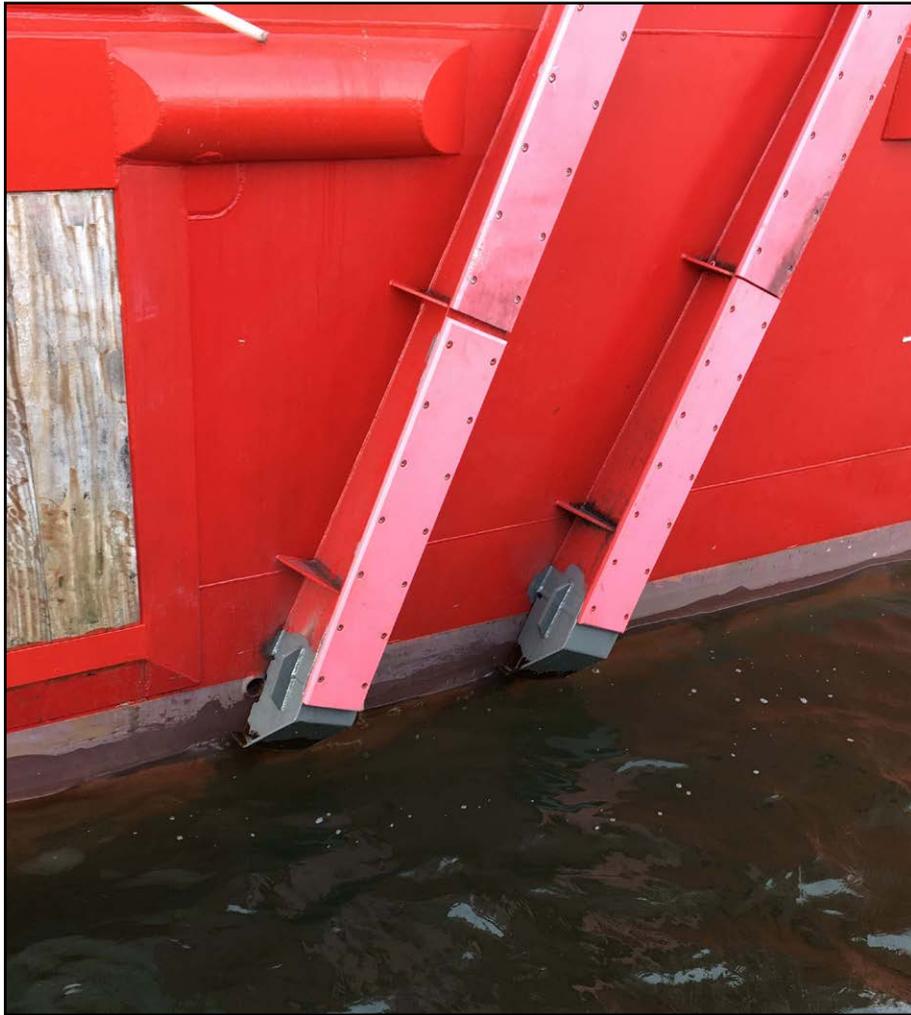
Figure 3: Modifications to fender ends after the accident

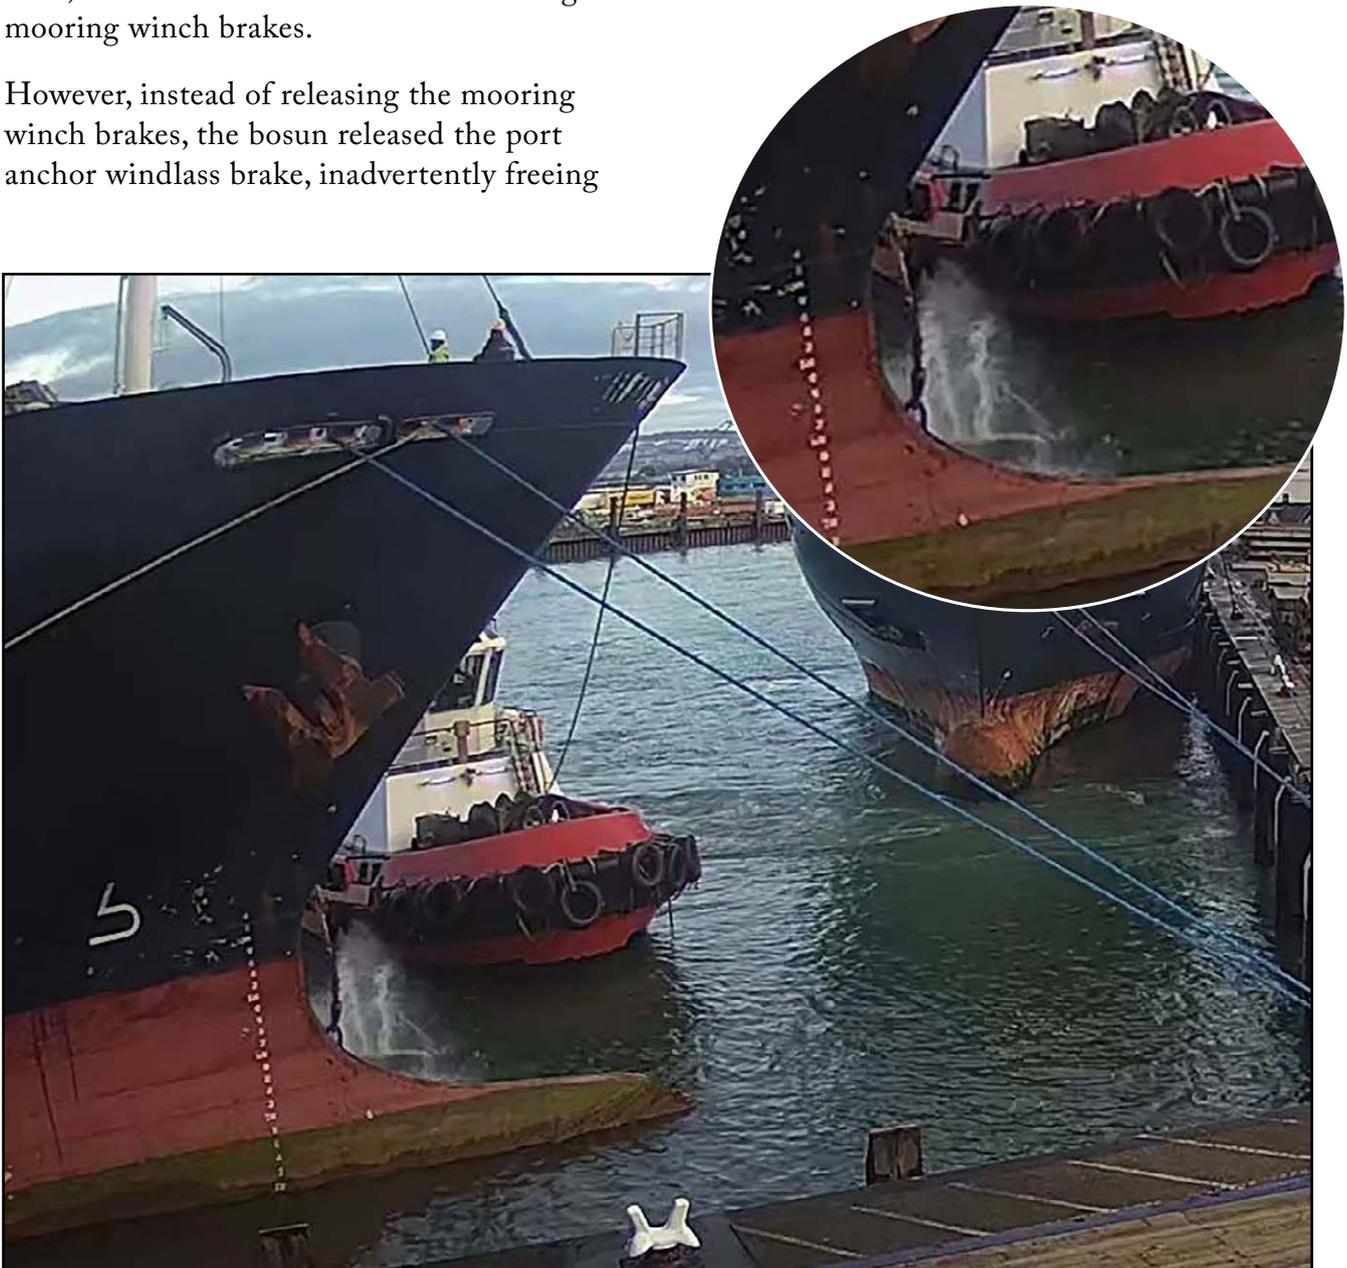
the port anchor, which dropped into the water extremely close to the tug (Figure 1). There was no damage to either vessel, and the departure proceeded without further incident after the port anchor had been retrieved.

Figure 1: CCTV still image of the moment the anchor splashed into the water

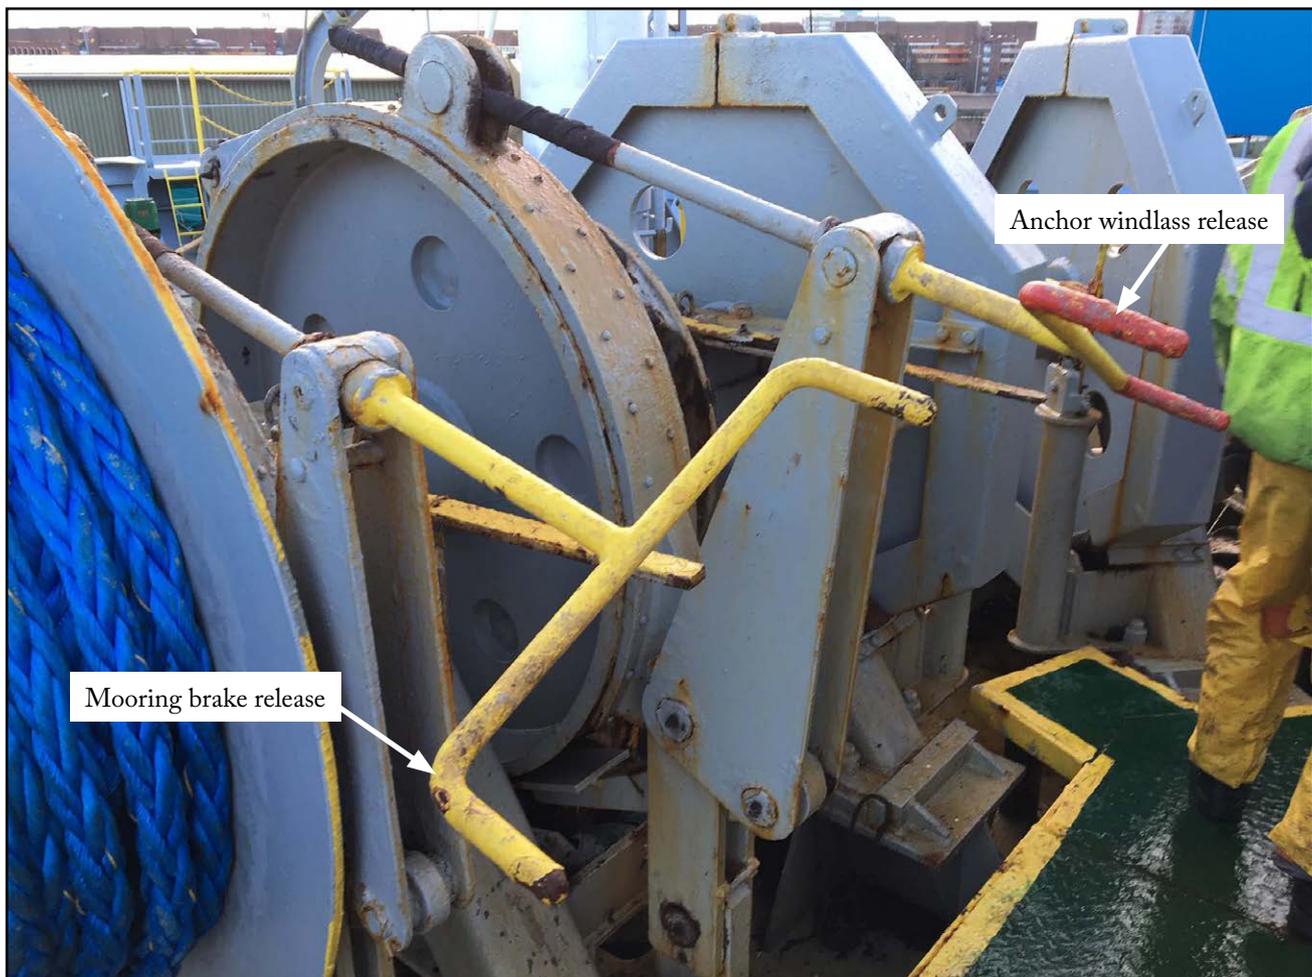
Figure 2: Adjacent mooring winch and anchor windlass brake handles

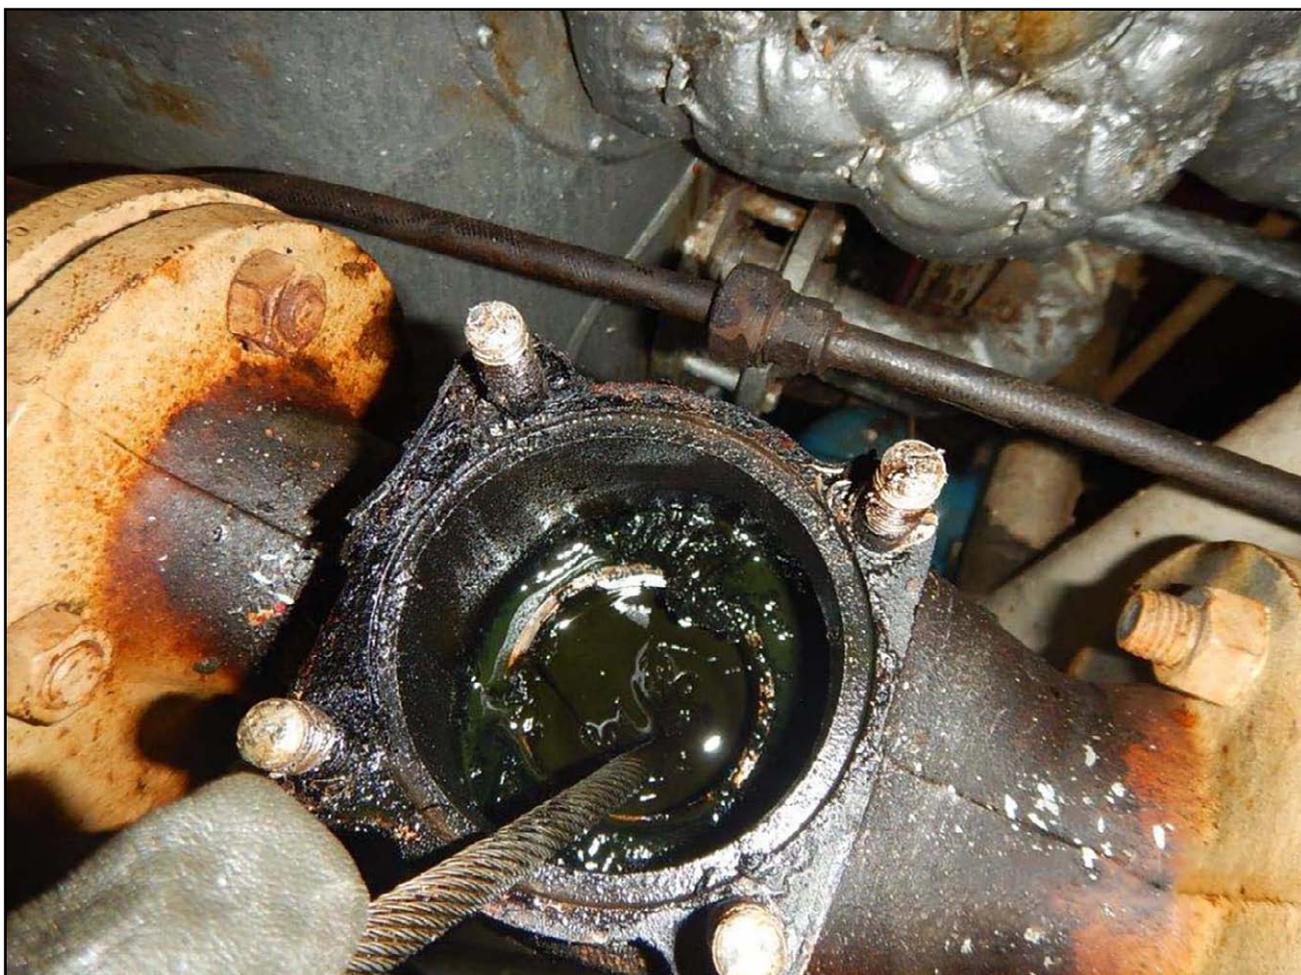
Figure 1: One of the cruise ship's fuel filters after the incident, clogged with the waxy fuel

In this case, the ship had been operating in Arctic waters where the air temperature had dropped to minus 14°C and the sea temperature was between 3°C and 5°C. In these conditions, the ship's engine room ventilation system allowed the ambient temperature to drop to very low levels, resulting in significant cooling of the MGO pipework. This created the environment for the crystals to form in the MGO fuel lying dormant in the supply pipework, which blocked the filters soon after the MGO fuel supply was selected. A number of actions could have been in place to minimise this risk, specifically: pipework insulation, pipework heating, circulation of the fuel back to the service tanks or the use of a fuel additive.

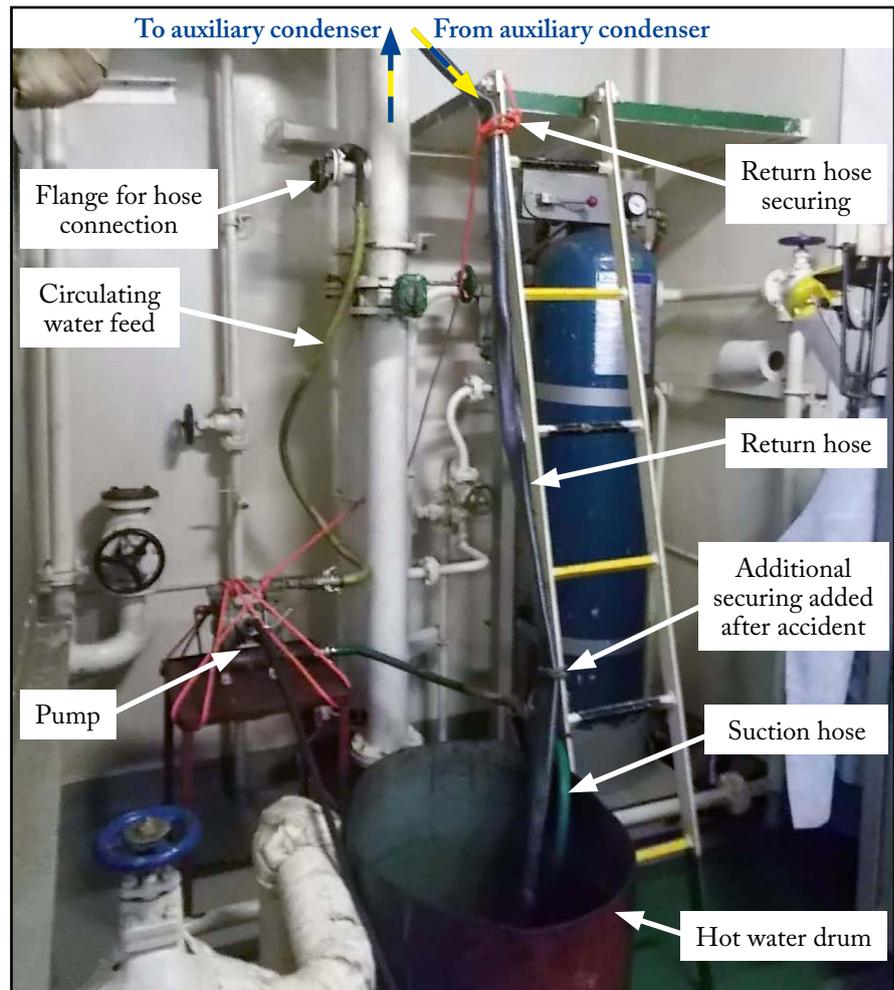
Figure: Auxiliary condenser cleaning arrangement in the post-accident condition

1. Consider securing arrangements carefully when rigging equipment for cleaning or other maintenance tasks. In this case the return hose flipped out of the drum because the securing arrangement at the top of the ladder caused a bottle neck effect and there was no securing at the lower end to prevent the moving hose escaping the drum.
2. Never underestimate the danger of hot water and the risk of scalding. If possible, check circulating arrangements with water of a lower temperature before introducing water hot enough to cause injury. In this case covering the drum might have been another way to reduce risk by placing a physical barrier between the hazard of the hot water and the crew.

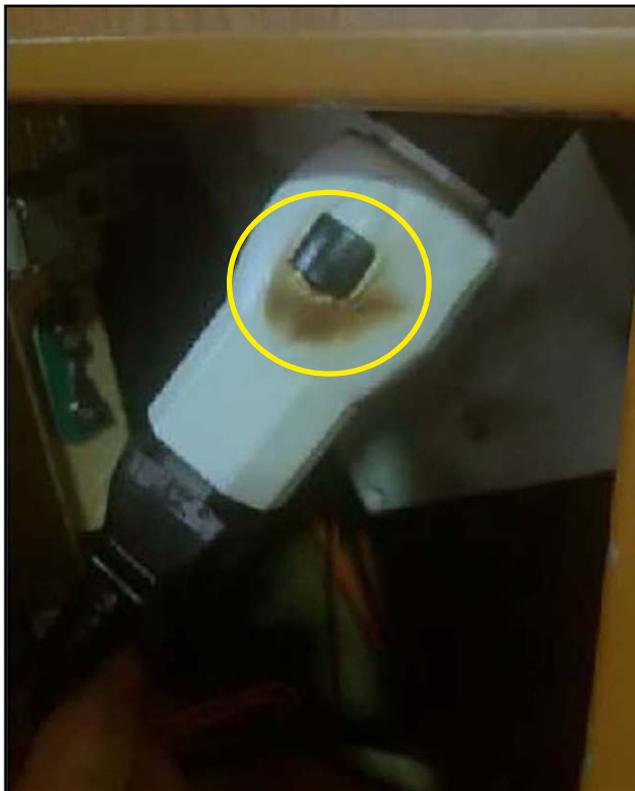
Figure 1: Surge protection system

The ferry owner's investigation identified that the surge protection units were unnecessary as the vessel's electrical systems were already protected with circuit breakers and the information screens had individual protection fuses. As a precaution, the owners removed the surge protection units and replaced the 100 volt transformers on all their ferries.

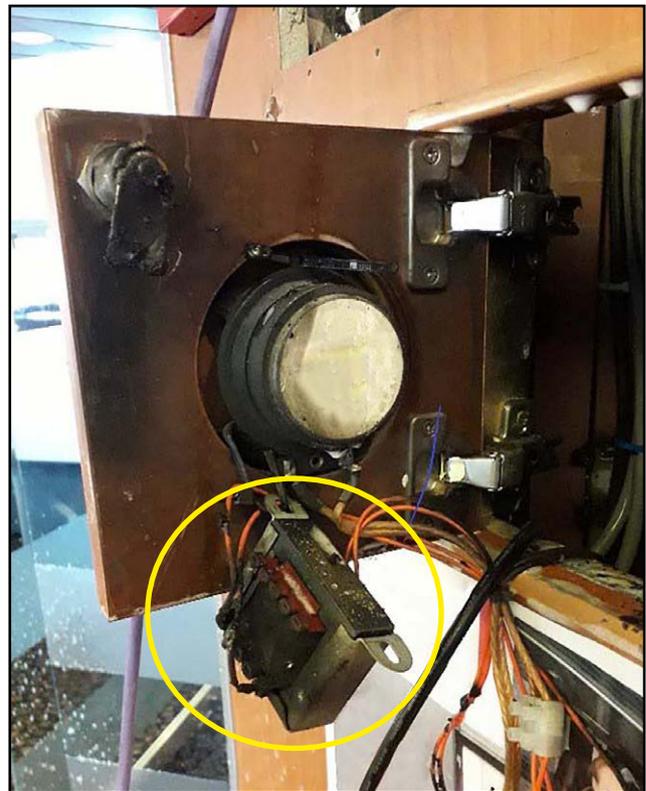
Figure 2: Overheated 100 volt speaker transformer

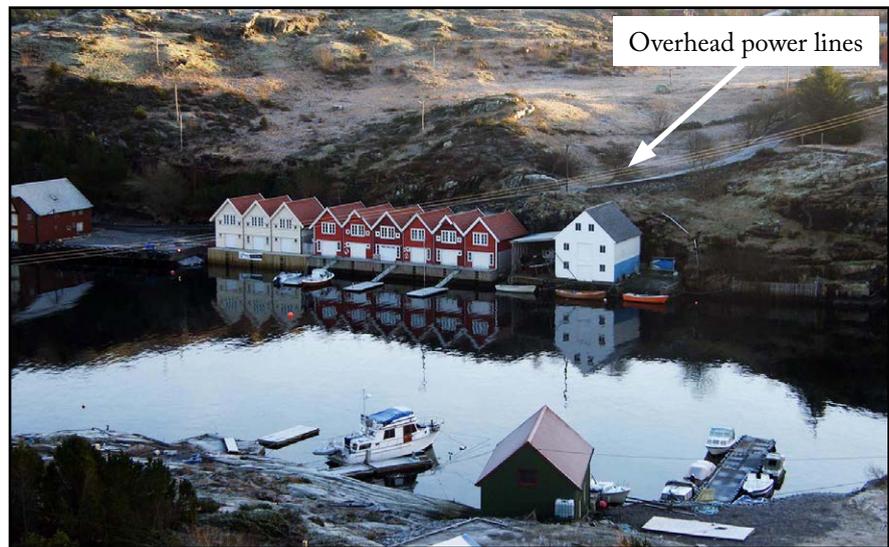
Figure: View of the harbour entrance showing the overhead power cable hazard

observed that the top of the mast had passed very close underneath power cables that were suspended above the harbour entrance (see figure). Once the vessel was alongside, the skipper discovered that all of the electronic systems that were connected through the mast had ceased to function.

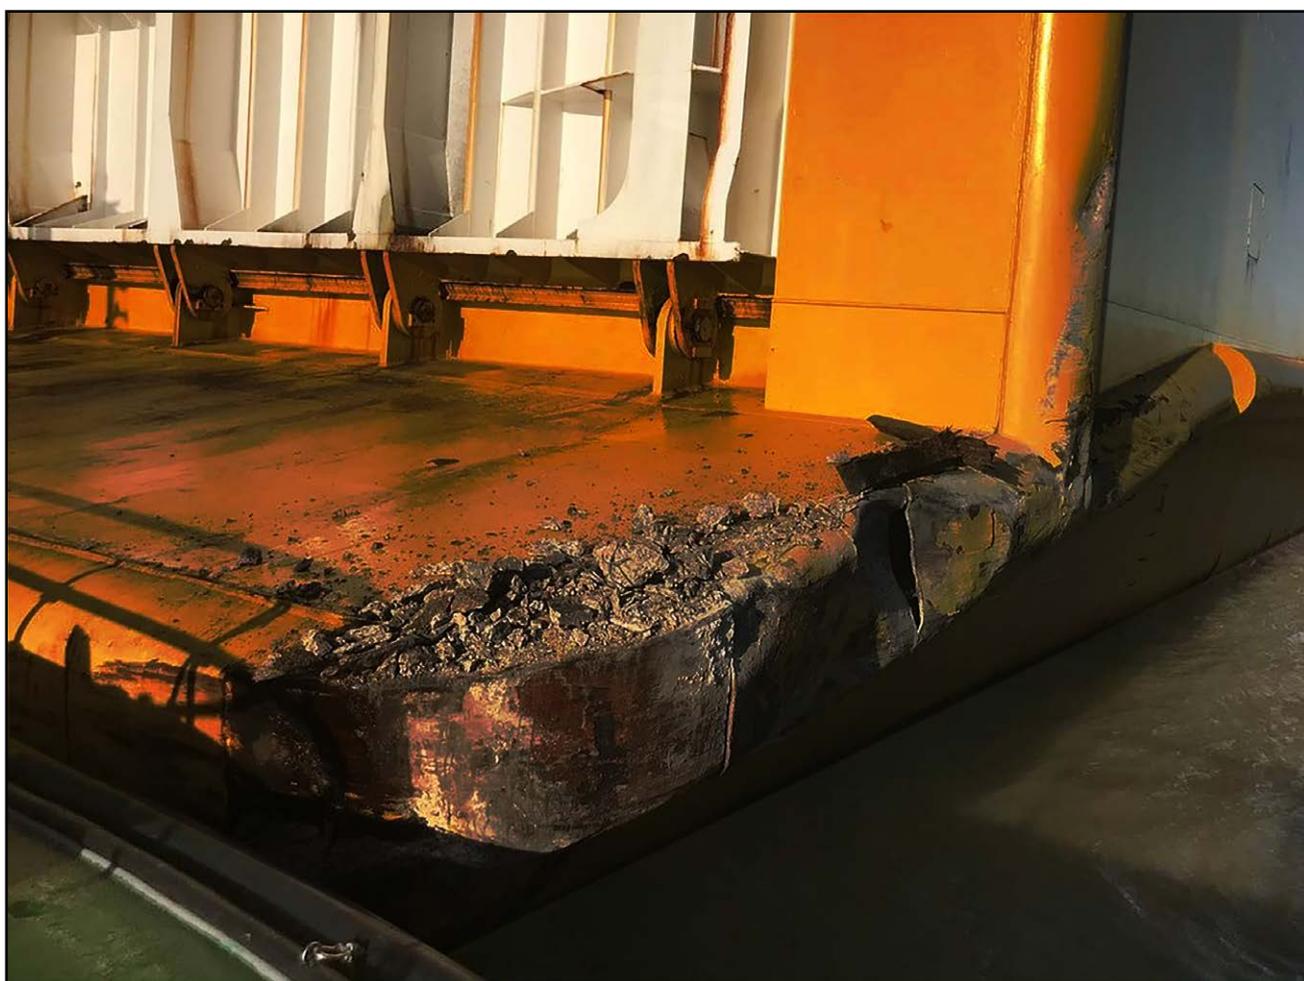
Observing that the wind was 22kts, the master's plan was to exit the harbour directly by going astern. Having unberthed the ferry, the wind started to increase, and the master struggled to maintain control. However, he pressed ahead with the plan. When approaching the breakwater, the wind was in excess of 30kts and control of the ferry was lost when both bow thrusters failed. The ferry then made heavy contact with a quay wall, resulting in damage to its starboard quarter (figure); there was also damage to the quayside.

Figure: Damage to the ferry's starboard quarter

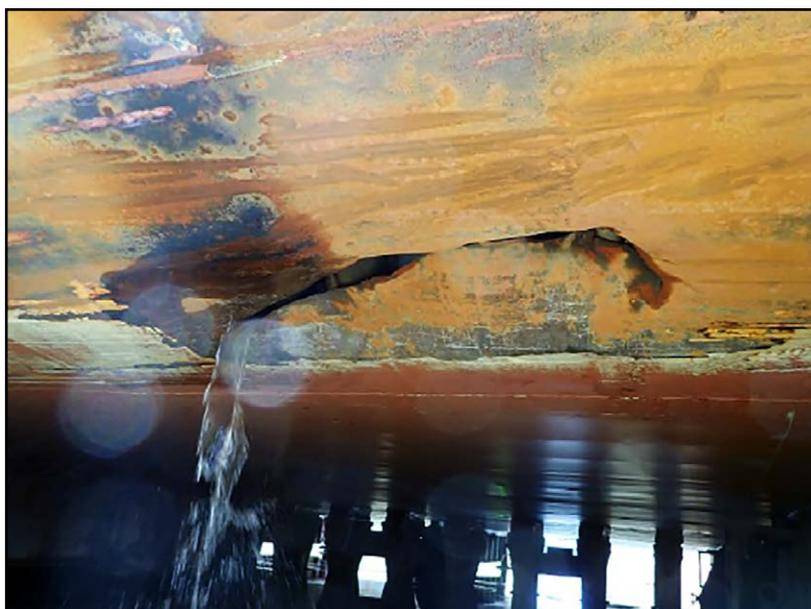
After the accident, the harbourmaster conducted an investigation, including an independent survey. The investigation revealed that, in several areas of the harbour, the actual depth of water was significantly less than shown on the contractor's locally produced chart, confirming that the vessel had grounded during its approach to the berth.

Figure: Detail of the hull damage to the bulk carrier's shell plating

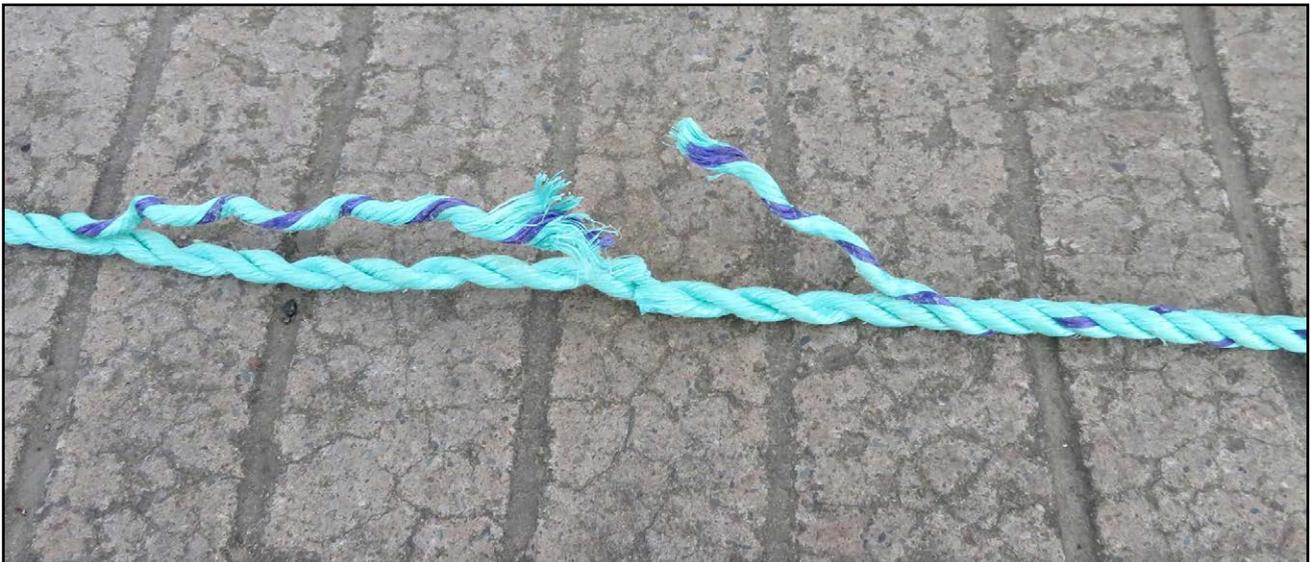
Figure 1: The partial cut in the back rope

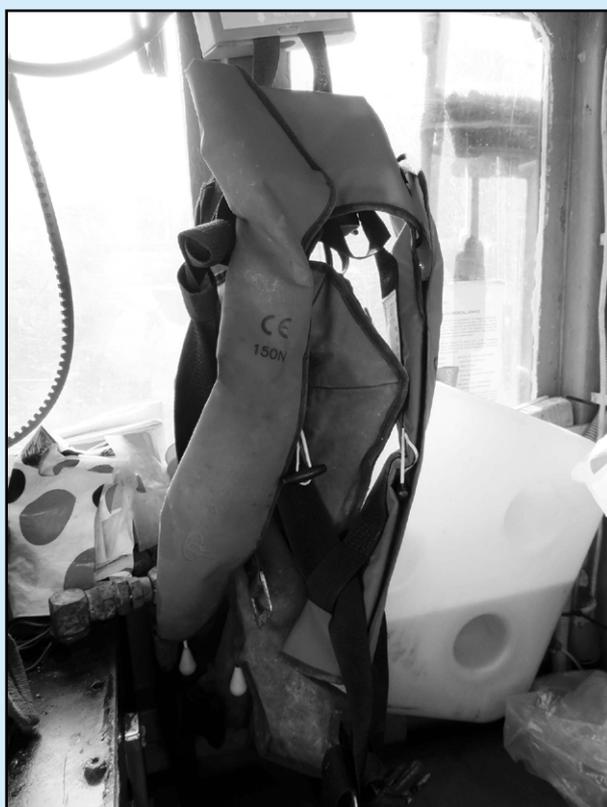
1. The missing skipper had been seen earlier in the day wearing an auto-inflate lifejacket. However, when he was recovered from the water he was not wearing it, and it was later found hanging up in the boat's wheelhouse (Figure 2).

Figure 2: The skipper's lifejacket as found

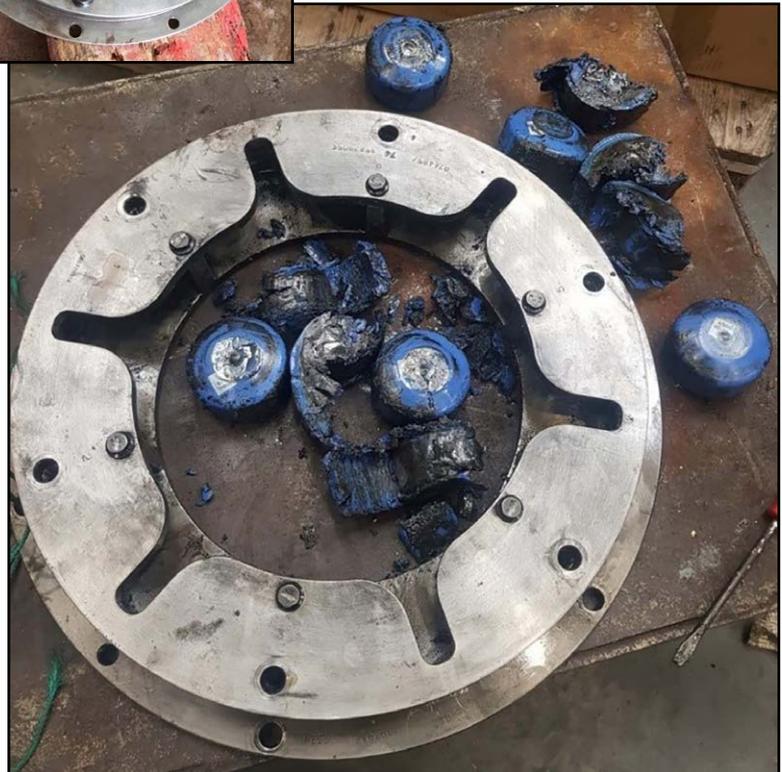
A gearbox inspection revealed that all 12 of the coupling pads had disintegrated to varying degrees (see figure). As the vessel carried no spare coupling pads, the vessel's engineer was unable to restart propulsion. The skipper called the coastguard for assistance. An hour and a half later a lifeboat was on scene to tow them to the nearest harbour.

The coupling pads were subsequently examined by the gearbox manufacturer and it was established that they were of the wrong type. They were not designed for varying torque applications such as a propulsion shaft gearbox

Figure 1: Damaged coupling pads (inset: new coupling and pads)

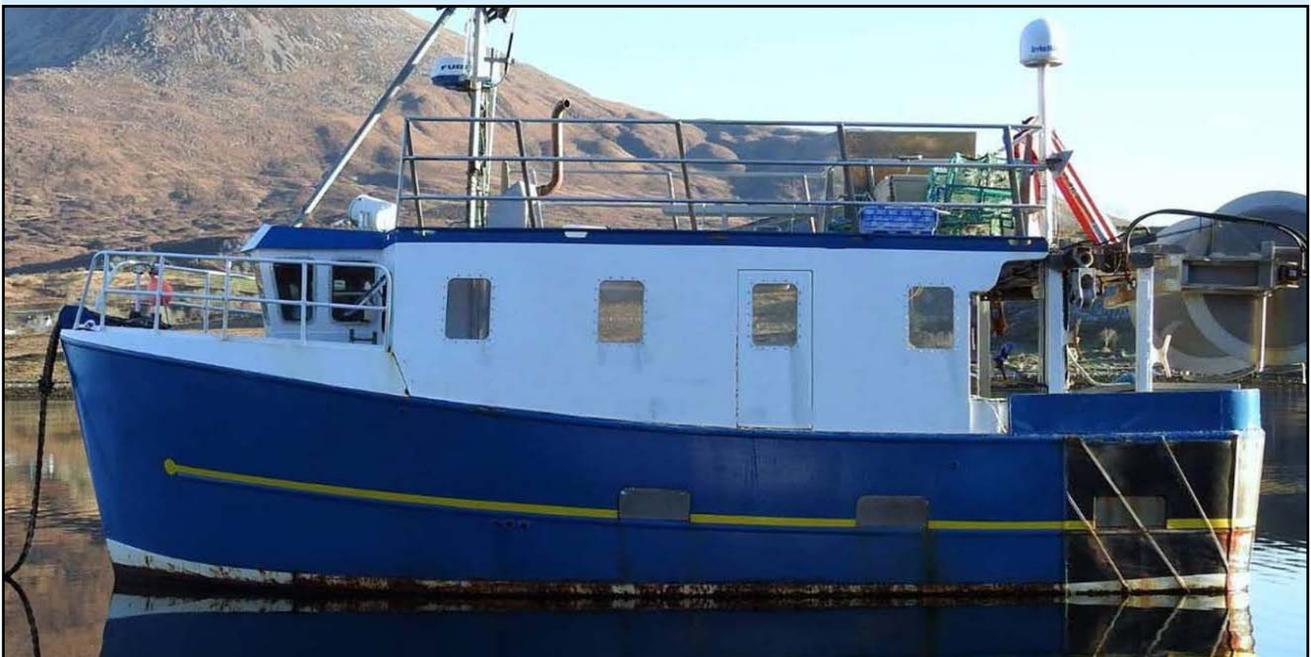
This fishing vessel had been extensively modified from its original design. Modifications made prior to the change of ownership included: the addition of a shelter deck, which extended almost the full length of the vessel; a hydraulic hauler, which weighed 400kg and was fitted 2 metres above the deck; and a vivier tank for storing live catch. Figures 1 and 2 show the vessel before and after the modifications. No checks on the vessel's stability had been made by the previous owner and the new owner assumed that it was safe. When heading to sea on the day of the accident, the boat was heavily loaded with strings of creels ready to lay for the first time. The combined effects of the modifications and the excessive loading high up created the unstable situation, resulting in capsizing and placing the lives of the crew in immediate danger.

Figure 2: The vessel post-modification and prior to the accident
