# **SAFETY DIGEST**

**Lessons from Marine  
Accident Reports  
2/2020**

**SAFETY DIGEST**  
**Lessons from Marine Accident Reports**  
**No 2/2020**

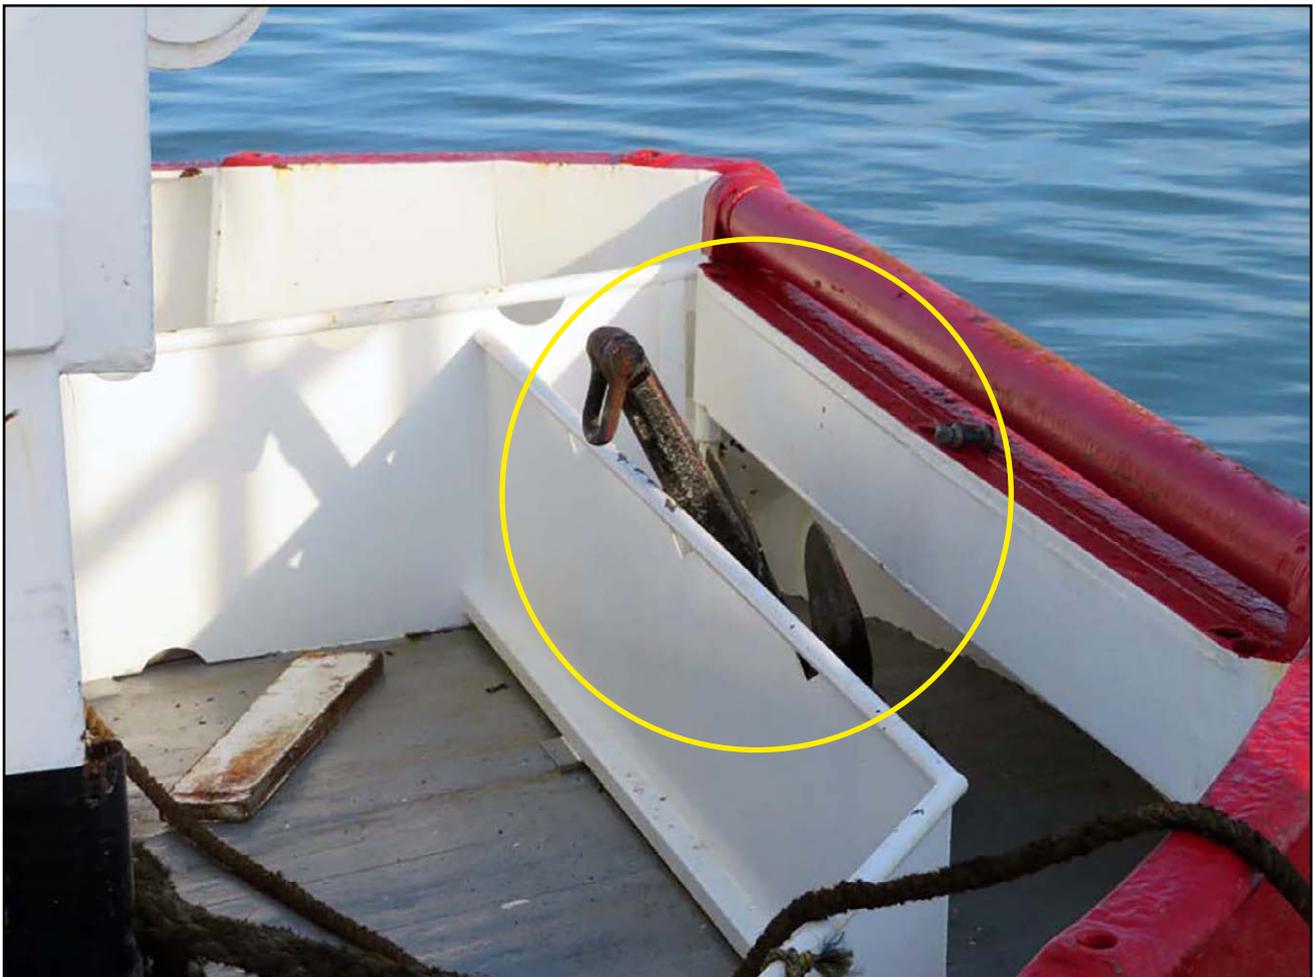
2. The fishing vessel's anchoring arrangement involved connecting a chain and rope to a kedge-type anchor (see figure) that was then deployed over the stern using a small crane. The anchor was routinely stored disconnected from the chain and rope and was not ready for quick use. Anchors are essential safety equipment and must be quickly deployable in an emergency. This is especially important when operating close to land, such as when entering or leaving harbour. If your engine is disabled and help is not close by, then anchoring before you drift into danger will often be the best option. At the very least, it gives more time for help to arrive and gains time to assess the problems and possibly make repairs.

Figure: Anchor stowed at stern, not connected to chain/rope

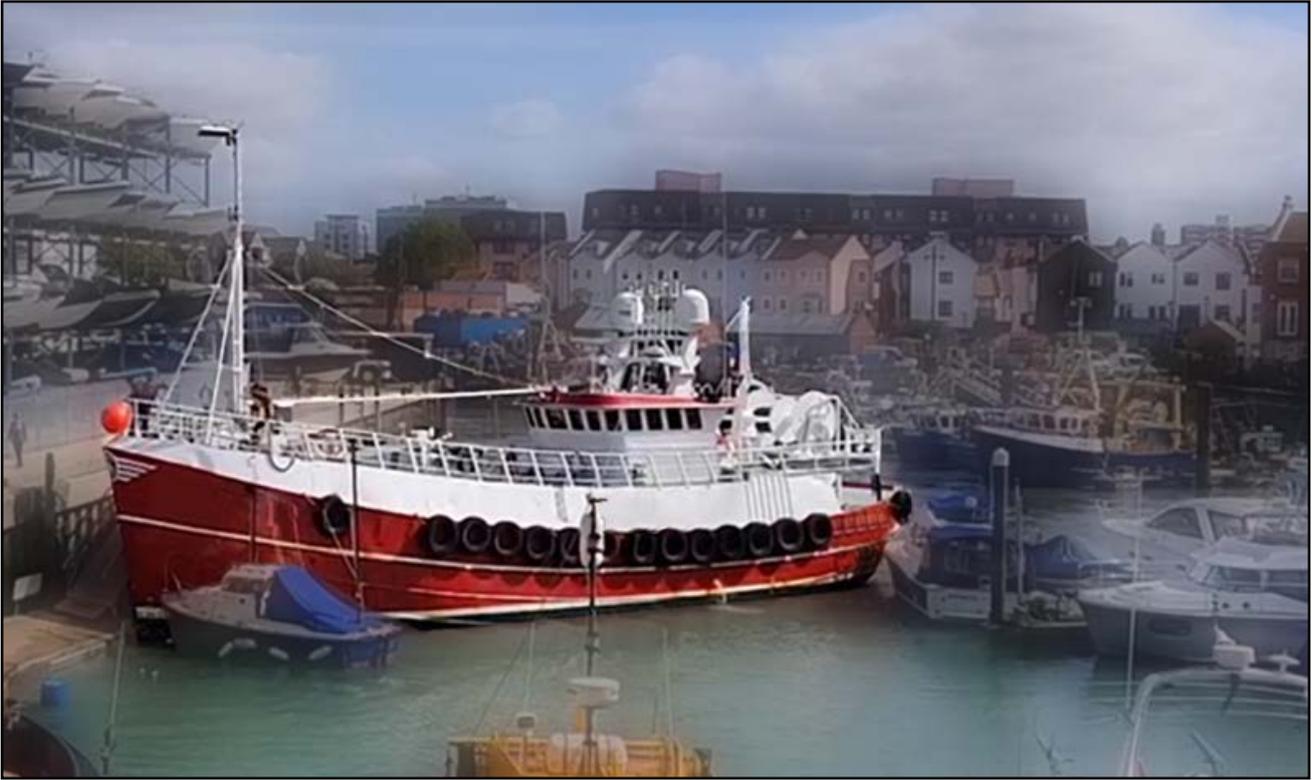
Figure 1: Fishing vessel coming to rest after damaging other vessels

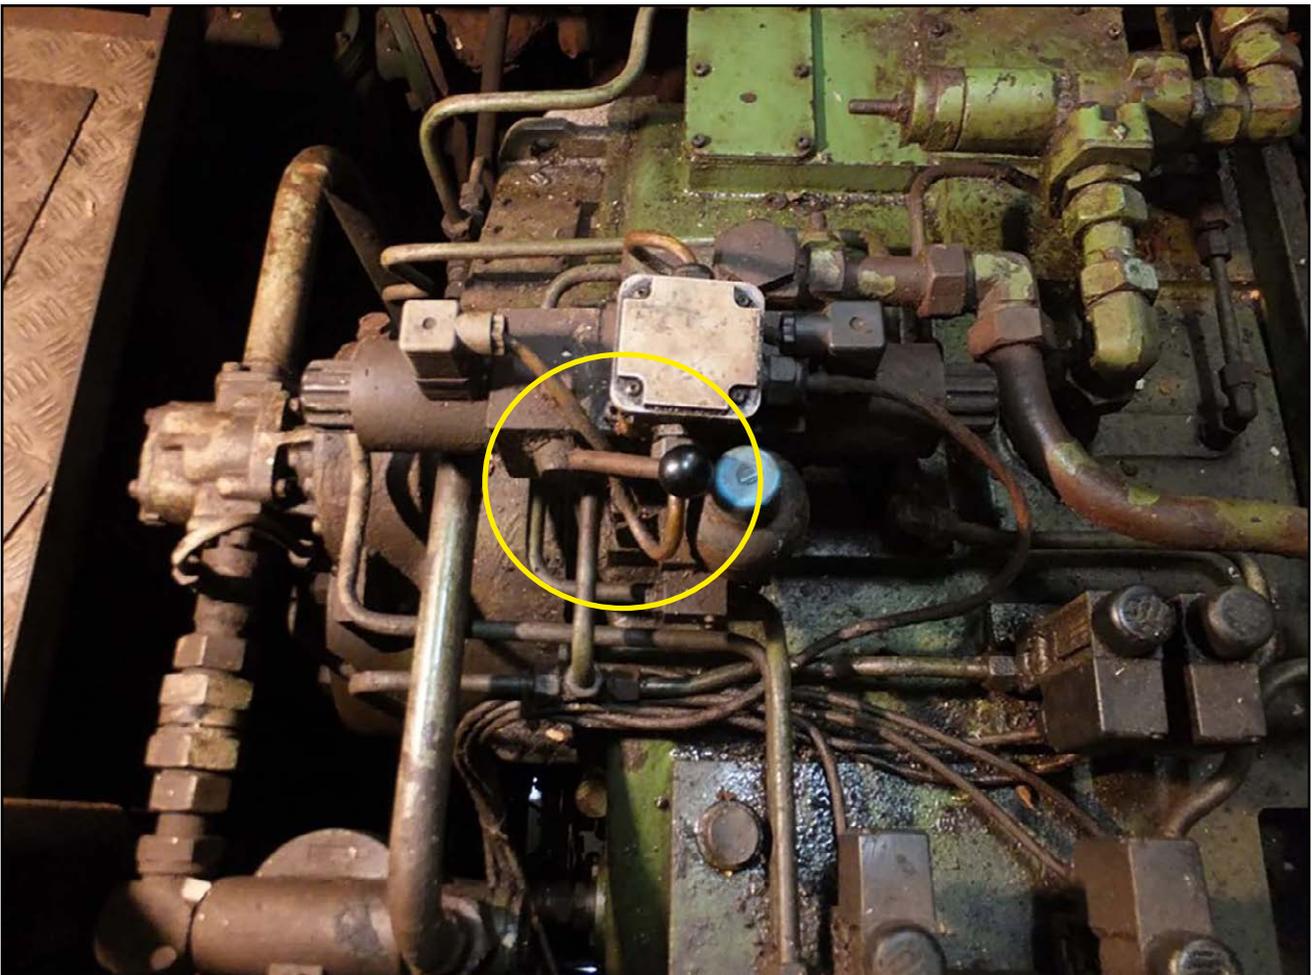
Figure 2: Gearbox override lever in the ahead position
