# MARITIME FEEDBACK

Issue 66  
February 2022

An independent and confidential reporting system for the maritime industry

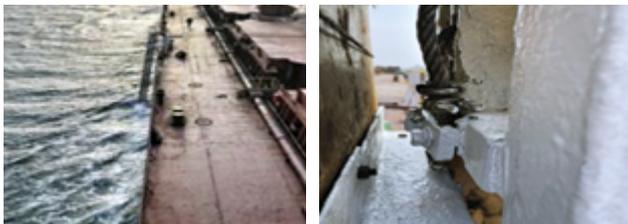
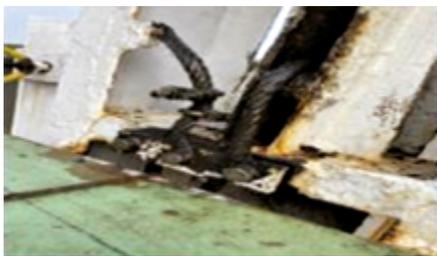
M1852

A pilot boarded a ship using a combination rig. After their embarkation, and while the accommodation ladder was being recovered, the wire falls parted, and the accommodation ladder dropped to the sea and trailed in the water as the vessel was underway to the port. The Master alerted the pilot to what had happened when the pilot reached the bridge.

A subsequent inspection revealed that the bolts securing the wire had failed. A full port state control inspection took place the next day following a report on the incident. The accommodation ladder had been inspected by a classification society 18 months earlier.

The Master undertook remedial action with respect to the accommodation ladder and the fall securing.

Reducing the periodicity for changing the falls to between 18 and 30 months for vessels that have accommodation ladders in these exposed areas should be considered, as should changes to the design for securing the falls. However, thorough maintenance must always be provided to the wires, sheaves and fixtures no matter how difficult the access to the wires may be.

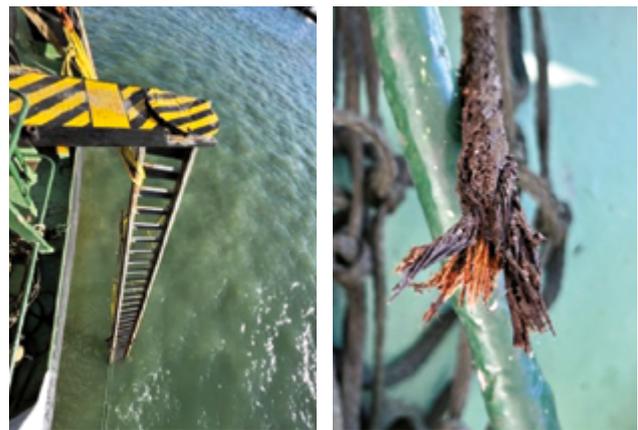
The photographs shown below highlight another failure of a gangway that has just occurred at the time of writing this report where the gangway wire had parted just after the pilot boarded the vessel.

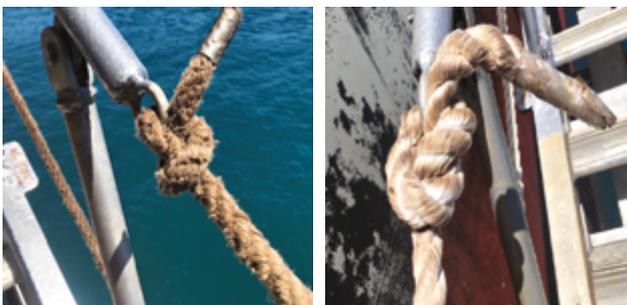
### M1875

While boarding a vessel at sea a pilot found that the combination ladder was affixed solely by overhand knots (see pictures). These easily unravel if there is strain from the standing part of the rope, e.g., under the weight of a pilot as they ascend or descend the ladder. This type of knot must never be used in the rigging of a pilot ladder or gangway.

The repeated use of overhand knots in this case indicates that either the officer did not correctly supervise and inspect, or that the crew have become desensitized to a deviance from standard procedures: the local practice on the ship or within the company for securing the pilot ladder rope with an overhand knot had become the accepted norm.

The correct knot in these circumstances is either a round turn and two half hitches or a bowline. The rigging of a gangway which is to be used as part of a combination ladder arrangement is a task normally undertaken by 2-3 deck crew. It should then be inspected by the officer detailed to meet the pilot.

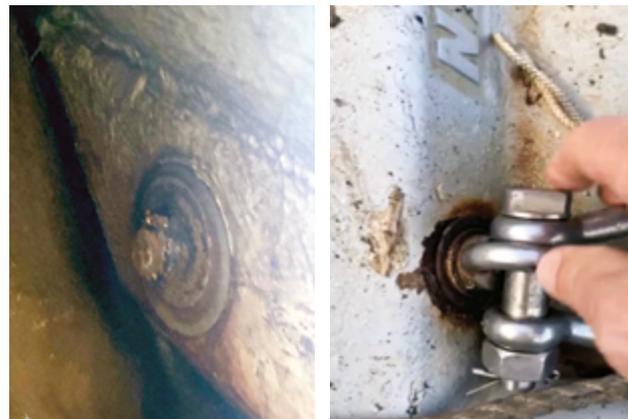
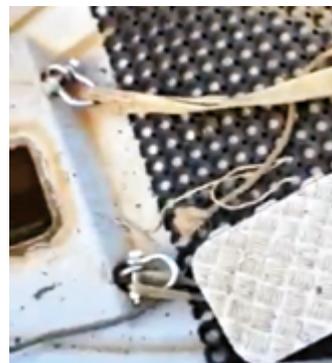
A new crew member inspected the ship's lifesaving equipment to familiarise themselves with the equipment on board. They discovered that the lifting eyes in the ship's workboat were damaged and loose, which meant it was not the eyes carrying the load but a length of threaded bar which appeared poorly maintained. If the lifting eyes had failed while the boat was being lifted it could have resulted in serious injury to the two crew members who are ordinarily inside when it is lowered into the water.

The condition of the items in the photographs suggest that neither inspection nor maintenance routines were effective, and that the boat's crew were either unaware that the lifting eyes were in a dangerous condition or did not feel empowered to report their concerns.

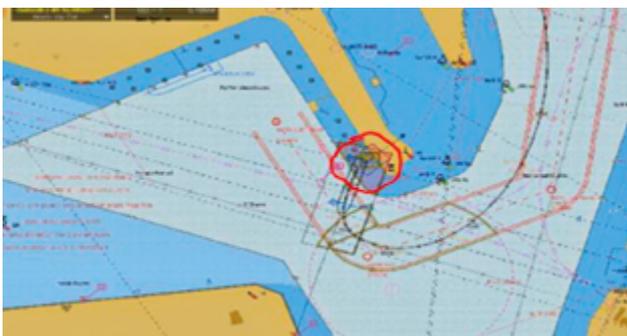
As it passed the mooring dolphin, the vessel turned short round to port, assisted by the tugs. About 5 minutes later the officer at the stern alerted the bridge that the vessel was drifting towards the end of the breakwater. The current was running in an easterly direction during the turn to port, which caused the drift, although the pilot believed that it was running in a westerly direction. The pilot gave several engine orders from dead slow to full ahead to increase the distance from the breakwater, but a noise was heard on the port quarter. Following checks within the engine room to ensure the hull was not breached, the vessel berthed port side alongside at the oil terminal.

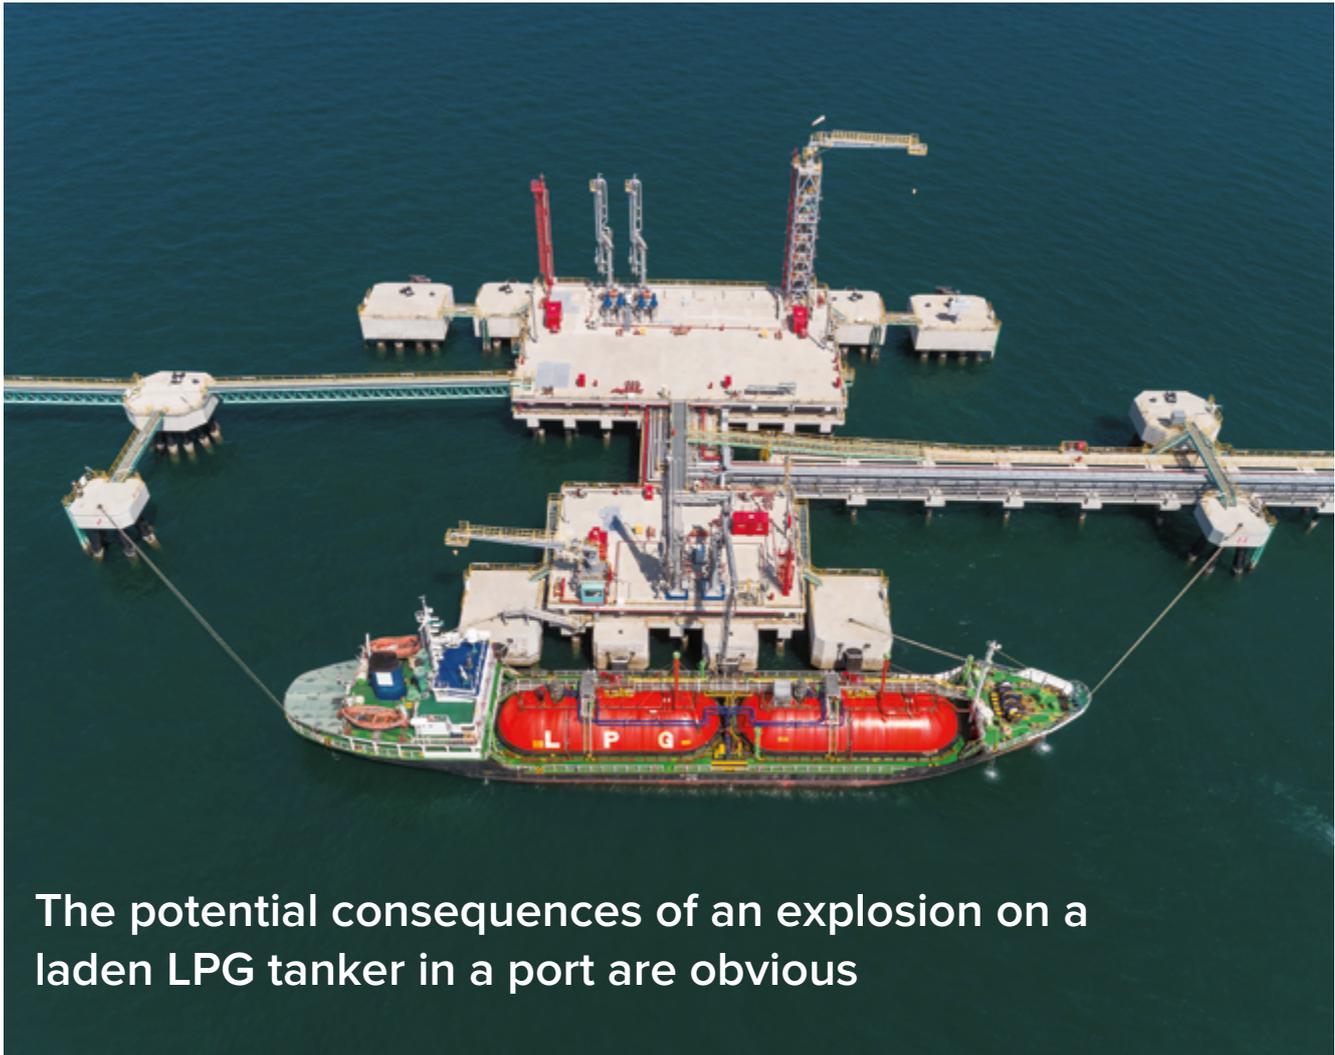
Once the smoke had cleared it was discovered that loose screws were allowing lubricating oil to leak onto the hot motor which started to combust. To enable the vessel to sail, the Master allowed the winches to be restarted for a very short time to allow mooring ropes to be slacked off before the motors were once again stopped. The ropes were recovered by hand. Keeping the winch switched off was the only sensible precaution to avoid a significant fire or explosion.

The reporter stated that this incident was the result of a near-miss being ignored for a long time, with maintenance

not being done properly because the ship's staff believed that the new ship was poorly built.

After the vessel had departed the port, full cleaning was carried out to thoroughly investigate where the source of the leakage had come from. The engineers carried out maintenance on the winch hydraulic pumps and replaced the gaskets to prevent further leakage.

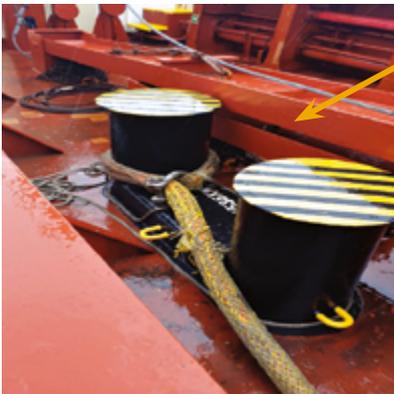
Log stanchion in lowered position

A lumber carrier embarked a pilot as it approached a loading berth where a tug waited to assist. The pilot requested that the vessel secure the tug's line to the mooring bits on the forward deck. After this was achieved, and as the tug came under the line to push up, the tug master realised that his line had been improperly secured: it had been wrapped around the bits and secured with a shackle, rather than the eye being dropped over the top of the bits.

When questioned the master explained that, when lowered, the log stanchions were so close to the bits that they obstructed the bits. The master was informed that they should not use a shackle in future, and that the bits should not be used when the log stanchions were lowered.

The vessel is relatively new, and the deck layout has not been modified since she was built. This suggests that the improper placement of the log stanchion and mooring bits is the product of poor design. This is known as a latent error, and CHIRP believes that there is a high probability that incidents will continue to occur on the vessel because the mooring bits cannot correctly and safely be used as intended. The likelihood of an incident is further increased because of the proximity of the bulwark brackets which create a trip hazard.

The trip hazard and inability to correctly work the mooring bits are evident, and CHIRP is concerned that these had seemingly not been detected either during commissioning trials, during flag and class inspections, or by the crew themselves. CHIRP is also concerned that other vessels of the same design might also contain the same latent design hazards.
