SAFETY DIGEST

Lessons from Marine Accident Reports

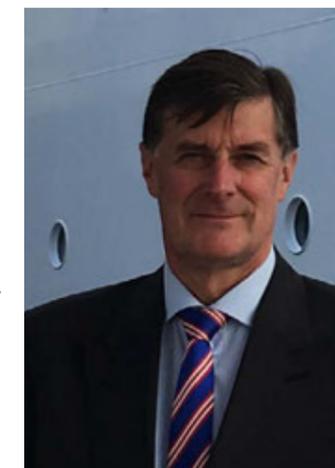
Bob Baker asks the questions, *Why did the officer of the watch switch off guard alarms on radars/ECDIS? And why is failure of the bridge team and poor communications such a fundamental issue and the most frequent cause of incidents in coastal/port waters?* He goes on to talk about the need for a cultural change in the way we embrace safety and in our approach to understanding why accidents happen. I could not agree with him more.

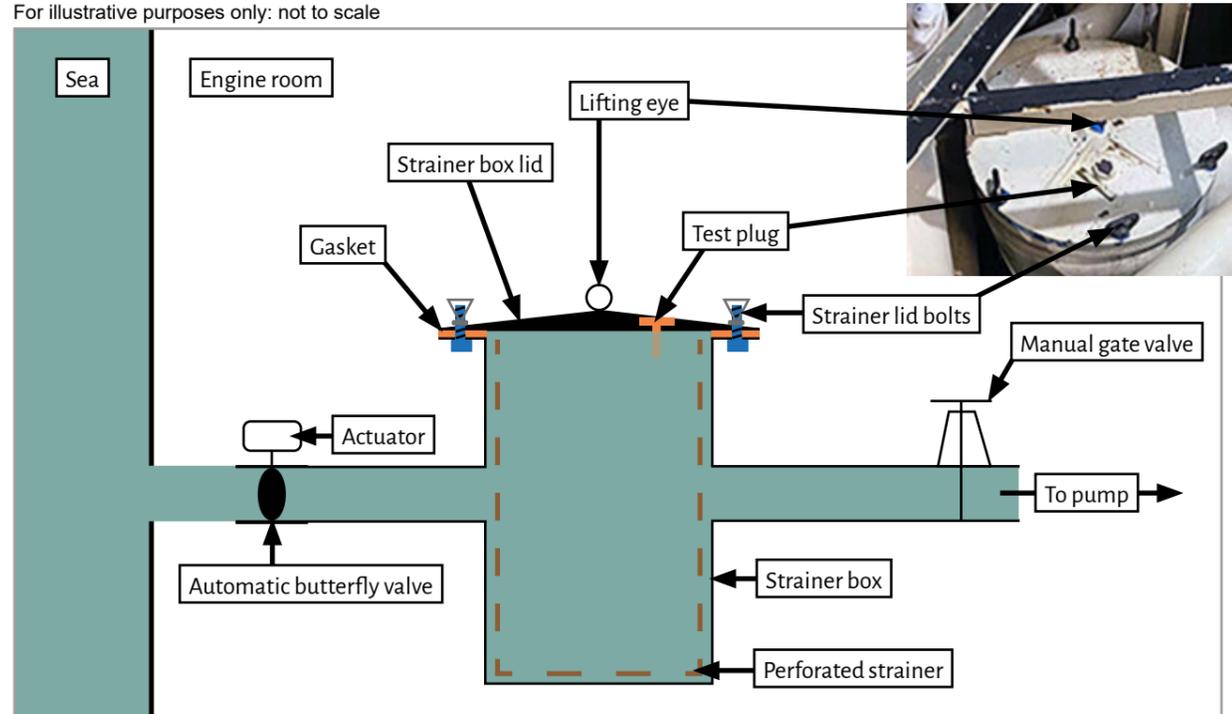
Figure 1: Ballast water valve and strainer arrangements

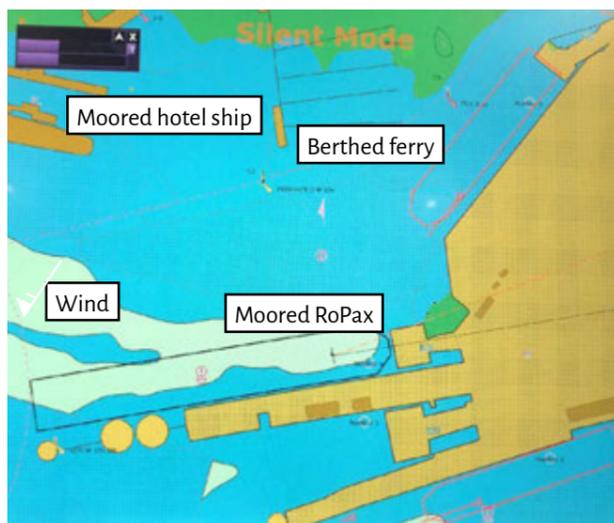
Figure 1: RoPax alongside before the moorings parted

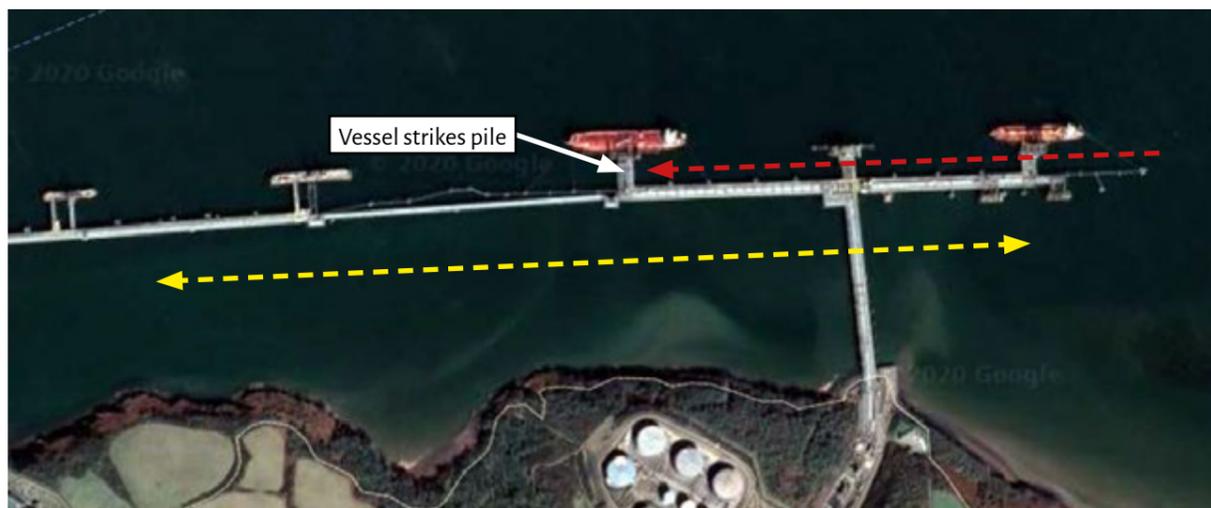
Figure 1: Workboat patrol route

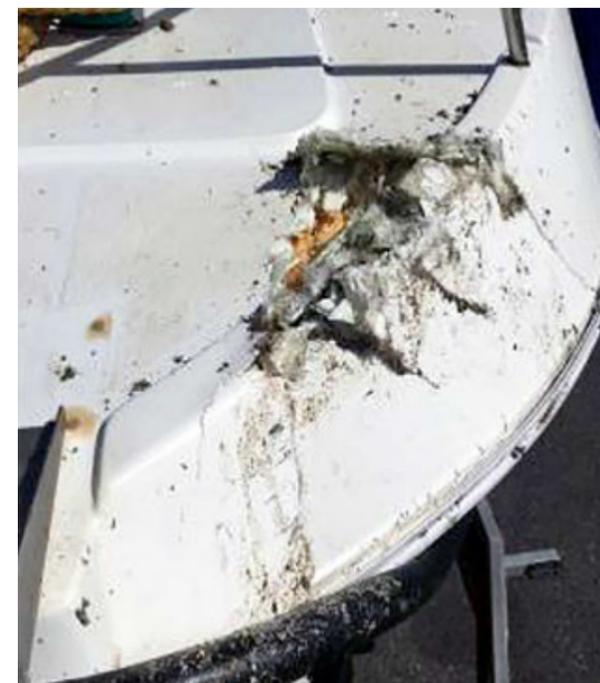
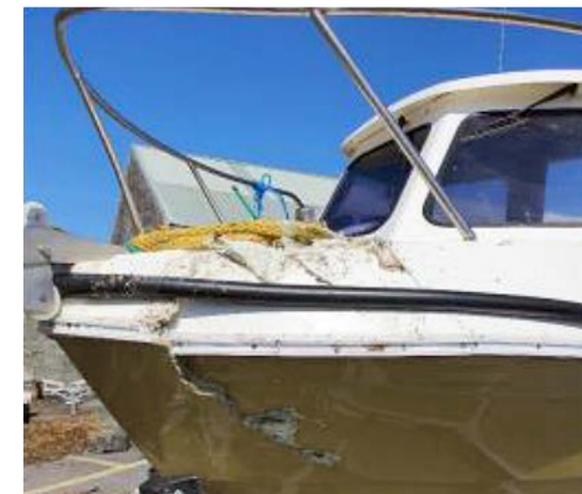
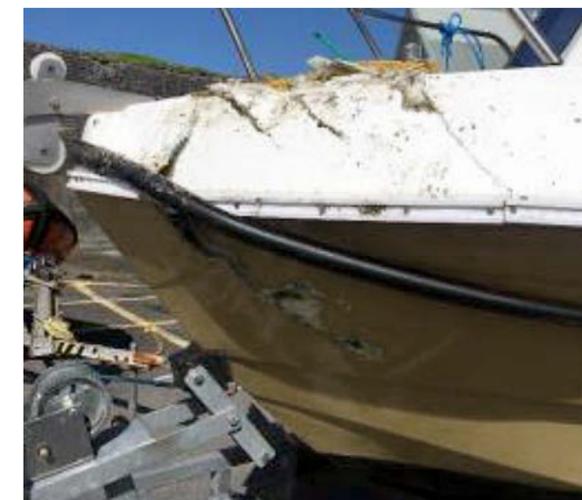
Figure 2: Damage to bow and deck delamination

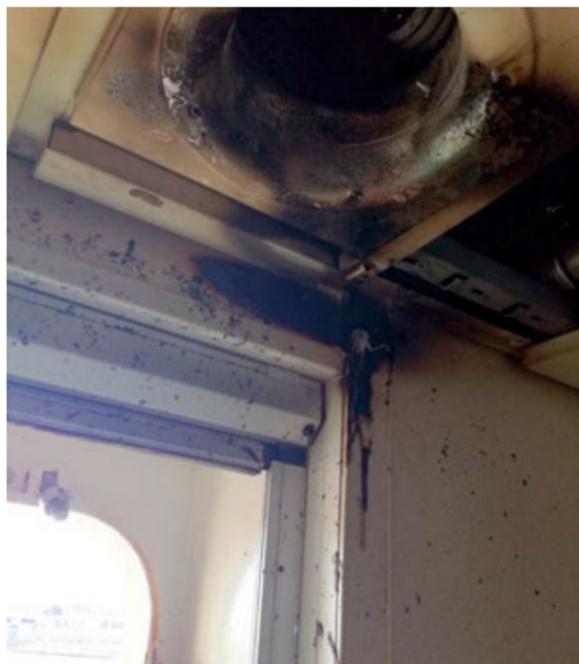
Figure 1: The ventilation duct post-fire

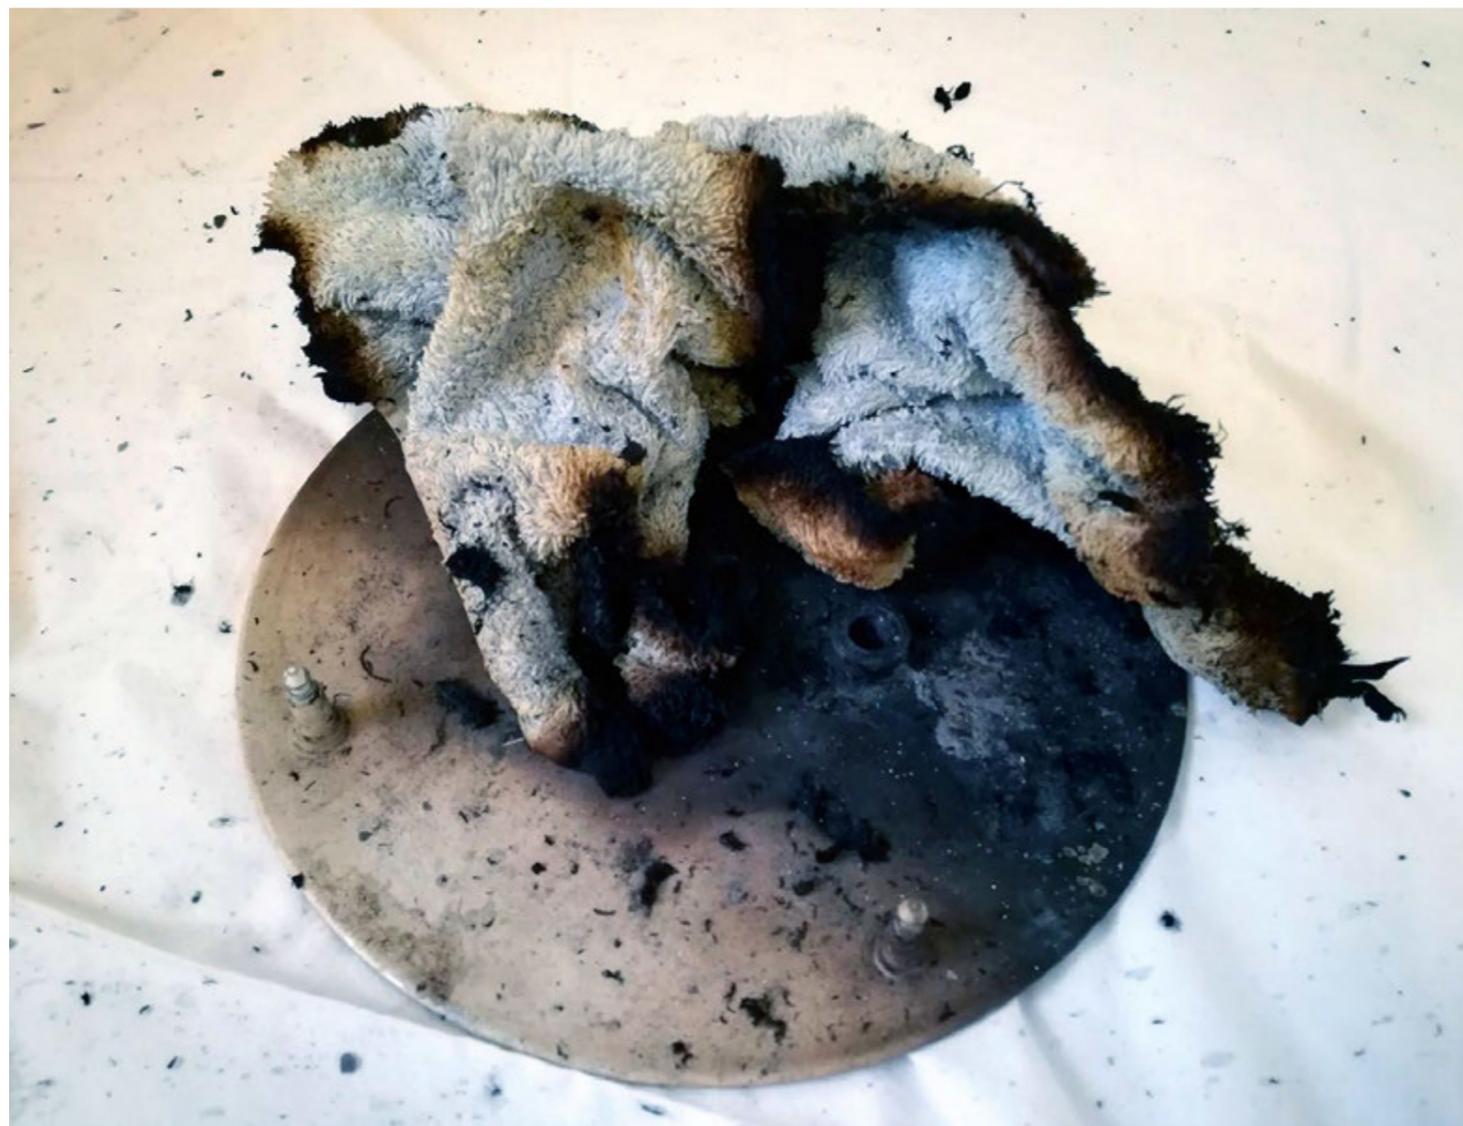
Figure 2: The towel that was stuffed into the ventilation duct

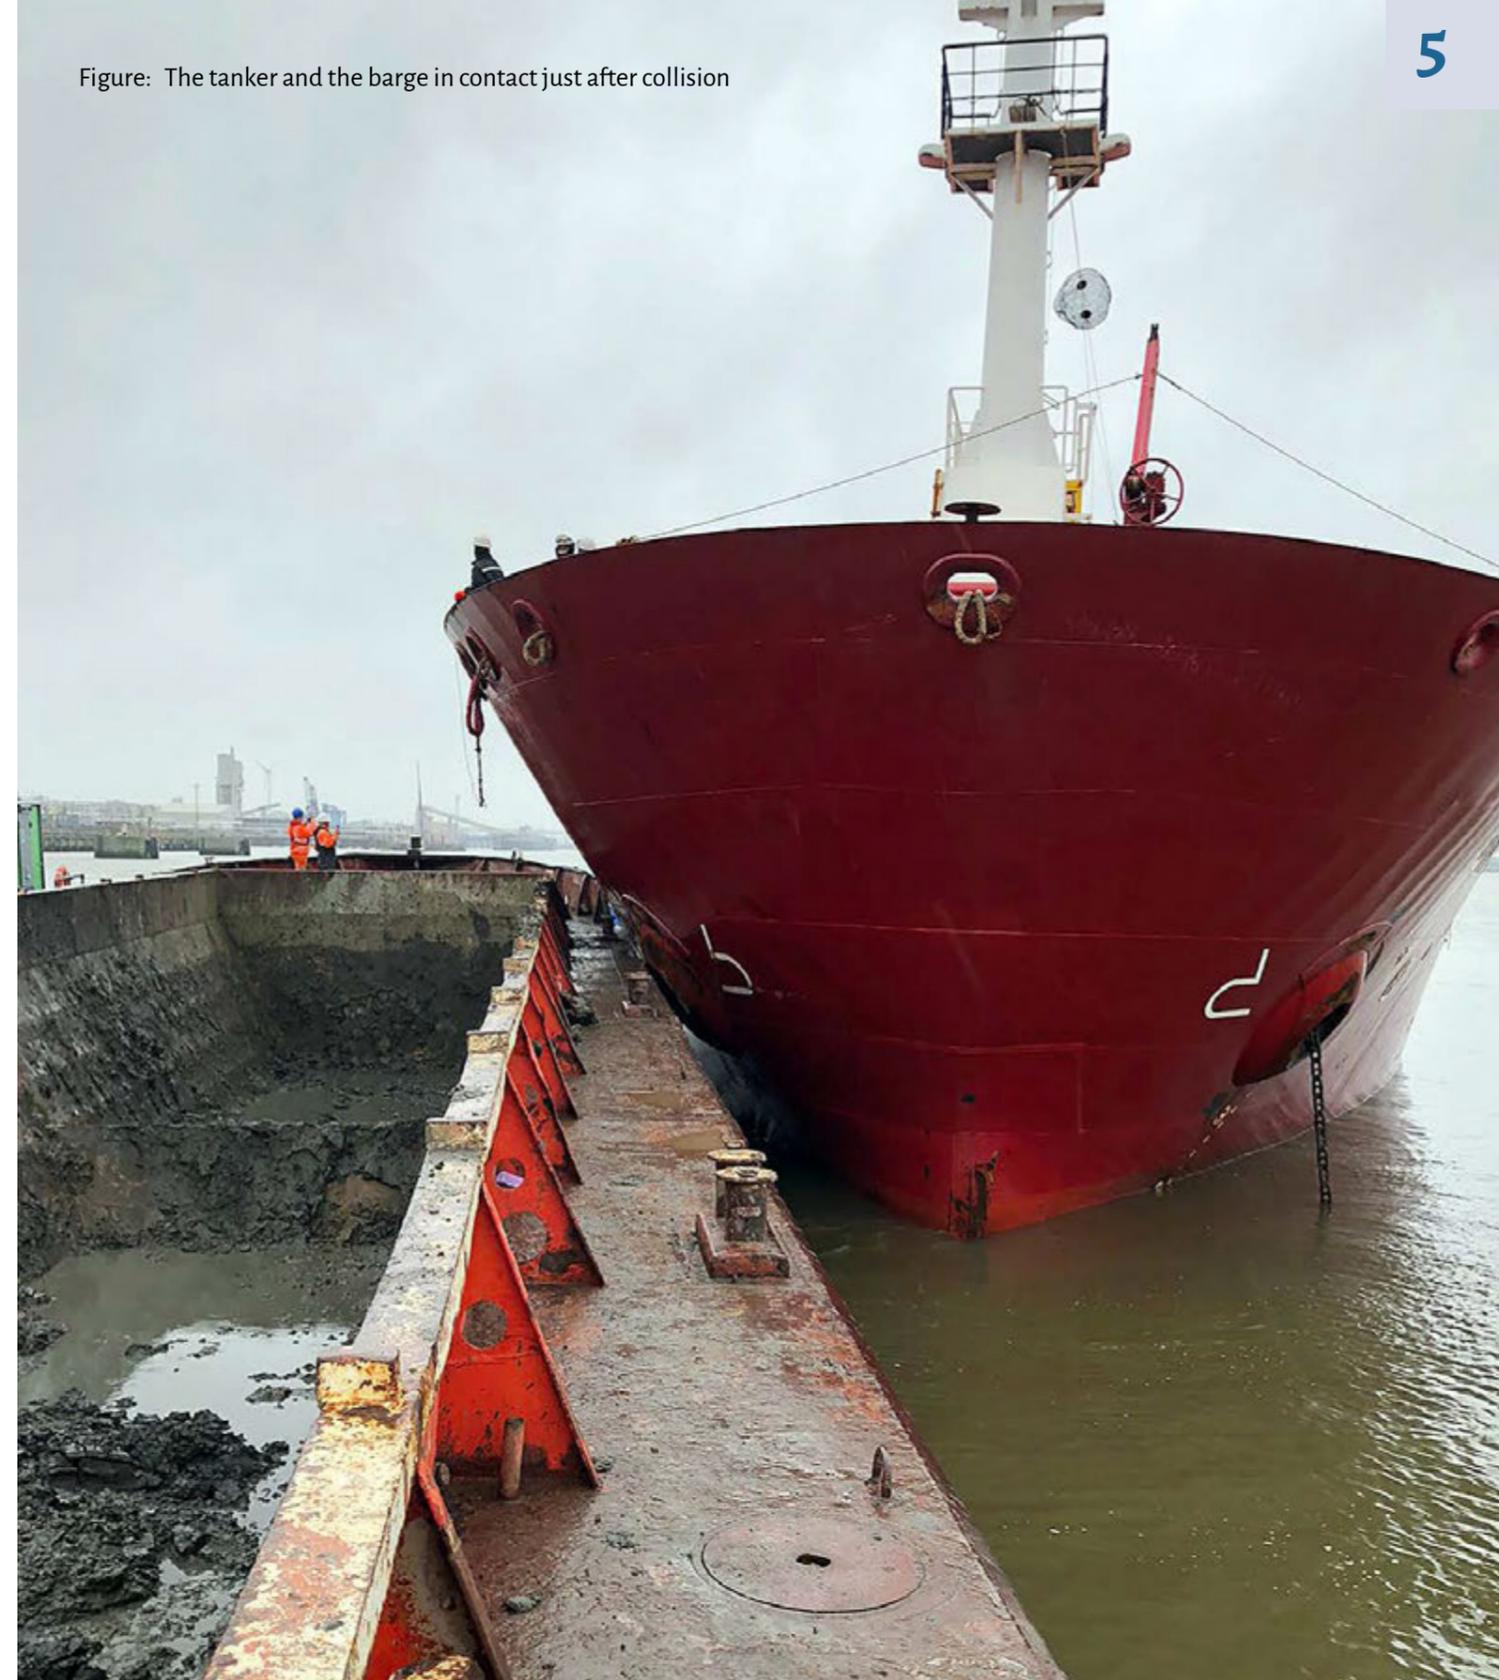
Figure: The tanker and the barge in contact just after collision

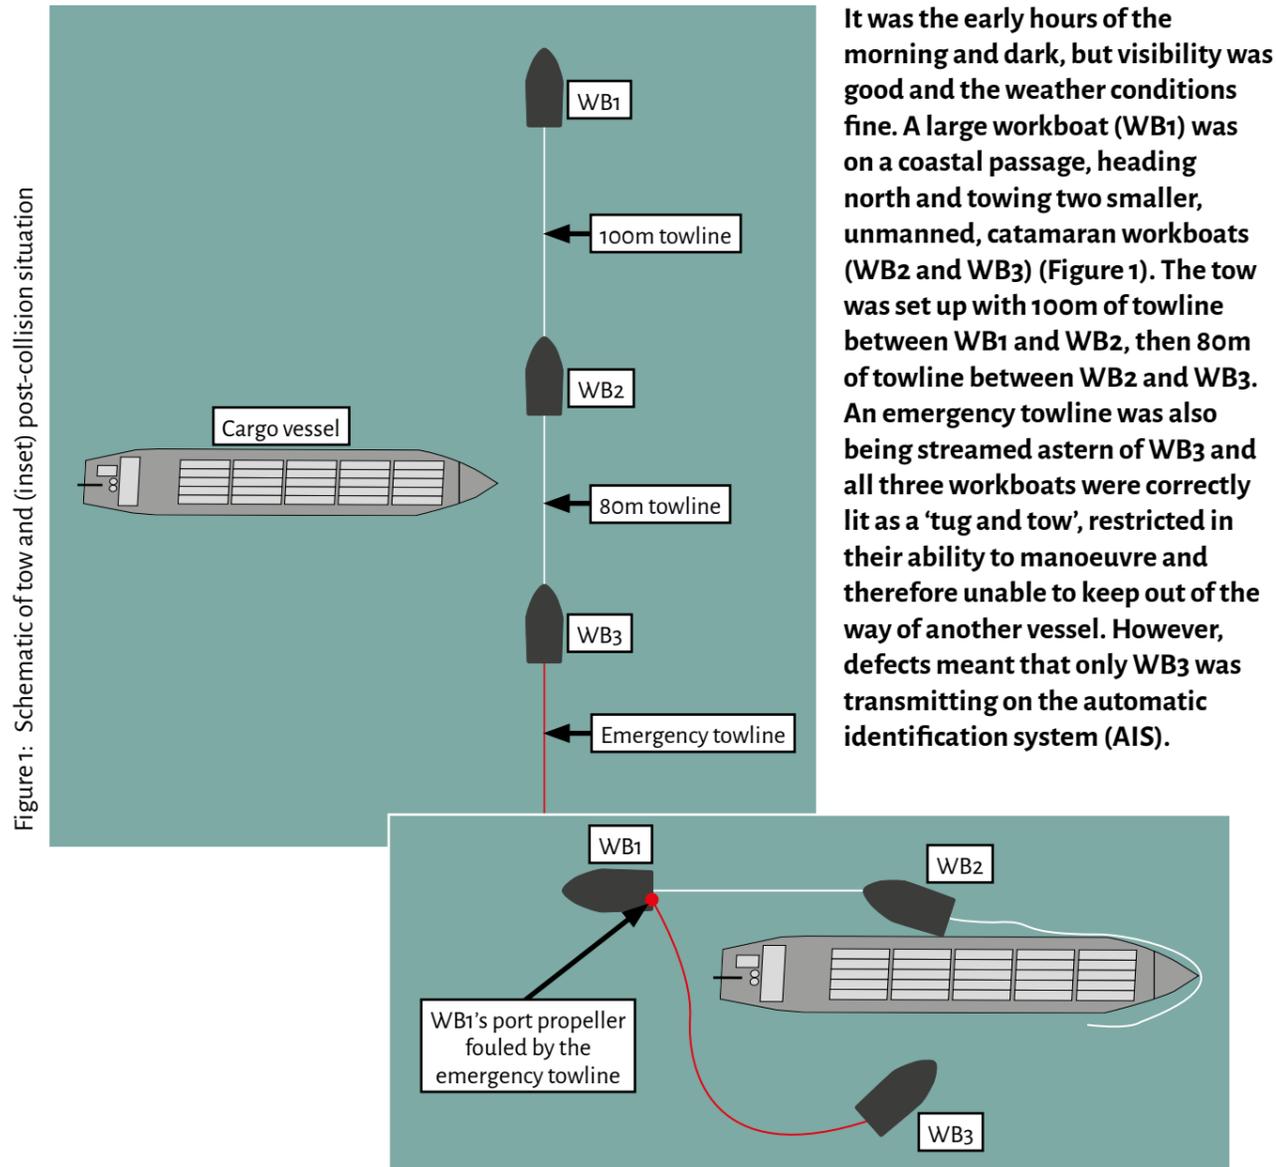
A small general cargo vessel was heading east on passage in the same area and had observed a vessel ahead by AIS and visual observation. The cargo vessel's officer of the watch (OOW) did not alter course and intended passing close by the contact.

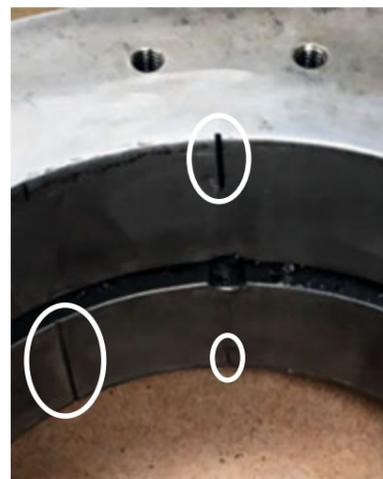
Figure 1: Bearing housing notches from disc cutter

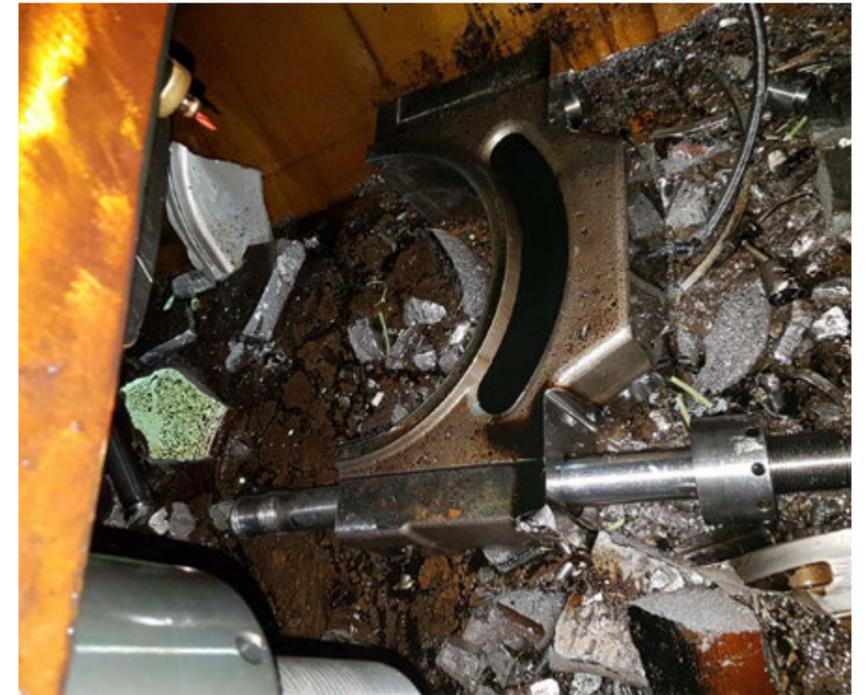
Figure 2: Post-failure engine component debris in sump

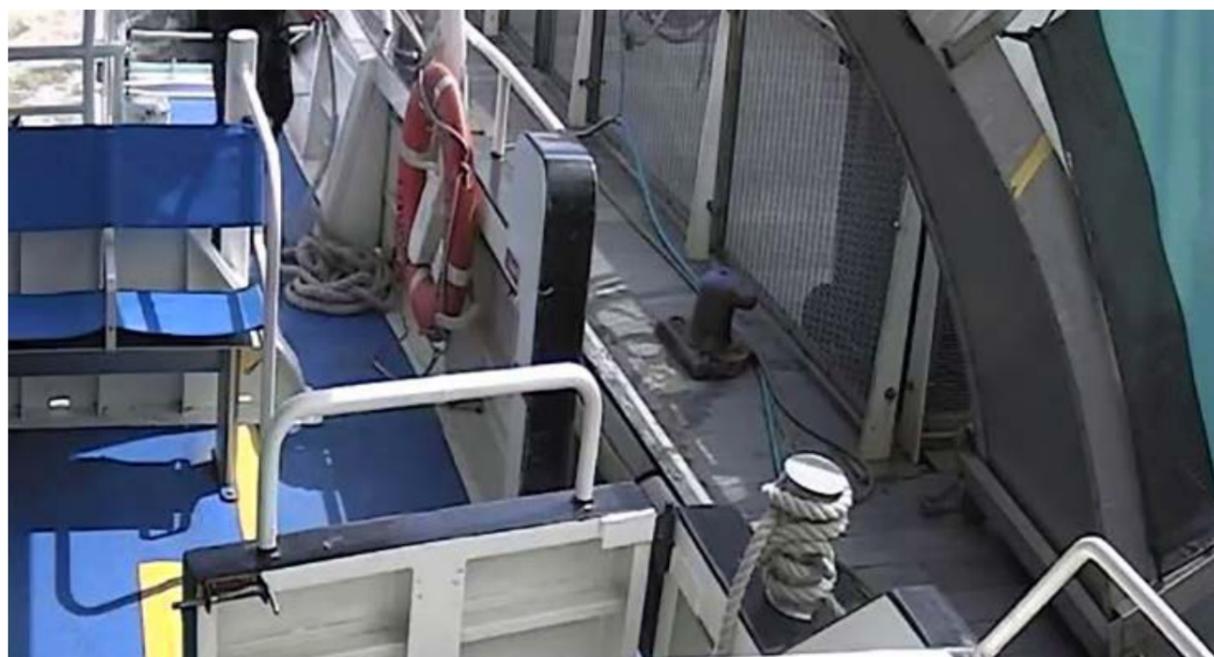
Figure 1: Shore gangway raised, and the stern line cast off

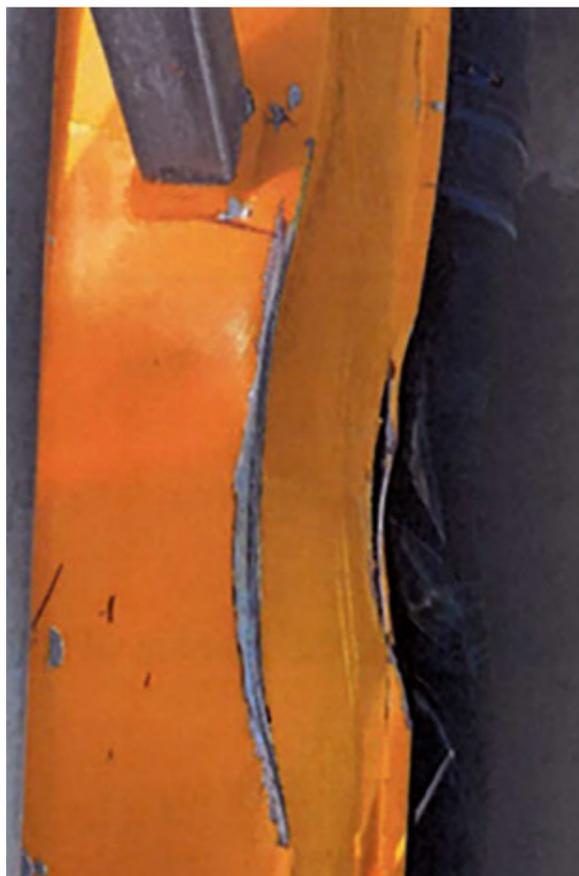
Figure 1: Indentation damage to the passenger transfer vessel's bow area

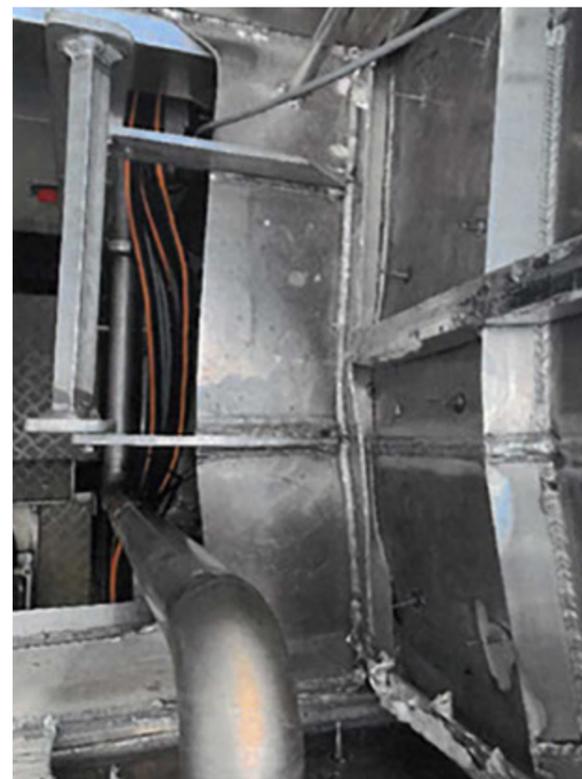
Figure 2: Deformed internal frames

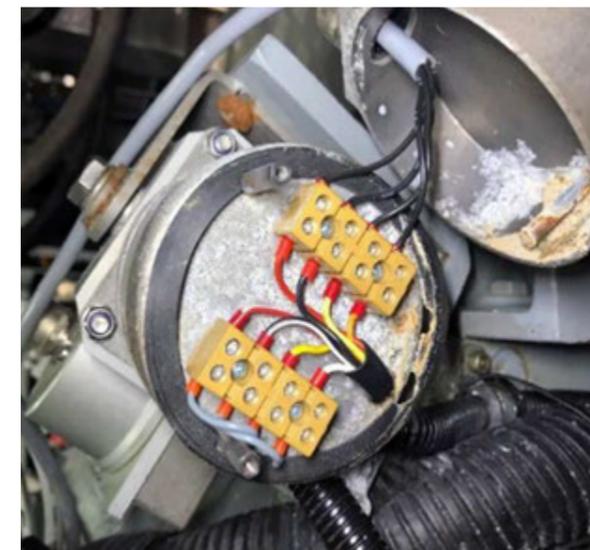
Figure 3: Water ingress damage (unrelated to the propulsion control loss)

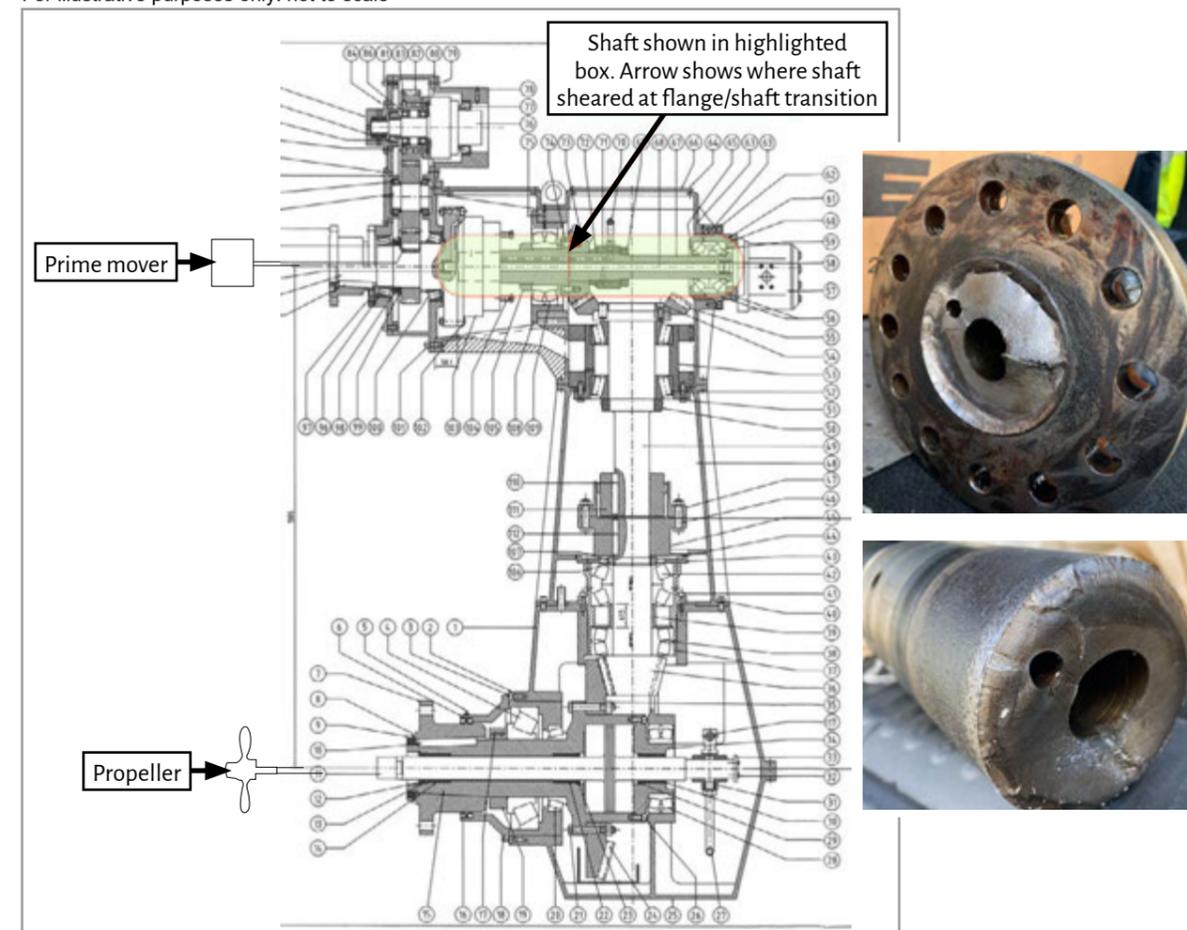
Figure: Gearbox damage and (inset) broken shaft

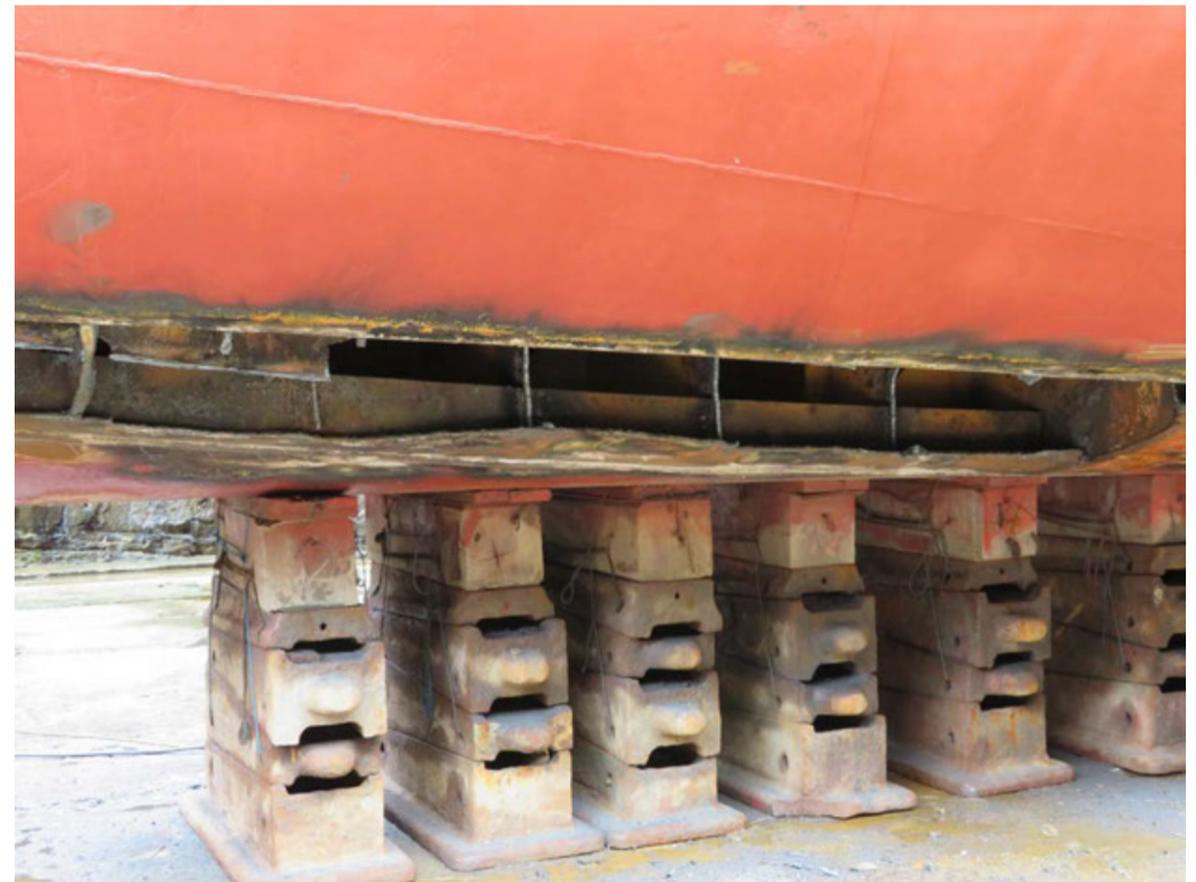
Figure: Damage to the port side of the hull

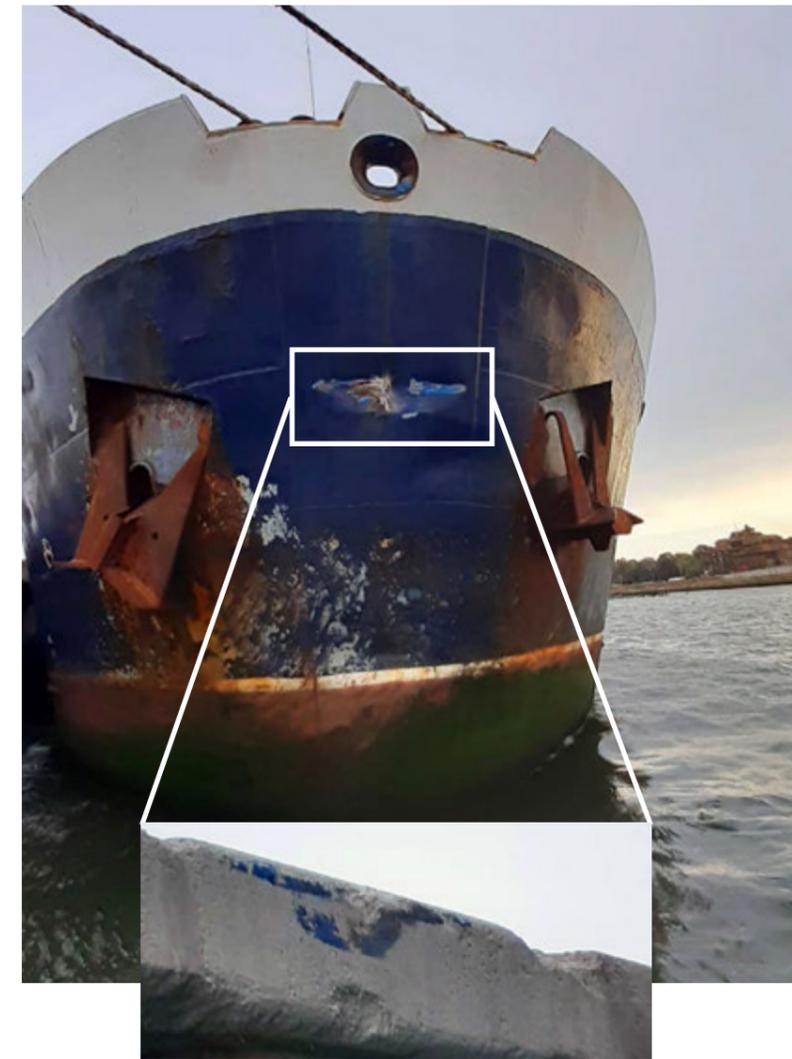
Figure 2: Damage to vessel and (inset) paint mark on the quay

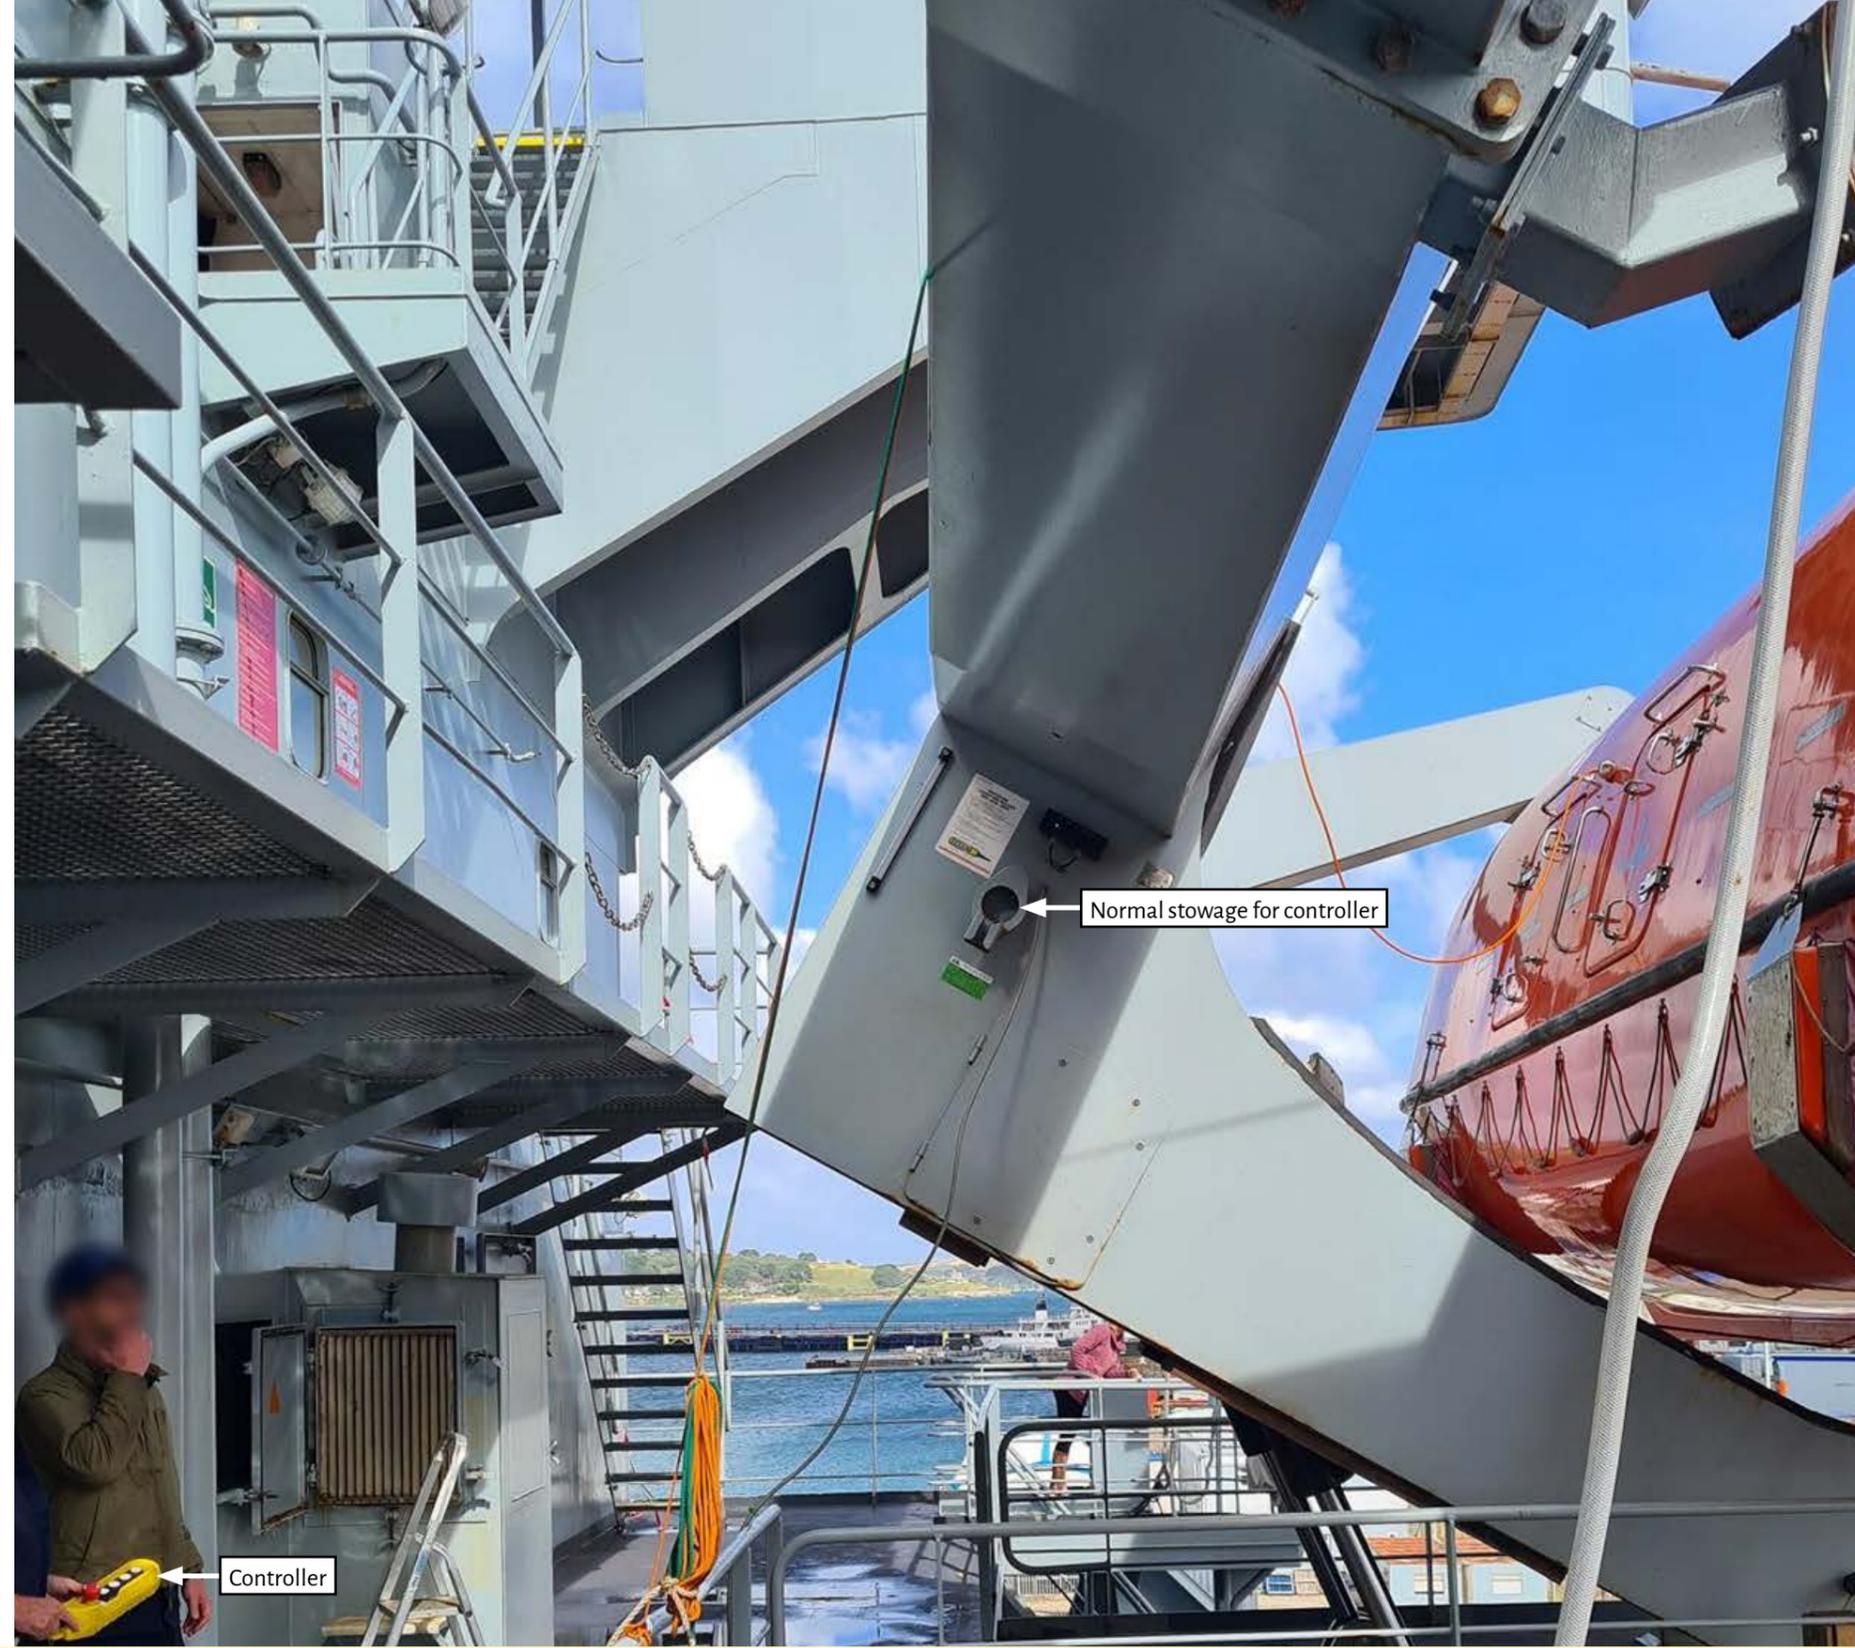
Figure: The partially deployed davit and lifeboat

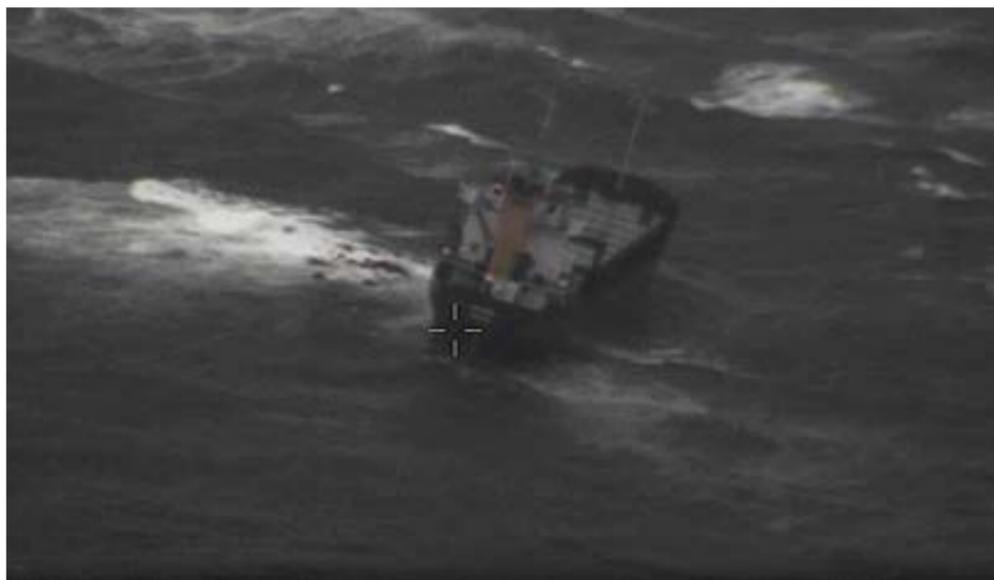
Figure 1: The general cargo vessel aground on the shoal

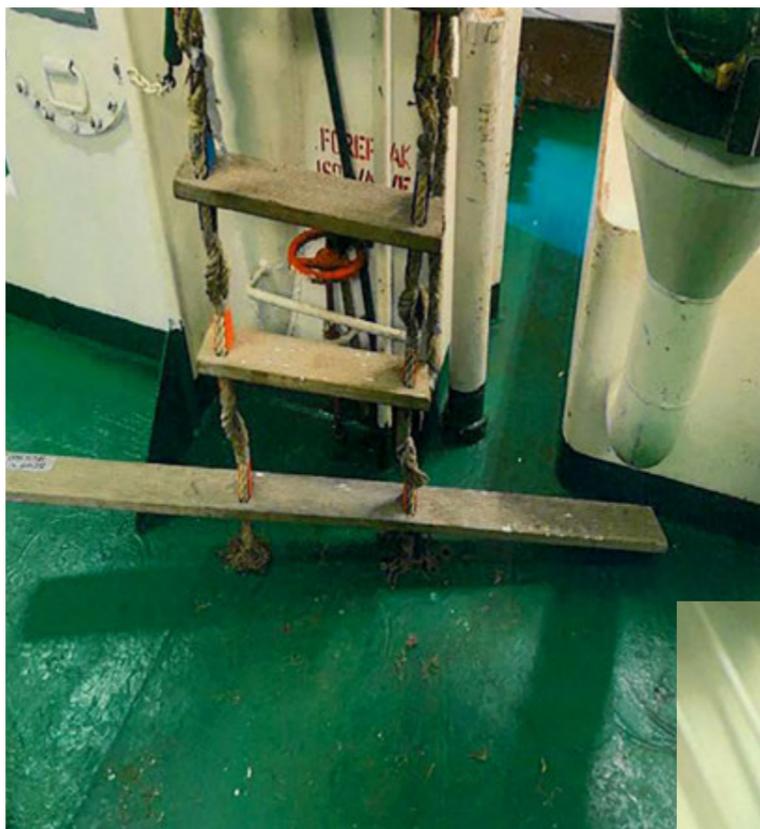
Figure 1: Example of an elderly ladder with its side ropes (inset) in an unsatisfactory condition

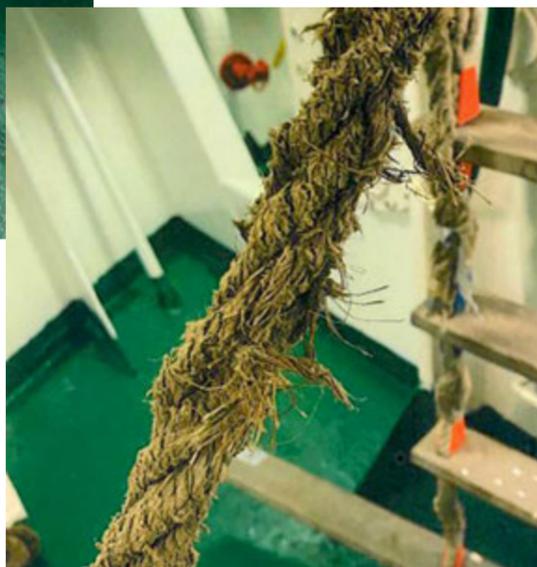
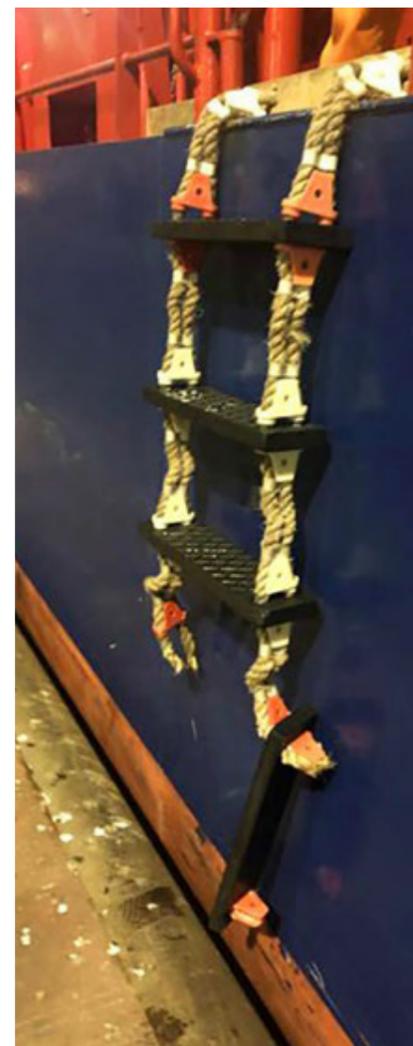
Figure 2: Example of a failed pilot ladder side rope

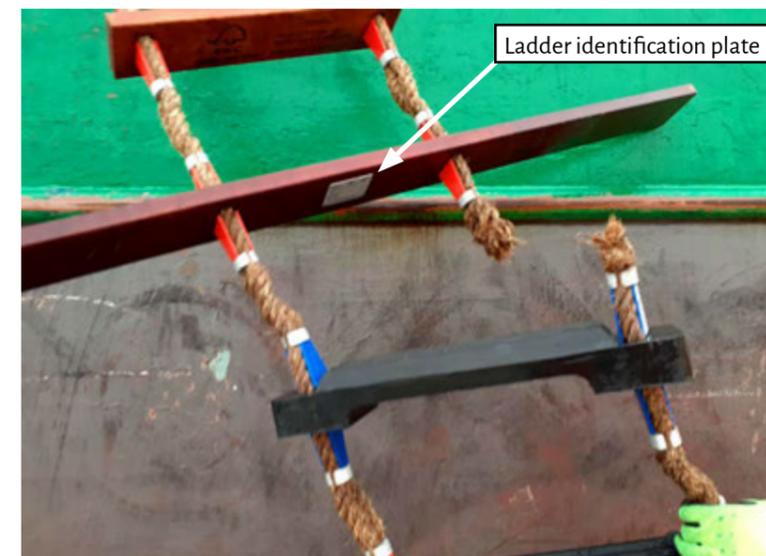
Figure 3: Failed pilot ladder, showing ladder identification plate location

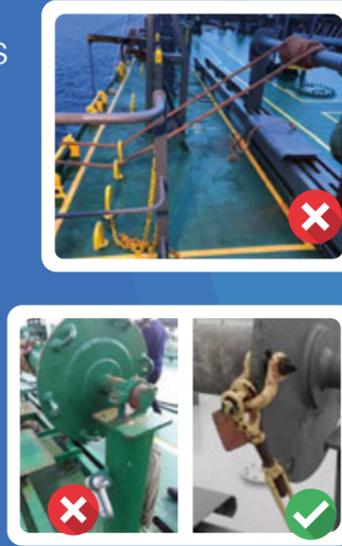
Trap Door Arrangements

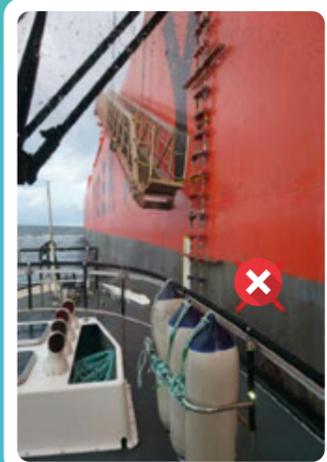
The lower platform of the accommodation ladder **should be** in a horizontal position and secured to the ship's side when in use. The lower platform should be a minimum of 5m above sea level.

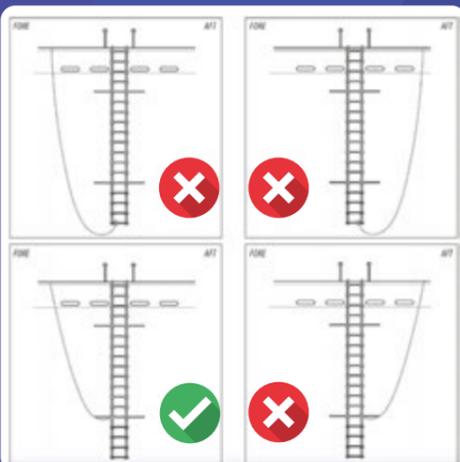
Retrieval lines can be dangerous to both pilots and pilot launches. Retrieval lines pose a trip hazard when climbing and if strung too low may foul the launch. The line **should be** attached above the last spreader and lead forward.

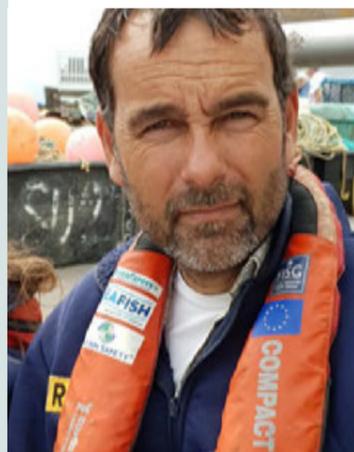
I suppose we can all look back on our past and think of a few 'close calls' or incidents that have occurred while fishing. Some probably stand out more than others. I guess I can say that I carry a few 'I owe you' cards. I have been
