SAFETY DIGEST

Lessons from Marine Accident Reports

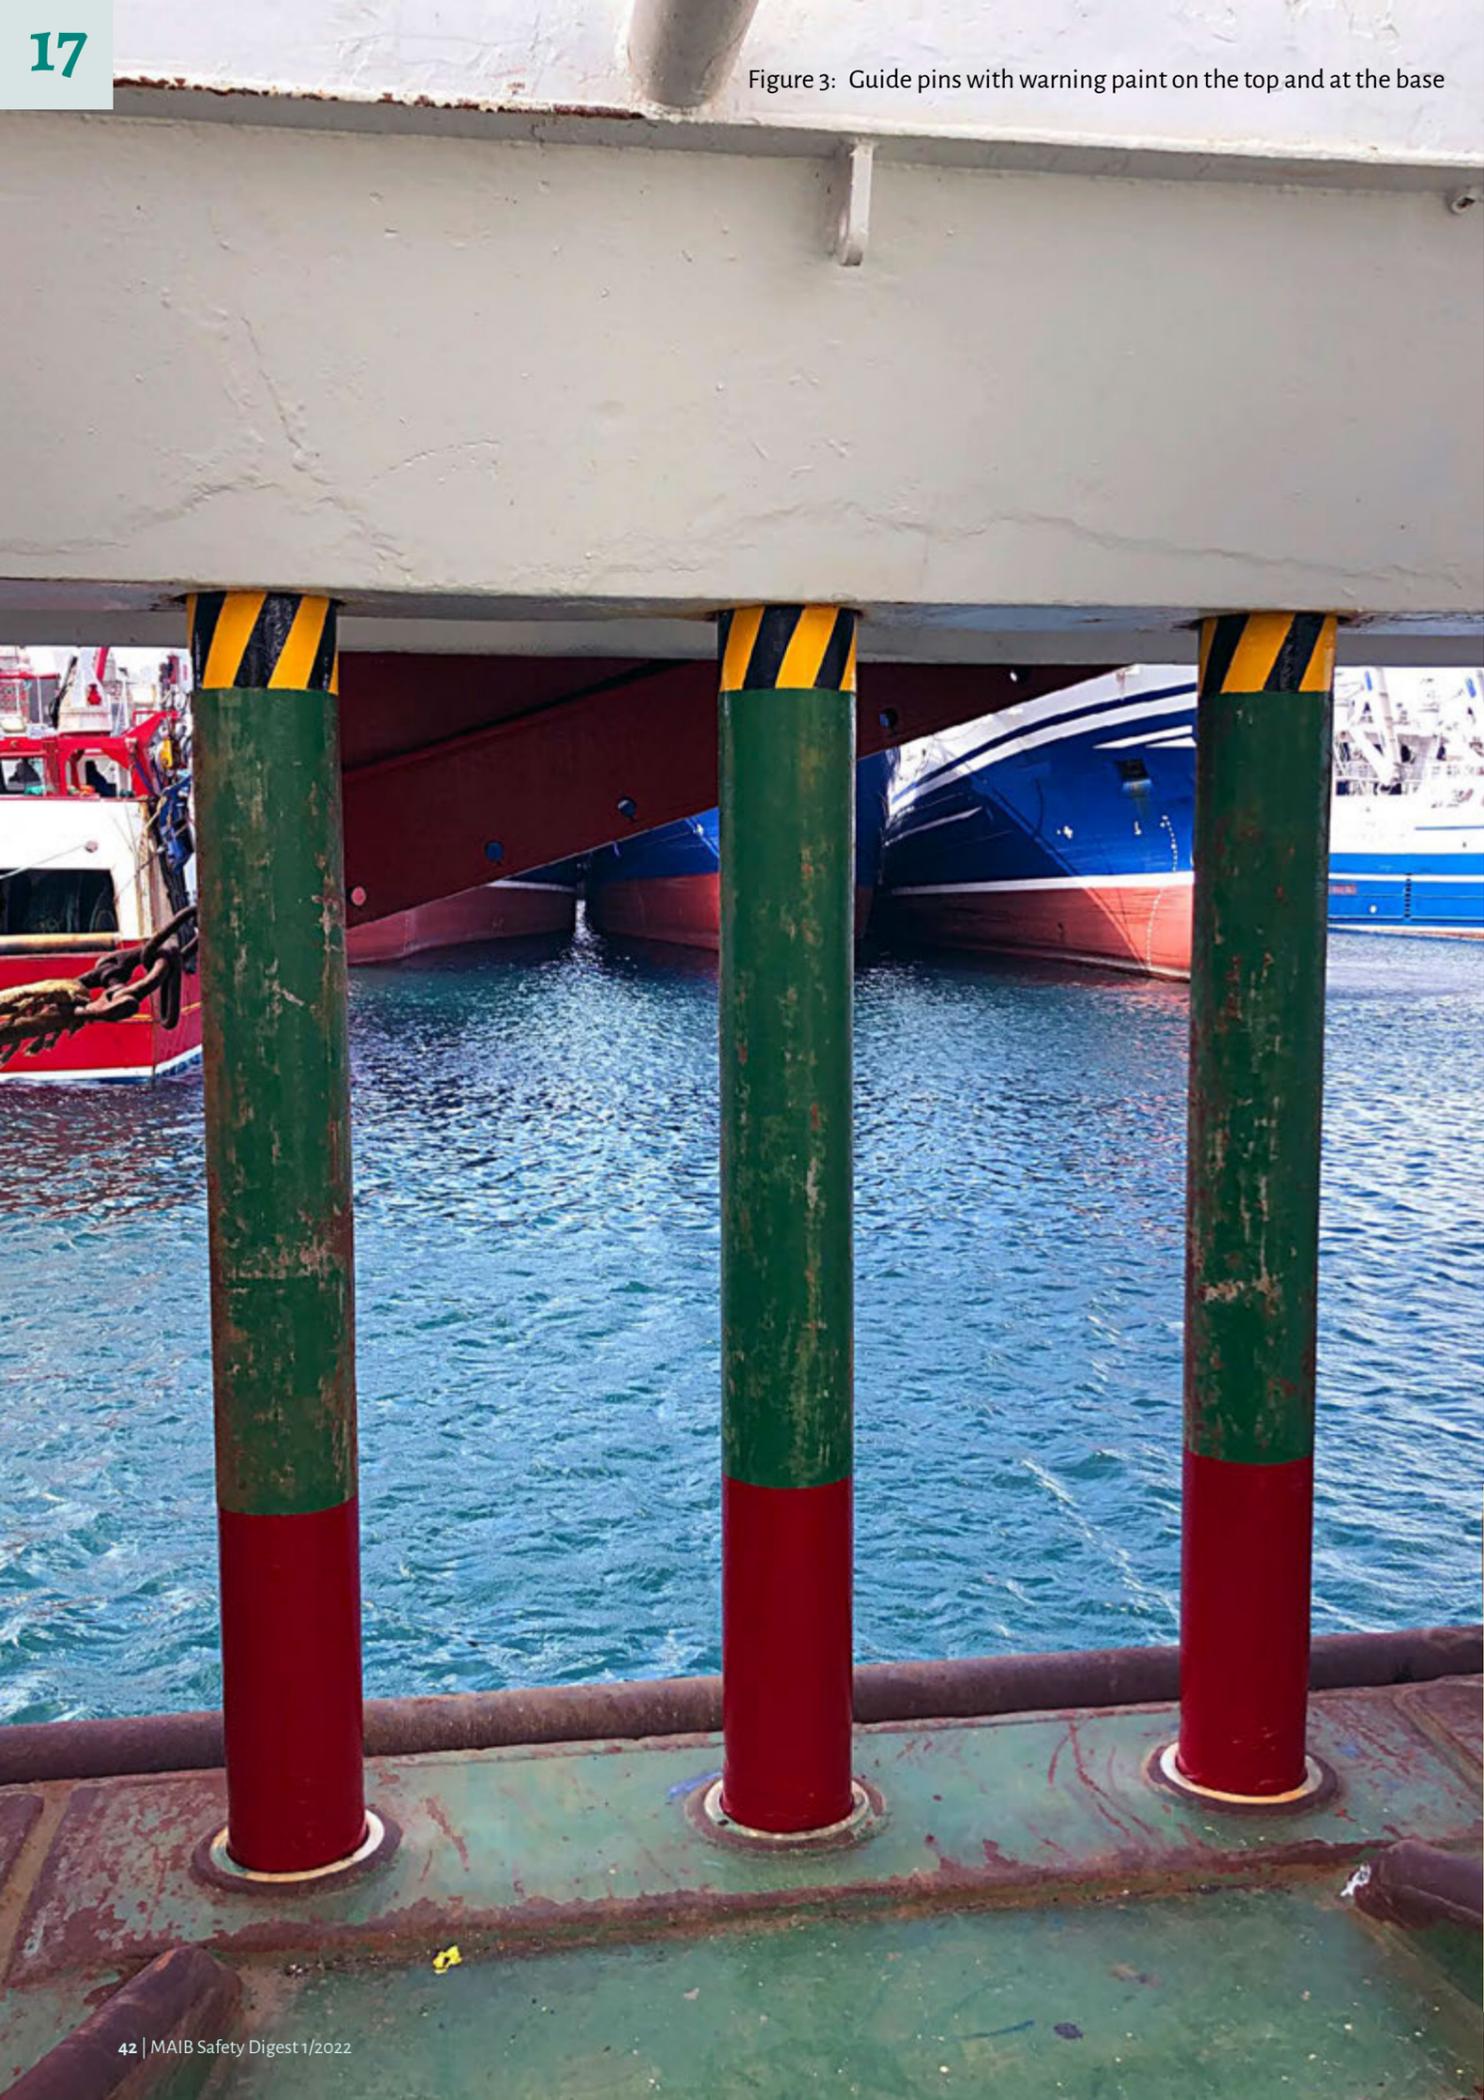
Water, water, everywhere

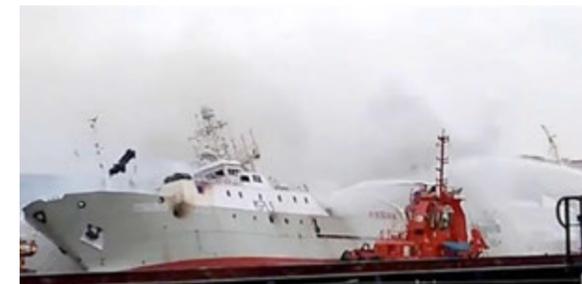
Figure : The fishing vessel

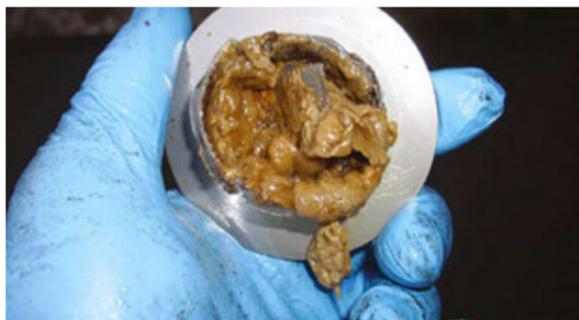
Figure: Fuel filter clogged with diesel bugs

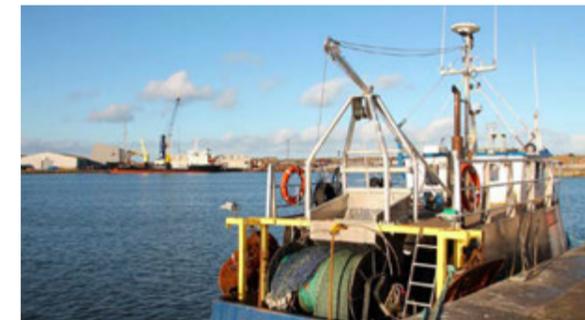
When the crewman pulled on the netting to reposition the net, the section he was pulling suddenly broke and came away in his hand. The crewman lost his balance and fell from the net drum to the deck below; landing upright on his feet he almost sat on the bulwark, but his momentum carried him backwards over the bulwark and into the sea.

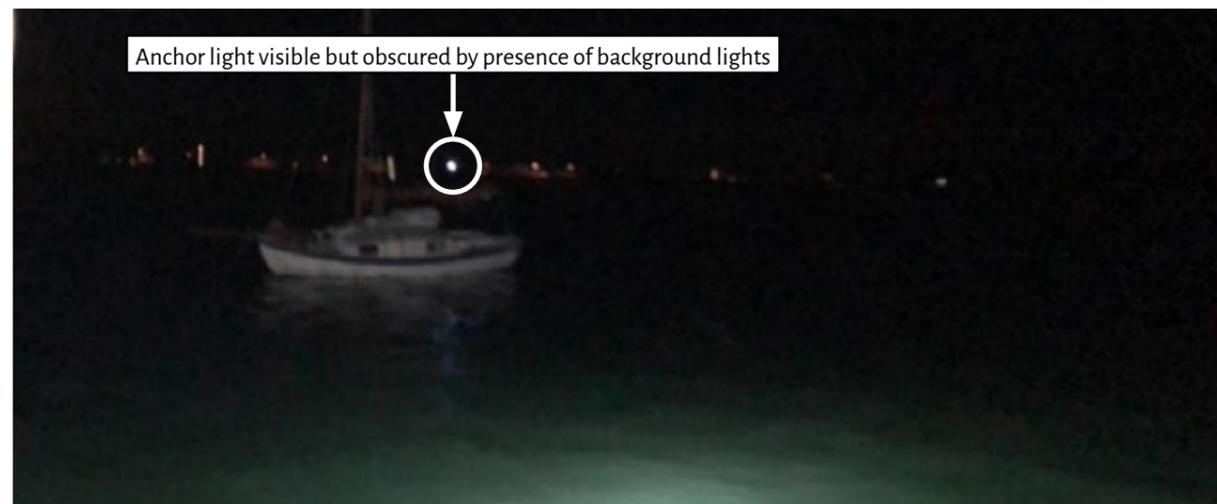
Figure 1: The anchored yacht post-accident against background lights from the shore

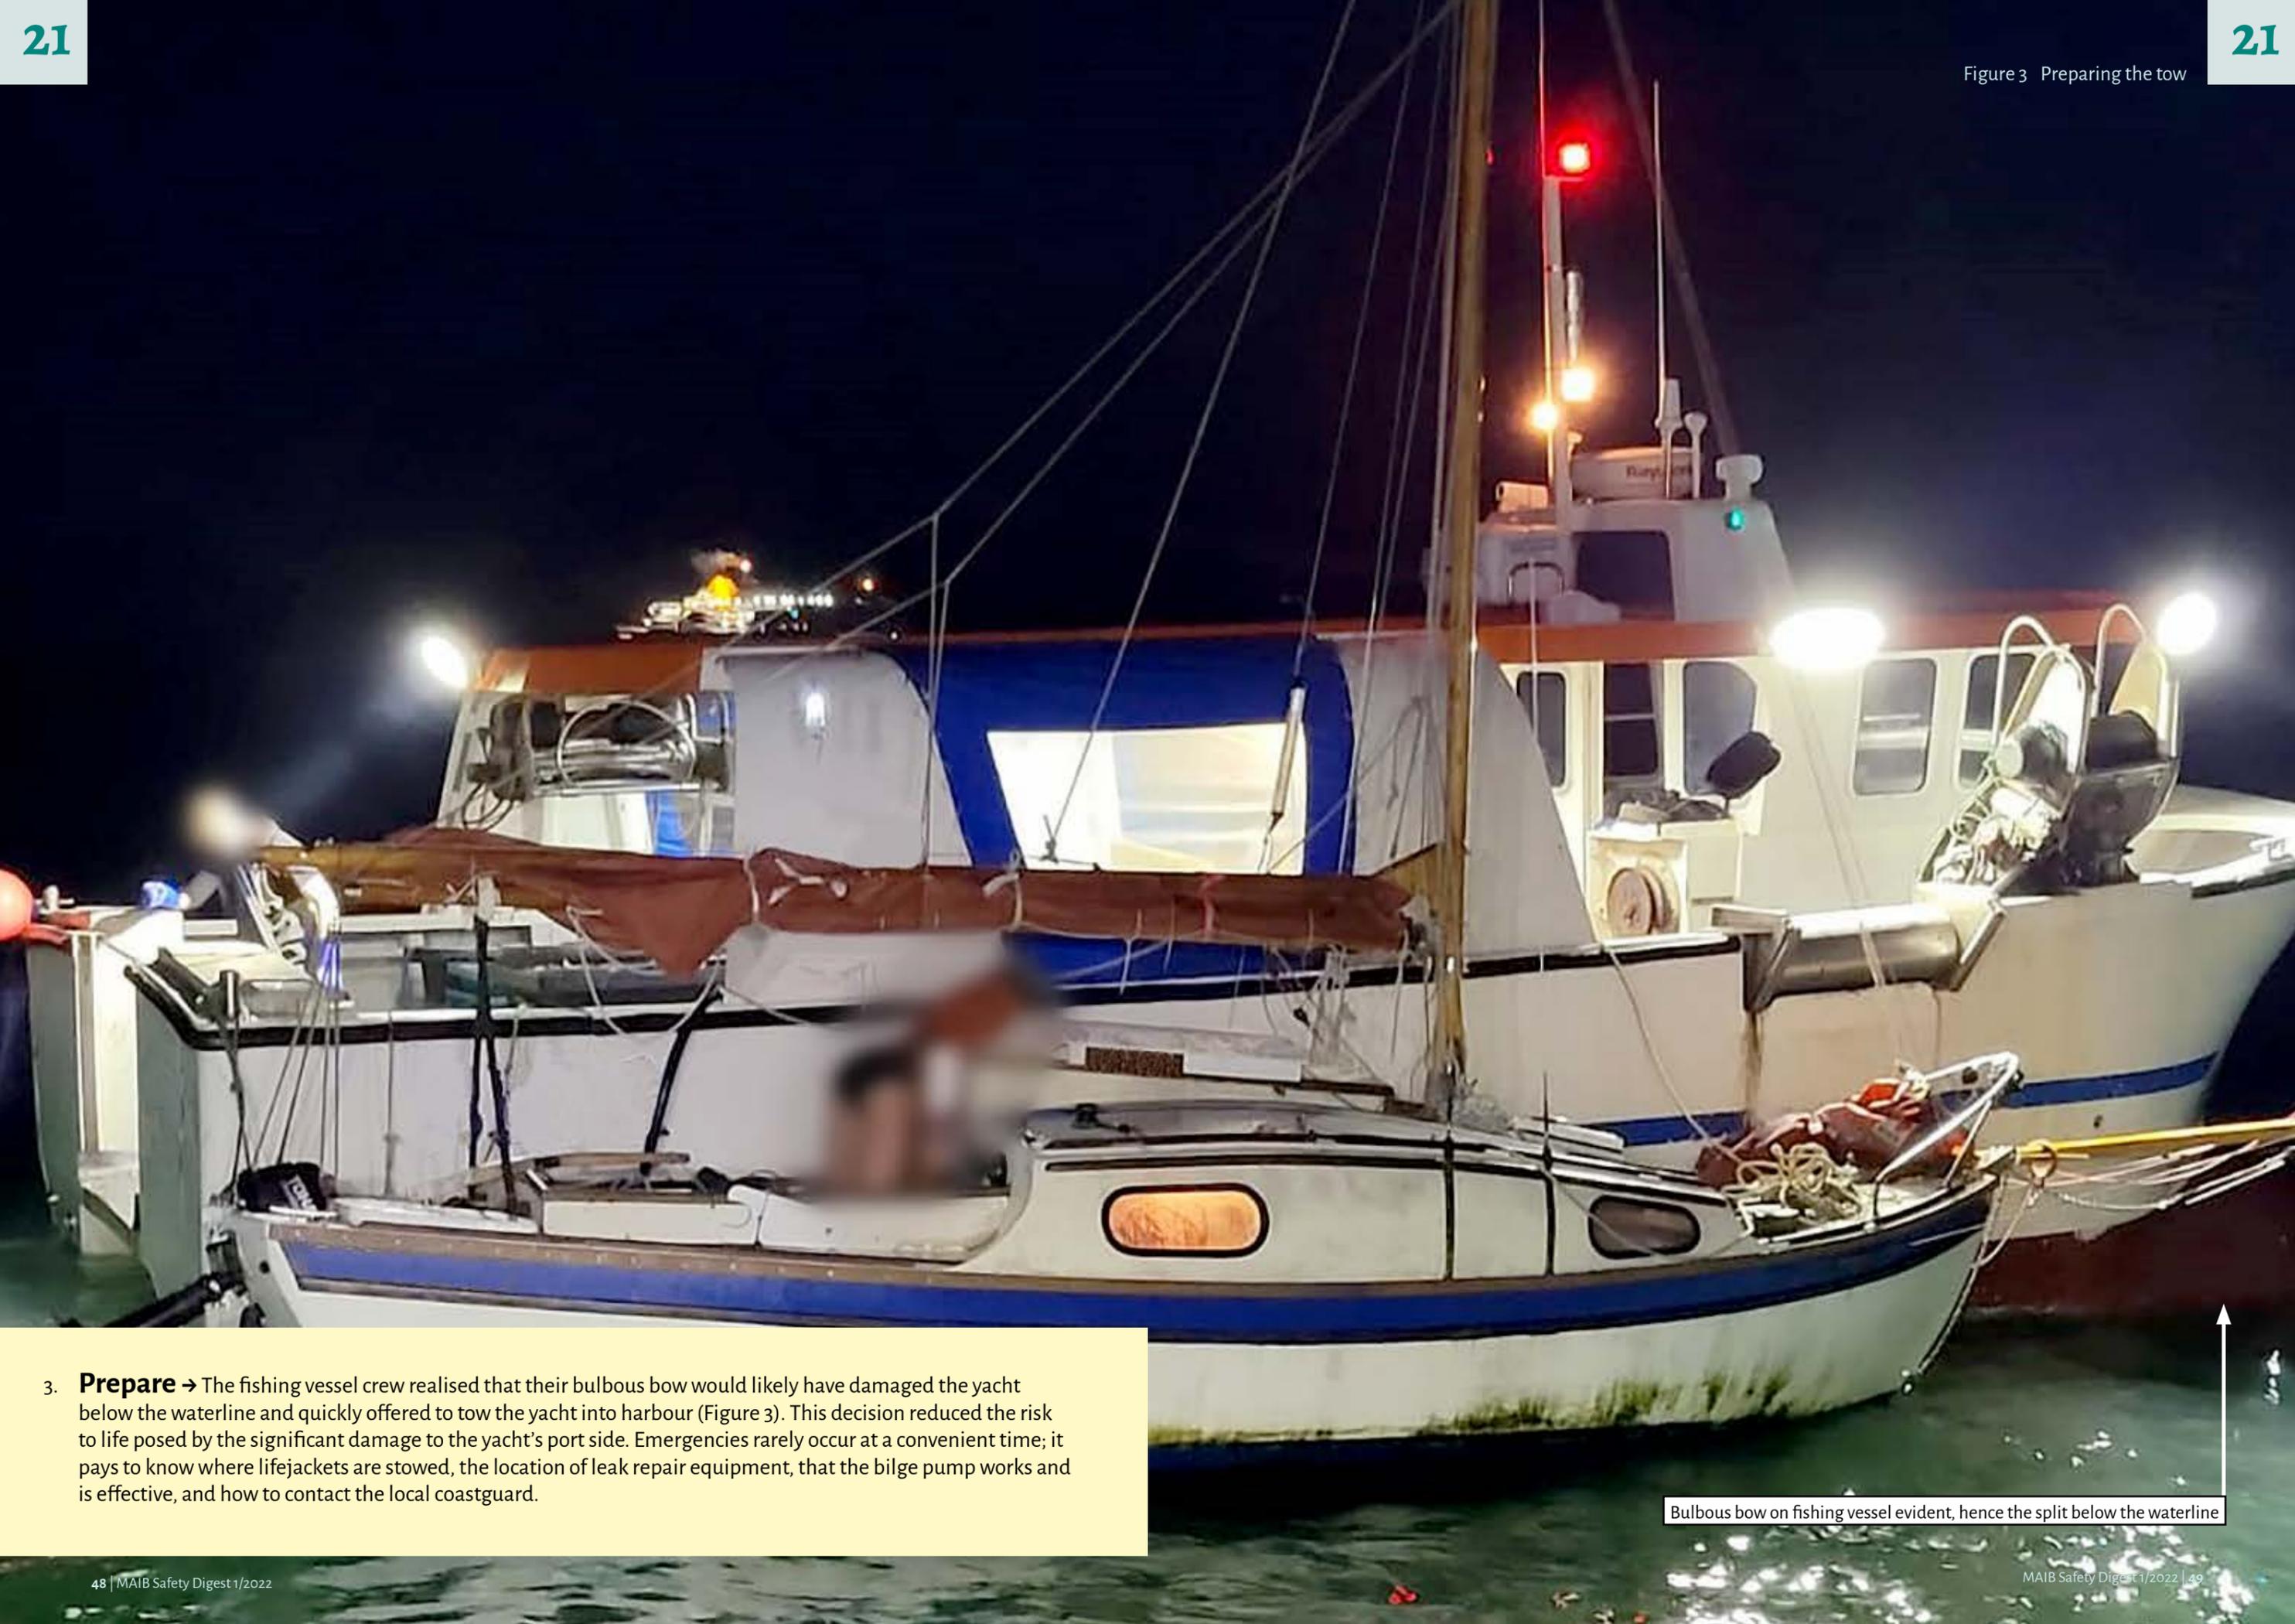
3. **Prepare** → The fishing vessel crew realised that their bulbous bow would likely have damaged the yacht below the waterline and quickly offered to tow the yacht into harbour (Figure 3). This decision reduced the risk to life posed by the significant damage to the yacht's port side. Emergencies rarely occur at a convenient time; it pays to know where lifejackets are stowed, the location of leak repair equipment, that the bilge pump works and is effective, and how to contact the local coastguard.

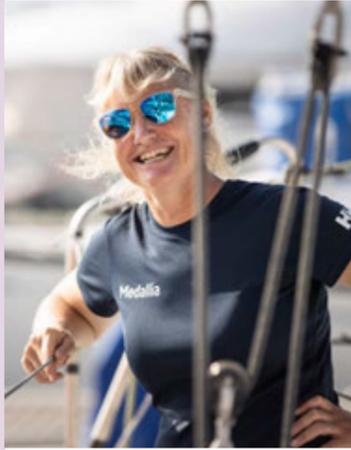
I have made my life and my career on the water. To me being afloat represents ultimate freedom; to learn, to challenge myself, to be self-reliant and to explore our incredible planet. But navigating a vessel on any body of water

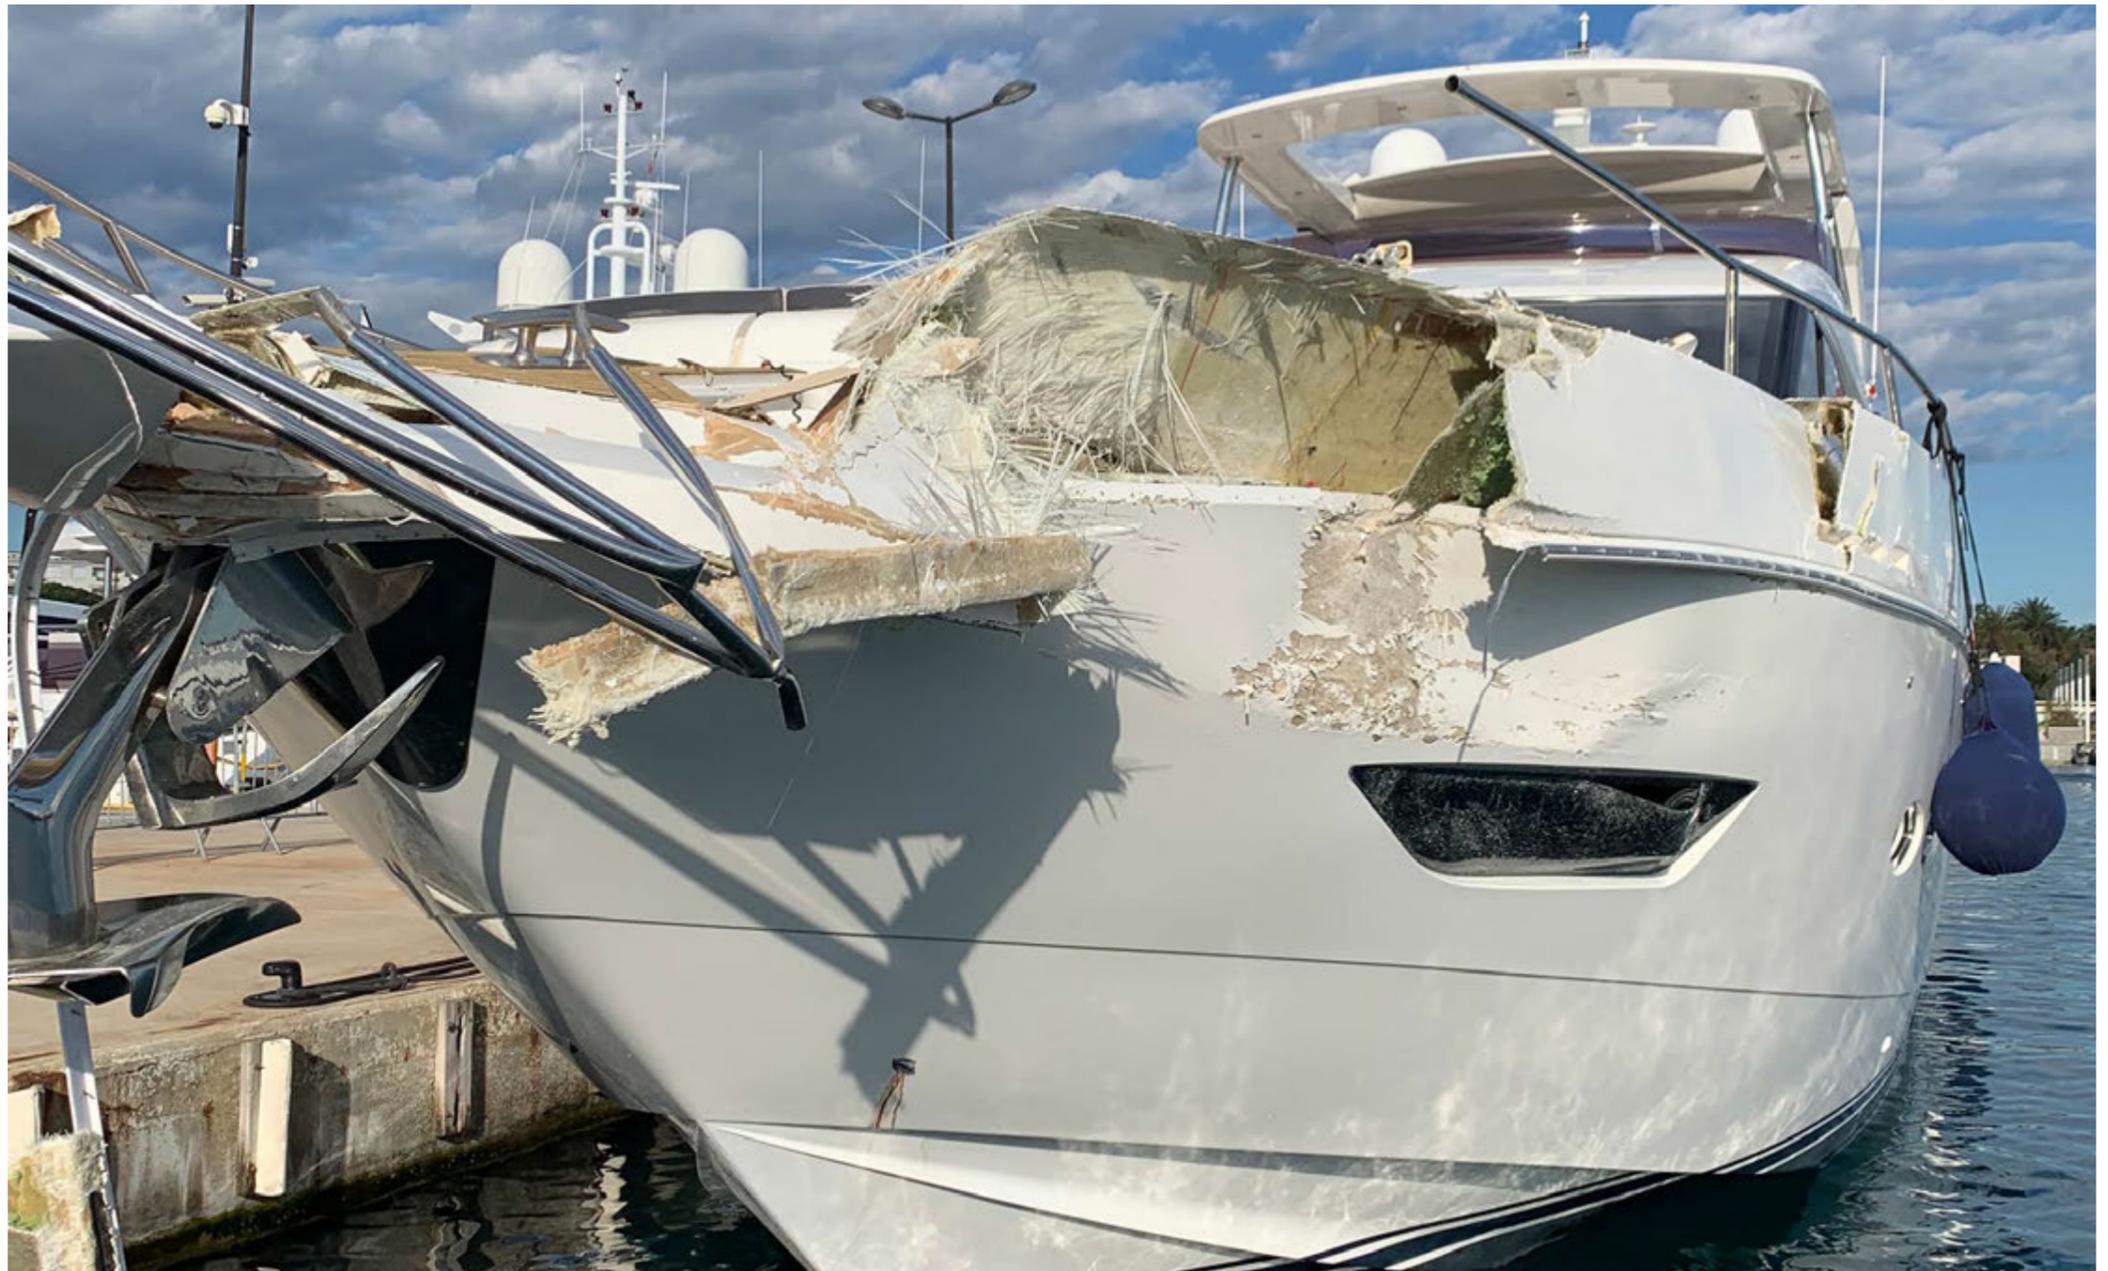
Figure: The damage to yacht B's bow

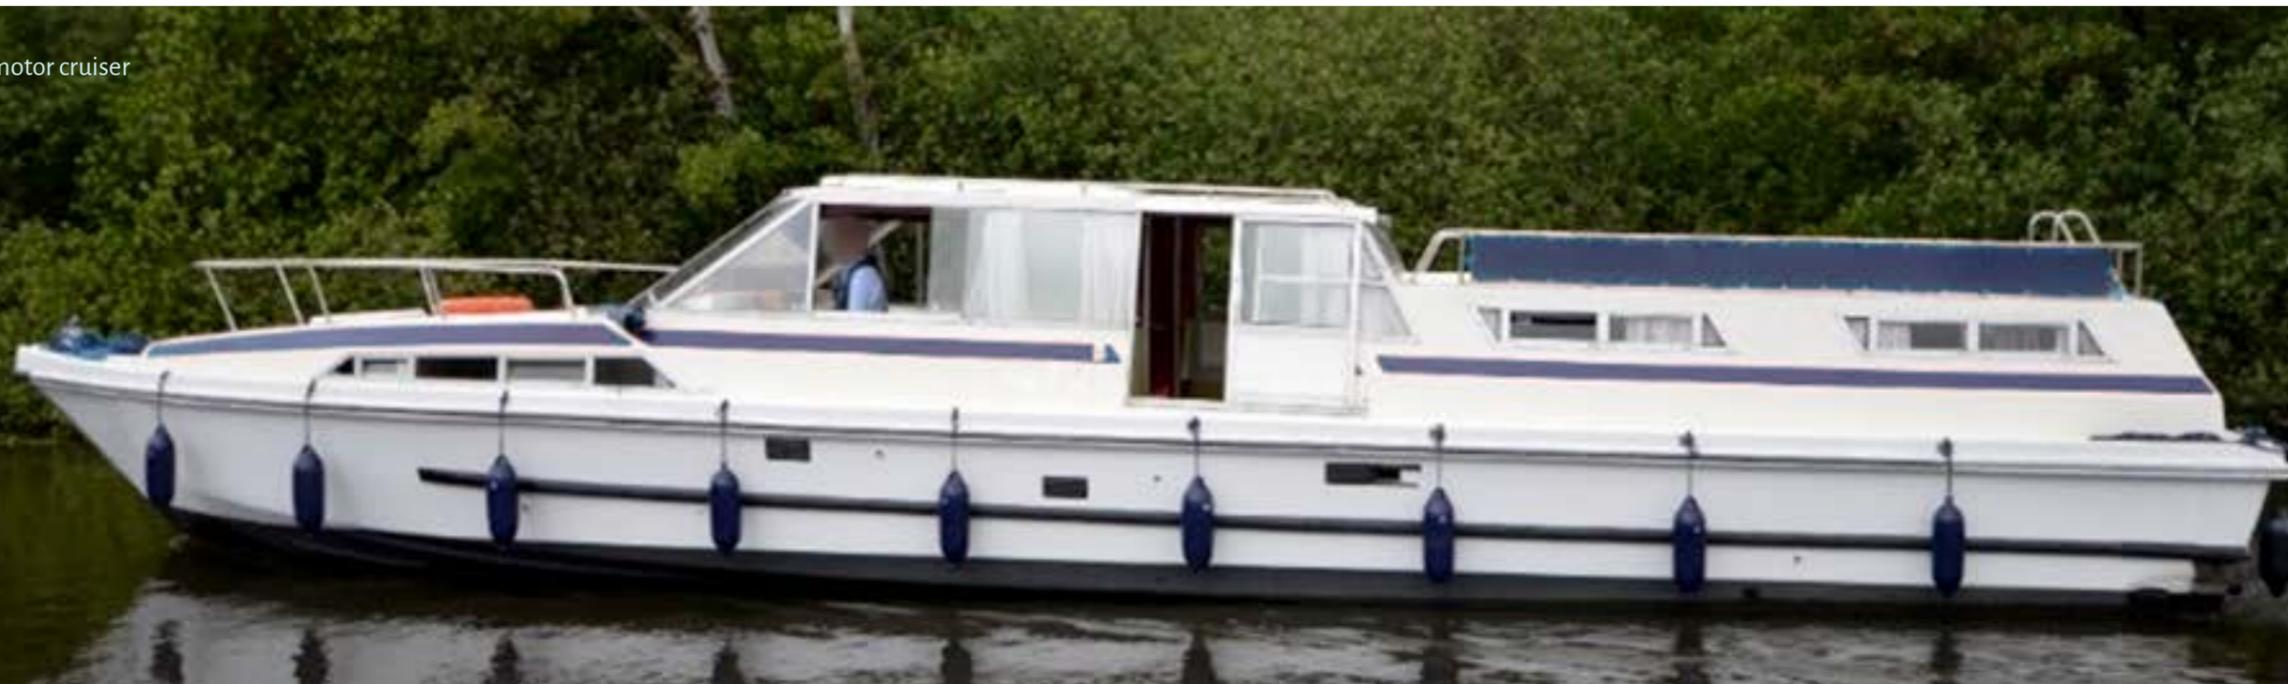
Figure: Inland waterways motor cruiser

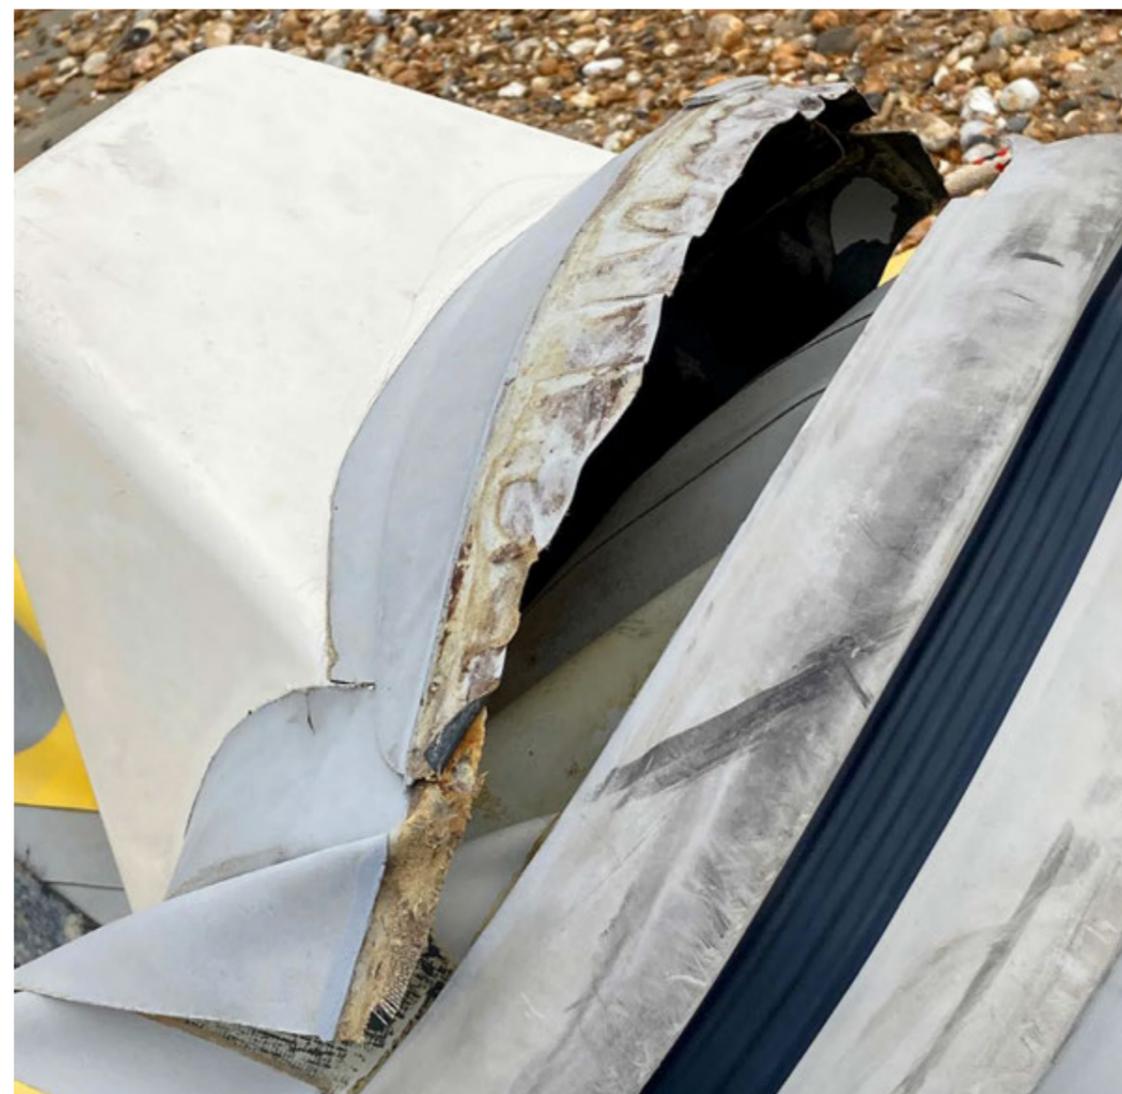
Figure: Detachment of fibreglass step from the buoyancy tube

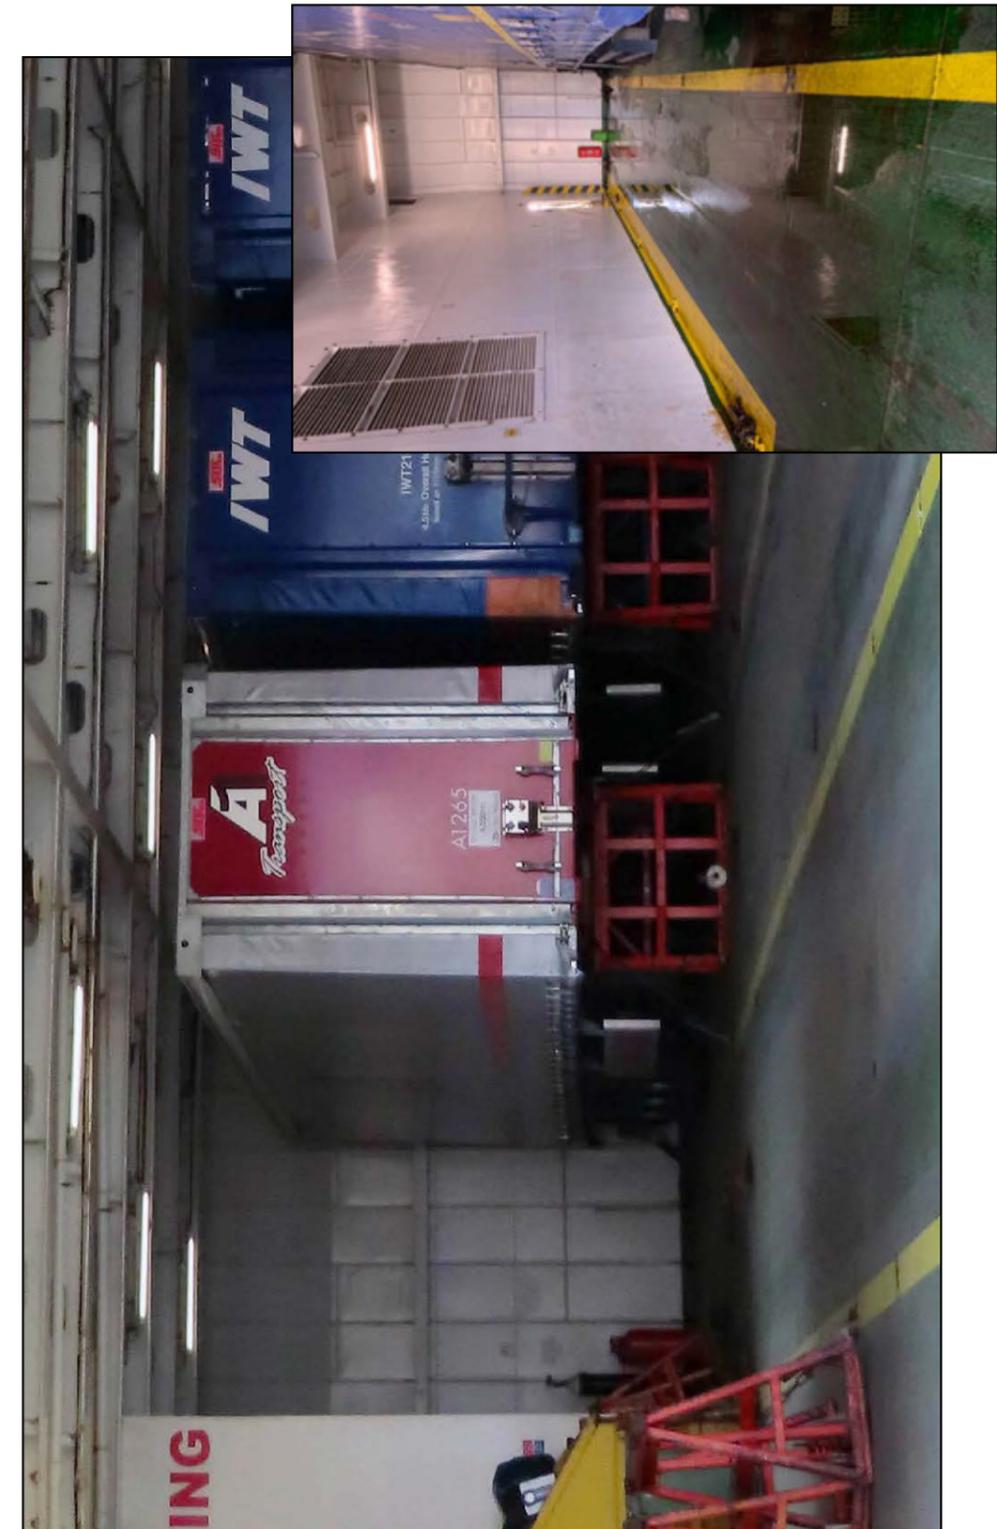
Figure 1: Reconstruction of the semi-trailer parking arrangement, with inset view of the space (post-accident)

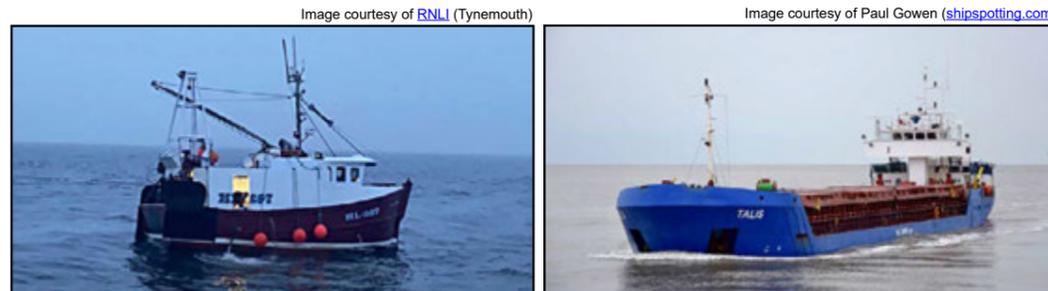
Collision between fishing vessel *Achieve* (HL257) and general cargo ship *Talis*, resulting in the sinking of *Achieve* off Tynemouth, England, on 8 November 2020

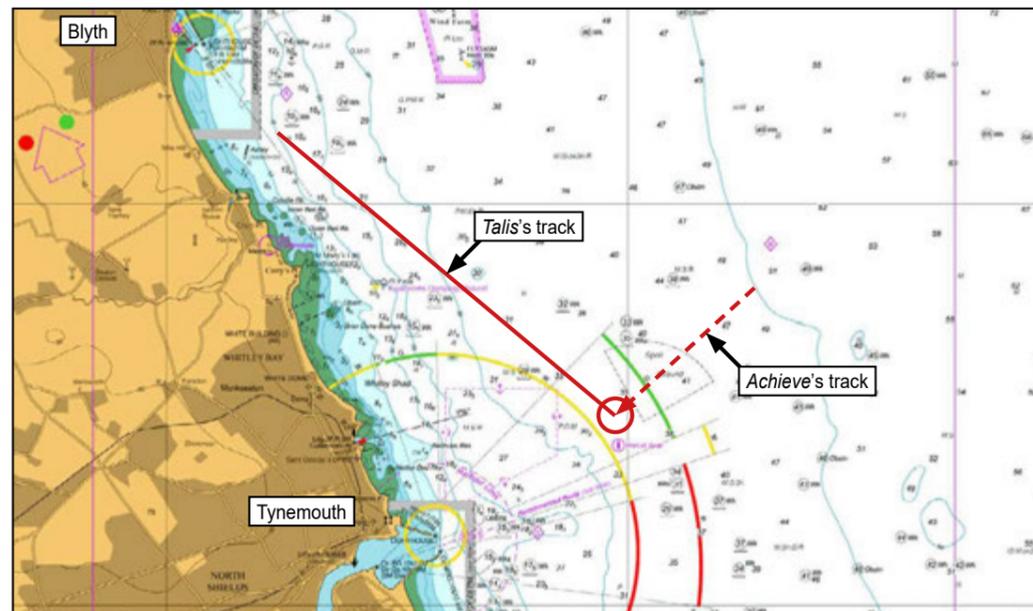
Chart showing tracks of *Talis* and *Achieve*

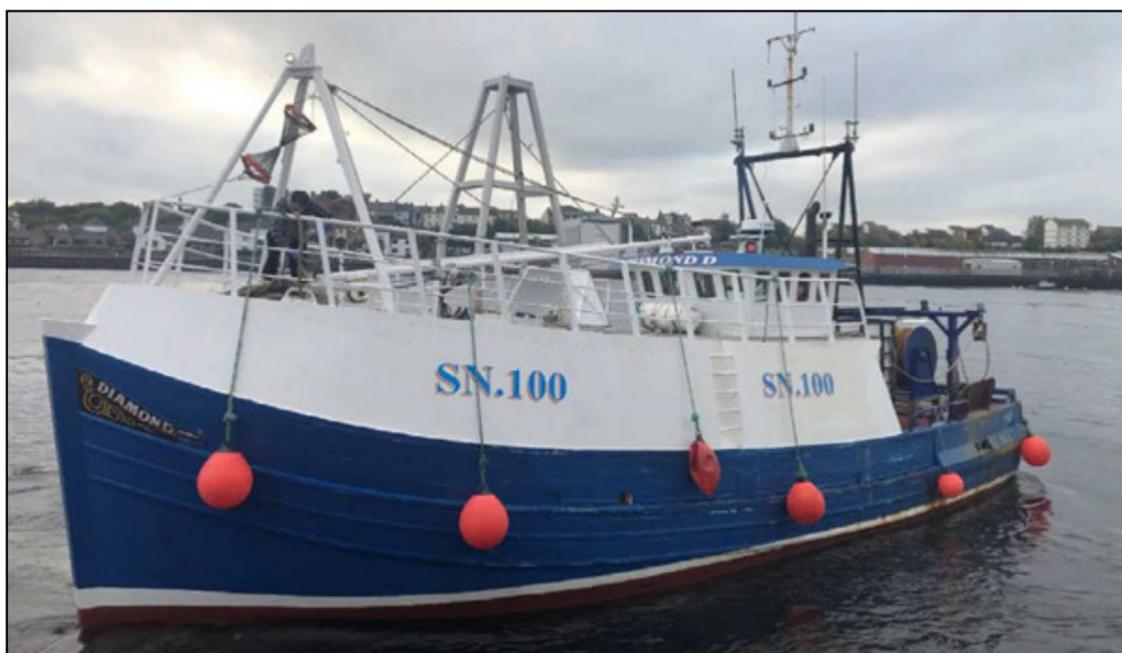
**Flooding, capsize and foundering of the trawler *Diamond D* (SN100)
north-east of Tynemouth, England, on 16 August 2020**
