Annual Digest
Reports and Insight Articles

2021

Annual Digest of Reports and Insight Articles 2021

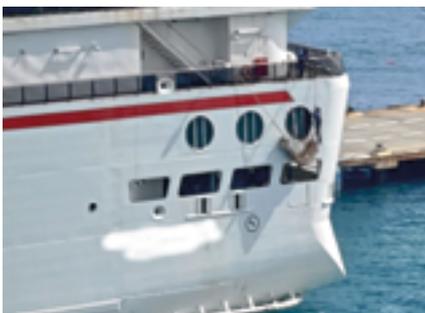
A cruise ship was moored on the pier opposite my ship. I noticed a stage which was rigged on the port shoulder being relocated laterally whilst a crew member was standing on it. Although the person on the stage was wearing some PPE, (safety harness, safety shoes, gloves, and an inflatable lifejacket), I consider it quite an unsafe act. The crew member working on the stage should have vacated it to a safe position on deck before attempting to reposition the stage. (See photos below).

Figure 1 of 3 – Unsafe repositioning of a stage

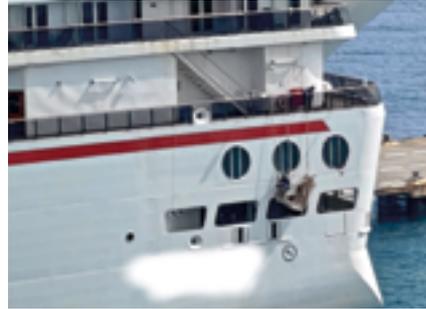
Figure 2 of 3 – Unsafe repositioning of a stage

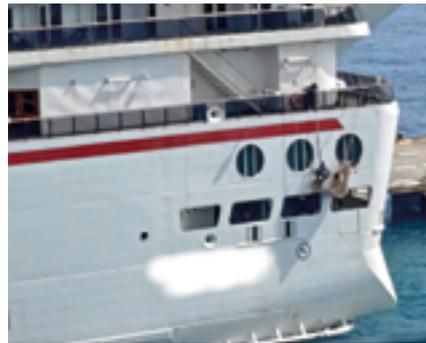
Figure 3 of 3 – Unsafe repositioning of a stage.

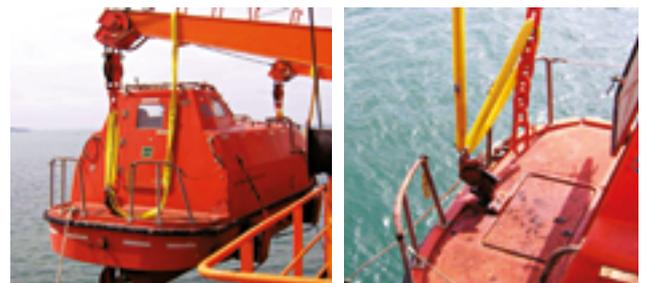
Since their introduction, on-load and off-load release systems for lifeboats have caused death and serious injury to crew when the operating systems have not been properly checked, maintained, and tested. The system should be regarded as a single point of failure unless fall preventer devices (FPD) are fitted.

Undertaking maintenance on the lifeboat hooks - the hanging-off strop is rigged along with the fall prevention device (FPD). Once the weight of the boat is taken by the

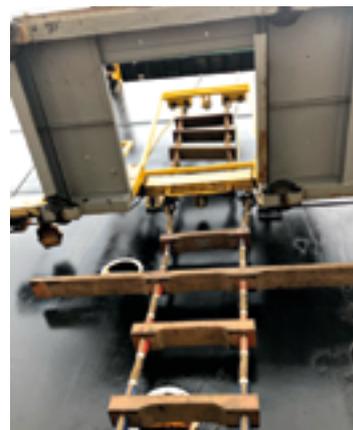
Figure 5.
PBA as presented:
Pilot ladder presented in two sections. Both sections are secured solely to the accommodation ladder platform instead of to the ship.

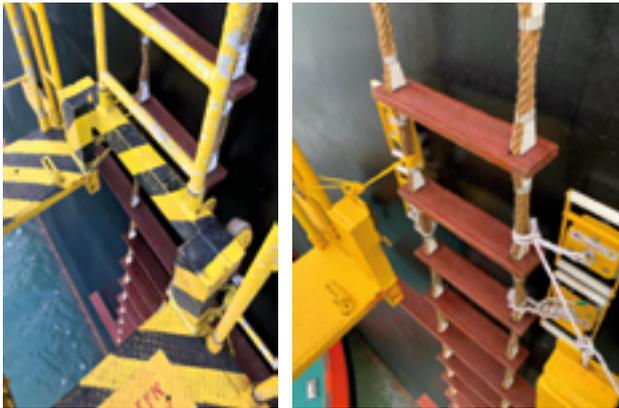
The vessel arrived at pilot station at night, pilot refused to board on arrival as ladder appeared to be non-compliant. (Figure 6).

Figure 6 (left) original arrangement as presented. Figure 7 (right) after modifications

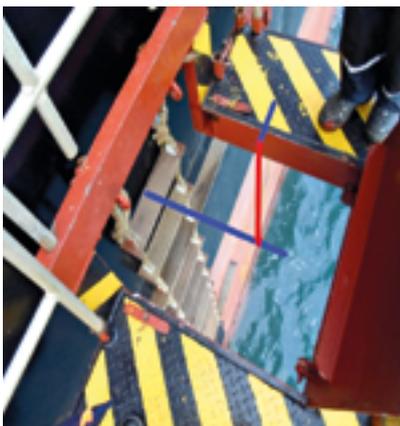
A trap door arrangement with the pilot ladder secured to the underside of the platform, so the ladder did not pass up through the hatch. Dialogue took place but no adjustments had been made, on arrival at port limits the vessel was refused pilotage until boarding arrangements were compliant and safe. After 3 days at anchor the arrangements had been adapted to a combination arrangement with the pilot ladder secured to strong points on the main deck.

Figure 8 (left) What was presented originally (rejected)

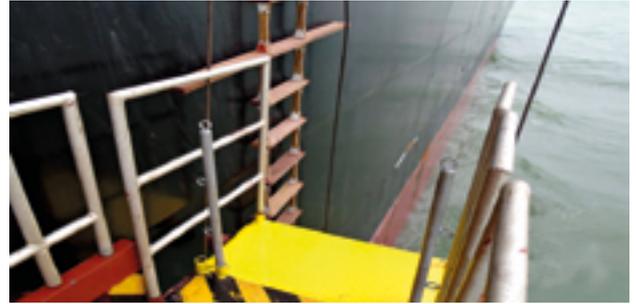
Figure 9 (below) This was the final arrangement (minus the securing magnets which were in place when used by a pilot)

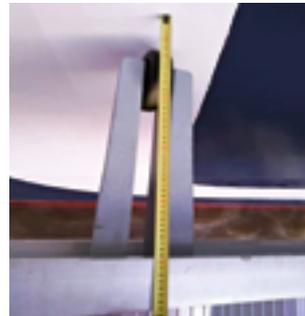
Figure 10 Before modification

Combination ladder, the gap between the pilot ladder and the lower platform was greater than 20cm (when measured it was 50cm). Dialogue took place with the vessel who originally stated this could not be modified. Sorry captain, but there will be no pilot boarding your vessel. They found a solution on board and reduced the gap to 20cm. A pilot boarded.

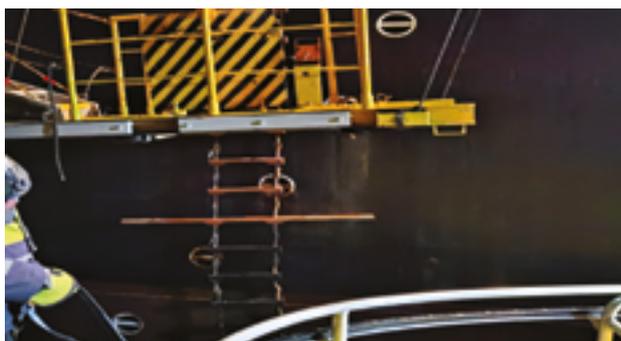
Trapdoor type combination, accommodation ladder platform less than five metres above the sea.

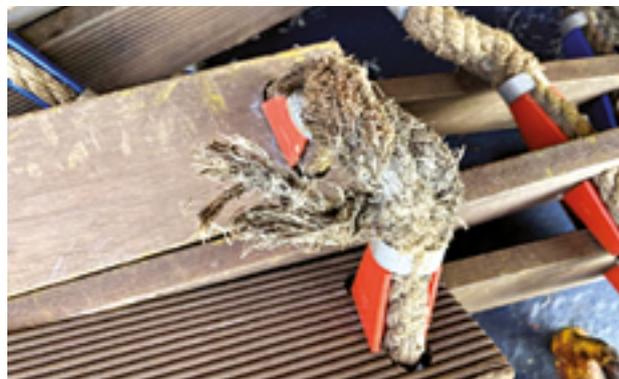
Pilot ladder did not meet SOLAS standards.

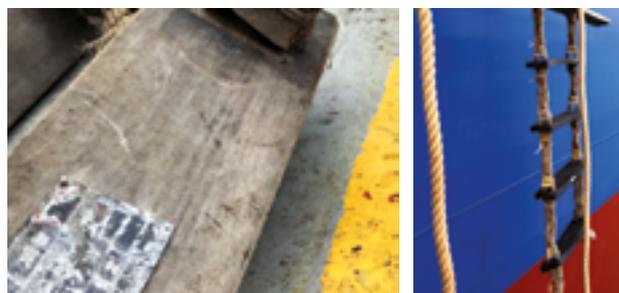
Comments from reporter: When disembarking from this vessel I found that the ladder appeared well-used, and the chocks and steps were loose. I advised the attending officer that the ladder should be replaced or repaired. The vessel was less than three years old, so I assume it was in use from her maiden voyage. The corrosion on the manufacturer's plate made it impossible to check details. (See photo)

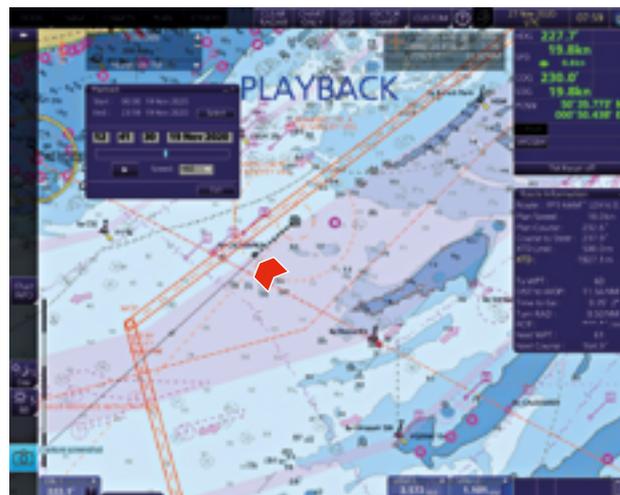
Figure 4 – Screen shot from the container vessel.

CHIRP also contacted the ISM managers for the container vessel, and details of the reported incident were passed to the DPA. Subsequently, after contacting the captain of their vessel, the DPA reverted to CHIRP with a response including a series of screen shots from the bridge of the container ship and a commentary from the captain with regards to the incident. The screen shots show that the container vessel was south of the planned route and outside the charted safety corridor in a position close to the boundary between the SW lane and the central separation zone.

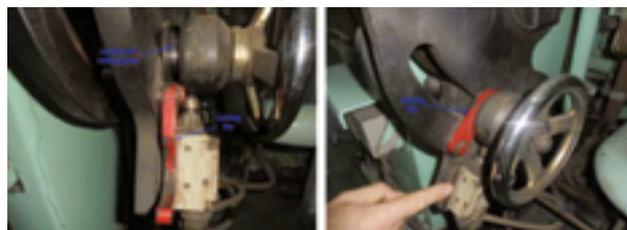
The emergency manoeuvring system located on the side of the engine is fitted with a locking arrangement which under normal conditions rests firmly inside the groove indicated in the photos below.

The investigation revealed that the direct cause of this incident was the disengagement of the emergency manoeuvring system's locking arrangement.
