Report on the investigation of
the capsizing and sinking of the fishing vessel

Joanna C (BM 265)

5 nautical miles south of Newhaven, England
on 21 November 2020

REPORT NO 7/2022

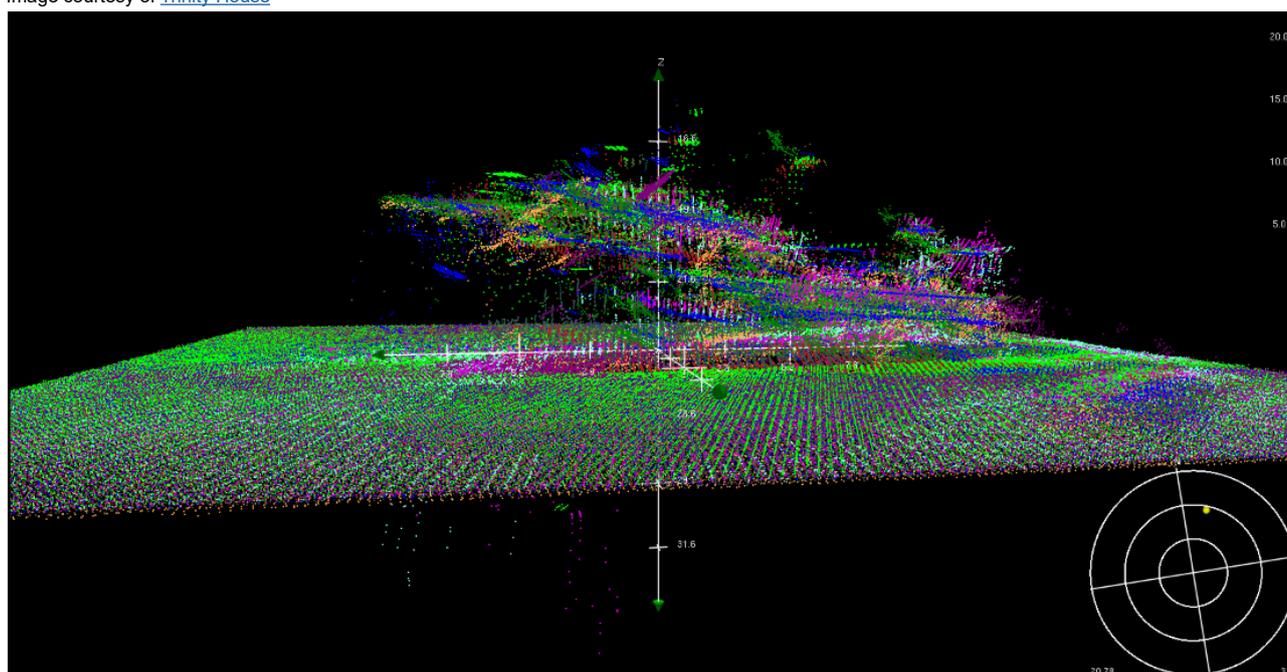
Figure 2: Survey image of *Joanna C's* wreck from THV *Galatea*

The search for the missing crewmen was suspended overnight and resumed at 0800 on the 22 November; however, only debris was recovered. At 1500, the search was terminated. That evening, THV *Galatea* located *Joanna C's* wreck (**Figure 2**).

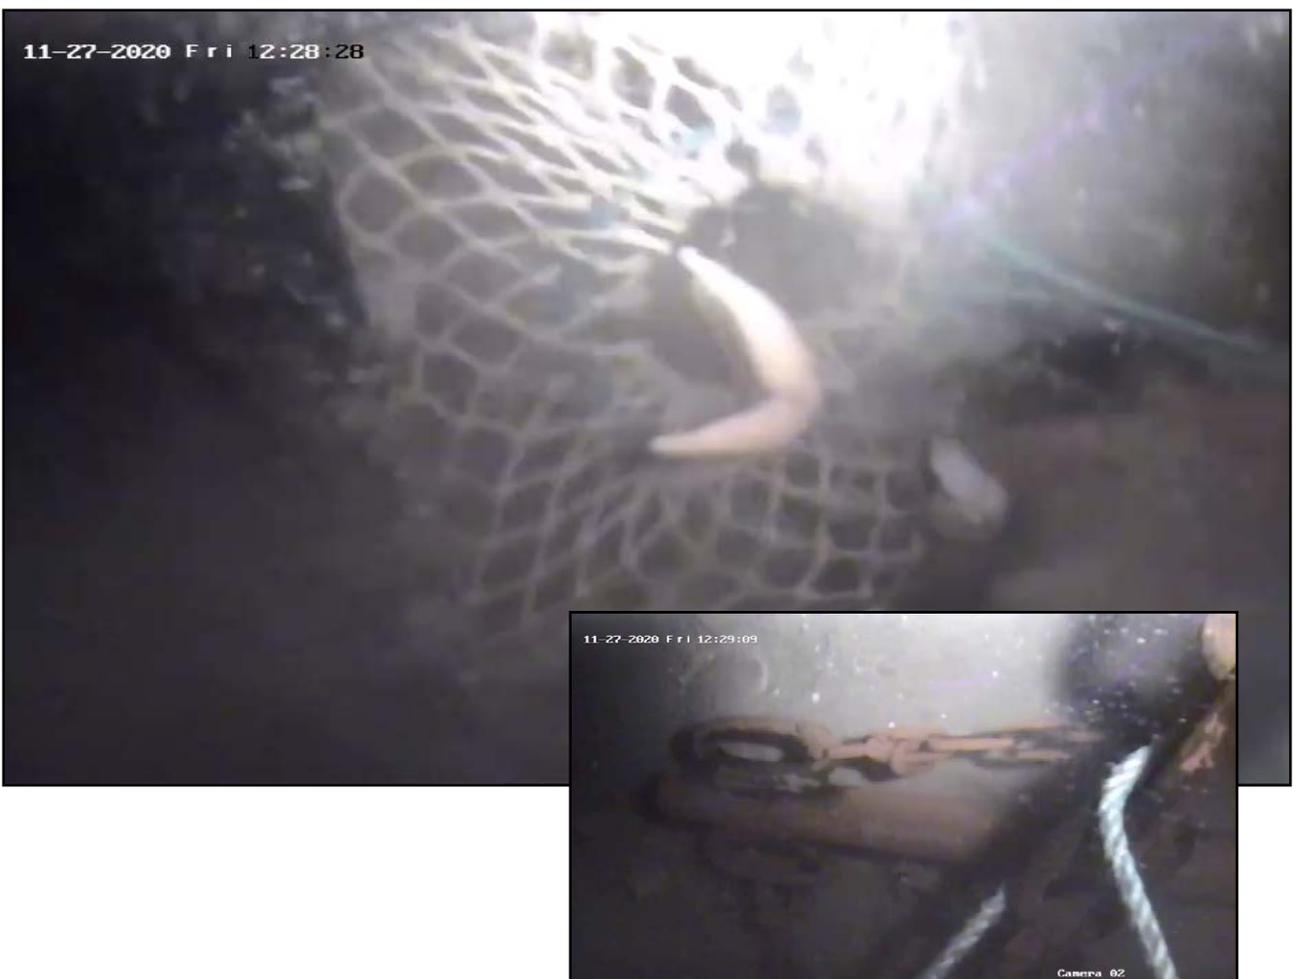
Figure 5: Image from dive survey, showing whelk pot on starboard dredge and (inset) rope caught round dredge bar

Joanna C's rapid capsizing was caused by the additional loading of the line of whelk pots on the starboard dredge bar. With the weight of the dredge bar, catch, and string of whelk pots acting at the point of suspension, *Joanna C* was effectively anchored to the seabed at the outboard derrick end. The vessel's centre of gravity was high as the derricks were in the raised condition and there was insufficient reserve of positive stability to overcome the starboard heeling moment induced by the whelk pots (**Figure 17**). Once *Joanna C* heeled beyond around 14°, and with the heeling moment continuing to be applied and including dynamic effects, capsizing was inevitable.

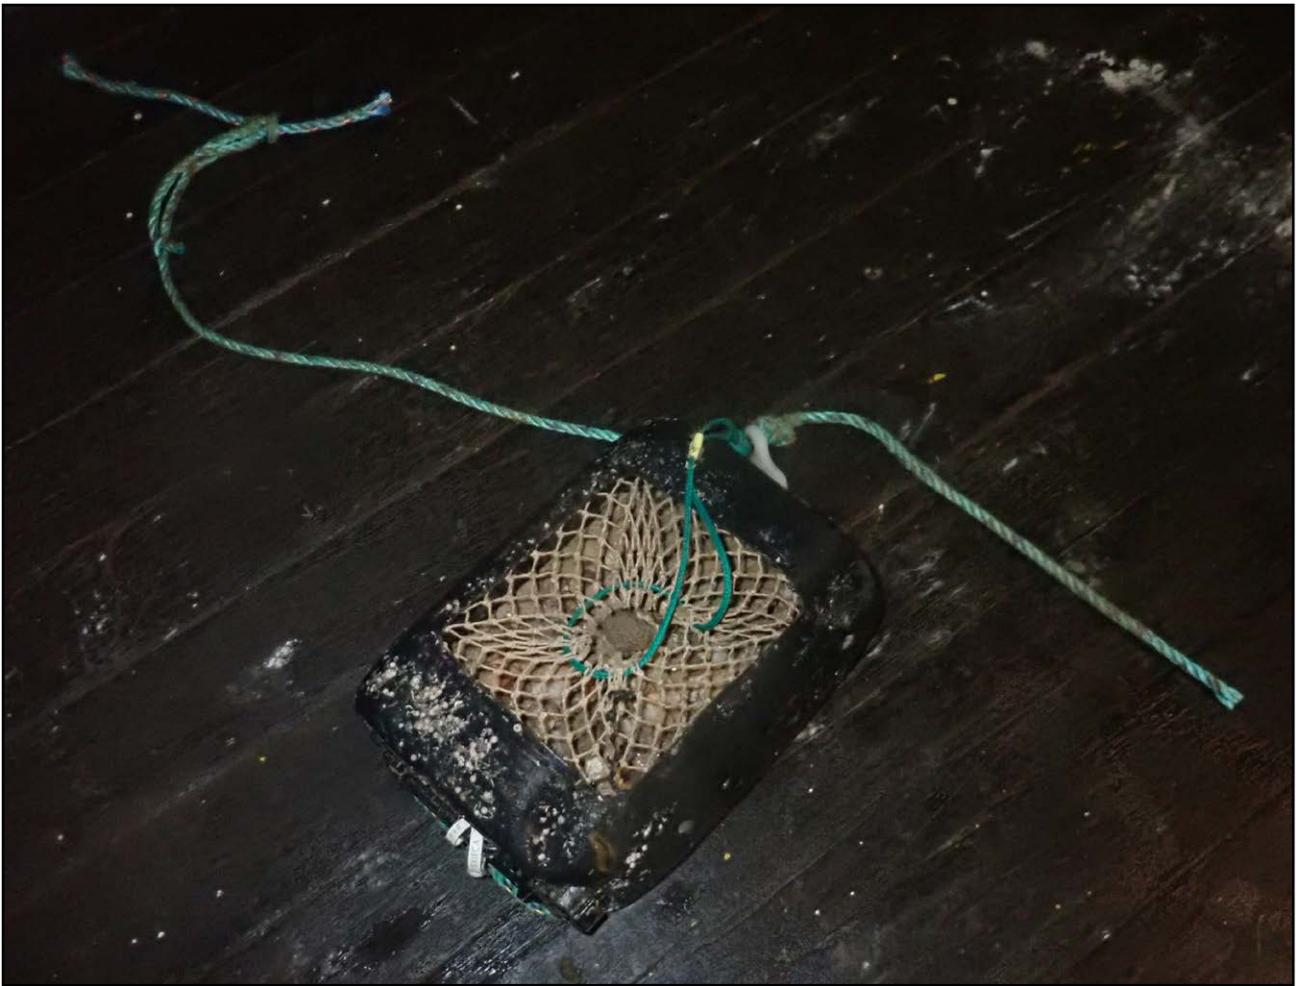
Figure 8: Recovered whelk pot

Whelk fishing gear typically consisted of individual weighted pots attached by short lengths of rope to a main line to form a string of pots, which was anchored to the seabed at each end. The number of pots in each string varied between operators, but strings of 50 to 100 pots were commonplace. Whelk pots varied in weight according to their construction; a 12kg pot was recovered during the dive survey (**Figure 8**).

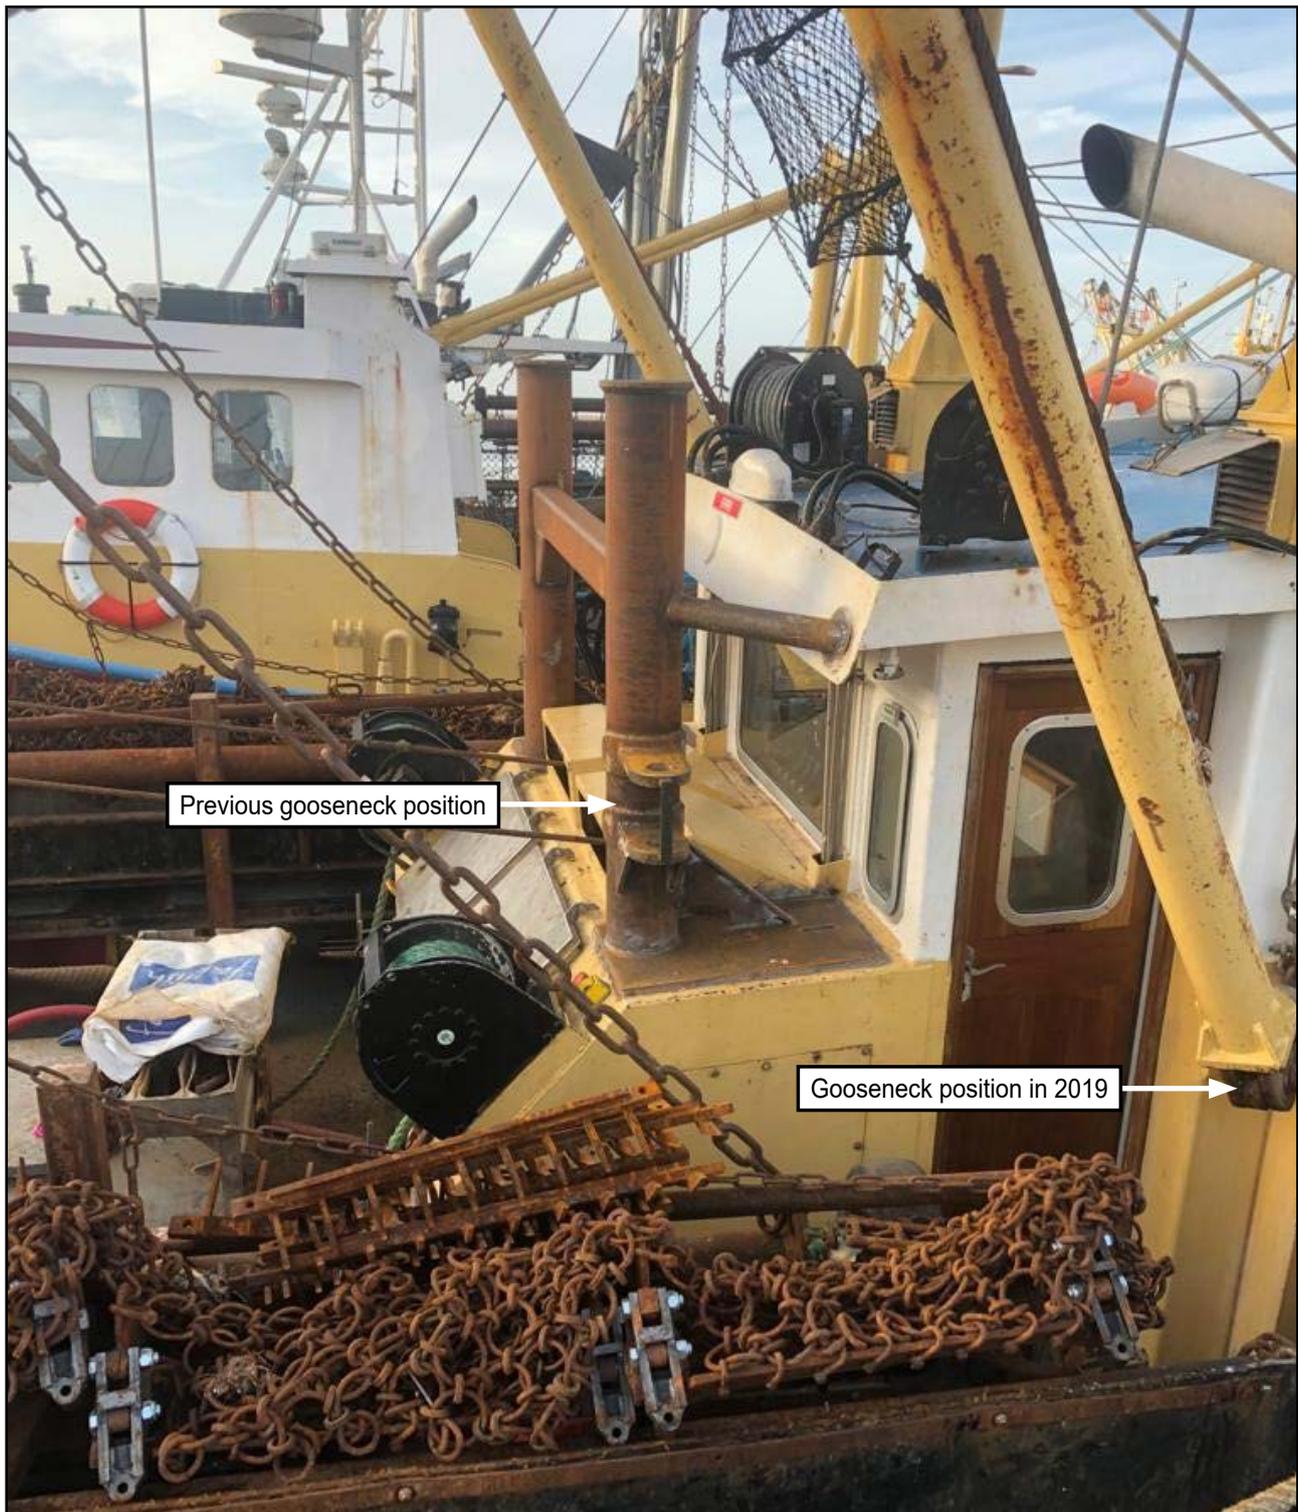
Figure 10: Derrick gooseneck position after the 2019 modifications

The 2019 modifications also included moving the derrick attachment points and main gantry from on top of the main winch housing to the sides and roof of the wheelhouse respectively (**Figure 10**). The MCA was not notified of the start of the 2019 modification work and became aware that the alterations had been carried out after completion.

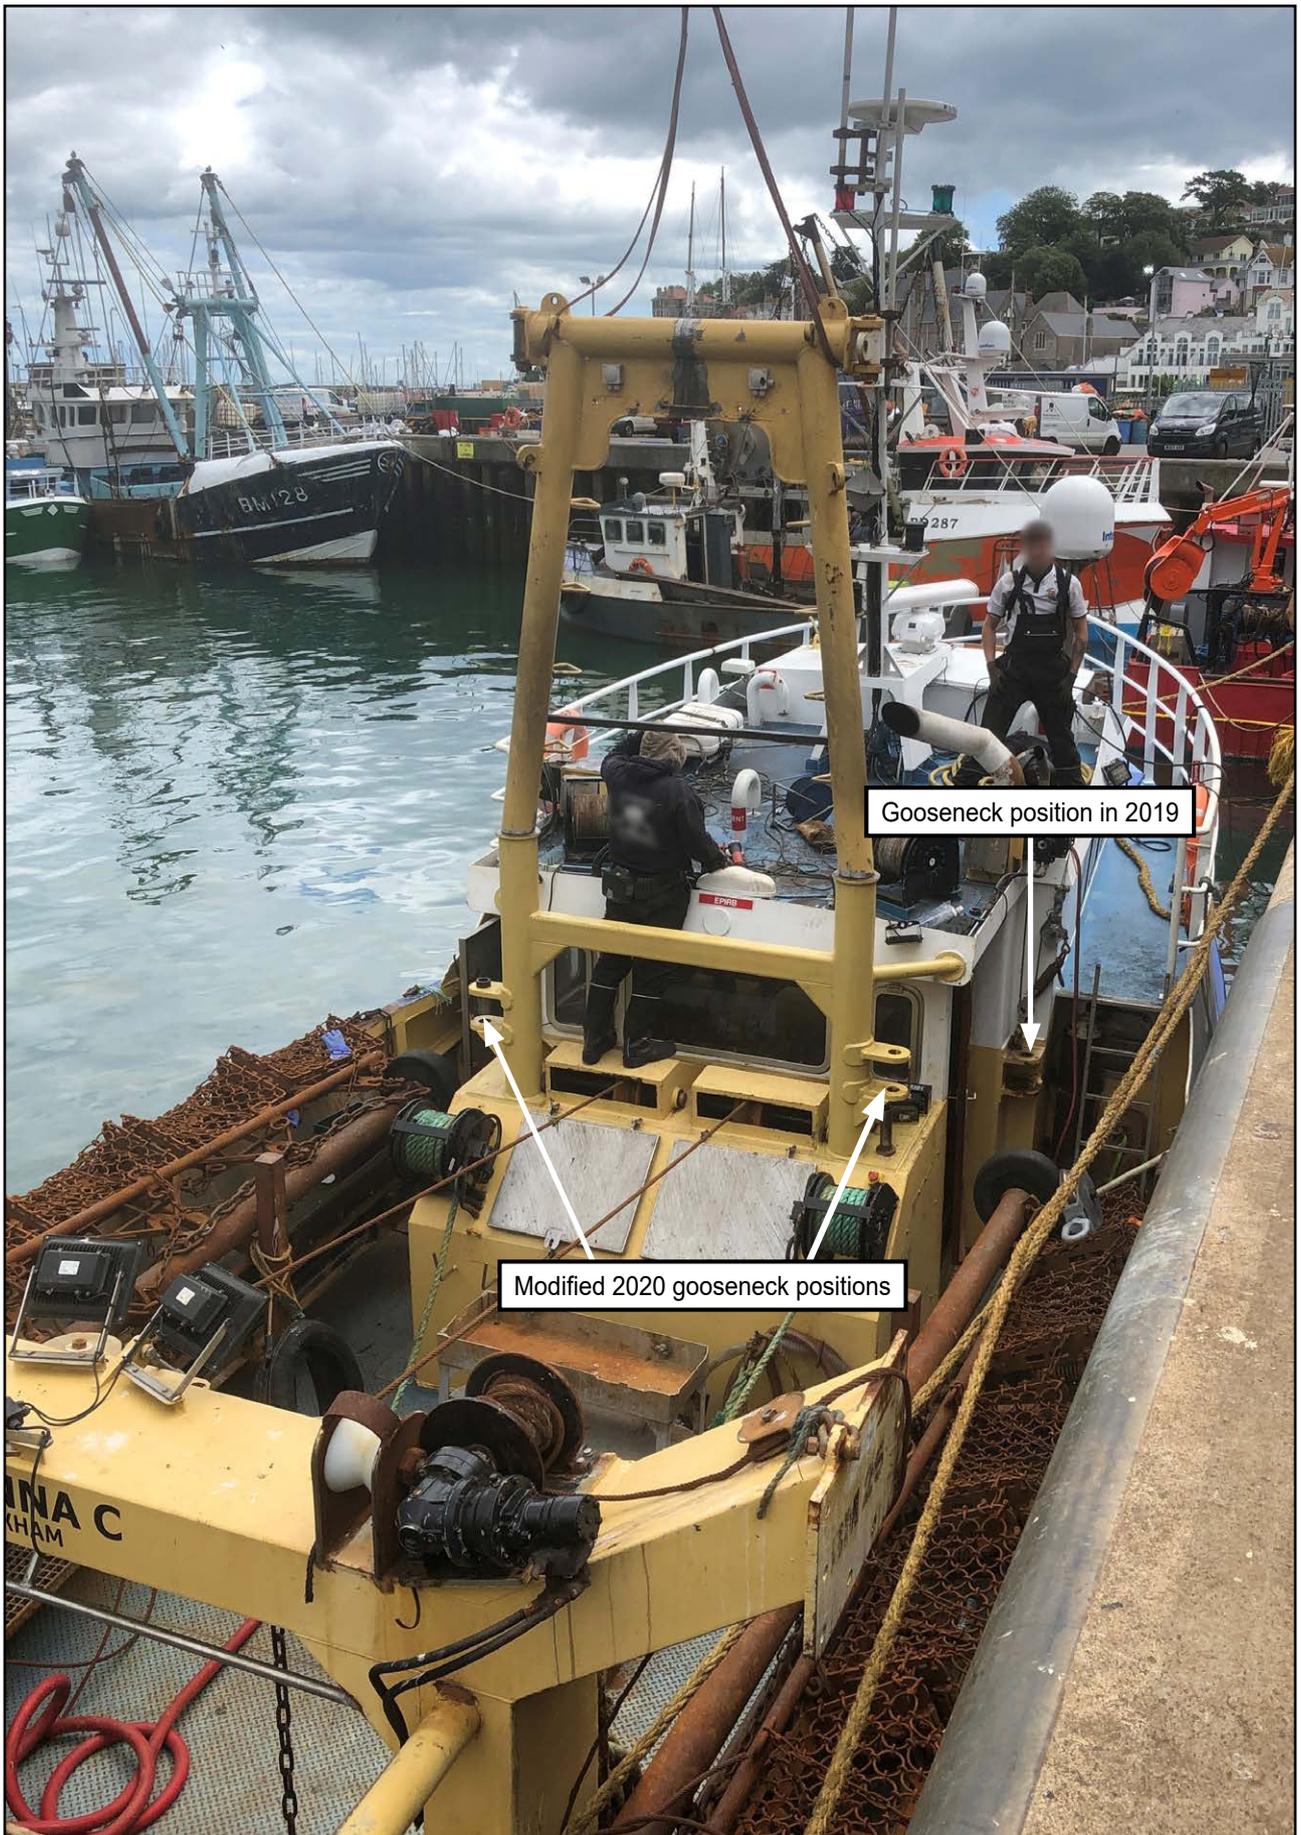
Figure 11: Derrick gooseneck position after the 2020 move

In July 2020, *Joanna C*'s derricks and gantry were moved back to their original position on the winch housing (**Figure 11**). The MCA was not notified.

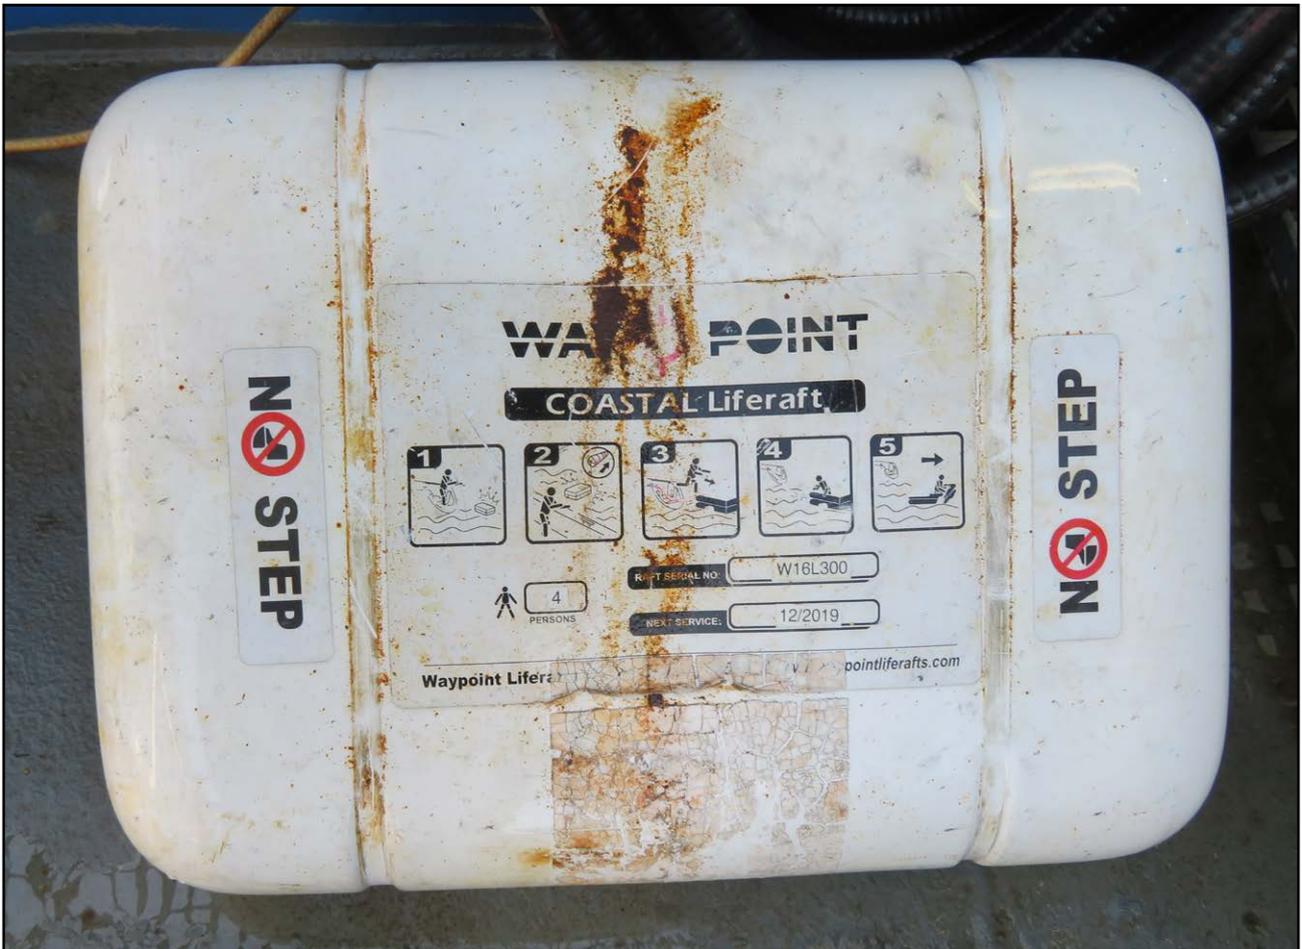
Figure 13: Joanna C's liferaft canister as recovered

After the capsize, *Joanna C*'s float free liferaft was released, but did not inflate because of insufficient buoyancy to trigger the inflation mechanism. The failure of the liferaft to inflate and come to the surface adversely affected the survival time of the crewmen in the water. The liferaft was not constructed or required to meet any industry minimum standard for buoyancy in the uninflated state, necessary to assure automatic inflation. As a result, an urgent MAIB safety recommendation was made to the British Standards Institution to propose the introduction of a minimum buoyancy requirement for liferafts certified by the International Organization for Standardization. The International Organization for Standardization's technical committee has subsequently included a buoyancy requirement for liferafts designed for float free launching in its revised liferaft standard. In light of this action, no recommendations have been made in this report regarding the buoyancy of uninflated liferafts.

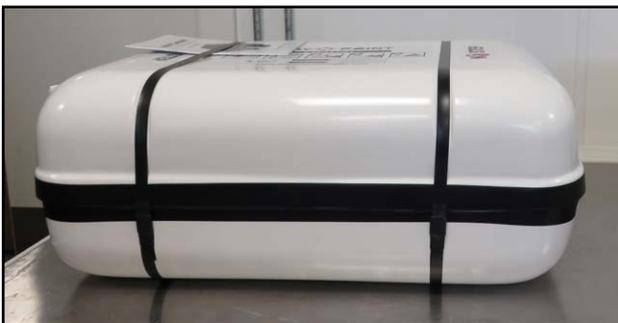
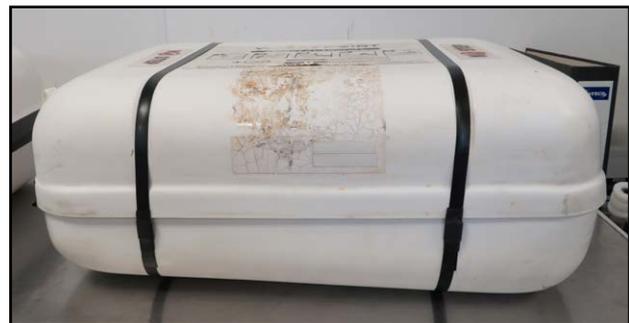
Figure 15: New liferaft, showing addition of manufacturer's black tape (left) and *Joanna C's* repacked liferaft (right)

After the accident, Joanna C's liferaft was returned to the manufacturer and repacked, the gas cylinder refilled and the inflation activation mechanism rearmed. The vacuum-packed liferaft was then placed into the original canister and straps fitted in accordance with the manufacturer's service protocol. The liferaft was then taken to Fleetwood Test House along with a new 4-man Waypoint Coastal liferaft. The new liferaft was identical to the accident raft except for a line of black tape across the join between the two halves of the canister. The manufacturer had introduced the tape in 2018 to inhibit water ingress into the canister (Figure 15).

During the buoyancy test it was observed that the black tape on the new liferaft was successful in minimising initial water ingress and the amount of air escaping from the canister was observed to be less than that from *Joanna C*'s liferaft. During the painter pull force test the flexible sealing grommet from *Joanna C*'s liferaft remained in place and the inflation activation wire and knot in the painter had to be pulled through it. On the new liferaft the grommet pulled out of the canister immediately as force was applied to the painter.

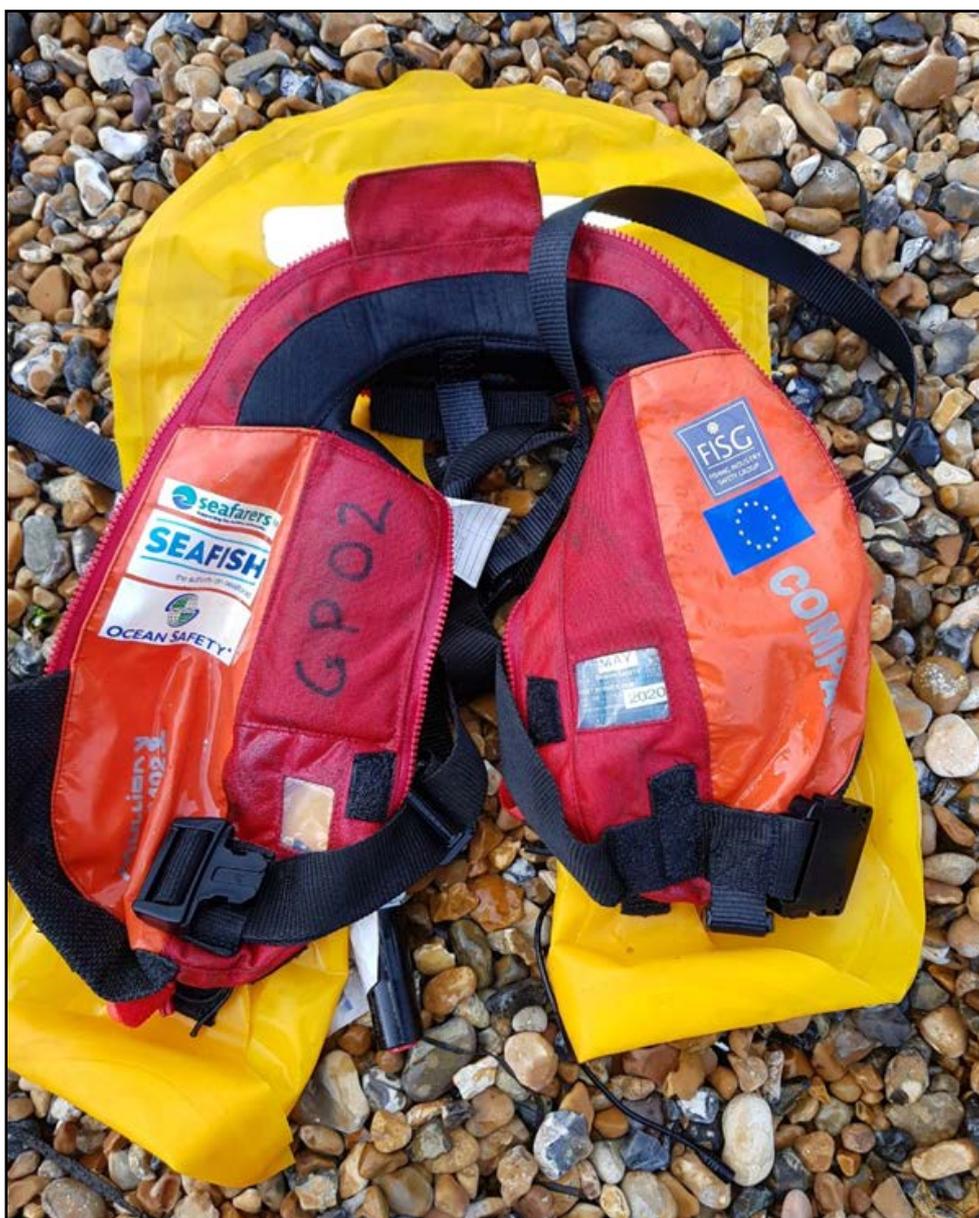
Figure 16: Personal flotation device recovered from Newhaven beach

Three days after *Joanna C* was lost, a Mullion Compact 150N inflatable PFD was recovered from the beach east of Newhaven (**Figure 16**). The lifejacket was marked with several logos, including that of Seafish and *GP02* was written on the outer fabric. The MAIB inspected the lifejacket and found that: it appeared well worn, the inflation mechanism status indicators were both red, the manual pull toggle was in the 'armed' position, the chest strap and crotch strap were both undone, the length of chest strap was approximately 90cm, and the lifejacket service indicator showed that it had been due for service in May 2020.

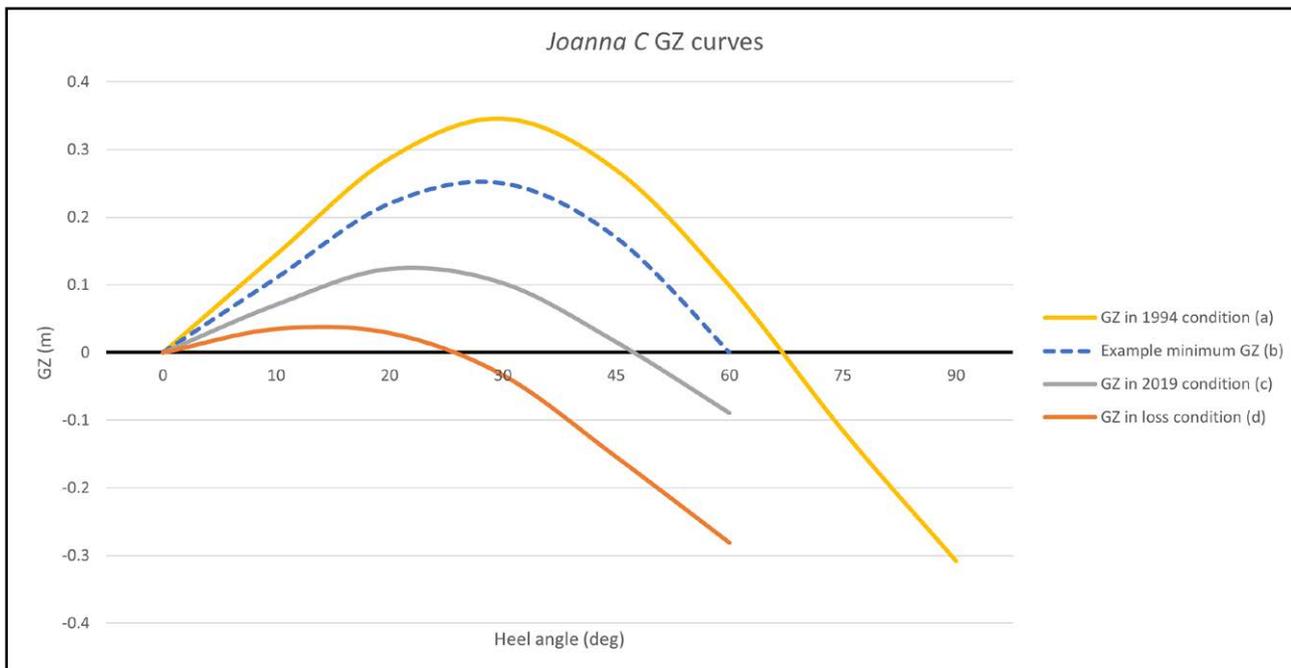
Figure 18: GZ curve comparison

Figure 18 shows *Joanna C*'s GZ curves over time, along with an example GZ curve meeting the minimum stability criteria (curve b). Curves a and c were derived from the 1994 and 2019 inclining experiments and were calculated for Condition 4²⁷. Curve d was calculated with the vessel in the estimated condition at loss, with 7t of scallops in the fish hold, derricks raised, and the full dredge bags suspended from the dredge bar. In this condition the weight of the dredge bars and catch was acting at the point of suspension, which was the outboard end of the derrick.

Joanna C had a very small range of positive stability with the derricks raised in the loss condition (curve d), and the angle of vanishing stability occurred at around 25°. The maximum GZ in this condition was 57% lower than the calculated value for the 2019 static condition and occurred at just 14° angle of heel; significantly lower than the required 25° minimum. The low angle of maximum GZ meant that after 14° of heel the righting lever rapidly reduced, and the ability to recover from any further heel diminished. The extremely low value and angle of occurrence for maximum GZ coupled with the low range of positive stability meant that *Joanna C* was vulnerable to capsize given any initiating heel factor in this condition. This was demonstrated when the addition of 300kg to the starboard dredge bar in the theoretical model reduced the positive stability to the point of nonexistence. *Joanna C*'s actual vulnerability was increased, as the stability analysis and modelling of the loss condition was for the static condition and did not take account of dynamic effects such as wind and waves, further reducing the vessel's ability to recover from an angle of heel.
