REPORT MARINE 2022/08

*Fire on board 'MS Brim' in the outer
Oslofjord on 11 March 2021*

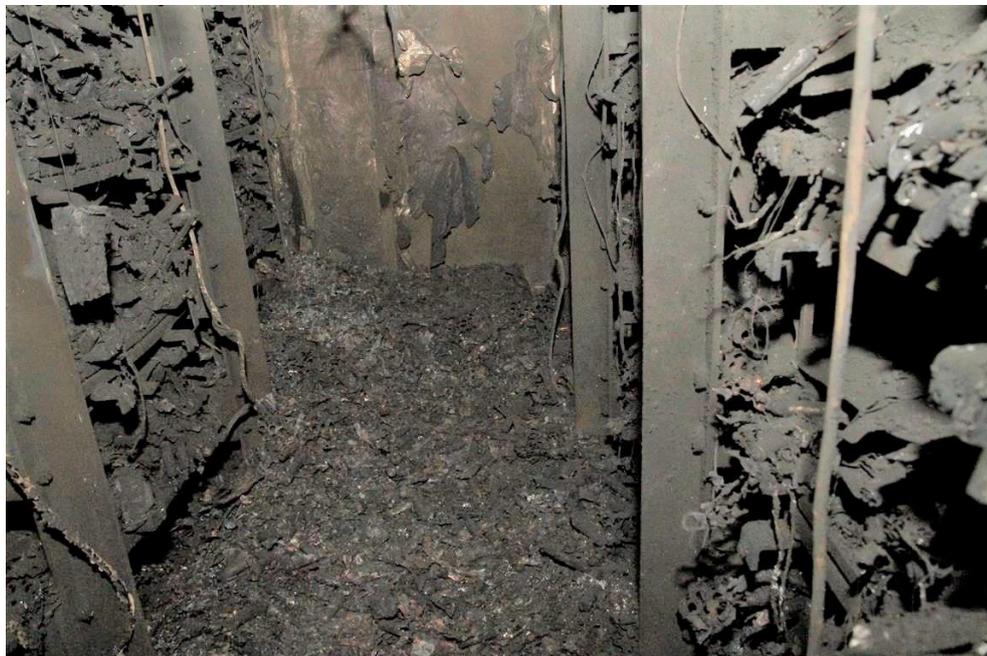
The battery room was a total loss; see Figure 6.

Figure 6: Fire damage to starboard battery room. Photo: Kripas

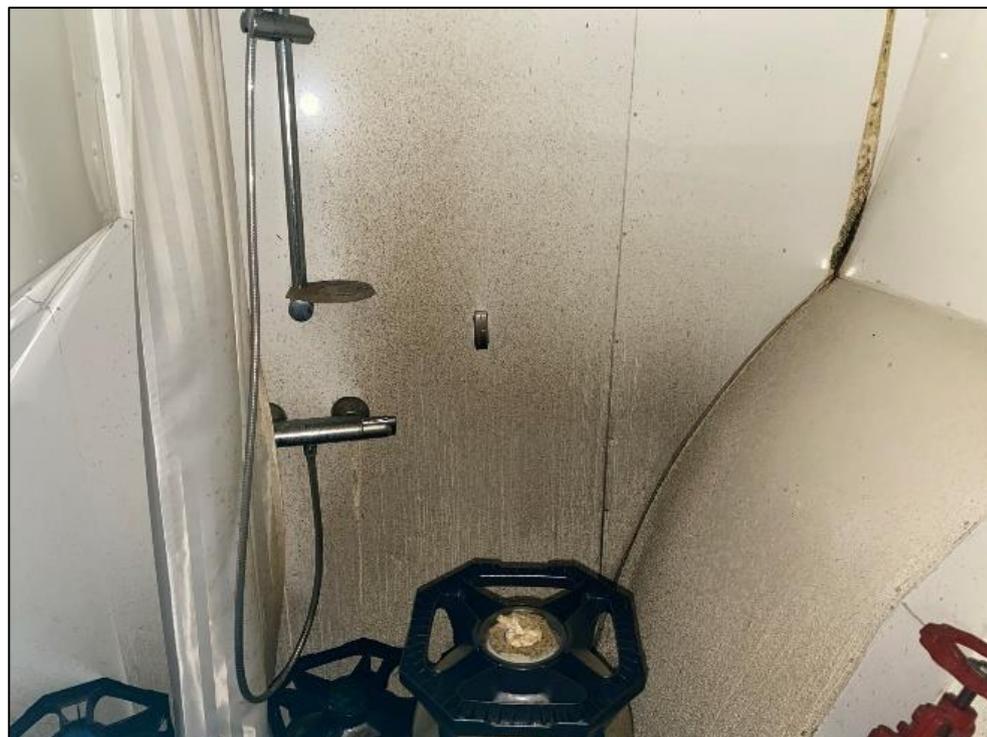
The adjacent cabin at the fore was damaged by smoke penetrating the bulkhead via pipe feedthroughs from the greywater tank located under the sole of the battery room; see Figure 7 and Figure 8.

Figure 7: Clear traces of high temperatures having damaged the wall adjacent to the battery room. Photo: The insurance company

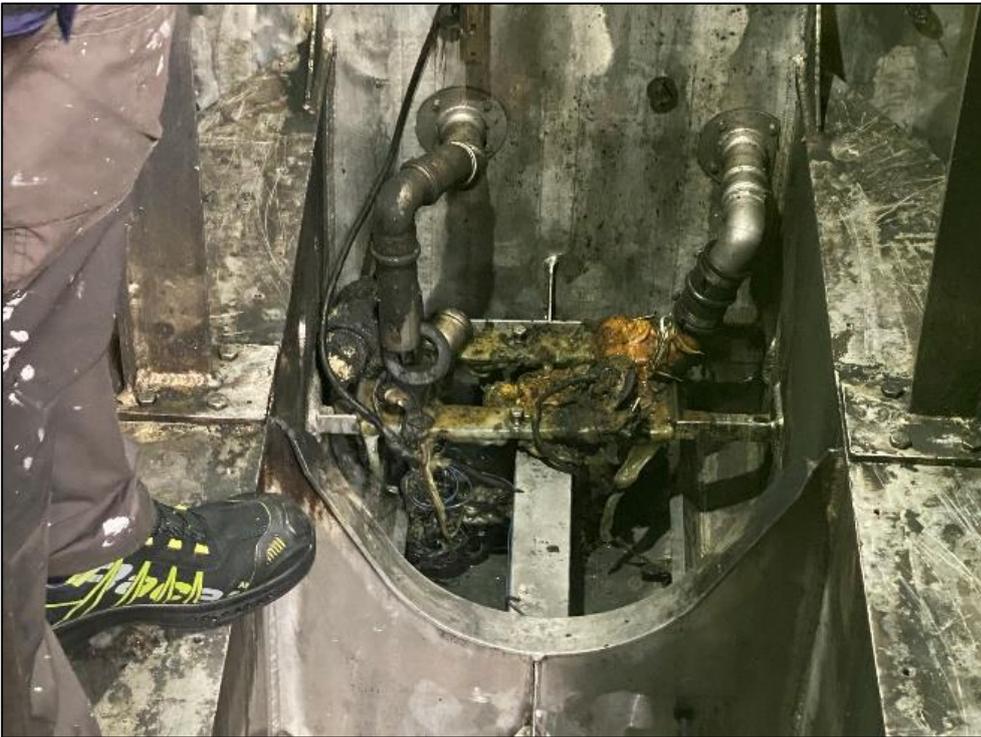
Figure 8: The greywater tank was located under the sole of the battery room. Photo: The insurance company

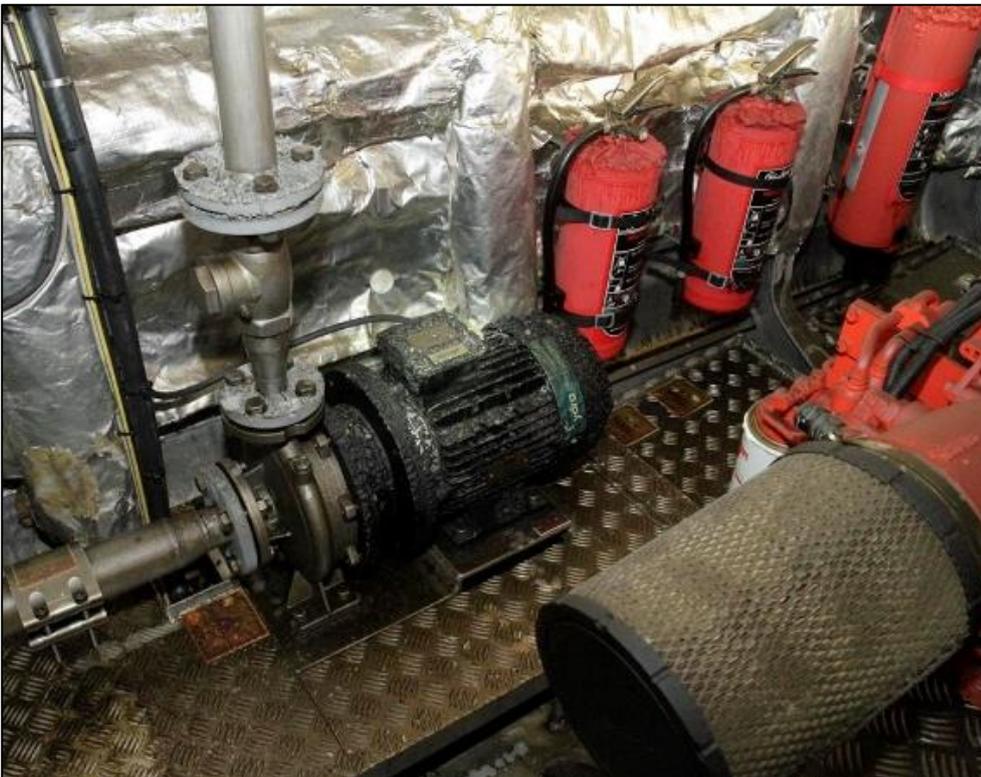
The engine room, the adjacent room at the aft, bore traces of both smoke and acid damage; see Figure 9.

Figure 9: Smoke and acid damage to equipment. Photo: Kripos

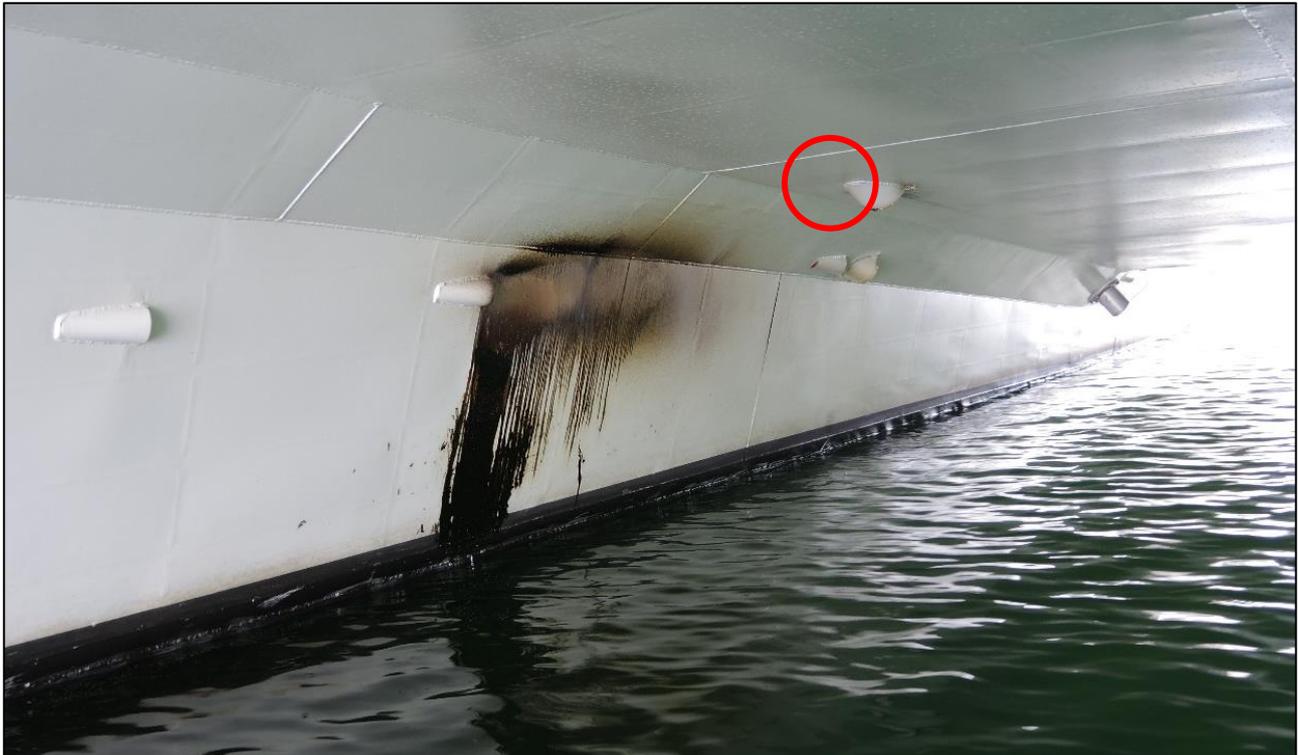
Figure 21: The ventilation outlet from the battery room to the tunnel marked with a red circle. The soot and fire damage inside the tunnel hull came from the cabin at the fore of the battery room. Photo: NSIA

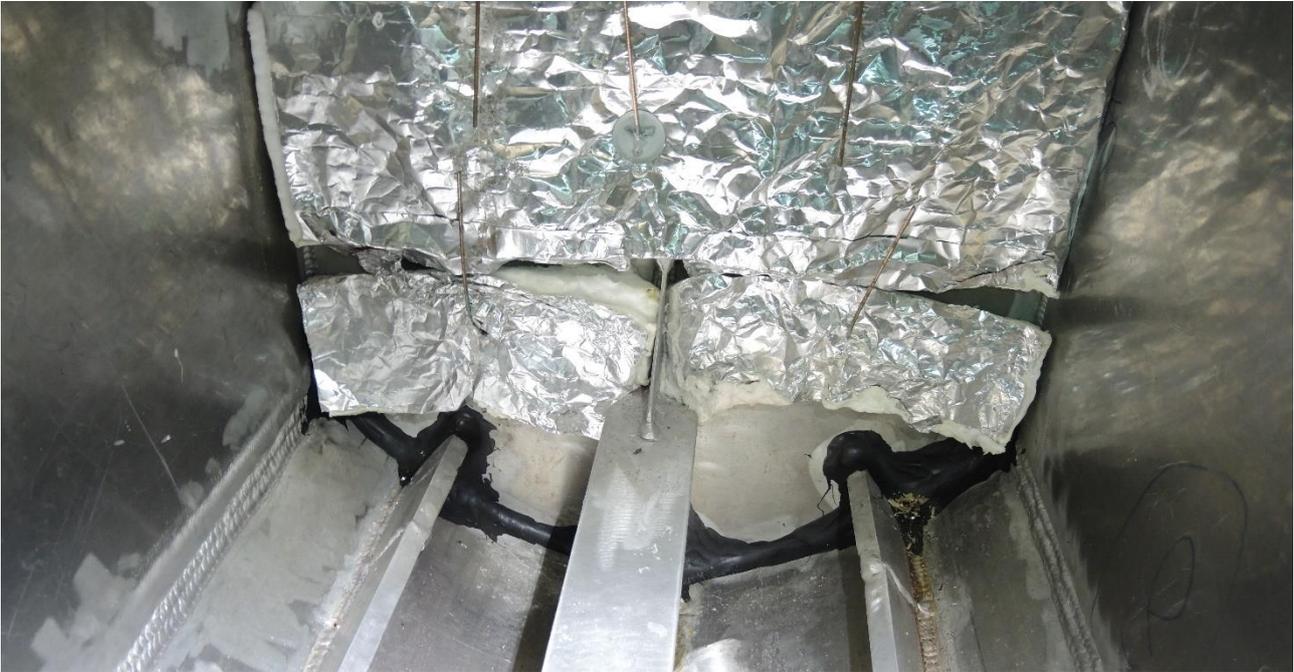
*Figure 23: Fire insulation almost all the way to the bottom of the vessel, with SIKA Firestop at the lower end.
Photo: NSIA*

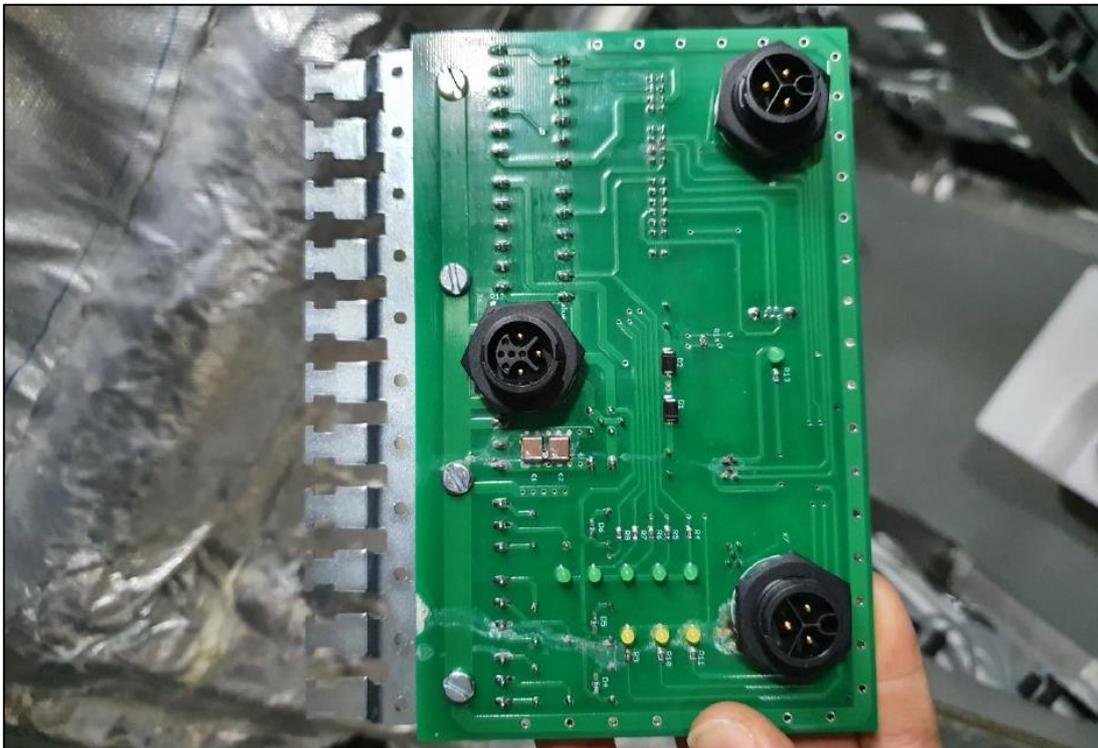
The vessel crossed the Stadhavet sea on 13 May exposed to westerly winds and waves to starboard. Shortly afterwards, the power failed, but the vessel continued the voyage to Bergen on the same day, with the batteries disconnected. The battery contractor came on board the vessel to troubleshoot the battery system. The service report concluded that the circuit board for the stack controller in the port battery room was damaged by water. The damaged circuit board was replaced; see Figure 28. Communication between the owners and the shipyard on 14 May 2020 made it clear that the circuit board had been exposed to water and bore clear signs of corrosion and fire damage.

Figure 28: The damaged circuit board that was replaced in stack 12. Photo: The battery contractor

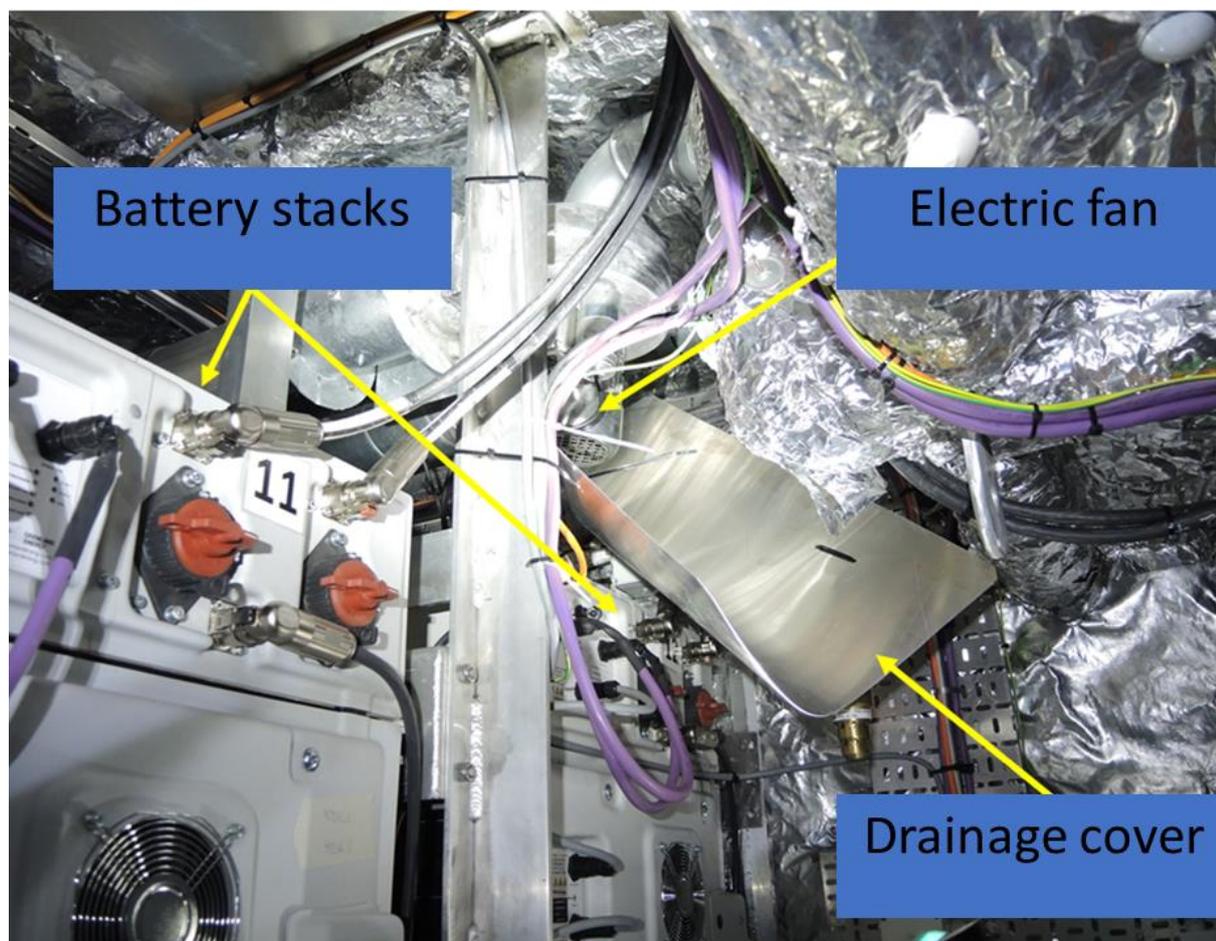
A few days after that, it was discovered that the fan in the port battery room had overheated and gave off a burning smell. The yard was notified, ordered a new fan and replaced it. As a consequence of the leakage from the fan, which was assumed to be condensation, the yard proposed making a drip pan for drainage into the keel. The yard sent drainage covers to lead the 'condensation water' away from the stacks and down to the soles of the battery rooms. The owners installed the drainage cover on the port side; see Figure 29. The fan was not replaced and no drainage cover was installed on the starboard side.

Figure 29: Electric fan above battery stack 12 with temporary drainage cover installed in port battery room to lead water away from the battery system. Photo: NSIA

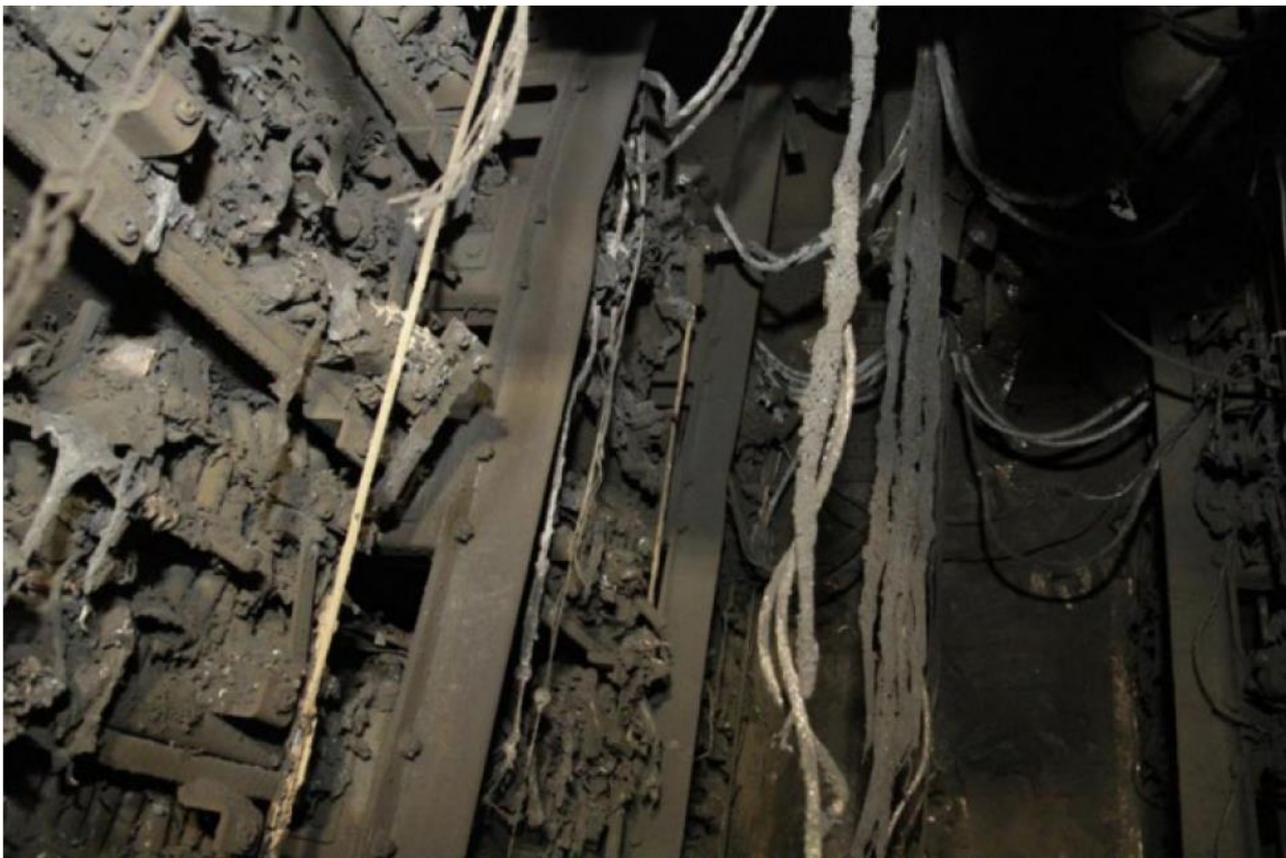
Figure 30: Damage to the battery room, seen from the battery room door. From left to right: battery stacks 6, 5 and 4. Photo: Kripos

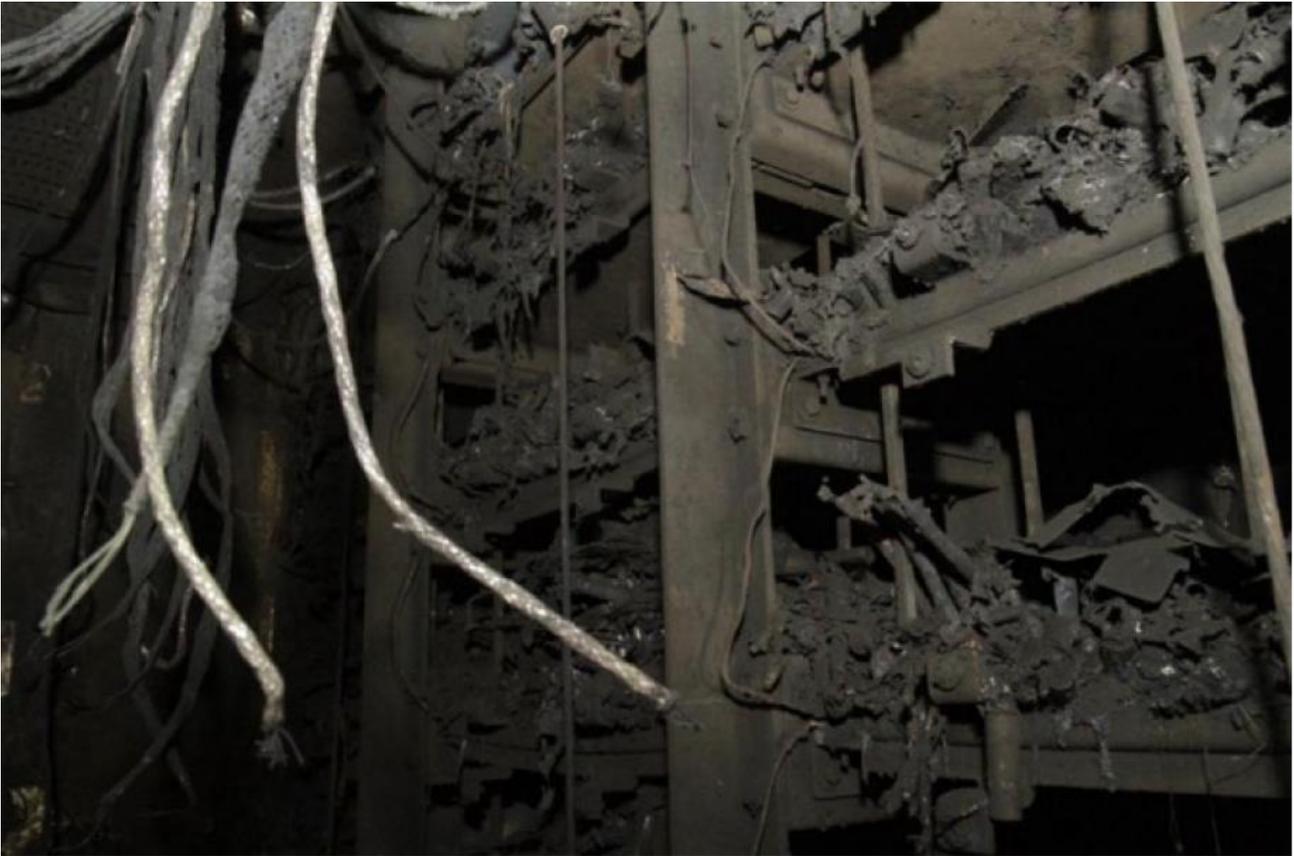
Figure 31: Damage to the battery room, seen from the battery room door. From left to right: battery stacks 3 and 2. Battery stack 1 (next to battery stack 2) cannot be seen in the photo. Photo: Krijpos

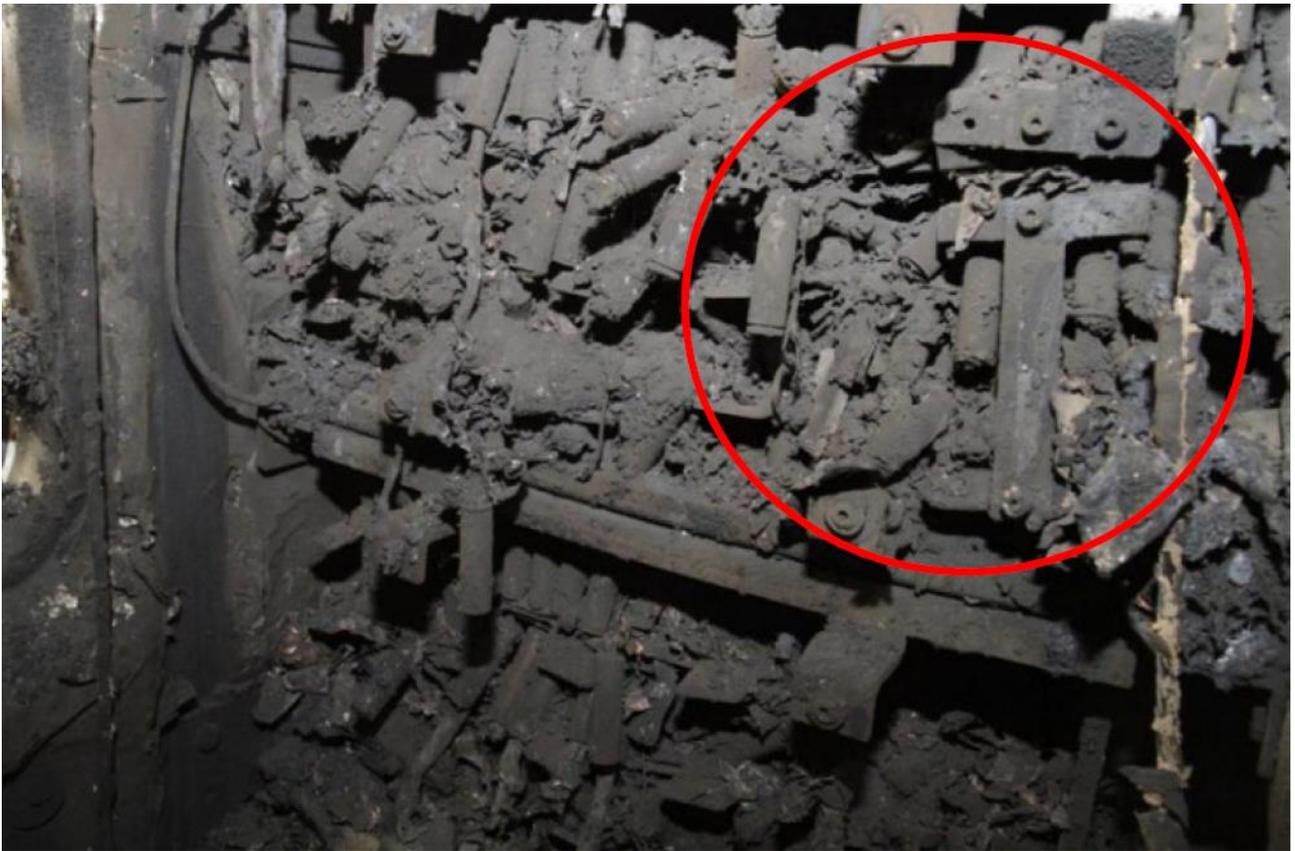
Figure 32: Remnants of battery module 2 in battery stack 6, with the copper strip encircled in red. Photo: Kripos

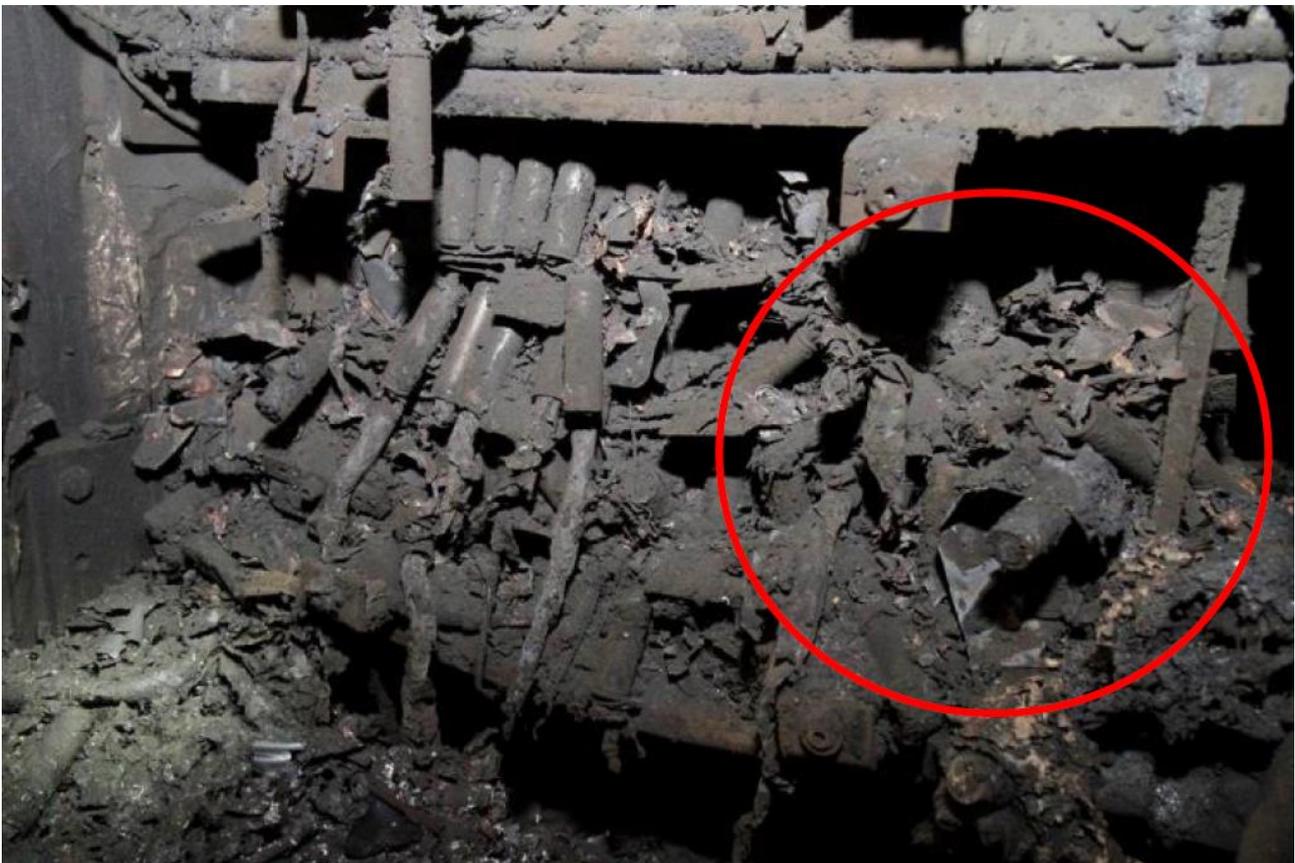
Figure 33: Remnants of battery module 1 in battery stack 6, with the area of the missing copper strip encircled in red. Photo: Kripos

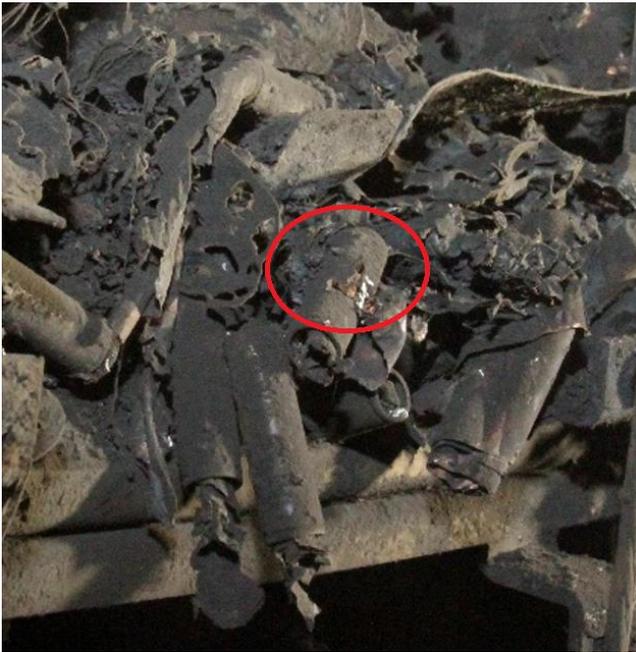
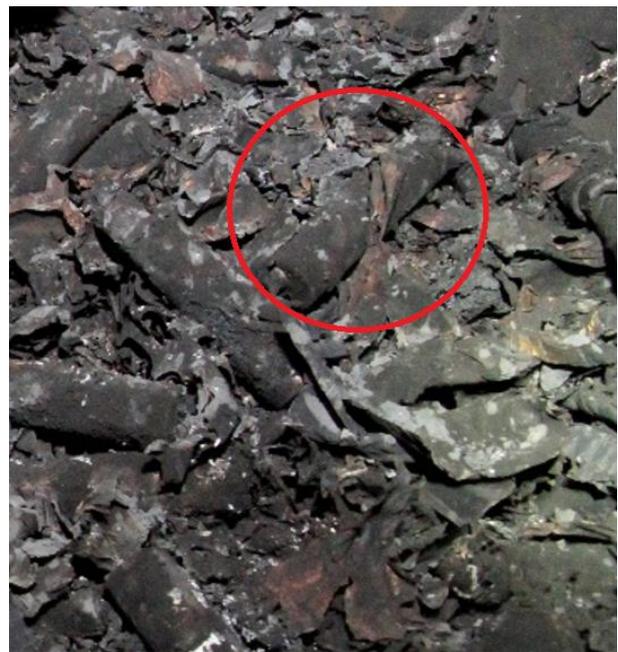
On examination, several battery cells showed signs of rupture in the cell walls; see Figure 34 and Figure 35.

Figure 34: Signs of rupture in the cell wall are encircled in red. Photo: Kripós

Figure 35: Signs of rupture in the cell wall are encircled in red. Photo: Kripós

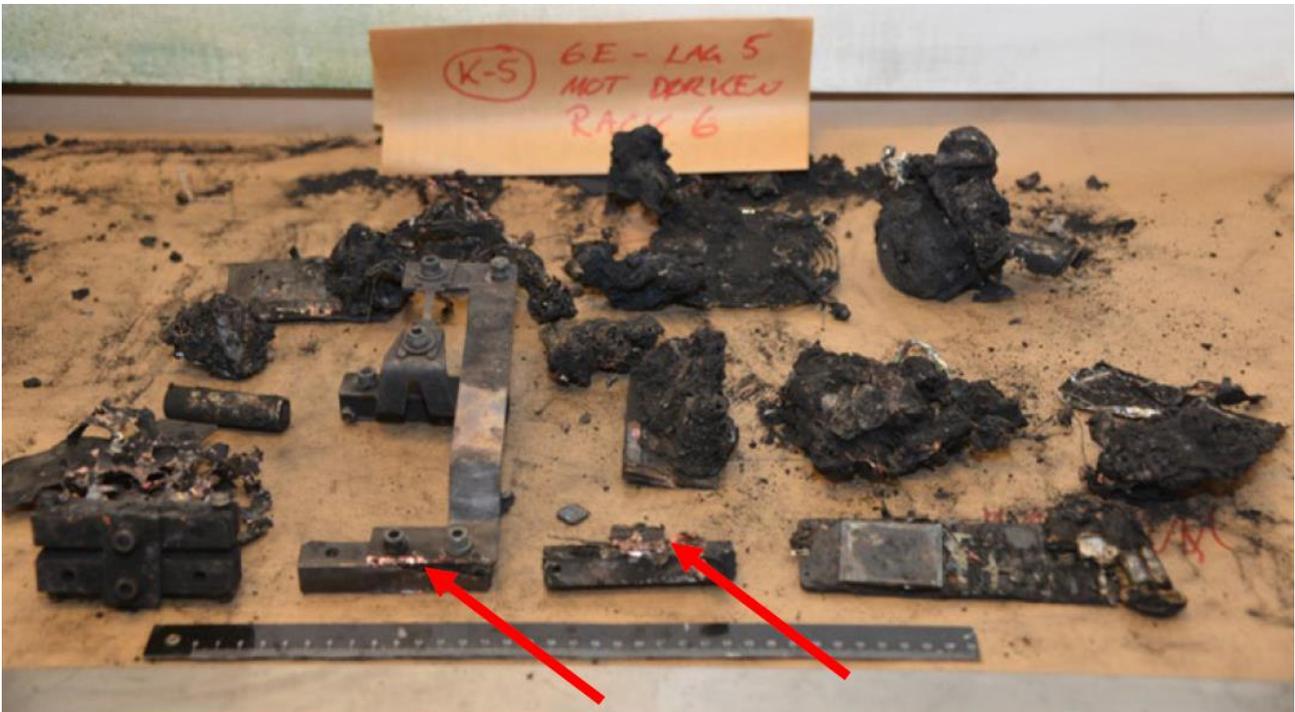
Figure 36: Debris from battery modules 1 and 2 in battery stack 6. The red arrows point to electric arc damage. Photo: Kripós

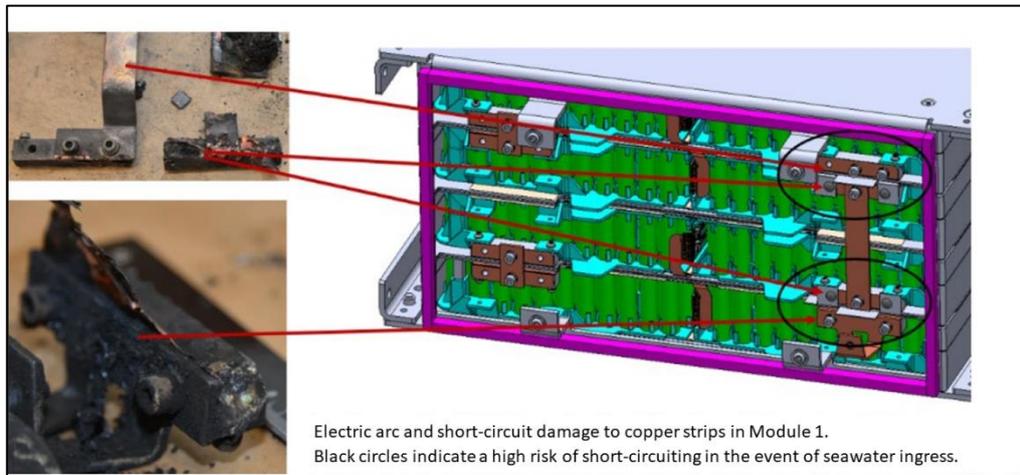
Figure 37: Position of copper strips with short-circuit damage in a drawing of module 1 with the copper strips intact. Photo: Kripos. Drawing: Kripos/The battery contractor/FFI

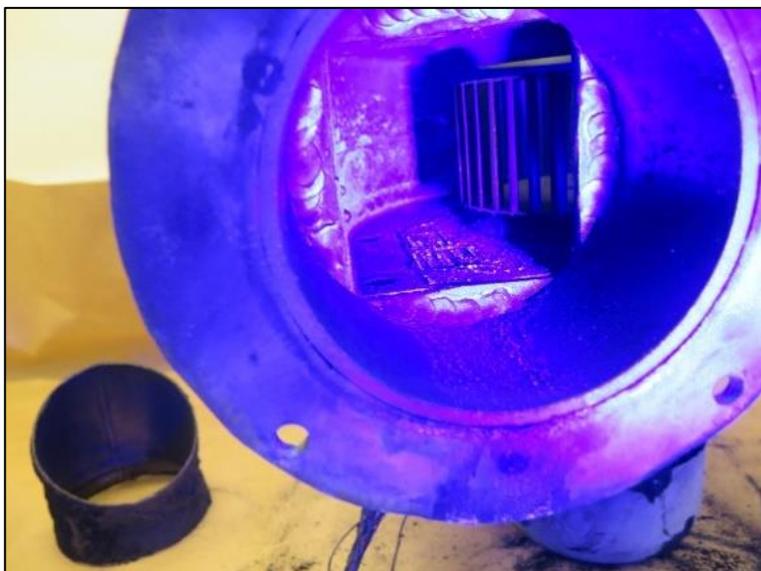
Figure 38: The inside of the starboard fan housing. UV light was used to identify traces of splashes and moisture. Photo: NSIA

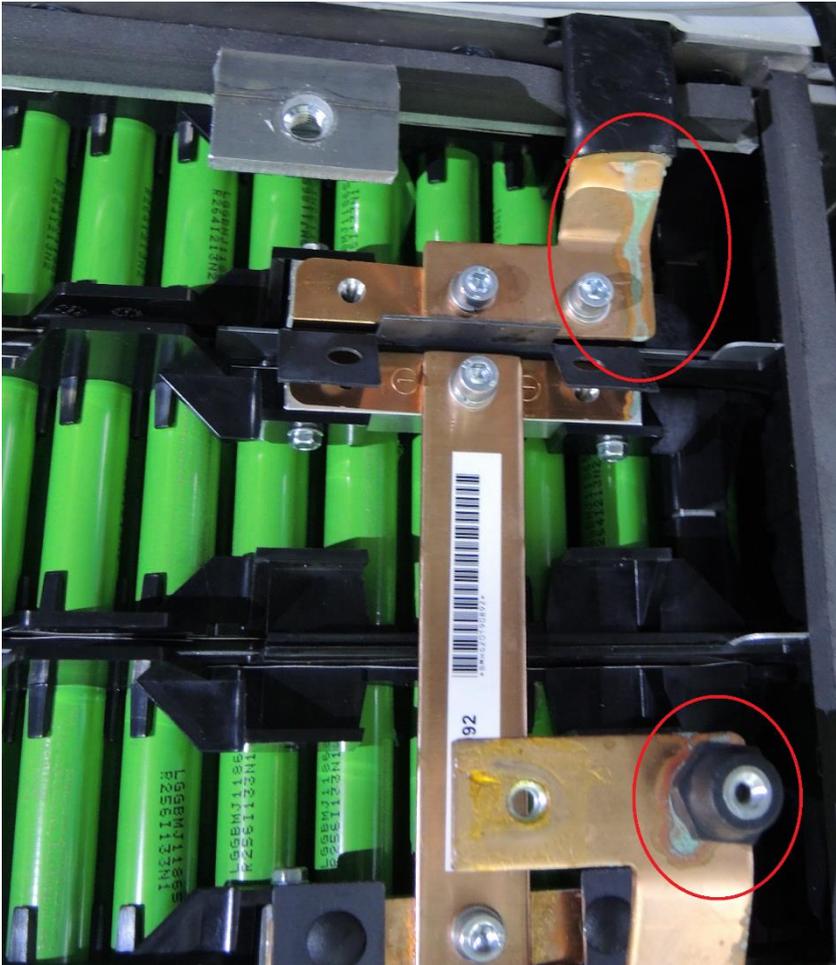
Figure 41: Corrosive stains on the topmost copper strip in battery stack 12, which was located below the fan in the port battery room. Photo: NSIA

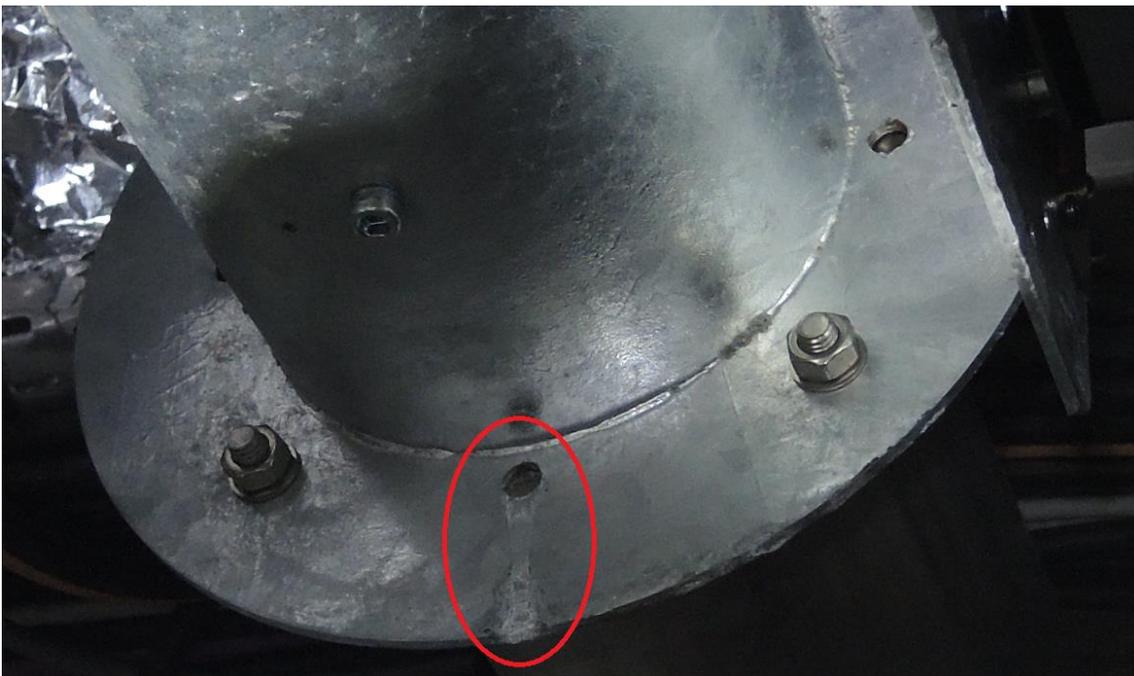
Figure 42: Salt deposit at the bottom of the flange for the fire damper in the ventilation outlet. Photo: NSIA

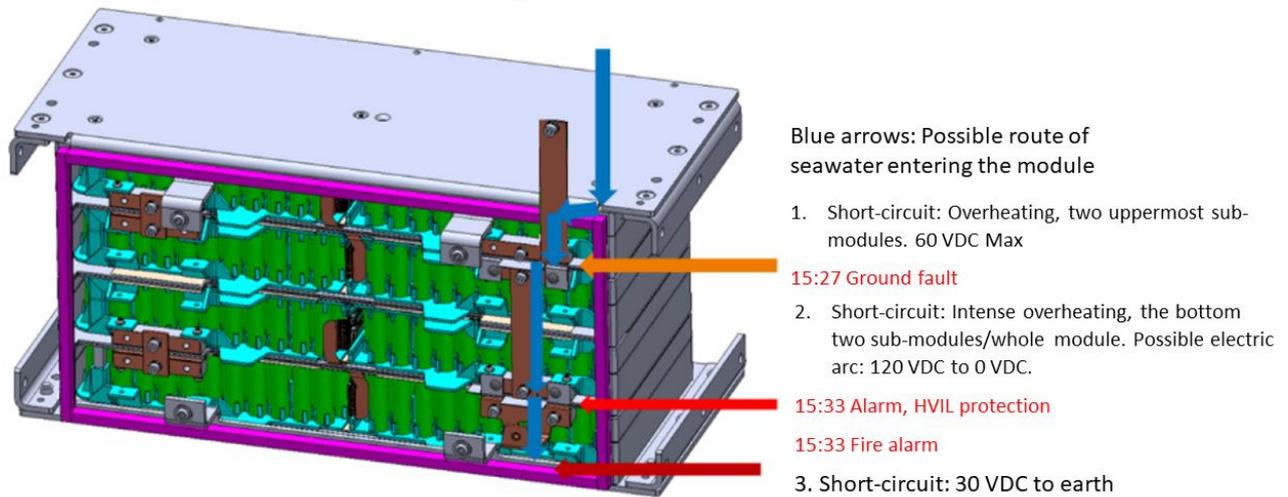
'BRIM' Battery pack 6 Module 1

Figure 44: Possible sequence of events on ingress of seawater to module 1 in battery stack 6. The blue arrows show how seawater may have ingressed and short-circuited the modules in several places. Illustration: The battery contractor/FFI

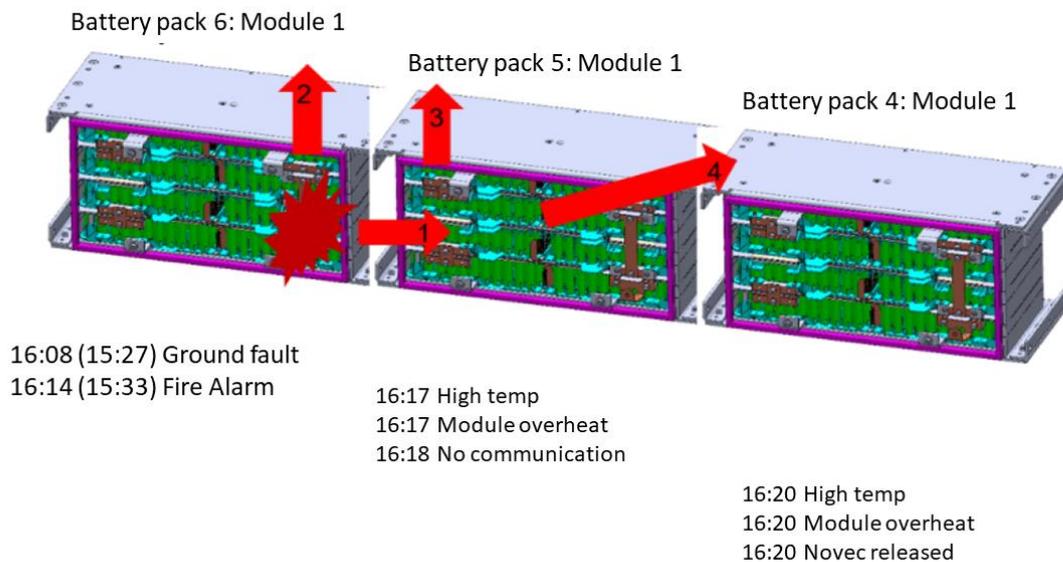
'BRIM' Possible sequence of events

Figure 45: Possible spread of fire between battery packs 4, 5 and 6 in the battery room.²⁰ Illustration: The battery contractor / FFI

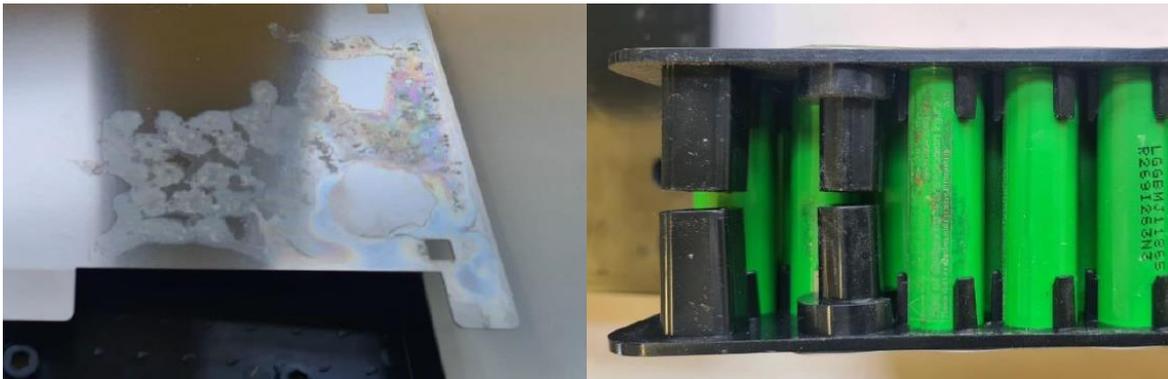
Figure 47: On the left: traces of dried-up saltwater on metal components in stack 12, module 2, cell module 2. On the right: corrosion on cell box and salt residue. Photo: The battery contractor

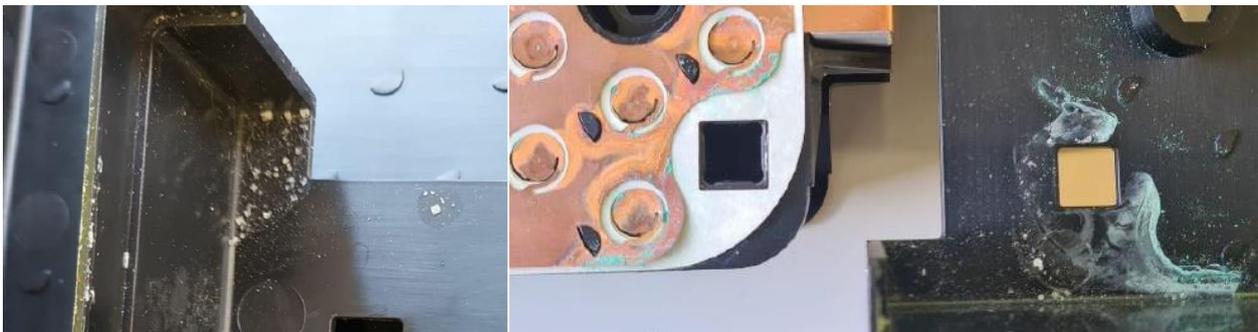
Figure 48: On the left: dried-up crystallised salt inside stack 12, module 5, cell module 2. On the right: visible corrosion and saltwater residue on data bus and cell module cover in stack 12, module 4, cell module 4. Photo: The battery contractor
