Loss of containers overboard from *APL England*

46 NM south-east of Sydney, New South Wales on 24 May 2020

ATSB Transport Safety Report

351-MO-2020-002

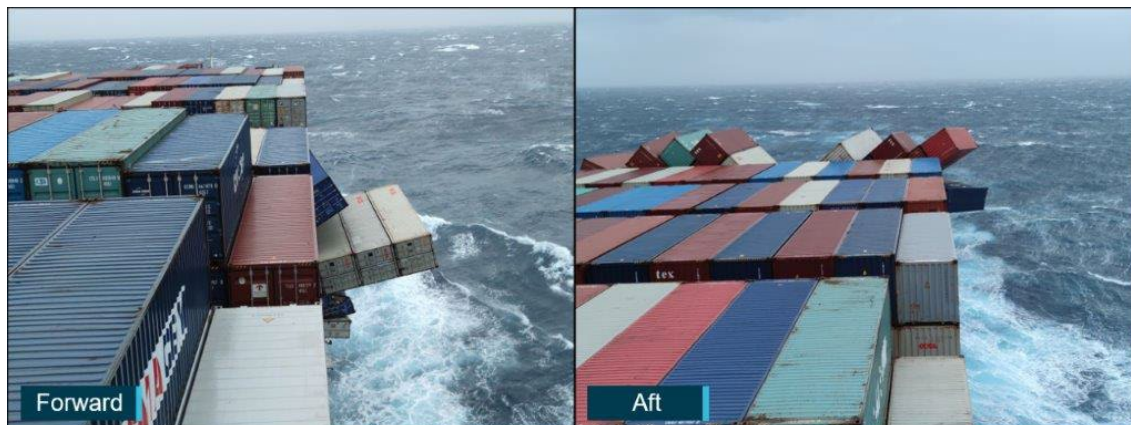
Figure 3: Looking forward and aft from navigation bridge at about 0700

As the skies lightened (sunrise was at 0647), the chief mate noticed fallen stacks of containers aft, from bay 62 (Figure 3 right). The master notified the company of the incident. Upon returning to the bridge about 10 minutes later, the master was further notified by the chief mate of the damage and loss of containers forward at bay 30 (Figure 3 left).

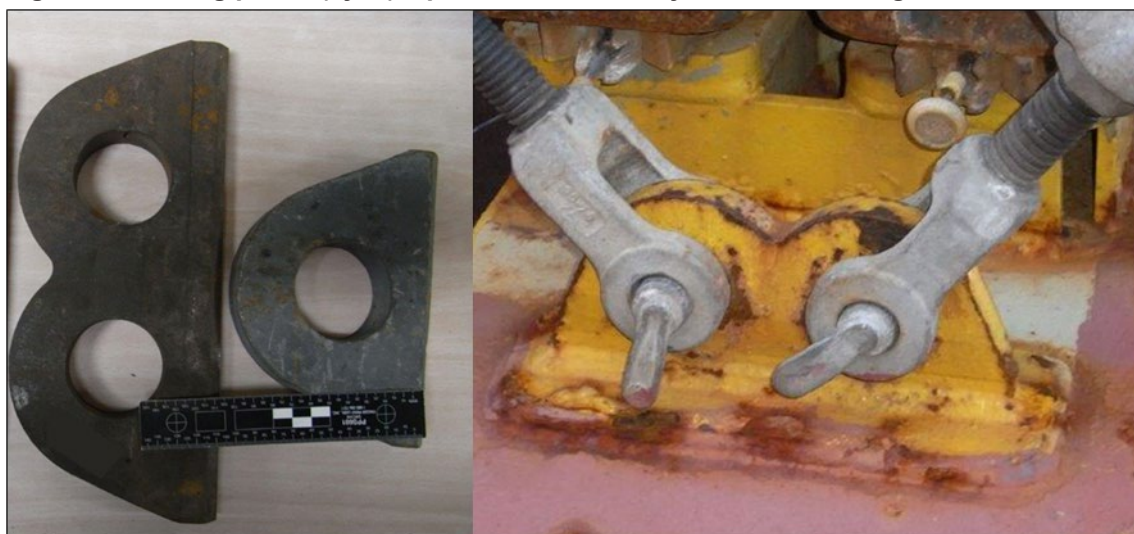
Chapter 2 of the CSM provided details on the fixed securing devices used on deck which included 1,500 lashing plates—686 single, 686 double and 128 swivel. Each lashing plate had a safe working load of 250 kN and a breaking load of 500 kN. The single and double lashing plates were welded to the ship's structure and were made from 25 mm thick steel plate (Figure 4).

Figure 4: Lashing plates (eyes), spare and as recently fitted to *APL England*

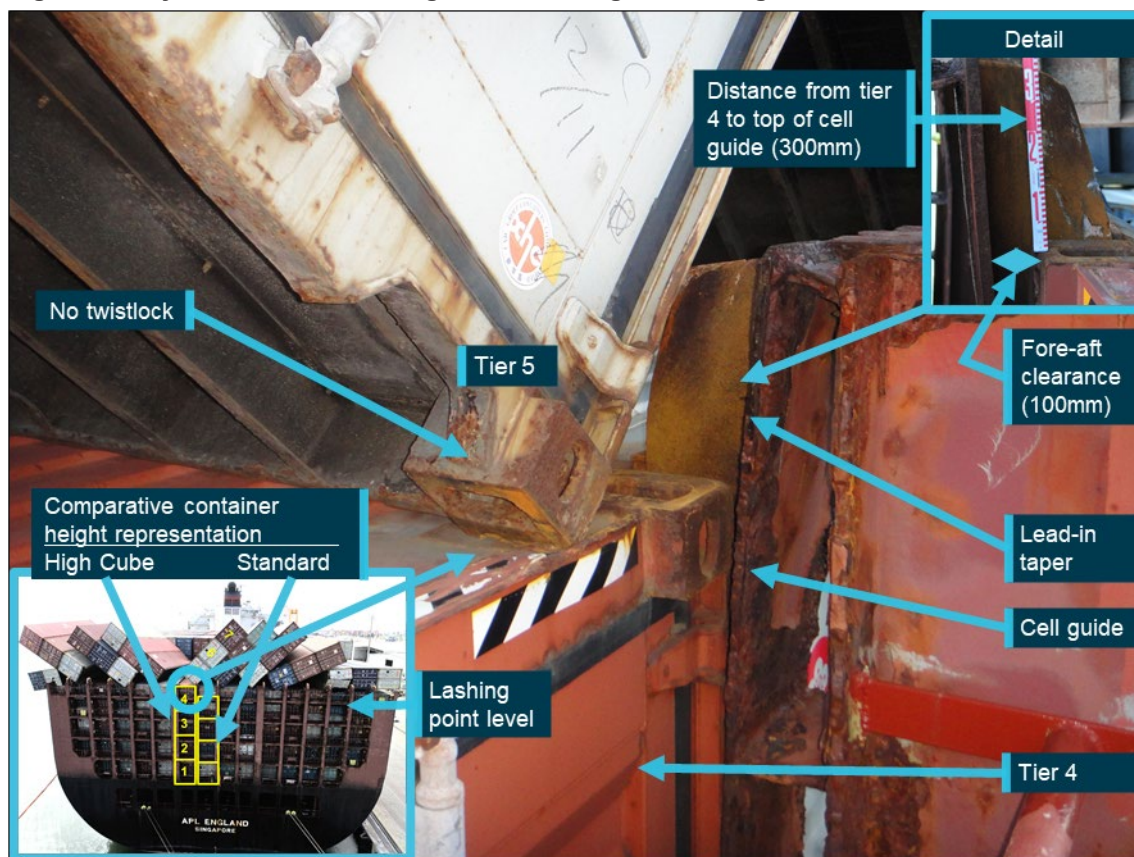
Contrary to the CSM requirements, *APL England* was loaded with exclusively high cube containers into bay 62. The top of tier 4 was therefore 1.2 m higher than if standard height containers had been loaded (Figure 5). This reduced the amount of the tier 5 containers held within the cell guides although the loading computer program considered them to be completely within.

Figure 5: Bay 62 container stowage versus cell guide arrangement

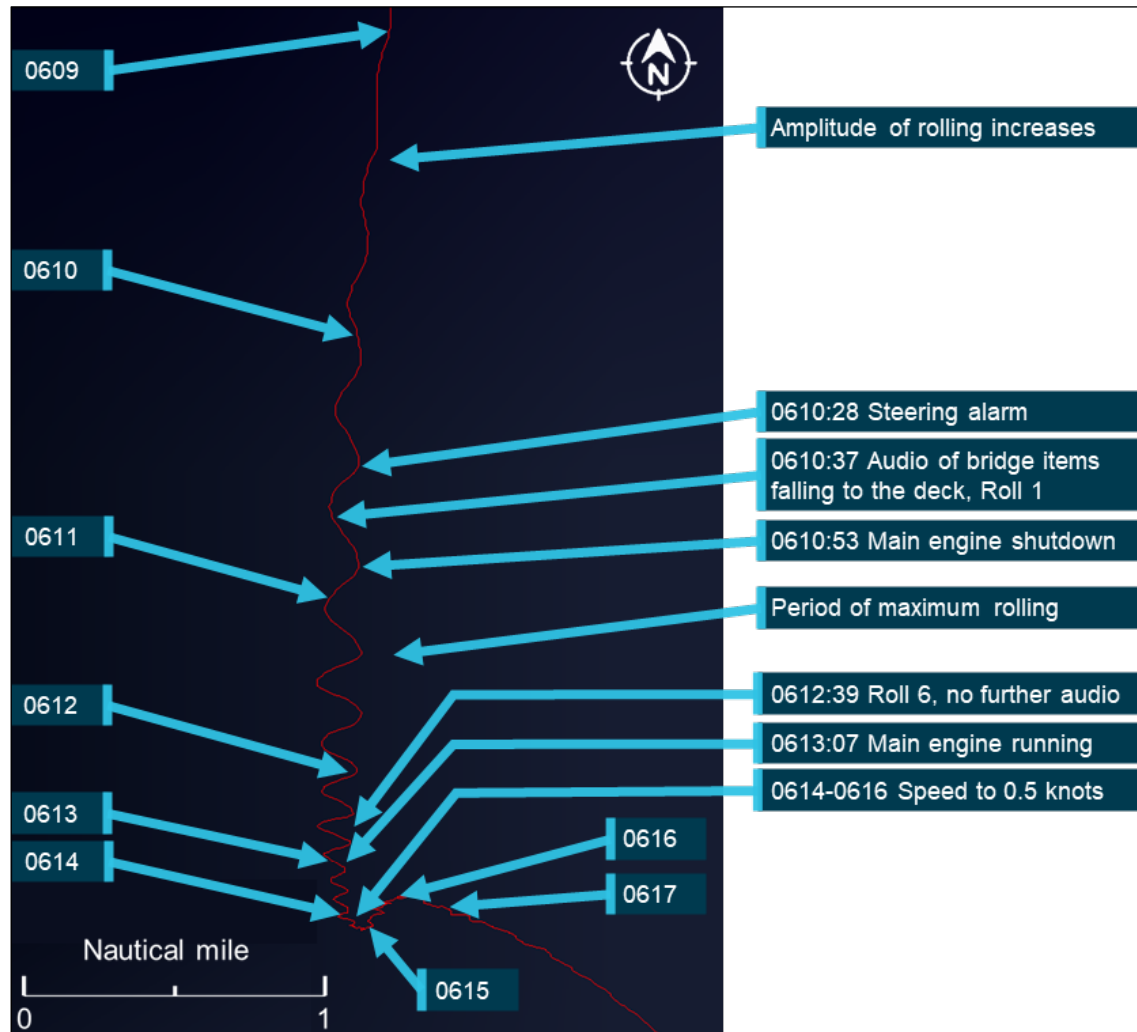
Figure 6: APL England's track from 0609 with times and events marked

Track waviness is related to the port-starboard motion of the GPS sensor (mounted about 25 m above the waterline) as the ship rolled. Annotation 0610:37 falling objects refers to audio of objects within the bridge falling to the deck, not external audio of containers falling. Source: Google Earth, with APL data, annotated by ATSB

The data showed that the rolling preceded the main engine shutdown and reached maximum as, or just after, the main engine stopped. The rolling then quickly diminished as the ship slowed and propulsion was re-established. No audio, or other recording, captured the moment the containers fell overboard.

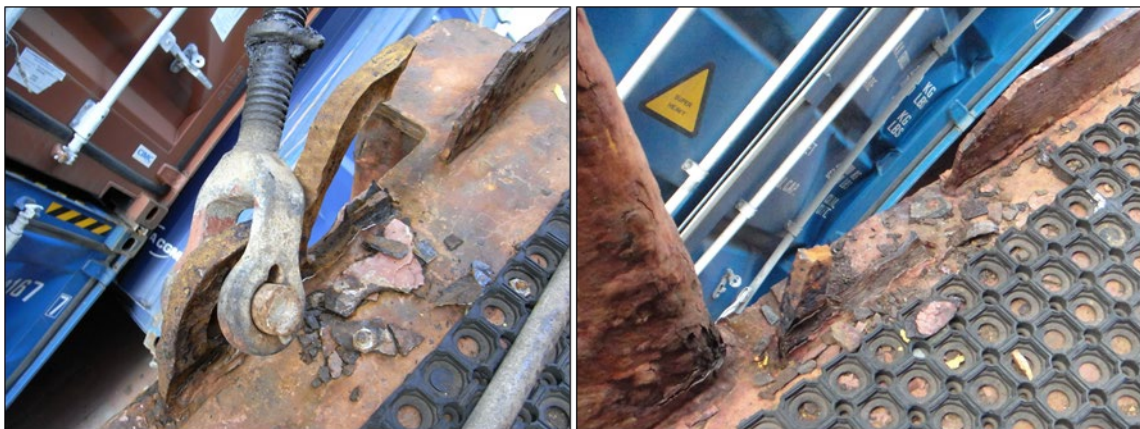
ATSB inspection showed this deterioration was apparent throughout the ship.

Figure 7: Typical, thinned, heavily wasted and failed double (left) and single (right) lashing eyes from bay 30

Post-incident inspections identified that more than 550 single and double lashing plates required replacement, along with significant amounts of deck steelwork and structures. This included lashing plates and structures supporting and securing containers lost overboard. *APL England* underwent repairs and departed the shipyard on 2 August to continue operating. DNV GL placed a condition of class on the ship noting that numerous corroded or thinned bracket/stiffener plates on the exposed weather deck and cross decks remained to be repaired.

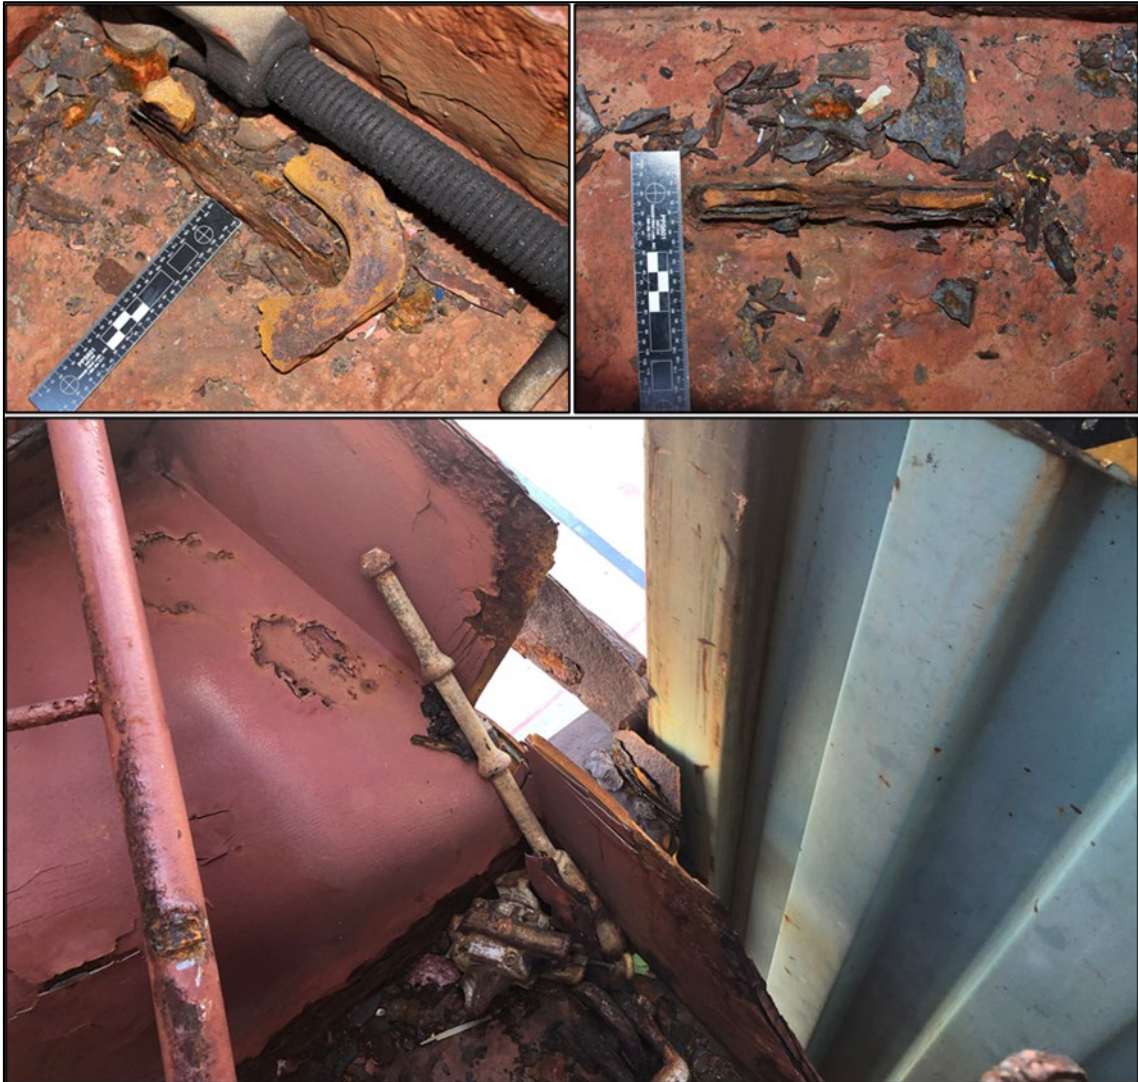
Figure 8: Thinned, heavily wasted and failed lashing eyes (top) and wasted and failed container support structure (bottom) from bay 62

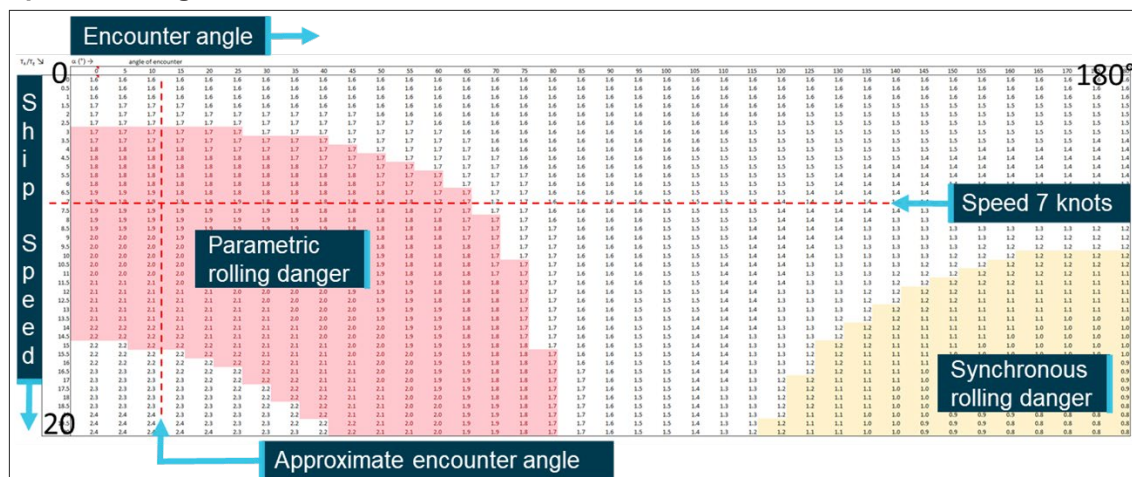
The ATSB analysis showed that a significant alteration in a ship's course and / or speed would have been required to change the conditions such that the ship was not susceptible to parametric rolling.

Figure 10: ATSB analysis map of dangerous rolling conditions for *APL England* based upon the dangerous motion criteria tool calculations

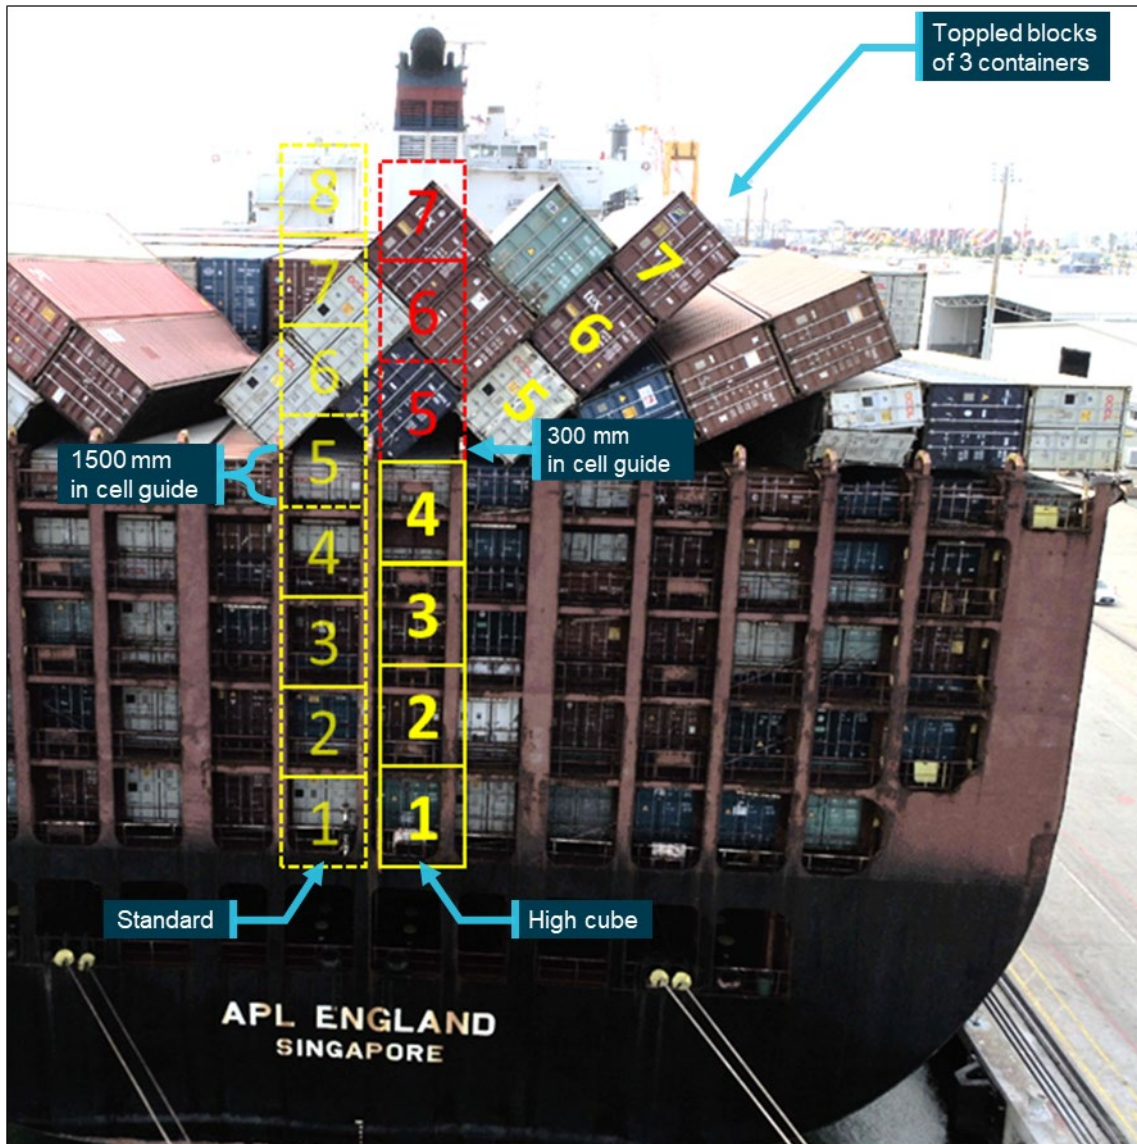
³¹ Containers within cell guides could not be secured together with twistlocks, nor was this required as the containers were considered secured within the cell guides.

Figure 11: Bay 62 stack comparison between standard height and high cube containers
