Collision between the motor yacht *Vision* and the anchored motor yacht *Minx*, resulting in one fatality at Île Sainte-Marguerite, near Cannes, France on 25 May 2019

SUMMARY

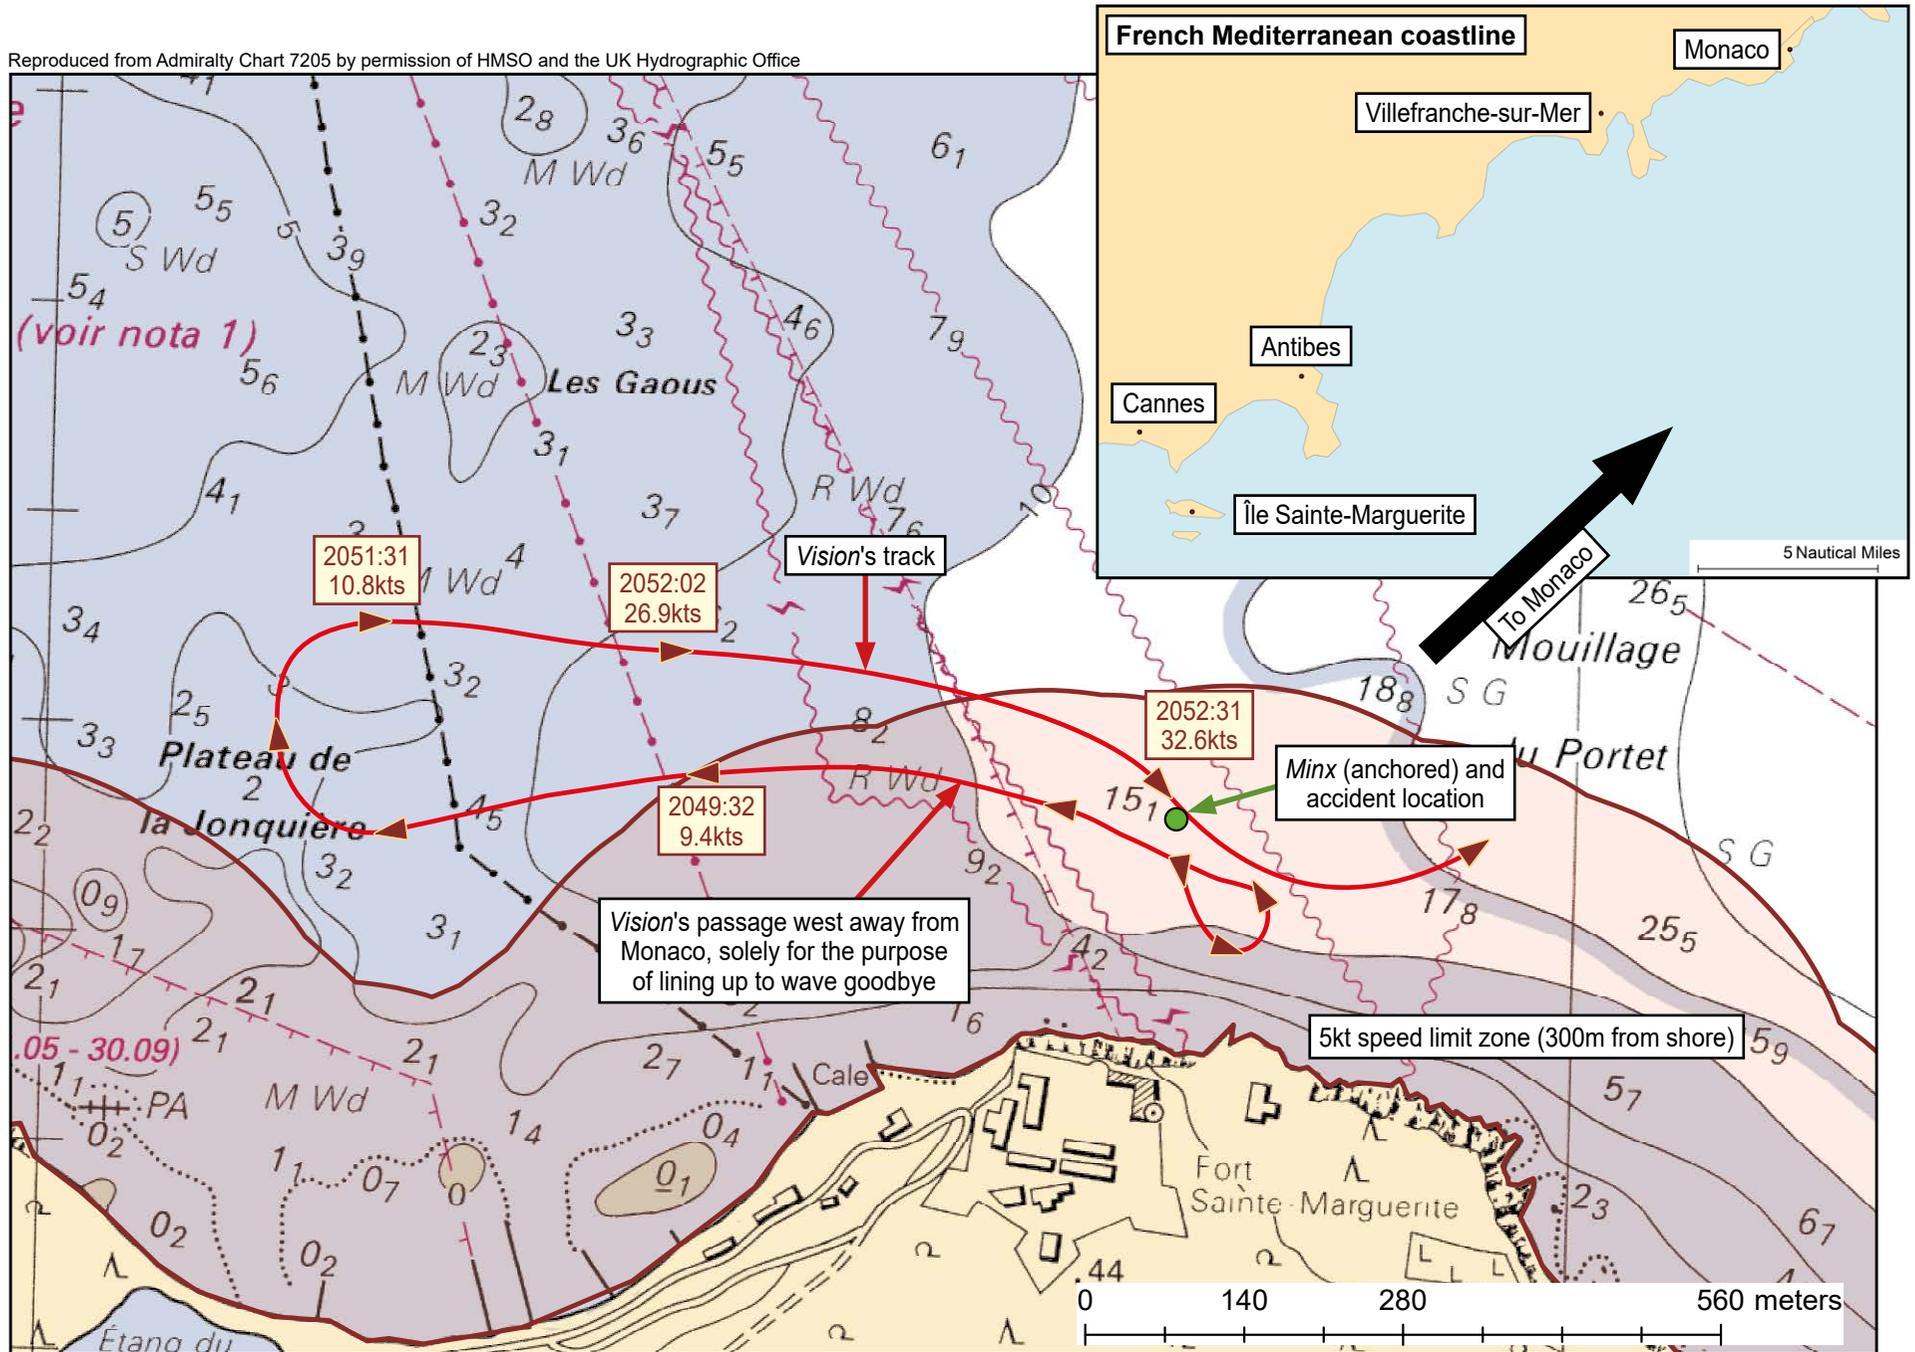
Figure 3: Vision's track derived from AIS data with times and speeds shown

mate, who had been stowing fenders, had joined the skipper at the internal steering position. In the final approach, *Vision's* skipper made an alteration of course to starboard to head directly towards *Minx*, intending to then swing almost immediately back to port close by the anchored yacht. During the manoeuvre, *Vision* did not respond to the skipper's application of port wheel and it collided with *Minx's* bow, striking the crewman. Automatic identification system (AIS) data shows that *Vision's* speed immediately prior to collision was just under 33 knots (kts).

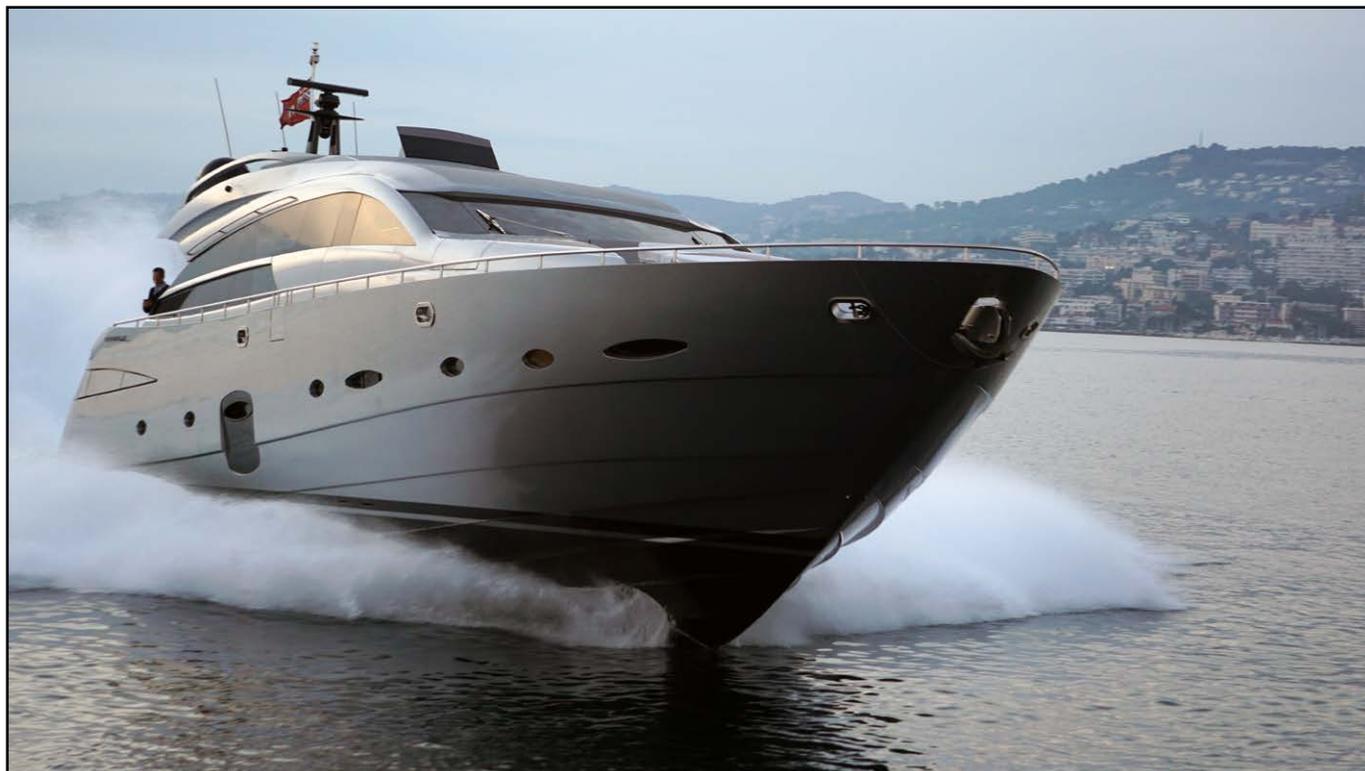
Figure 4: *Vision* immediately prior to collision with *Minx*

The image at **Figure 4** was taken immediately prior to collision and shows *Vision* planing¹⁰ with a slight bow up angle, slight heel to port and rooster tail wake. In this condition, *Vision* would have been difficult to accurately steer because of a combination of hydrodynamic effects restricting the skipper's ability to turn significantly to port.

The turning force (or lever) achieved was a function of the distance between the surface-drives and the centre of lateral resistance; the larger the distance, the greater the turning lever or 'tightness' of the turn. The presence of the rooster tail wake (**Figure 4**) indicates that *Vision* was planing with the surface-drives almost certainly trimmed up; in this condition, the yacht would tend to adopt a bow up angle, reducing the 'wetted' hull surface area. In turn, this would cause the centre of lateral resistance to move aft, reducing the turning lever (**Figure 8**). When adjusting the surface-drives horizontally to turn significantly to port, *Vision* would have heeled to port, which would have resulted in the port surface-drive going lower into the water and developing a higher 'grip' and, therefore, more power, counter-intuitively creating a starboard turning force (**Figure 8**). Additionally, after the slight turn to starboard, the momentum of *Vision* was directly towards *Minx*, and the attempt to steer away, when planing, would almost certainly have resulted in a momentary 'lateral slip', where the yacht would tend to slide sideways over the surface, rather than turning through the water.

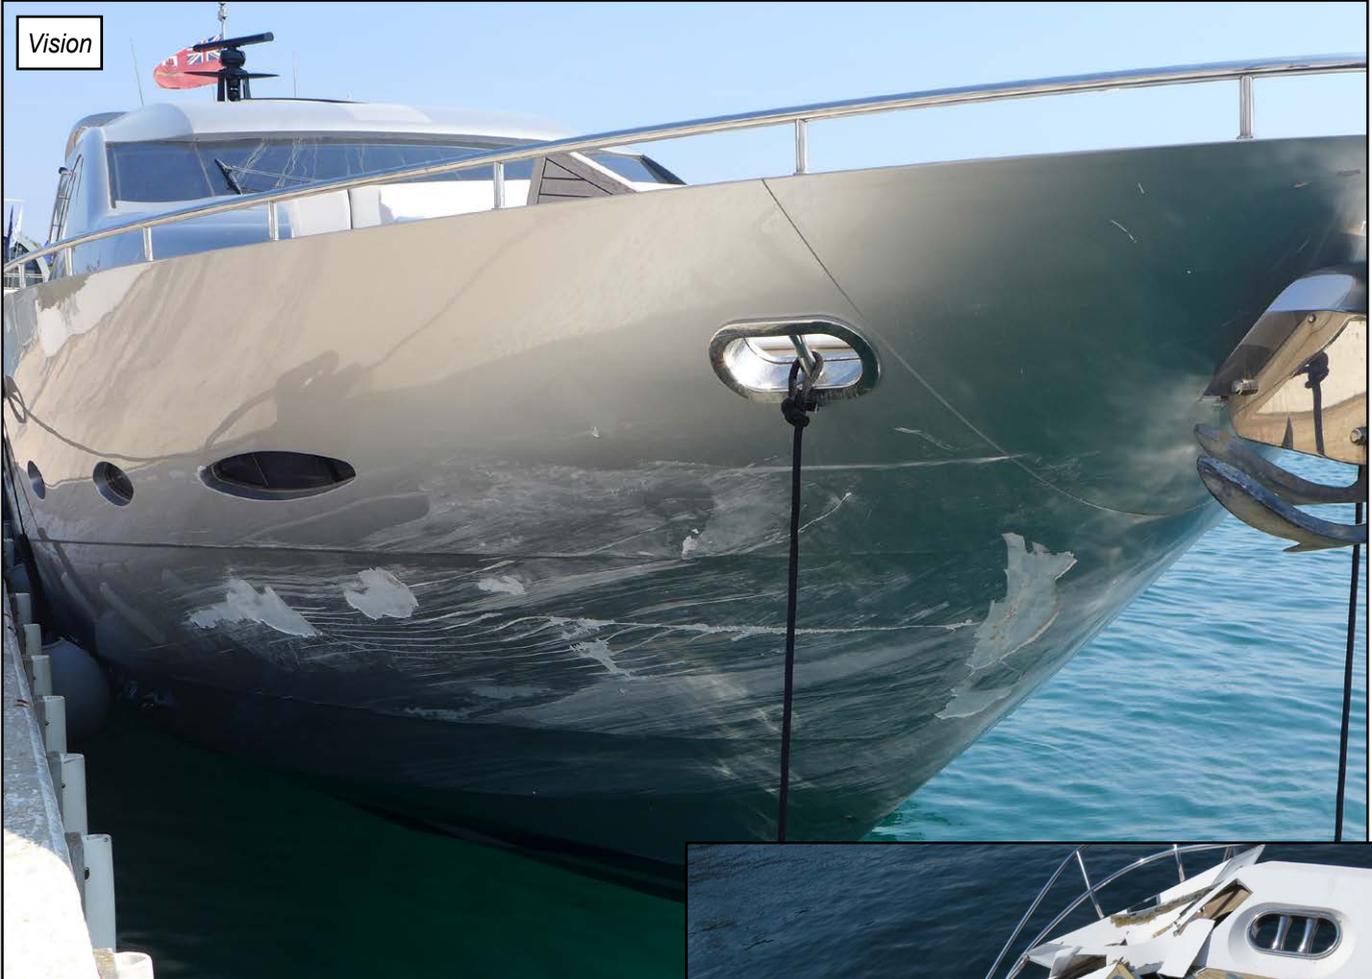
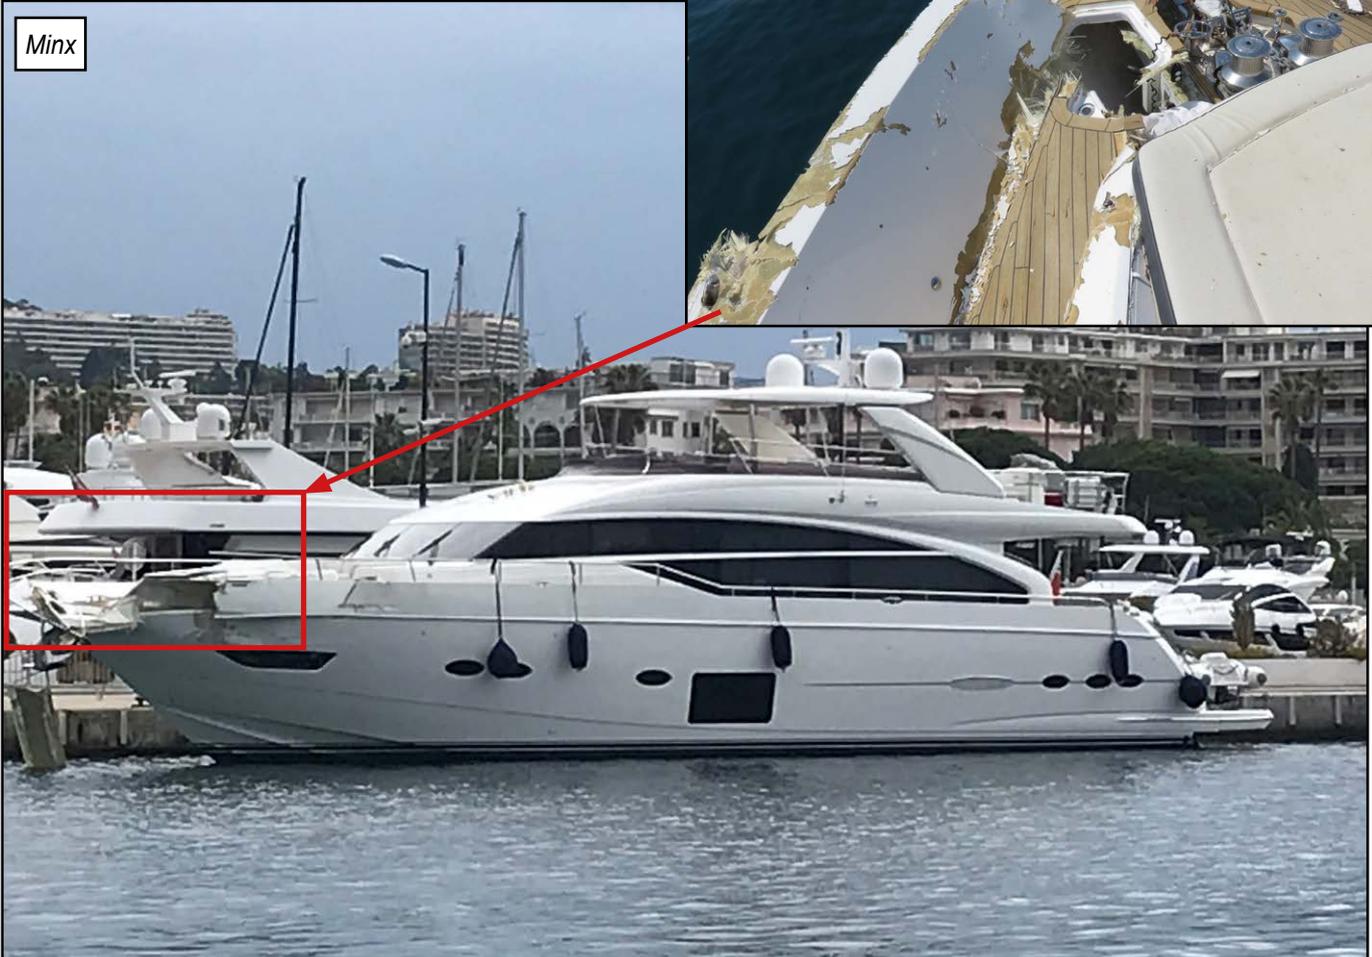
Figure 5: Detail of damage to both vessels

Vision's skipper was shocked by what had happened so the mate took control and anchored the yacht. After the accident, French emergency services and maritime police attended the scene; the injured crewman could not be resuscitated. Later that evening, both yachts proceeded under police escort to marina berths in Cannes. Both yachts were damaged in the accident (**Figure 5**).

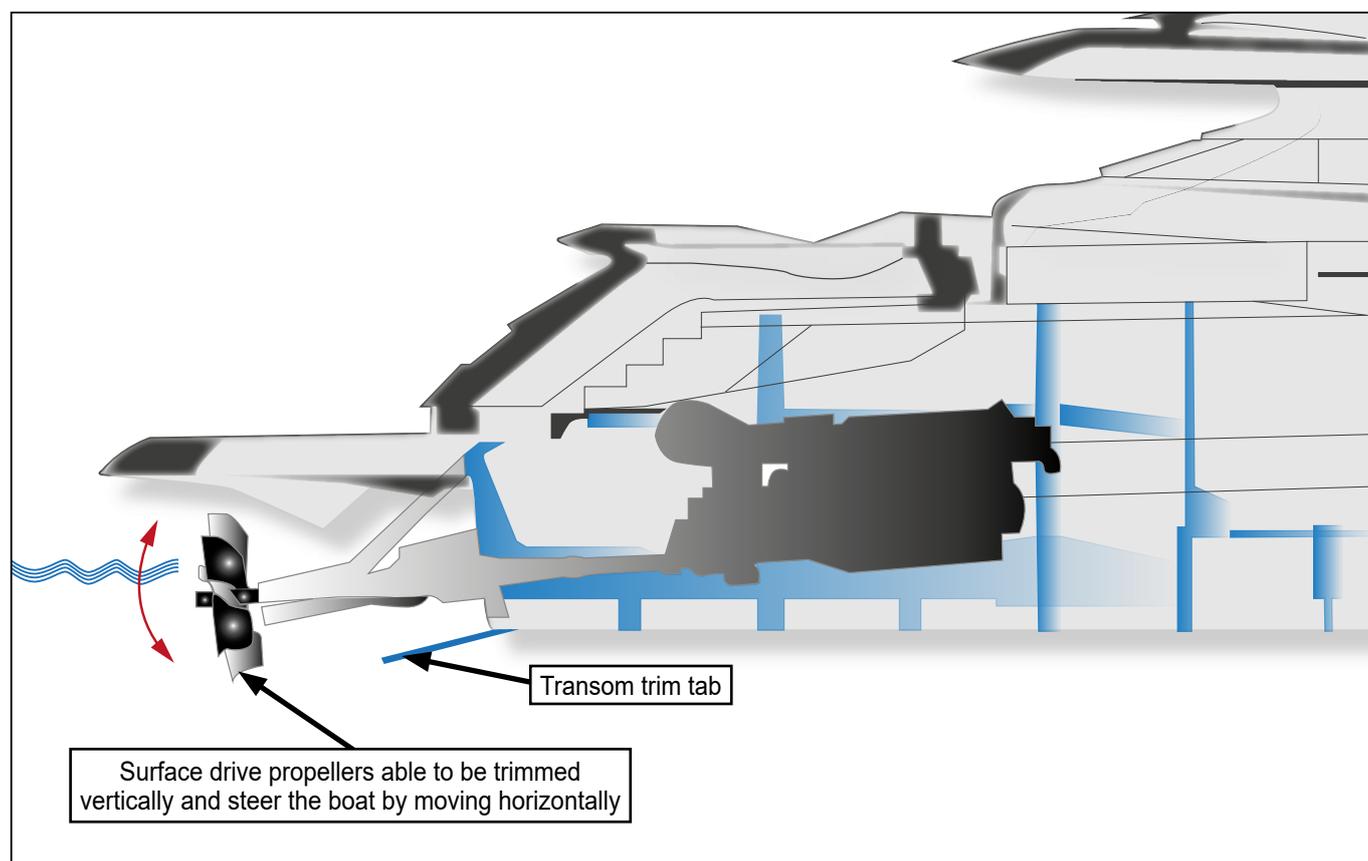
Figure 6: Diagram of *Vision's* surface-drive propulsion system

Vision was not fitted with rudders; instead, it was steered by horizontal movement of the surface-drive units. The surface-drive propeller shafts (**Figure 6**) were locked together by an articulating bar and could be operated in tandem in both the horizontal and vertical axes. Vertical (or elevation) movement of the surface-drives, described as 'trimmed up' or 'trimmed down', was used to optimise the propulsion power and minimise drag by having only the lower half of the propeller underwater when at high-speed. When the surface-drives were trimmed up, the yacht would tend to adopt a bow up angle and a large fan-like wake or 'rooster tail' would be produced. *Vision* had a defect with the surface-drives' indication system, which meant that the exact elevation position was not always indicated correctly on board; the skipper was aware of the defect.

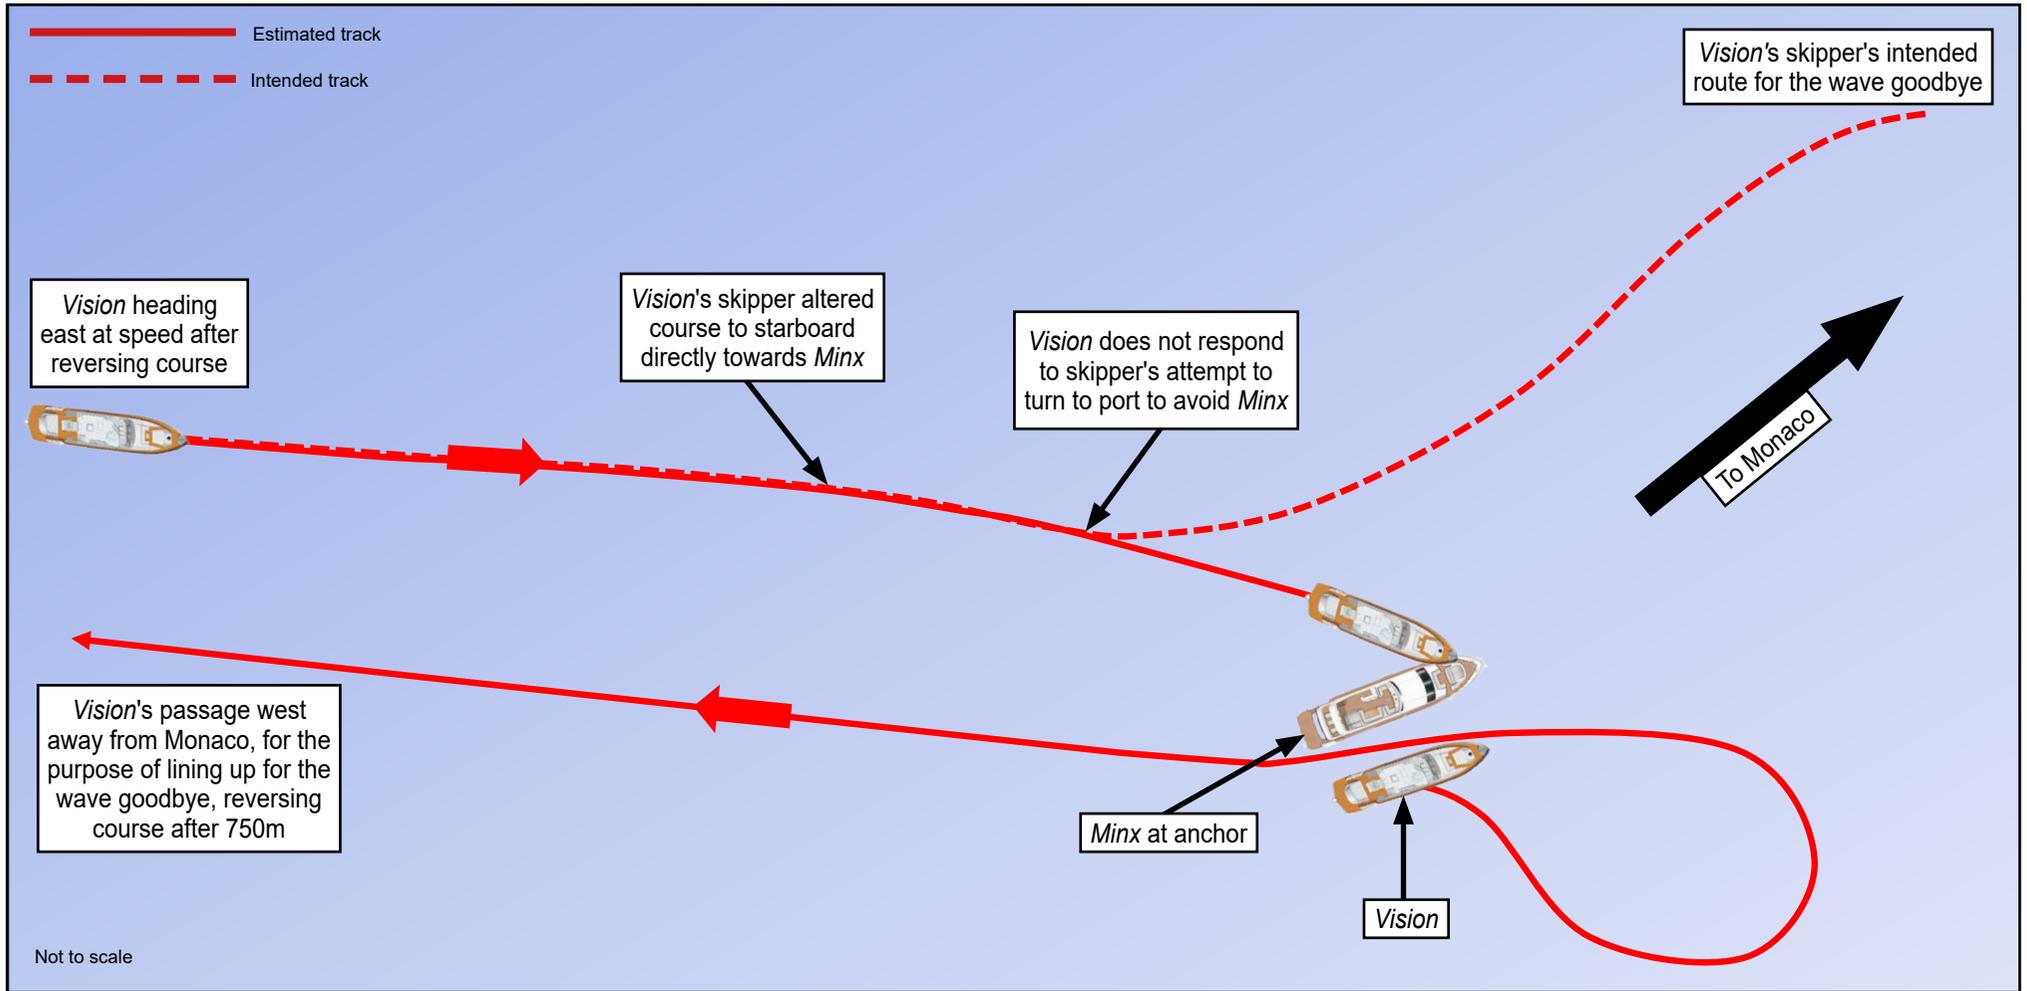
Figure 7: Diagram showing the intended and actual track of *Vision*

In summary, *Vision's* skipper's plan to depart the anchorage and head directly back to Monaco was disrupted by the idea of conducting a pass to provide a good opportunity for the guests to wave goodbye; thereafter, there was no safe navigational plan. *Vision's* skipper then placed both yachts and their occupants in danger by effectively heading directly towards *Minx* at speed with no margin for error; during the approach any misjudgement, loss of control or material failure would create a high risk of collision.

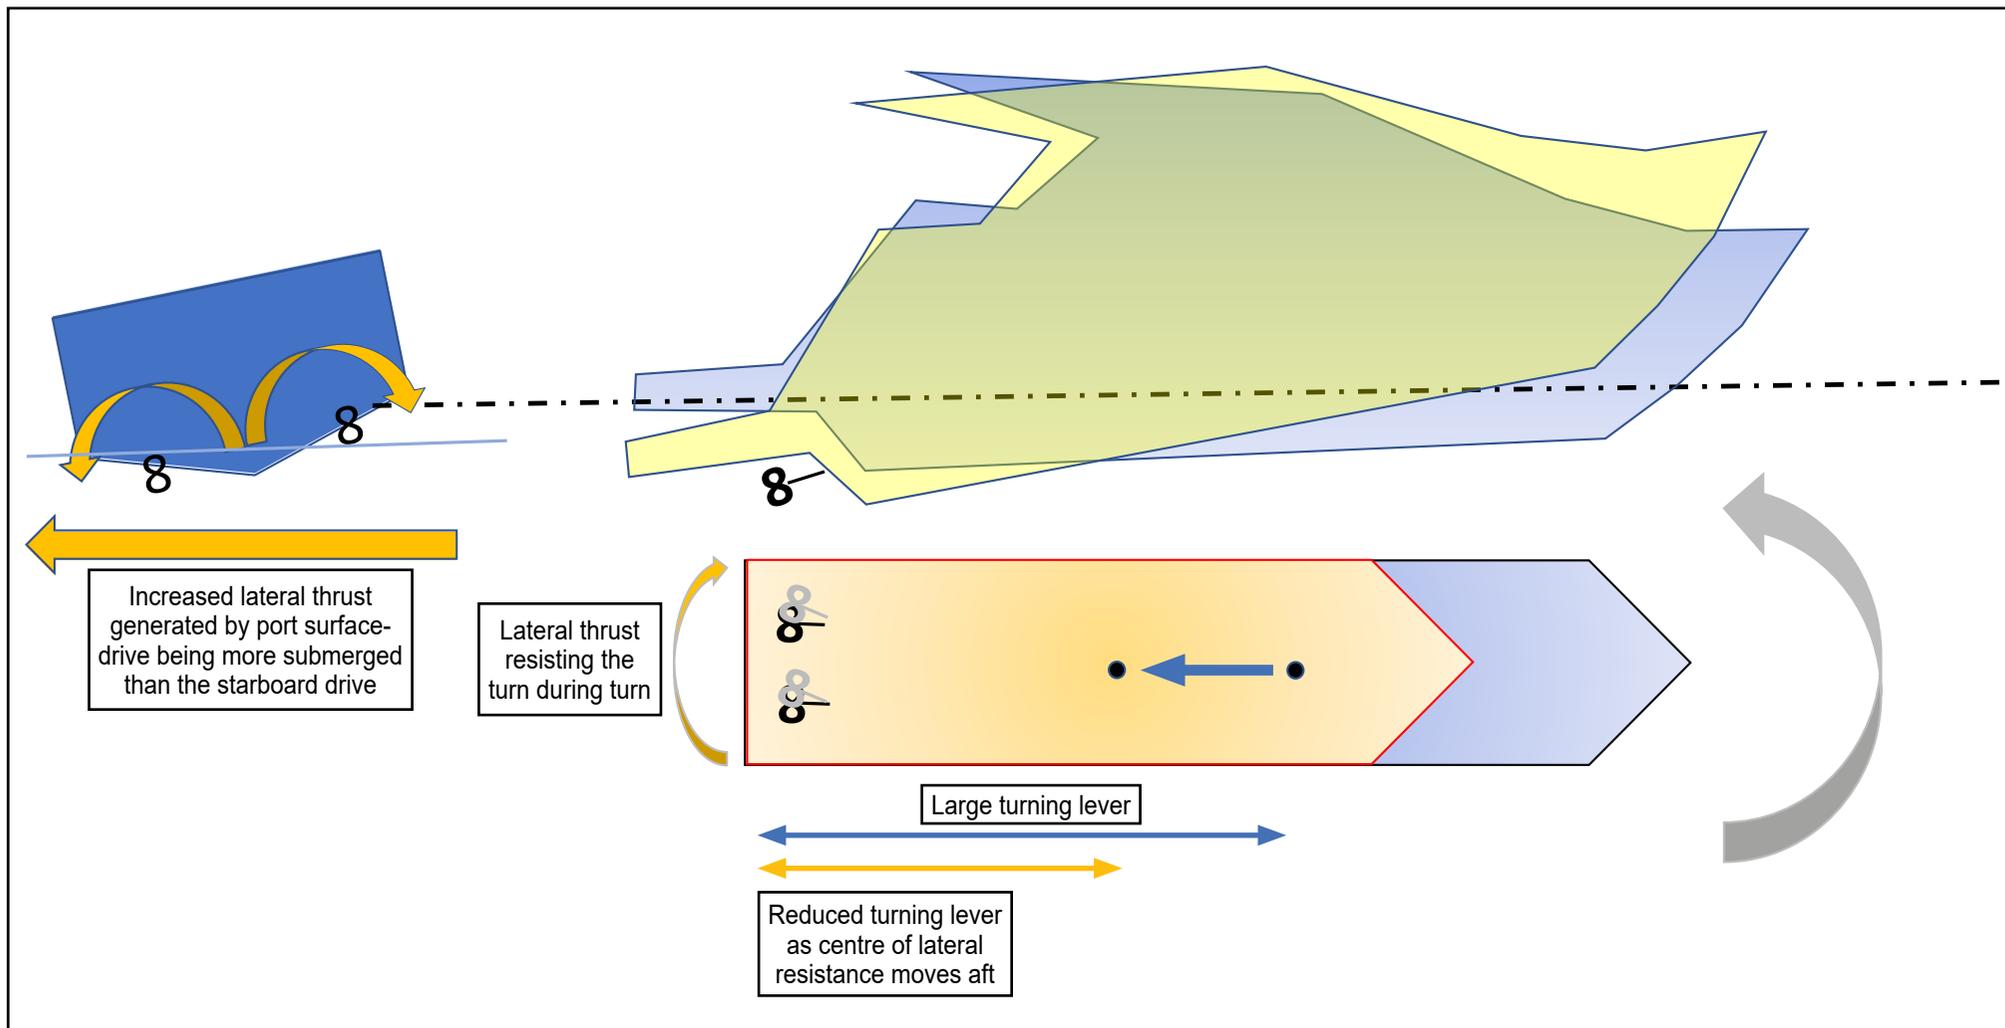
Figure 8: Factors affecting *Vision's* manoeuvrability immediately prior to collision

In the brief moments prior to the accident, a series of hydrodynamic effects resulted in a momentary loss of control, preventing *Vision*'s skipper from avoiding *Minx*. Although *Vision*'s skipper had experience with surface-drive propulsion craft, this combination of factors would have been difficult to predict or counter; therefore, it is almost certain that the skipper underestimated the difficulty he would experience trying to keep *Vision* under control in very close proximity to another vessel.
