# National Transportation Safety Board

## Marine Accident Brief

### Engine Room Fire on board Towing Vessel *Susan Lynn*

<b>Accident type</b>	Fire/Explosion	<b>No.</b> DCA20FM001
<b>Vessel name</b>	<i>Susan Lynn</i>	
<b>Location</b>	Barataria Waterway, Lafitte, Louisiana 029°43.56' N, 090°7.32' W	
<b>Date</b>	October 8, 2019	
<b>Time</b>	0600 central daylight time (coordinated universal time – 5 hours)	
<b>Injuries</b>	None	
<b>Property damage</b>	\$1,350,000 est.	
<b>Environmental damage</b>	None	
<b>Weather</b>	Visibility 10 miles, mostly cloudy, winds 7 knots from north, air temperature 74°F, twilight 0635, sunrise 0659	
<b>Waterway information</b>	Barataria Waterway is part of the Gulf Intracoastal Waterway, a 150-foot-wide, 12-foot-deep channel.

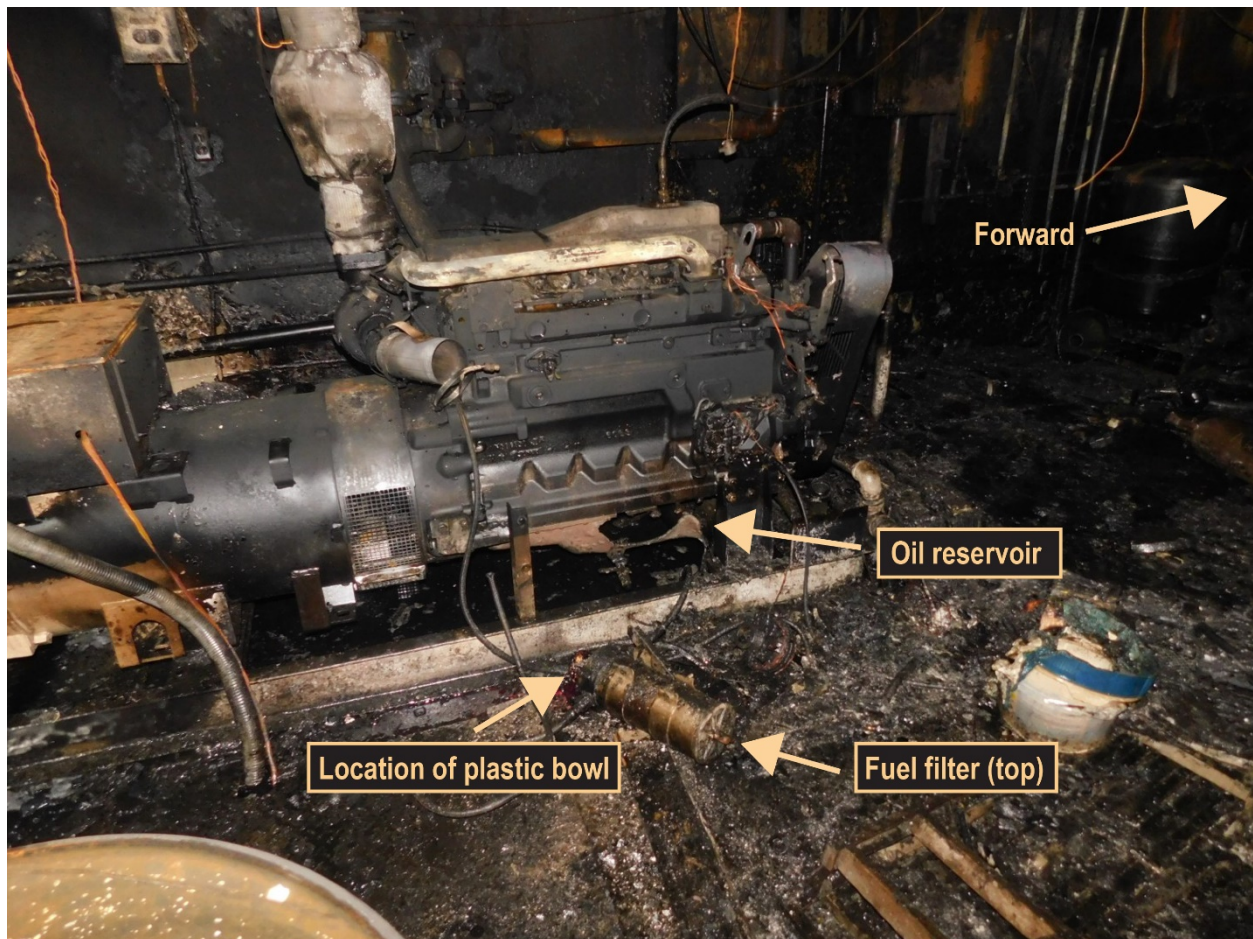
The *Susan Lynn* port generator and lower engine room following the fire. (Source: Louisiana Office of State Fire Marshal, annotated by NTSB)

The owner of Four Rivers Towing told investigators that he noticed the connecting rod had separated from piston number 3 and was hanging down through the hole of the ruptured oil reservoir and still connected to the crankshaft. The owner could not identify the heat source that would have ignited the fire. He did note that the plastic bowl at the bottom of the port generator’s Racor fuel filter, adjacent to the engine, was melted. He suspected lube oil may have first ignited near the generator, and then, over a short period of time, ignited the fuel oil that would have fueled the fire after the flames and heat melted the fuel filter bowl, releasing fuel oil into the engine room. Photographs taken after the accident showed the fuel filter laying on the floor plates of the engine room with a damaged bowl, with one of its two supporting brackets attached to the filter and fuel lines still connected.

Because of the limited evidence, the exact cause of the fire and the generator's engine casualty cannot be determined. However, based on the evidence that there was damage to the port generator engine's number 3 cylinder connecting rod and oil reservoir, the rupture of the oil reservoir may have been caused when part(s) of the failing connecting rod and/or a piston struck the inside wall of the oil reservoir. A rod and/or piston striking and then rupturing the oil pan would have released oil into the engine room under heat and pressure. This ejected lube oil mist may have ignited off a hot surface, potentially the generator's unlagged (not insulated) exhaust components. The intensity and duration of the fire was likely exacerbated by the melting of the bowl on the bottom of the generator's Racor fuel filter combined with the vessel's fuel shutoff valves not being closed, allowing additional fuel for the fire.

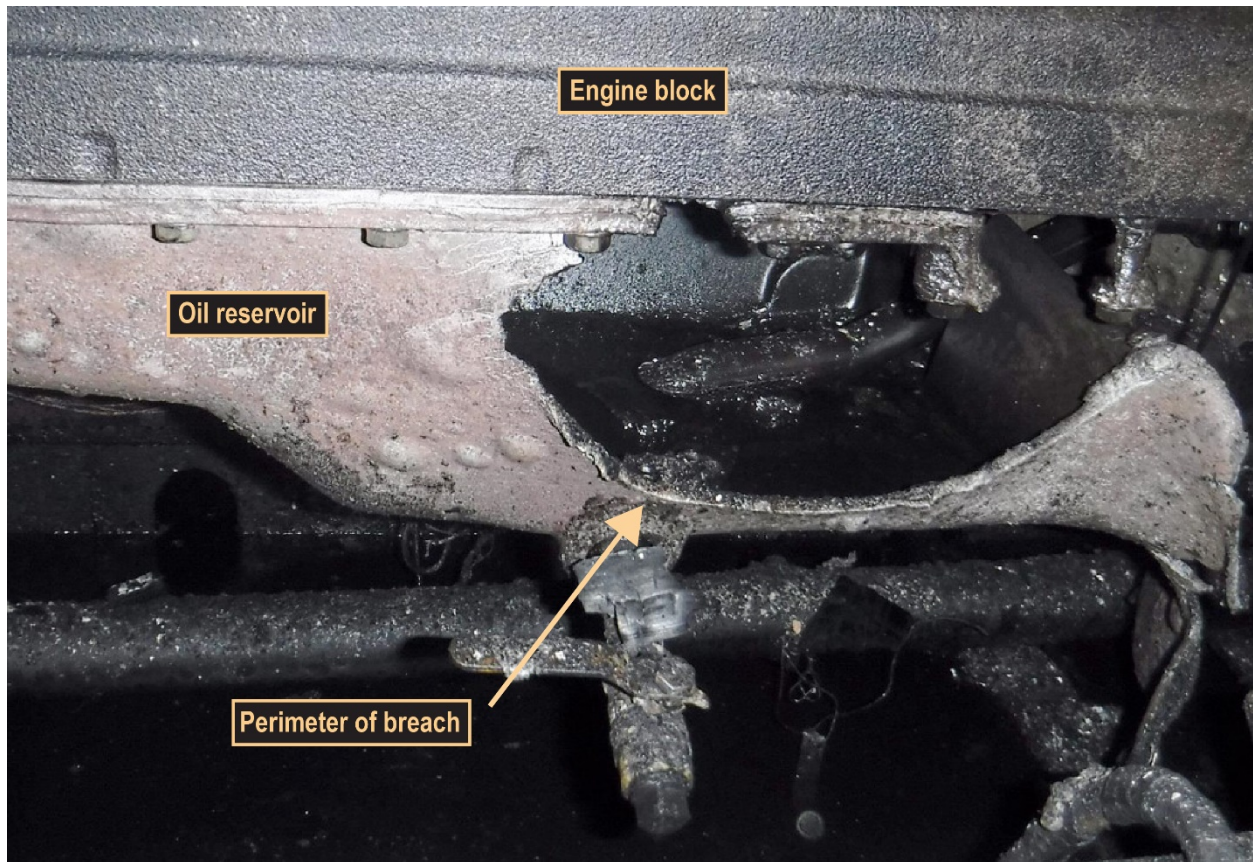
Ruptured *Susan Lynn* port generator oil reservoir. (Source: US Coast Guard, annotated by NTSB)

The engine damage and failure described by the owner of Four Rivers Towing was similar to what was found by NTSB investigations of two towboat and one offshore supply vessel accidents since 2014.<sup>2</sup> The previous mechanical engine failures on these three vessels led to the ejection of lube oil mist, which likely ignited on the two towboats, resulting in engine room fires (in the offshore supply vessel accident, the engine failure did not result in a fire).

The National Transportation Safety Board determines that the probable cause of the fire on board the *Susan Lynn* was a catastrophic engine failure resulting in an oil reservoir breach and an ensuing fire initiated by ejected lube oil igniting off a hot surface. Contributing to the extent of the fire were the open engine room doors and the unsecured fuel shutoff valves.

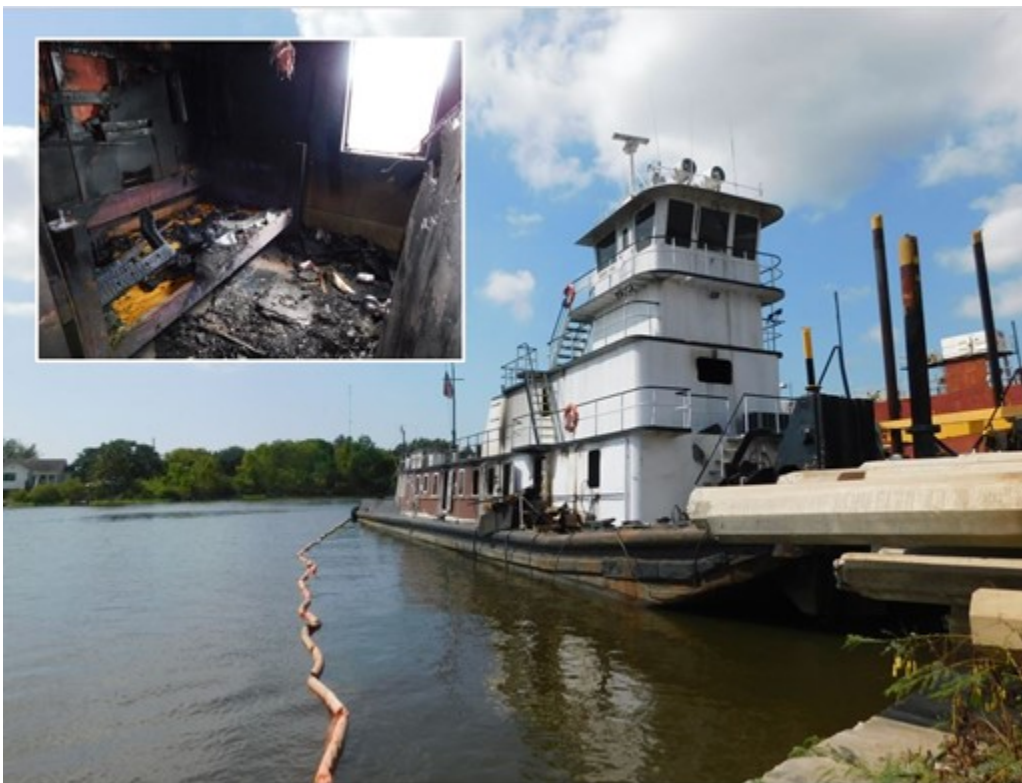
The *Susan Lynn* at its berth following the fire. Inset: crew quarters on board the *Susan Lynn*. (Source: Louisiana Office of State Fire Marshal)

The heaviest fire damage was in the engine room, near the generators, with additional damage on the main and second decks forward of the galley. The vessel was equipped with fuel shutoff valves, which are intended to secure fuel to the engine and engine room in an emergency. Had they been secured, there would have been less fuel available to feed the fire. The fire's spread beyond the engine room was likely the result of the interior forward and after centerline upper engine room doors being left open while the vessel was laid up and remaining open throughout the fire. Minimal damage was visible in the galley where a similar type door on the centerline between the laundry space and the galley was shut. The only visible damage in the galley was a blackened area of the overhead surrounding the galley vent fan located in the overhead just aft of the door to the laundry space. While the vessel was in layup, the normal position of the engine room doors should have been closed, as a fire safety measure.
