TECHNICAL AND REGULATORY NEWS No. 02/2016 – Technical

# INCREASED SAFETY RISK DUE TO SEVERE CORROSION RELATED TO BOX COOLER ARRANGEMENTS

January 2016

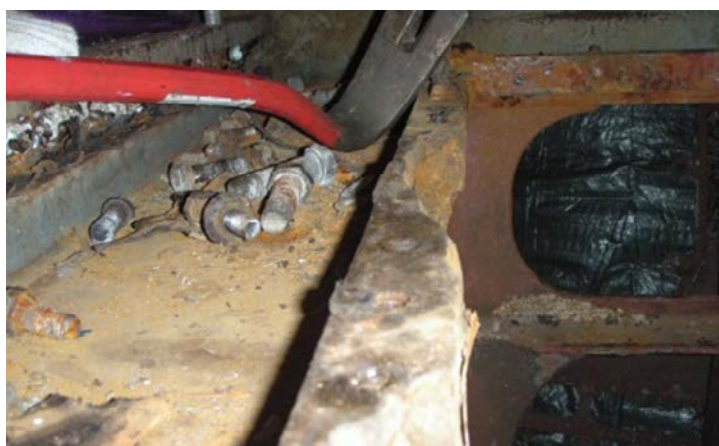
Heavy local corrosion of the flange of a box cooler.

In a number of cases, severe corrosion damage has been observed in the carbon-steel mounting flange on top of the sea chest, including the bolts and shell plating of a sea chest in way of the box cooler. Considerable sea water leakage in a corroded sea chest may cause a large ingress of water in the engine room if not noticed in time.

- Exposed noble materials (corrosion resistant) in the box cooler tubes impose galvanic currents between the cooler tubes and the sea chest, causing galvanic corrosion of the adjacent steel structure, if proper electrical insulation is not maintained.

- Look for signs of corrosion and leakage in the mounting frame and the corresponding sea chest.
- The condition of the corrosion protection arrangement of the specific box cooler and sea chest. If new coating is applied, do not coat the tube bundle, anodes or cathodes, as applicable. A small area of damaged coating in the sea chest will concentrate galvanic corrosion to the area of exposed steel.

- Class inspection will focus on: Inspection of the mounting flange, bolts and gasket(s)
- Inspection of the isolation parts (if applicable)
- Inspection of the sea chest inlet and outlet grids (to ensure sufficient free flow area)
- Marine growth (barnacles, shells, etc.) may cover severe local corrosion, especially in the upper part of the sea chest. Thorough cleaning is therefore necessary to check surface condition

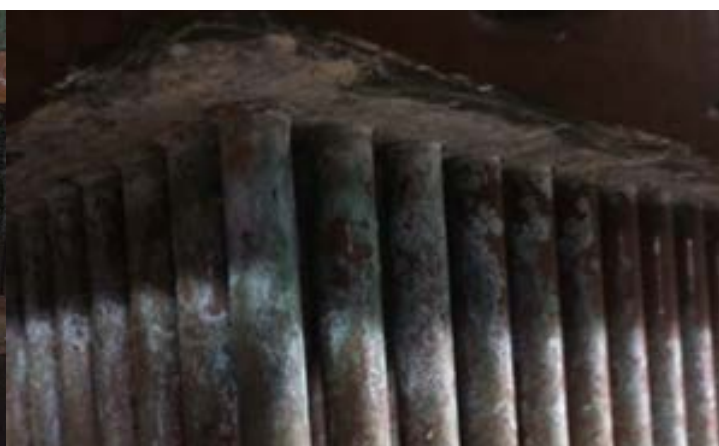
Coating failure of the cooling pipes on a box cooler

- The corrosion protection systems applied (coating of U-tube bundle, if applicable; coating of the surrounding steel structure, sacrificial anodes and/or impressed current cathodic protection) are not able to suppress the corrosion rate of the sea chest. This can occur due to poor design, damage during installation or in service, or lack of necessary inspection and maintenance.
