**Mooring line failure resulting in serious injury to a  
deck officer on board  
*Zarga*  
alongside South Hook LNG terminal,  
Milford Haven  
on 2 March 2015**

## MAIB SAFETY BULLETIN 1/2016

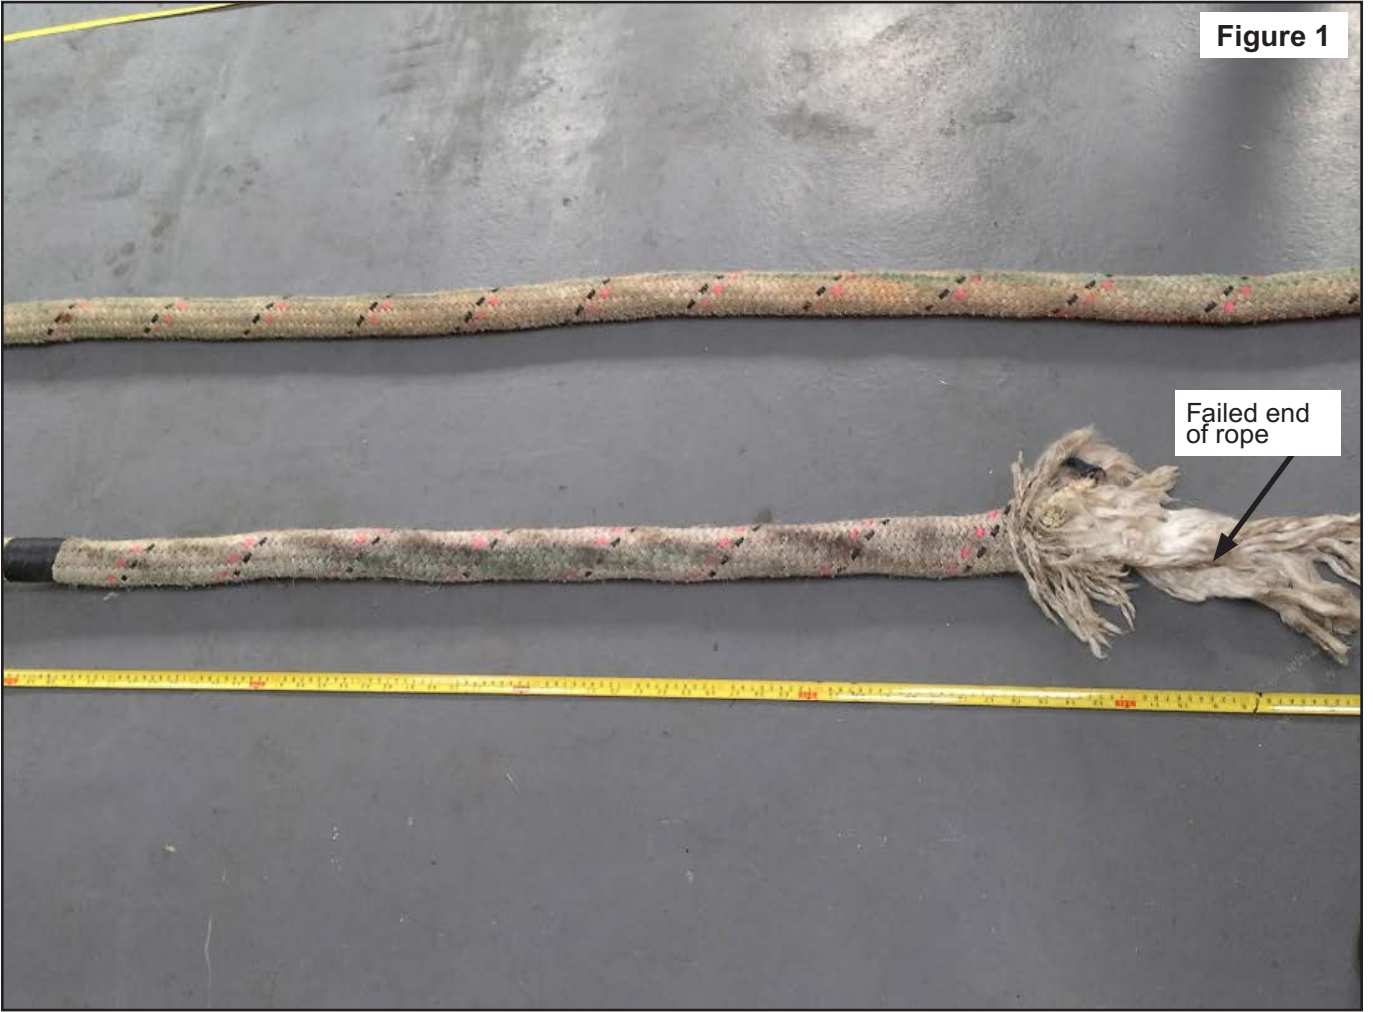
Figure 1

The rope failed at an indicative load of 24 tonnes. Subsequent non-destructive assessment of the rope by an industry expert did not identify any defects that would indicate that it had been used or operated incorrectly (**Figure 1**).

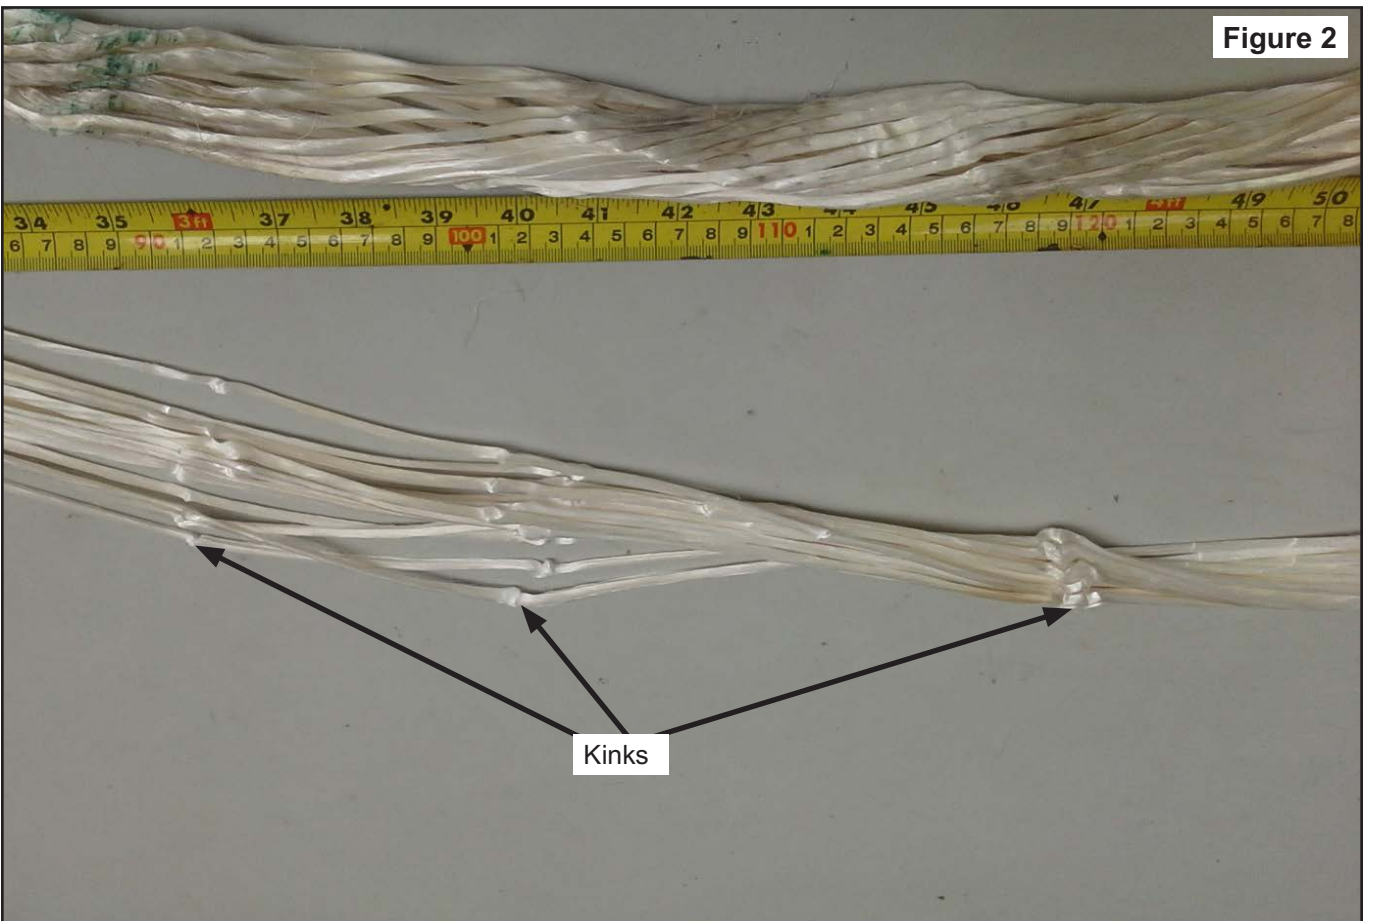
Figure 2

When the close-fitting jacket was removed from the rope at each side of the failure point, the rope yarns in all three strands exhibited moderate to severe kinking. The Z-shaped kinks were visually apparent and were found at close intervals with, for example, 22 occurring over a length of 2.78m (**Figure 2**).

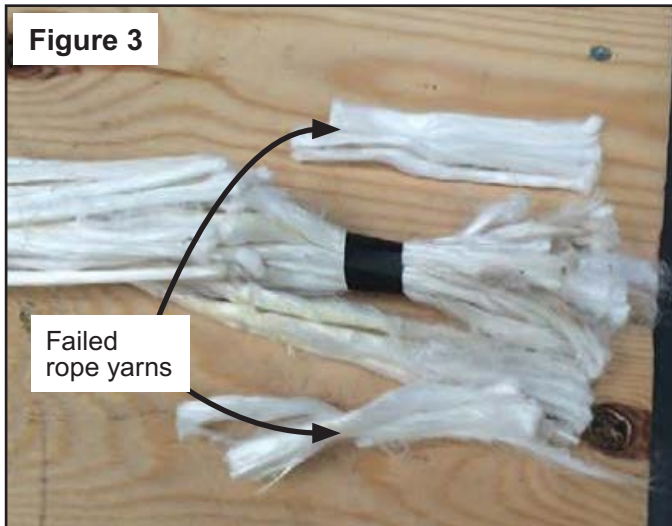
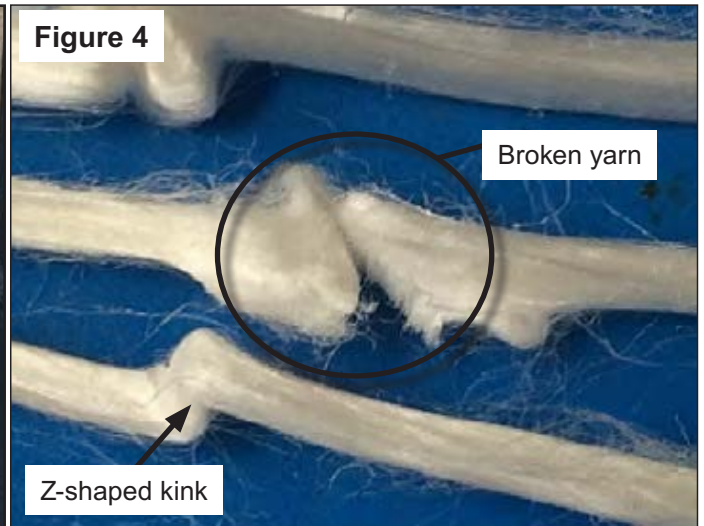
During the rope's dissection, 12 of the 96 rope yarns were found to have separated. The rope yarns were found to have failed at kink points and had separated as if they had been cut with a sharp knife at 45 degrees (**Figures 3 and 4**).

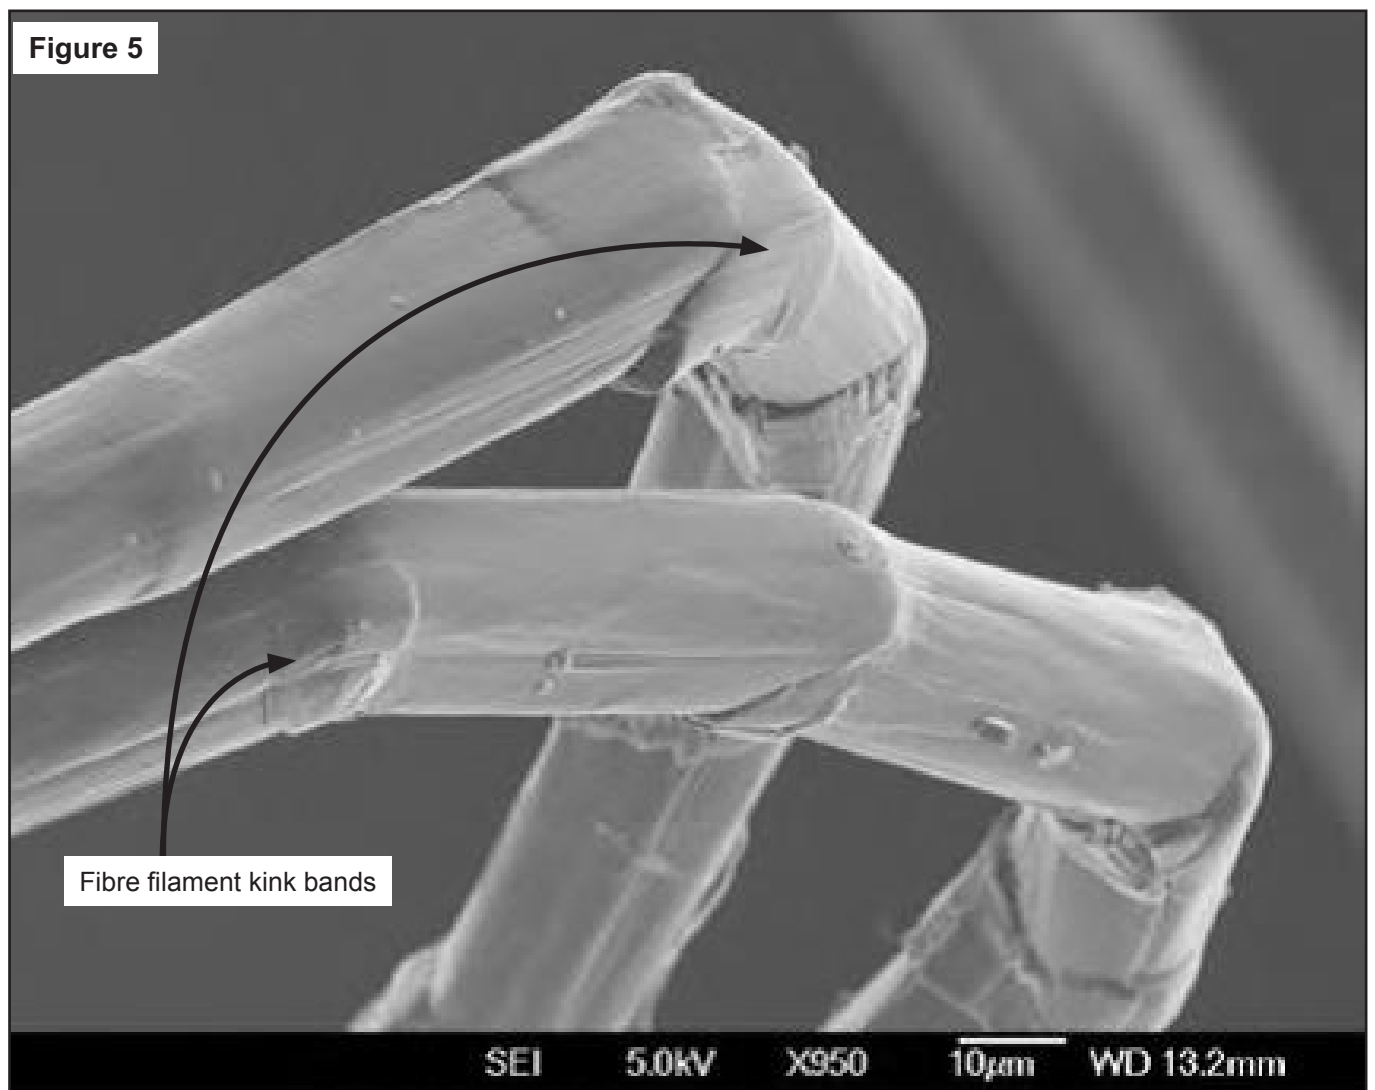
Following the identification of the kinking and failed rope yarns, a number of additional sections of the rope were inspected. Further rope yarn failures and damage to the rope yarns at filament level were seen (**Figure 5**). The damage identified was consistent with axial compression fatigue.

Operating ropes around tight bend radii can exacerbate axial compression fatigue and also cause internal abrasion damage. In this case, the failed mooring rope had been run from its winch drum to the LNG terminal hook via a deck roller bollard and a ship's side roller fairlead. The diameters of the rollers for both the deck bollard and deck fairlead were less than the minimum recommended by the rope manufacturer for its 44mm HMPE jacketed ropes.

Close-fitting jacketed synthetic fibre ropes with low twist constructions are more prone to failure under normal operating conditions than other mooring rope constructions. This is especially the case where the diameter to diameter (D:d) ratio between a ship's deck fittings and its mooring ropes, is less than that recommended by the rope's manufacturer. The nature of the close-fitting jacket precludes visual inspection of the rope's core for signs of degradation. Operators of vessels using close-fitting jacketed synthetic fibre mooring ropes are strongly advised to contact the rope's manufacturer/supplier to:

- Confirm or otherwise that the rope is suitable for its intended use and envisaged operating conditions including, specifically, that it is compatible with the vessel's deck fittings, and,
- Ensure that an appropriate regime exists to monitor the condition of the ropes in use so as to maintain a high level of confidence that they can be replaced before they become materially weakened or degraded.
