**Lessons from Marine
Accident Reports
1/2016**

SAFETY DIGEST
Lessons from Marine Accidents
No 1/2016

April 2016

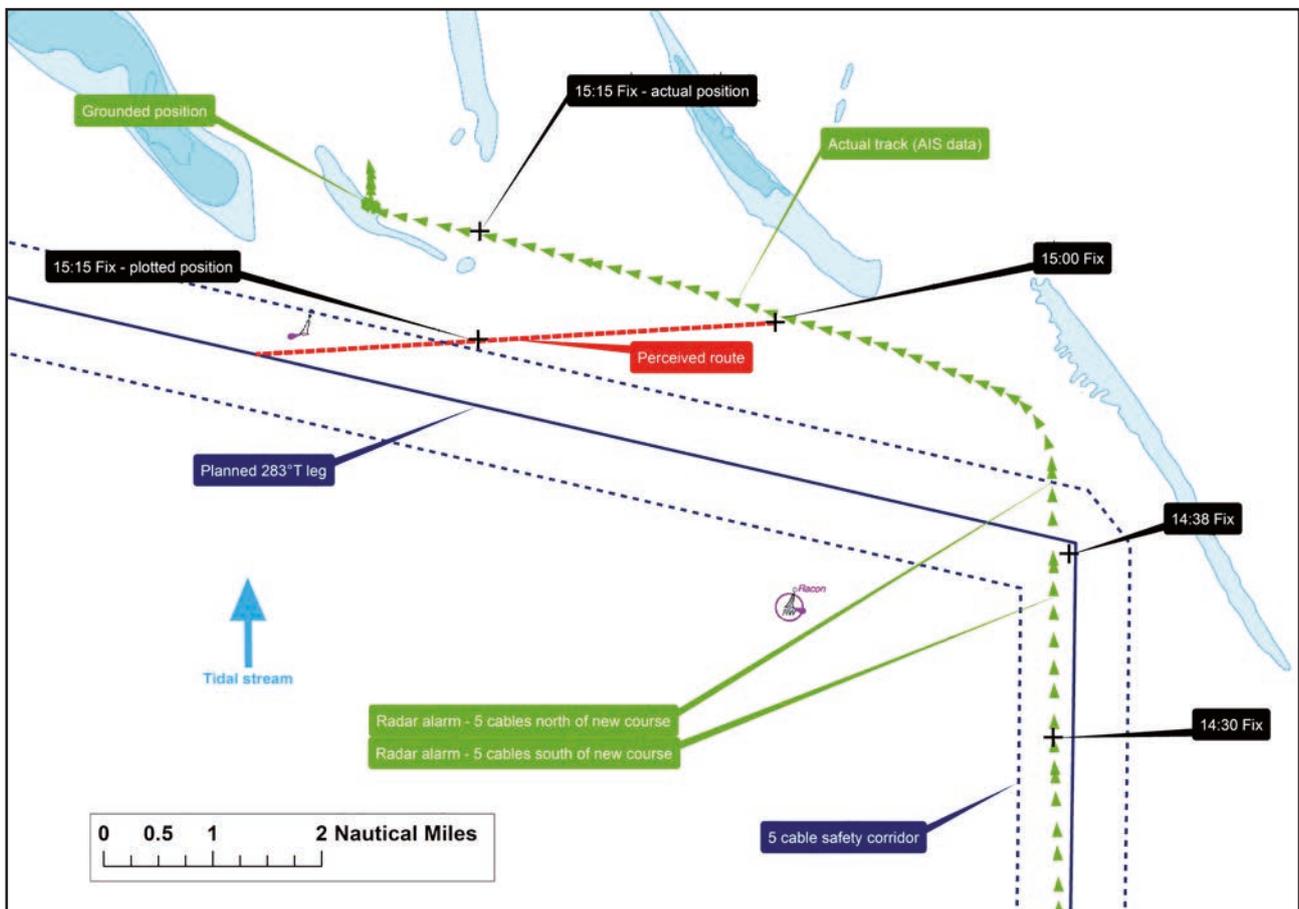
Fifteen minutes later, the OOW correctly recorded a fix in the bridge logbook but incorrectly plotted it 1 mile south of the vessel's actual position. This error led him to assess that the vessel was regaining track; however, a few minutes later, the strong northerly tidal stream caused the vessel to ground on a sandbank.

Figure 1: Analysis of perceived route

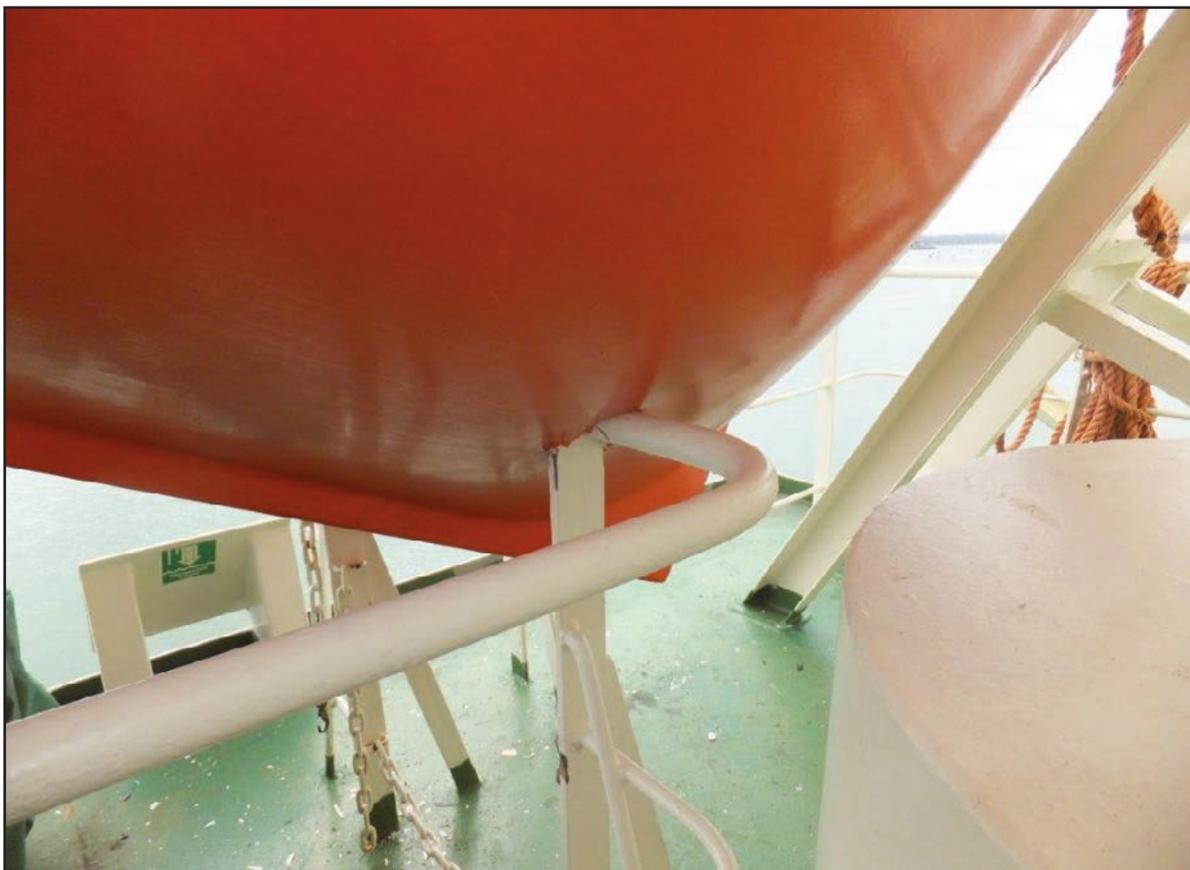
Figure 2: Lifeboat hull damage

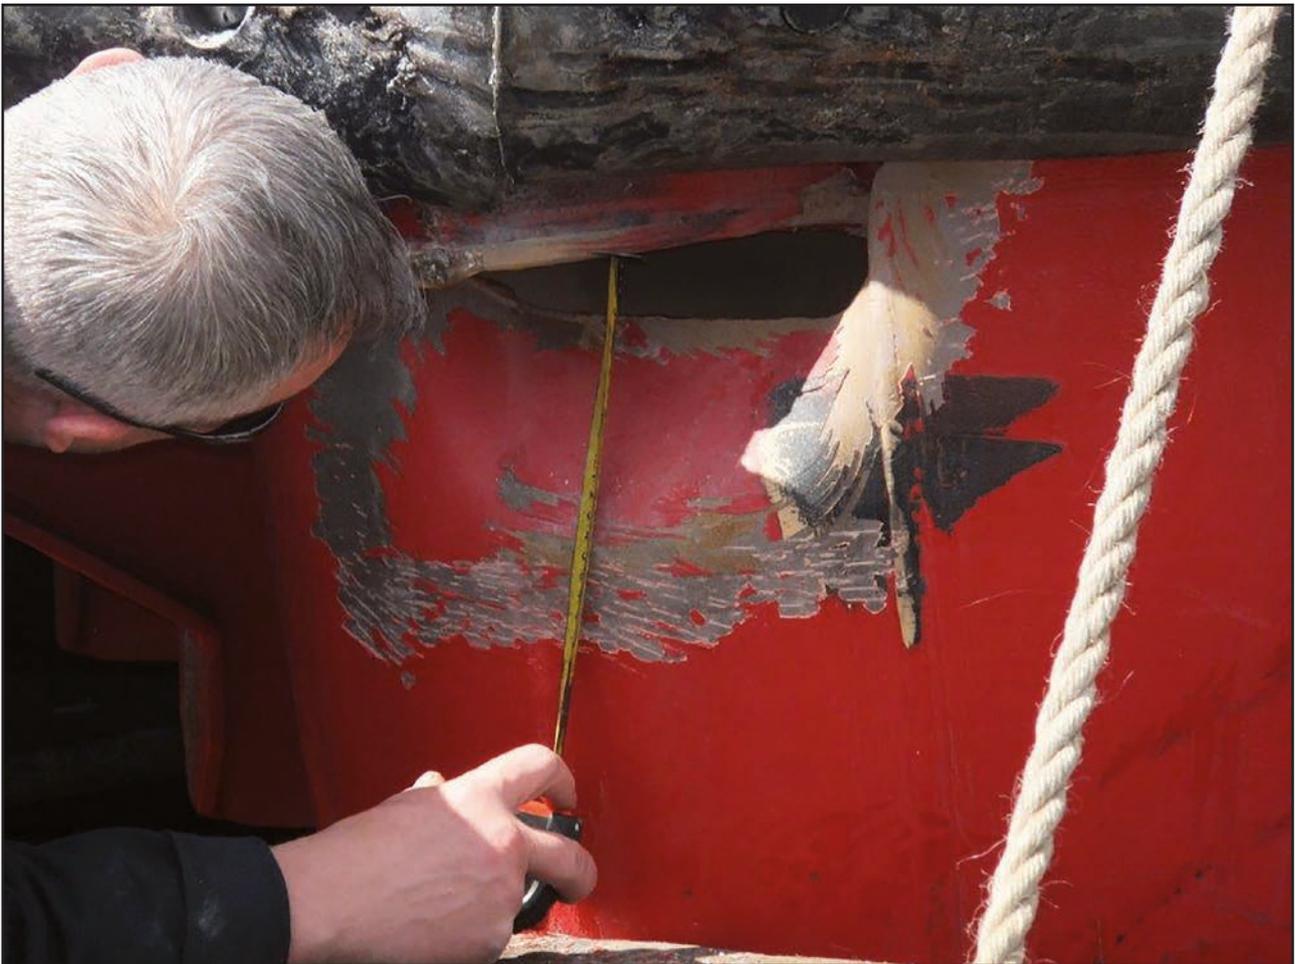
After the accident the vessel, which had been holed above the waterline (Figure 1), proceeded to a nearby berth where the emergency services boarded and assisted the injured passengers. The vessel was taken out of service for a few days while repairs were carried out. The bridge was undamaged.

Figure 1: Vessel was holed above waterline

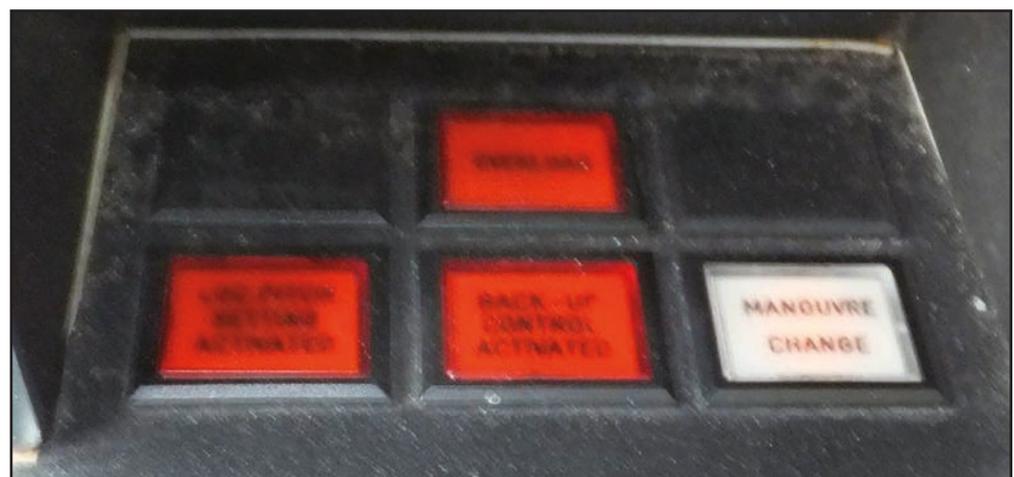
The investigation found that when the starboard CPP back-up control mode was inadvertently selected, the master lost bridge control of that propeller. The starboard

Figure 2: Bridge wing console CPP back-up control system indicator lamps

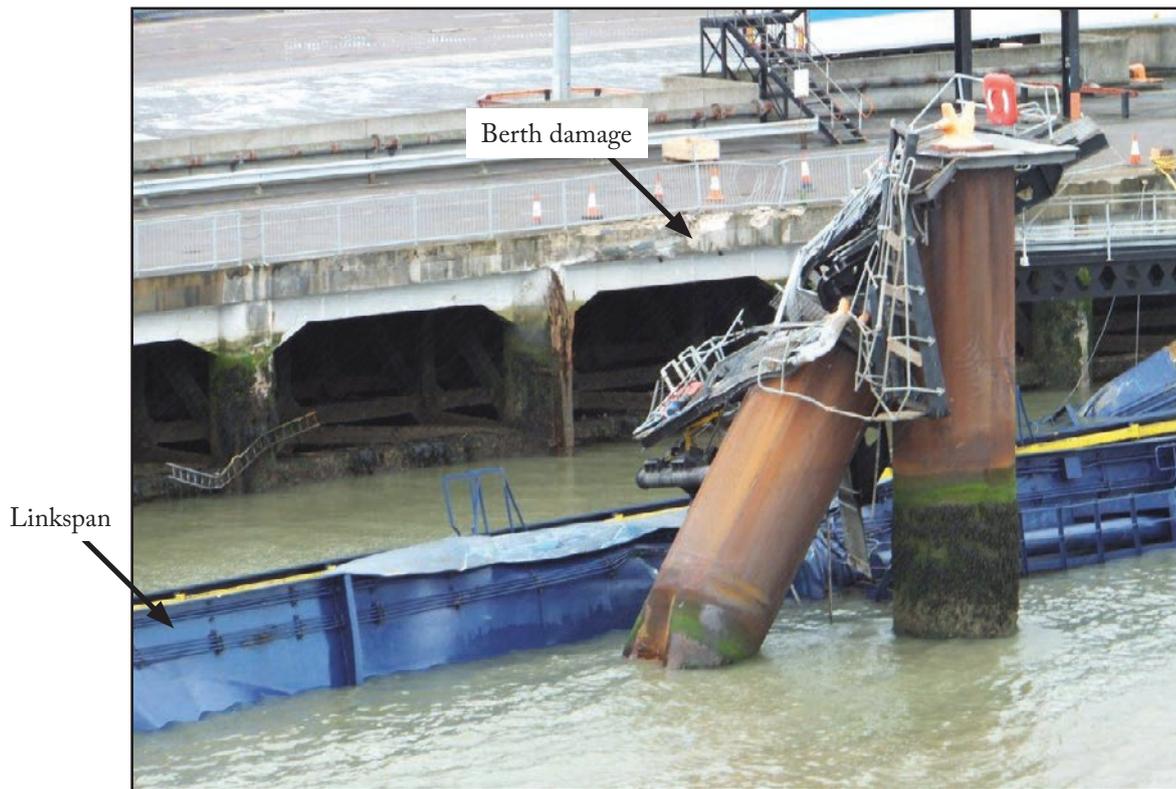
The master's actions proved ineffective as the vessel tore through the linkspan at a speed of about 7 knots and made heavy contact with the concrete berth (Figure 3). Almost immediately, bilge alarms, indicating water ingress into the vessel's forward spaces, began to sound. The pitch on both propellers was brought to zero but the main engines were kept running. The bridge team made safety announcements to the passengers, alerted the port authorities and requested tug assistance. The ship's crew conducted an initial damage assessment and carried out emergency damage control measures. While these efforts were underway, one of the vessel's CPPs was seen to be thrusting ahead, so its propulsion engine was stopped.

Figure 3: Damage to linkspan, mooring towers and berth

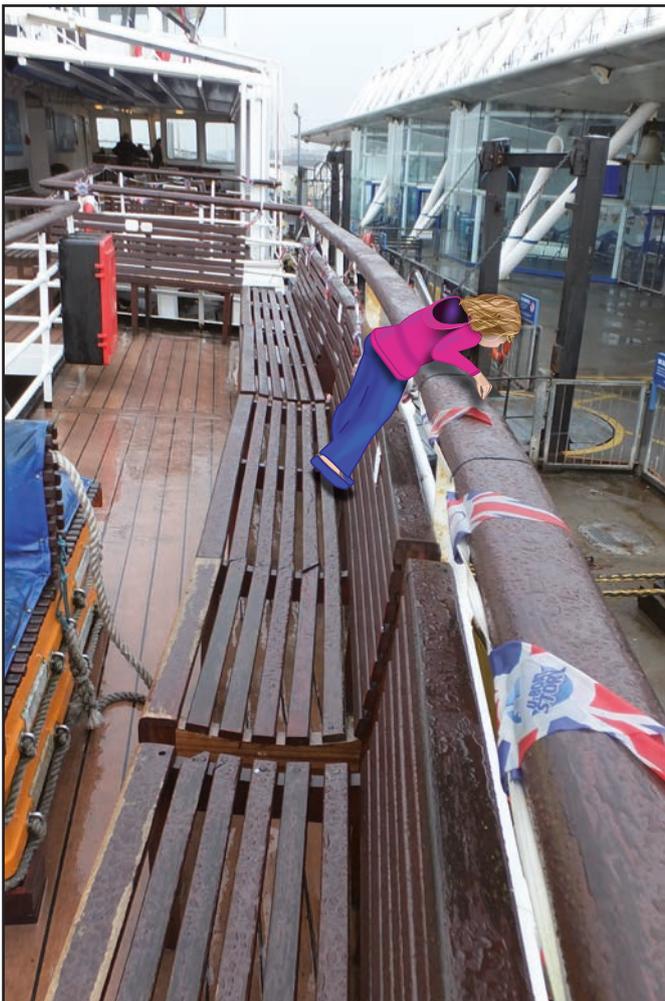
Figure 1: Position of child prior to falling overboard

Ships' side rails are installed to protect individuals and reduce their chance of accidentally falling overboard. On this particular vessel the side rails were 1100mm high, which was higher than the mandated minimum. However, seating was arranged next to the side rails, which meant that if someone stood on the seating, the effective height of the rail from the seat to the top was reduced to approximately 635mm. This then introduced a hazard, which had been recognised by the management through its

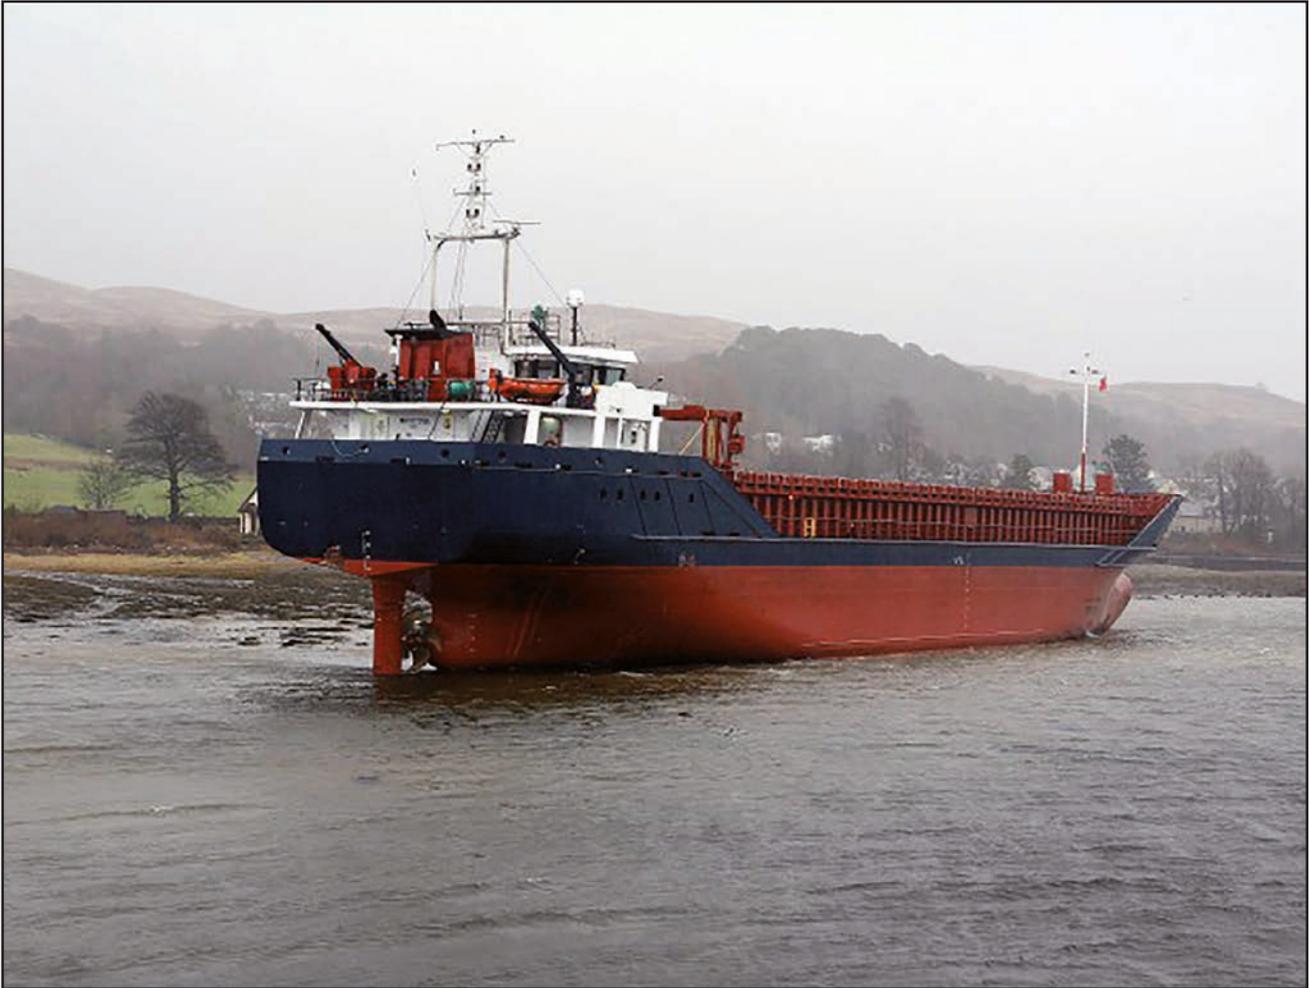
In order to avoid further damage the master decided to abort the berthing operation, but he was unable to regain control of the vessel before it grounded, approximately 60m from the berth (Figure 1). Despite attempts to refloat the vessel, it was hard aground and, as the tide fell, ended up high and dry (Figure 2).

Figure 2: Vessel aground at low water

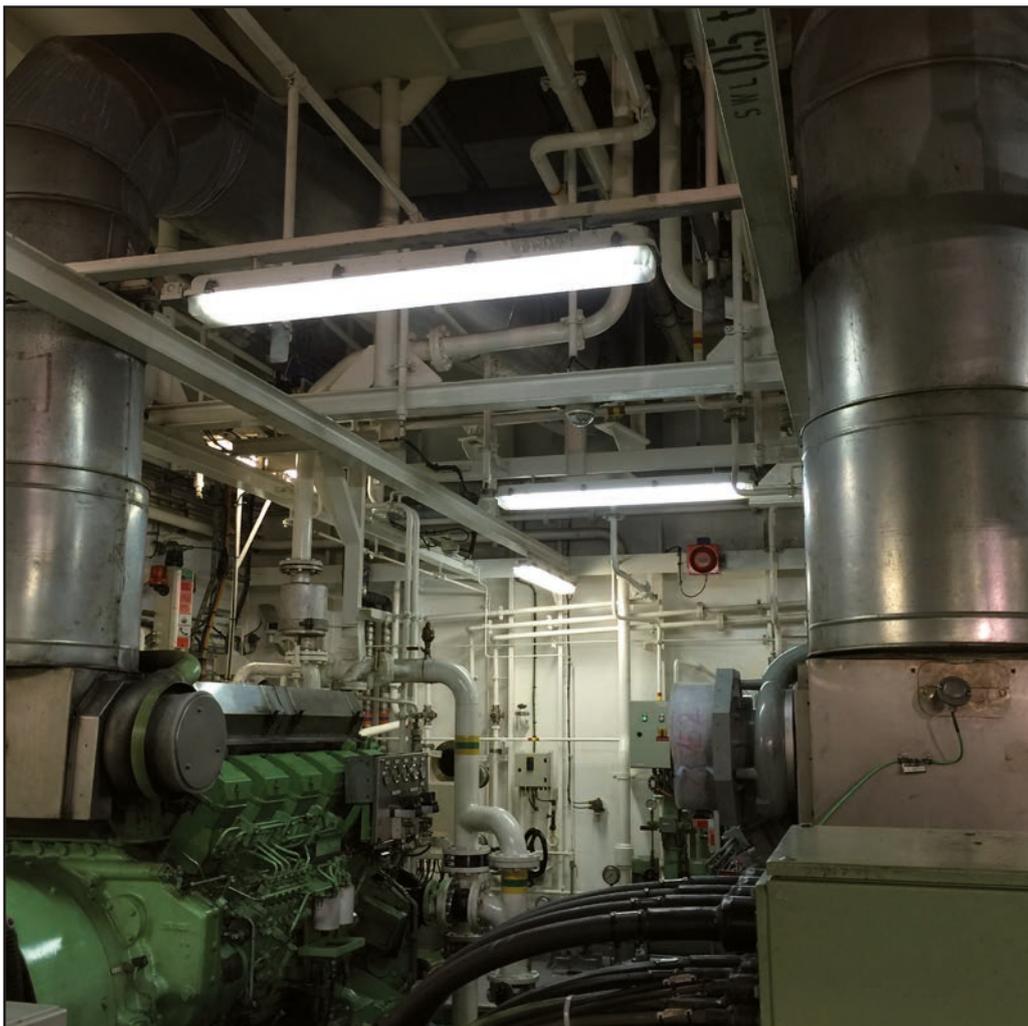
A fully loaded ro-ro passenger ferry was en route to its next port when the engineers in the control room acknowledged a low oil pressure alarm on one of the generators (Figure 1). On the CCTV they observed that oil from this generator was spraying on to the adjacent generator. While they were investigating the source of the leak oil that had been sprayed on the exhaust casing of the adjacent engine caught fire.

Figure 1: Location of the generator with the loose oil plug and the adjacent generator with the uninsulated section of the exhaust piping

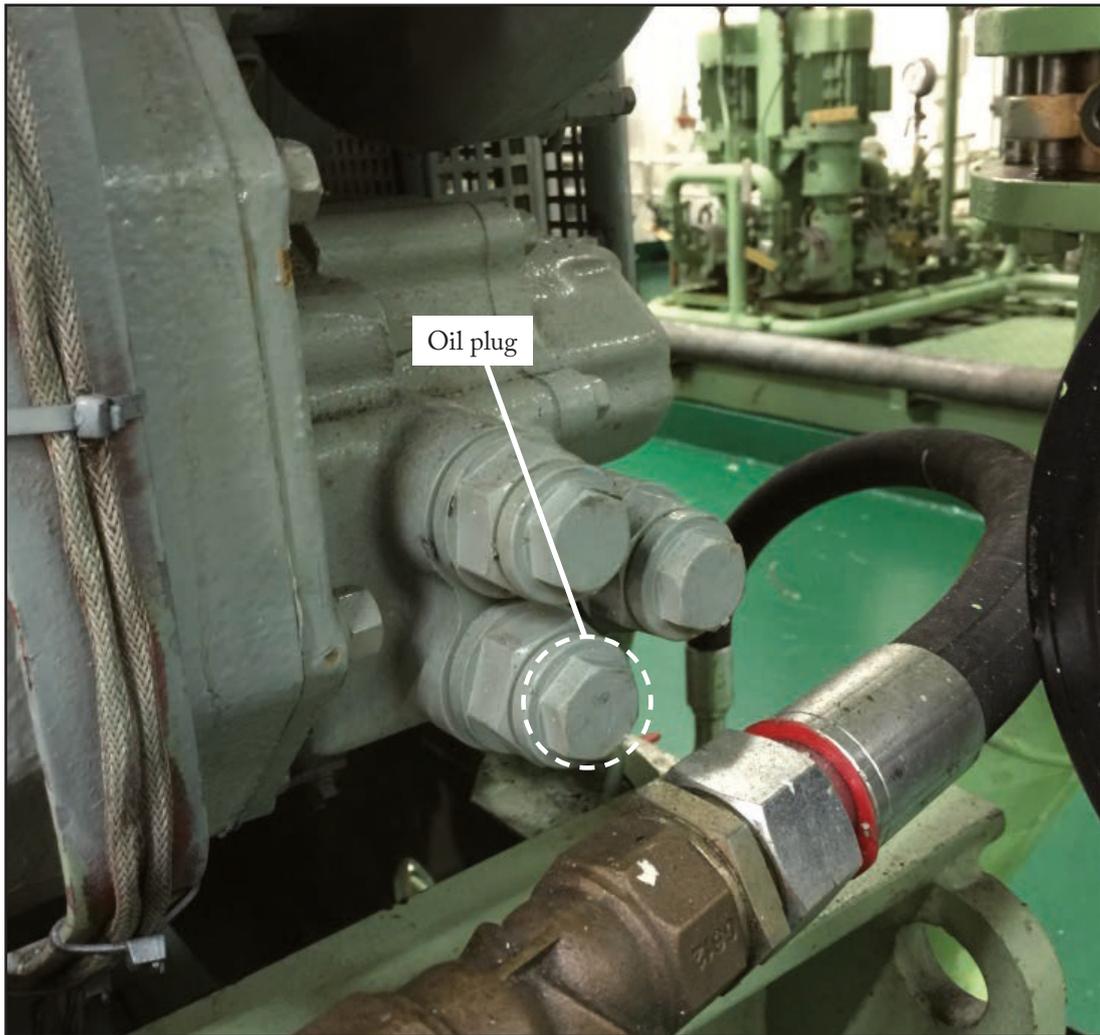
- The oil had come from a loose plug on the generator's engine-mounted lubricating oil pump (Figure 2a). This had vibrated loose as a result of it being insufficiently tightened by shore staff during a recent dry dock.
- A section of the adjacent generator's exhaust piping had been left unlagged following its overhaul during the recent dry dock (Figure 2b). This was hidden from view by the exhaust casing.
- Fine oil spray ignited when it came into contact with the hot exhaust casing.

Figure 2a: Oil plug on lubricating oil pump which vibrated loose

4. All fittings including nuts, bolts, screws and plugs can come loose if the vibration levels on the engines exceed acceptable limits. Overall vibration velocity can be measured with very simple instruments. If excessive, frequency analysis of the vibration waveform can often identify the root cause of excessive vibration levels.

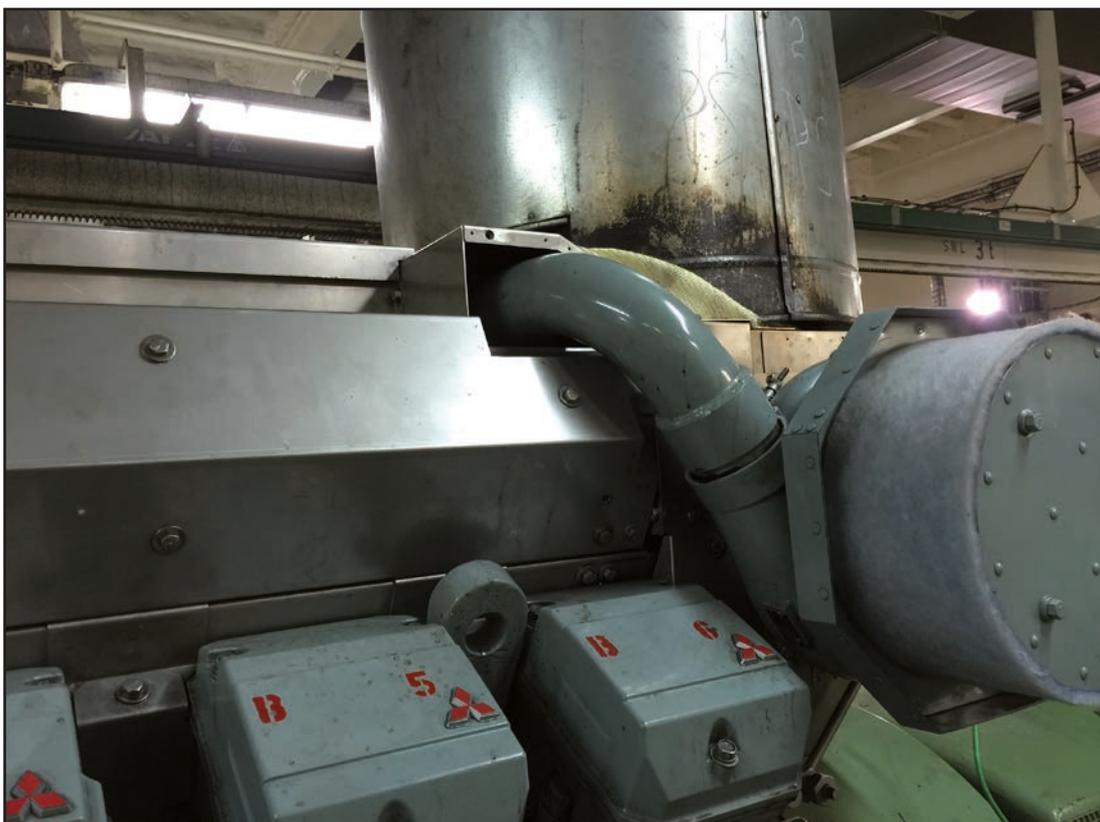
Figure 2b: Section of exhaust casing concealing the uninsulated section of exhaust piping

3. All vessels are required to comply with SOLAS regulations regarding the maximum allowable temperature of an exposed surface (Chapter II/2):
 - *All surfaces with temperatures above 220°C which may be impinged as a result of a fuel system failure shall be properly insulated.*

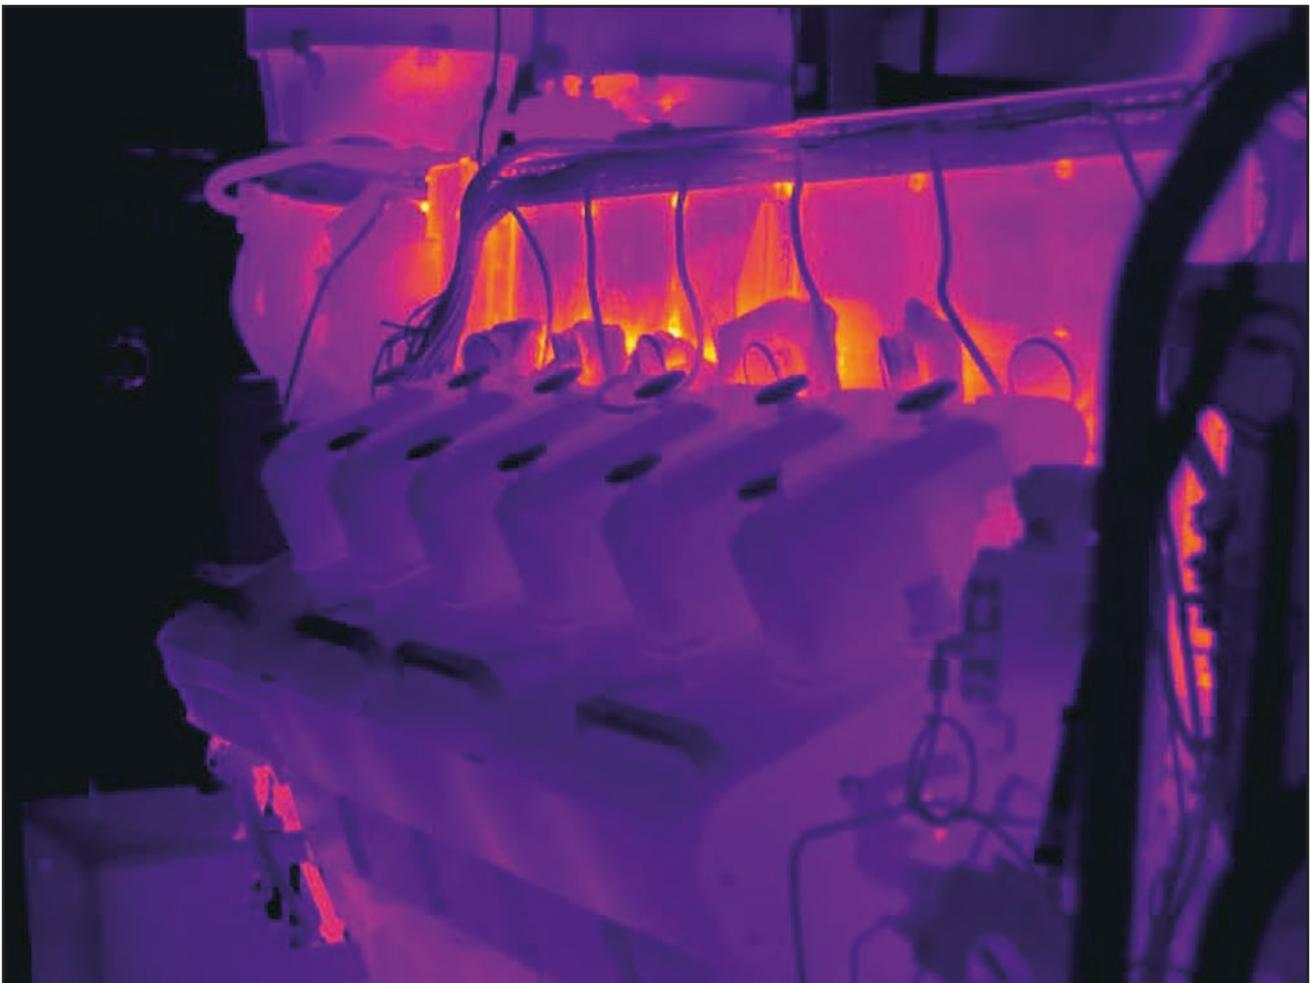
Figure 3: Example of a thermal image showing 'hot spots' on uninsulated sections of the exhaust system

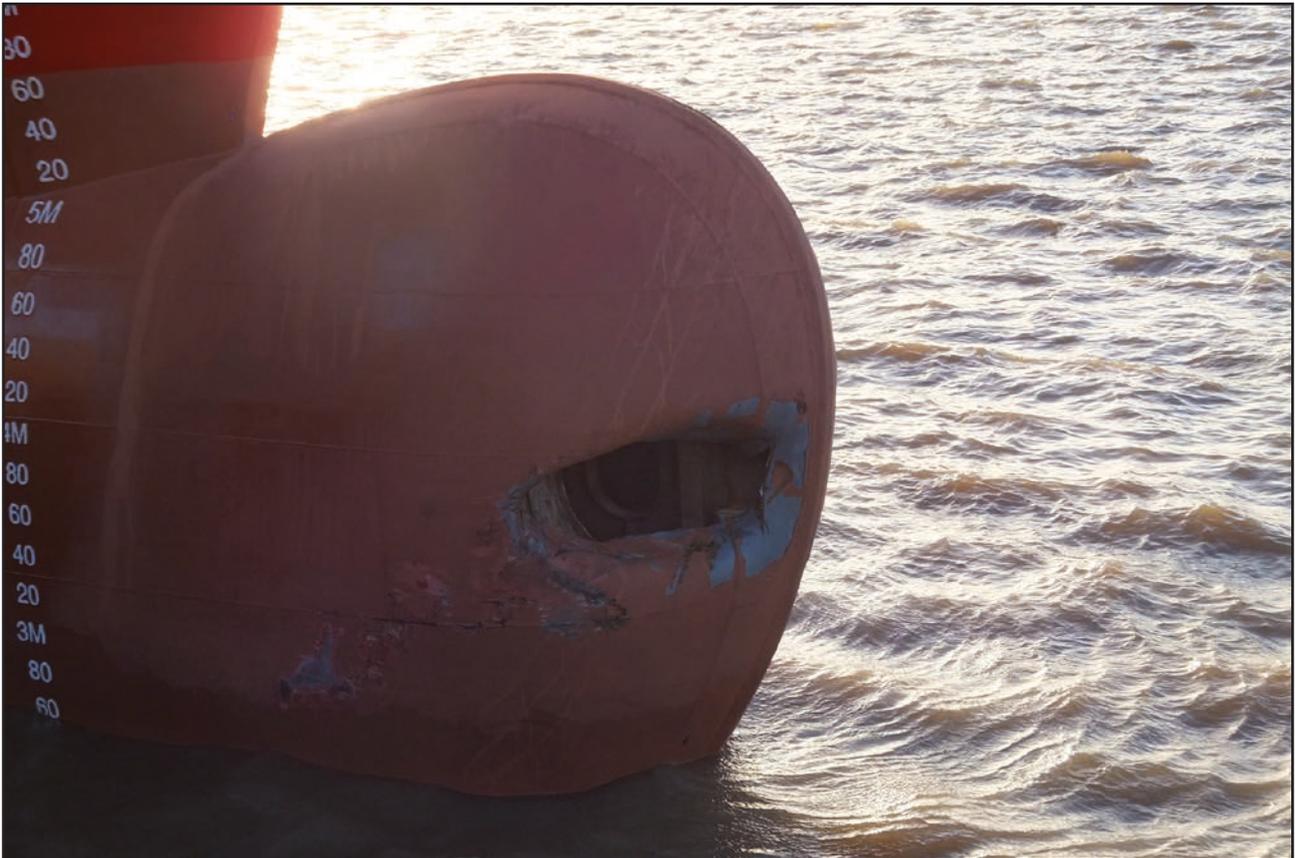
A chemical tanker was being manoeuvred to its designated jetty. As the vessel approached the quay, the pilot ordered an astern movement to enable a turn into the lock. The vessel did not respond and continued to proceed ahead. Despite placing the pitch control to full astern, the CPP did not respond in time and the vessel's bow struck the quay. The bulbous bow was holed, but fortunately the damage was above the waterline (Figure 1).

Figure 1: Bulbous bow damage caused by contact with the quay

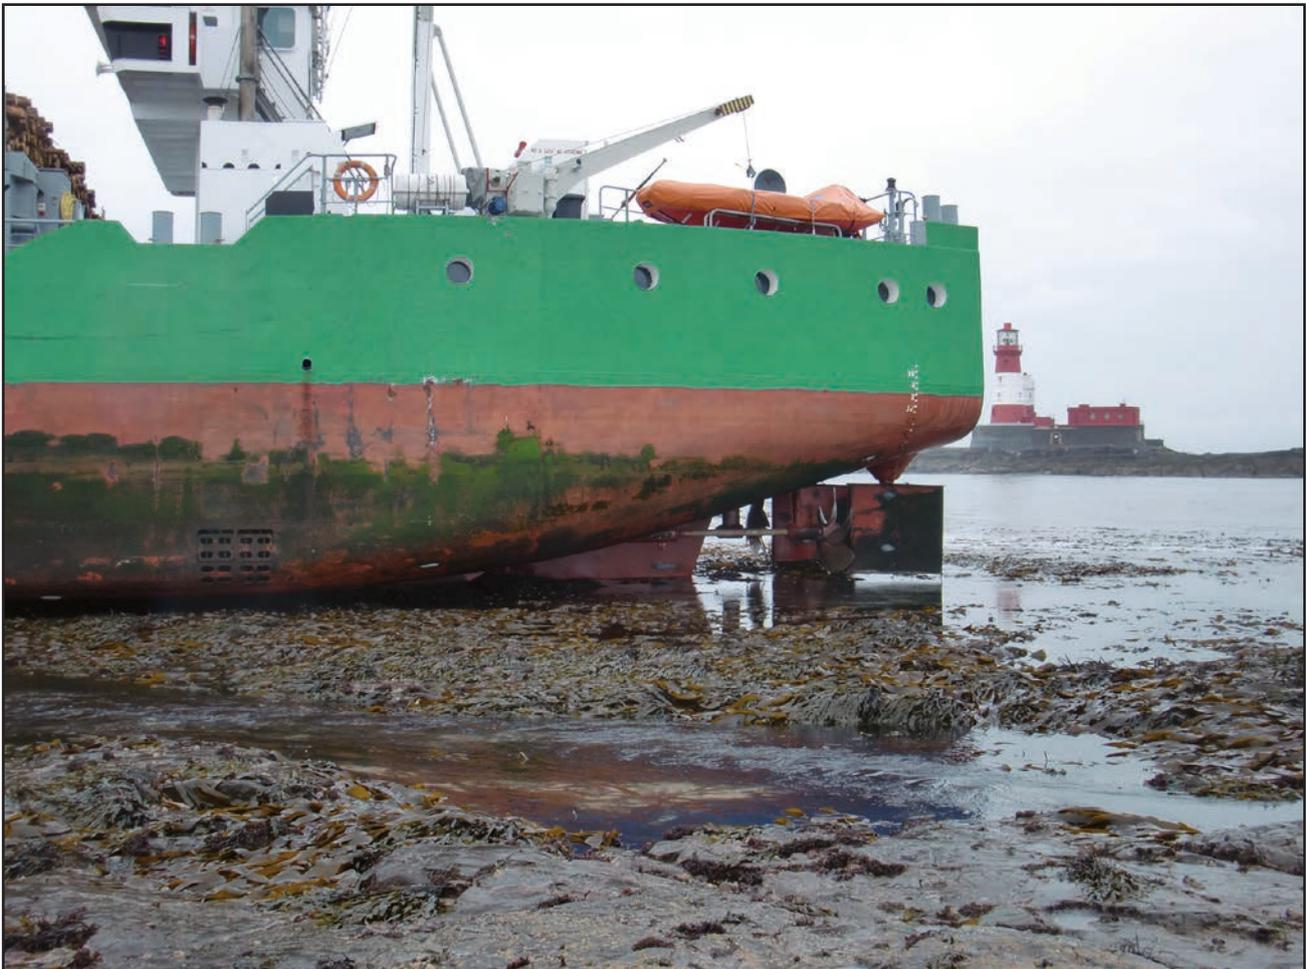
Just before dawn, the vessel ran aground (Figure 1) on a rocky island at 9 knots. The chief officer woke up on impact and placed the engine controls astern in an attempt to re-float the vessel. However, this proved futile, and with the changing tides over the next 24 hours the vessel settled further onto the rocks, causing severe damage to the vessel's internal structure aft and the starboard propeller and rudder.

Figure 1: The vessel aground

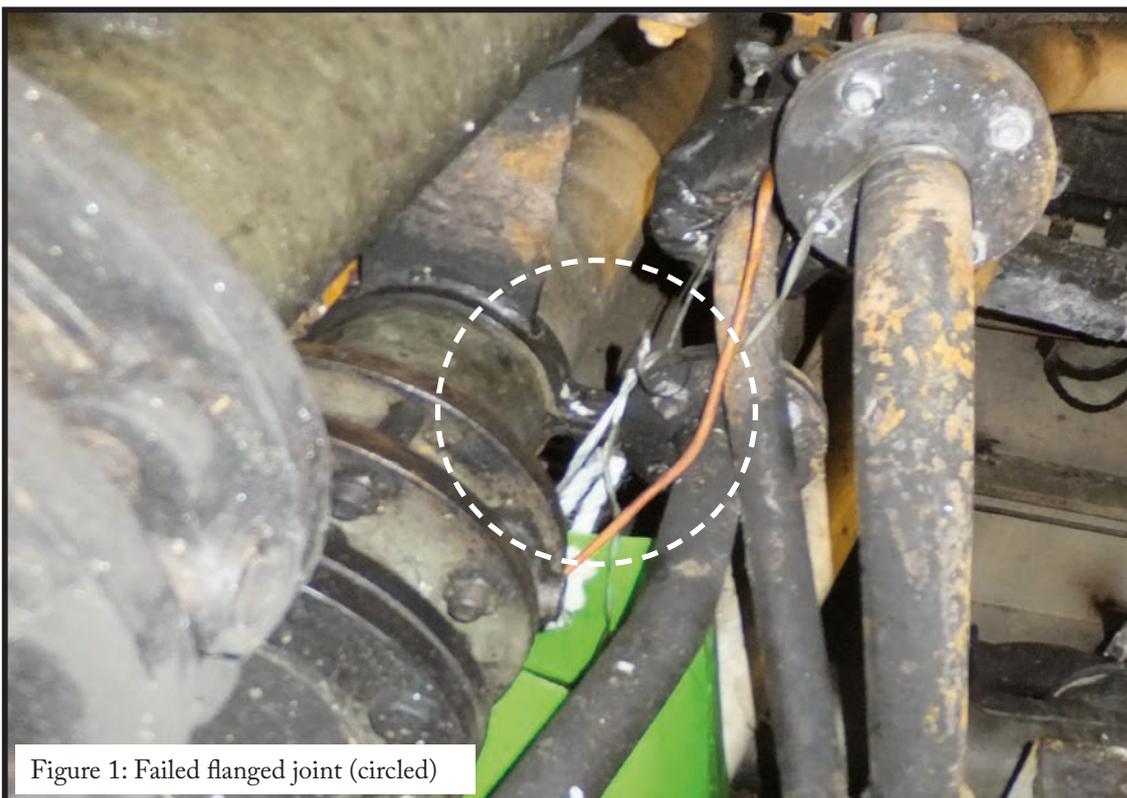
Extensive damage was sustained to the main engine room, and the ship was later towed to a repair yard for refit. On examination, it was discovered that the back pressure valve in the starboard CPP system had become worn and had jammed, leading to the return line of the system becoming over-pressurised. The pressure relief valves in the system had not been tested or inspected during their 20 years of service. The flanged joint that had failed was positioned between the two starboard main engine uptakes and had not been fitted with a spray shield (Figure 1).

Figure 1: Failed flanged joint (circled)

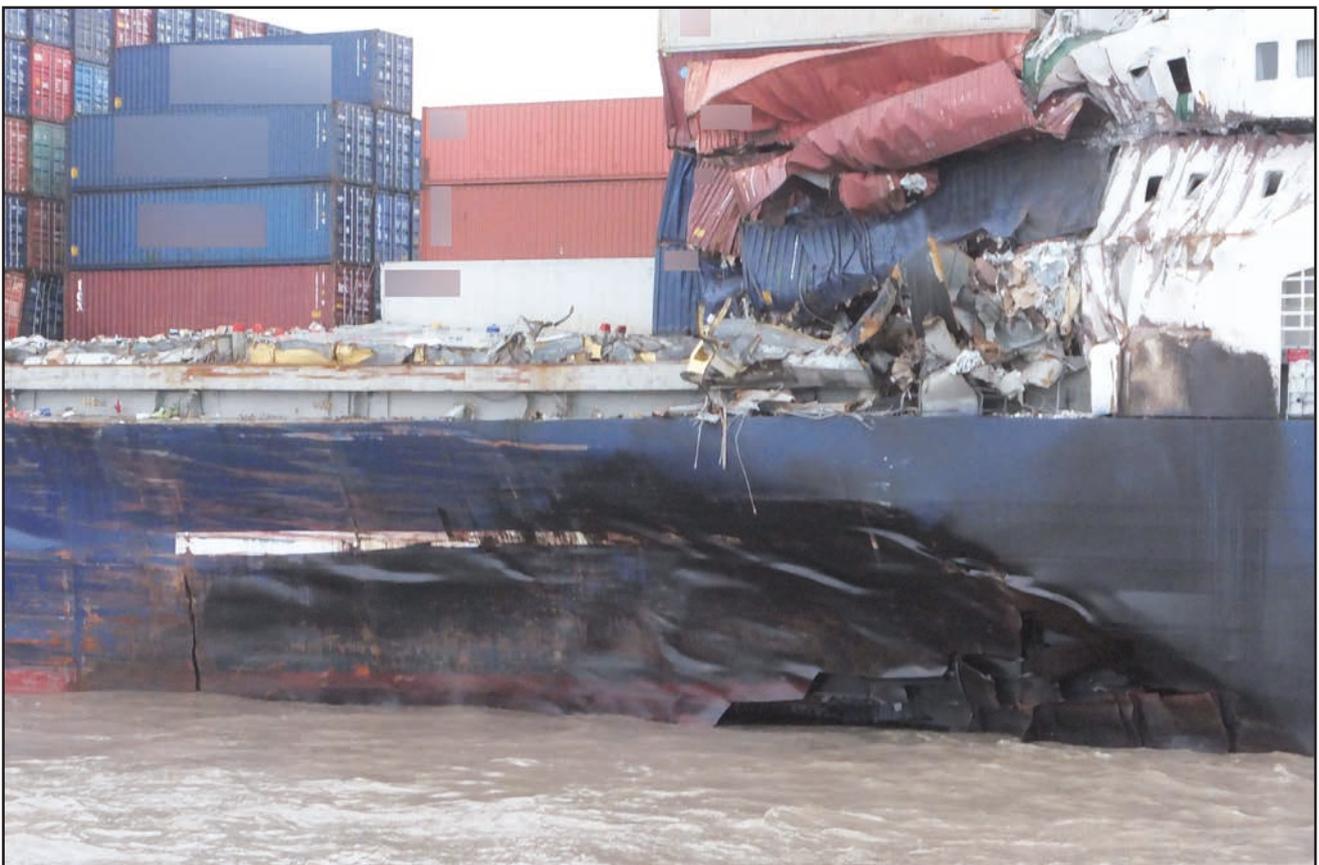
There were no resulting injuries. However, both vessels sustained serious damage (Figure 2), and about 600 tonnes of heavy fuel oil were spilled.

Figure 2: Damage to the container vessel

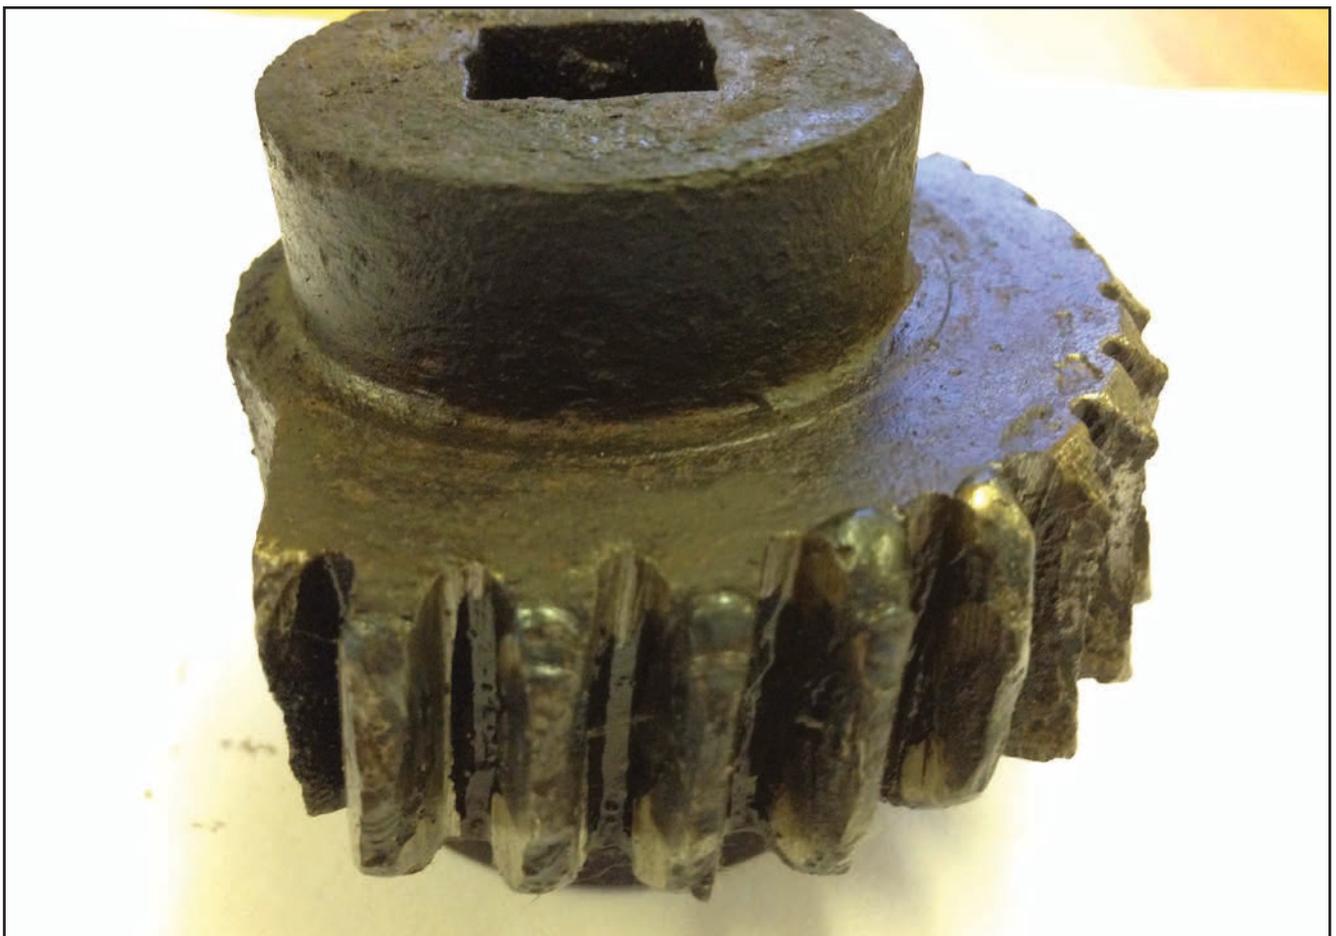
Figure 3: Gearbox quadrant, showing signs of damage and previous repair

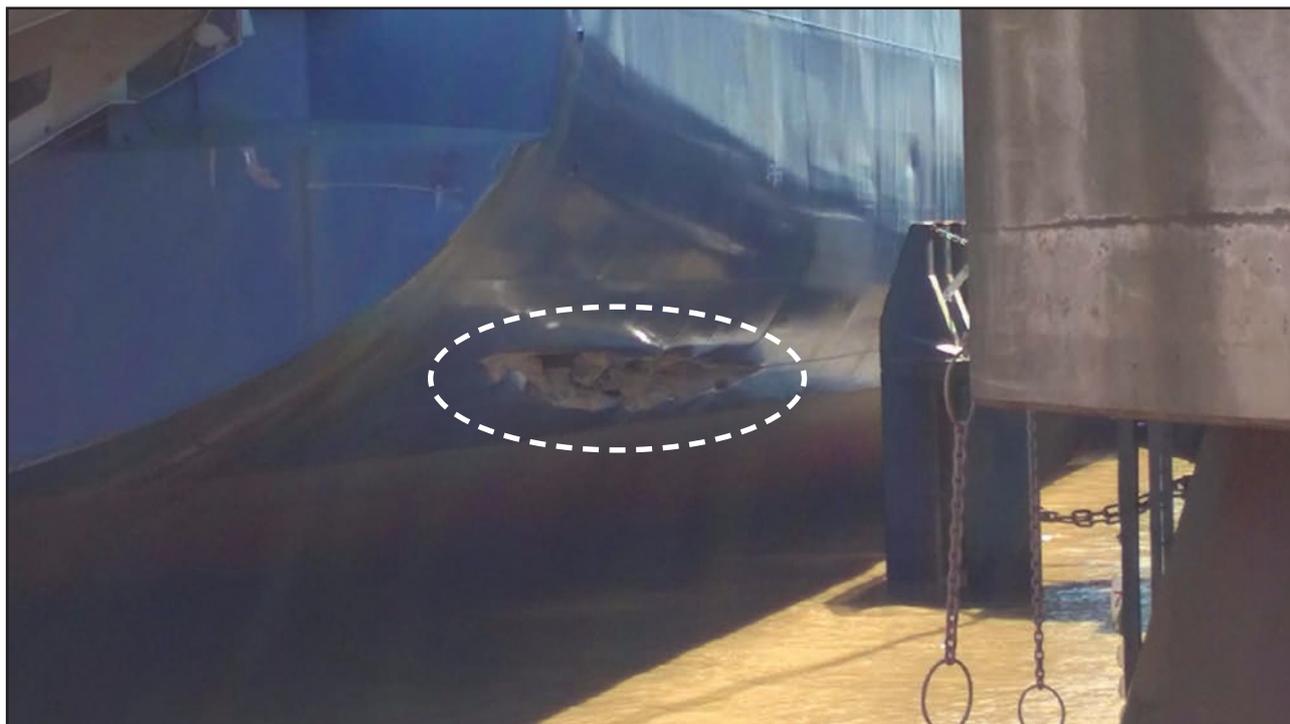
Figure 1: Damage sustained to the vessel

It was fortunate that the damage to this vessel was above the waterline and into a ballast tank. Had this been below the waterline, there could have been serious flooding. Had the damage been in way of a bunker tank, this could have resulted in a pollution incident. It was clear that the lead pilot had lost situational awareness; once he lost his electronic aid he did not properly utilise the resources available to him.

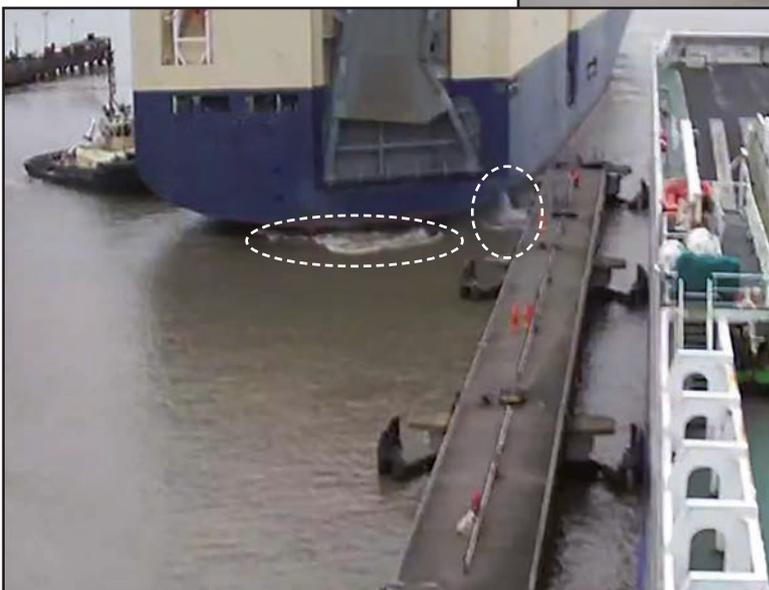
Figure 4: Vessel engine and rudder used after collision and damage to tank causing leak

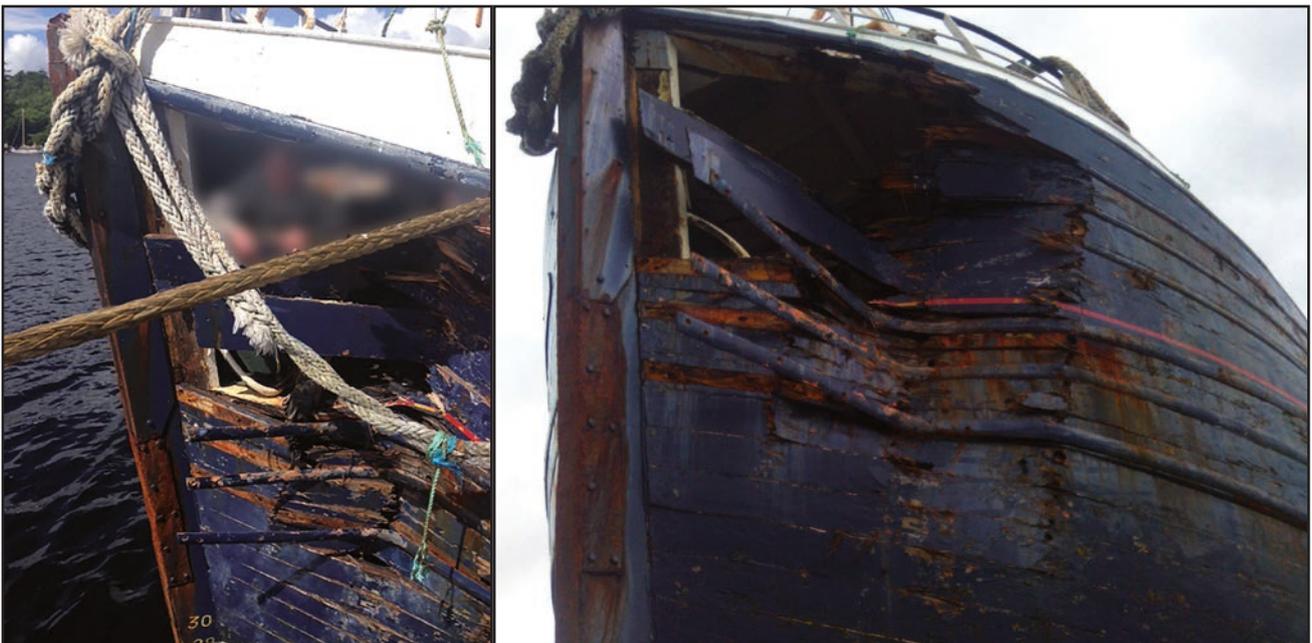
At about 0115 there was an extremely loud noise and frightening shudder, heard and felt by both crews as vessel B ran into vessel A. The skipper of vessel B realised what had happened and called vessel A by VHF radio to find out what the situation was. It took a few moments for vessel A's crew to realise what had happened, but all became clear when vessel B called them. Having established that no-one was injured, the skipper of vessel B informed the coastguard and both vessels proceeded back to the home port together. Vessel A had suffered significant damage above the waterline near the port bow (Figures 1 and 2) and, although there was no flooding initially, it began to take on water during the passage home; vessel B was effectively undamaged.

Figures 1 and 2: Damage to vessel A's port bow area

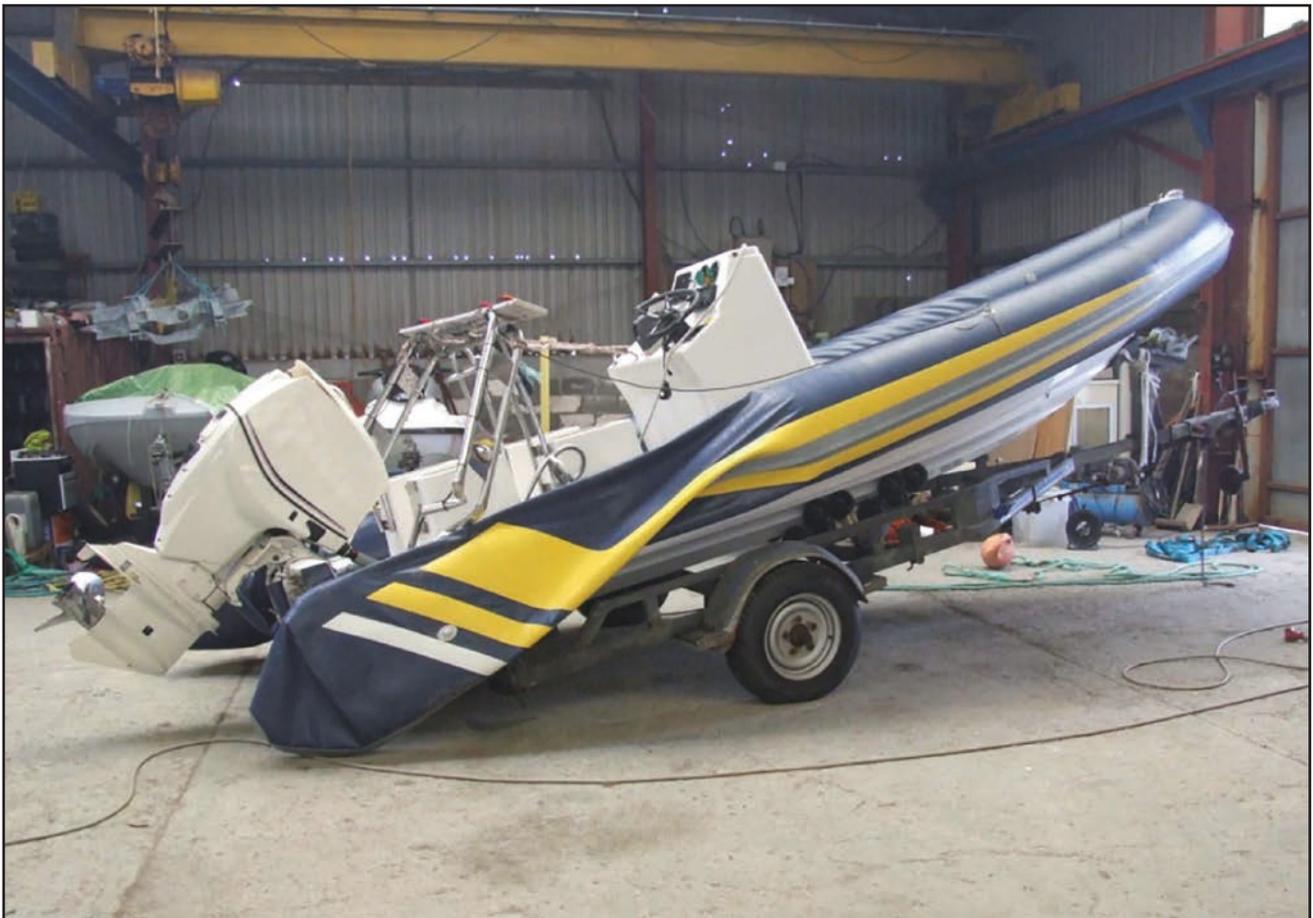
Figure 1: Recovered RIB
