Report on the investigation of the collapse of a crane

on board the workboat

Carol Anne

Loch Spelve, Isle of Mull, Scotland

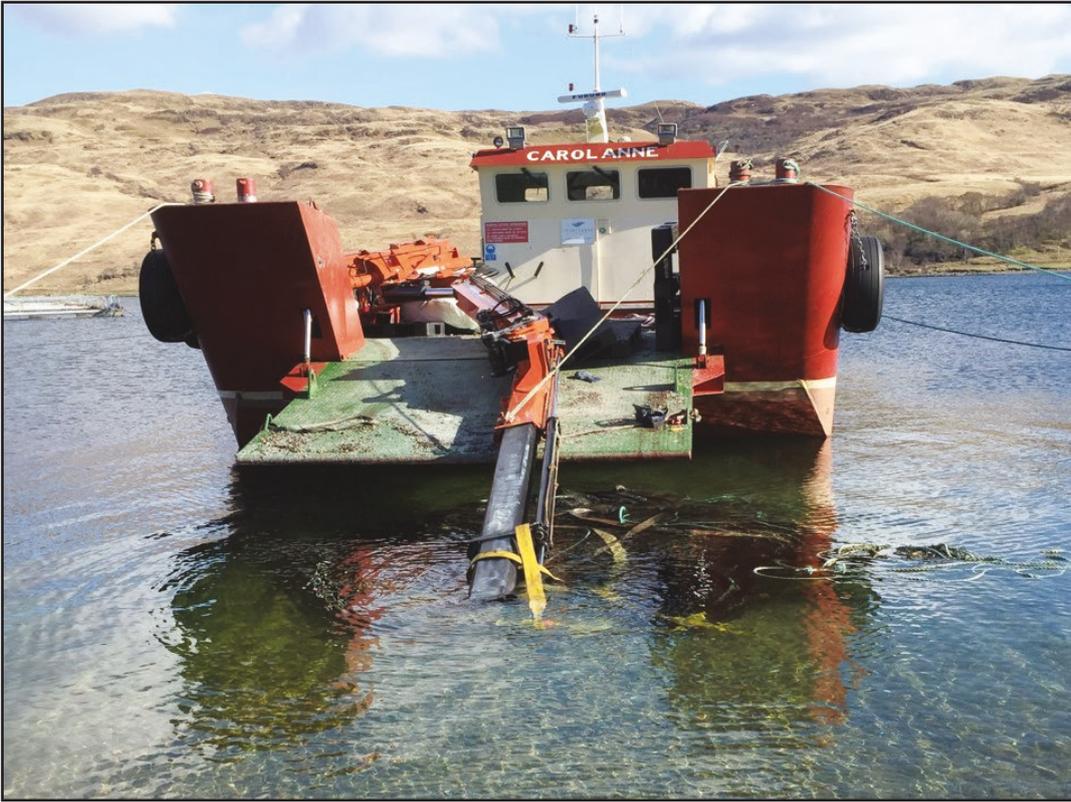
Figure 4: Collapsed crane

The examination and testing of the fastenings used to secure the crane to *Carol Anne's* deck (paragraph 1.13.1) indicate that the crane collapsed because the threads of the four lock nuts securing the outboard side of the crane pedestal were stripped. The damage to the four inboard fastenings probably resulted from the crane toppling. **Figure 22** shows the distribution of the loads acting on the four outboard fastenings at varying jib slew angles. At the time of the collapse, the crane jib was slewing towards the centreline forward from the starboard side and the aft, outer fastening (No 4 in **Figure 22**) was bearing the highest load. Therefore, it was probably the first fastening to fail. However, the proportion of the load on this fastening would have instantaneously transferred to the remaining fasteners, leading to their failure.

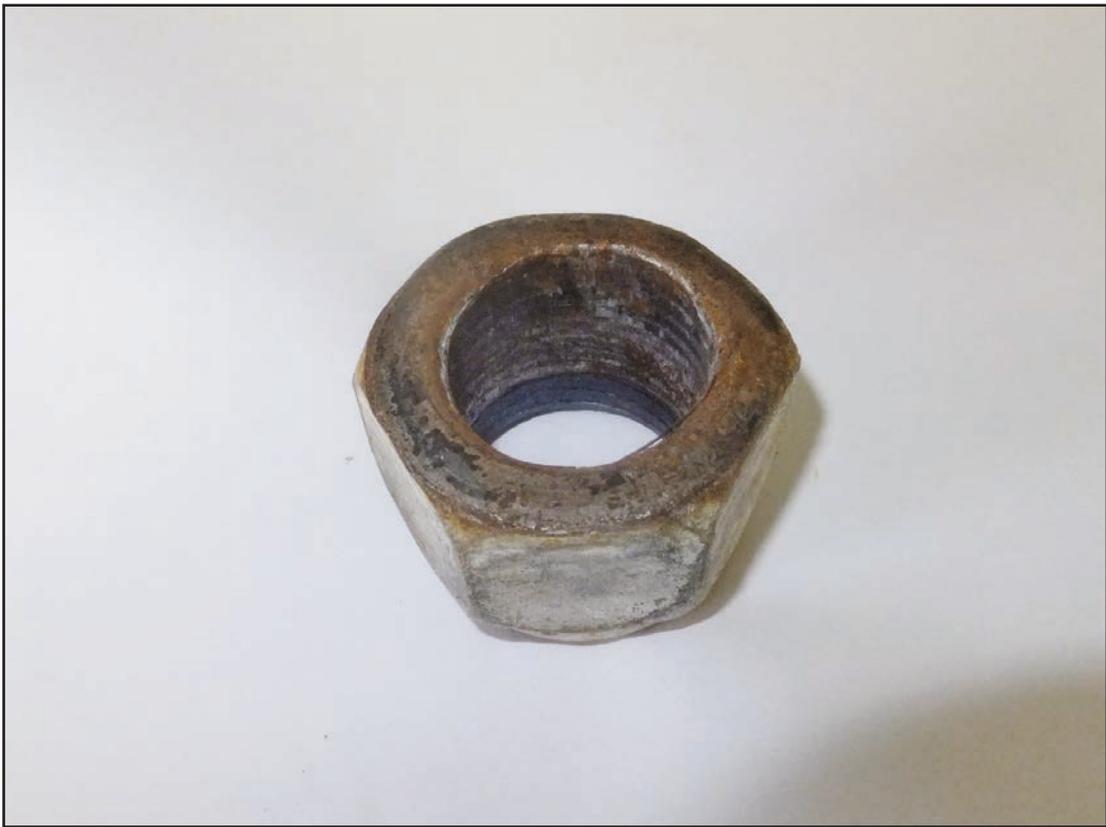
Figure 6: One of the failed nylon inset lock nuts

The four outboard lock nuts and one of the inboard lock nuts had failed by thread stripping. The remaining three inboard nuts had not failed. One of the failed nuts was not recovered.

The mechanical properties of the M24 nylon insert lock nuts did not meet the requirements of BS EN 898- Part 2:2012 for a grade 8, M24 nut with a fine pitch thread; the nuts had a hardness of 211 HV10 whereas the standard requires a hardness of between 233 and 253 HV10.

The studs were compliant with BS EN ISO 898 Part 1: 2013 grade 10.9. The incident nuts were marked as grade 181 and were found to be compliant, in so far as tested, with BS 3692: 2014 grade 181. BS EN 898 Part 2: 2012 grade 8 nuts have a higher specified hardness and therefore strength than grade 181 nuts to BS3692: 2014.

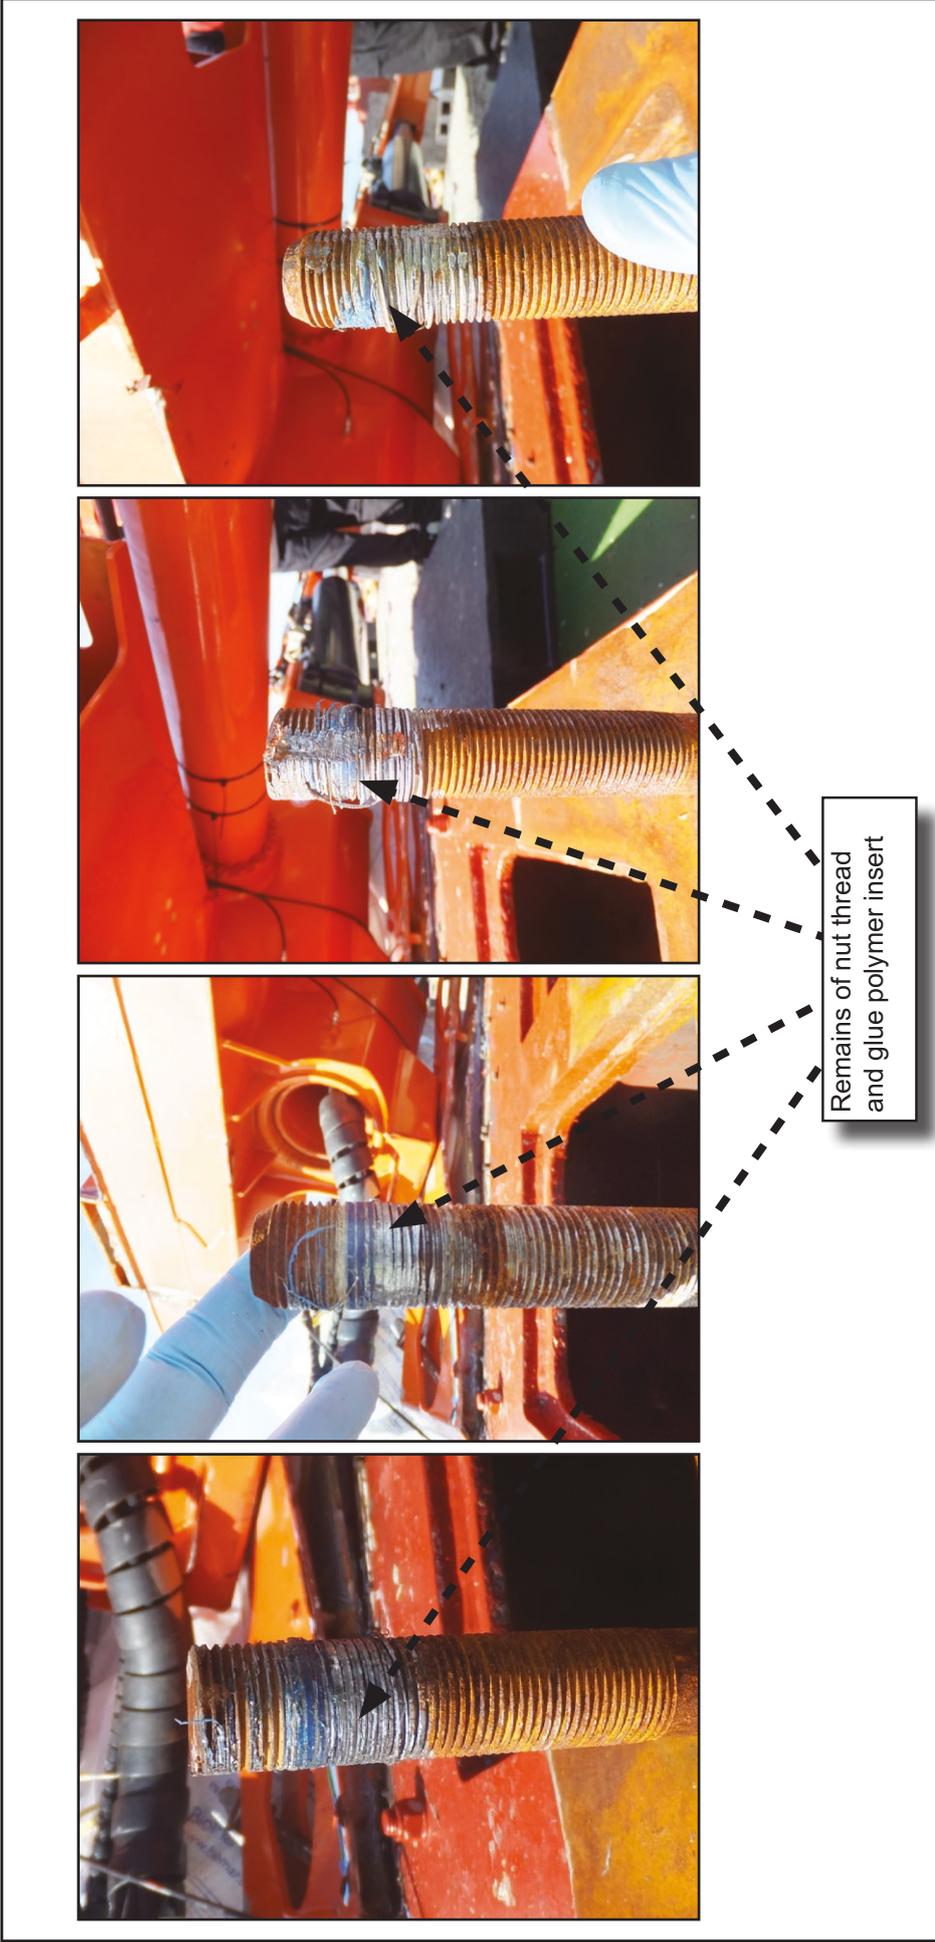
Figure 8: Tie bolts on the outboard side of the crane pedestal with the remains of the stripped lock nut threads

The four outboard bolted connections failed by thread stripping of the nut. Of the four inboard bolted connections, one failed by thread stripping of the nut. Two of the four connections had fractured at the stud thread root by ductile overload in bending as the threaded regions protruded above the mounting plinth in the area in which bending occurred. The fourth connection did not fail, but the tab washer deformed allowing the sub-frame to pass over the washer.

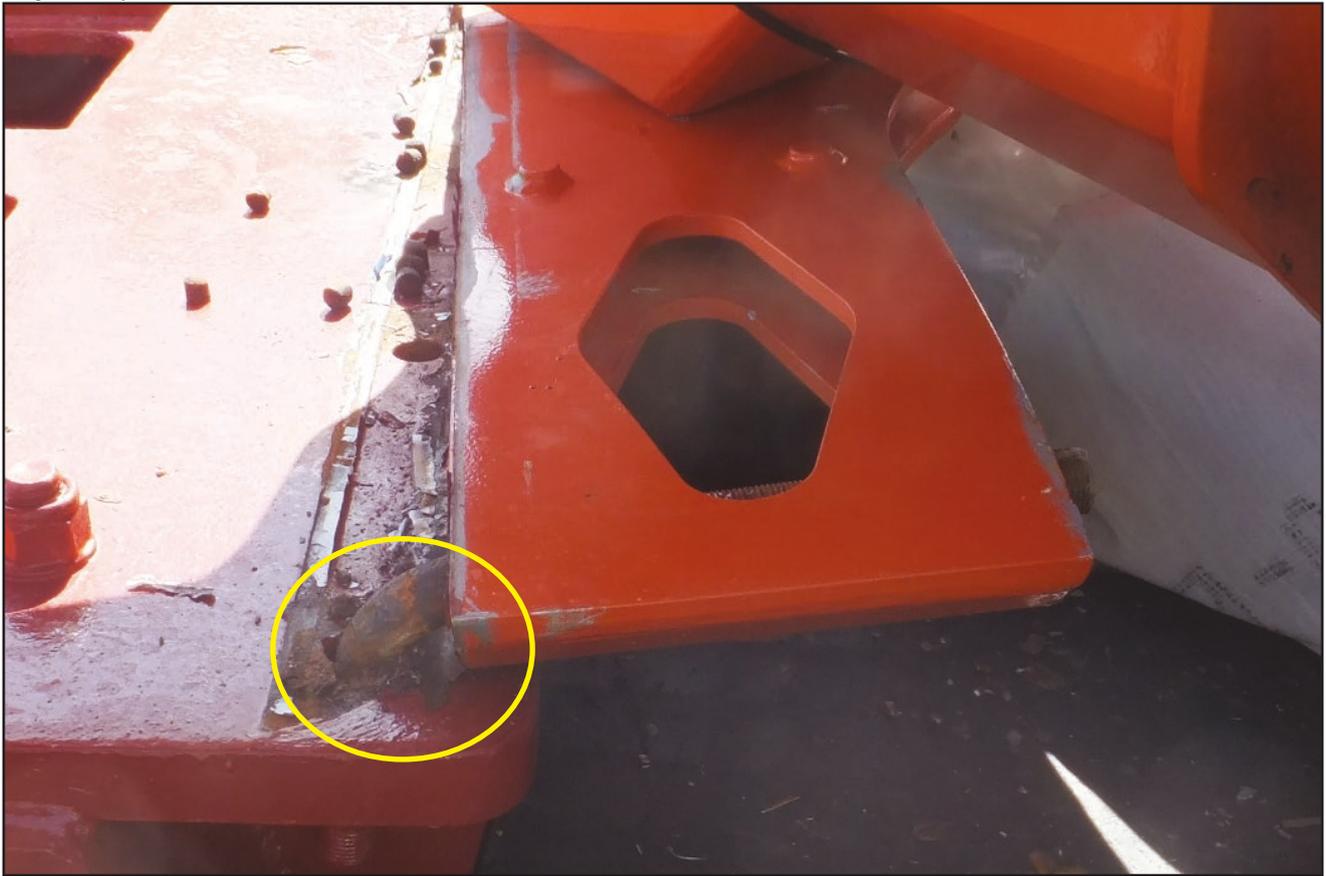
Figure 9: Bent tie bolt on the inboard side of the crane pedestal (circled)

When the tie bolts were removed from the accident site, it was found that two of the four inboard bolts had fractured during the incident. The other two inboard bolts had bent and were removed by flame cutting.

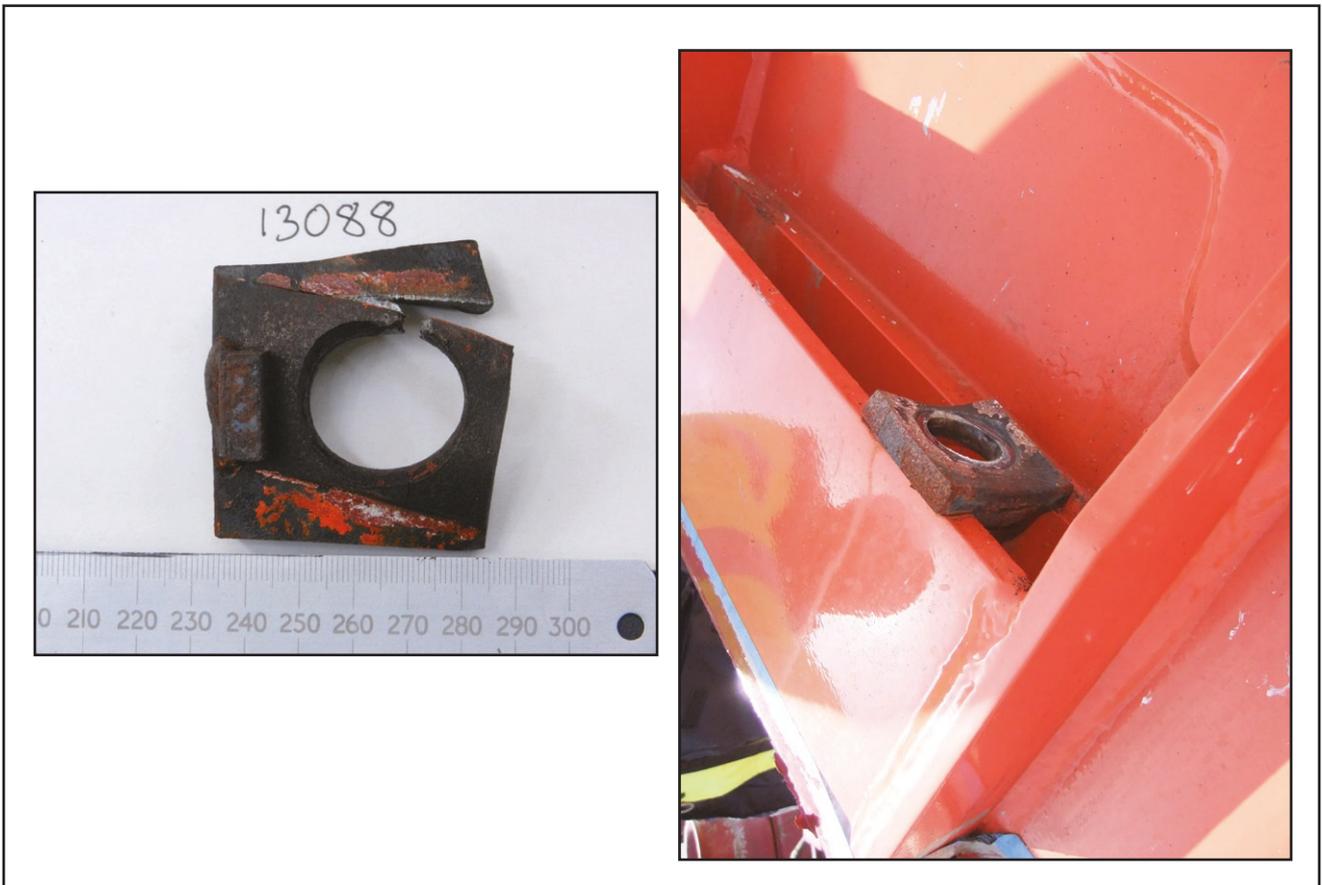
Square tab washers onto which the lock nuts had been secured were deformed and showed signs of shear stress (**Figure 10**). One of the tab washers could not be found.

Figure 10: Recovered tab washers

Seven of the eight tab washers (**Figure 10**) were recovered. All showed evidence of plastic deformation with imprints of the nut on the upper surface and the sub-frame on the lower surface. The missing tab washer would have been located on the rear-most outboard position.

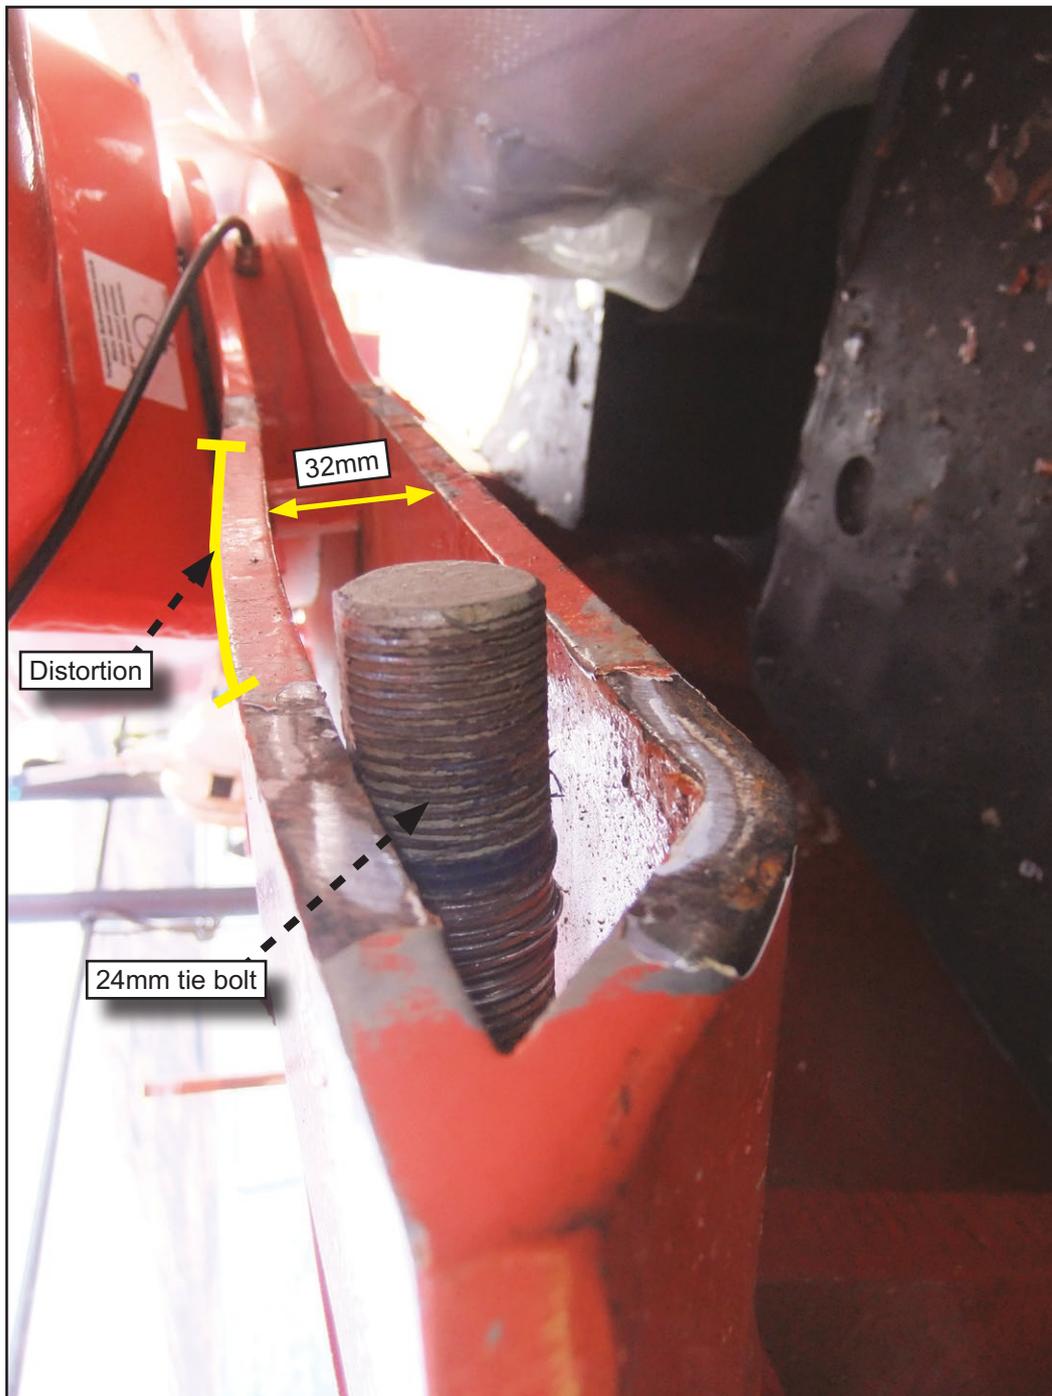
The slots in the box sections of the crane's pedestal, through which the 24mm tie bolts had been secured in order to attach the crane to a base plate welded to *Carol Anne's* deck, were 32mm wide (**Figures 7, 11 and 12**). Neither a load radius diagram² nor any indication of the crane's safe working load (SWL) was found.

Figure 12: A 24mm tie bolt through a 32mm slot
(inboard side)

- The proof loads of the M24 fastenings were lower than the M30 fastenings. The proof load for an M30 lock nut grade 8 (style 1) with a friction coefficient of 0.14 was 516kN, whereas the proof load of the intended M24 lock nut grade 8 (style 1) was 395.5kN. Significantly, the proof load of the grade 6 (style 0) lock nuts used on board *Carol Anne* was only 230kN.
- The tab washers used in conjunction with the M24 tie bolts and nuts were 30% thinner than the tab washers used in conjunction with the M30 tie bolts and nuts. They were therefore much weaker.
- The use of M24 tie bolts in the 32mm slots in the box mountings on the crane's pedestal, which were intended to be used with M30 tie bolts, resulted in the bolts having 8mm freedom of movement (**Figure 12**).

The larger than intended freedom of movement of the tie bolts before tightening led to the misalignment of some of the tab washers, placing them in shear loading rather than compression. Furthermore, as the tab washers were supported only at their extremities (**Figure 24**), and were thinner than the washers used in the M30 mounting kit, they were prone to bend downwards under load (**Figure 10**). Such deformation, which could have occurred when the lock nuts were tightened or when the crane was under load, would have led to uneven loading on each of the lock nuts. In turn, this would have reduced the lock nuts' ability to withstand thread stripping.

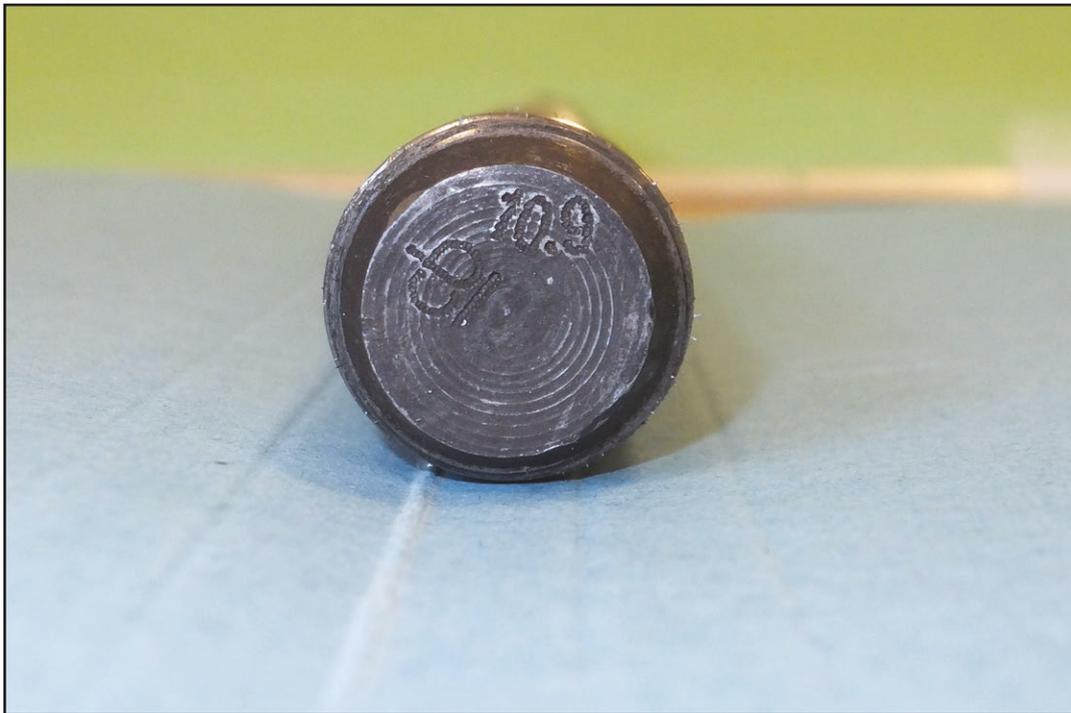
The tie bolts were marked with '10.9' at one end (**Figure 20**), which indicated the grade of steel. The mechanical and chemical properties of the M24 tie bolts met the requirements of BS EN ISO 898 Part 1: 2013¹⁵ for a 10.9 grade bolt. Each tie bolt was 450mm long with a threaded section at each end. One threaded section was 204mm long and the other 57mm long. The centre section of each tie bolt had been machined to give a plain diameter of 22.5mm. The threads had been machined to give a diameter of 23.9mm and a pitch of 2.0mm, which is a fine pitch thread.

Figure 20: Grade marking on the M24 tie bolt

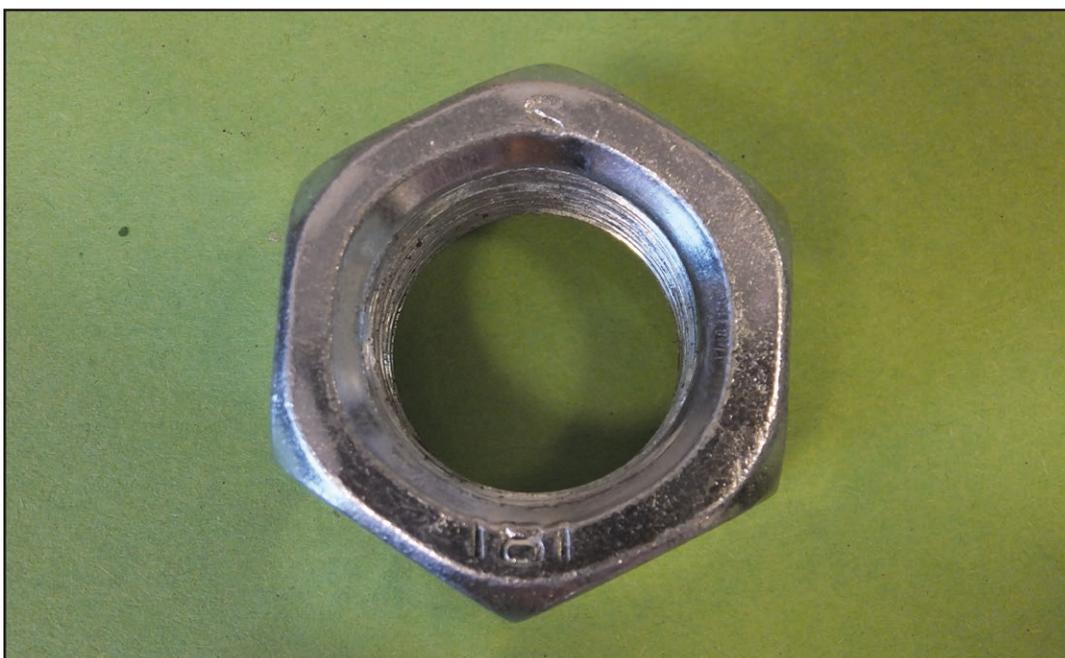
The pitch of the M24 nylon insert lock nuts matched that of the tie bolts. Each nut was 22.9mm high and 35.1mm across the flats with a threaded bore diameter of 21.9mm. A blue polymer insert was fitted at one end. The nuts were marked with the symbol |8| (**Figure 21**) to indicate their grade, and were galvanised.

Figure 21: Grade marking on the M24 nylon insert lock nut

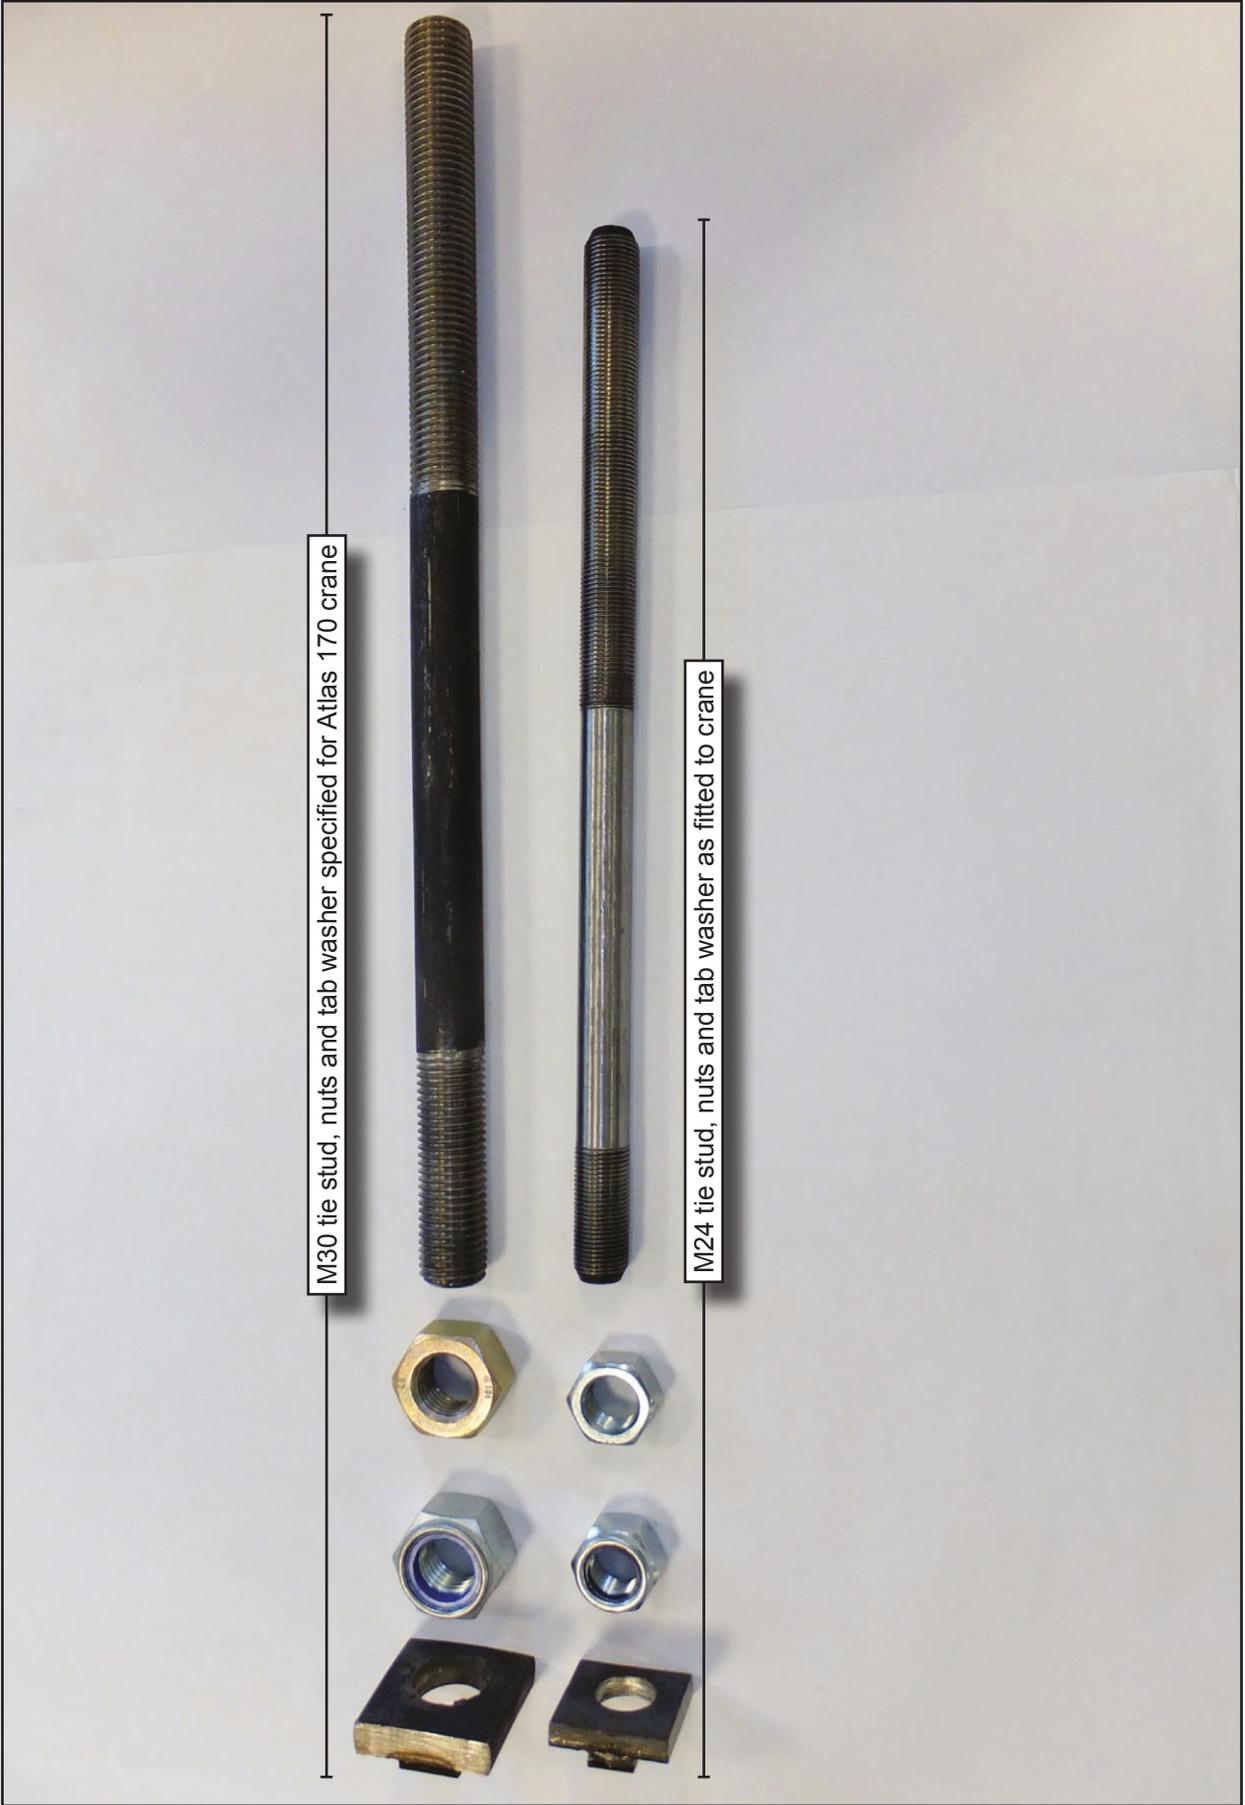
Figure 23: M30 and M24 mounting kits

When tested the M24 lock nuts used on board *Carol Anne* were found to be equivalent to grade 6 (style 0) and had a proof load of 230kN. They were significantly weaker and less resistant to thread stripping than the lock nuts that were intended to be used, which were grade 8 (style 1) and had a proof load of 395.5kN (paragraph 1.13.2).

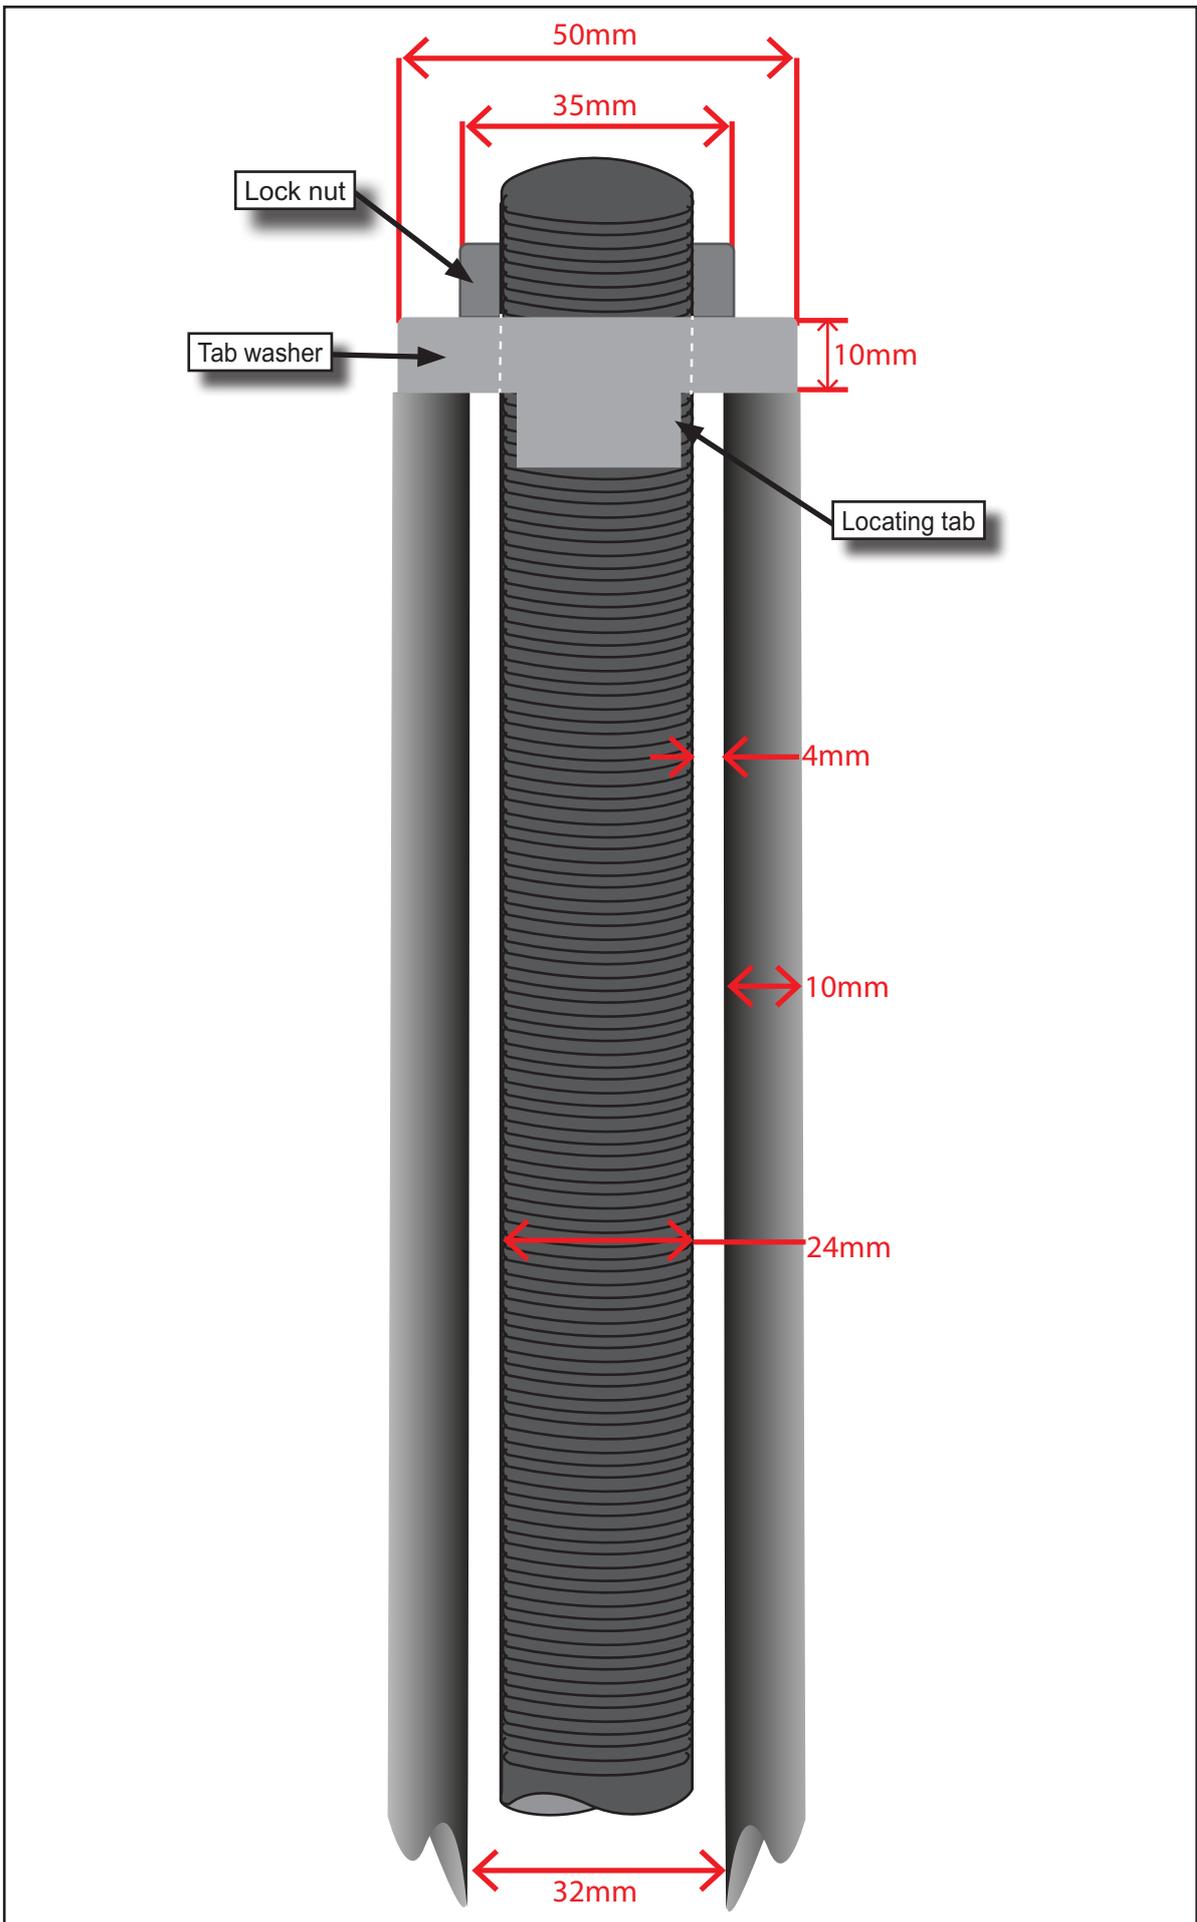
Figure 24: Diagram showing the tab washer arrangement
