Report on the investigation of the grounding
of the cruise ship
Hamburg
in the Sound of Mull, Scotland

11 May 2015

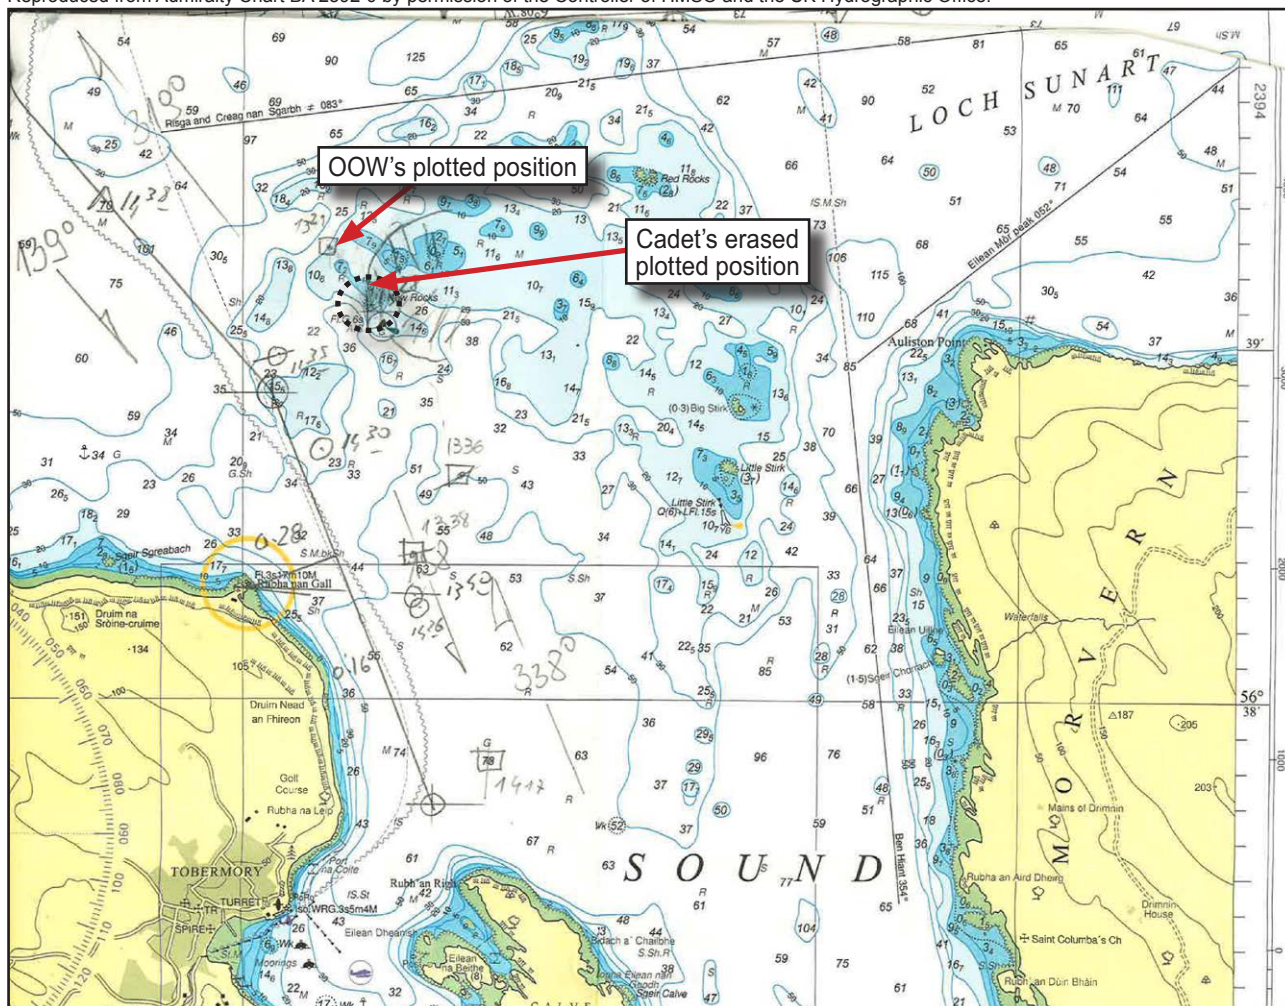
Figure 5: Extract of chart BA 2392 showing plotted position at 1321

At 1321 both the OOW and the cadet plotted *Hamburg's* position on the chart (**Figure 5**). The cadet saw that his plotted position was some distance away from the OOW's position but closer to the New Rocks shoal. Without consulting the OOW, the cadet assumed his own position was incorrect and removed it from the chart using an eraser. At 1322:55 the OOW reduced the starboard radar display to the 1.5nm setting (**Figure 6**).

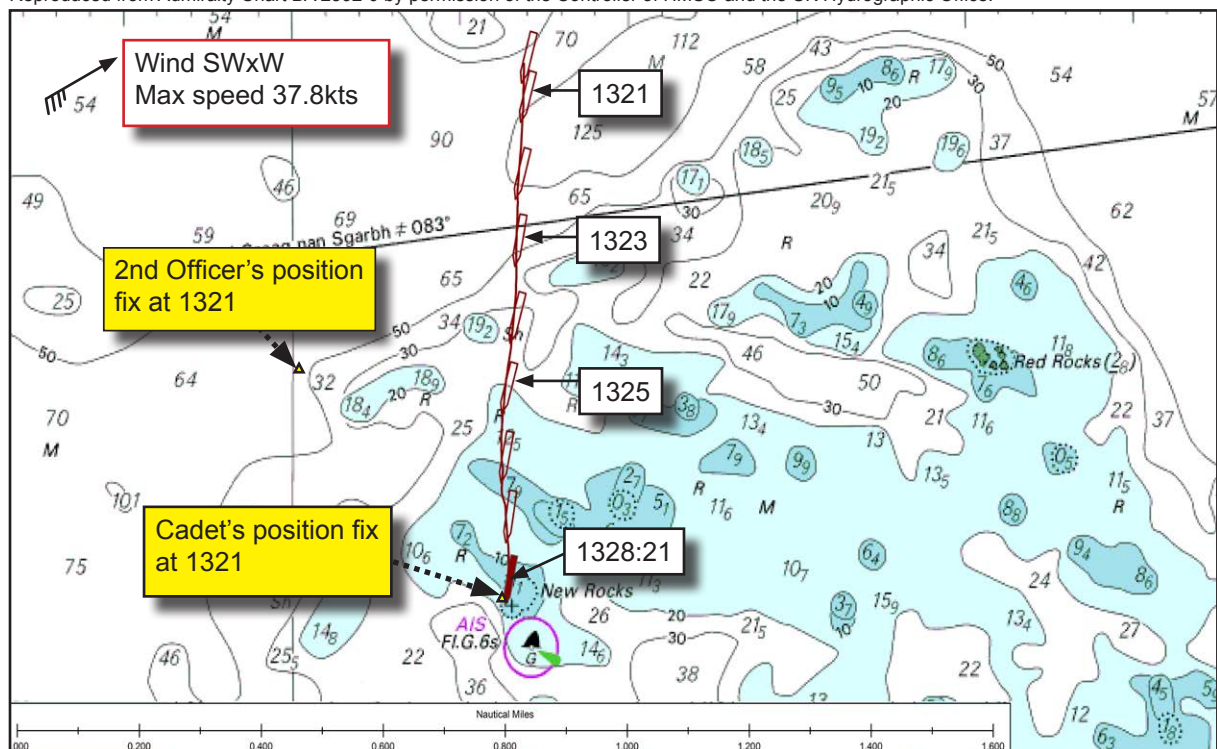
Figure 8: Extract of chart BA 2392 showing *Hamburg's* track and relative headings between 1321 and 1328

The expected CPAs between the three vessels and *Hamburg* remained very close at less than 0.2nm. The master was preoccupied with the traffic situation but he was also aware that *Hamburg* was approaching the New Rocks buoy. At 1328, the safety officer arrived on the bridge again and the master asked him to visually check the vessel's position off the New Rocks buoy. The safety officer went onto the port bridge wing to take a bearing of the buoy's position and, at 1328:21, as he returned to the bridge, *Hamburg's* port quarter grounded to the north-east of the New Rocks buoy with a SOG of 6.37kts.

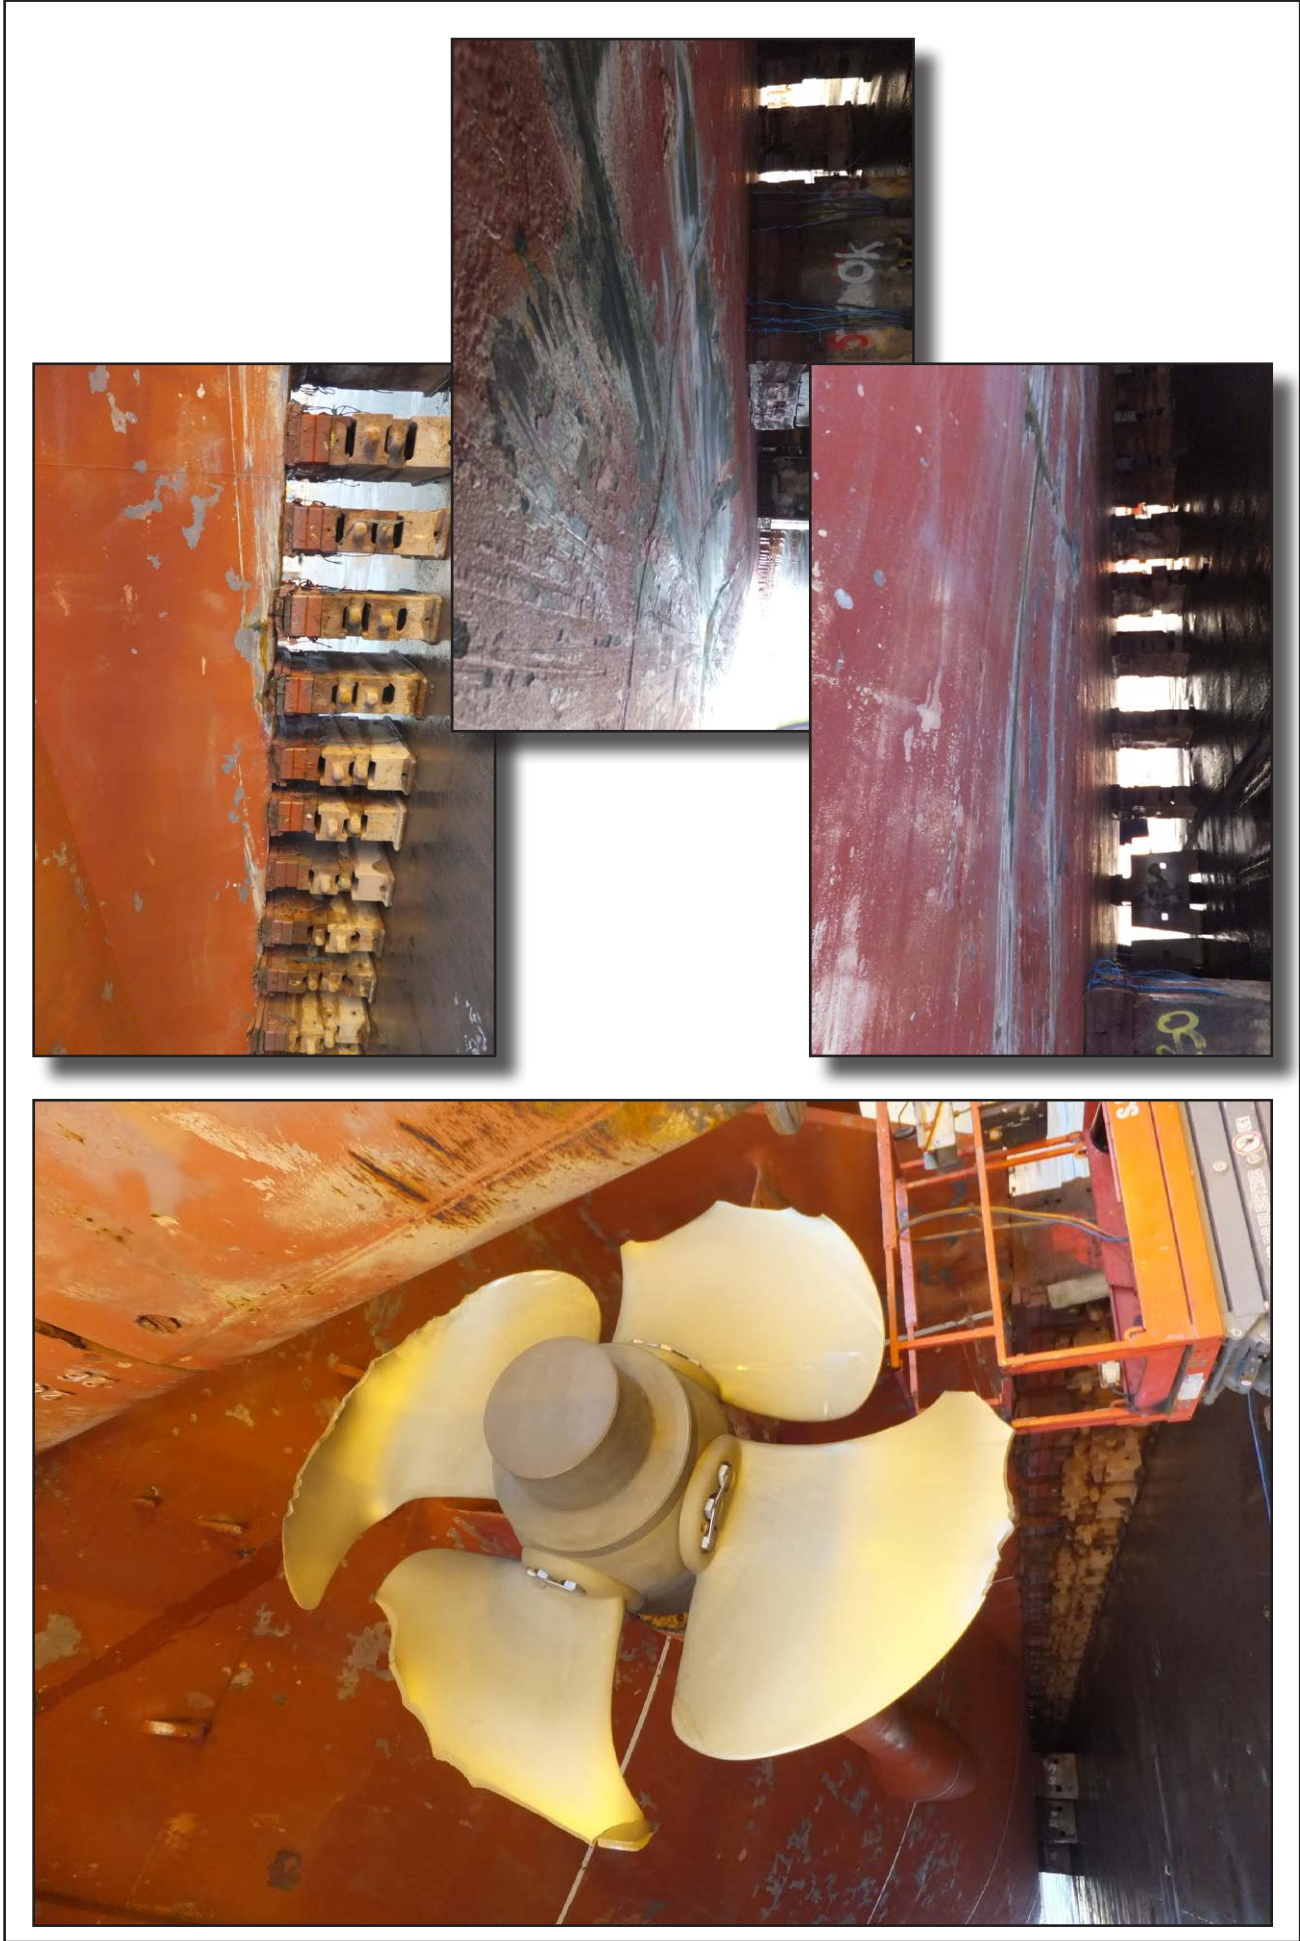
Figure 11: Photographs of hull and propeller damage

At 1824 on 12 May *Hamburg* arrived at Belfast and an underwater inspection was completed. This indicated that the damage attributed to the grounding appeared to be substantial but, due to the poor water visibility, the exact extent of damage could not be ascertained. The surveyor from the vessel's classification society, Det Norske Veritas Germanischer Lloyd (DNV GL), and representatives from V.Ships and HCSA agreed that the cruise ship needed to be dry docked in Belfast. Later that day, the cruise ship entered the dry dock, where significant damage to the port propeller, port propeller shaft, port propulsion auxiliary equipment, port rudder/rudder stock and hull were identified (**Figure 11**).

On 13 May, the DNV GL surveyor directed that *Hamburg* should remain in Belfast for temporary repairs. Consequently, the remainder of the cruise was cancelled and passengers were repatriated from the vessel that day. *Hamburg* remained in dry dock at Belfast until 30 May, when the cruise ship sailed under a single voyage safety certificate to Bremerhaven for permanent repairs. *Hamburg* returned to service on 10 August 2015.

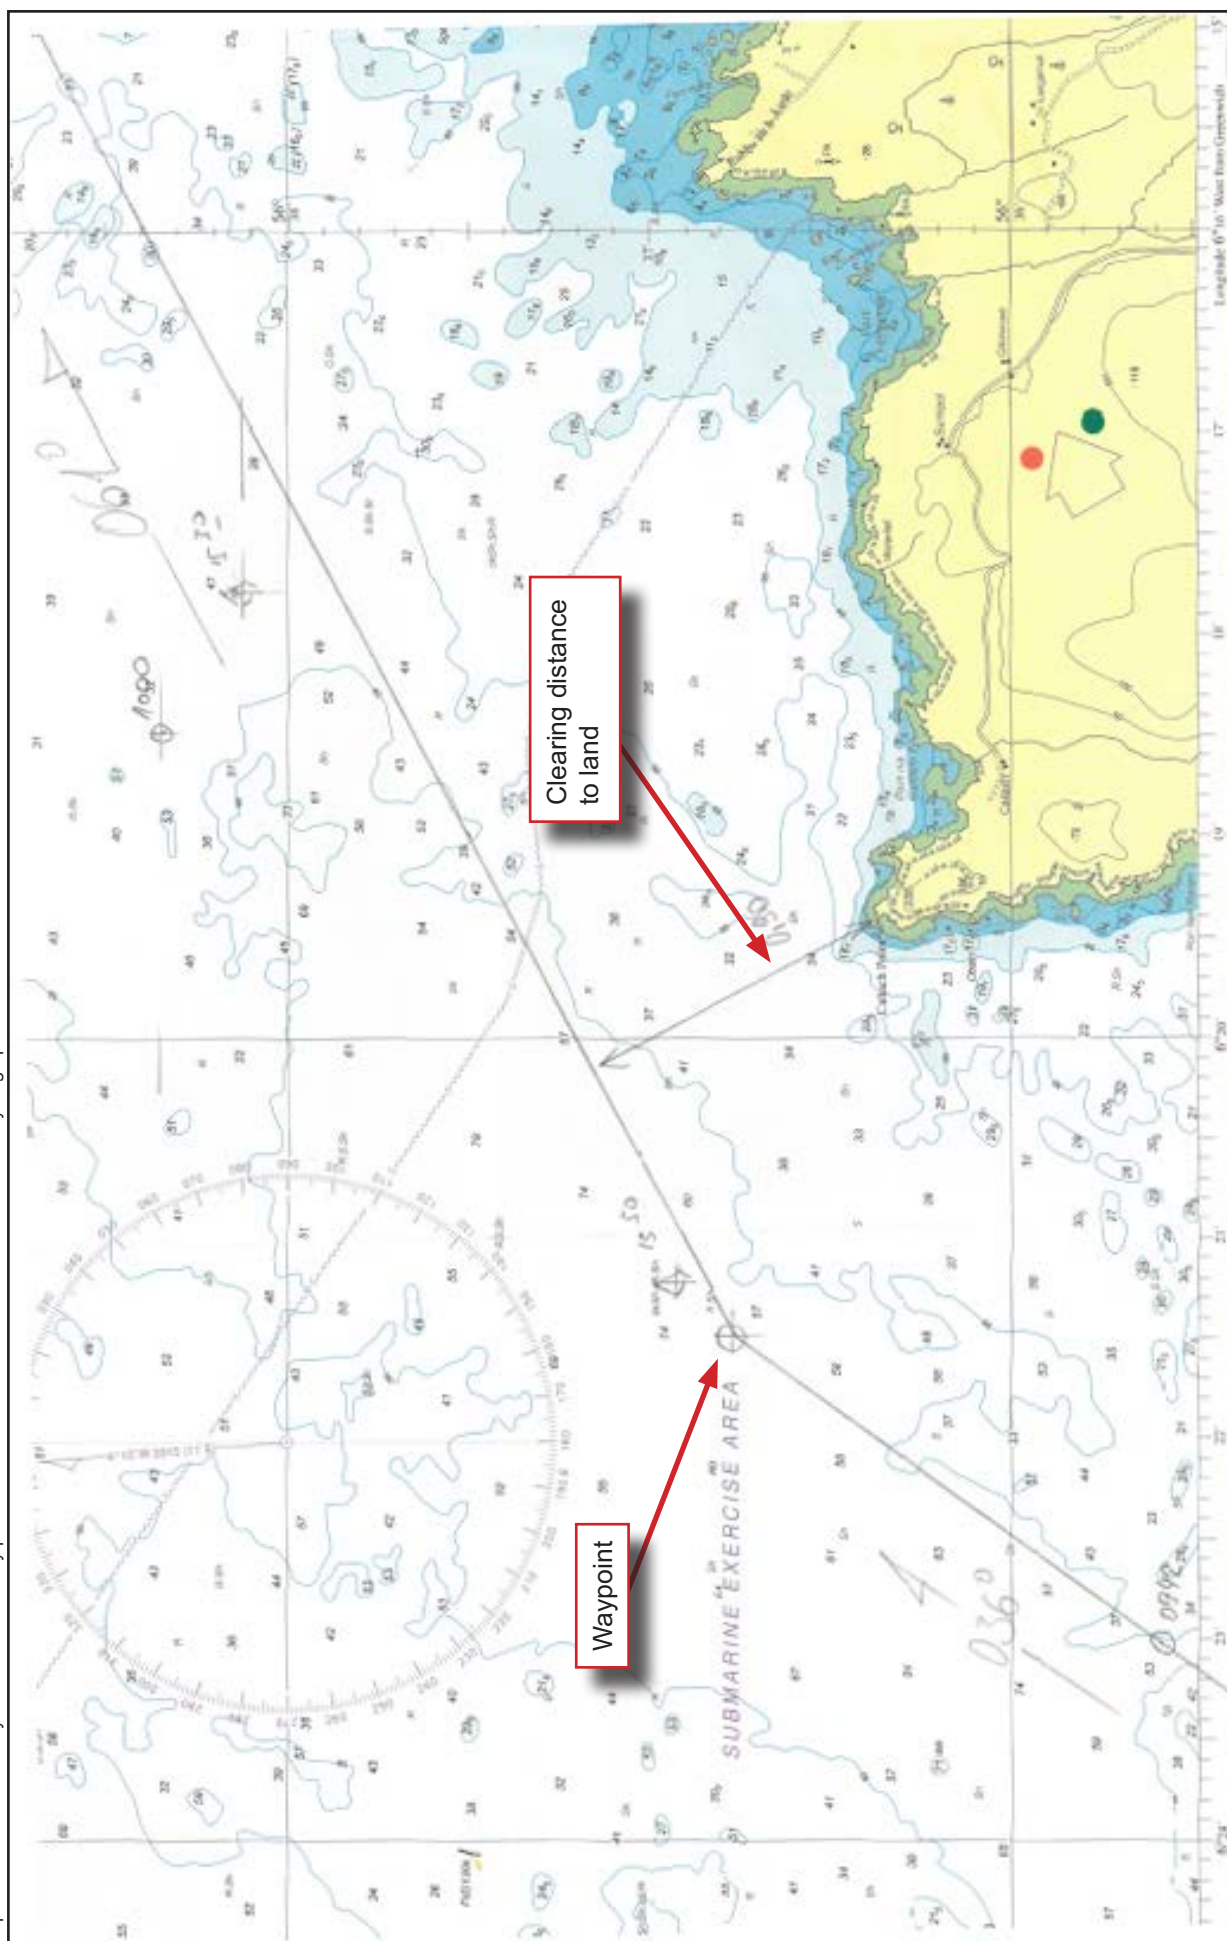
Figure 13: Extract of chart BA 2392 showing passage planning details

The charts used for the passage from Dublin to Tobermory were also examined. Navigational practices such as wheel-over positions, no-go areas, abort points, clearing lines and navigational warnings in place were not marked on the charts. It was also noted that positions were plotted infrequently at irregular times and denoted by a wide variety of symbols.

- None of the cross track margin, check lines and red and green condition boxes had been marked as checked.
- The minimum distance from land was stated to be '*As Per Captains Order.*' [sic]
- There were several notations directing the user to '*See Charts.*'

- Under keel clearance was stated as per the '*Exemptions marked on chart*' but there were no markings on the charts.
- Position fixing frequency was required to be '*1h in deep sea, 30 min in coastal approaches and 15 min in approaches*'.
- No primary or secondary position fixing method was identified for each stage of the passage as required by the SMS.
