MARINE ACCIDENT
INVESTIGATION BRANCH

SAFETY DIGEST

**Lessons from Marine
Accident Reports
2/2016**

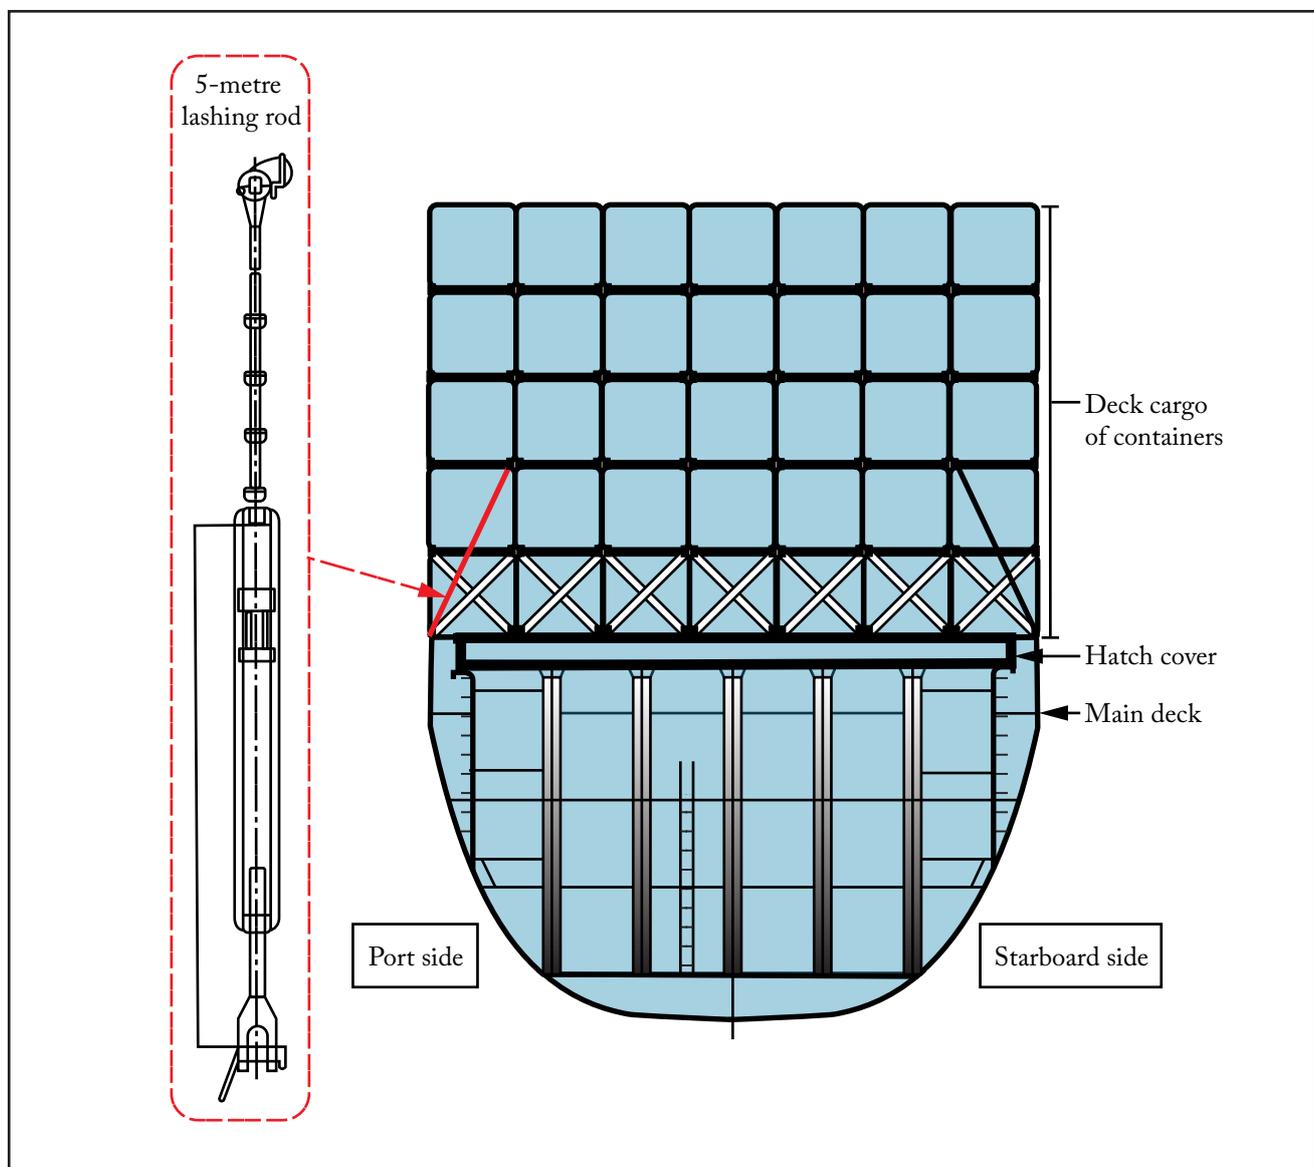
Figure: Diagram of ship viewed from aft to forward, indicating location of lashing rod

Precautions against falling should have included the assistance of another crewman in disconnecting the lashing rod, the wearing of a safety harness and lanyard, and appropriate supervision. Furthermore, in view of the risk of him falling into the water, the crewman should have worn a personal flotation device. Implementation of such measures could have been expected had a proper risk assessment been conducted for the task.

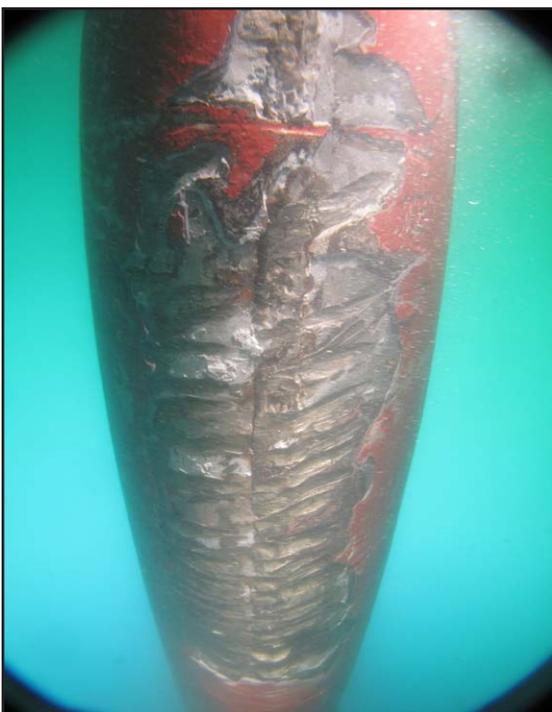
The ship sustained some minor damage to both of its rudders (Figure 1), a propeller tip (Figure 2) and the underside of its skeg. The seaward chain of the chain ferry parted (Figure 3) as a result of the accident, requiring the chain and its associated hydraulic motor to be replaced.

Figure 1: Damage to port rudder

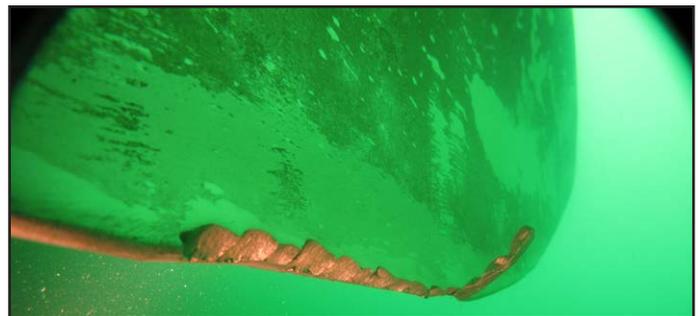
Figure 2: Damage to starboard propeller tip

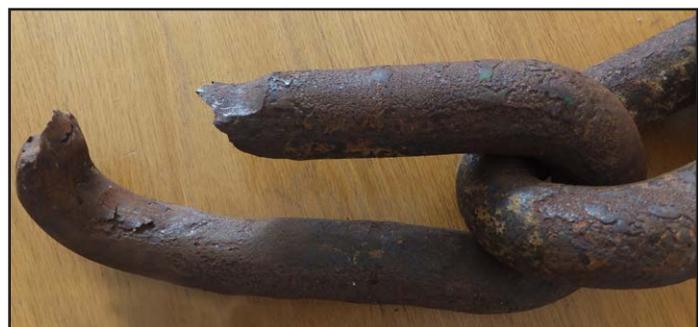
Figure 3: Parted seaward chain

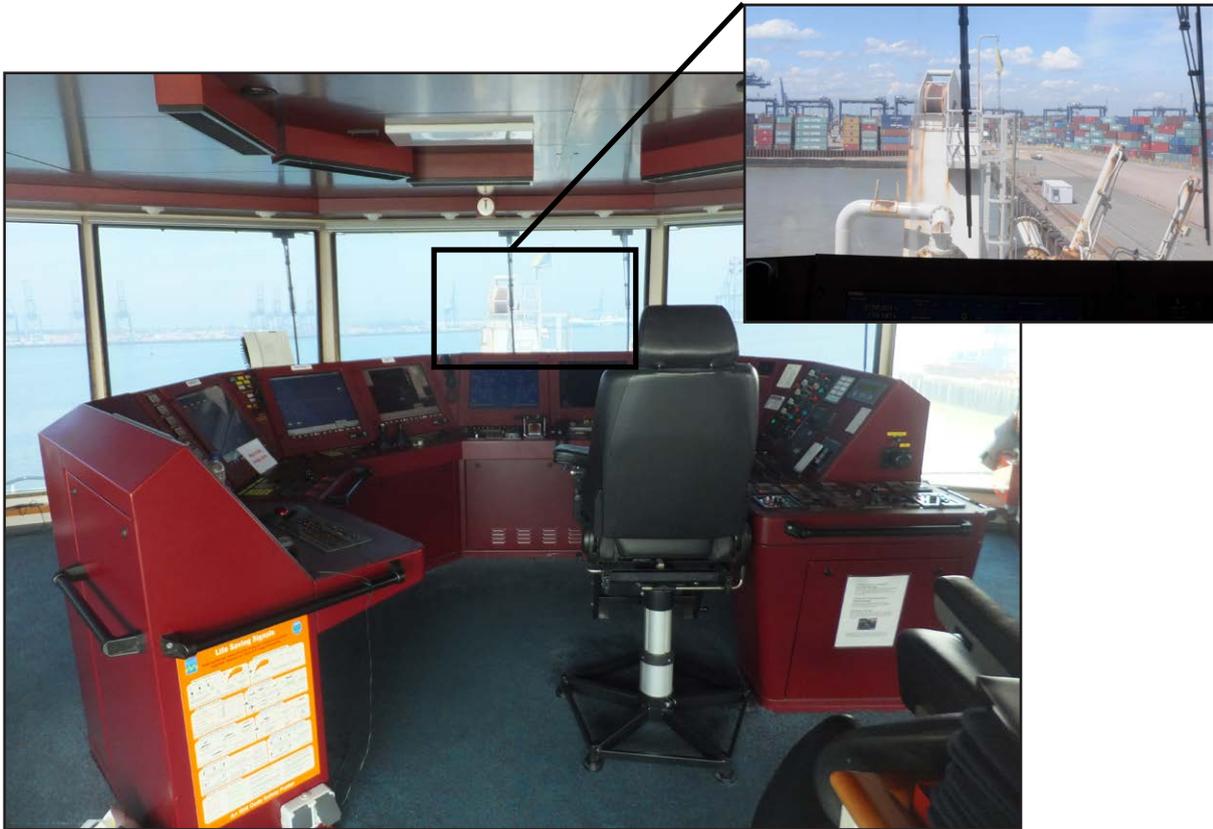
Figure 2: Bridge conning position (inset: obstruction)

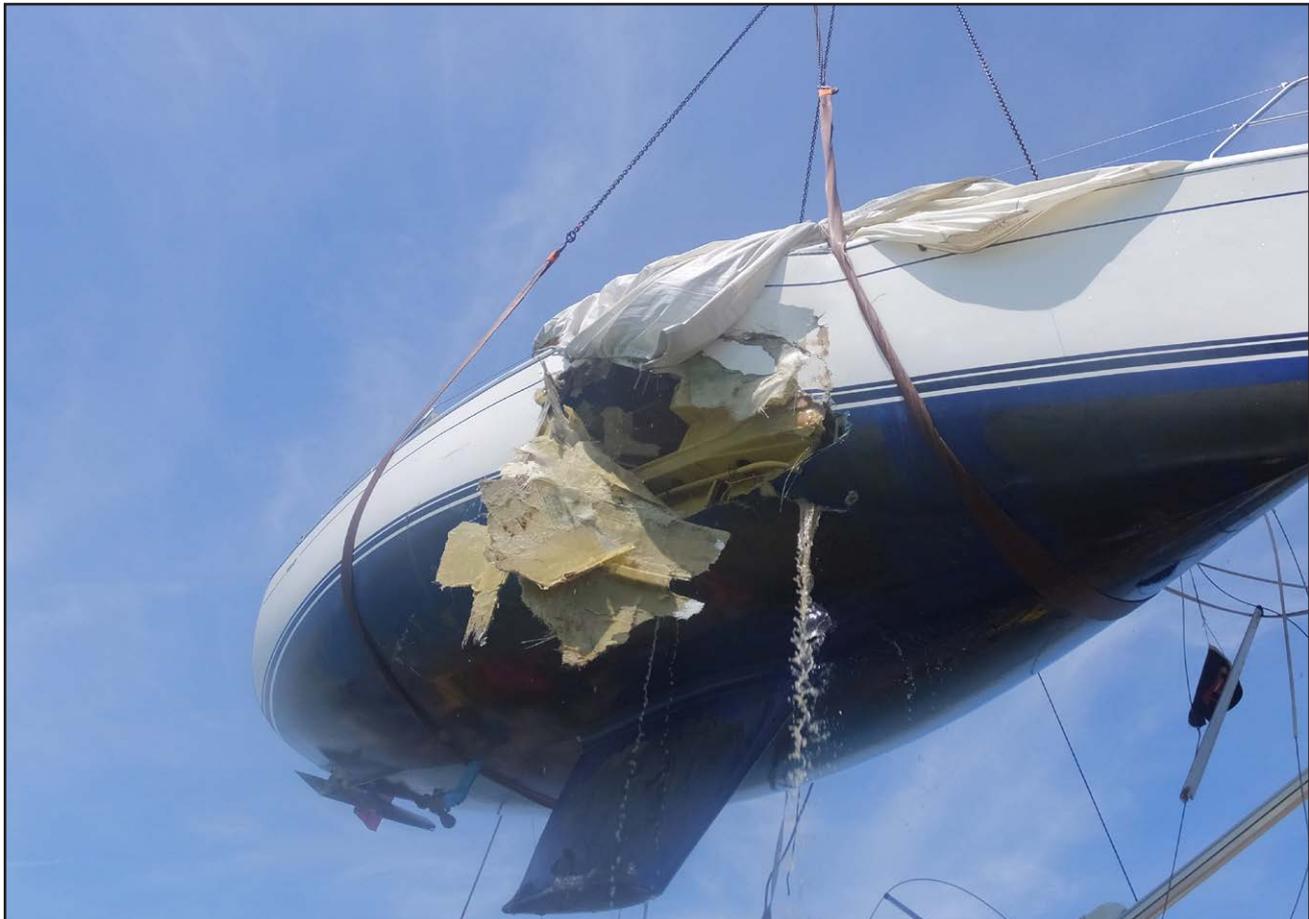
Figure 3: Damage to starboard side of yacht

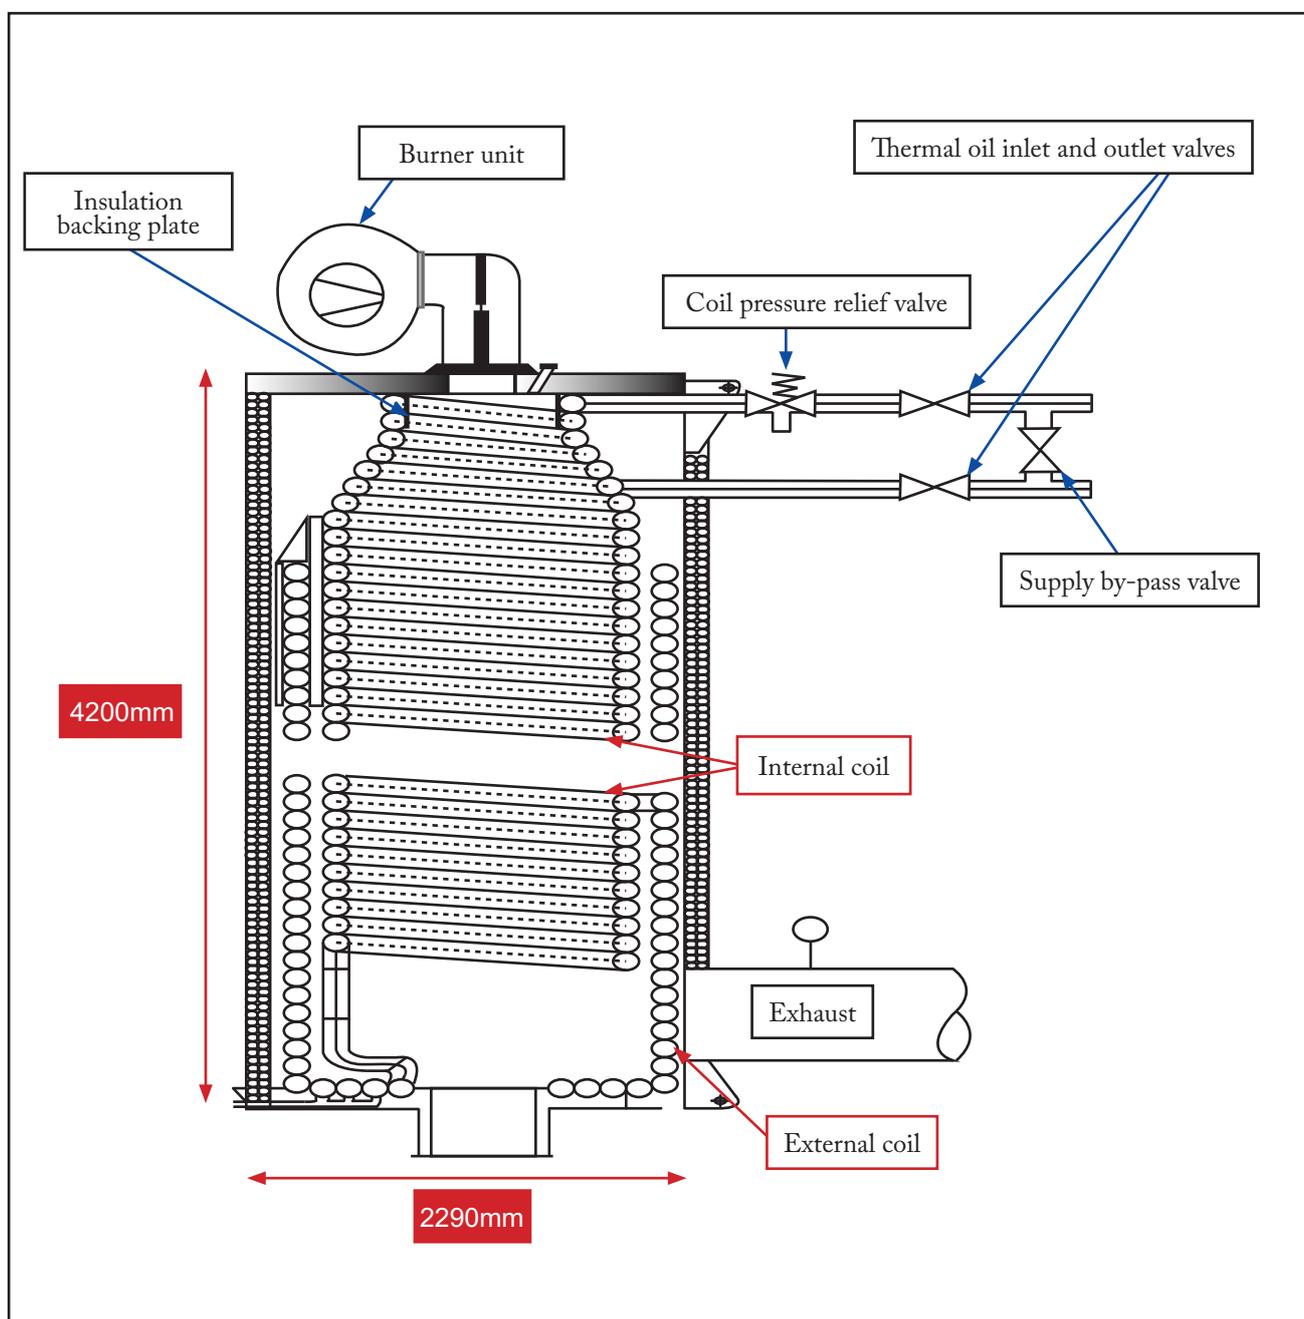
The boiler room ventilation was stopped from the bridge and fire-fighting teams were prepared. Meanwhile, the chief engineer gave instructions for the port thermal oil heater to be shut down, the burner fuel and air supplies to be isolated, the thermal oil supply by-pass valve to be opened, and the thermal oil heater coil inlet and outlet valves to be closed (Figure 1).

Figure 1: Diagram of the port thermal oil heater

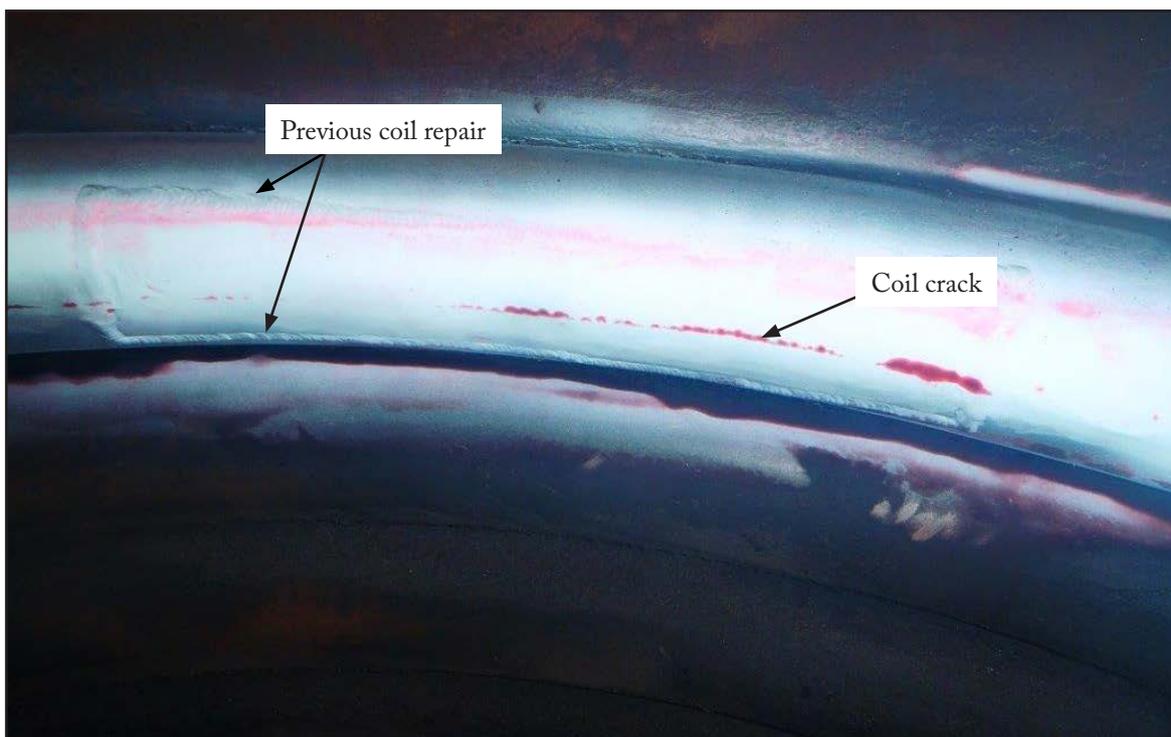
The chief engineer considered that the fire had probably been caused by a coil failure that had allowed thermal oil to pass into the furnace. He advised the master accordingly, who informed the port authority and requested that the local fire and rescue service meet the ship on arrival.

Figure 2: Port thermal oil heater coil fracture

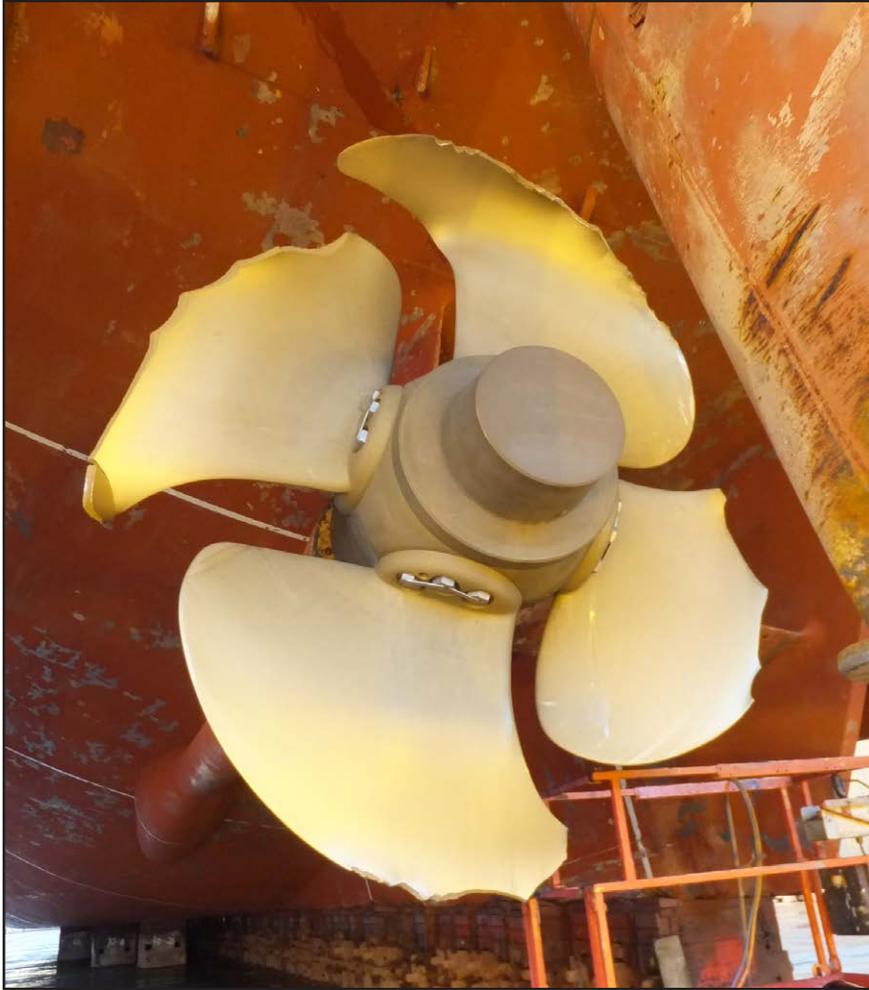
Although the master and bridge team were immediately aware of the grounding and that they had lost use of the port propeller, no crew muster was sounded. Despite the unknown extent of the damage to the ship, the master decided to continue into the confined bay.

Figure 1: The damaged port propeller

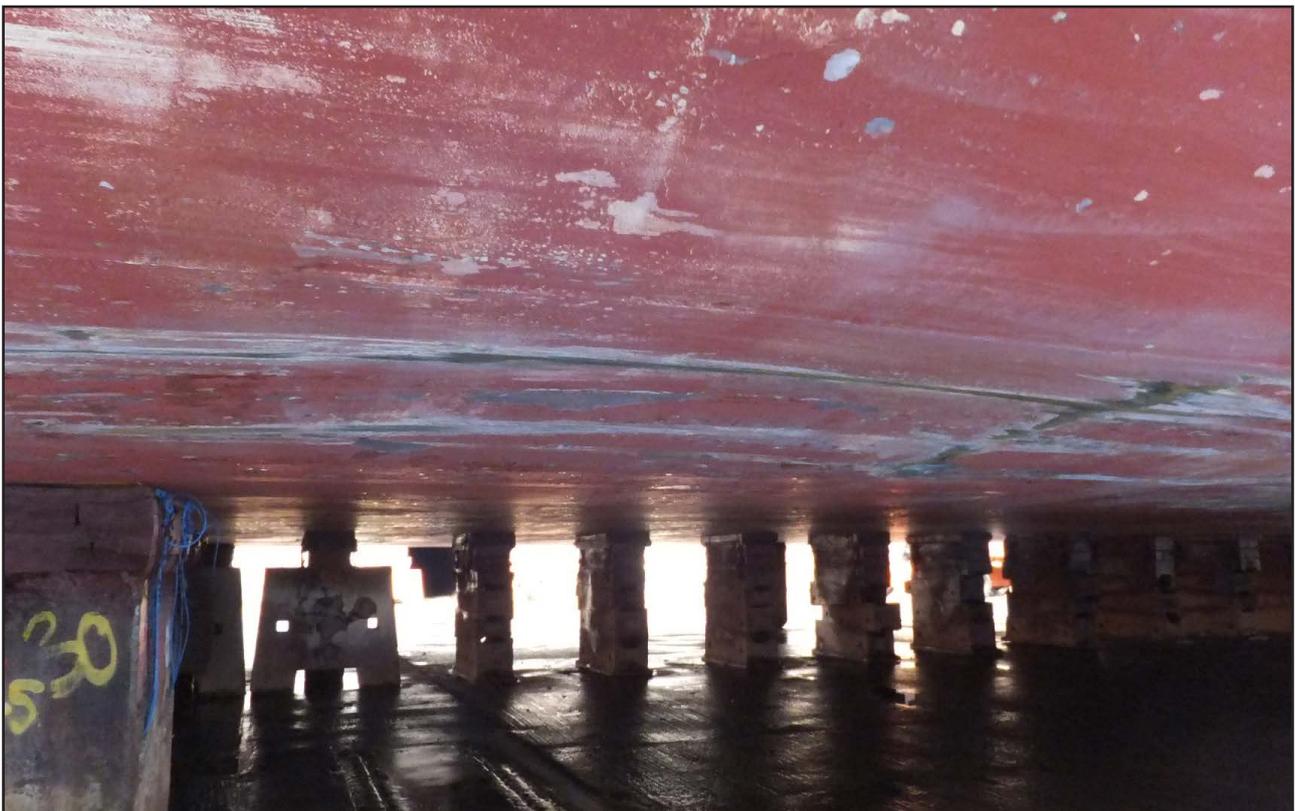
Figure 2: Hull damage

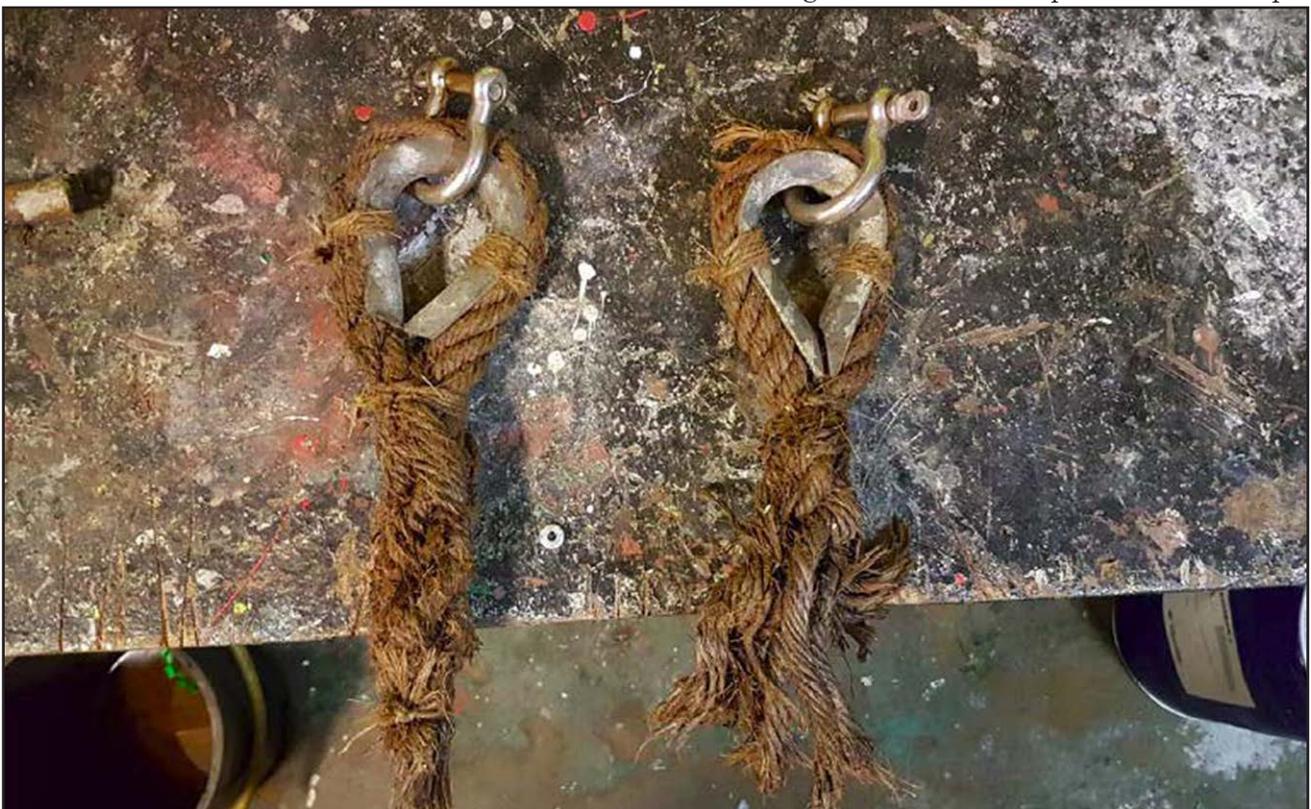
Figure 1: Remnants of pilot ladder side ropes

The pilot ladder was 18 months old and was permanently connected by shackles to the deck within a small pilot boarding well. When the remnants of side ropes (Figure 1) were inspected after the accident, the ladder was found to have failed at the point the side ropes passed over the lip of the pilot door frame, and the core of the manila rope was found to have suffered severe degradation. The port pilot ladder was not used as often as the starboard ladder and, unlike the starboard pilot station, the ropes had not been protected from the door frame's sharp edges (Figure 2).

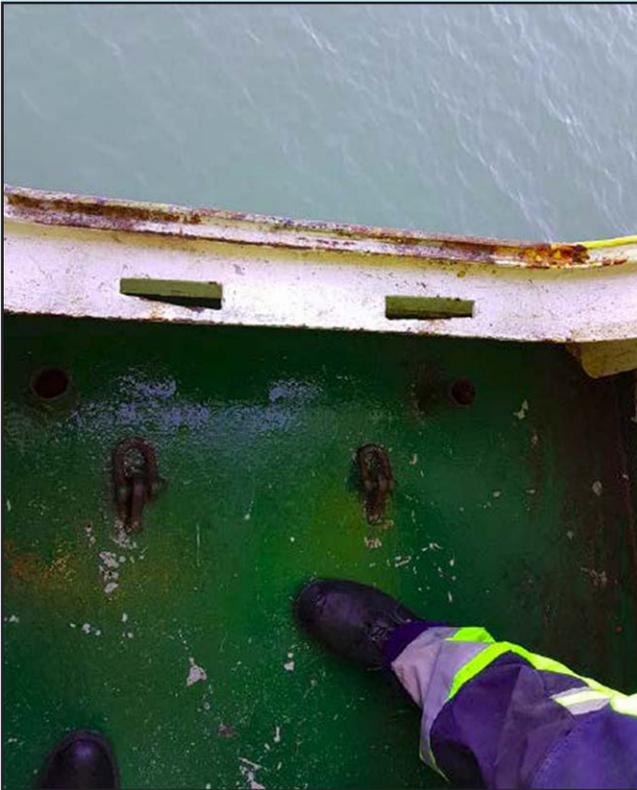
Figure 2: Pilot door frame

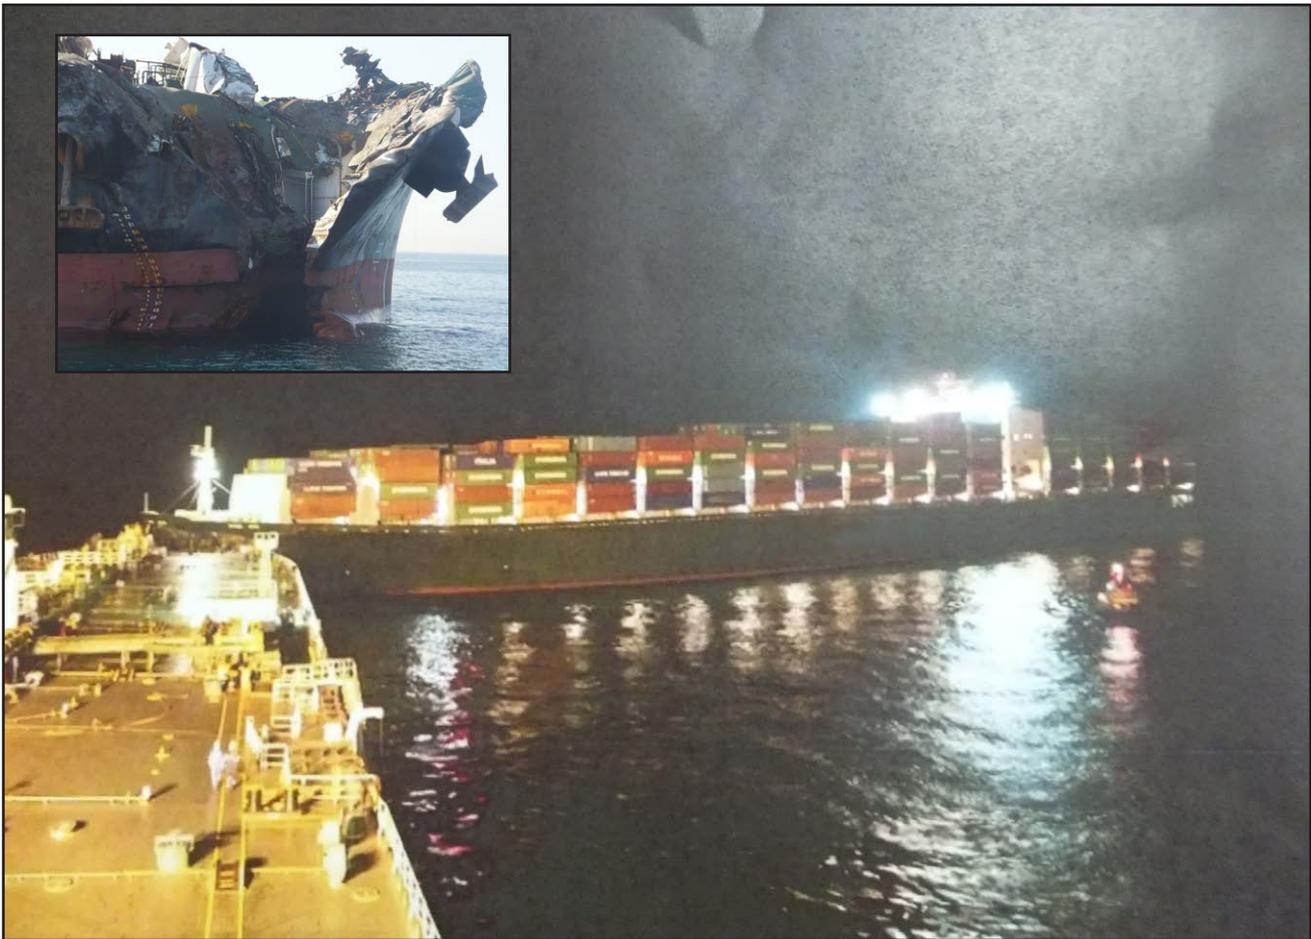
Figure 3: The moment of impact (inset: damage to the tanker)

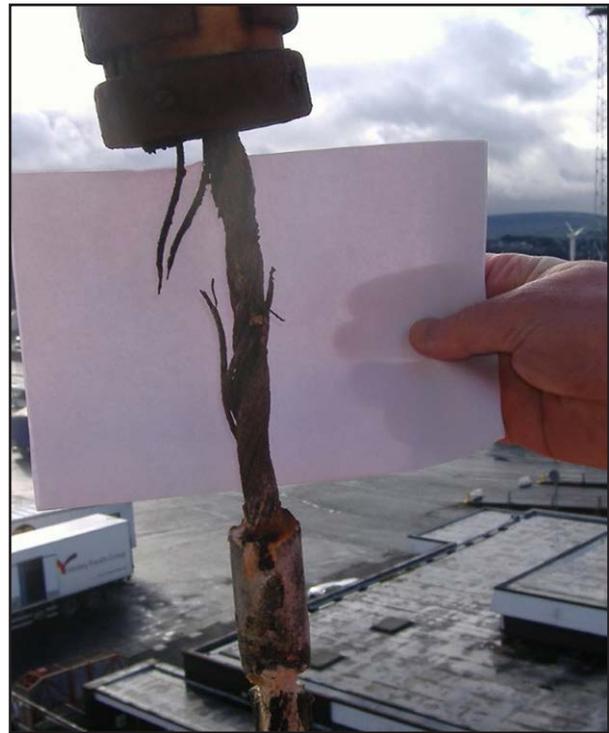
An inspection of the fall wire identified a 15cm section of corrosion at its bottom end. Also, three wire strands had parted (see figure), tearing a thin, black plastic tape that had covered the corroded section. Similar black plastic tape was found wrapped around the bottom 15cm of the port FRC's fall wire. When the tape around the port wire was removed, the wire was discoloured but there was no corrosion.

The black tape had probably been on the fall wires since their installation and would have been difficult to see under the black grease. It is evident that, over time, moisture and salt had slowly penetrated under the tape on the starboard fall wire, which caused the wire to corrode, degrade and eventually fail. The discolouration of the port wire indicated a lack of lubrication.

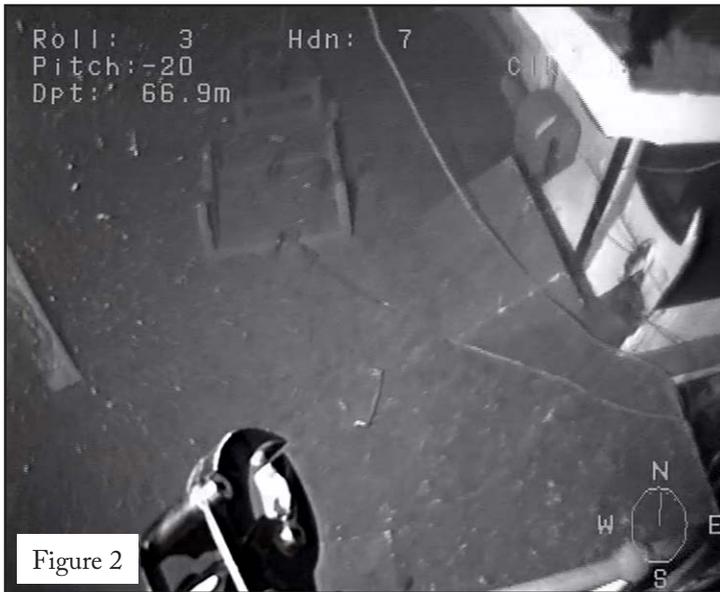
The survey also found that the hydrostatic releases on both liferaft canisters had activated correctly, but their painters led into the shelter deck (Figure 2). It was concluded that once released from their cradles, the liferaft canisters had been pulled, by in-rushing water, into the vessel's shelter deck area during the capsizing, from where they were unable to float free.

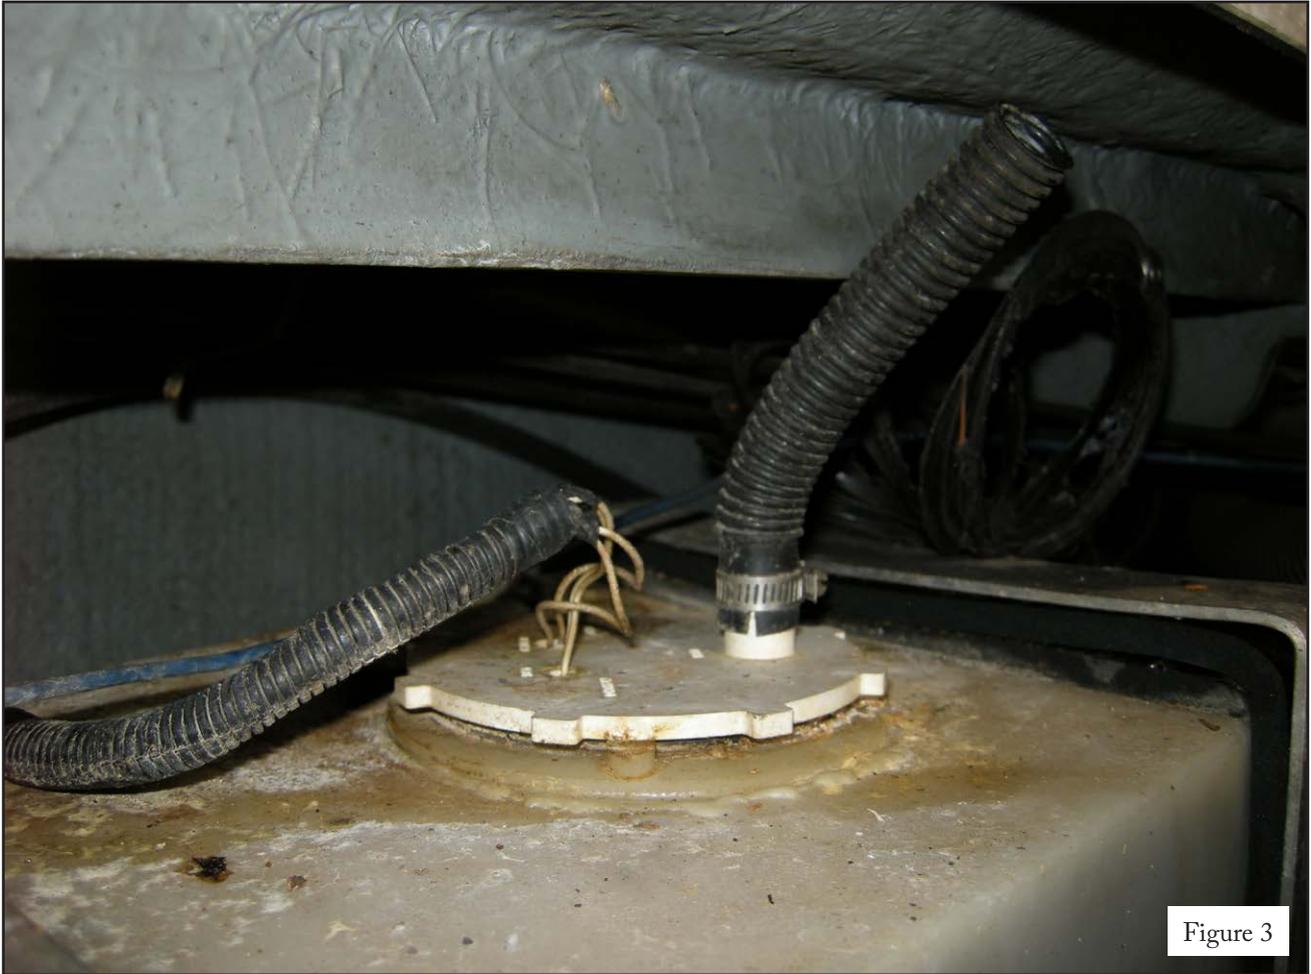
Figure 3

The explosion was probably caused by petrol vapour from the waste tank that vented directly in to the engine bay (Figure 3) instead of outside of the boat. The vapour was sucked into the engines' air intakes, causing the engines to stall. The vapour was then ignited by the activation of the electrical starter system when the driver tried to restart the engines.

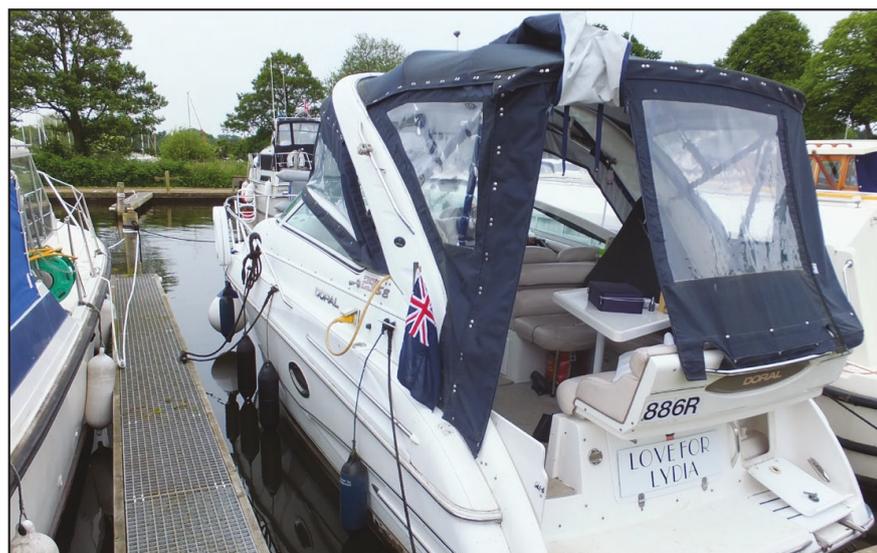
Figure 1: Boat alongside a marina following the accident (canopy as found)

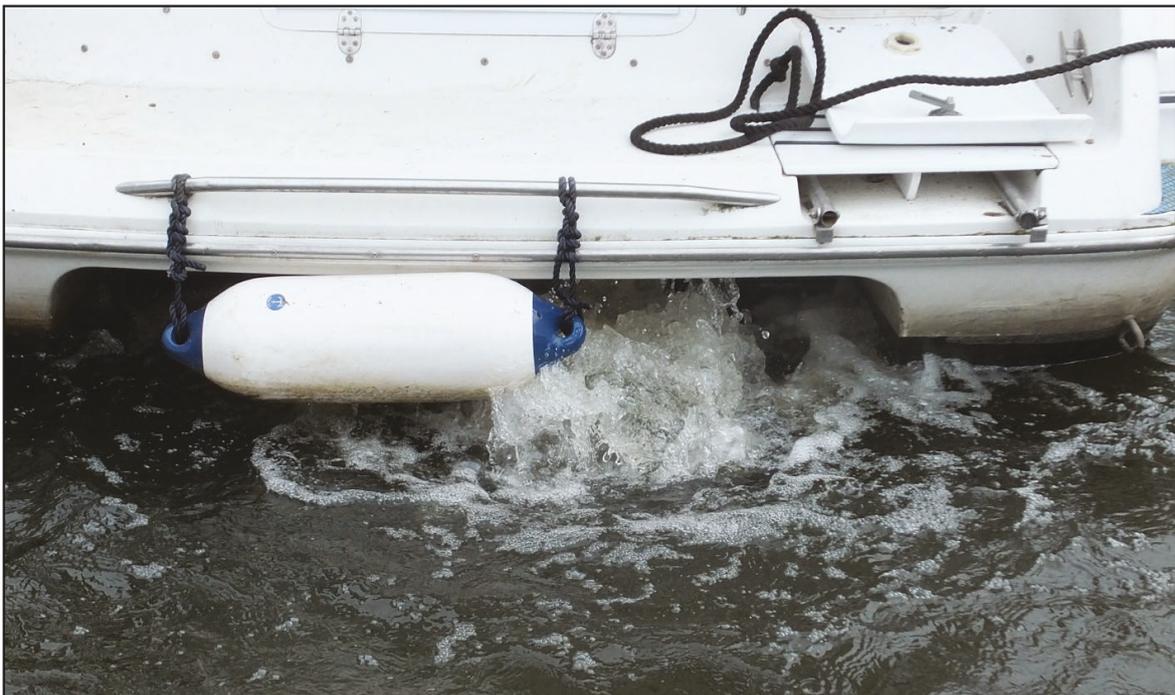
The motor cruiser's 5.7 litre petrol-driven inboard engine had been left running at 3000rpm while it was moored alongside, probably to charge the batteries. A slight wind blowing from the stern caused exhaust gas emitting from below the aft transom to enter the canopy covering the aft deck (**Figure 1**) from where it spread down into the accommodation area forward. During in-situ tests with the engine running the concentration of carbon monoxide from the wet exhaust (**Figure 2**), reached high levels in the accommodation in less than 3 minutes. The accommodation area was not ventilated and the couple and their dog were overcome. No carbon monoxide alarms were fitted.

Figure 2: Wet exhaust at boat's stern
