Final report MO-2013-203: DEV *Aratere*, fracture of starboard propeller shaft,
resulting in loss of starboard propeller, Cook Strait, 5 November 2013

Marine inquiry MO-2013-203
DEV *Aratere*,
fracture of starboard propeller shaft
resulting in loss of starboard propeller,
Cook Strait,
5 November 2013

Approved for publication: November 2016

Transport Accident Investigation Commission

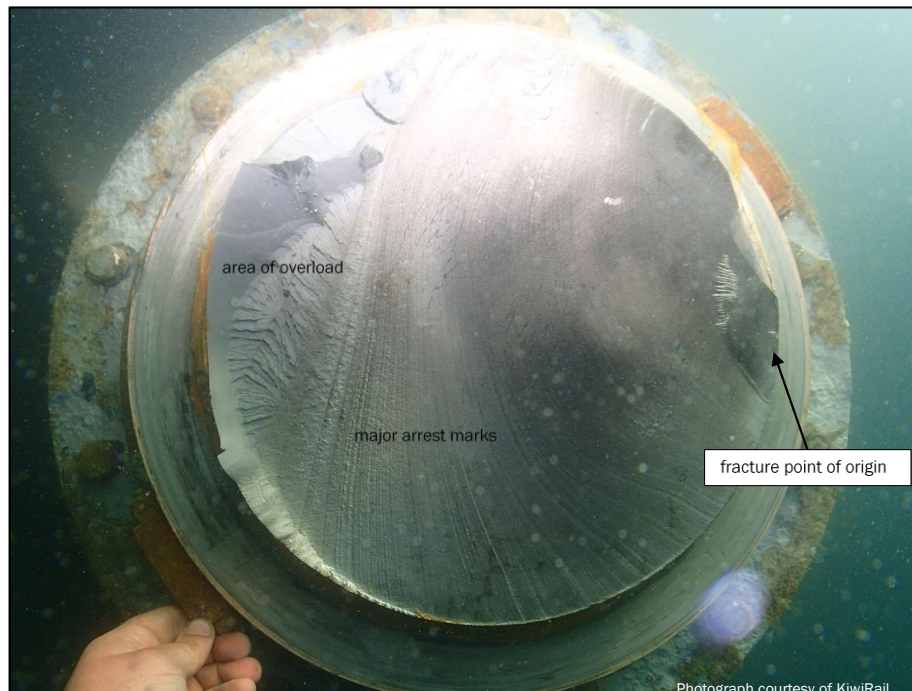
Figure 7
Underwater photograph of the shaft fracture face in the Aratere

- 5.1.3. The Commission determined that the fracture was a fatigue fracture typical of that resulting from bending forces being applied. Figure 7 demonstrates that the fracture seen on the *Aratere*'s starboard propeller shaft had all the hallmarks of a bending fatigue failure, with readily identifiable fracture origin and progression/arrest marks, and an instantaneous/overload fracture zone.

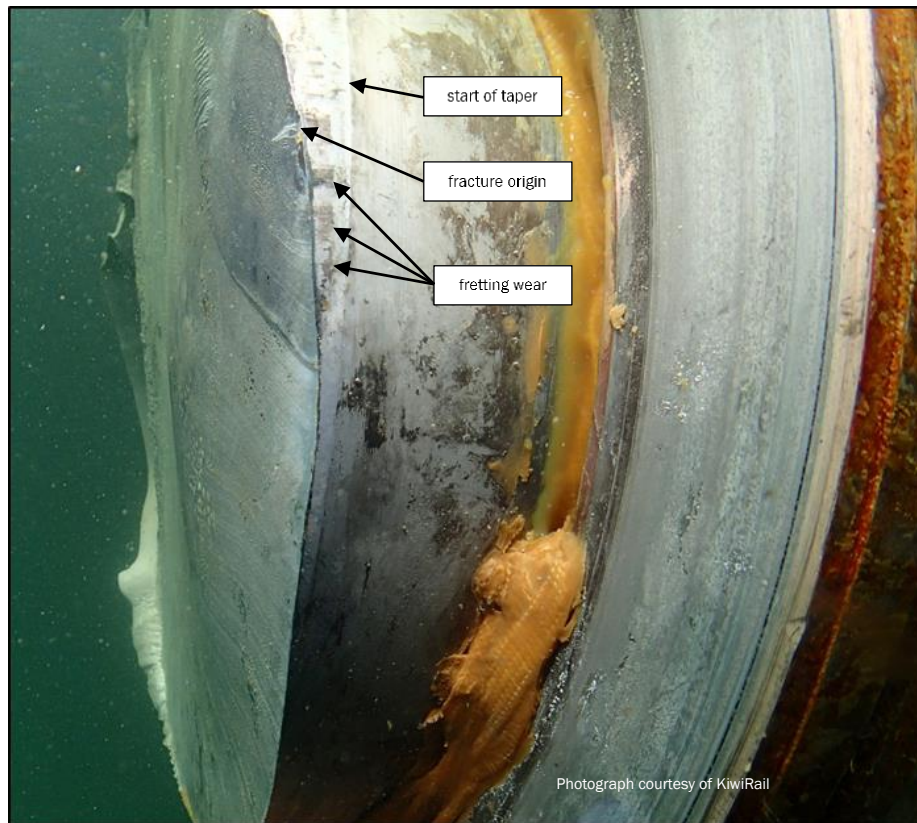
5.2.2. If bending is sufficient to cause fatigue failure of the propeller shaft, the fracture would occur at the point of highest bending load on the shaft. That point is at the edge of the last bearing at the end of the stern-tube. On the *Aratere*, however, the fracture occurred approximately 14 mm inside the tapered fit of the propeller hub, the fracture began at a point between the roots of blades C and D, which corresponded with the trailing edge of blade C. In other words, the failure of the propeller shaft inside the hub could not have been the result of bending forces alone. Some other factors must have been present to cause the fatigue fracture to occur (see Figure 8).

Figure 8
Origin region showing surface wear/fretting and the start of the taper

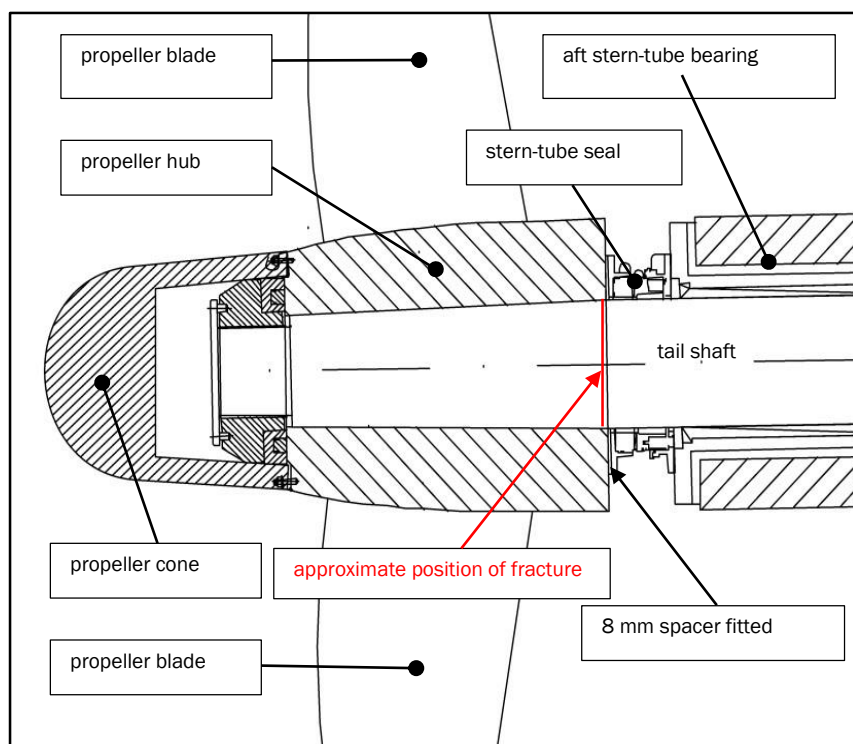
- 7.2.14. When the propeller was fitted onto the tail shaft in dry-dock it should have pushed right up to the end of the taper, where the propeller hub would mate with a mechanical seal on the end of the stern-tube. However, it fell about 8 mm short. Instead of adjusting the bore of the propeller hub, the propeller was withdrawn and an 8 mm spacer was inserted to achieve the required mating between the propeller hub and the mechanical seal (see Figure 9).

Figure 9
Location of the 8 mm spacer

- 7.2.15. It is not clear whether the 8 mm spacer was required as a result of an overall error in the size of the taper in the propeller hub, or because of high spots and imperfections in the bore created during the propeller manufacturing process. Given that only a 40% interference fit was achieved on the first attempt to mate the propeller hub with the tail shaft, the latter was more likely to have been the case. If this was the case, a substantial amount of 'linishing'²⁵ would have been required to achieve the minimum 70% interference fit. Interviews with KiwiRail staff who were assisting with the fitting procedure revealed that this process of blueing, fitting, removing and linishing of the propeller bore was repeated several times in an attempt to get the required interference fit.

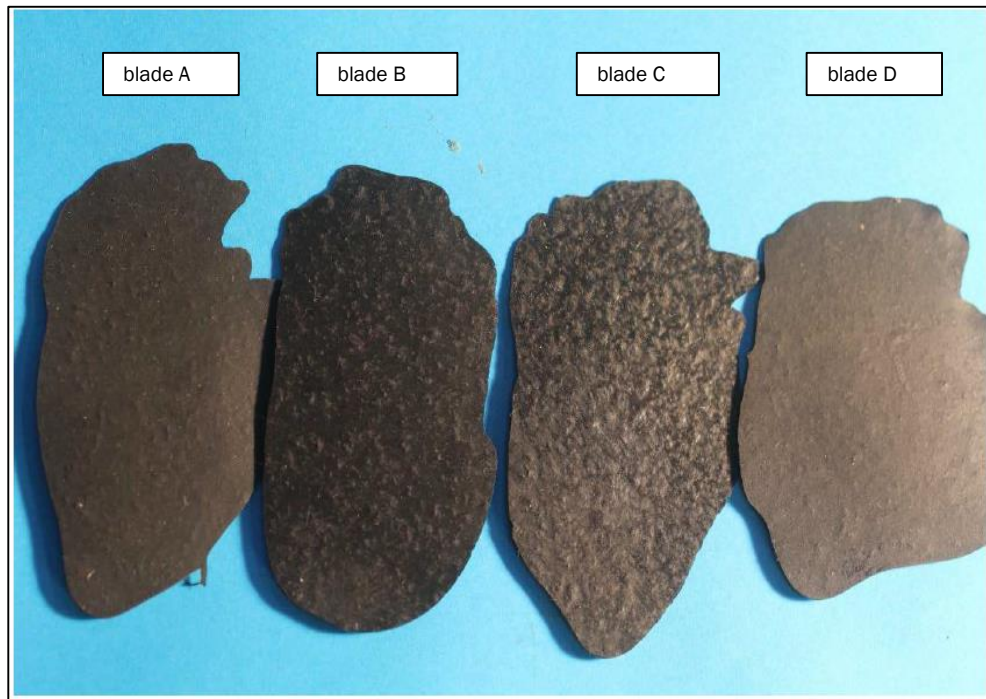
Figure 10
Surface replicas of the cavitation erosion on the blades of the starboard propeller

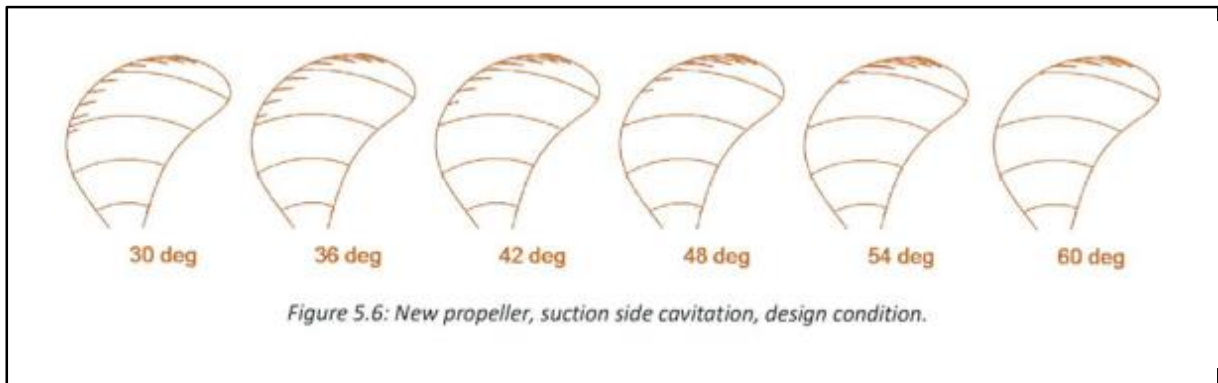
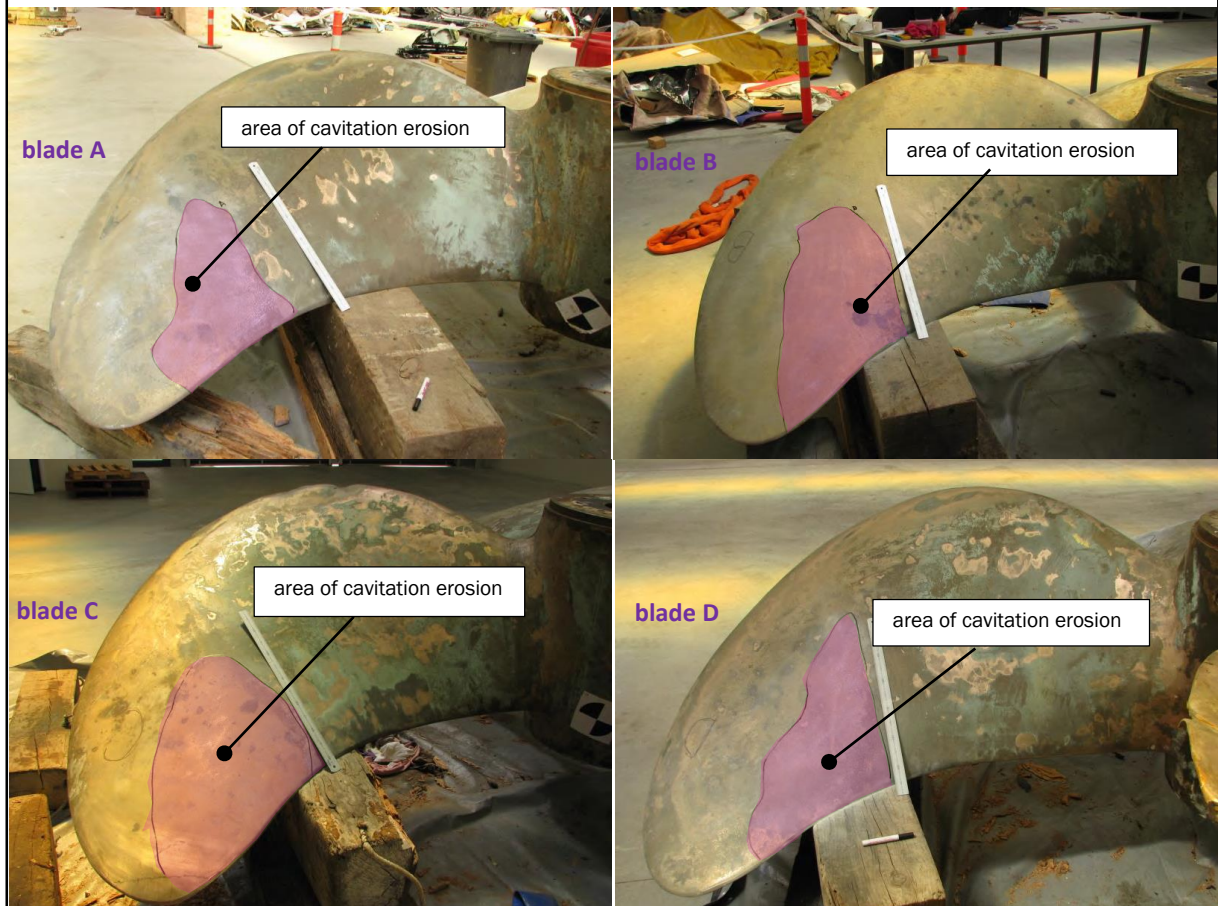
Figure 11
Designed cavitation diagram (top) and observed cavitation erosion on the suction side of the blades of the starboard propeller

- 9.3.6. The areas of cavitation erosion generally coincided with the areas of difference between the as-designed and the recovered propeller, including the damage sustained between 2012 and 2013 (see Figure 11). The variation in the patina strongly suggested that, at some stage, the flow pattern around blade C had been significantly different from the flow pattern around the other blades. If a resonant flutter had occurred in blade C as a result, this could have caused vibration stress in the shaft and explained the location of the fatigue crack's origin.³⁸

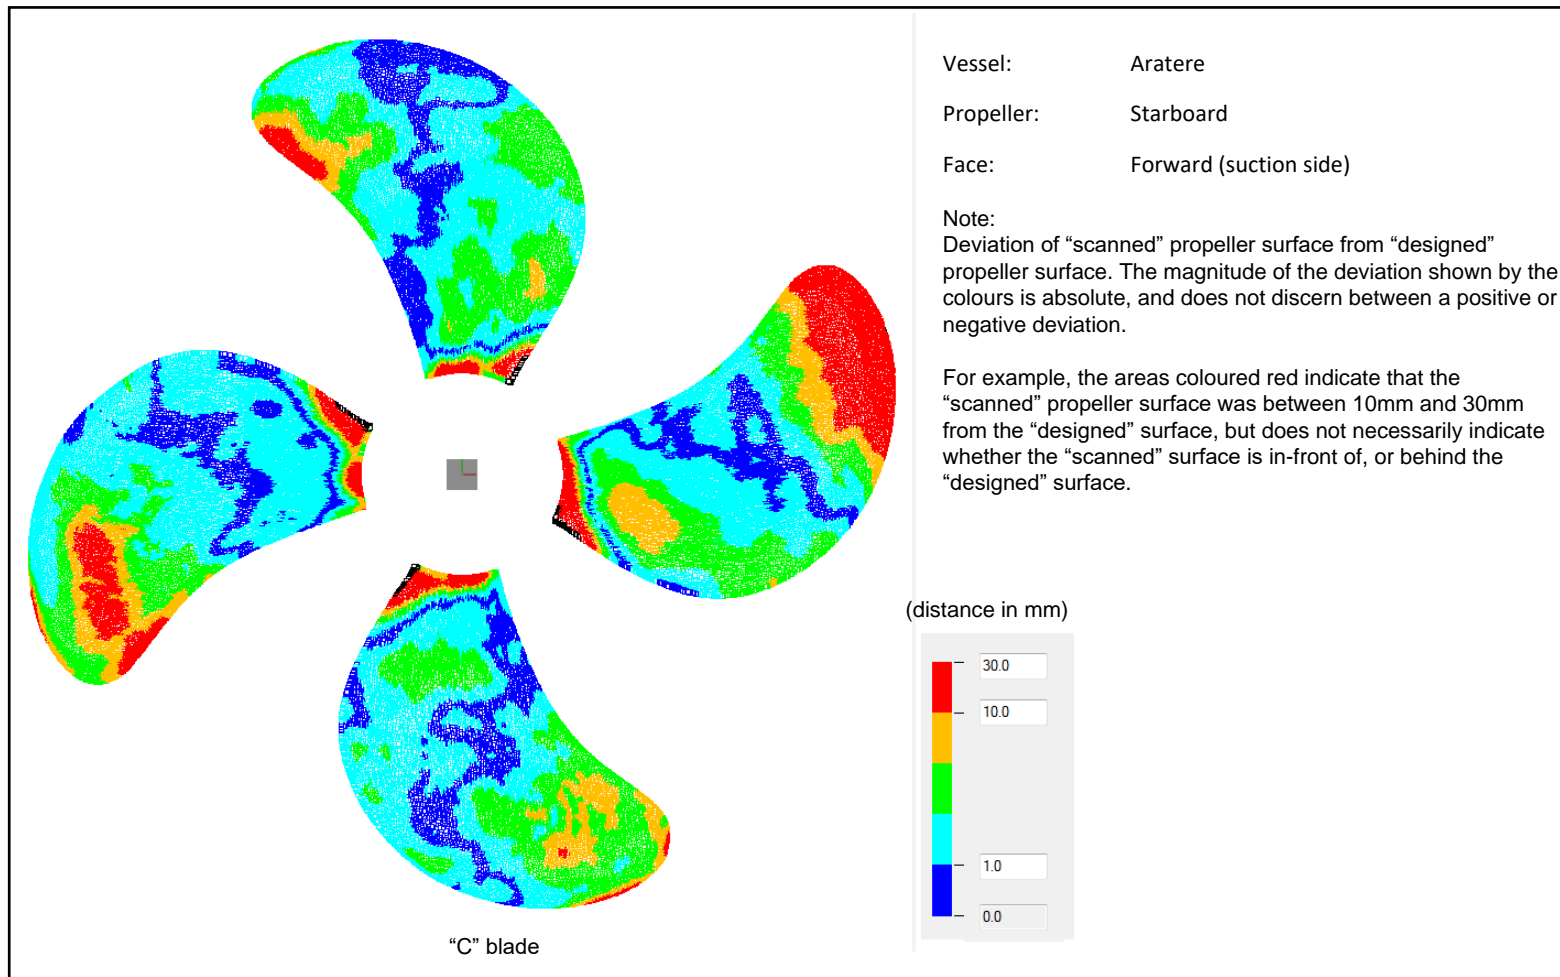
Figure 12
Comparison between the as-designed propeller and the recovered starboard propeller

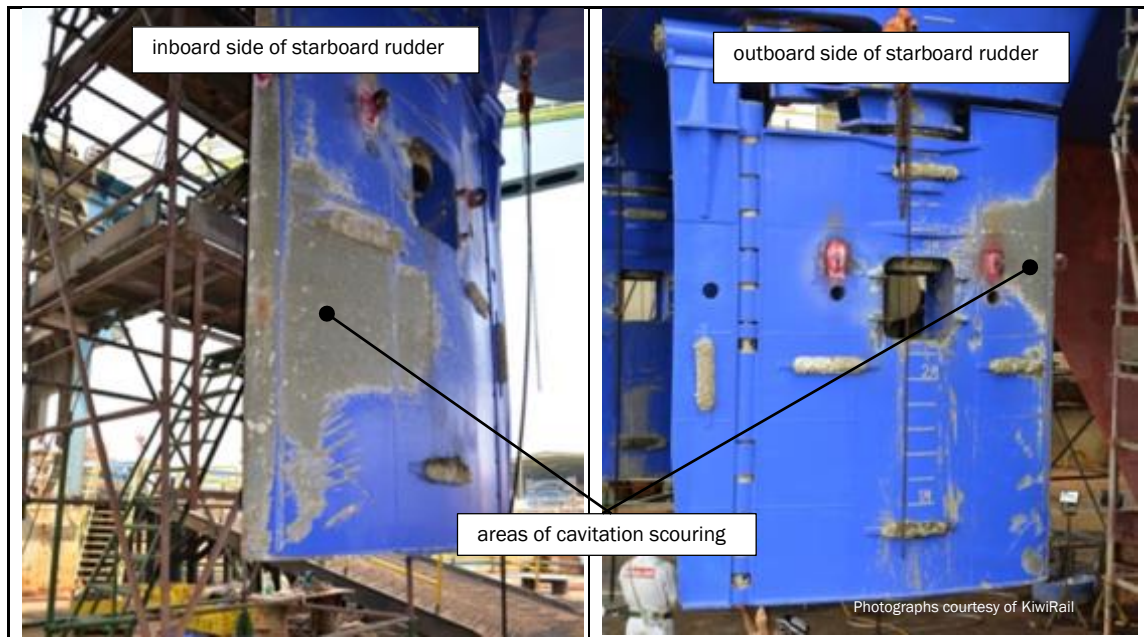
- 9.4.1. When the *Aratere* dry-docked in Singapore it was found that the paint had scoured from the surface of the rudder in two distinct areas (see Figure 13 and Figure 14). This scouring was characteristic of the effects of cavitation from the propeller.
- 9.4.2. The Commission reviewed the recordings from DNV's in-water surveys carried out between the fitting of the 'new' propellers and the incident. Cavitation scouring of the paint on the starboard rudder was evident in both recordings, which further suggested that the starboard propeller had been cavitating from the time it had been fitted.
- 9.4.3. Cavitation scouring was also present on the port rudder but not to the extent seen on the starboard rudder.

Figure 13
Cavitation scouring on starboard rudder

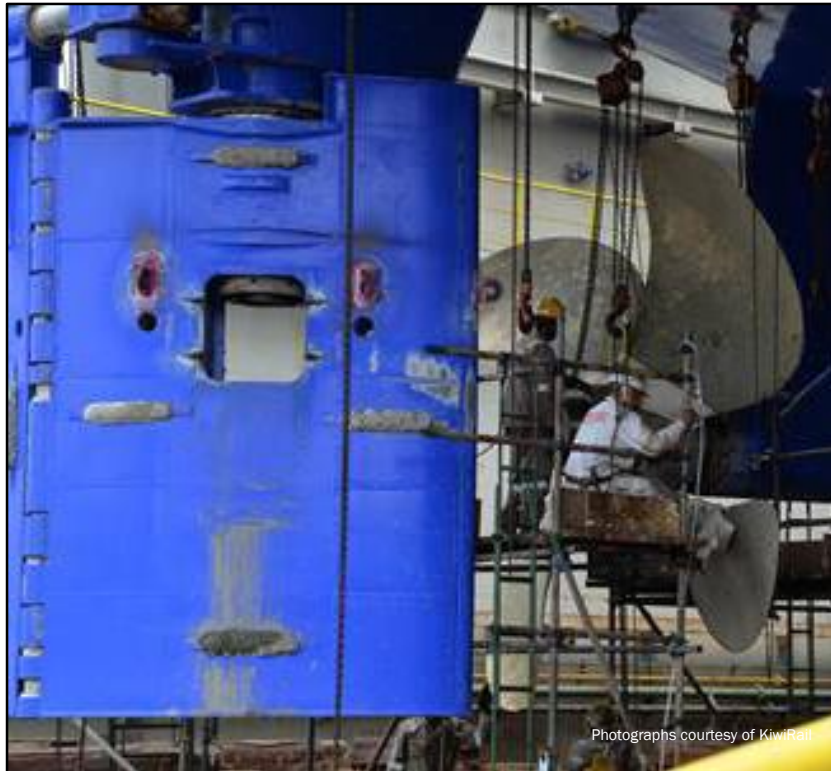
Figure 14

Inboard side of the port rudder showing significantly less loss of paint than on the starboard rudder

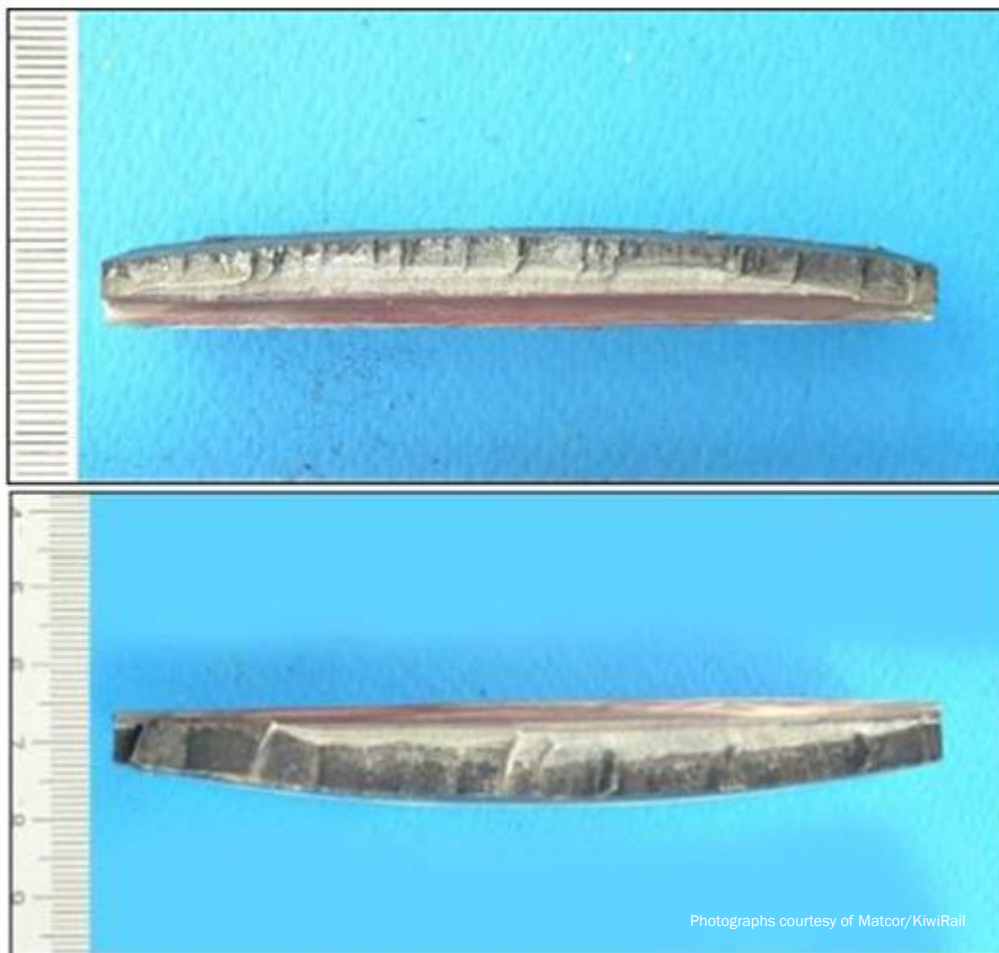
- 11.1.2. While the *Aratere* was in dry-dock after the incident, the port and starboard rudders were removed so the tail shafts could be removed and refitted. When the tail shafts had been reinstated and the rudders were about to be refitted to the rudder stocks, a crack was observed on the starboard rudder stock (see Figure 15). Further investigation found the rudder stock was cracked horizontally on both the outboard and inboard faces. An examination of the port rudder stock showed it was also cracked, but to a lesser extent.
- 11.1.3. KiwiRail had to replace the starboard rudder stock because the cracks were of a depth that could not be repaired. KiwiRail decided to replace the port rudder stock also, even though it could have been repaired.

Figure 15
Fracture surfaces found on the starboard rudder stock

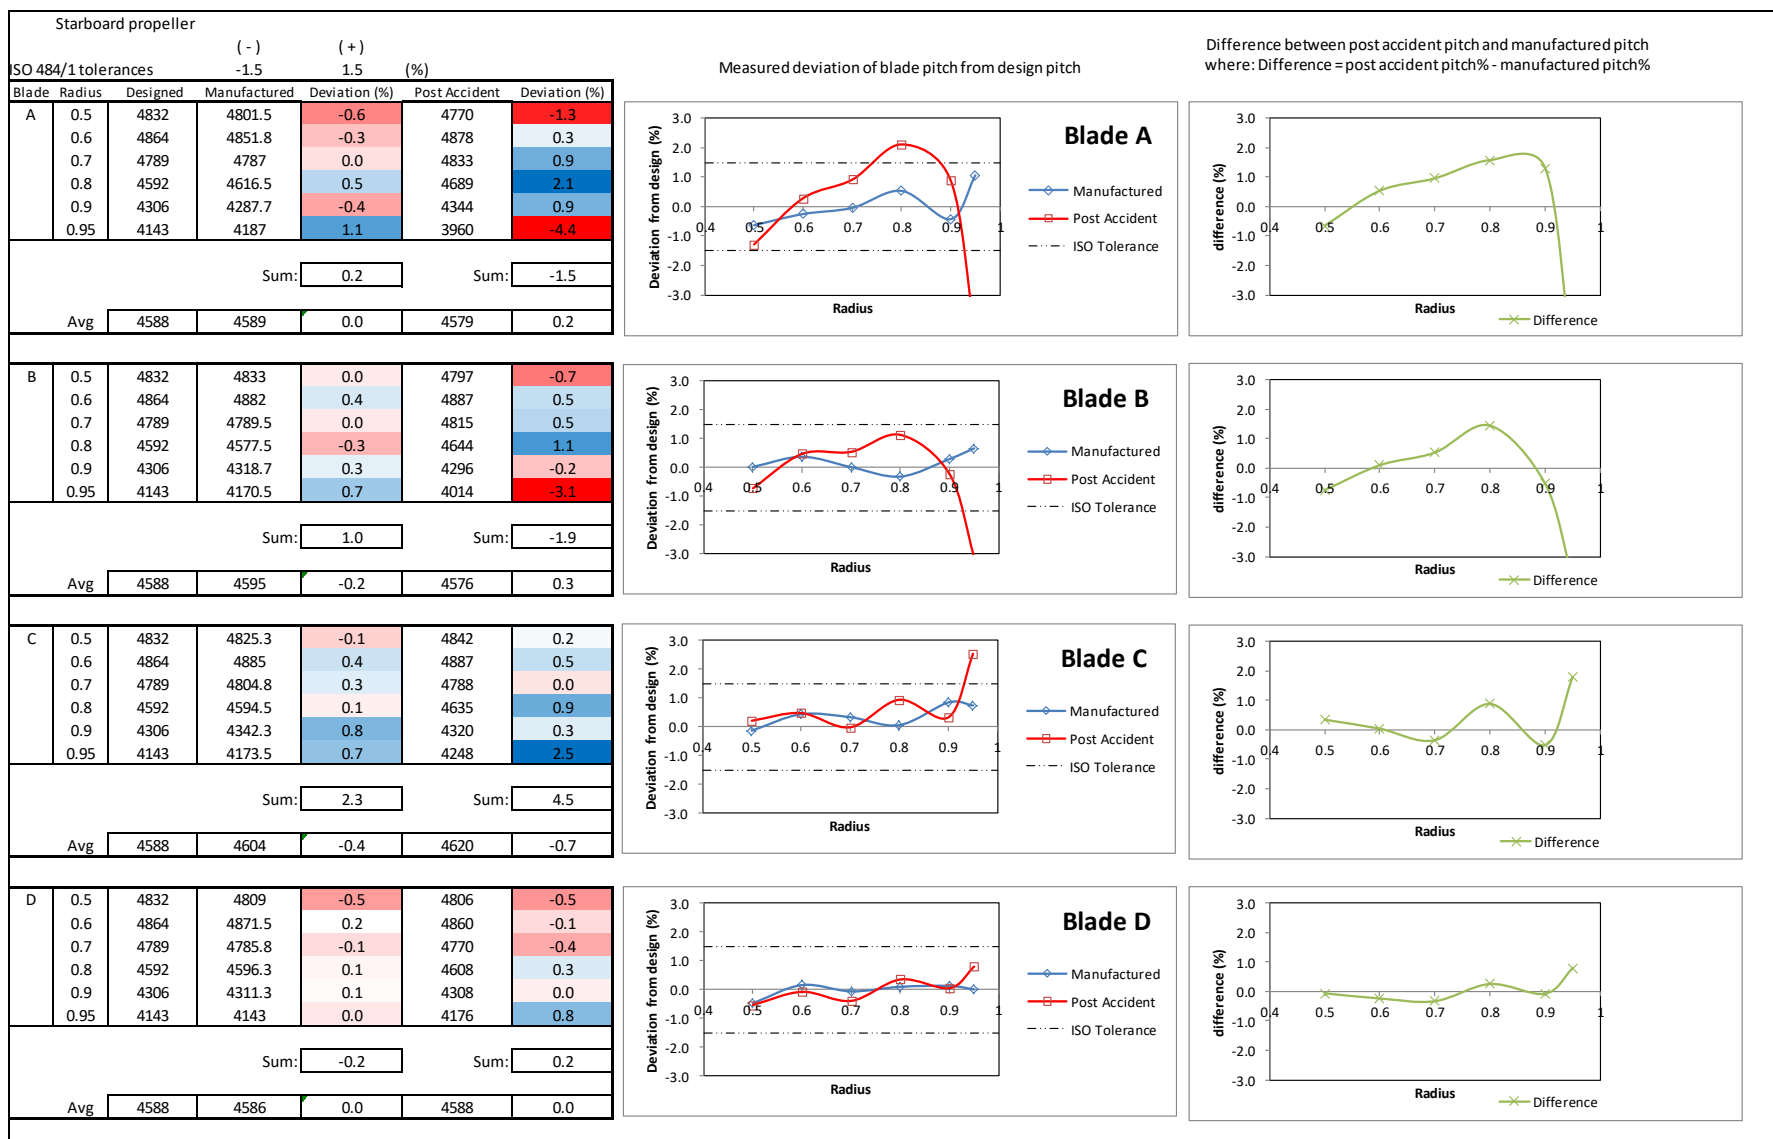
Comparison of manufactured pitch against post-accident pitch – starboard propeller blades

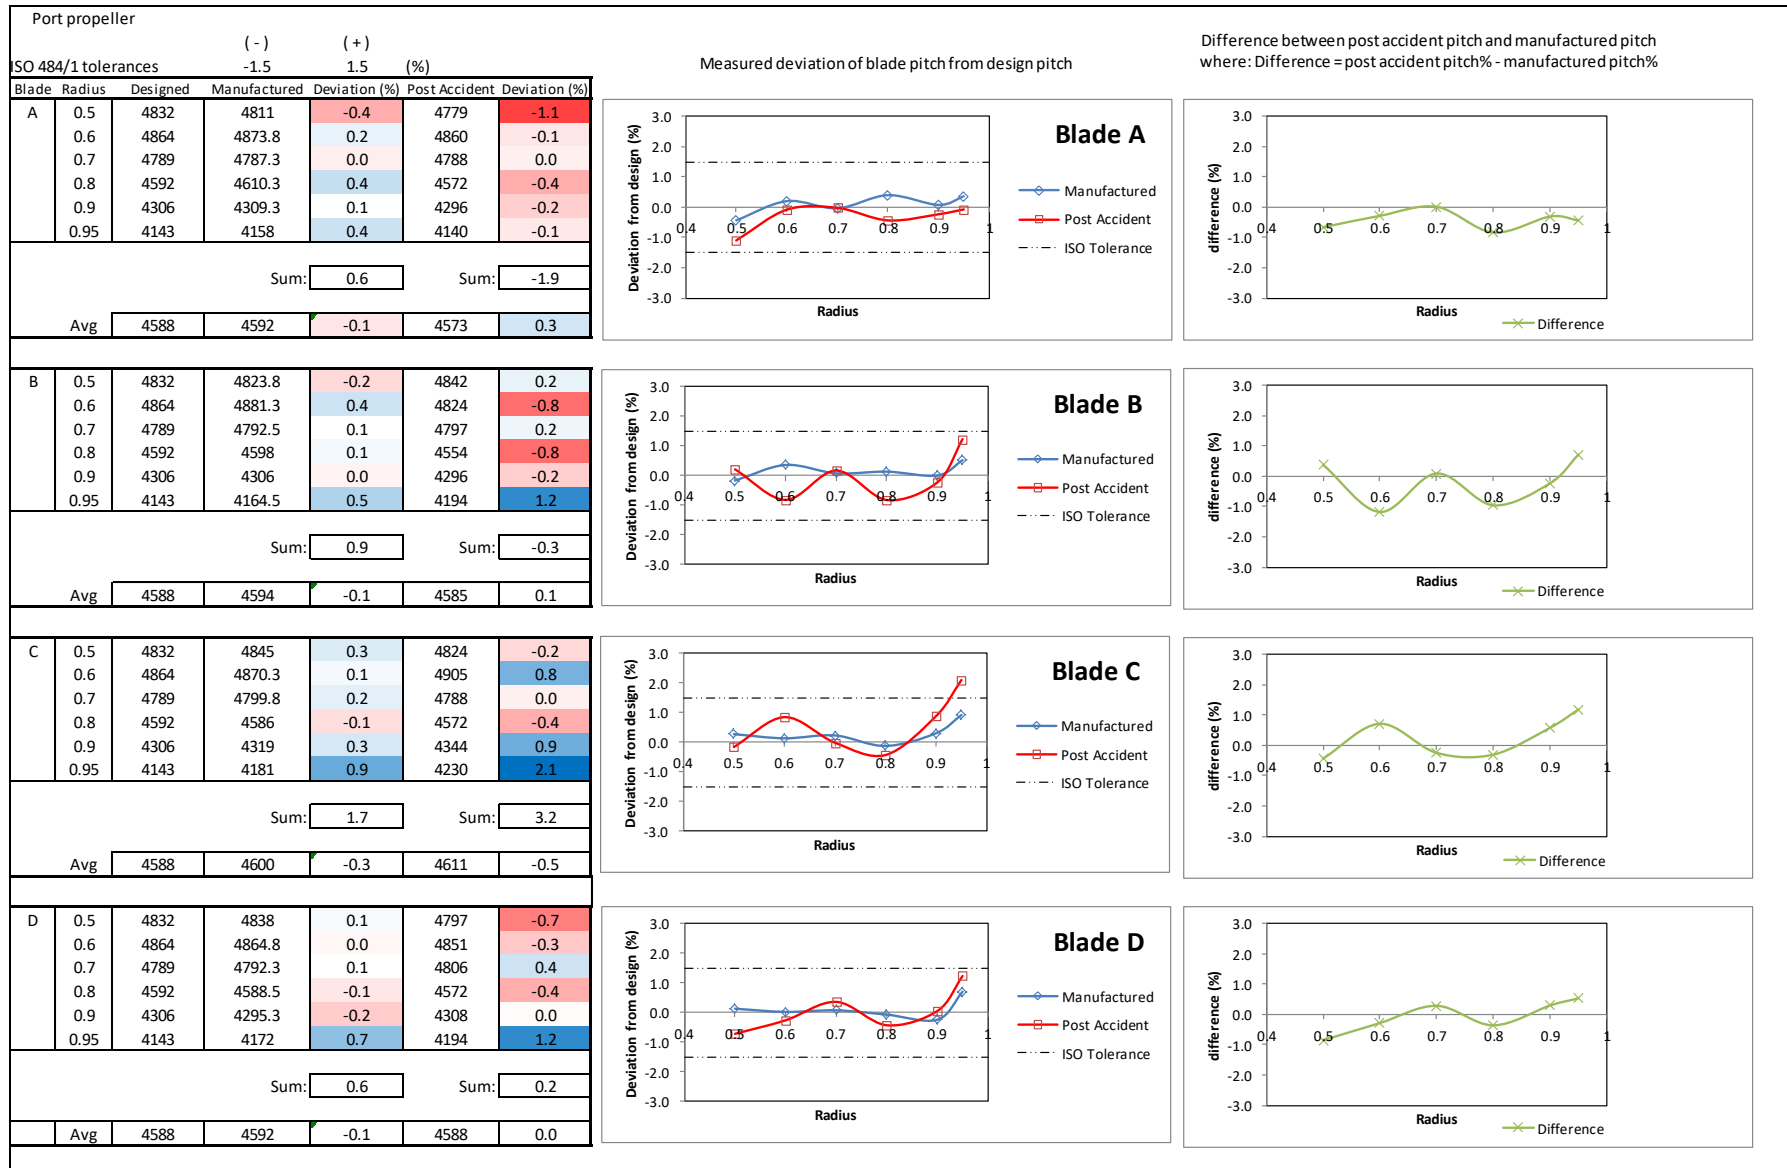
Comparison of manufactured pitch against post-accident pitch – port propeller blades
