## SAFETY ALERT No. 17-07

### Master Link Failure HN330 320 IND MASTERLINKS HA-32 Pear Links

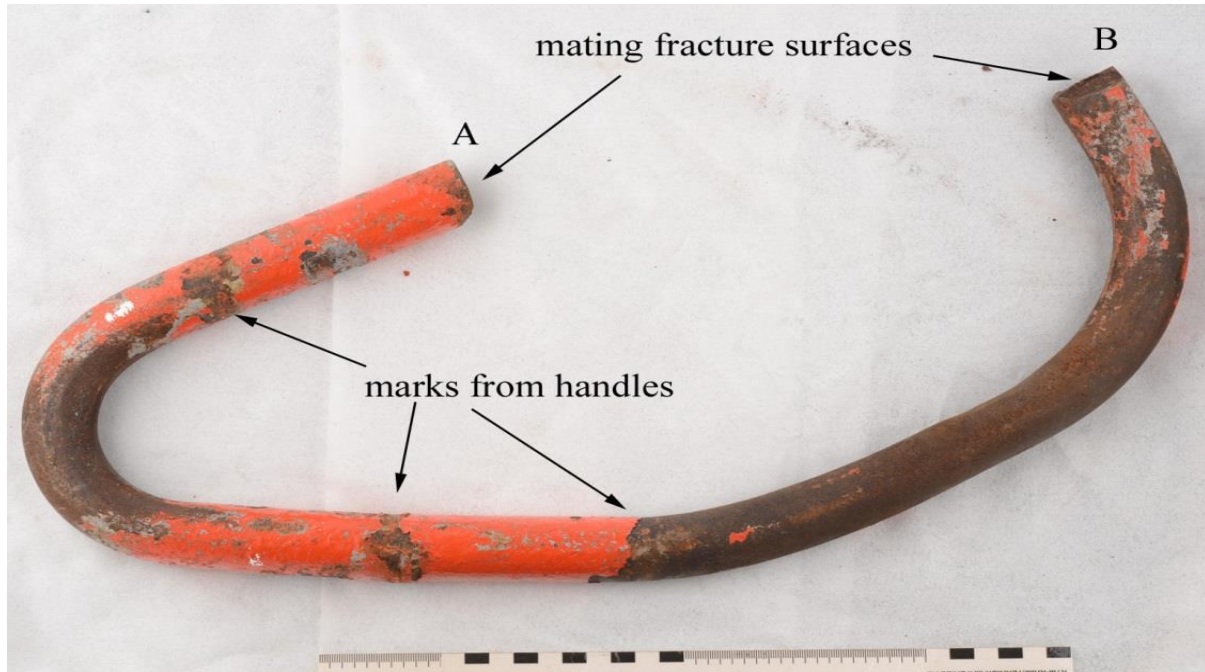
- 2.1 A tender boat onboard a cruise ship registered in the Commonwealth of the Bahamas suddenly fell from its stowed position into the water. The immediate cause was a catastrophic failure of the link that connects the fall block to the release gear/hook (see figure 1). No persons were injured; however the tender boat itself was a total loss.
- 2.2 An immediate internal investigation was commenced by the Owners who also instructed the vessel's Classification Society to conduct material examination to determine the failure mechanism of the master link. The conclusions drawn from the investigation are detailed below.

Figure 1: Fractured master link with handles removed

- 3.1 The connecting link material composition was not in accordance with the supplied certificate. The break load tests conducted on the intact link which is most likely to be from the same batch based on chemical analysis proved that the break load was below what was described on the certificate and below that of the minimum required by the LSA Code (Chapter VI, 6.1.1.6). The certificate and LSA Code both specify a minimum safety factor of 6:1; the actual measured safety factor was between 4.1:1 and 4.6:1.

- 3.2 The master link suffered a fatigue fracture. The initiation of this is most likely attributed to the location of the stainless steel handle which was attached to the straight part of the link. The mechanism is believed to be either corrosion fatigue (galvanic corrosion) or fatigue initiated from a minor indent at the surface.

the crack originating, propagating without being noticed and caused final catastrophic failure.

- 5.1 It is recommended that the above information is taken into consideration and the condition of master links be verified by a competent authority to ensure the structural integrity is not compromised.

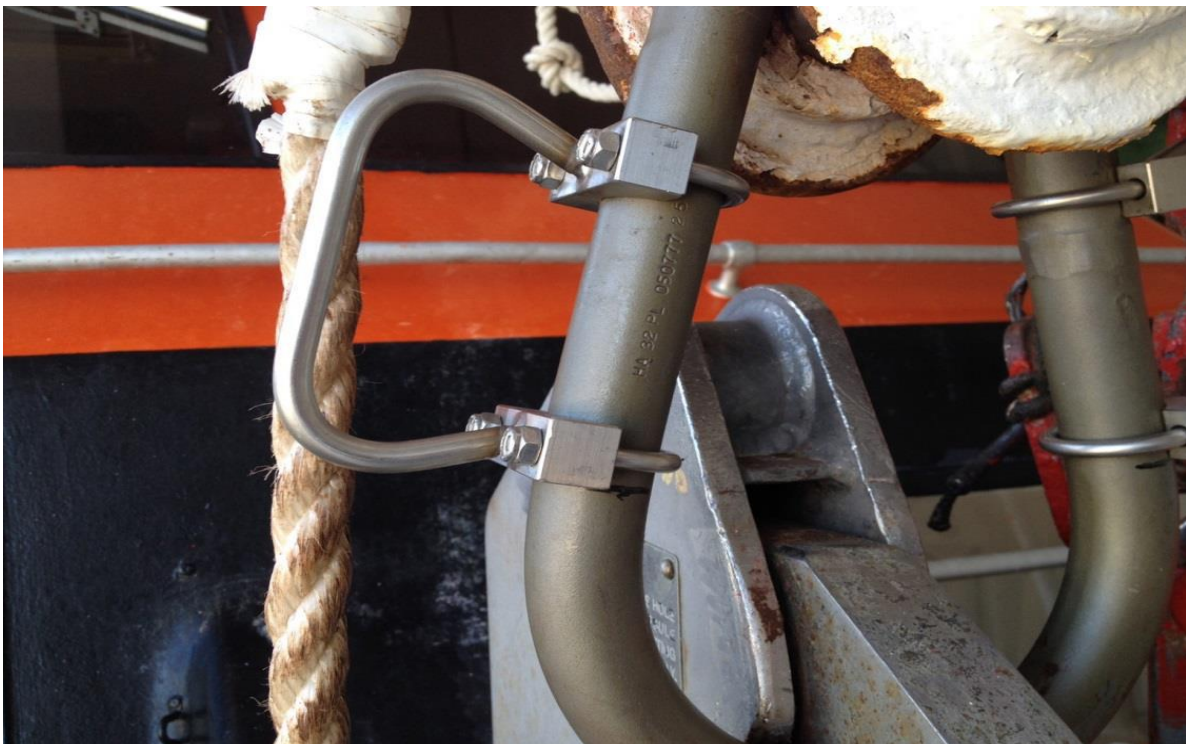
Figure 2: Master link in service with bolted on stainless steel handles

- 3.2 The material used was high tensile strength steel, with increased notch sensitivity. The link was fitted with bolted on stainless steel handles (as per original design and delivery) which serve as an originator of notches into the link, if subjected to outside force or if tightened too hard these can cause potential galvanic corrosion, due to material difference compared to the links themselves.

- 3.3 The addition of these stainless steel handles obstructs complete visual inspection of the links.

- 4.1 Despite annual and 5-yearly inspection by competent person, the substandard condition of the connecting link was not uncovered. No non-destructive testing (NDT) was carried out to verify the condition of the links, and the bolted on handles were not removed to ensure full visual inspection nor were the dimensions of the connecting links measured to uncover potential reduction in diameter as a result of corrosion.
- 4.2 The connecting links were of a substandard material, below LSA Code safety factor requirements, fitted by design with handles that obstruct visual inspection and cause galvanic corrosion. This overall resulted in
