Danish Maritime Accident  
Investigation Board

# MARINE ACCIDENT REPORT

## December 2016

**INUK II**  
**Foundering on 14 August 2016**

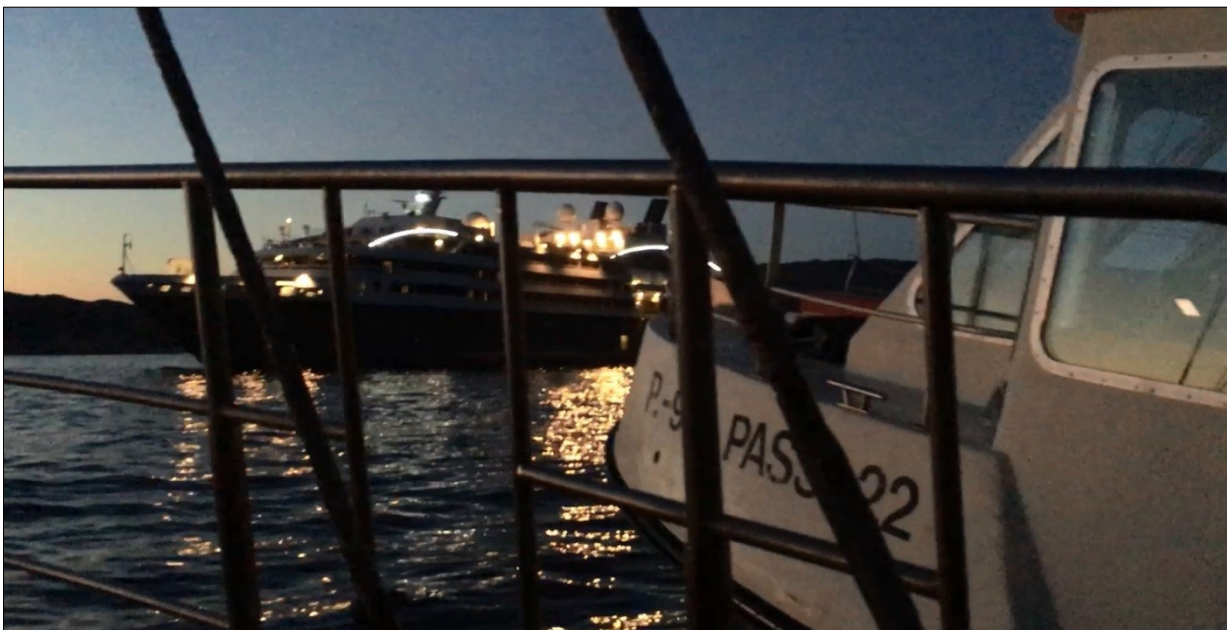
*Figure 3: INUK II and the cruise ship L'AUSTRAL at the time of the accident*  
*Source: Private photo*

An alarm by the conning station suddenly sounded. It was the bilge alarm indicating that there was liquid in one of the compartments below deck, and it was common that it was activated by minor water leakages, e.g. from the engine. Therefore, the alarm was in general not considered to be an indication of an emergency. As a precaution, the master started the bilge water pump, and the deckhand inspected the compartments forward below deck. He saw nothing out of the ordinary. The rest of the ship's compartments were not inspected because the master did not want to make the passengers anxious. Furthermore, INUK II was close to the cruise ship, and the passengers were to be disembarked within a short while. As the voyage proceeded, the deckhand noticed water on the aft deck, but it did not concern him because it was not uncommon to have the stern wave wash onto the deck. Simultaneously, the guide noticed that INUK II was becoming increasingly unstable and had started to roll excessively. At this point, it was around midnight and dark.

Suddenly, all steering was lost and the boat became unstable, and the aft deck was about to be submerged. The master, using the VHF, called for assistance from a nearby tour boat CLANE. The master's intention was to ask CLANE to tow INUK II to the cruise ship so that they

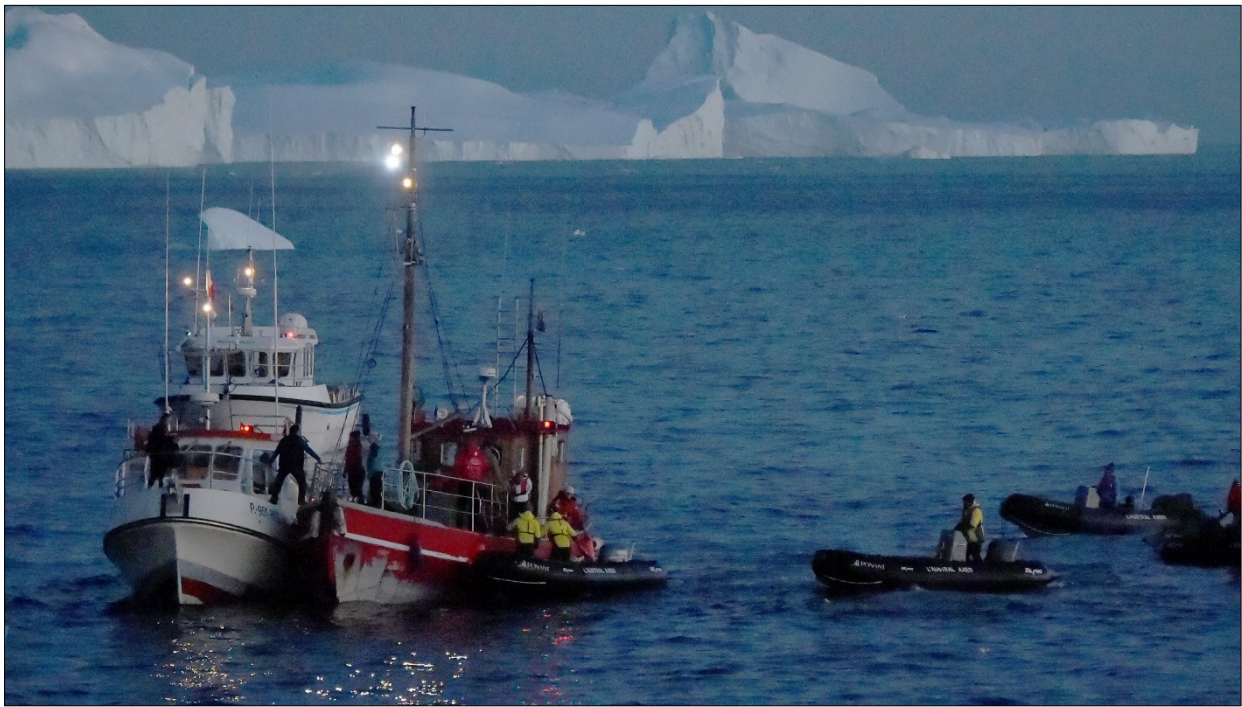
*Figure 4: Evacuation from INUK II at approximately 0036 on 14 August 2016*

The master on INUK II instructed the deckhand to make a distress call on the VHF, but the deckhand overheard it. However, the master of CLANE sent a VHF mayday relay to Aasiaat Radio at 0017 and called the cruise ship on the VHF. The master of INUK II overheard the distress call and was thereby reassured that the distress message had been sent. Moments later, four zodiacs from the cruise ship arrived (figure 4).

The passengers became wet and cold from standing in the water that flooded the aft deck, and some of the elderly passengers found it difficult to climb onto CLANE as INUK II became increasingly submerged. Therefore, a crew member from one of the zodiacs went on board INUK II to evacuate some of the passengers to the zodiacs. When the last passenger had been transferred from INUK II, the master of CLANE asked one of the crew members on INUK II to search the cabin for passengers, but he was nervous about going in the cabin while the boat was sinking. Finally, a seaman from one of the cruise ship's zodiacs went on board and checked all the compartments above deck to verify that all the passengers had been evacuated.

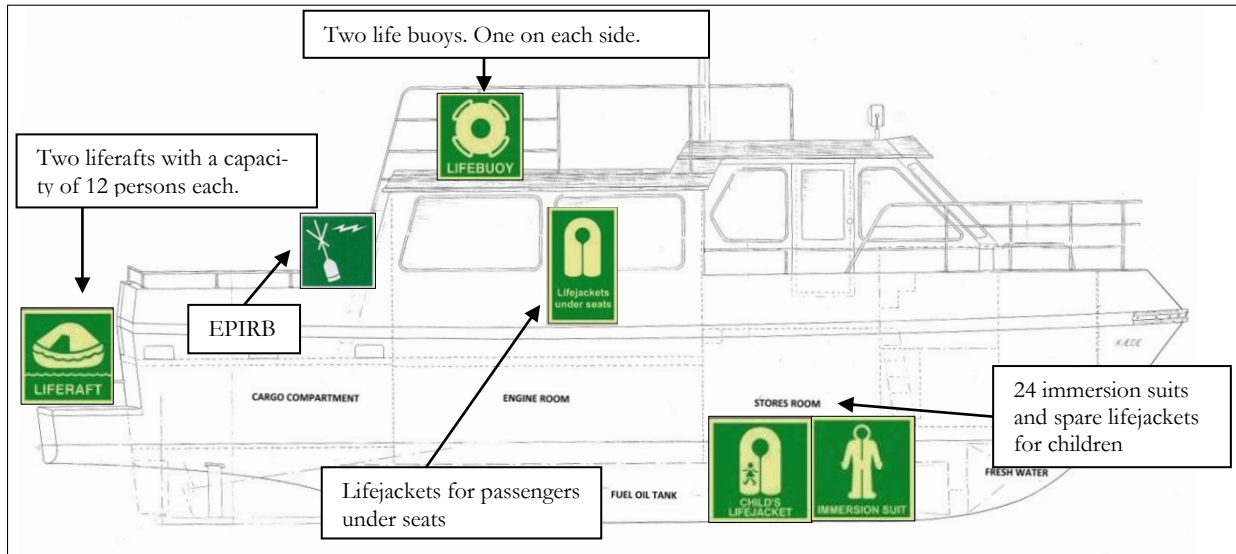
Figure 5: Extract from general arrangement drawing  
Source: Faaborg Shipyard/ DMAIB

INUK II did not have a safety plan. To illustrate the location of the on-board safety equipment, the DMAIB has made an illustration showing the equipment on an extract from the general arrangement plan (figure 5).

The boat was equipped per the regulatory requirements (see section 4.4) with two certified liferafts with a capacity of 12 persons each. They were located on the aft ramp of the boat and mounted with hydrostatic release mechanisms ensuring that the liferaft would be automatically released when submerged below a given water depth. Originally the liferafts had been mounted above the passenger lounge, but it was decided to replace them with a different type and move them to the aft of the boat, because it provided more stability when the passengers stood on the roof of the passenger lounge (see figure 5). The crew had never seen either type of liferaft inflated and were therefore not familiar with their design.

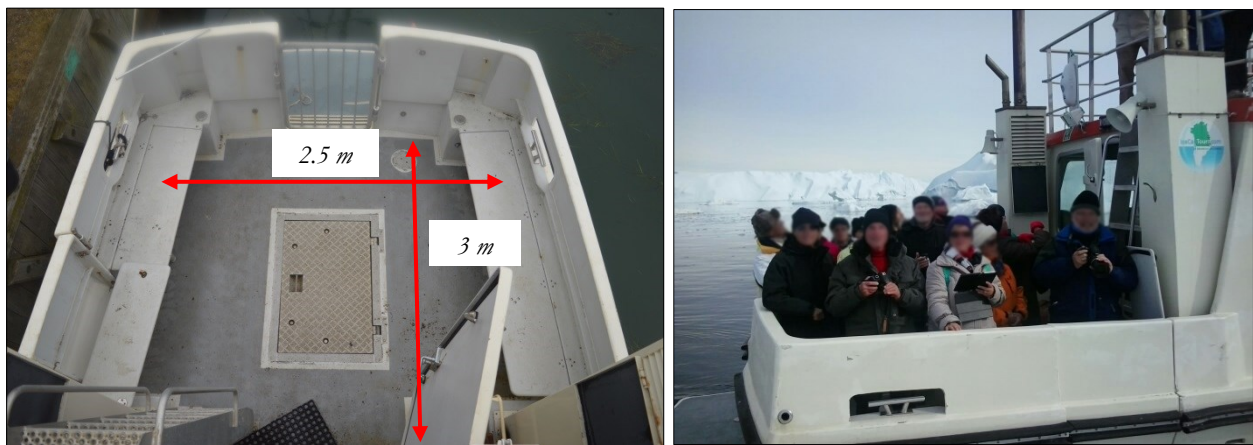
Figure 6: Photo of the aft deck  
Source: DMAIB/private photo

In the evacuation procedure, it was described that the evacuation was to be made from the deck area where the passengers were to don the immersion suits and lifejackets. The boat was designed so that there was no room for the immersion suits and lifejackets outside; therefore they were stored inside. All the immersion suits were stored behind a ladder in a storage room in the forward part of the boat. In an evacuation scenario, all the immersion suits had to be removed from the storage room and distributed among the passengers and crew according to size and type. It is uncertain how much time the passengers need to put on the immersion suits and lifejackets. In this context, it becomes relevant to consider how much space is available in order to estimate the time needed to make the passengers ready for disembarkation. Below, the picture on the left shows the aft deck on INUK II (figure 6).

The aft deck area was the only place with direct access to the inflated liferafts. The aft deck area was approximately 7.5 m<sup>2</sup> which gave 22 passengers about 0.3 m<sup>2</sup> each. The picture on the right shows approximately 13-15 passengers on the aft deck. From the picture, it is evident that it would not be possible to accommodate all the passengers on deck while assisting them in donning the lifesaving equipment. The lack of space would have the implication that most of the passengers would have to be on standby in the passenger lounge if there should also be room for the crew members to inflate and secure the liferafts. In an adverse situation with fire, flooding or loss of stability, this scenario would result in a situation where the doorway to the passenger cabin would become a bottleneck where passengers would insist on having access to the deck area.

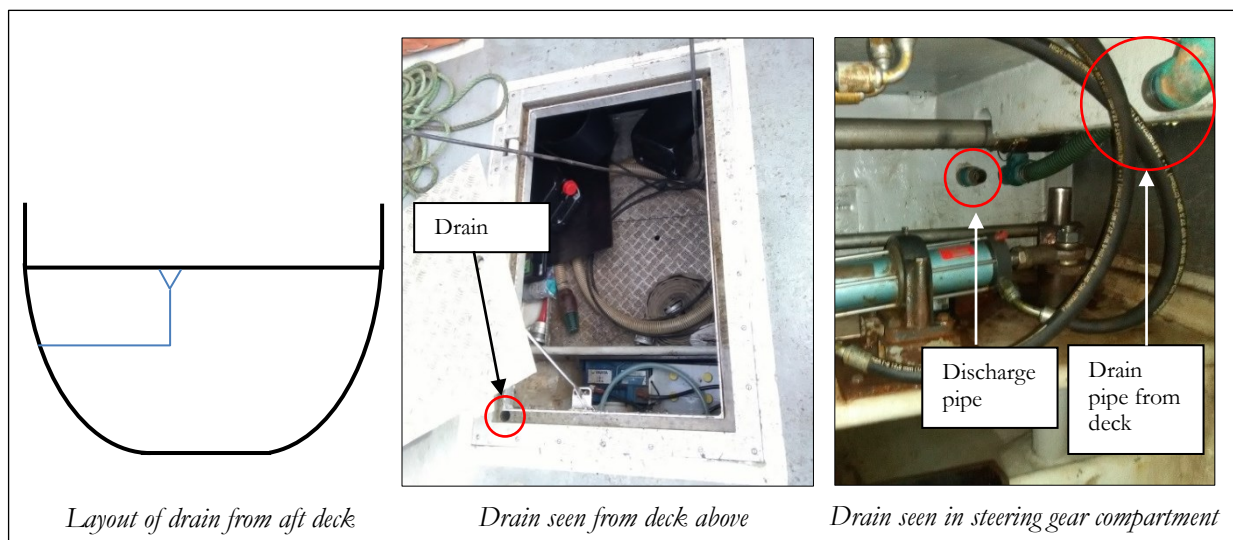
Figure 10: The drain from aft deck  
Source: DMAIB/Private photos

An investigation of the steering gear/storage compartment revealed a missing hose which had connected the drain from the aft deck to the over board discharge. On figure 10 below is an illustration of the layout of the drain.

The drain was designed to drain water from the aft deck preventing it from entering the compartment below deck when the hatch was opened. Both the drain hole and the discharge pipe were made of 1 inch galvanized steel pipe, which were normally connected by a flexible hose. It was established from the investigation of the wreck that the flexible hose was missing. It is likely that the hose was removed while INUK II was at the local workshop for repairs. To get access to the rudder stock it was necessary to dismantle the hose connecting the drain from the deck to the discharge pipe. After the reassembly of the rudder stocks, the repair team did probably not connect the hose again leaving the discharge pipe open to the sea. It was, however, also a possibility that the hose was removed during the repairs of the boats fuel system lo-

cated in the steering gear compartment. It has therefore not been possible to determine with certainty why the drain hose was missing. The hose has not been found by DMAIB.

The investigation has established that, during the repairs of INUK II's rudder stock or the fuel system, a hose connecting the aft deck drain to the discharge pipe was removed. After the repairs were completed, the drain hose was not mounted again. Once INUK II was put into operation, it was only a matter of embarking enough passengers before the discharge pipe would be submerged below the waterline resulting in flooding of the boat. On the day of the accident, INUK II was transporting the maximum number of passengers which increased the draught to such an extent that the hull discharge pipe was submerged. INUK II gradually lost all buoyancy as water flowed into the steering gear/storage compartment and subsequently into the engine room because none of the other compartments were separated by watertight bulkheads.

The investigation did not bring clarification to why the hose was not mounted after having been removed. Presumably the mechanic for unknown reasons forgot to mount the hose again after having removed it to get access to components in the cramped steering gear compartment. The local workshops that carried out the repairs were not able to test the systems on the boat while it was on shore or in the water, because it was not customary for the workshops to carry out sea trials as they were not specialized in boat repairs. Therefore, the deckhand on INUK II made the inspection of the boat prior to and after the boat was set afloat. During the inspection, the deckhand was preoccupied with the overboard valves below the waterline and therefore the aft deck drain was not inspected. The deckhand did not have experience and/or training in marine engineering, and there was no written guidance on how to inspect the functioning of the boat's machinery and equipment. In the absence of technical knowledge and procedural guidance, the deckhand's inspection of the boat's reliability was mainly based on the sea trial, which did not reveal any malfunction. On that basis INUK II was put into service. The master on INUK II made a visual inspection of the boat on 13 August 2016 before embarking the passengers for the first excursion and no anomalies were found.

The water ingress was caused by the absence of a hose connecting the drain from the deck to the discharge pipe mounted in the boat's hull, which enabled water to penetrate the hull through the discharge pipe into the steering gear/storage compartment. During repairs of the boat, the hose had been removed, but had not been refitted after the repairs were completed. Once INUK II was put into operation with the maximum amount of passengers, the discharge pipe was submerged allowing water to flow into the boat.

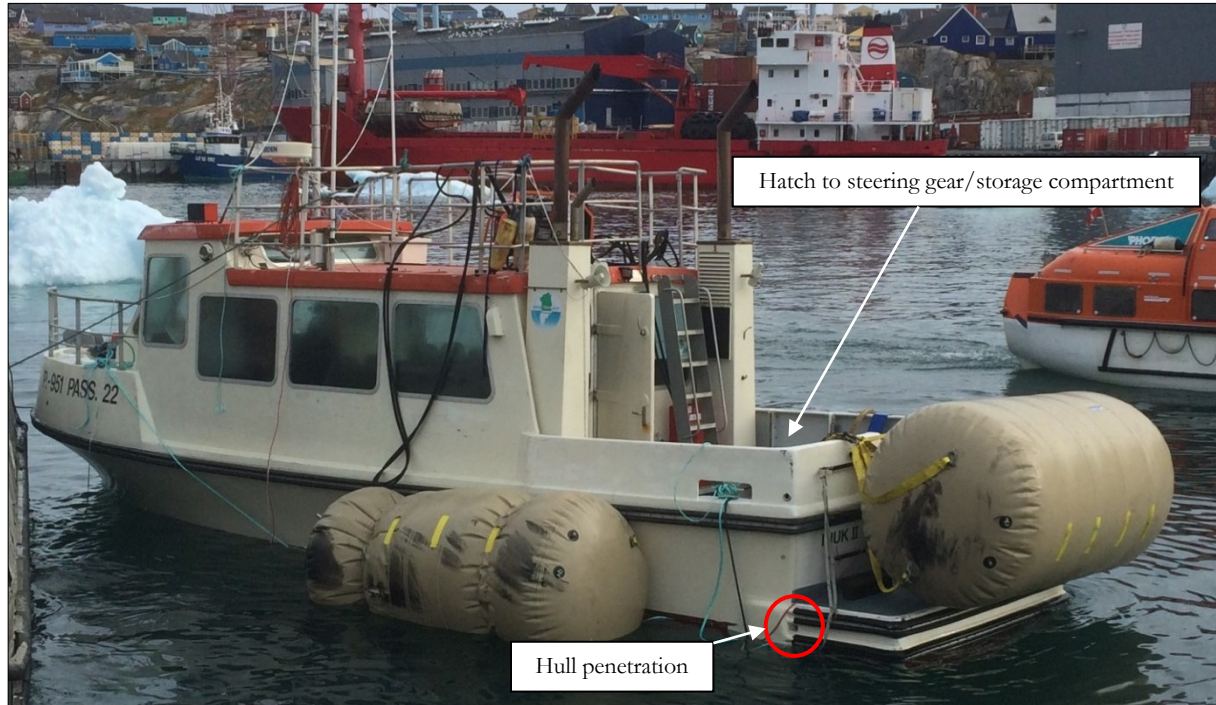
Figure 11: The salvaged INUK II  
Source: DMAIB/Private photo

INUK II was salvaged on 25 August 2016 and brought to the port of Ilulissat. The boat was found to be structurally undamaged except for minor damage on the aft ramp most likely caused by the foundering and the salvage operation. The liferaft containers had been released, but were not inflated. The other lifesaving equipment was still stored on board, i.e. lifejackets and immersion suits.

Below is a picture of the salvaged INUK II (figure 11). The red circle on the picture shows the penetration of the hull where the discharge pipe was mounted.

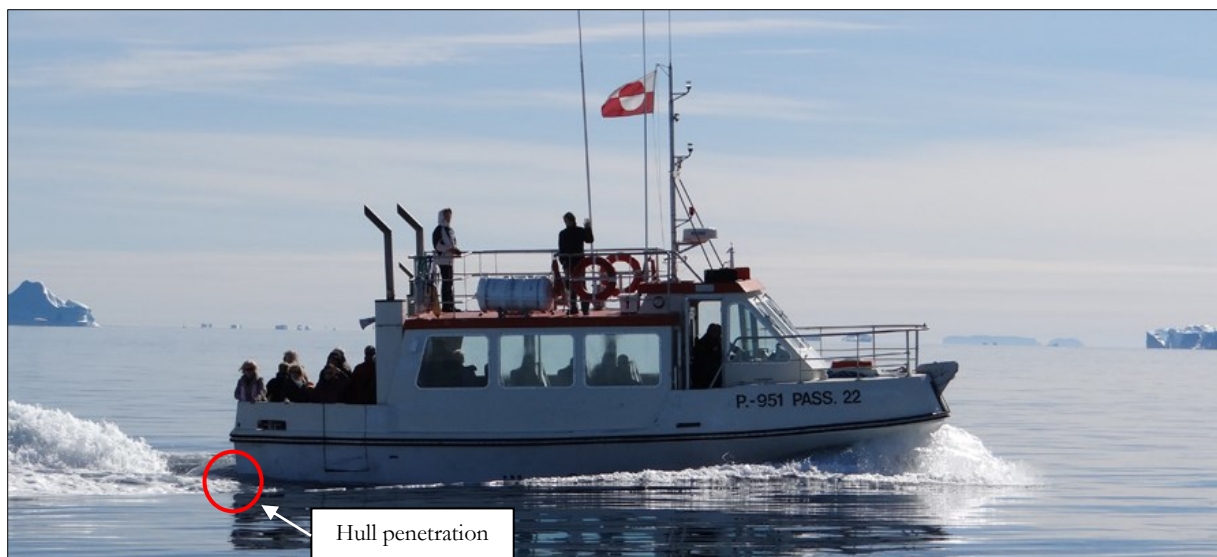
Figure 12: The starboard side of INUK II  
Source: Private photo

During normal operation, the hull penetration was above the water line on the port side. However, if the boat had embarked the maximum number of passengers, then the hull penetration where the discharge pipe was connected would be below the water line, which can be seen on the photo (figure 12) below showing the starboard side.

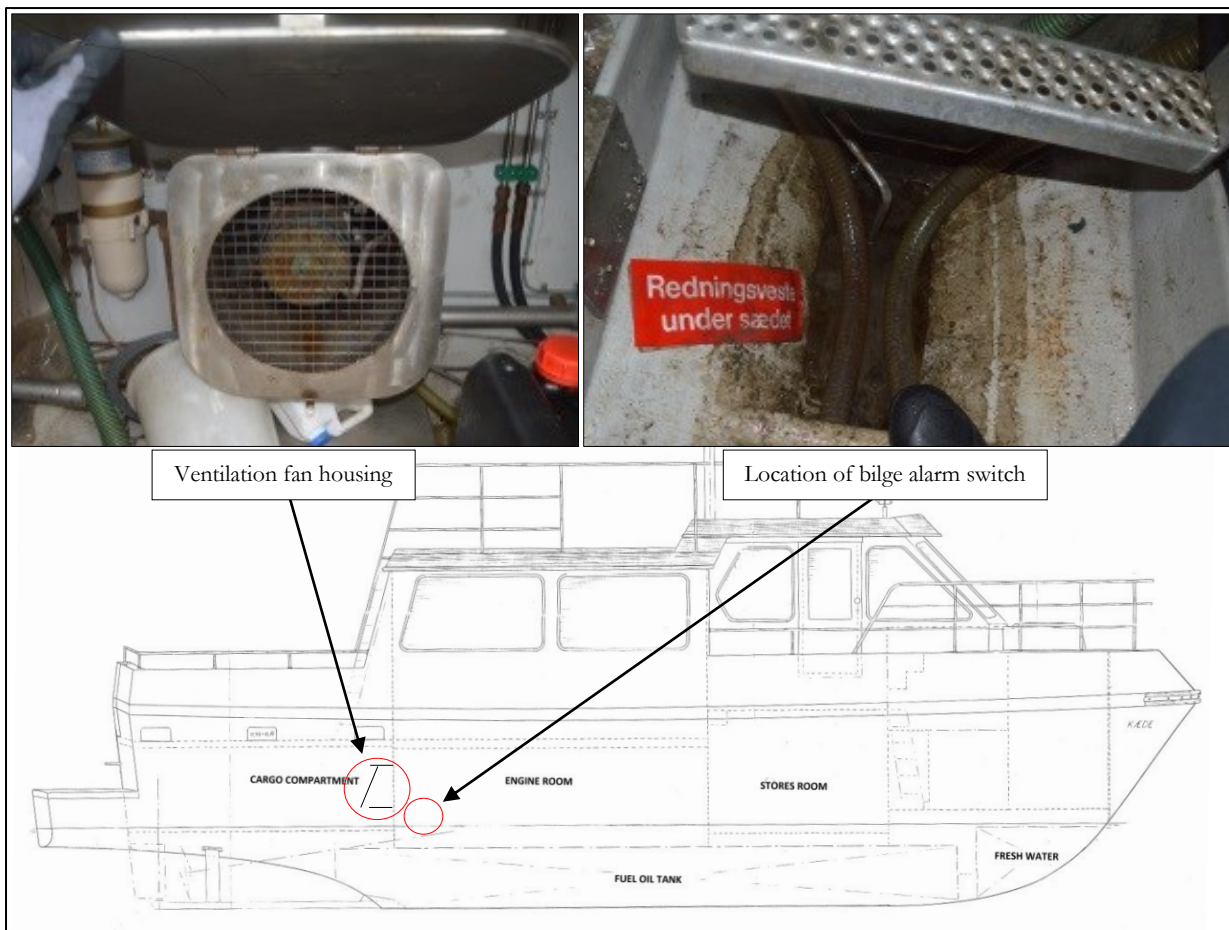
Figure 13: INUK II

The steering gear/storage compartment was not equipped with a bilge alarm, but a bilge alarm was mounted on the aft part of the engine room (figure 13). This meant that the crew members were unaware about the water ingress until the water had reached the aft part of the engine room. The bilge alarm switch was mounted 2-3 inches from the bottom of the engine room in a recess (figure 13), which meant that it would be triggered by relatively small amounts of water. The sensitivity of the alarm was consistent with the crew members experiencing frequent bilge alarms from small amounts of bilge in the engine room.

Later, when the water had reached a level of approximately 300 mm in the steering gear/storage compartment, the water gushed through a ventilation fan housing opening connecting the steering gear/storage compartment with the engine room (figure 13). By then the free surface effects of the water in the compartments made INUK II unstable and the weight of the water made the buoyancy diminish.

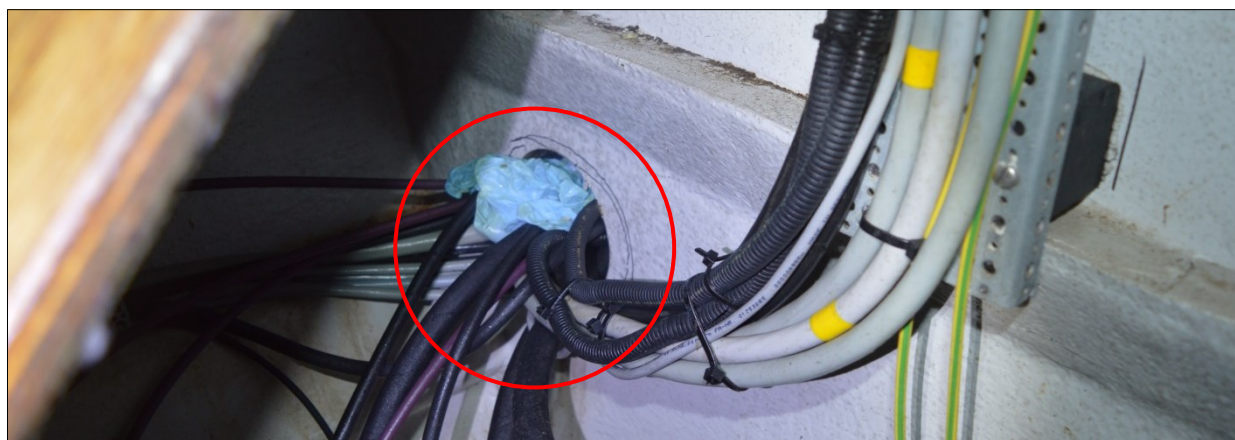
Figure 13: Cable penetration in forward storage compartment on INUK II

The platform mounted on the rear of the boat was hollow and water tight and thereby provided some buoyancy, which delayed the loss of buoyancy in the aft part of INUK II. This delay gave the passengers and crew time to evacuate the boat. As the steering gear compartment was gradually filled, the water could flow into the forward storage compartments via the openings in the bulkhead made for cable penetrations (figure 13).

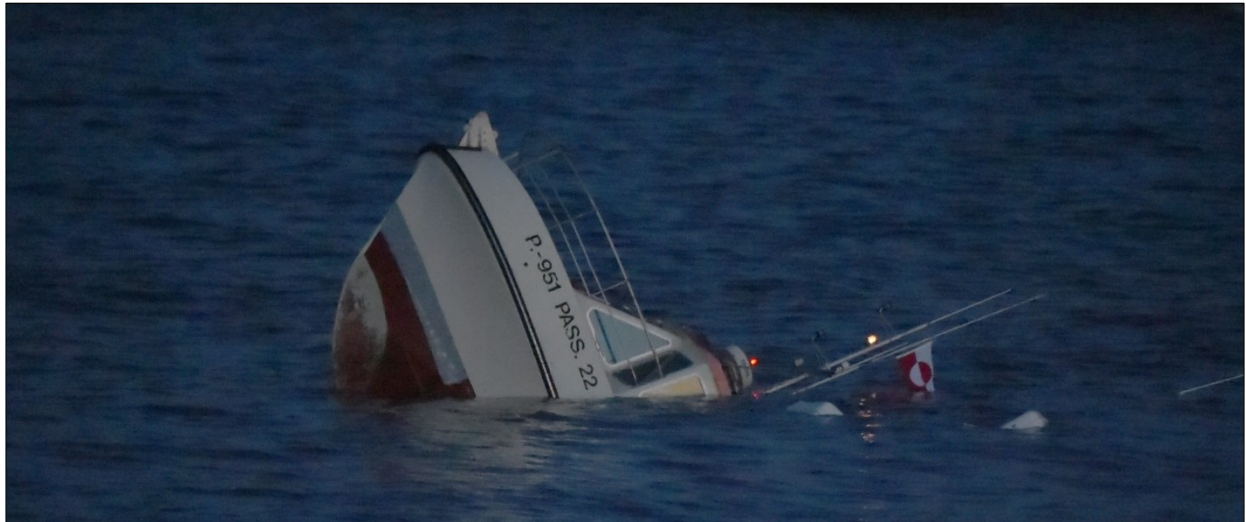
*Figure 14: INUK II at approximately 0050 on 14 August 2016*

In the steering gear compartment, the hydraulic steering gear was mounted on a pedestal thereby delaying the malfunctioning of the steering gear. The steering gear malfunctioned approximately at the same time as the forces from the waters' free surface came into full effect. At this point the passengers and crew noticed the boat becoming unstable because it started to roll excessively. During the process of evacuation, the rolling motion was dampened because INUK II was tied to the tour boat CLANE and because a crew member used his body weight as a righting lever by leaning out from the ship's side. In the final stages of the evacuation, the water level on the aft deck was approximately one metre. The aft deck area was gradually submerged until the aft part of the boat was finally submerged at approximately 0050 (figure 14).
