## MARINE SAFETY INVESTIGATION REPORT

**Safety investigation into the mooring equipment failure and  
subsequent fatality of a Shipyard worker  
on board the Cyprus registered ro-ro passenger**

***GALAXY***

MARINE SAFETY INVESTIGATION REPORT NO. 02/2017

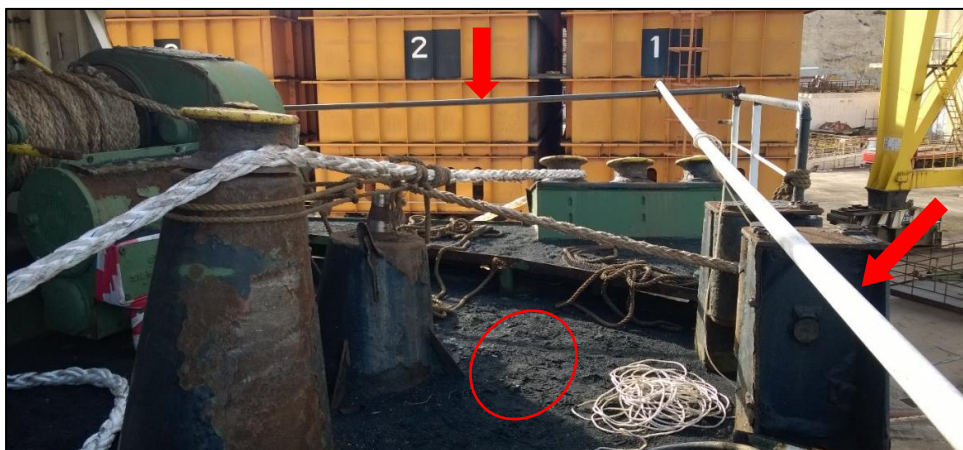
Figure 5: Temporary railing and grit on the aft mooring deck

The railing around the aft mooring station had been removed during the repairs and replaced by a temporary railing, consisting of a single steel pipe secured by spot welding and clamps to secure to the ship. The deck around all the mooring station was covered with layer of grit which was about 1.5 cm thick. The grit had been left there after grit blasting of the entire superstructure. Markings, safety signs, snap back zones, *etc.*, were neither visible underneath the grit on the deck (Figure 5) nor was marking at the entrance to the mooring station (cautionary signage) noticed by the MSIU.

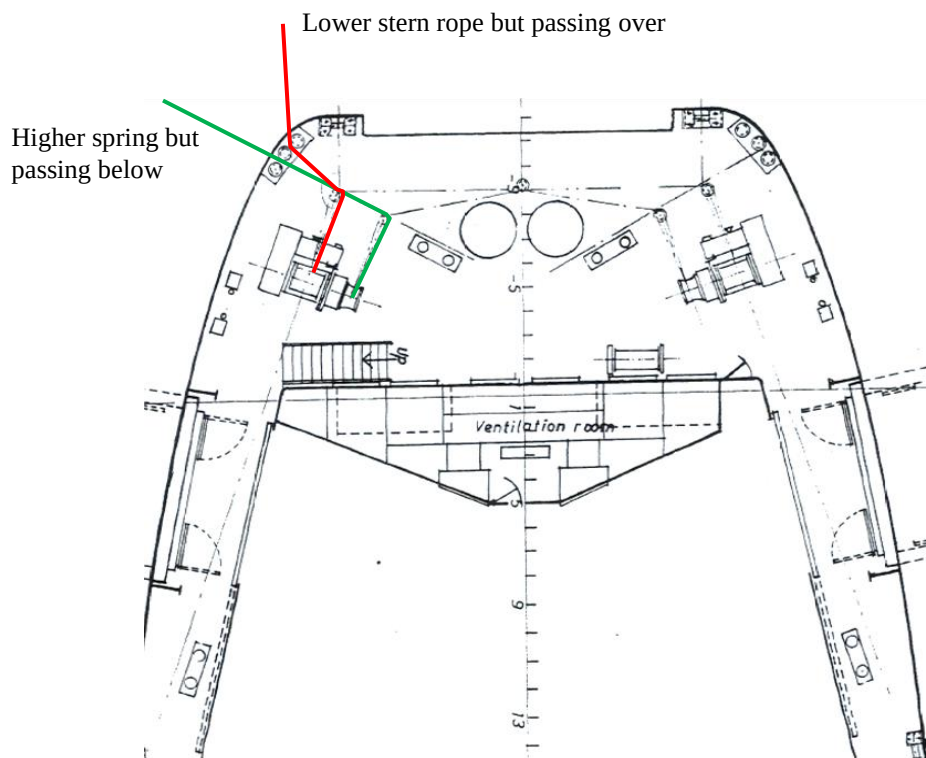
**Figure 9: Aft mooring rope arrangement just before the accident happened (green - spring and red – stern line)**

Evidence indicated that the first rope out of the starboard quarter was the one stored on the starboard single-drum winch. It was passed around the lower pedestal fairlead and sent out ashore as a stern rope in between the two aftermost button-rollers. A second rope from the aft was then taken out of the rope storage bin and sent out ashore between the two forward-most button-rollers on the starboard quarter and used as a spring. This resulted in the spring line (higher line) crossing from below the stern line (lower line) (Figure 9).

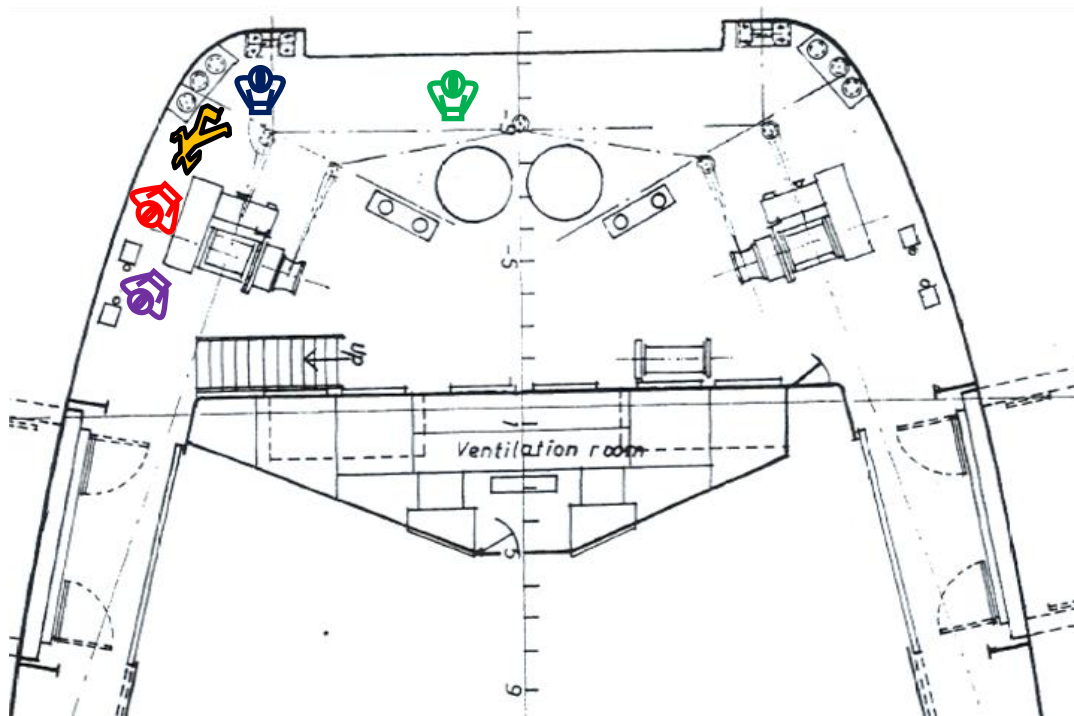
**Figure 10: Sketch showing the (approximate) position of persons at the aft mooring station**

It would appear that the fatal accident occurred at around this time. Immediately prior to the accident, the engine rating was at the (aft) winch controls, the chief engineer with the portable VHF radio standing adjacently by the side railing next to the mooring winch, one of the Shipyard workers (welder 1) close to the side button-roller chock and the other Shipyard worker (welder 2) adjacent to the rope storage bins close to amidships. The Assistant Ship Repair Manager was initially close to welder 1 (outside the snap back zone) but then, for some reason, he moved to a position close to the shipside and entered the trajectory path of the lower pedestal fairlead, serving the mooring single-drum winch (Figure 10). The Dockmaster, who was standing ashore, spotted the Assistant Ship Repair Manager and yelled at him to walk clear of the area.

It was reported that at one point in time, the Assistant Ship Repair Manager walked from this position towards the shipside railing, between the winch controls and the lower pedestal fairlead, which fell in line with the dangerous trajectory path of the pedestal fairlead. At this time, the mooring ropes must have been under tremendous stress, causing the spring to become very tight, exerting an upward component on the stern rope passing over it and around the lower pedestal fairlead, as described elsewhere in this safety investigation report.

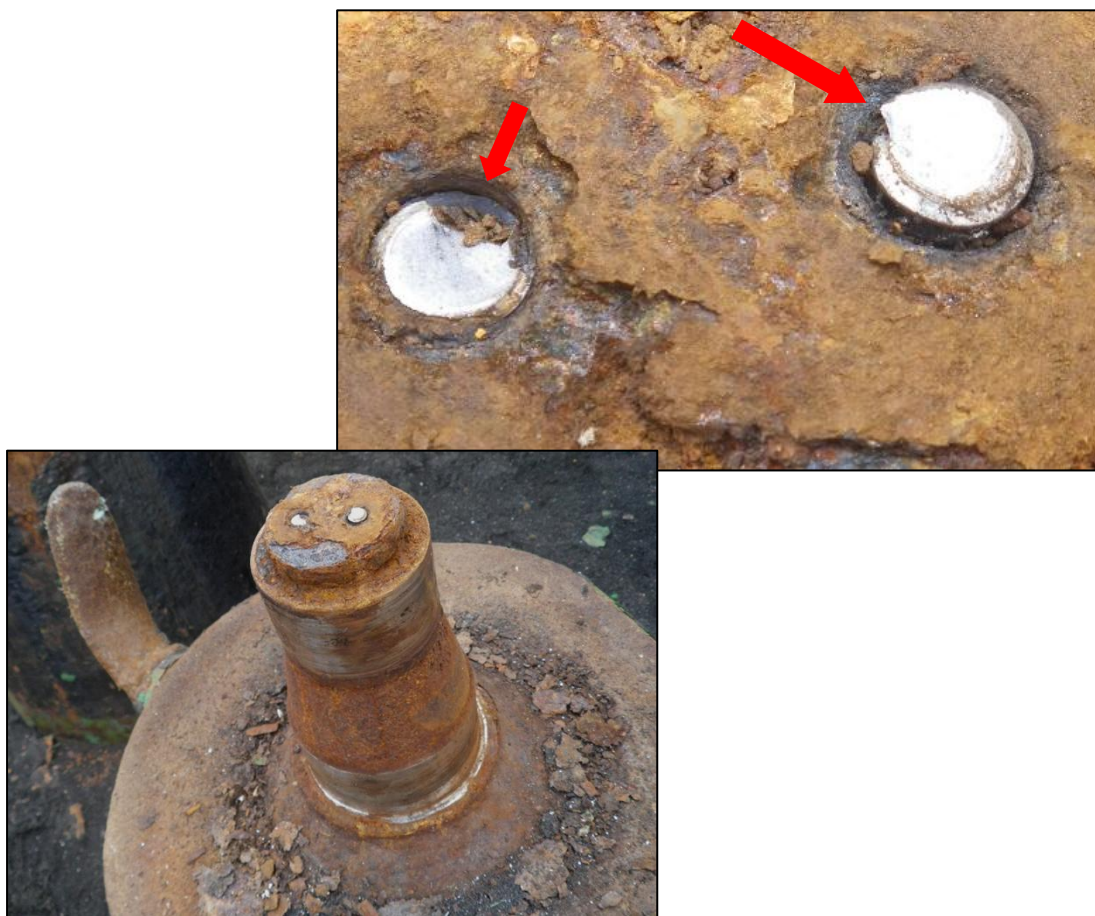
**Figure 11: Details of the sheared bolts holding the roller-keep**

The immediate cause of the failure of the roller from the pedestal fairlead was the failure of the two 10 mm bolts holding the roller-keep in place. The bolts sheared off under the tension generated by the mooring ropes. Observation of the state of the failed roller-keep holding down bolts revealed two areas which had clear signs of corrosion (Figure 11). The MSIU was unable to extract the remaining parts of the sheared bolts shown in the figure and therefore no metallurgical tests have been carried out.

The MSIU did not exclude that surface corrosion, which seemed evident in Figure 11, may have resulted in stress corrosion cracking at the thread. Considering the applied axial force on the thread and the generated high loads, it was hypothesised that the bolts eventually failed at the threads, which were weakened by corrosion.

- .3 Observation of the state of the failed mooring roller-keep holding down bolts revealed two areas which had clear signs of corrosion.
- .4 It is probable that surface corrosion may have resulted in stress corrosion cracking at the thread. Considering the applied axial force on the thread and the generated high loads, it was hypothesised that the bolts eventually failed at the threads, which were weakened by corrosion.

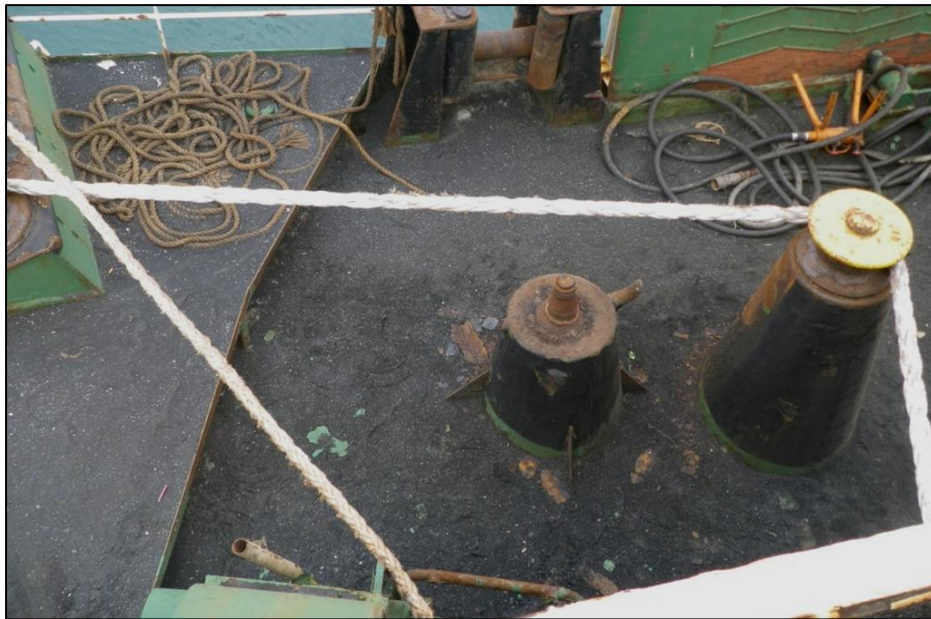
**Figures 12: The two pedestal fairleads showing the different height**

Studying the layout of the moorings at the aft mooring station, it was noticed that the pedestal fairleads were of different heights above the deck (approximately 0.40 m difference) (Figures 12 and 13).

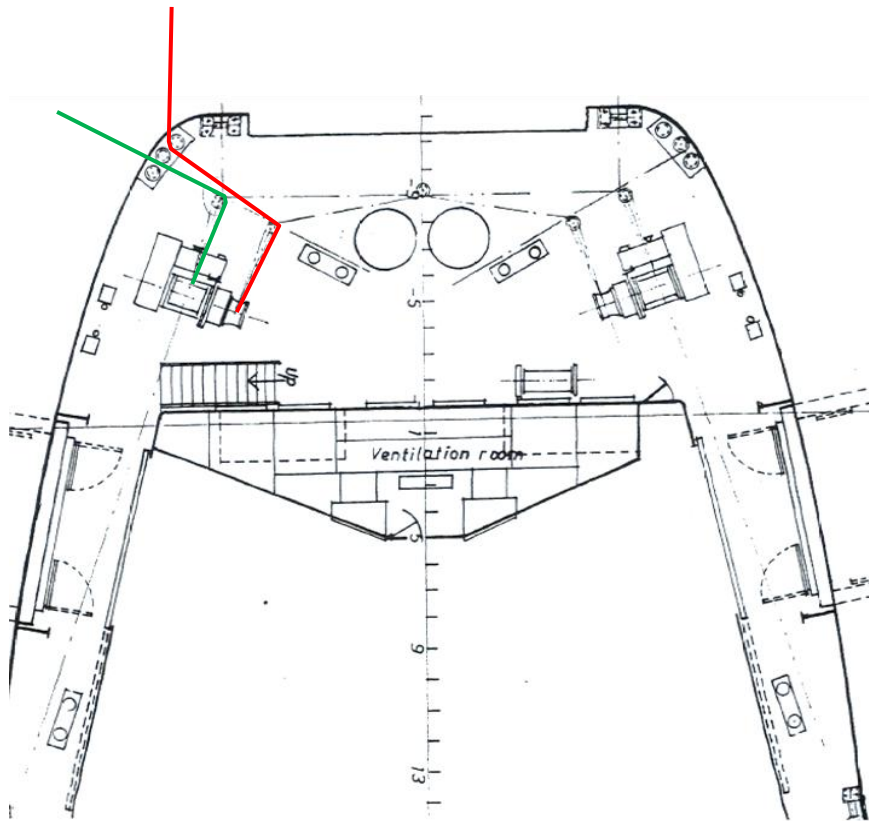
**Figure 14: Mooring ropes laid out in a way which avoids crossing (green - spring and red – stern line)**

This set-up actually necessitated that the mooring rope on the single-drum winch be sent out over the lower pedestal fairlead as spring around the foreword most button-roller on the starboard quarter, while the loose mooring rope (which would have to be hove in tight over the warping drum end) be sent out as stern rope around the aftermost button-roller on the starboard quarter, so that when both ropes are being worked and winched in, they would never cross (Figure 14).

The MSIU believes that this minute but important detail was missed by the persons at the aft mooring station on the day of the accident<sup>3</sup>.

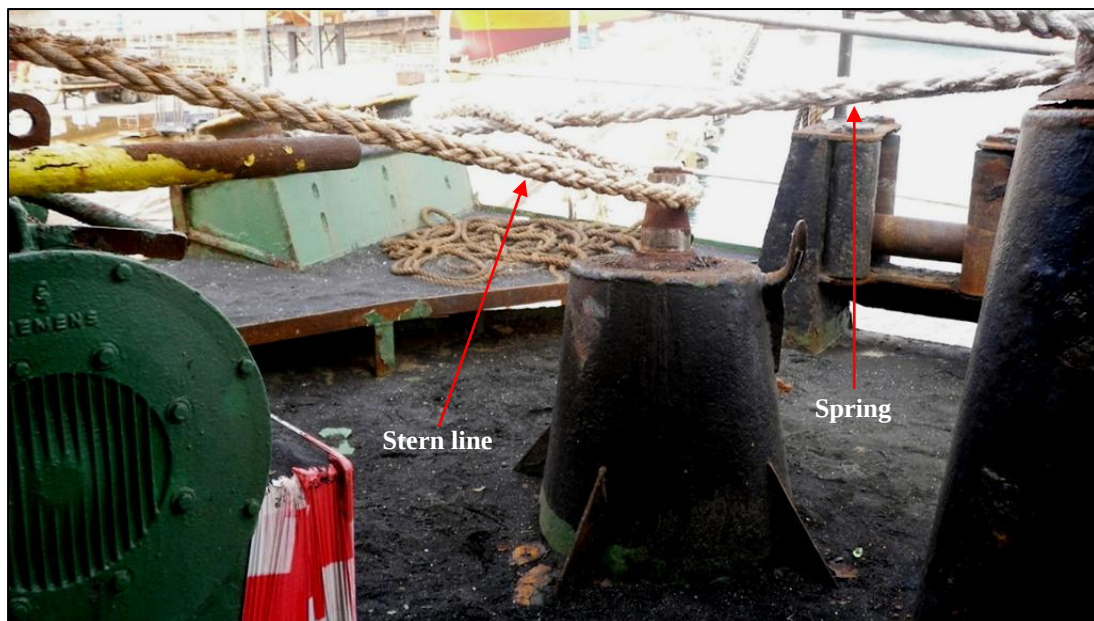
**Figure 15: Reproduction of the rope arrangement at the time of the accident (photo taken after the accident)**

The tremendous tensile forces on the mooring ropes caused the stern line to become very tight. Moreover, an upward component of the force in the spring line as it was being tightened by the warping drum end, acted on the stern rope passing over it and around the lower pedestal fairlead (Figure 15).

This upward component of the force was enough to cause the two (weakened) bolts holding down the roller-keep over the lower pedestal fairlead (around which the stern rope was passing) to shear, causing the roller to fly off in a trajectory towards the shipside. The force was created by the difference in height of the pedestal fairleads and the way the ropes were positioned, with the rope on the higher pedestal fairlead crossing below the mooring rope on the lower pedestal fairlead.

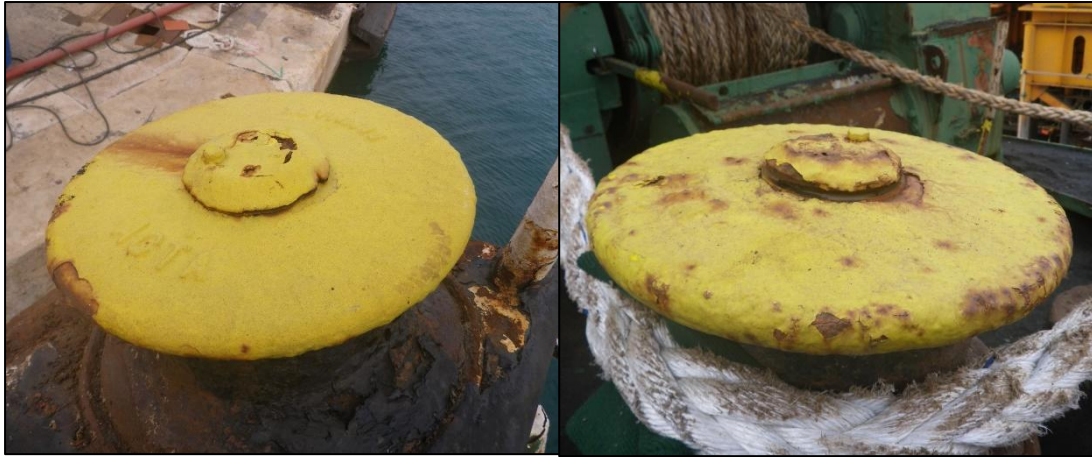
**Figure 16: Other rollers at the aft mooring station**

Observations of the rollers at the aft mooring station revealed that although there was considerable rust and heavy scale with paintwork in poor condition, the other rollers at the aft mooring station could rotate freely (Figure 16).
