IMCA Safety Flash 35/16

December 2016

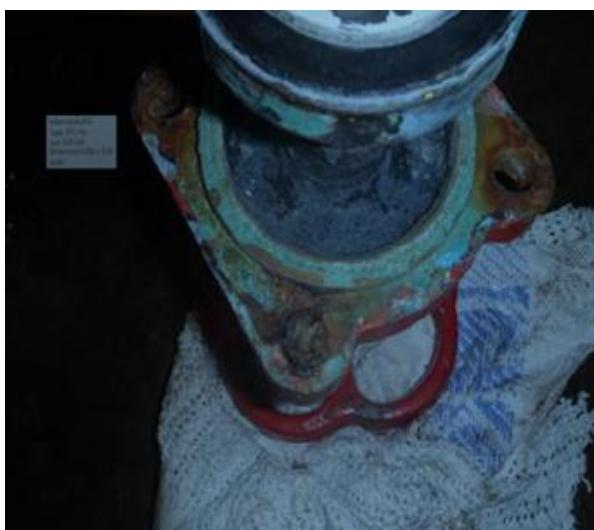
Failed studs

- ◆ There was an unexpected failure of the hydrant valve assembly studs. These studs were of type 303 Stainless Steel;
- ◆ Expert analysis reveals that type 303 Stainless Steel is particularly susceptible to stress corrosion cracking (SCC) in a high ambient temperature (tropical environment);

- ◆ Metallurgic analysis examined both "failed" and "non-failed" studs were provided by the vessel. The report stated that the cause of failure was chloride induced SCC, which is a common failure mode for austenitic stainless steels, including types 303, 304, and 316;

- ◆ The **root cause** of this incident was the incorrect material specification of the studs for the environment and application.

- ◆ Careful consideration given to the increased likelihood of SCC in stainless steel for vessels operating extensively in tropical or high temperature environments, particularly for vessels designed and built in temperate climates;
- ◆ All affected studs on fire hydrants to be replaced.

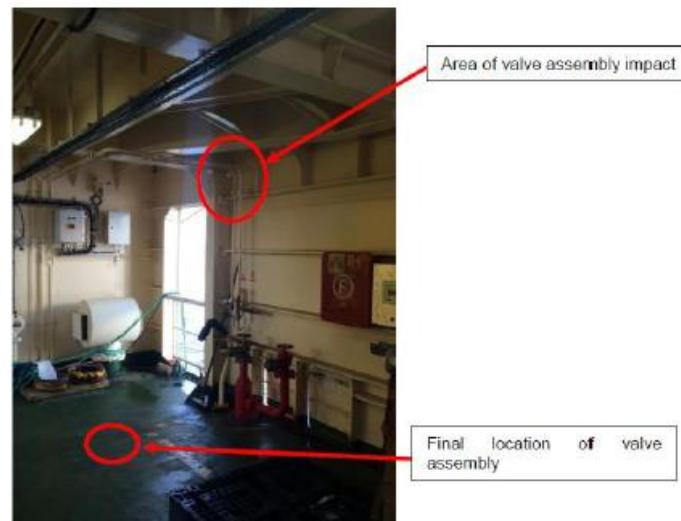
A member has reported an incident in which a fire hydrant valve failed under pressure. The incident occurred during testing of the helideck firefighting system. A hydrant valve assembly on the starboard side of the main deck failed under pressure. The 2kg valve assembly struck the deck head approximately 2 metres above, chipping paint on impact, and then fell to the deck below. No-one was injured. Whilst no-one was in the immediate area, the impact was heard by several people. The force associated with the hydrant valve assembly failure had the potential to cause a significant injury or fatality.

Where the incident occurred

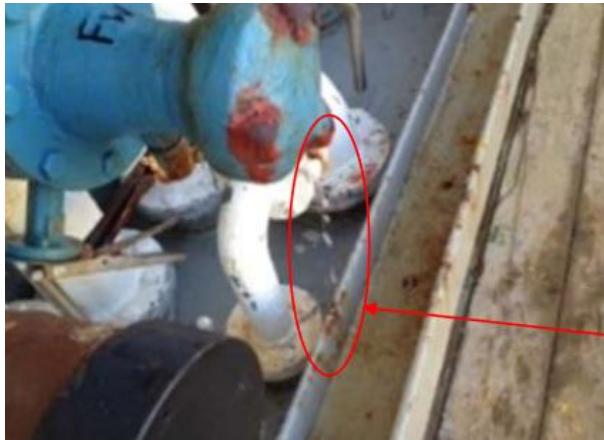
Port mid-ships fresh water manifold showing water leaking from the cap.

- ◆ During the bunkering process fuel had been leaking from the fuel sample/drain cock into the drip tray and draining overboard along with the fresh water originating from the water manifold;
- ◆ The **root cause** and contributing factors were found to be:
 - the leaking fresh water manifold valve
 - failure to fully ensure the requirements of the ‘pre bunkering’ check list were met
 - although a watchman was in place there was a failure to maintain a proper watch on all areas from which fuel could possibly leak.

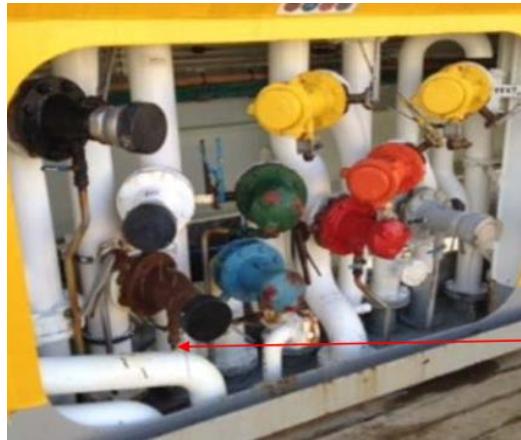
Port mid-ships hose bay & fuel sample/drain cock location

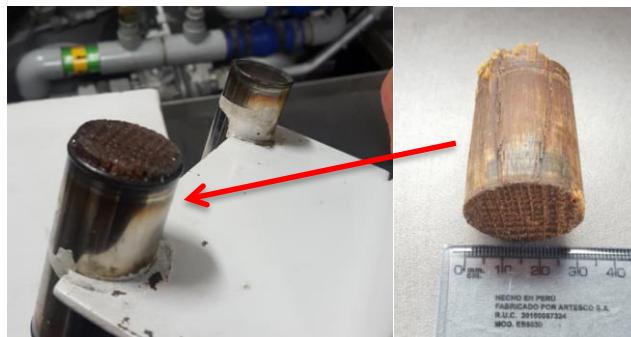
Initial investigation revealed a lack of coolant movement, causing the motor to overheat which in turn was causing the generator to automatically shut down. Further investigation (not by the crew) found a blockage was located within the coolant line. The blockage was a wooden bung.

When performing a minor repair, a wooden bung had been used to prevent any coolant loss during removal of a pipe. The repair was completed and the pipe was replaced, but without the bung being removed.

- ◆ **Causal factor:** poor mechanical practice;
- ◆ Recommendation: ensure proper record-keeping and logging of events during repairs, particularly when repairs span several shifts, to ensure that what has happened is clearly understood by all involved.

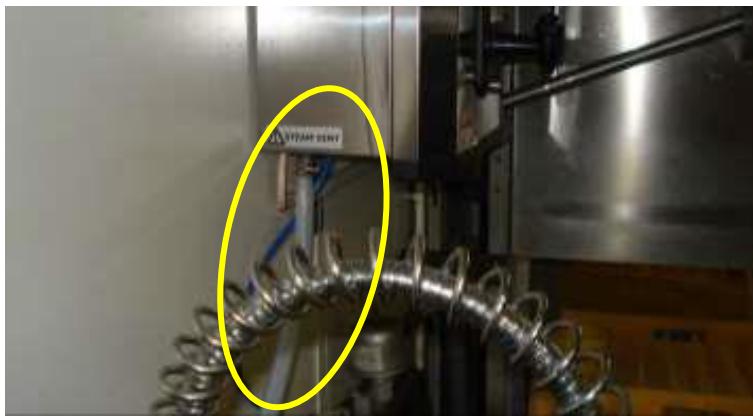
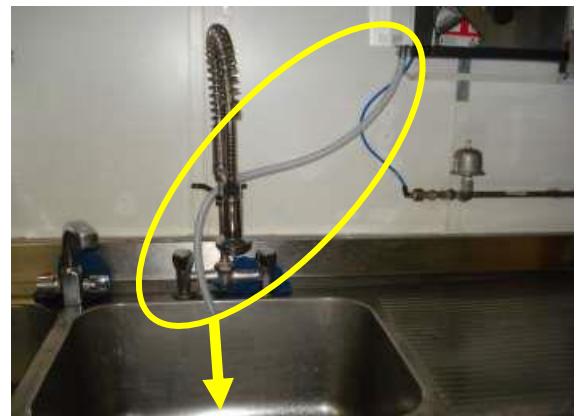
A member has reported an incident in which a person was scalded when working in the kitchen/pantry area onboard a vessel. The incident occurred when the injured person was rinsing dishes in the ships pantry, near a boiler. The boiler exhausted steam through a vent pipe, and so a plastic tube was retro-fitted to the vent, allowing any condensate to drain into the sink in which the dishes were rinsed. Steam vented from the boiler and the condensate ran down the tube, exiting the pipe in to the sink and coming in to contact with the injured person's right forearm. He immediately ran cold water over his arm and reported directly to the medic who carried out first aid.

Above – vent tube and exit to sink

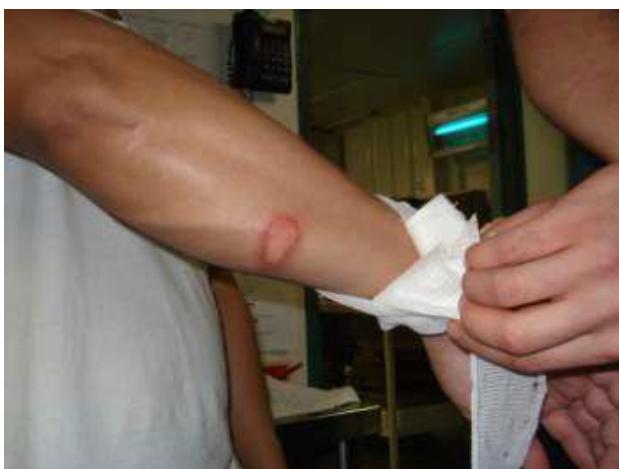
The injury
