Collision between *Petunia Seaways* and *Peggotty* on the River Humber 19 May 2016

SUMMARY

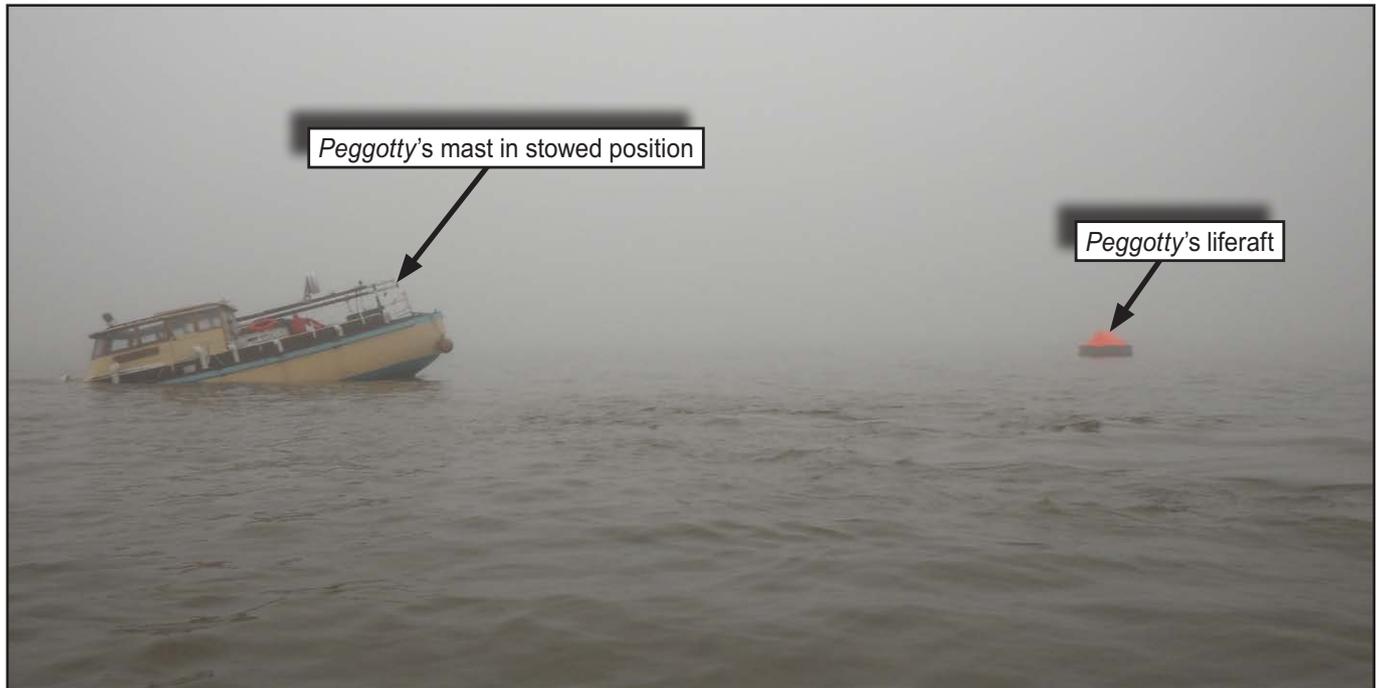
Figure 1: *Peggotty* following the collision (note: stowed mast and deployed liferaft)

As *Petunia Seaways* continued on its voyage, *Peggotty*'s crew were shocked but uninjured. *Peggotty*'s upper structure had been seriously damaged, and as the skipper began to gather his belongings together he saw that the forward cabin space had water seeping up through the deck. At 0454 *Peggotty*'s skipper called VTS and advised that the launch had been 'brushed by a ferry' and that *Peggotty* was taking on water and required assistance. During the resultant VHF conversation, the VTSO established that *Peggotty*'s own bilge pumps were working but not able to cope with the volume of water ingress, and that its position was just north of the Middle Burcom buoy. At 0457:38, encouraged by the buyer's representative, the skipper called a "Mayday" on his VHF as *Peggotty* began to sink by the bow.

Peggotty was a historic launch and of sound construction when built. However, at the time of the accident the launch was over 70 years old and it had not been subjected to a structural survey for at least 20 years. It is without doubt that *Peggotty*'s wooden hull failed in the collision with *Petunia Seaways*. As no direct source of water ingress was visible, it is likely that the launch's planking failed along the upper limit of the lower hull's fibreglass coating, leading to catastrophic damage and making the loss of the launch inevitable.

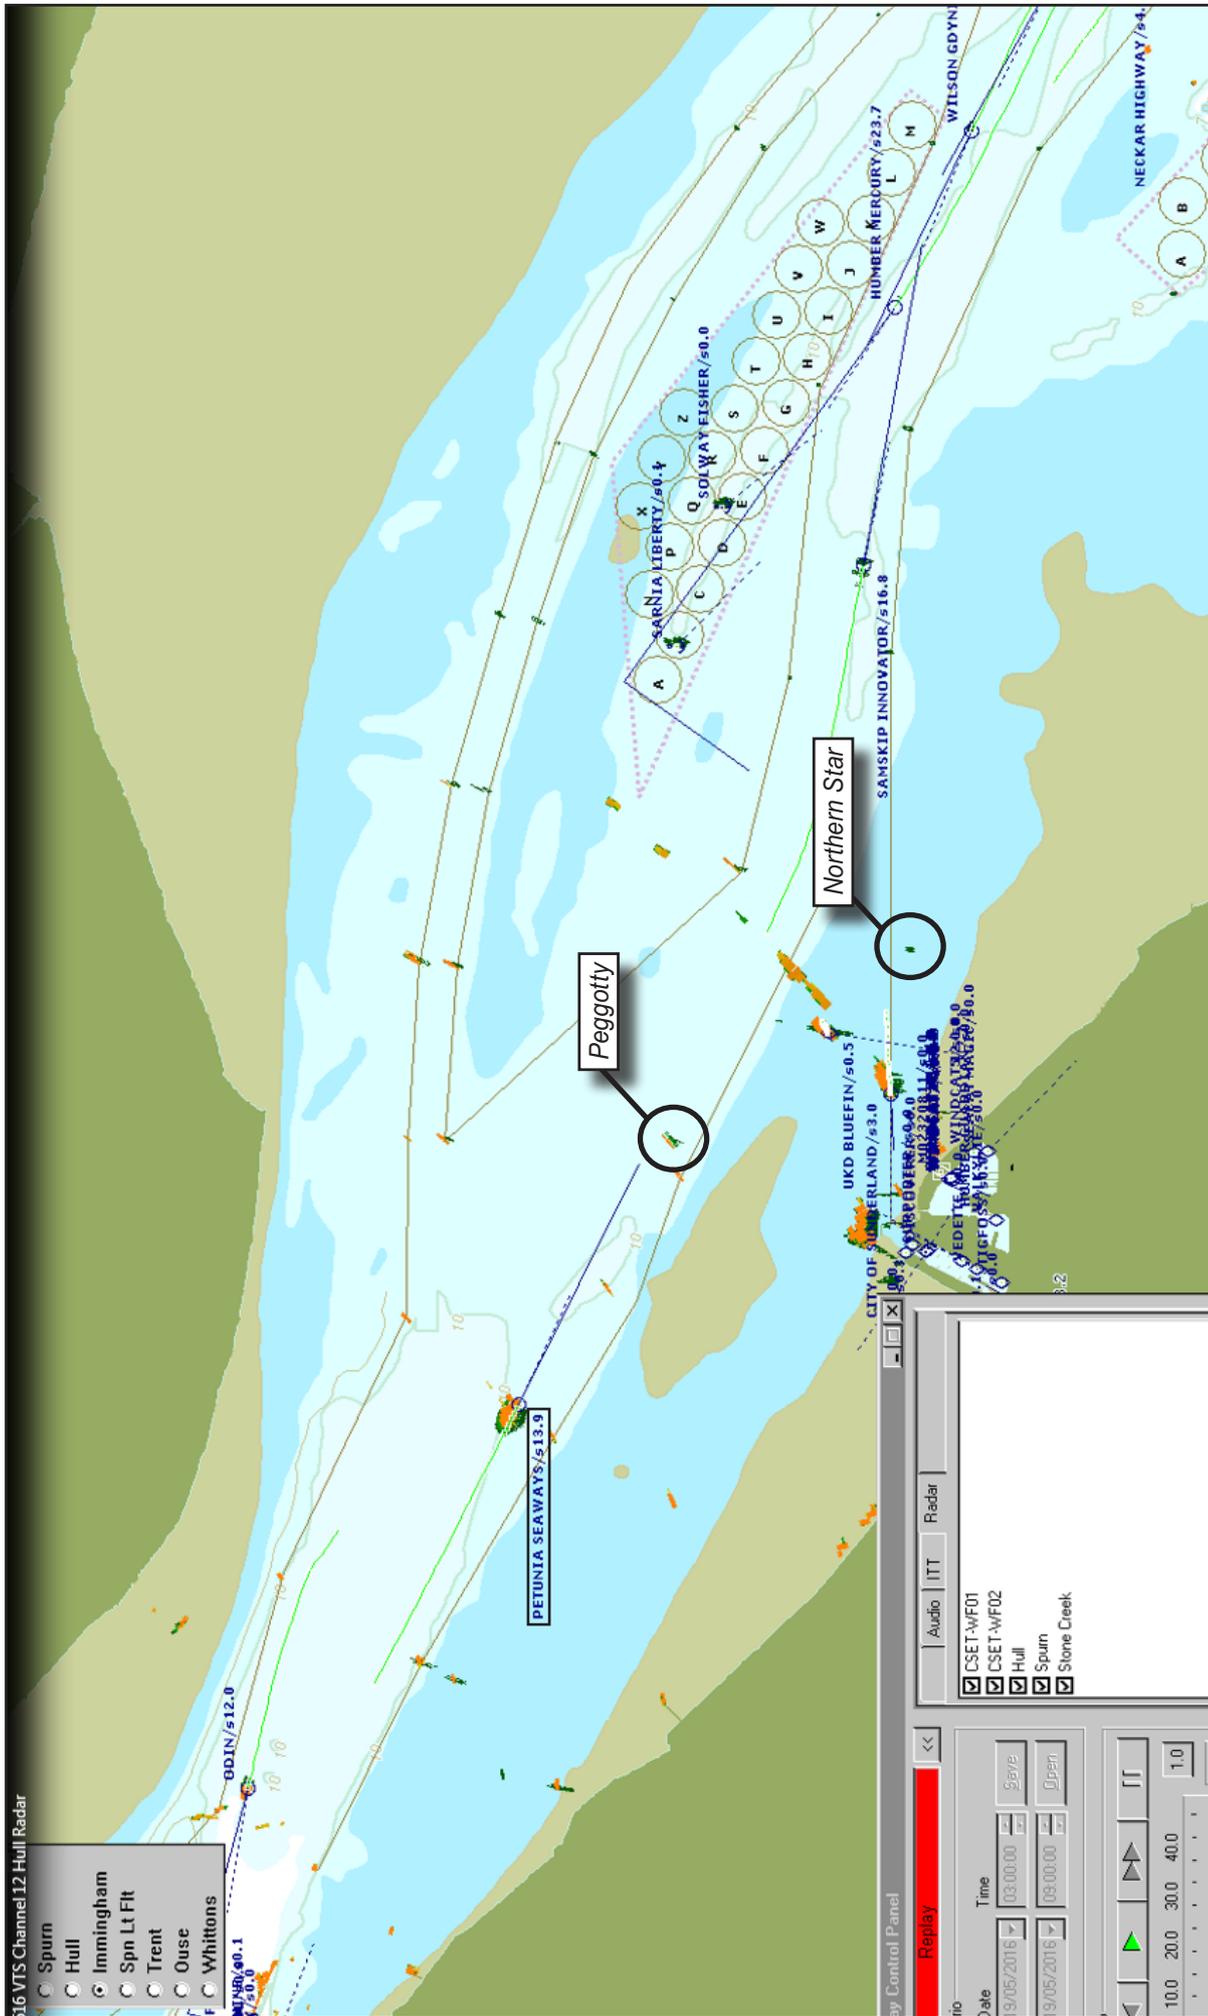
Peggotty's skipper continued to steer a north-westerly course, across the southern buoy line and, at 0444:32, the launch entered the main shipping channel. Shortly afterwards *Northern Star's* skipper called VTS Humber to request permission to cross the channel. During the VHF conversation that followed, the VTSO advised the skipper that he could not see *Northern Star* on his radar display. He also stated that at that time *Petunia Seaways* was outbound with a speed at 14 knots. A screenshot of the VTSO's radar display at 0446 is at **Figure 2**.

Figure 2: VTSO's radar display at 0446

Given the size of the channel 12 area and the lack of information and communication from *Peggotty's* skipper prior to the collision, it is not surprising that the VTSO did not identify the small target on his radar screen as being *Peggotty*. However, following his brief to the skipper of *Northern Star* regarding the outbound *Petunia Seaways*, it is unfortunate that the VTSO did not notice the small target in the main channel directly ahead of the ro-ro vessel. Furthermore, the VTSO did not identify *Northern Star* on his screen despite having been given accurate positional information about the vessel's position. Additionally, he failed to speedily identify *Peggotty's* position post-collision, again having been given an accurate position of the vessel.
