MARINE ACCIDENT
INVESTIGATION BRANCH

SAFETY DIGEST

**Lessons from Marine
Accident Reports
1/2017**

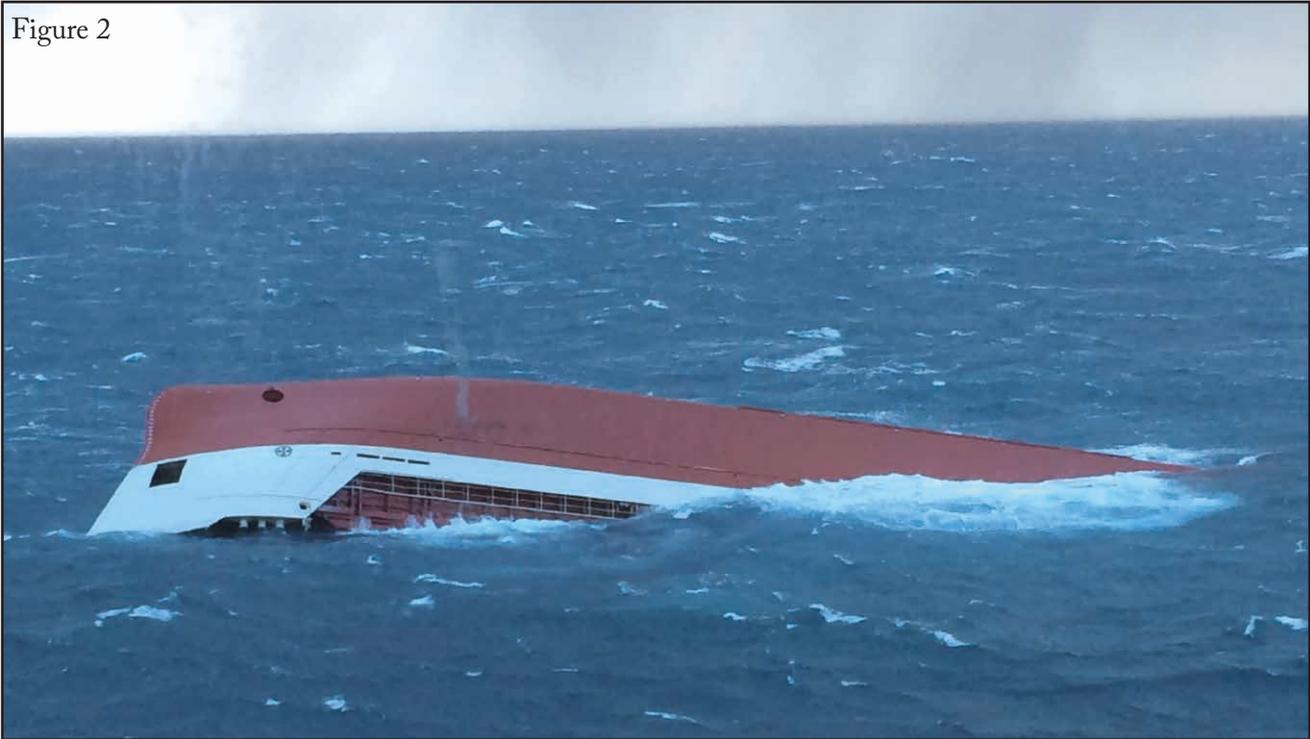
Figure 2

of the crew survived. The alarm was not raised until about 25 hours later when the upturned hull was spotted by a passing ferry (Figure 2). The accident had gone unnoticed because: the capsizing was so rapid that there was insufficient time for the crew to call a "Mayday", the EPIRB almost certainly became trapped and did not float free, and the AIS transmissions ceasing was not observed ashore.

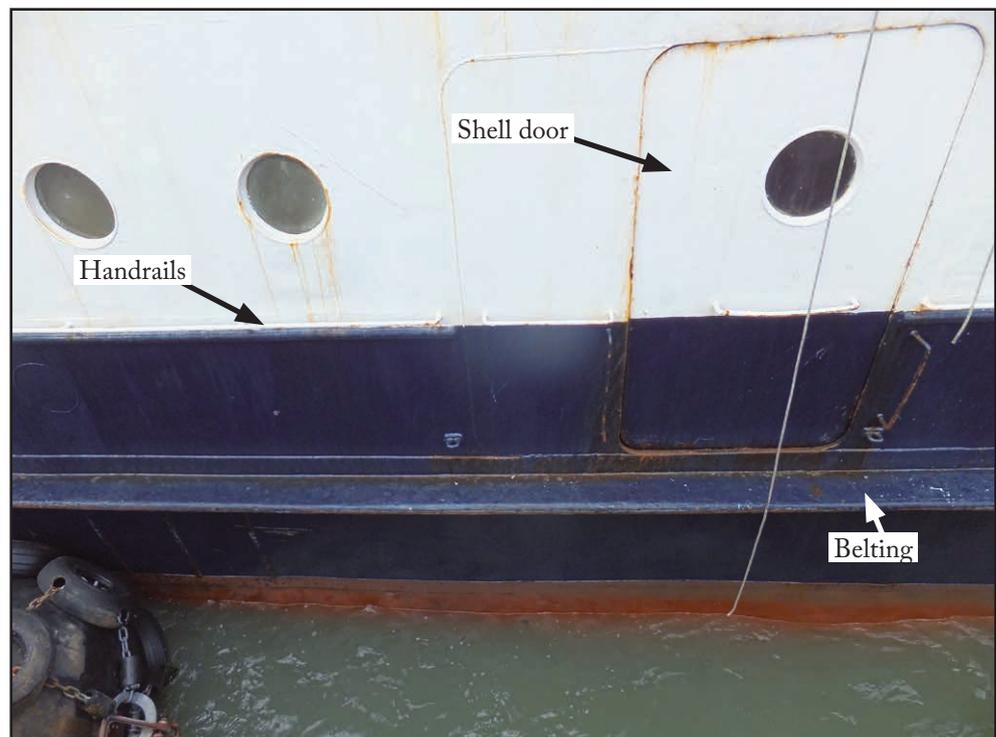
Figure 1: Shell door, ship's side belting and handrails

1. The shore worker's training had not included shipboard operations and so he did not recognise the danger of using the shell door to disembark instead of the gangway.
2. Owners should ensure that anyone they allow to access their vessels unescorted is trained in the potential hazards they may encounter on board.
3. The crew regarded the line handler as a co-worker rather than as a visitor to the vessel.
4. Procedures need to be in place to ensure that crews understand the importance of supervising and/or training visitors.
5. The hazards associated with leaving the shell doors open and unguarded when in port, with no passengers embarked, had not been recognised. Owners and crews should ensure that risk assessments cover all aspects of their vessels' operations.

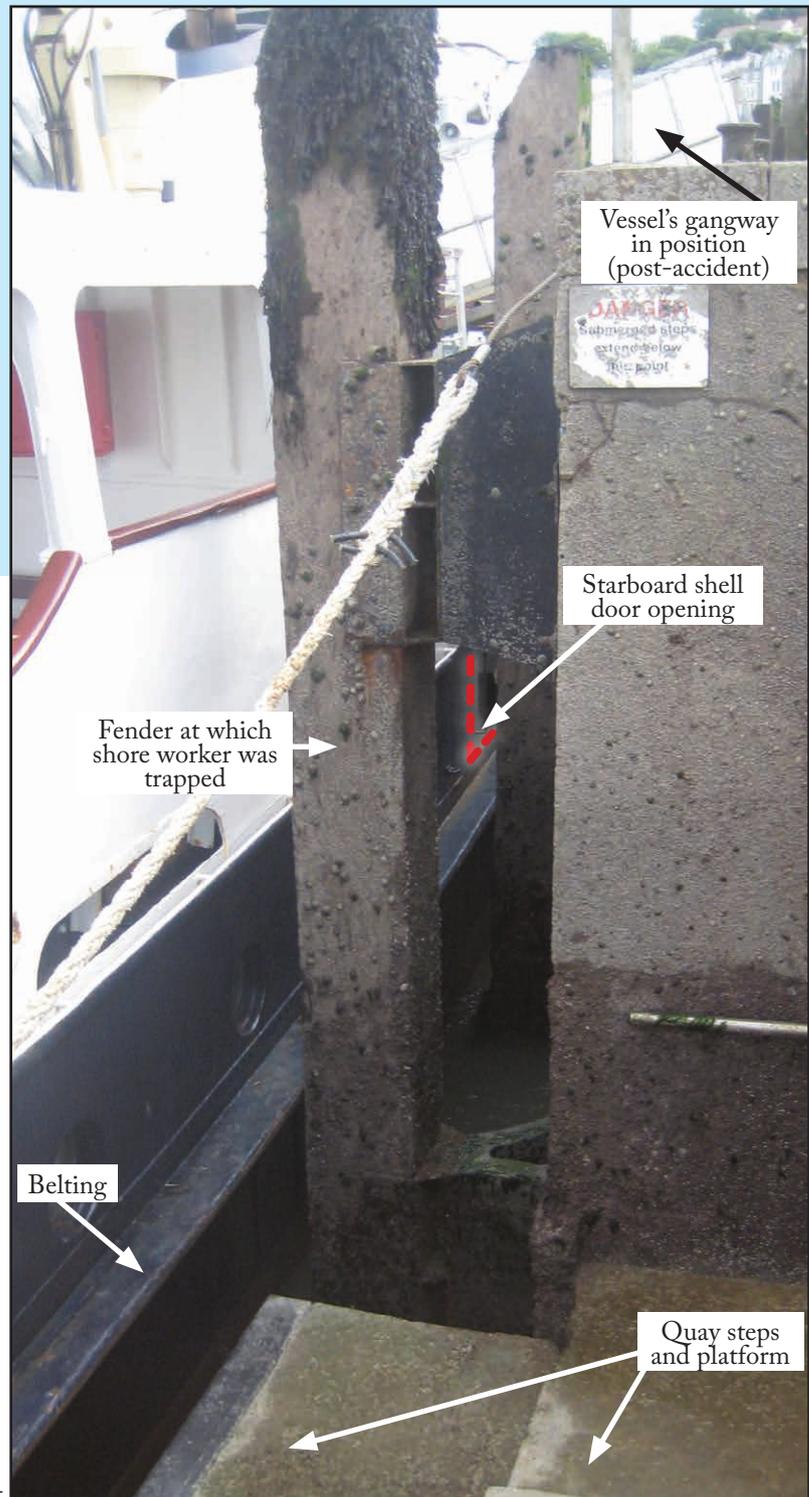
Figure 2: Location of entrapment

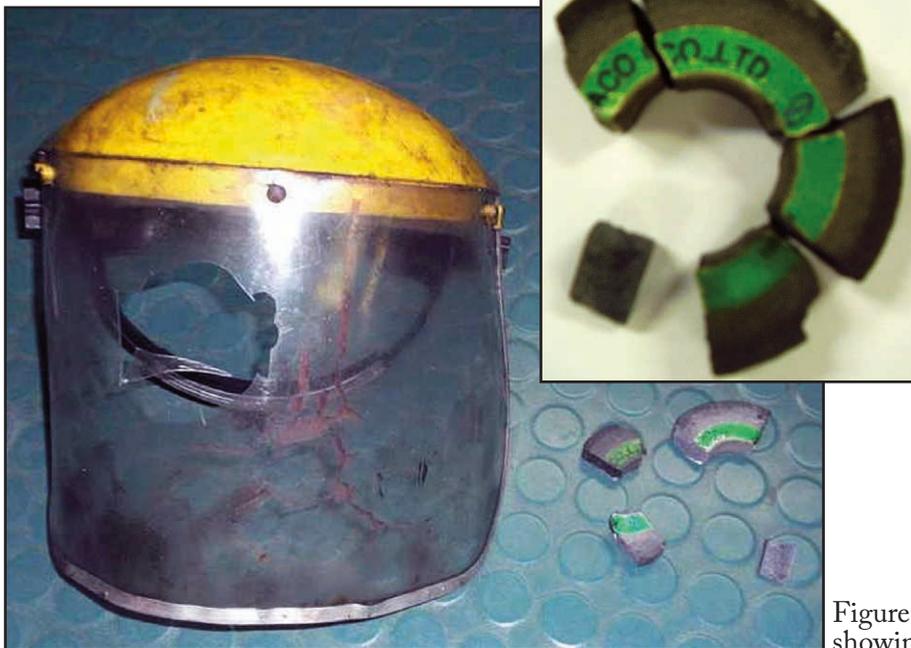
The crew could not determine the speed rating of the exploded grinding disc as there were no more similar discs on board. It was most likely to have been rated well below 22000rpm as most general purpose grinding discs are rated between 5000 and 15000rpm.

Figure: Damaged face mask with inset showing the exploded grinding disc

1. Exceeding the safe operating speed of a grinding wheel can cause it to crack or disintegrate. When the wheel speed is doubled, the stresses it experiences are quadrupled. Always ensure that the tool's rotational speed does not exceed the maximum allowed speed of the grinding disc.
2. Face protection masks are not designed to withstand the impact of high momentum objects striking them. It was extremely fortunate that the second engineer did not lose an eye or suffer fatal injuries.

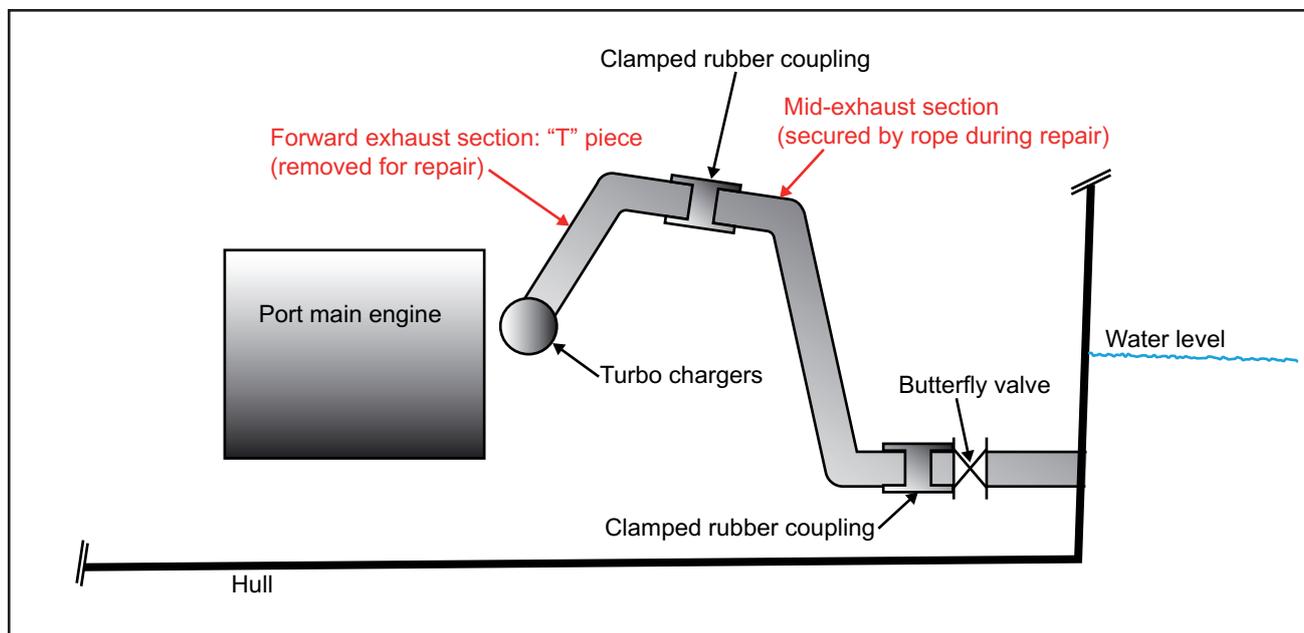
The vessel had undergone maintenance, carried out by contractors in the week leading up to the foundering. The crew had reported water ingress and exhaust gas leaks in the port side engine room. Contractors had attended and had identified a defective section of corrugated exhaust pipe connected to the port

main engine turbo charger. The decision was taken to remove the defective section of pipe (Figure 1) and to fabricate a new one at the contractor's workshop.

Figure 1: Port main engine exhaust

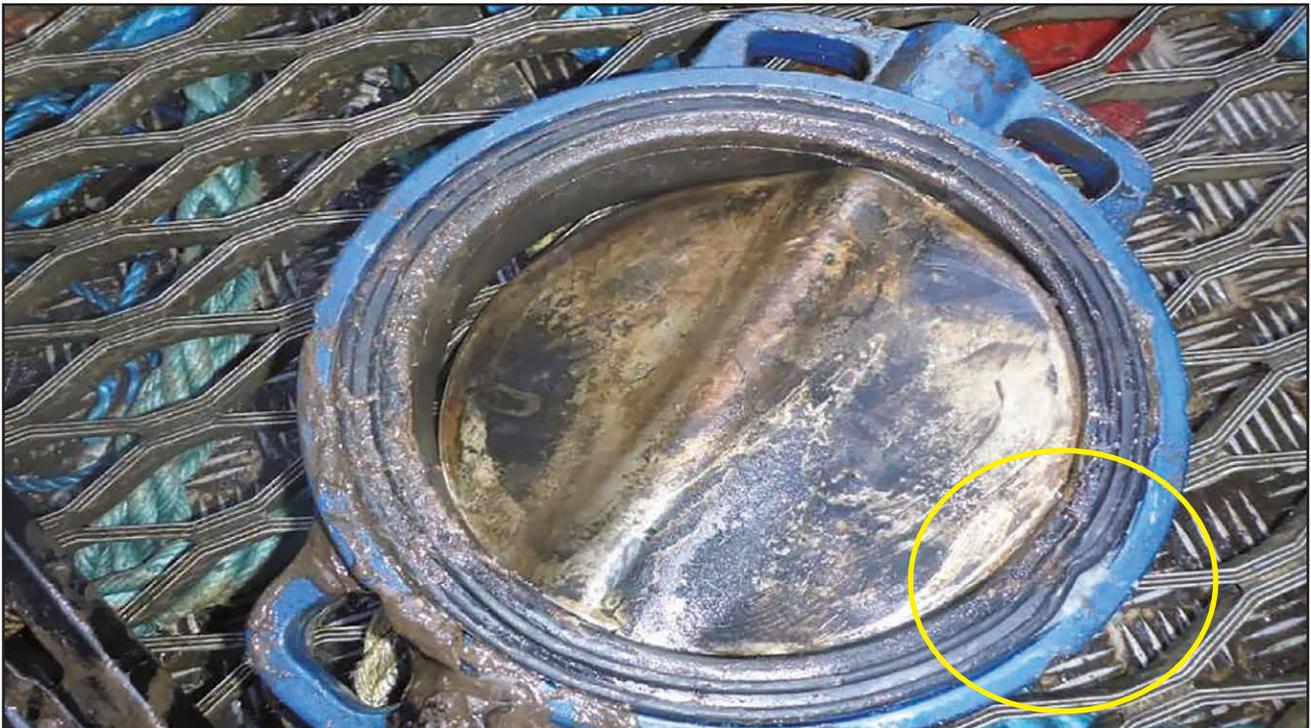
Following the vessel's recovery the affected ship side valve was checked in situ and it was found that it could not be fully closed. The valve was removed from the vessel; on inspection it was noted that the valve body was damaged (Figure 2). As found it would not have been possible to fully close the valve; this was not apparent to the contractors or the

vessel's crew prior to the accident. The water ingress and subsequent flooding occurred as either the rope, holding the remaining section of exhaust pipe above the waterline, failed, or the short section of rubber hose connected to the valve lost its seal as it was lifted by the rope.

Figure 2: Defective butterfly valve

2. A single ship side valve is a single point of failure. Any associated works on a system connected to such a single point of failure must be fully risk assessed and appropriate control measures put in place prior to maintenance being undertaken to vessels afloat.

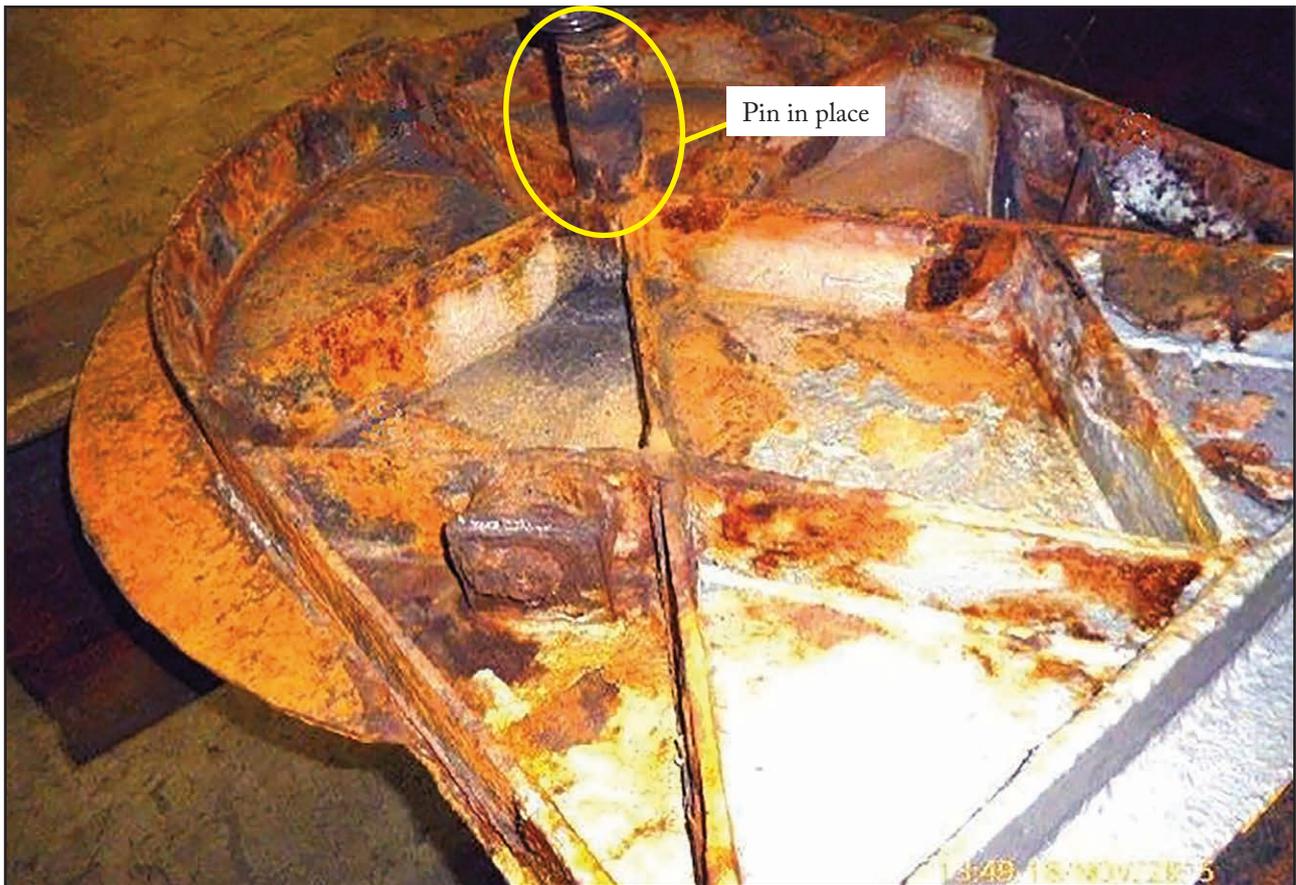
Upon investigation it was found that the failure of the accommodation ladder was due to the corrosion of the central pivot pin, which had caused the turntable to detach from its support platform (see Figures 2 and 3). In addition, the turntable's roller bearings were completely rusted and had seized solid. The surrounding metal structure of the platform was also wasted due to corrosion.

Figure 2: Port turntable (upside down) with pin in place

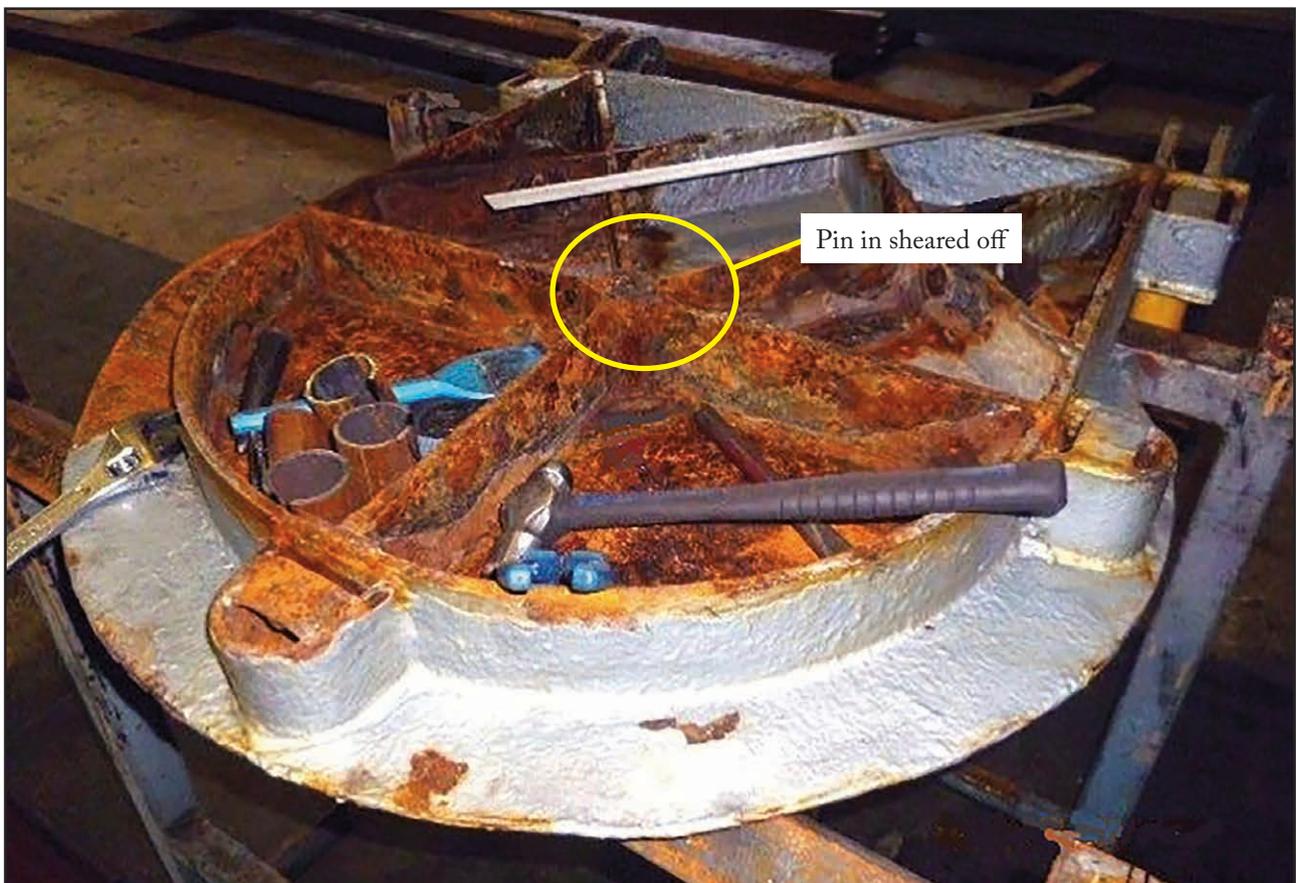
According to the ship's maintenance management system, the ladder, turntable and support platform should have been inspected and greased on a monthly basis. It was evident from the post-accident inspection, that the greasing point in the centre of the turntable had not been used for some time. It was also evident that the roller bearings could not be inspected or greased without unbolting the turntable from the platform, and dismantling it. There was no record of this task ever having been done.

Figure 3: Starboard turntable (upside down) with pin sheared off

2. The importance of routine preventative maintenance is clearly demonstrated in this incident where three crew members were badly injured. It is very easy to miss out that one inspection or maintenance routine, particularly if at first glance the equipment looks in good condition, and proper inspection or maintenance would be difficult and time consuming. However, as in this case, looks can be deceiving, and the more accessible, well painted topsides of the turntable masked the poor condition of the structure beneath.

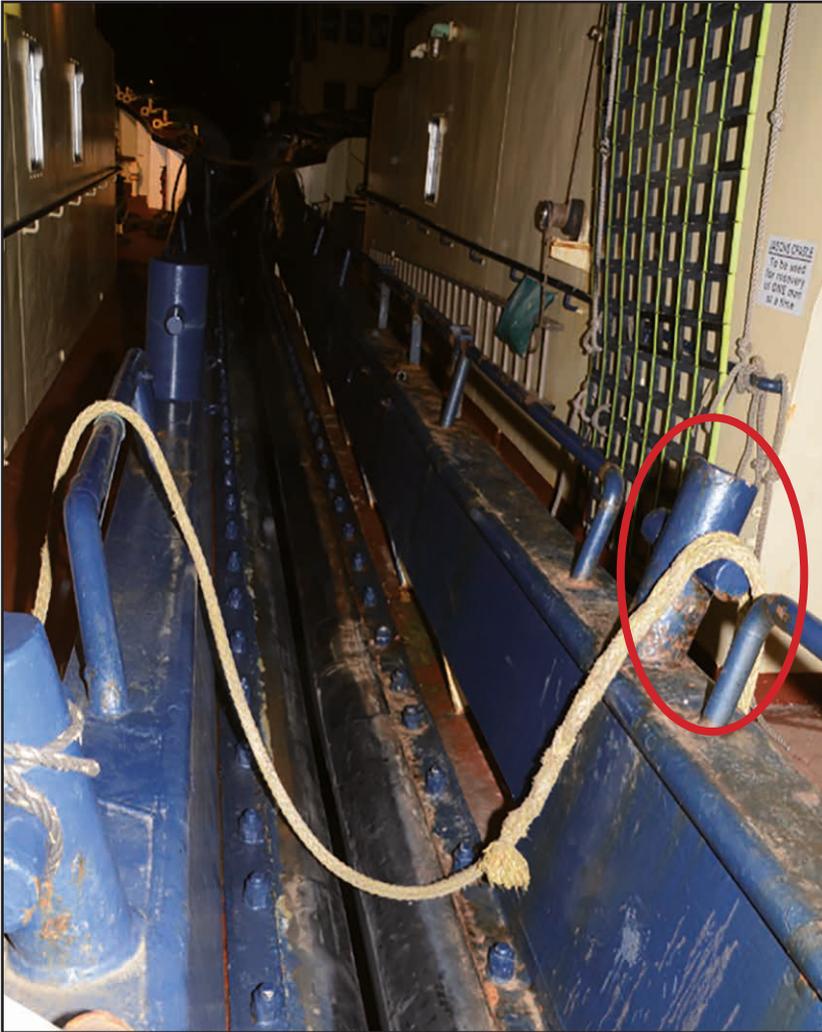
Figure 1: Reconstruction of how the amidships mooring rope was found after the accident

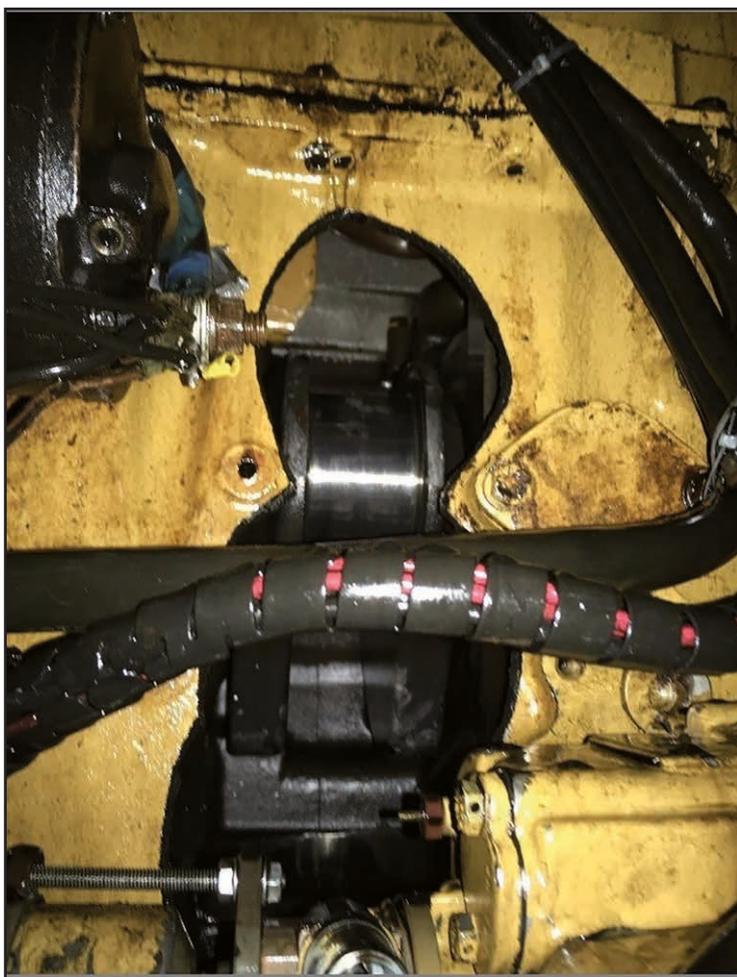
A bottom end bearing bolt on one of the engines had failed, resulting in the connecting rod and piston assembly being ejected through the side of the engine casing. The engine's

Figure 1: Crankcase damage caused by connecting rod/piston assembly

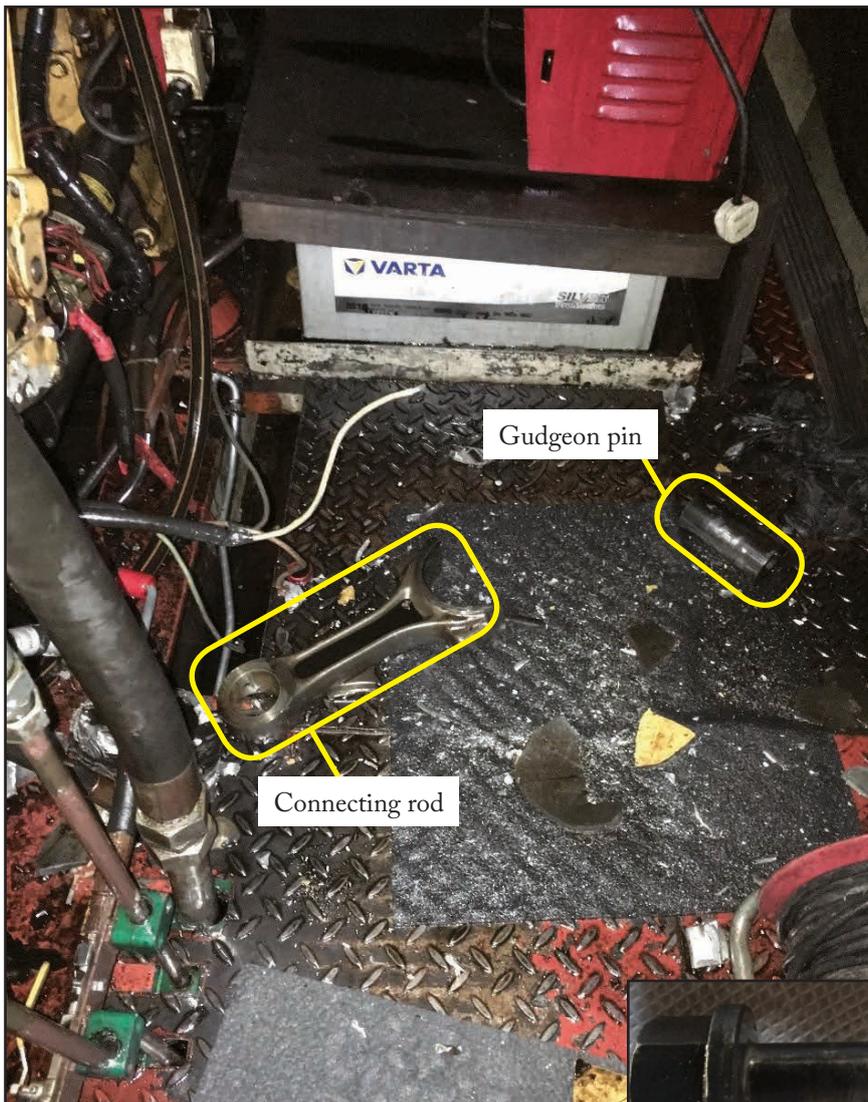
Figure 2: Connecting rod, piston and gudgeon pin ejected from the engine (inset: failed bottom end bearing bolt)

1. Some older vessels are not required to have a fixed smoke/fire detection system in their engine rooms. However, mandatory requirements for these will soon be introduced. Be safe and proactive by fitting an appropriate system before it becomes mandatory.
2. Bottom end bearing bolts have a fixed fatigue life. Consult the engine makers and implement their recommendations for replacing these on your vessels.

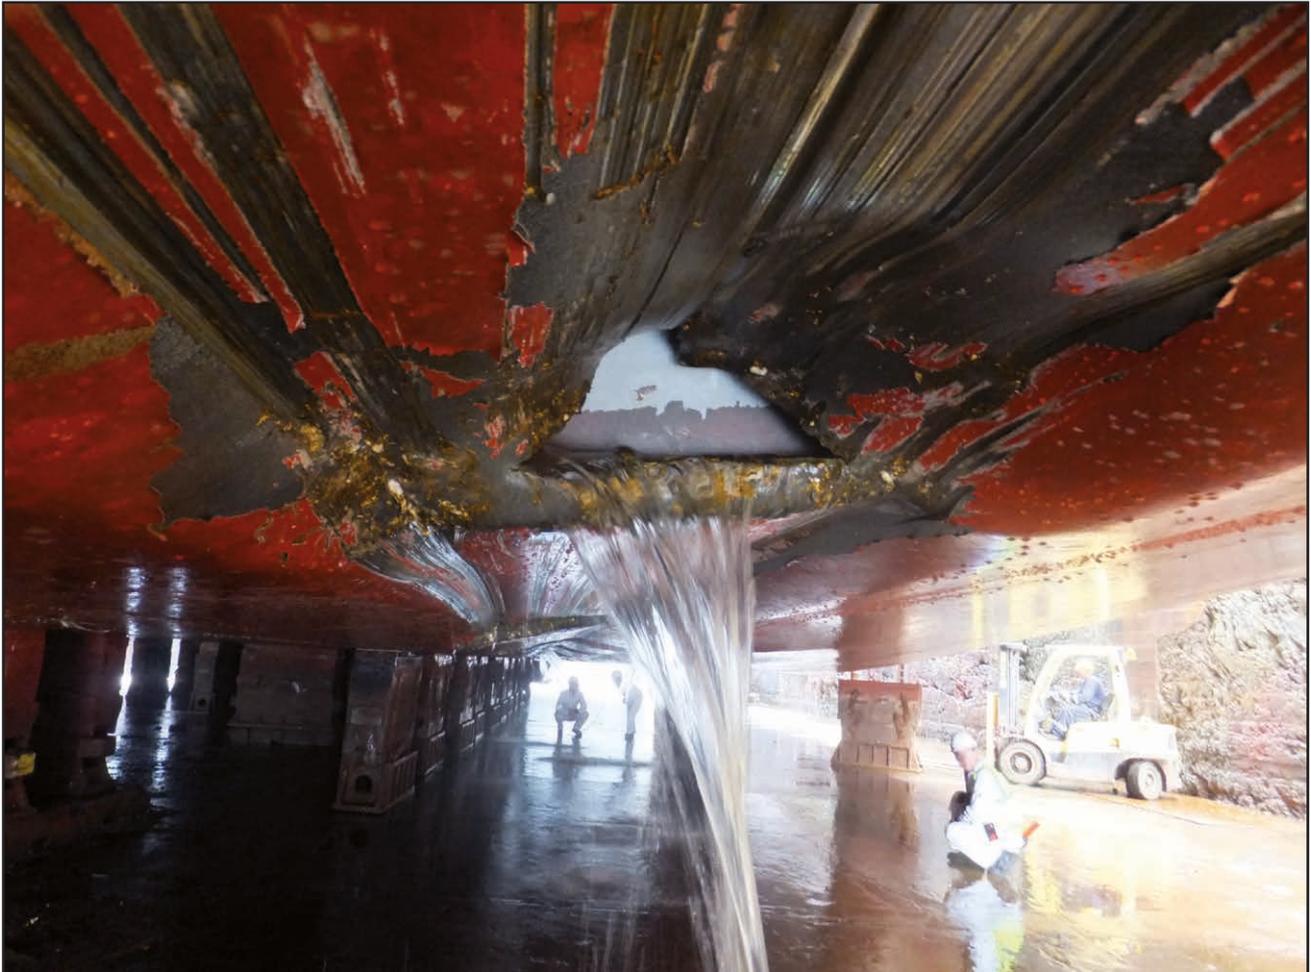
of its length (Figure 2). The hull was breached in several places but the subsequent flooding was contained in the double-bottom void spaces.

Figure 2: Hull breach and raking damage

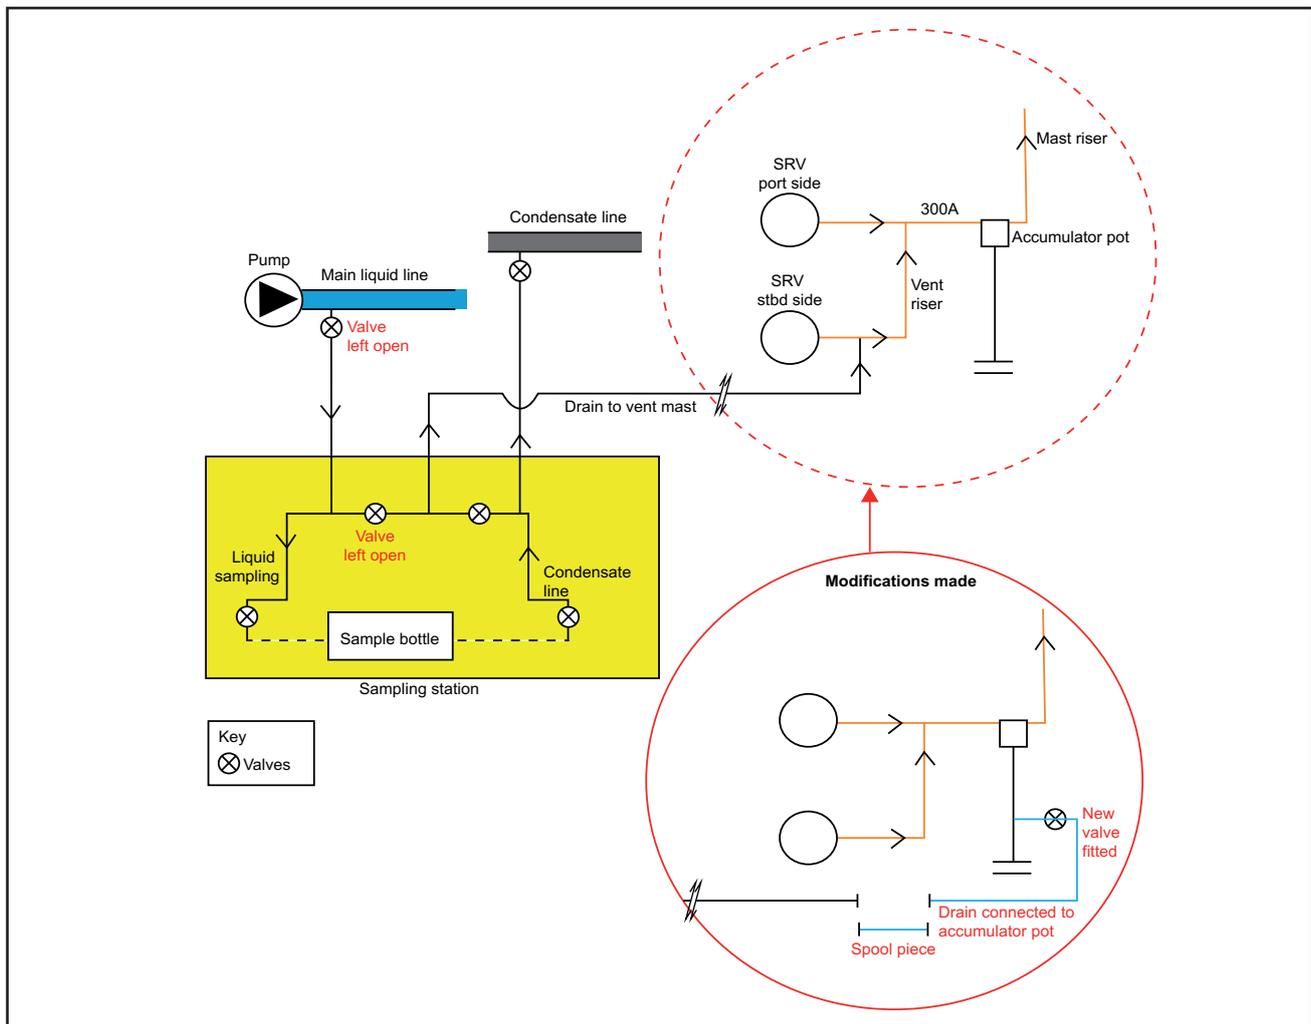
and led to the piston cracking open, as well as the main seat leaking while seated. This led to the SRVs lifting, which resulted in the gas discharge.

Figure: Before and after modification

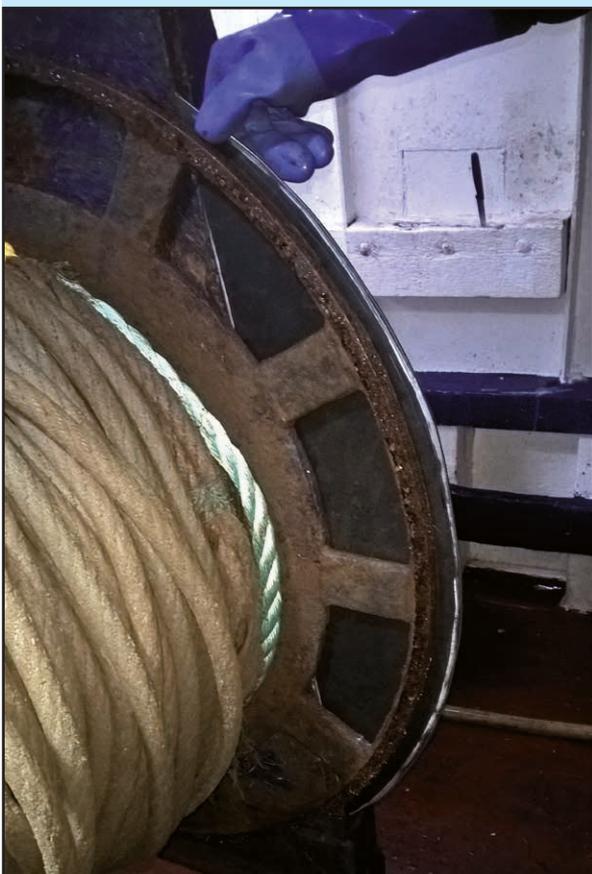
Figure 3

- The skipper realised that the area in which the accident occurred was unnecessarily restricted due to the wheelhouse door opening towards the winch. He changed the door around so that it opened away from the winch, allowing clear access to the wheelhouse from aft of the winch (Figure 2).
- The side cheeks of the winch were exposed and there were no guards to prevent entrapment. The skipper therefore fitted metal plates to the winch housing (Figure 3) to prevent anyone becoming trapped in the future.

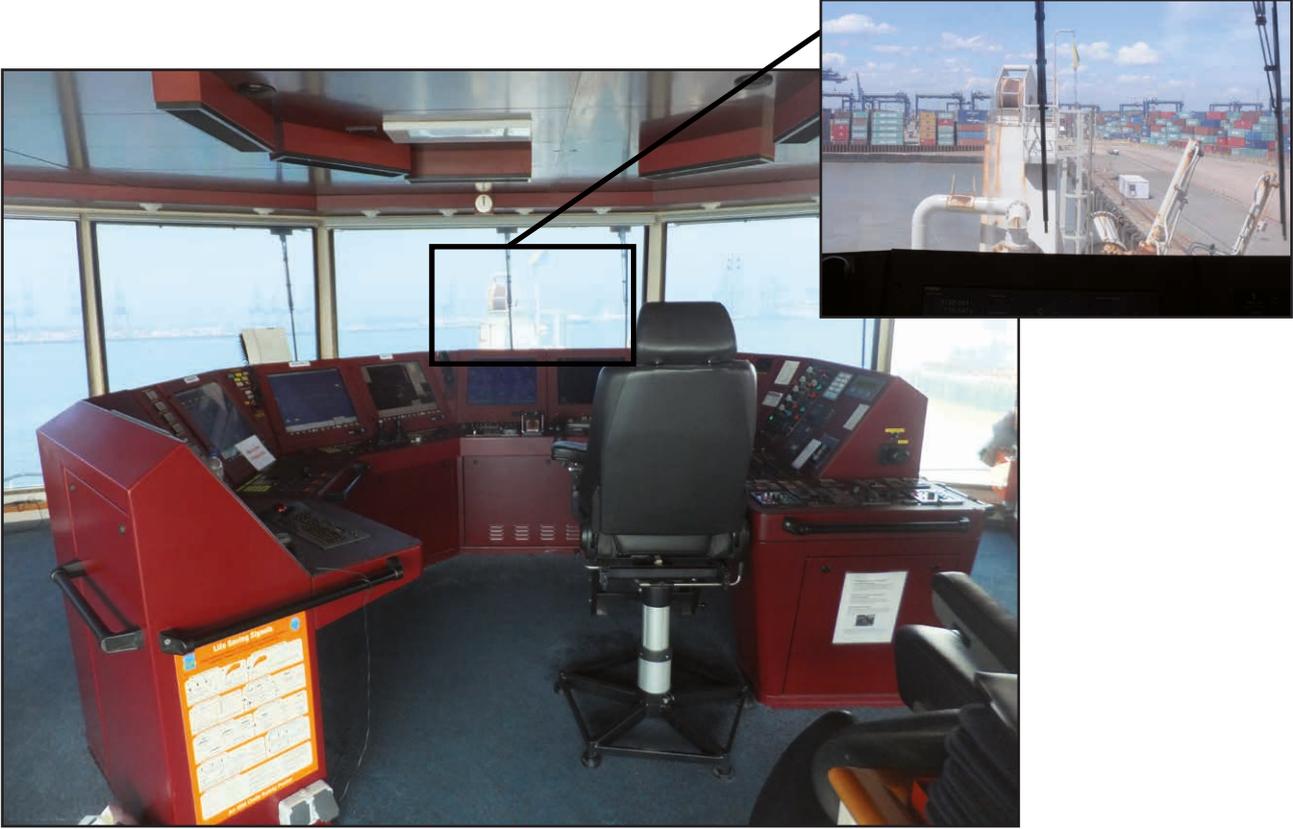
Figure 2: Bridge conning position (inset: obstruction)

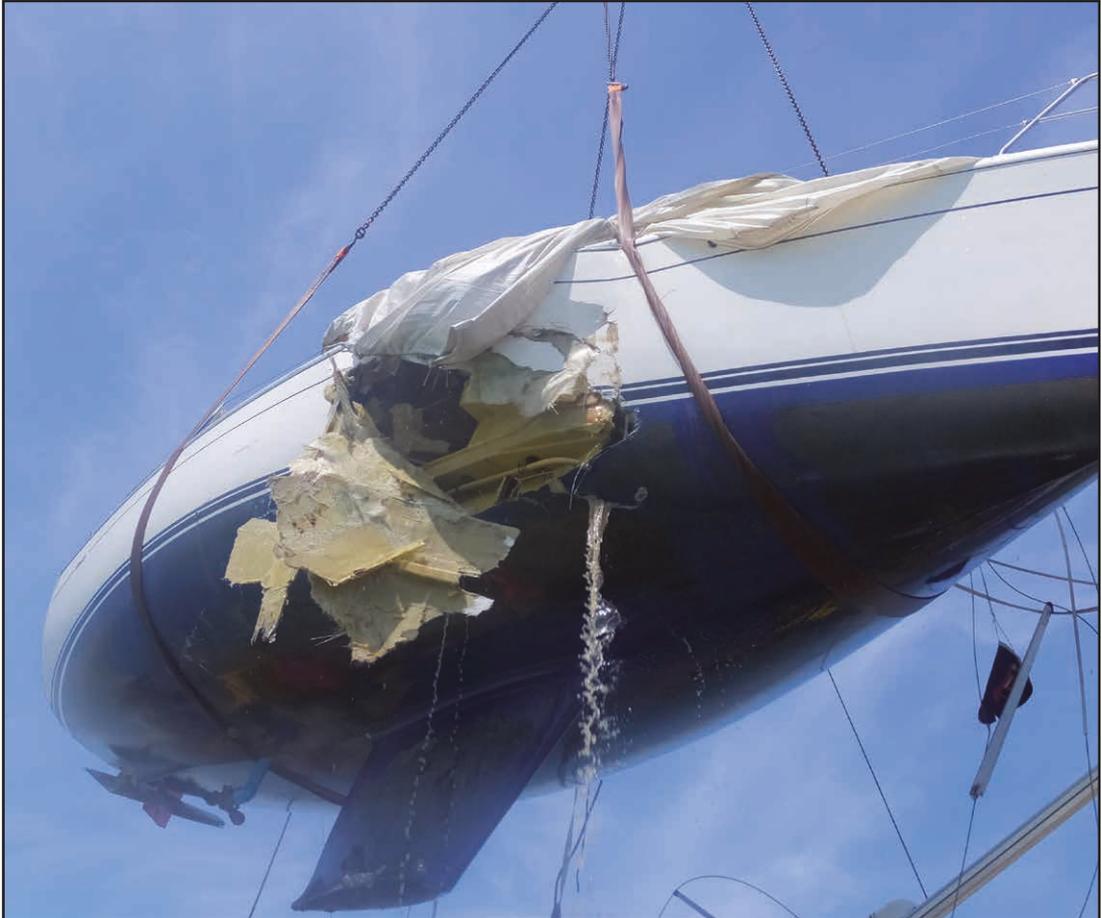
Figure 3: Damage to starboard side of yacht
