National Transportation Safety Board

Marine Accident Brief

Sinking of Towing Vessel *Spence*

Accident no.	DCA16FM011
Vessel name	<i>Spence</i>
Accident type	Sinking
Location	Caribbean Sea, about 115 nautical miles (nm) north of Cartagena, Colombia 12°17.6' N, 75°38.1' W
Date	December 14, 2015
Time	1540 eastern standard time (coordinated universal time – 5 hours)
Injuries	Non-life threatening injuries to three crewmembers
Property damage	\$1.5 million est.
Environmental damage	None
Weather	Clear skies with 12 nm of visibility, winds north-northeast at 20–25 knots, seas easterly at 6 feet, air temperature 83°F
Waterway information	The Caribbean Sea is bounded by the Greater and Lesser Antilles to the north and east, and by South and Central America to the south and west.

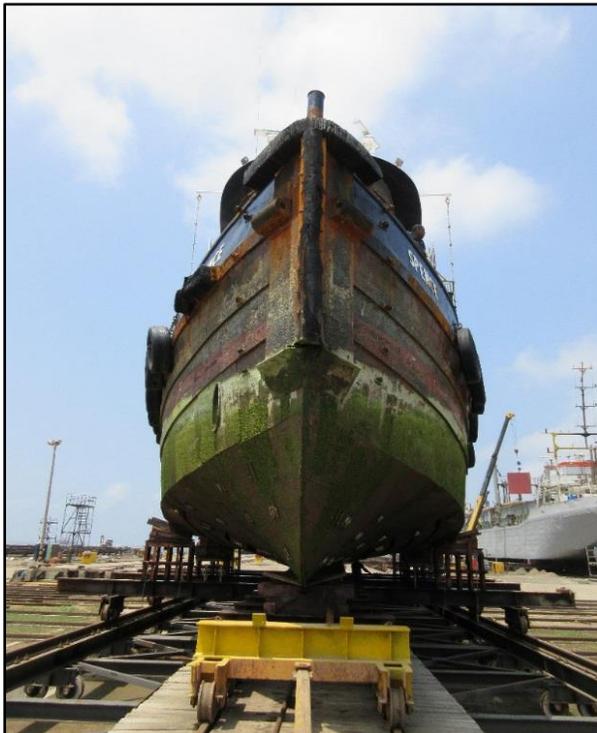
***Spence* in the COTECMAR dry dock, September 2015, before repair work had begun. (Photo courtesy of COTECMAR Shipyard)**

On October 2, an American Bureau of Shipping (ABS) surveyor identified an additional 29 repairs required to renew the towing vessel's international load line certificate.² These included repairs to buckled bulwarks, wasted side-shell plating, a wasted forepeak ballast tank structural section, and a corroded rope locker hatch coaming on the main deck.

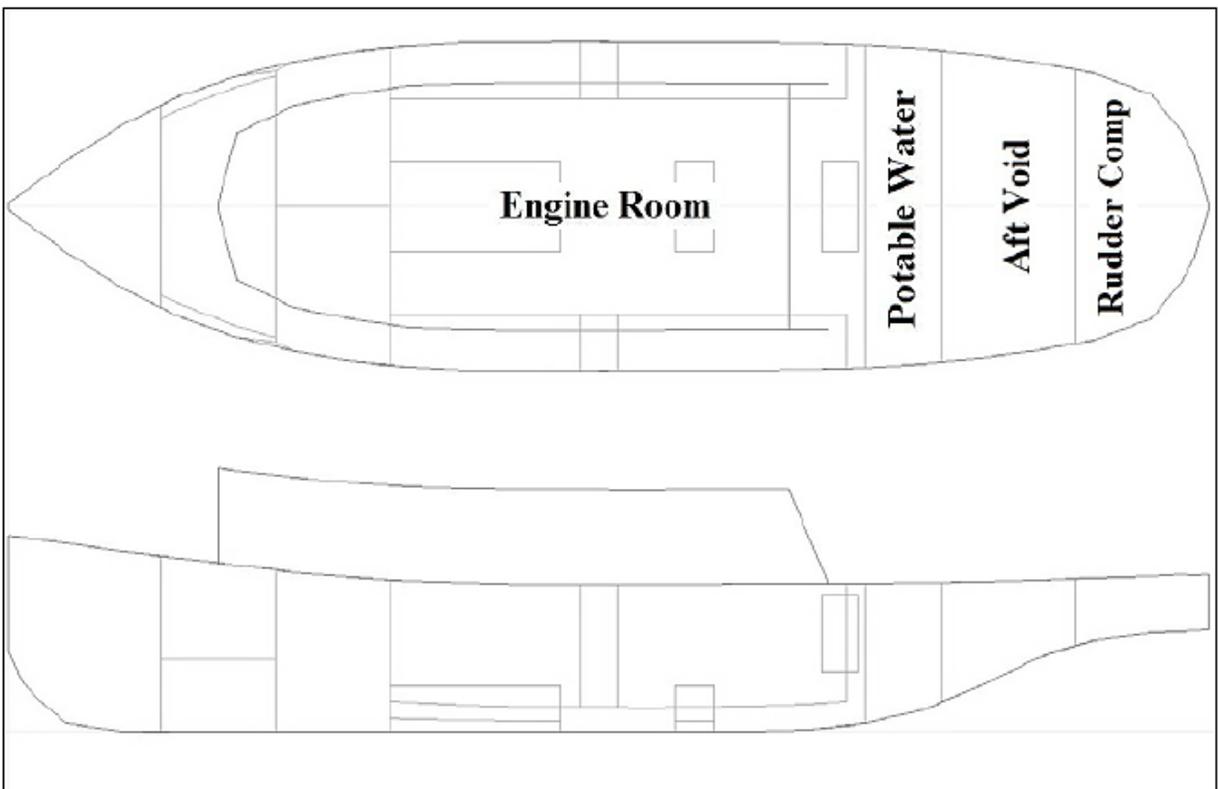
The engineer told the captain the engine room appeared normal; the bilges were dry, the fuel tanks and potable water tank were not leaking, the main engine and generator were running normally, and the rudder hydraulic pump was running. The mate stated that they concluded that one of the aft compartments—either the void space or the rudder equipment room—had flooded, possibly where the stern tube or the rudder stock penetrated the hull. The engineer began transferring fuel from starboard to port, but this did not correct the list. During this operation, he suffered minor burns to his arms, leg, and feet from contact with the generator exhaust manifold.

General arrangements, annotated by the Coast Guard Marine Safety Center, for *Spence* stability study. Shown are compartments extending aft of midship beneath the main deck. (Provided by US Coast Guard)

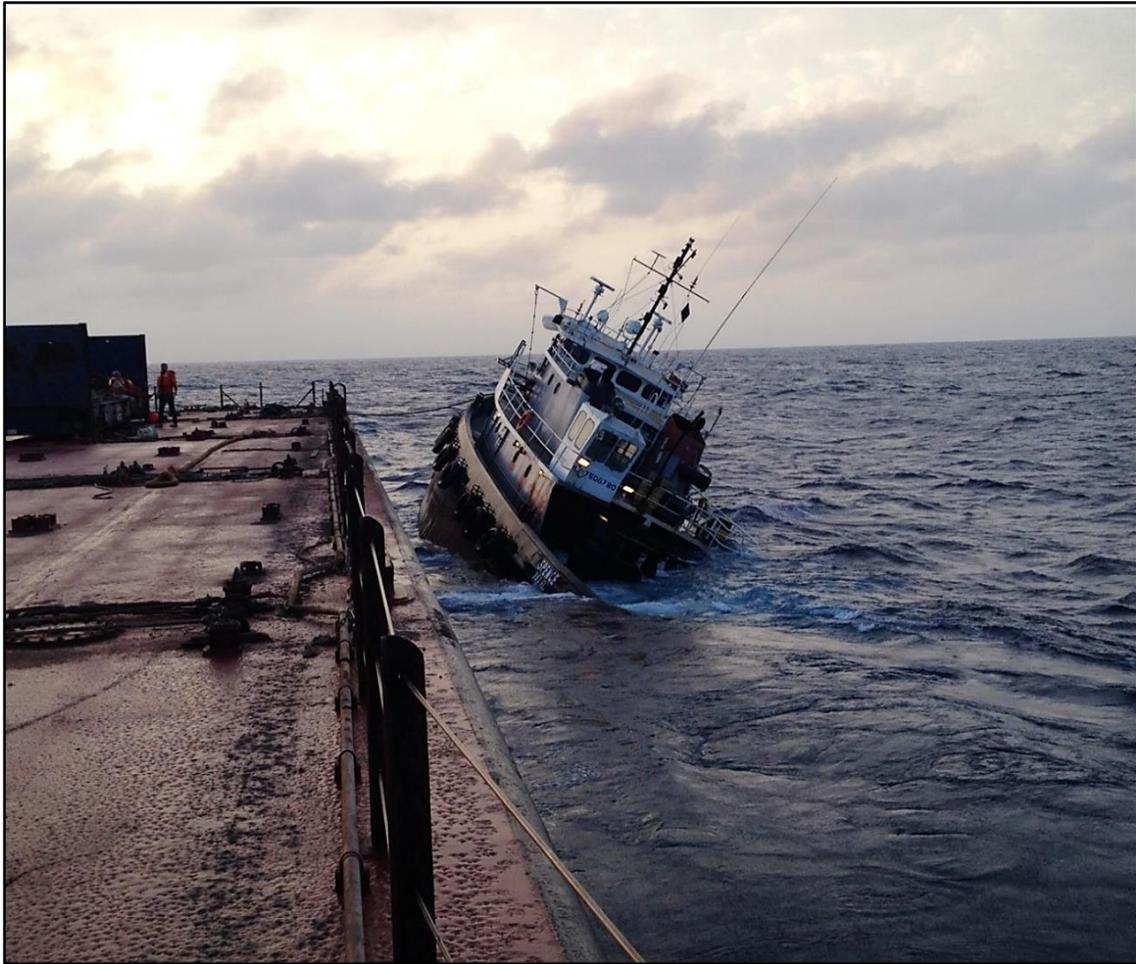
***Spence* shortly before sinking, after crewmembers had abandoned ship to barge *Guantanamo Bay Express*. (Photo by *Spence* crewmember provided by Coast Guard)**

About 1730, the towing vessel, while still connected to the barge by the towing wire, began drifting away and sank without capsizing. An hour or two later, the crew felt and heard three bangs, presuming that the noise was the towing line parting as the 189-gross-ton *Spence*, with an estimated value of \$1.5 million, sank under the barge. The charted depth was 11,500 feet. The crewmembers stated they spent a windy and cold night on the barge awaiting rescue.

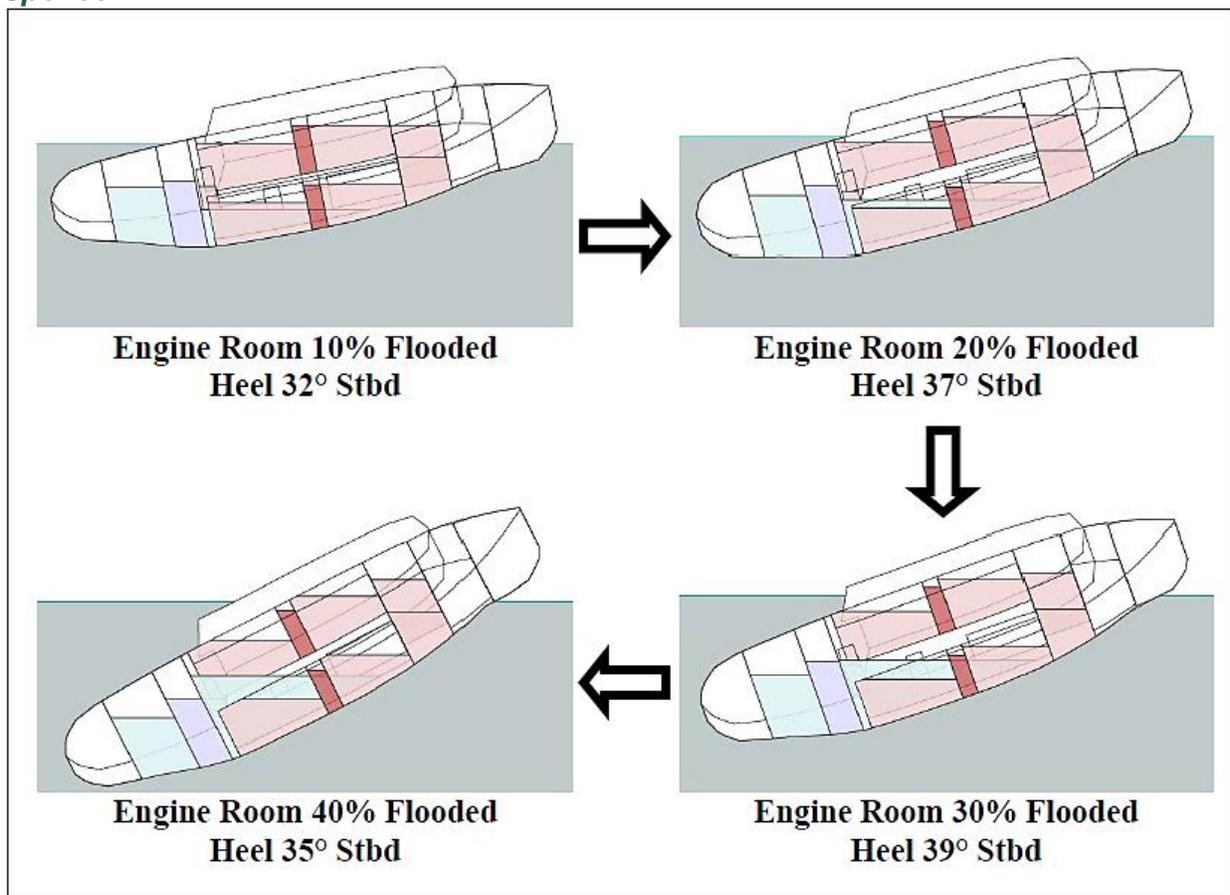
The MSC then analyzed gradual flooding of the aft void in 10-percent volumetric increments. The results showed that for a range of vessel VCGs, when the aft void was flooded approximately 70–90 percent, the vessel would likely enter a lolling condition, resulting in a sudden list to starboard of 20–30 degrees, consistent with crew reports.⁵ The study determined that, at a minimum, downflooding could have occurred through several gooseneck vents at the aft end of the superstructure, which likely submerged in the lolling condition. Additional analysis with the aft void flooded 70 percent and the engine room progressively flooding through downflooding points indicated the vessel would sink by the stern without capsizing.

The effects of progressive flooding in the engine room after the vessel entered the lolling condition. In this evaluation, the overall VCG is 9.9 feet, the aft void is 70 percent flooded, and the rudder compartment is dry. (Provided by Coast Guard)

The MSC stated, “the most likely sinking scenario involved gradual flooding in the aft void, which caused the aft deck to submerge and the vessel to enter a lolling condition, resulting in a sudden list to starboard. In this state, water would then have likely entered other spaces through downflooding points, causing progressing flooding and sinking by the stern without capsizing.”

The National Transportation Safety Board determines that the probable cause of the sinking of the towing vessel *Spence* was gradual flooding from an unknown point of ingress into the aft void space followed by downflooding to the engine room.
