# Loss of propulsion of the passenger cruise ship *Norwegian Star*

Bass Strait, 18 nm SW of Cape Liptrap, Victoria on 10 February 2017

**ATSB Transport Safety Report**  
Marine Occurrence Investigation  
329-MO-2017-003  
Preliminary – 27 April 2017

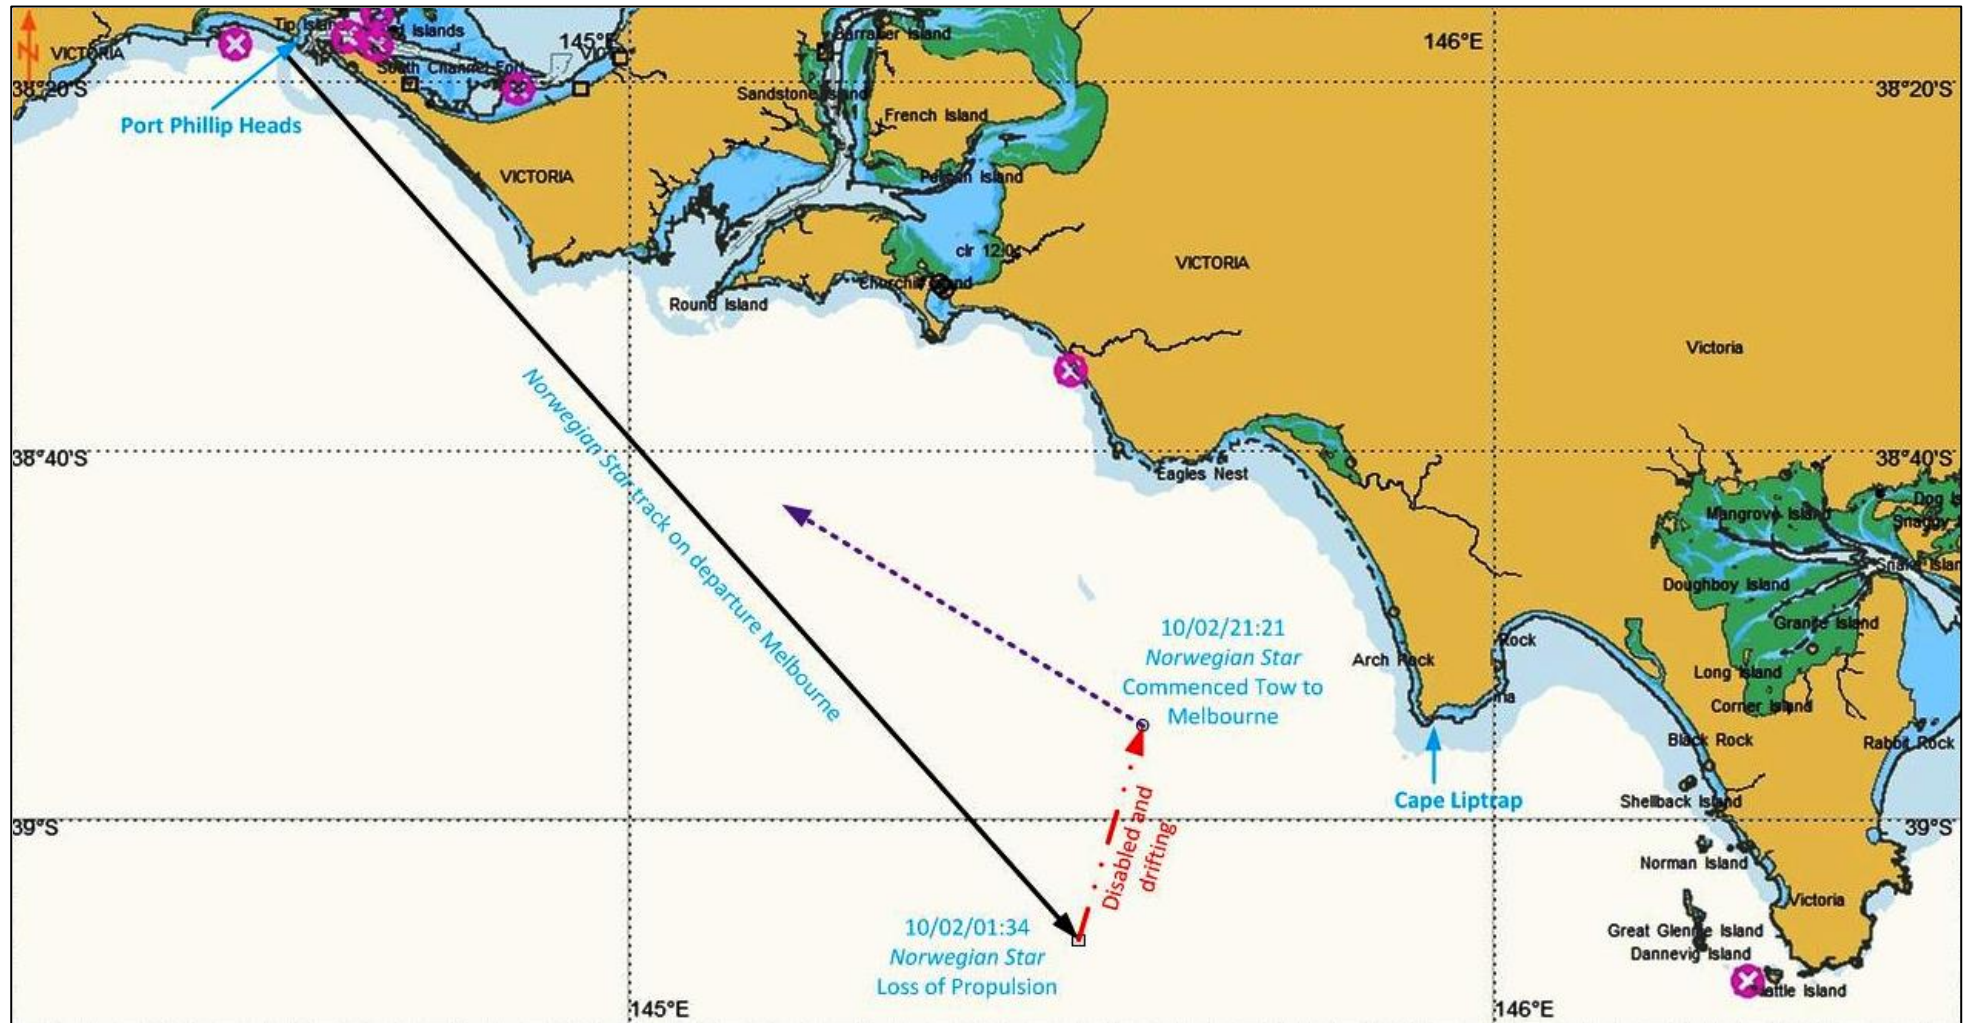
Figure 2: Pictorial of *Norwegian Star's* track and drift before being towed back to Melbourne

*Norwegian Star* was disabled and drifting in an approximately north-north-easterly direction in about 75 metres depth of water. The wind at that time was from the SE at about 5 knots, the sea condition was slight and the swell about one metre. It was partly cloudy and the visibility was good. The current was negligible. The master used the vessel's bow thrusters to manoeuvre the ship's head into the wind and reduce the drift from about four knots to about one knot.

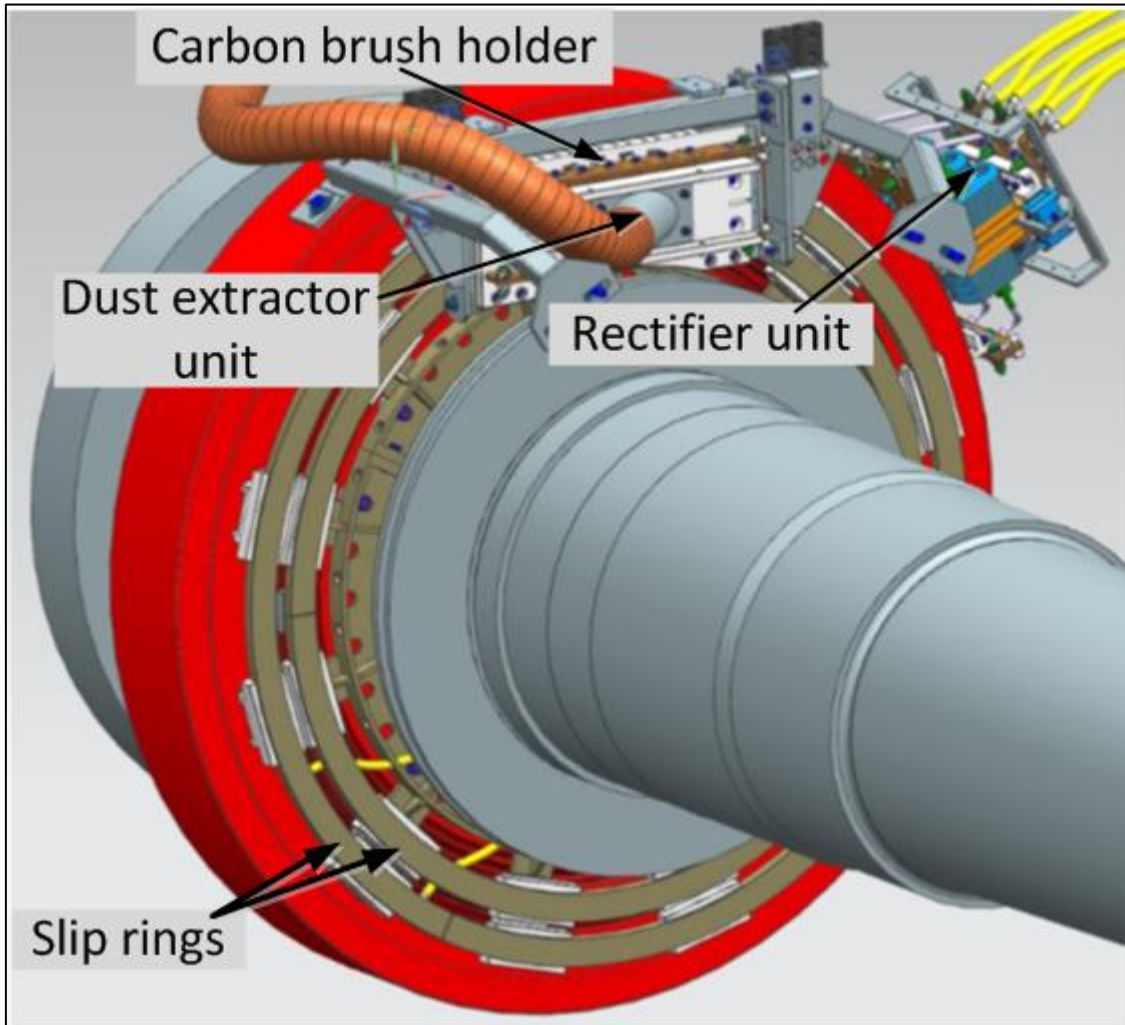
Figure 5: Modified slip ring design exciter unit

Inspection of the modified exciter unit found arcing marks on the outer slip ring, indicating that the brush holders had come into contact with the slip ring.

The modification to a slip ring unit with brushes consisted of the installation of a slip ring assembly, diode bridge assembly, carbon brush assembly and dust removal unit mounted on the existing exciter rotor and stator hub assembly. The transformers for each phase were mounted in the cycloconverter room and cabling installed from the transformers to the slip ring unit in the pod.

There are two slip rings of the face type located concentrically, mounted on the original exciter rotor. The carbon brush unit and the rectifier unit are mounted with supporting brackets on the original exciter stator frame.

Both Azipod units were repaired in Melbourne with further modifications to the slip ring exciter units. On 14 February 2017 both propulsion units were commissioned and *Norwegian Star* resumed its voyage to New Zealand.
