FLYER TO THE SMALL COMMERCIAL VESSEL INDUSTRY

Collision between RIBs *Osprey* and *Osprey II* resulting in serious injuries to one passenger, 19 July 2016

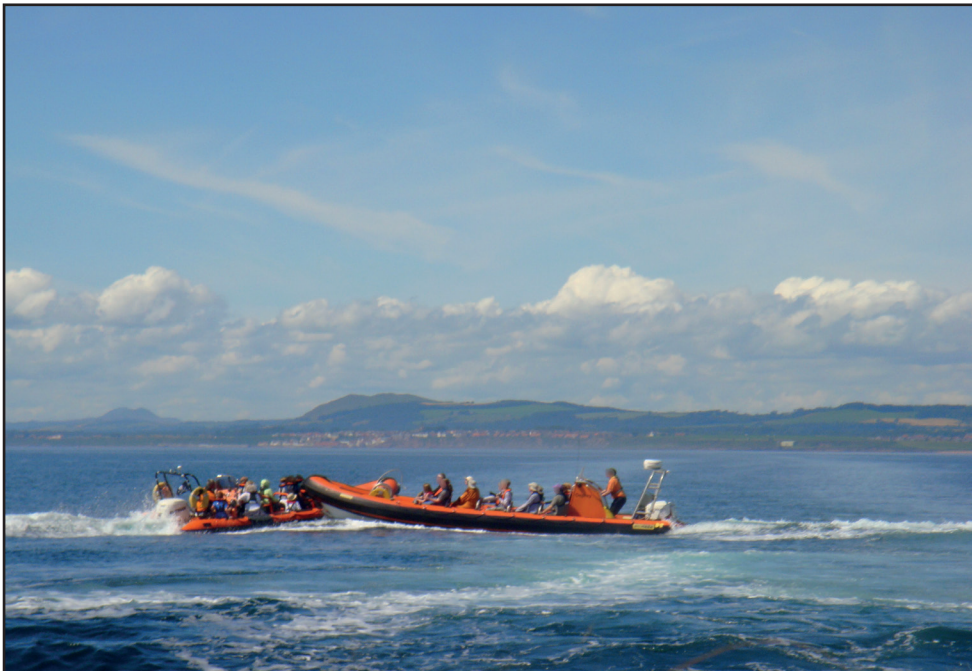
Figure 1: *Osprey* and *Osprey II*

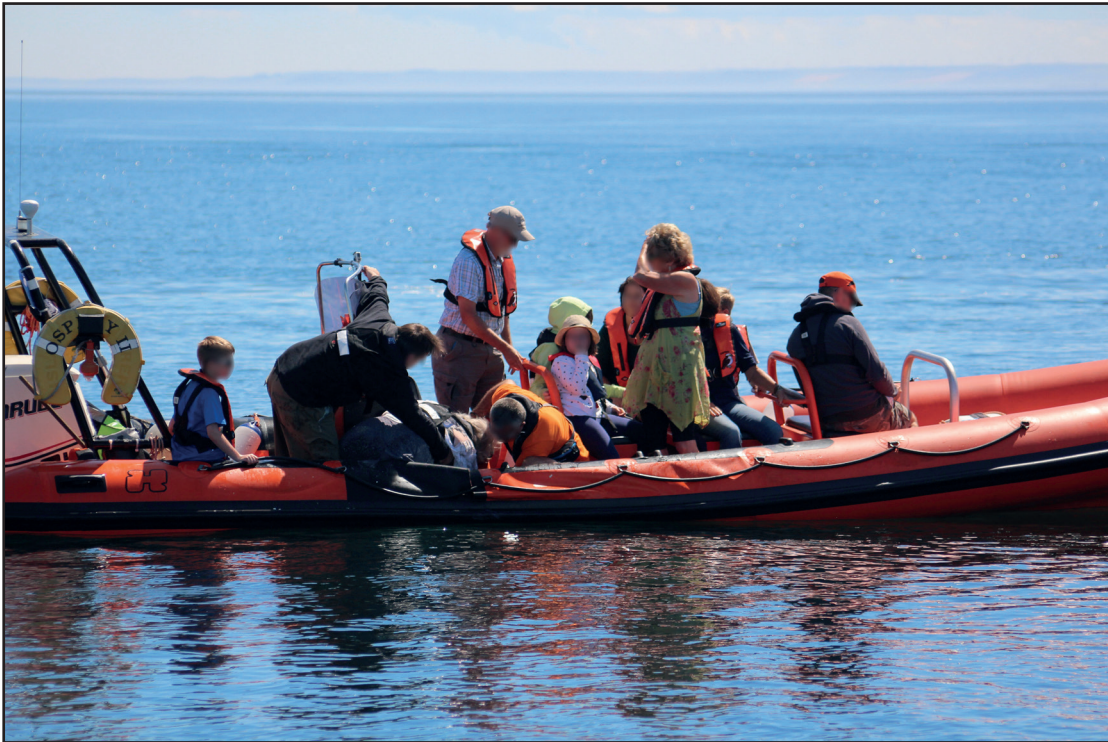
At 1252 on 19 July 2016, two passenger carrying rigid inflatable boats (RIBs), *Osprey* and *Osprey II*, collided in the Firth of Forth. A passenger who was sitting on an inflatable tube of *Osprey II* was crushed between *Osprey*'s bow and *Osprey II*'s helm console, resulting in her sustaining serious injuries. *Osprey II* was certified to carry 12 passengers, but only had inboard seating provided for 8. On the day of the accident the RIB was carrying 11 passengers, 3 of whom were sitting on the inflatable tubes.

Figure 2: Injured passenger in slumped position following accident

Passengers seated on the inflatable tubes of passenger tour RIBs have an increased risk of falling overboard, are at significant risk of musculoskeletal injuries and are more exposed to serious injury in the event of a collision.
