National Transportation Safety Board

Marine Accident Brief

Fire aboard Towing Vessel *Thomas Dann*

Accident no.	DCA16FM048
Vessel name	<i>Thomas Dann</i>
Accident type	Fire
Location	Atlantic Ocean, about 9 nautical miles east of St. Augustine, Florida 29°41.0' N, 081°04.3' W
Date	July 22, 2016
Time	1700 eastern daylight time (coordinated universal time – 4 hours)
Injuries	None
Property damage	\$2.5 million est.
Environmental damage	None
Weather	Partly cloudy, clear visibility, east winds at 5–10 knots, seas at 2–3 feet, air temperature 88°F, sea temperature 87°F.
Waterway information	Atlantic Ocean

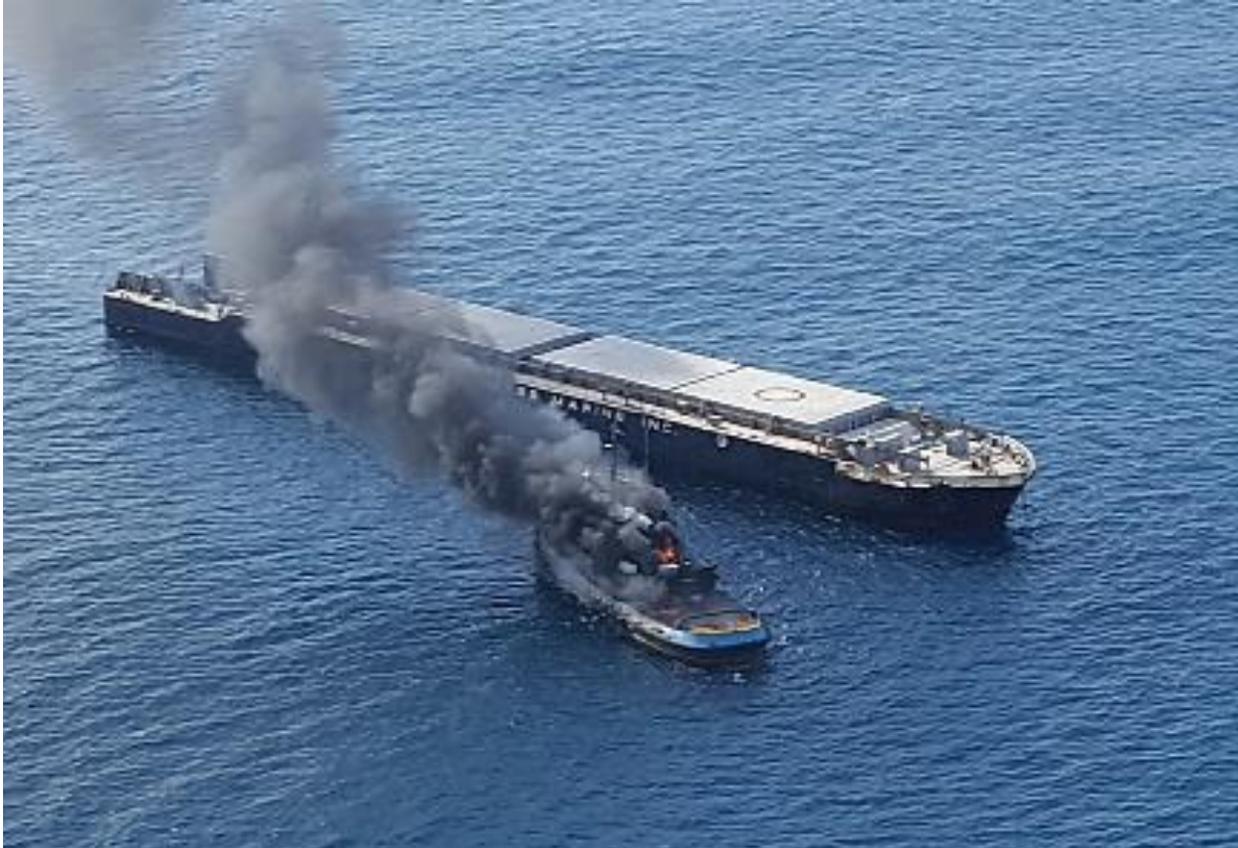
Thomas Dann ablaze and abandoned near barge *EMI-1152*. (Photo by Daytona Fire Department)

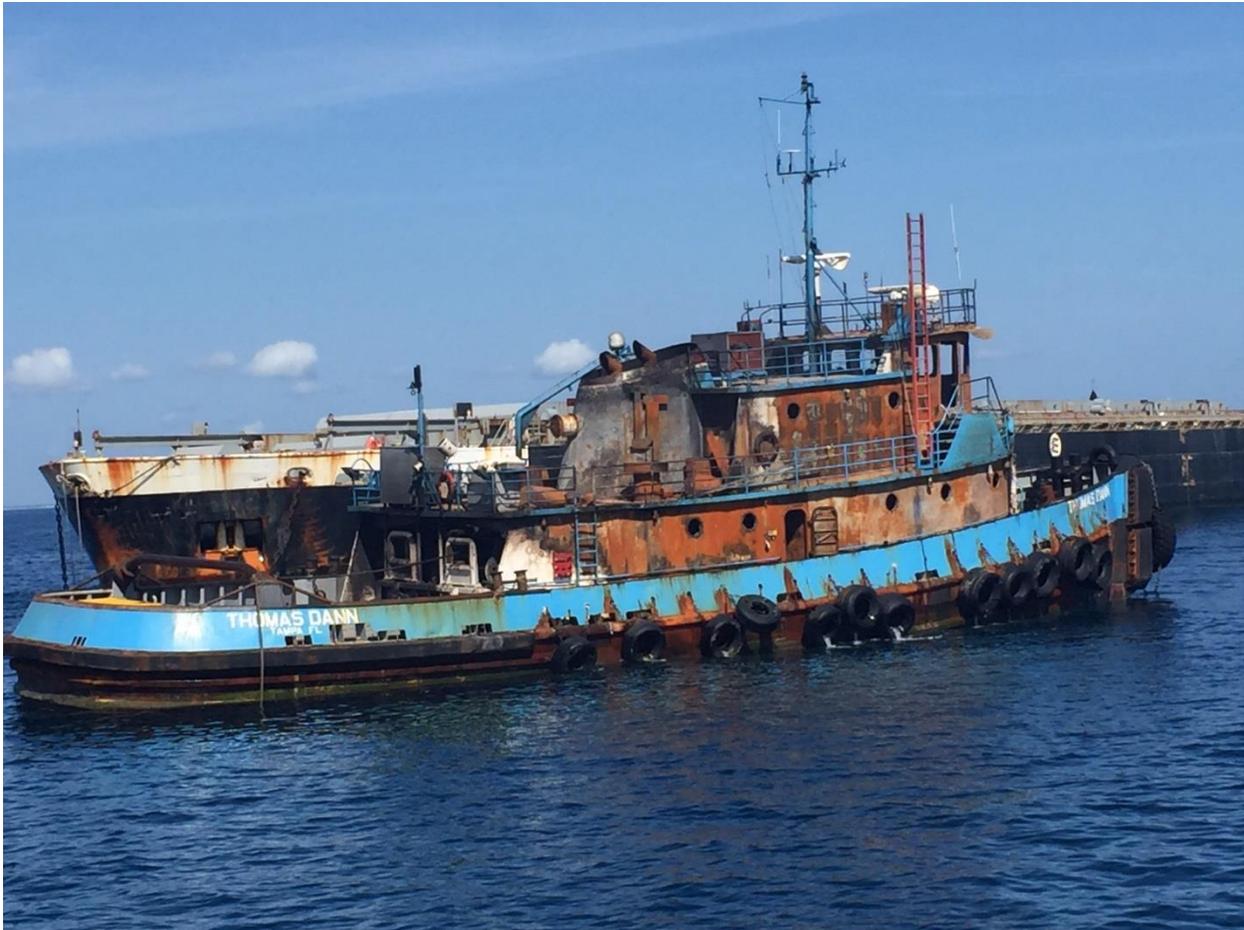
Fire damage to *Thomas Dann*, with barge *EMI-1152* in the background. (Photo by Coast Guard)

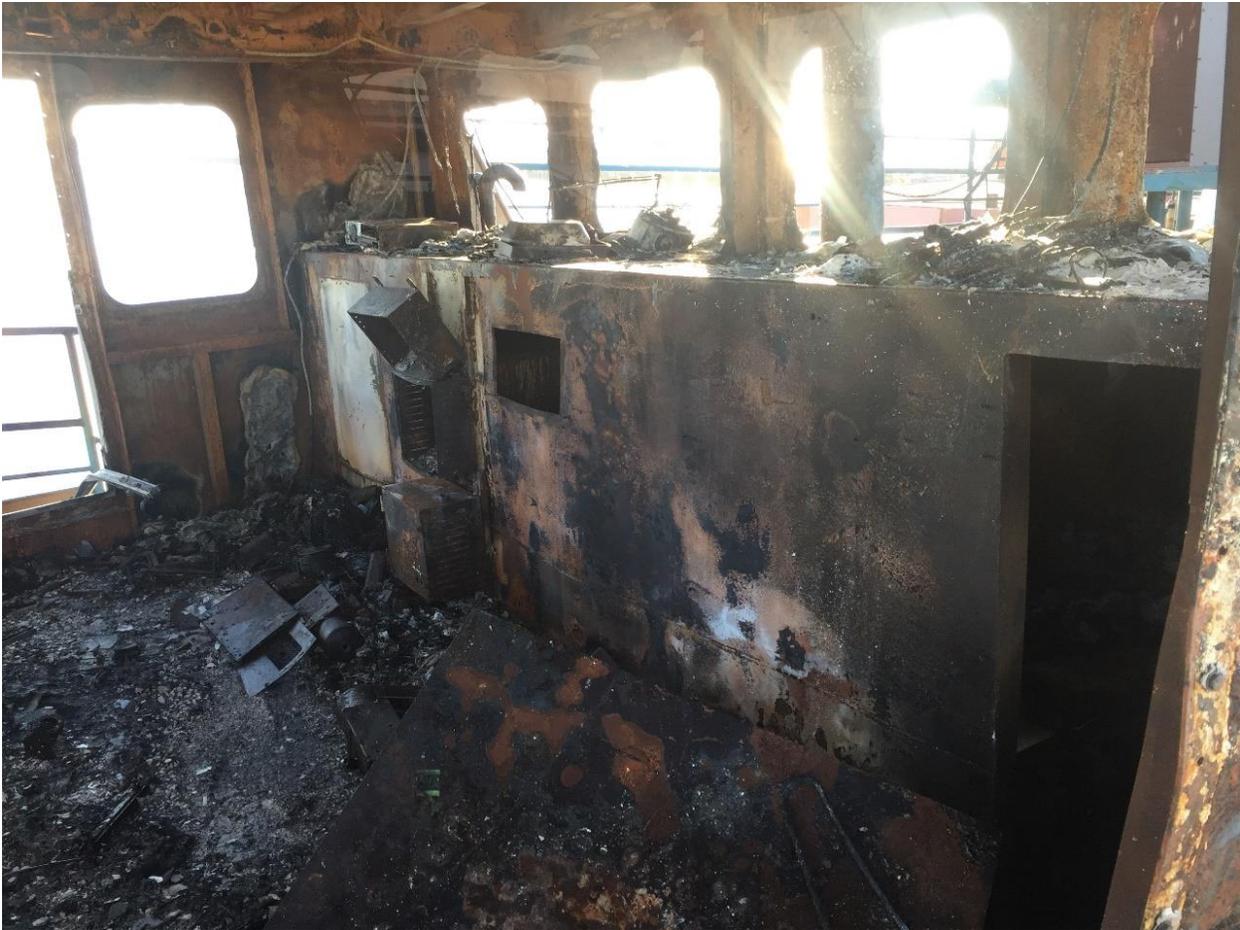
Thomas Dann's wheelhouse after the fire, showing the aft starboard bulkhead. (Photo by Coast Guard)

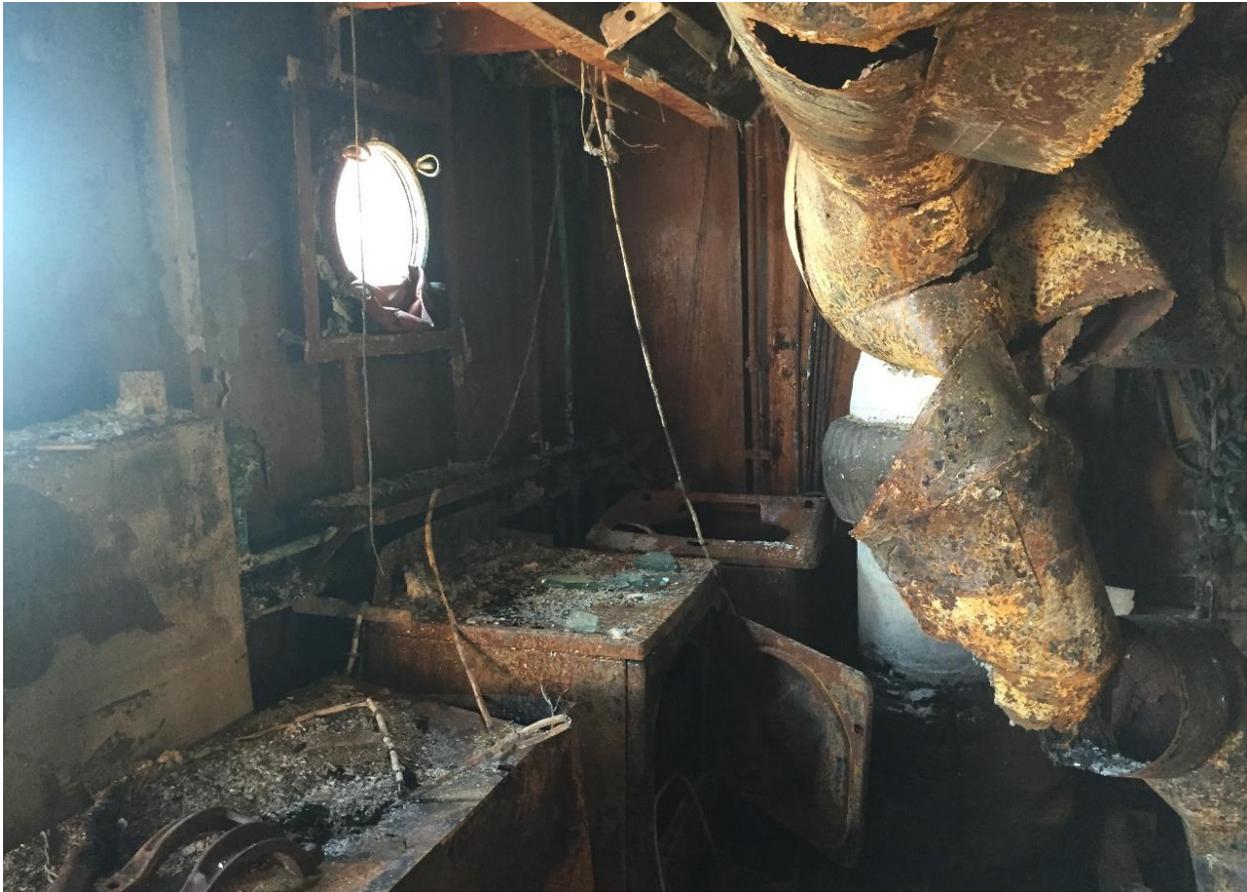
The upper engine room where the fire was determined to have originated. (Photo by Coast Guard)

The fire investigation was conducted by the Coast Guard and a fire inspector whom the vessel owner hired. The greatest fire damage was located at the central portion of the upper engine room, with severe heat damage to the steel structural members. In addition to the extra hoses for the fire pump that were stored there, a drum of waste oil had also been placed in the upper engine room, providing combustible material to stoke the fire. The insulation wrap around the exhaust system also demonstrated heavy fire damage. All wiring in this area was brittle and damaged due to fire. The deckhouse, crew quarters, wheelhouse, and galley also sustained significant fire, heat, and smoke damage; the lower engine room suffered moderate damage.

An electrical fuse box that was located on a vertical post in the central portion of the upper engine room bore evidence of electrical arcing at its aft side. There was also evidence of electrical arcing to wiring in this area. As a result of the heat damage, the source of those wires could not be traced. Arc mapping of all electrical wiring, which is a systematic evaluation of fire-damaged electrical circuits, further indicated that the electrical fuse box was the general area of origin.

In addition, electrical cables and other equipment (including fuse and switch boxes, extension cords, electrical tools, and lights) located in and around the area could not be ruled out as an ignition source. However, two freezer units and a washing machine and dryer were ruled out as potential causes of the fire. Due to the amount of damage to the area of origin, the precise cause of the fire could not be determined.

The National Transportation Safety Board determines that the probable cause of the fire aboard towing vessel *Thomas Dann* was an ignition originating near an electrical fuse box in the upper engine room. Contributing to the intensity of the fire was the presence of combustible materials in the upper engine room.
