# **SAFETY DIGEST**

**Lessons from Marine  
Accident Reports  
2/2017**

**SAFETY DIGEST**  
**Lessons from Marine Accidents**  
**No 2/2017**

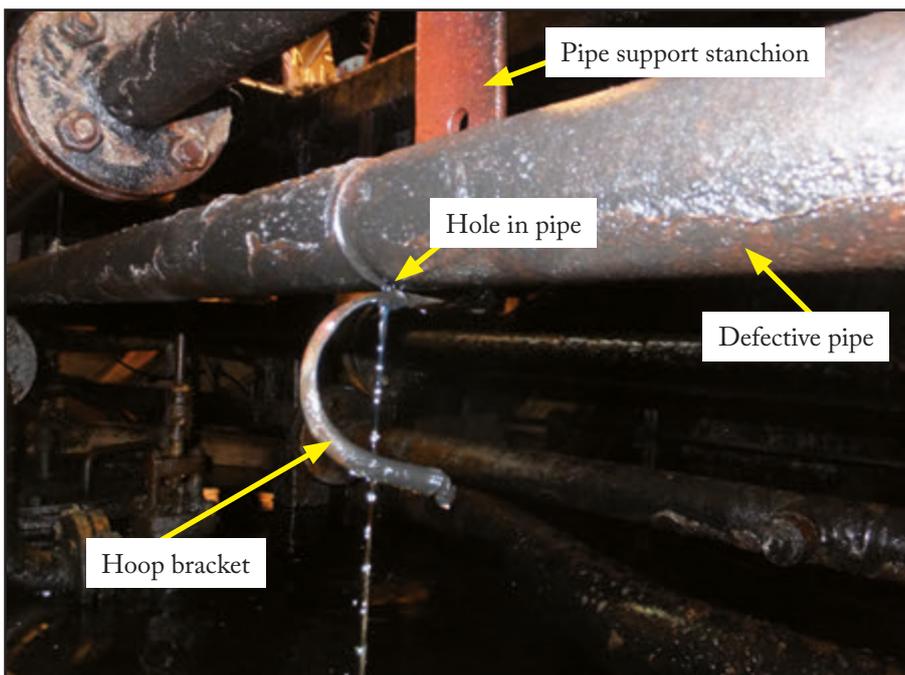
Figure 1: Leaking low pressure fuel pipe

Having discovered a fuel leak on the low pressure fuel return from the main engine, the duty engineer decided that he could complete a temporary repair without needing to shut down the engine. He collected tools from the workshop and began the task. It became apparent that to access the leak he would need to remove a pipe support bracket. The pipe run was under the engine room floorplates, and on inspection the pipe, bracket and securing bolts were found to be in poor condition. In order to remove the bracket, he decided to crop the support using a portable angle grinder (Figure 1).

In order to progress the repair, the engineer climbed into the bilge to access the bracket. Fuel from the leaking pipe atomised on contact with the surrounding structure (Figure 2) and soaked the engineer's coverall with diesel. Sparks generated during the cutting process ignited the atomised diesel, setting light to the engineer's coverall and starting a fire in the engine room.

4. Like on board many other vessels, the low pressure fuel pipework ran beneath the engine room floorplates and was therefore out of normal sight. The contents of IMO circular MSC.1/Circ.1321 - a paper aimed at reducing the risk of fires in pump rooms and engine rooms - recommends a 6-monthly inspection of all low pressure fuel system components to be included in a vessel's SMS.

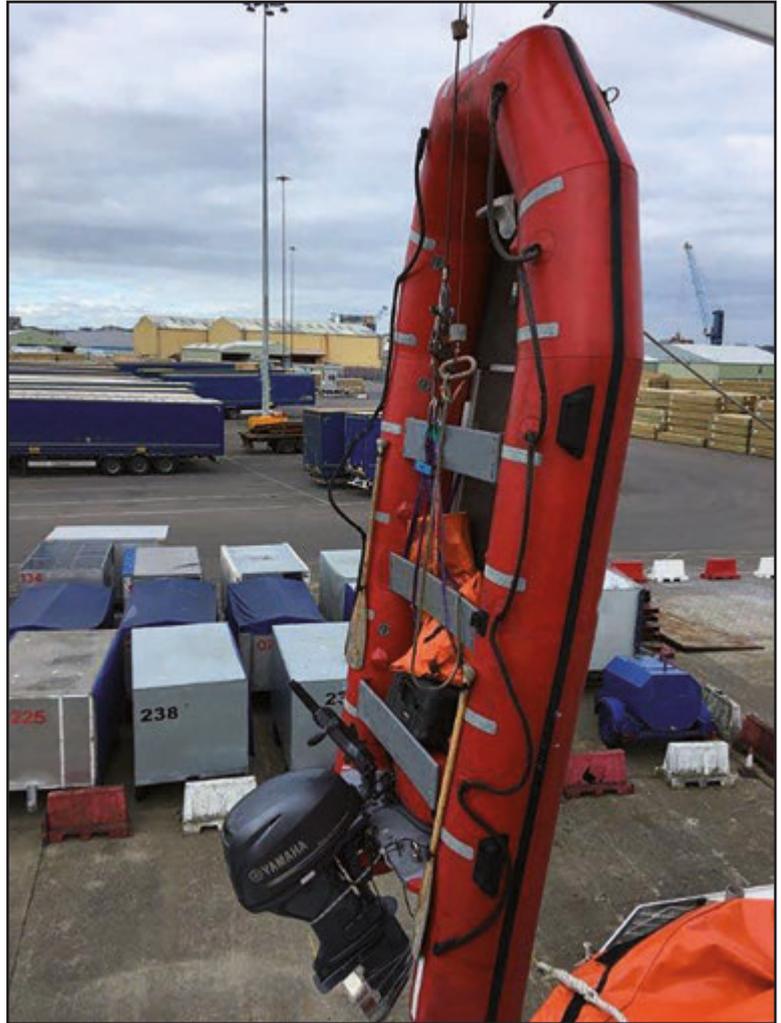
or not it was an issue that affected both boats, the crew repeated the procedure using the starboard boat. The result was the same. On further investigation it was found that this class of inflatable rescue boat was fitted with multiple lifting points, and discussions with the senior master of a similar ship revealed that the new lifting strops had been fitted incorrectly. Specifically, the rear pair of strops had been connected to the lifting points on the boats' decks rather than the boats' transoms.

Figure 1: Lifting strops incorrectly fitted unbalance the boat and cause it to flip up

1. Replacing or repairing equipment without reference to technical documentation is always fraught with risk. In this instance the crew attached the strops to what they genuinely thought were the correct lifting points, inadvertently creating a dangerous situation. The owner has now addressed this by reviewing the ship's documentation to ensure that details, such as how to attach the rescue boat strops, are properly recorded. The lifting points within the boat have also been clearly marked.

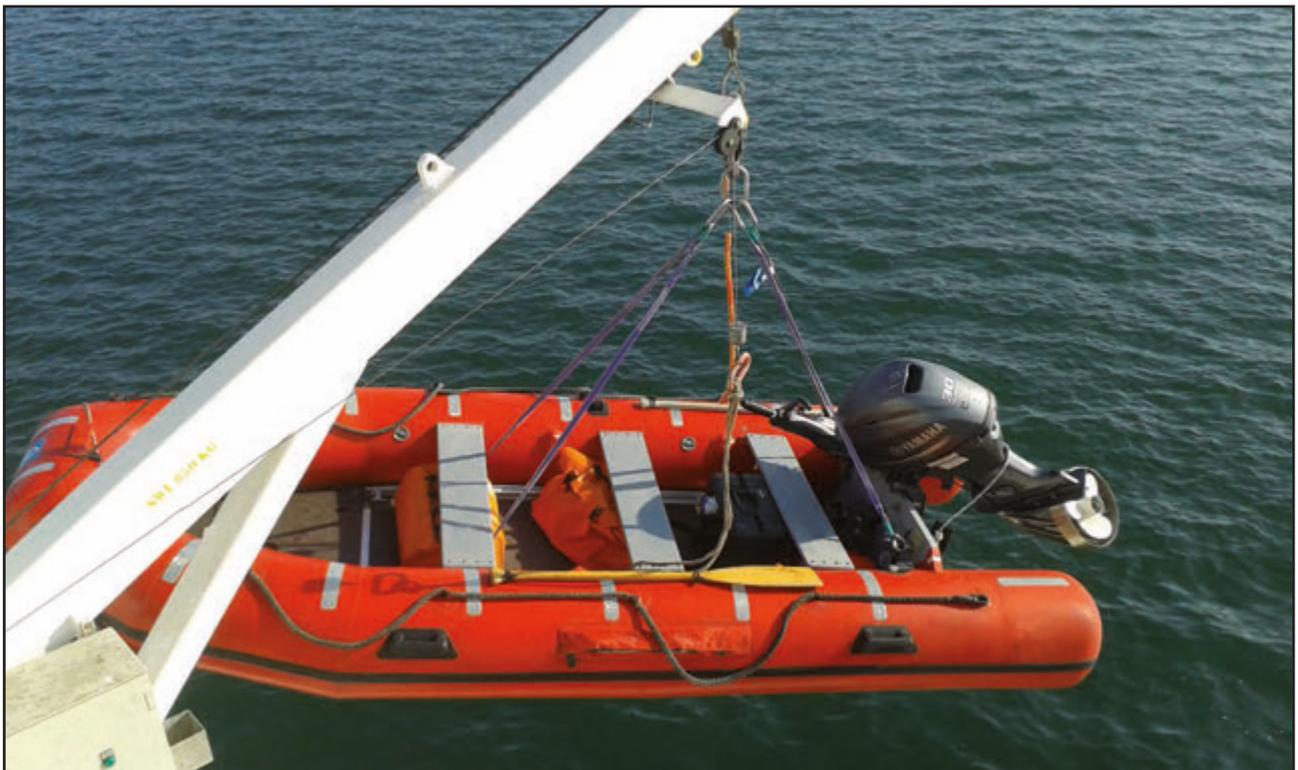
Figure 2: Lifting strops correctly fitted to inflatable rescue boat

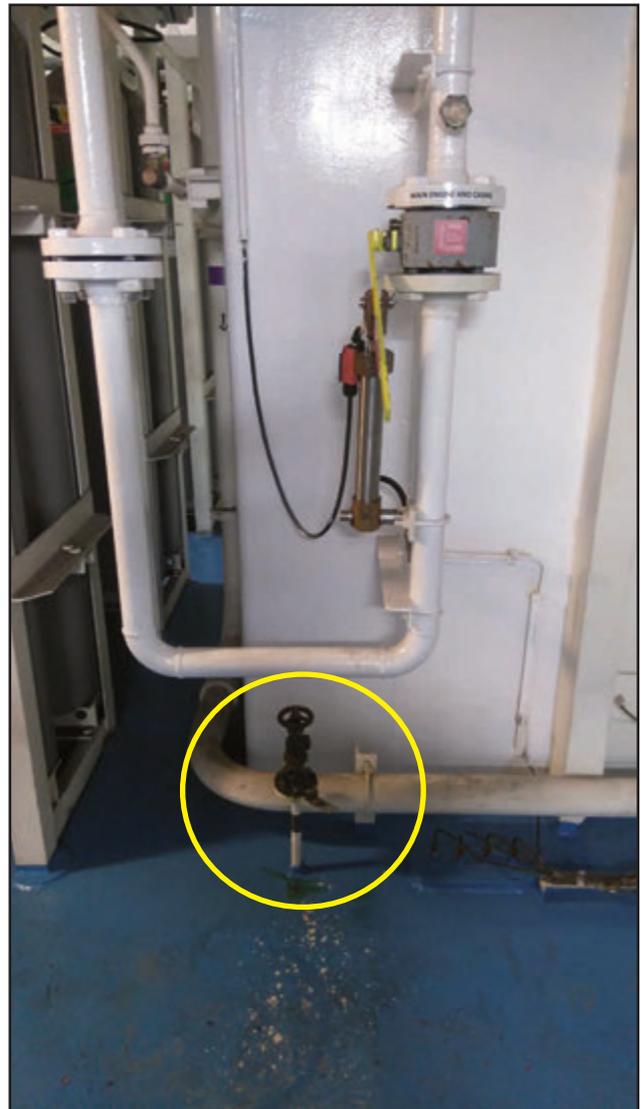
Figure 1: Compressed air hose connection

Following the incident, security of the access to the CO<sub>2</sub> space (Figure 2) was improved. The compressed air hose connection inside the space was also blanked off to control its use.

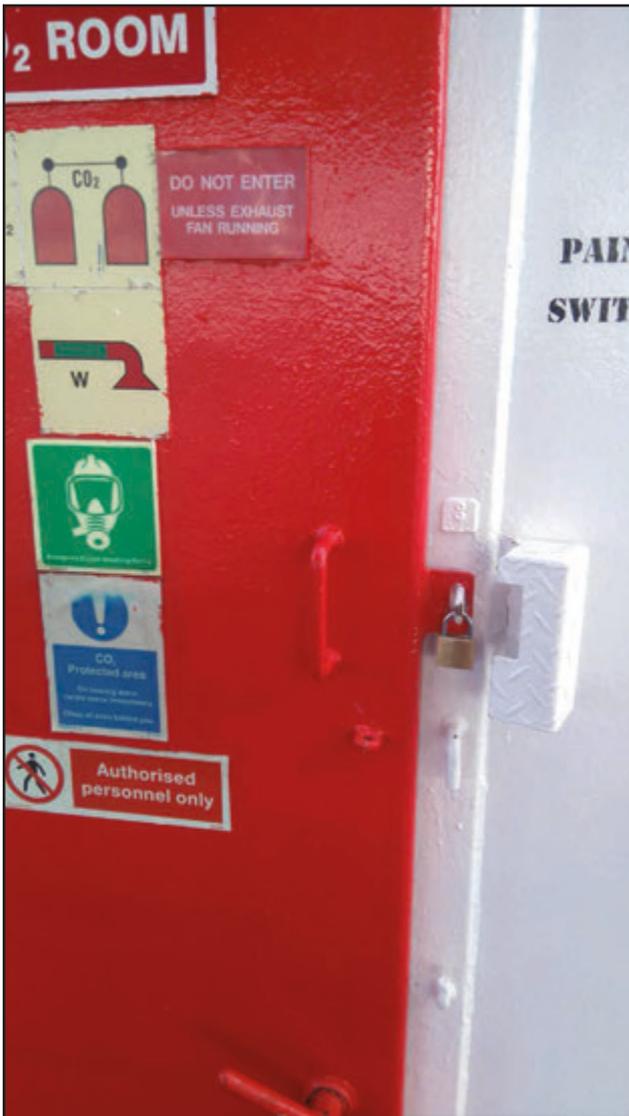
Figure 2: Access to CO<sub>2</sub> space

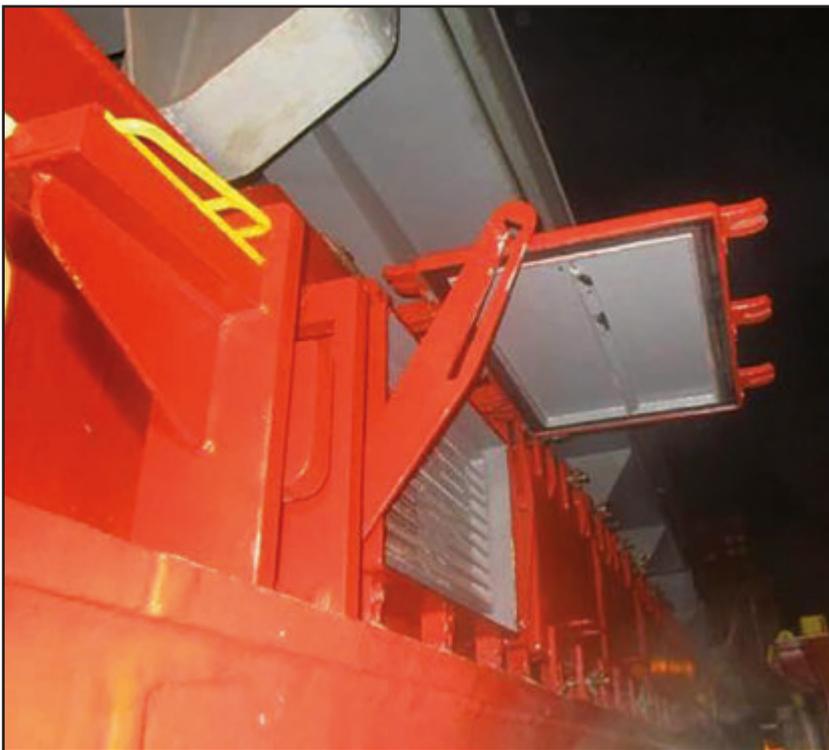
Figure 1: Cargo bay ventilation cover

The cargo bay vents were located on the sides of the hatch cover, 2.5m above the main deck (Figure 1). To close them, the officer climbed onto the hatch cover. He then went to the edge of the hatch, bent down and released the ventilation cover. As he did so, he lost his balance and almost fell off the side of the hatch cover. A stevedore, who witnessed the event, asked the officer if he was okay. In reply, the officer gave the stevedore a 'thumbs up' signal.

2. In this case, the task could have been carried out from the main deck below the vents; the vessel carried step ladders specifically for the task. It is always better to avoid hazards rather than trying to control them, and working close to the edges of unprotected hatch covers should be avoided whenever possible.

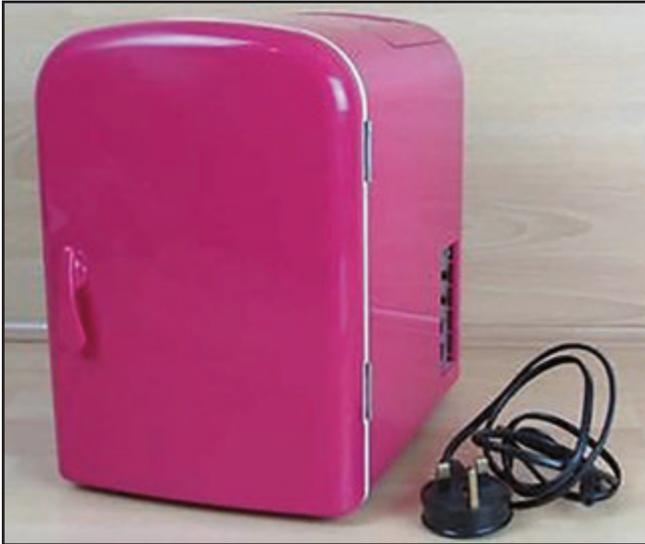
Once the area was declared safe, the ship's fire investigation discovered that the seat of the fire was located where a mini fridge (Figure 1) had been placed. The carpet, cabin furniture and surrounding bulkheads were damaged, with smoke deposits and scorch marks clearly indicating that the fridge was the source of the fire. The fridge's plastic casing had melted and its power cable had suffered severe damage (Figure 2). The metal centre core of the fridge and the cans of juice inside were almost undamaged.

The fridge had been in the cabin for about 4 years, and always located in the same position - on top of the carpet, against the wardrobe. The investigation concluded that, due to its location, the fridge didn't have proper ventilation around it, and therefore this could have caused it to overheat. The investigation further found that the cabin inspection routine had neither identified this hazard nor picked up that personal electrical equipment was not being inspected.

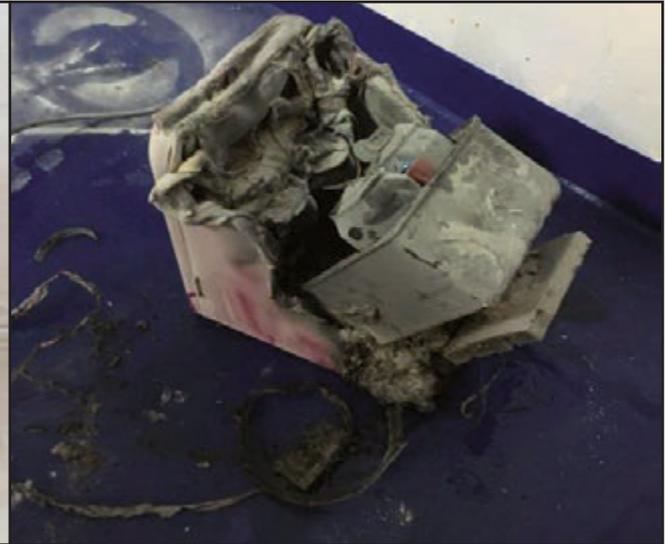
Figure 1: Similar travel fridge to the one in the cabin      Figure 2: Remains of the fridge after the fire

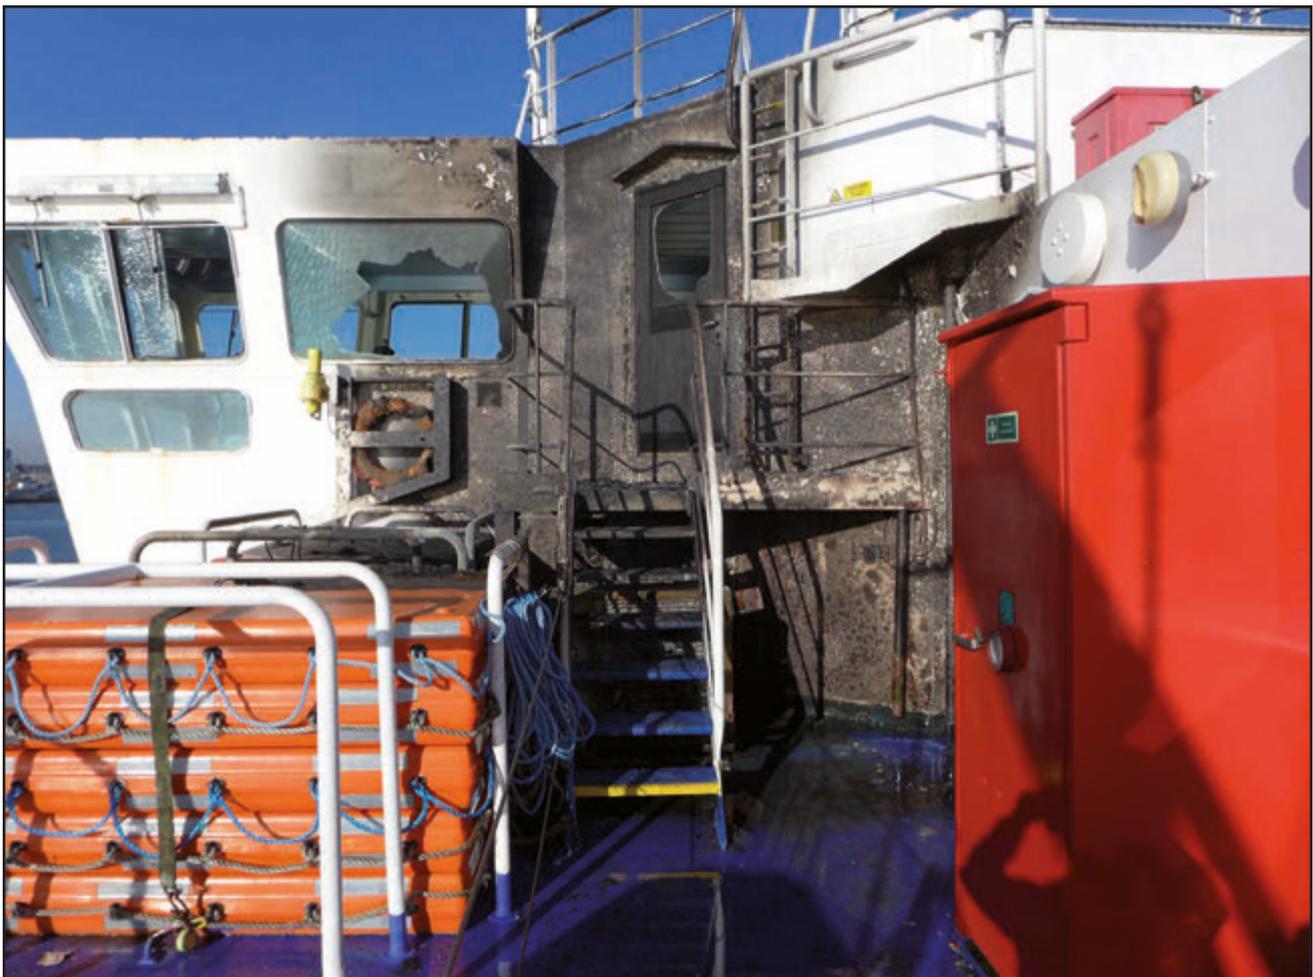
The damage caused by the fire was significant and included shattered bridge windows, scorched paintwork, and damaged wiring and equipment (Figure 1). Thankfully, due to the crew's prompt action the fire was quickly contained and the ferry was out of service for only a few days while repairs were carried out.

Figure 1: Damage caused by the fire

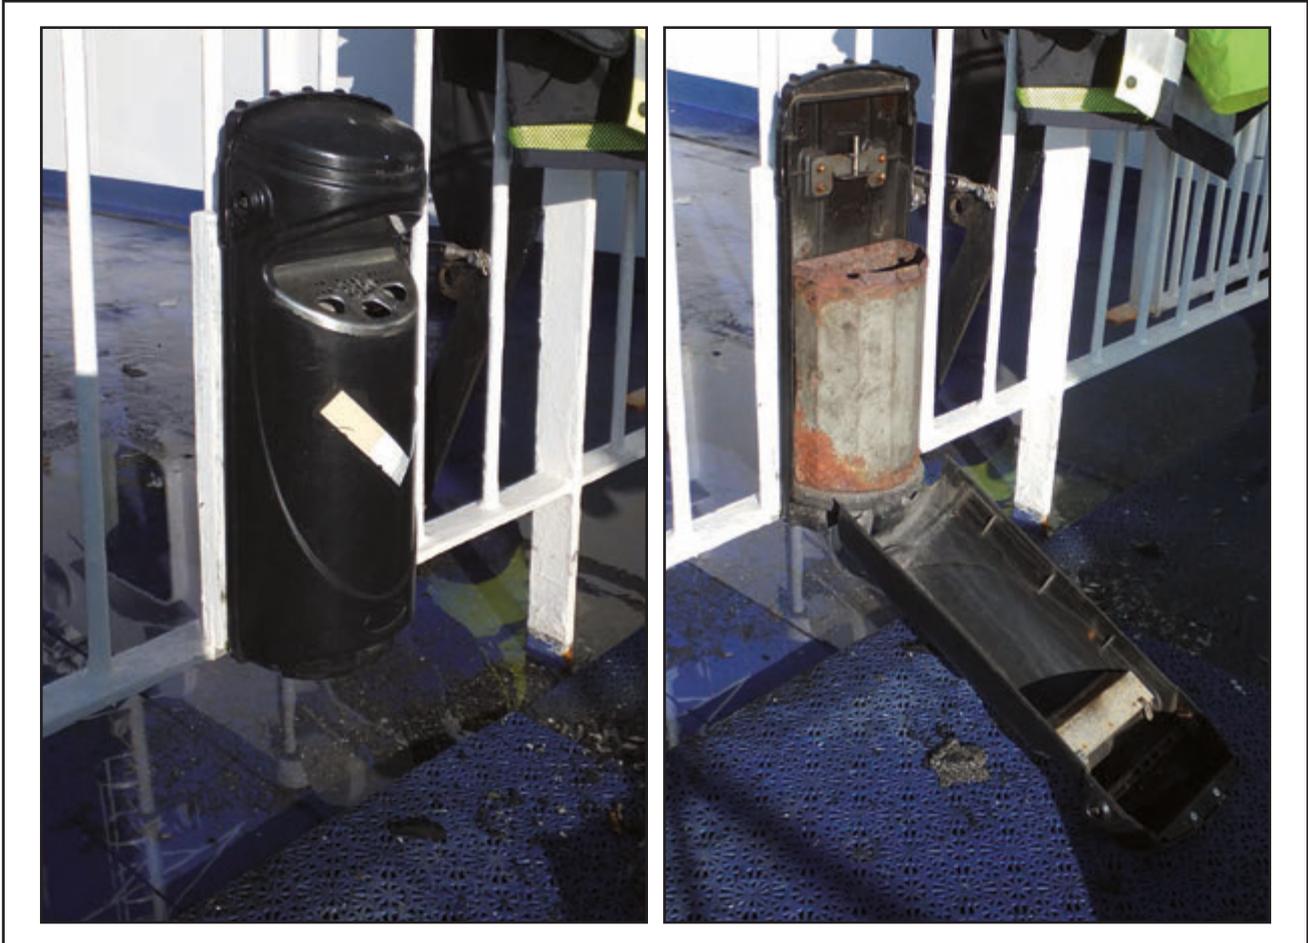
The investigation discovered that the fire had started when a cigarette bin caught fire. Further investigation found that the bin caught fire because its metal liner was missing, which caused the plastic exterior to melt. This melting plastic then fell into an open container of highly flammable paint thinners that had been left underneath the bin, causing the

fire to really take hold (Figure 2). After the incident the ship operator introduced a more frequent routine to empty and inspect these bins, discovering in the process that other bins were missing metal liners.

Figure 2: Cigarette bin and open bin with liner, which was missing from the bin that caught fire

1. Cigarette bins require regular housekeeping to prevent them becoming a fire hazard. Owners and operators should require that regular safety rounds of smoking areas are conducted, and that cigarette bins are emptied and inspected. They must also encourage a culture where all incidents are reported so that action can be taken to prevent more serious accidents from taking place.

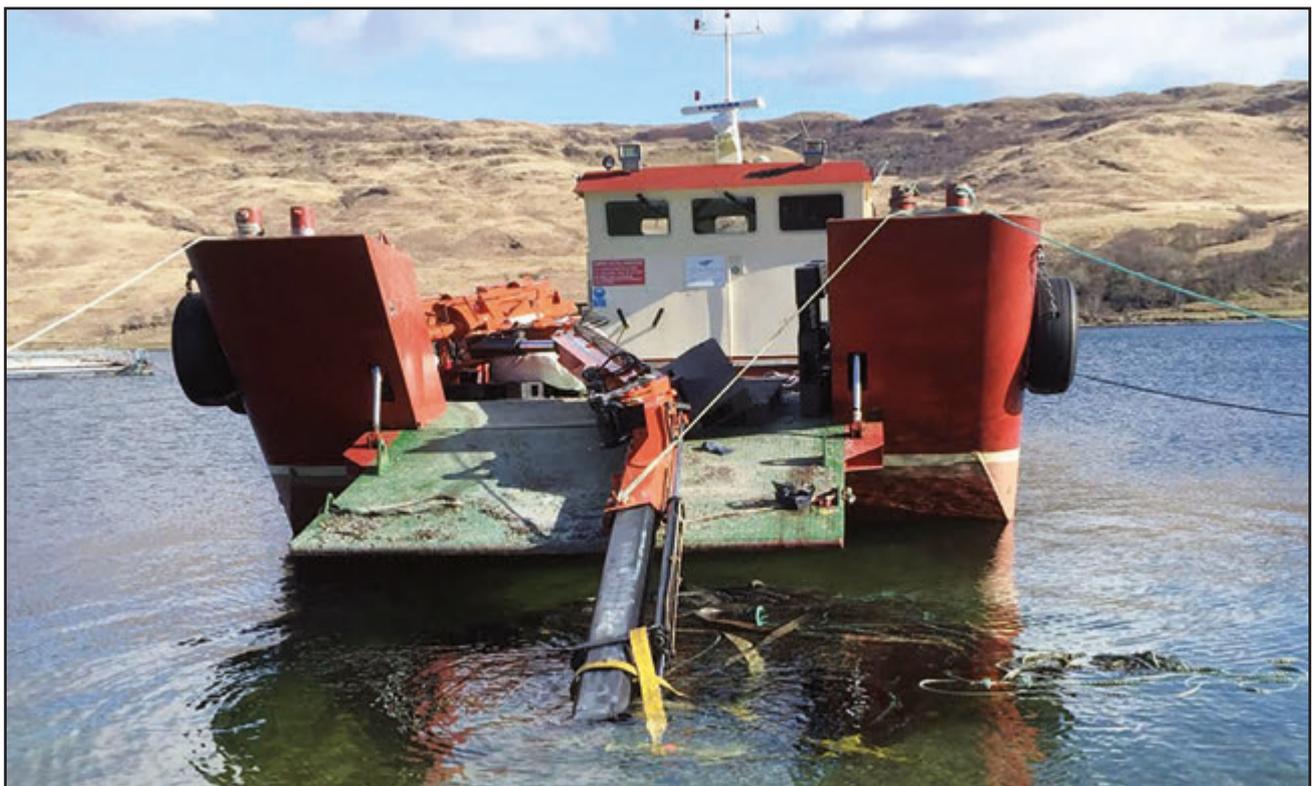
- No installation guidance was provided with the crane.
- The crane was installed with smaller and fewer tie bolts than intended by its manufacturer.
- The lock nuts were of a lower grade material strength than indicated by their markings.
- The statutory thorough examination and test of the crane following its installation did not identify the inadequacy of the mounting arrangement.

Figure 1: Collapsed crane

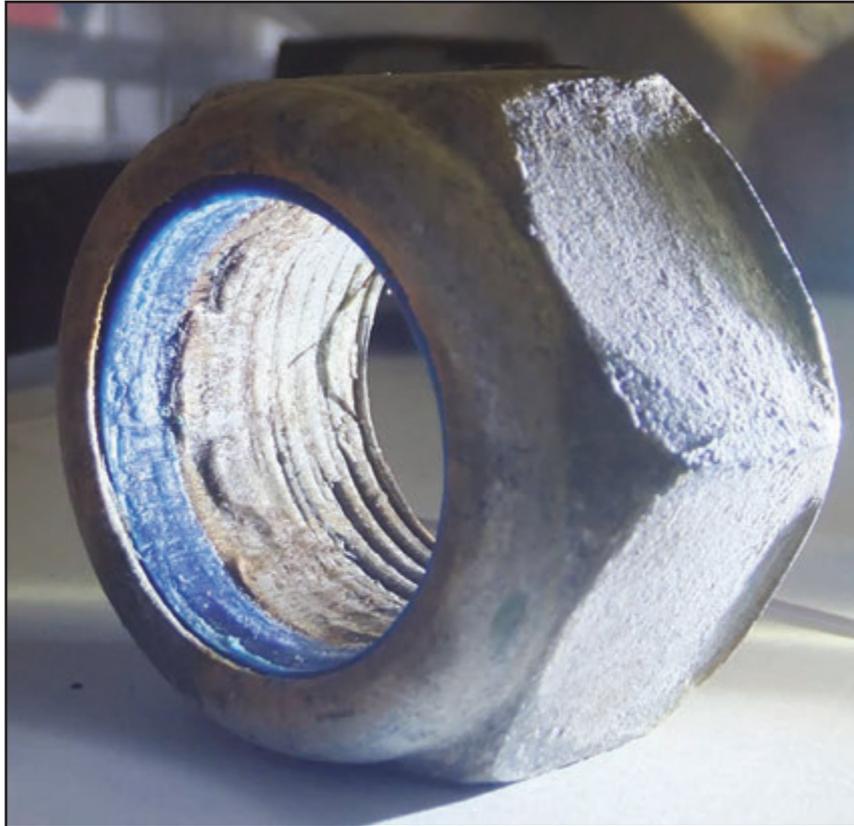
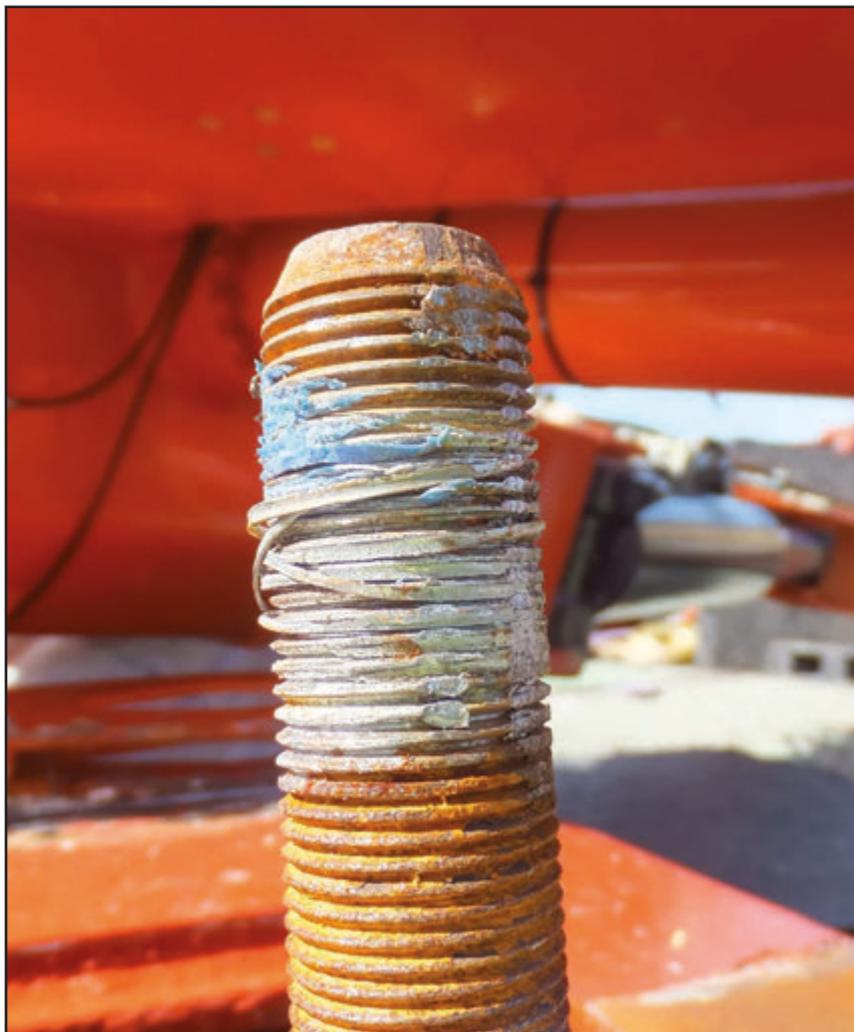
Figures 2 and 3: Failed nut and tie bolt

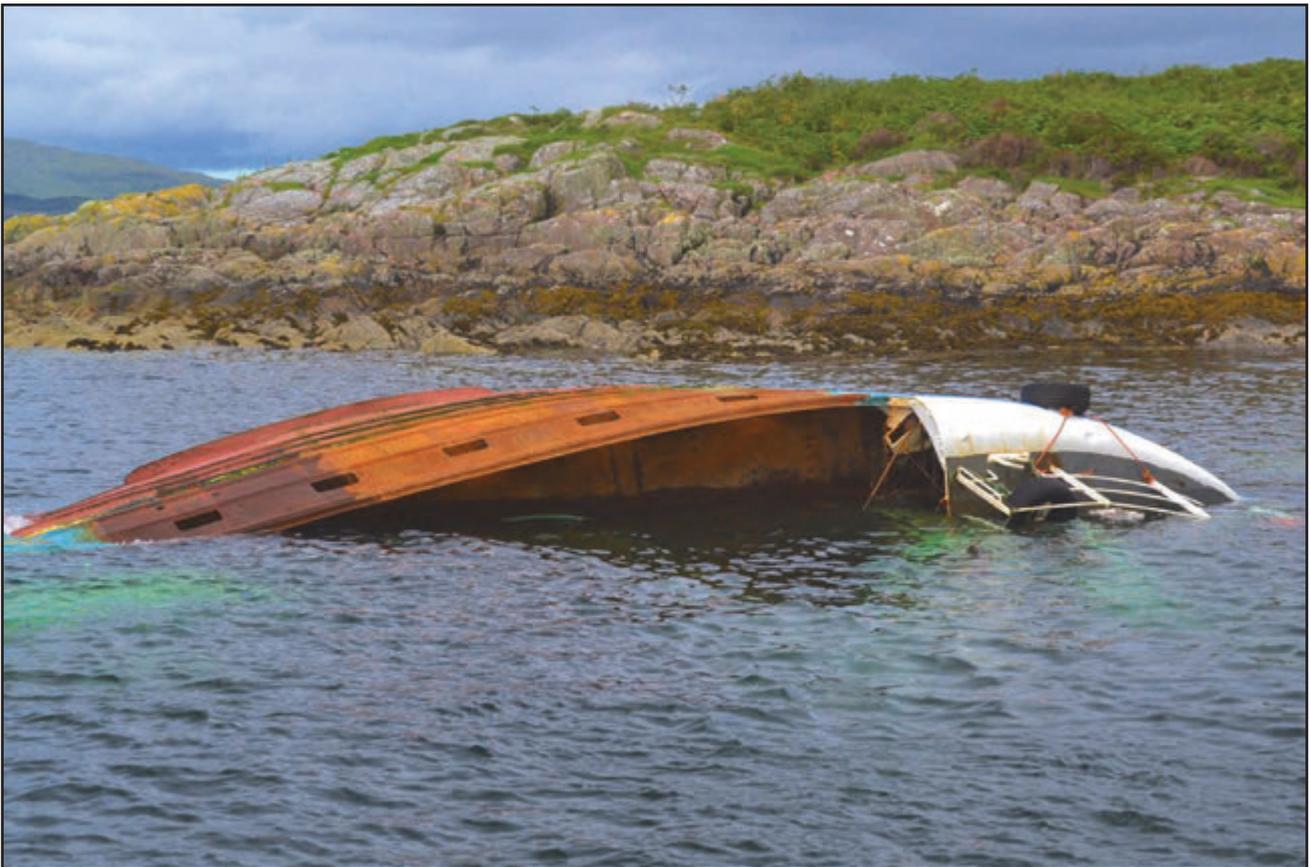
A short time later, the scalloper began to flood and it eventually settled on its starboard side in shallow water (Figure 2). The vessel was later salvaged, but the cost of repair meant that it did not return to service. The cause of the scalloper's sudden deviation from the planned heading is not known.

Figure 2: The partially submerged vessel

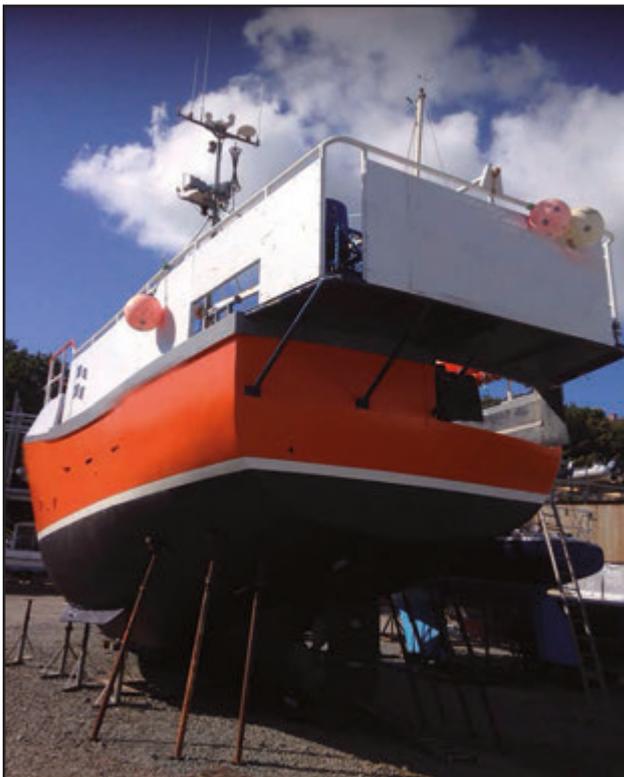
The boat was designed to allow self-shooting, with a large opening in the transom through which the baited pots were deployed. Each string worked by the boat contained between 50 and 60 pots. As each string was hauled the catch was removed, the pots re-baited and then stacked three pots high on the port side of the main deck, ready to shoot. Despite the vessel being designed for self-shooting, the normal practice on board required a certain amount of manual intervention by the crewman on deck.

Figure 1: Opening in transom

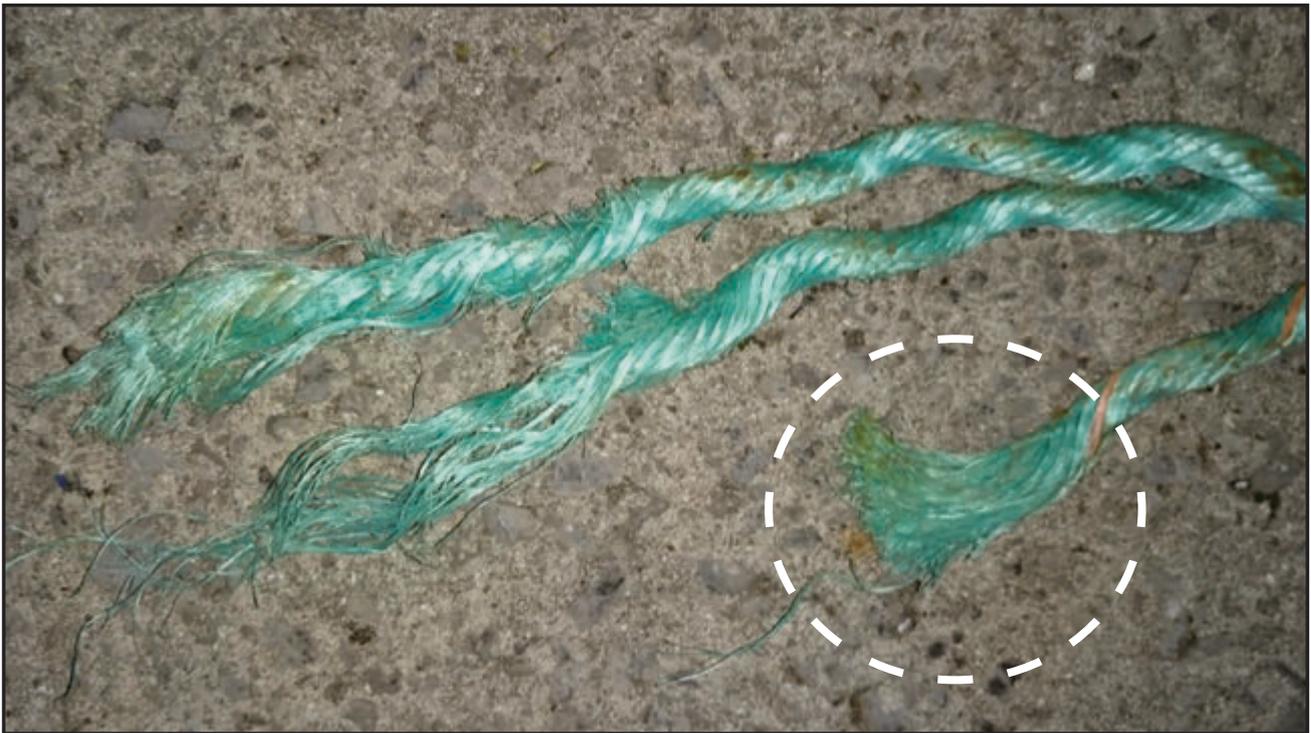
The boat's pots were hauled by other local fishing boats in the days after the accident. One string of pots recovered from the fishing grounds indicated that an attempt might have been made to cut the back rope on one of the strings of pots (Figure 2).

Figure 2: Broken back rope, indication that at least one strand had been cut

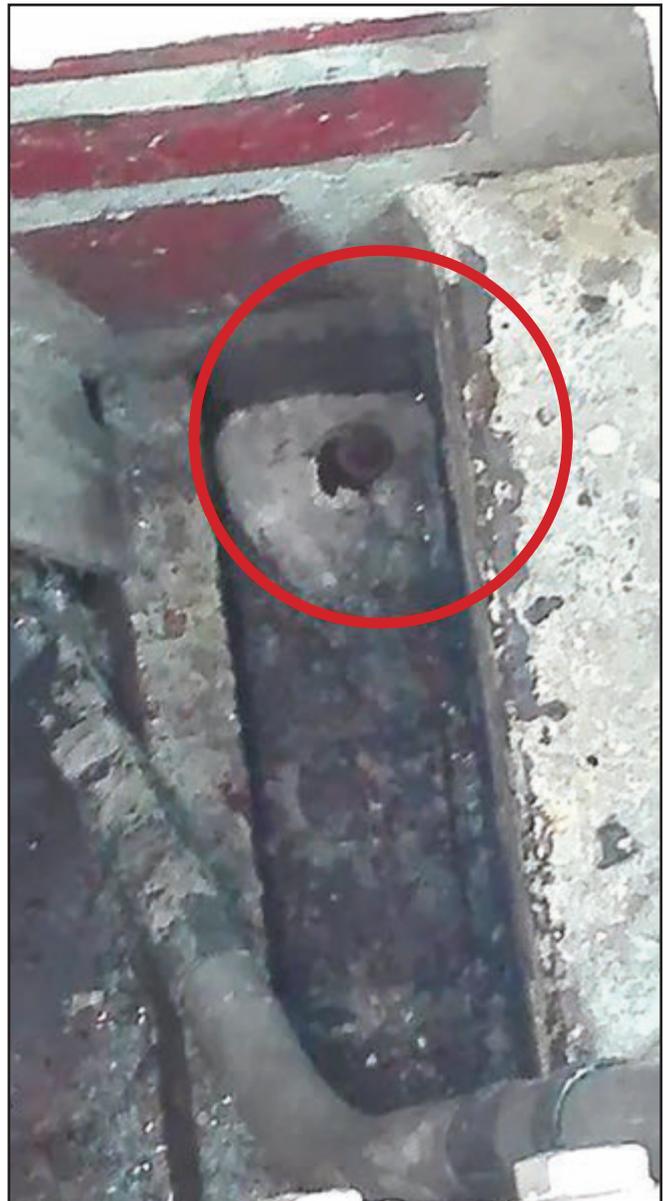
Figure 3: Bung in place

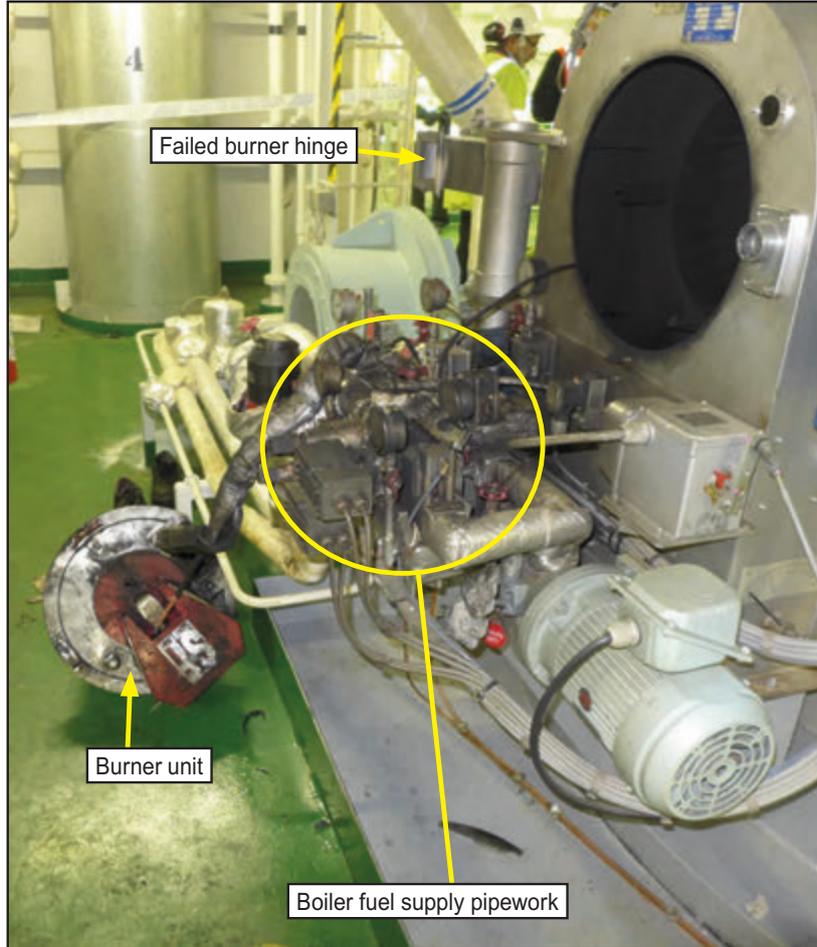
**Figure 2:** Boiler and burner unit
