Grounding of *Bow Singapore*

Port Phillip, Victoria | 19 August 2016

ATSB Transport Safety Report
Marine Occurrence Investigation
326-MO-2016-005
Final – 5 October 2017

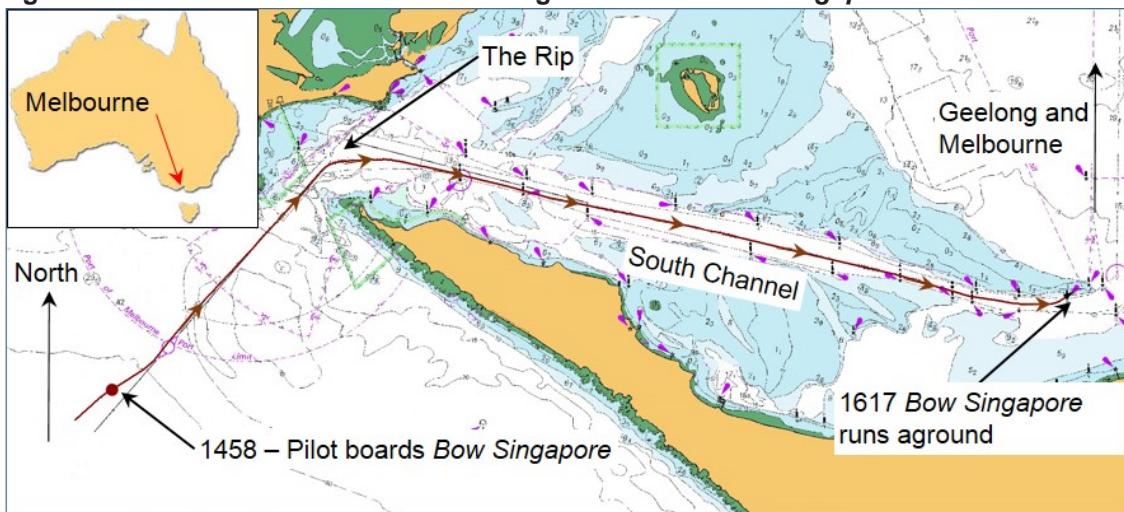
Figure 1: Section of chart AUS 158 showing the track of *Bow Singapore*

At 1458, a Port Phillip Sea Pilot boarded the ship for the inbound transit (Figure 1), through The Rip and South Channel to an anchorage off the Port of Geelong. The master and pilot exchanged information regarding the ship and the inward passage and the pilot then took the conduct.²

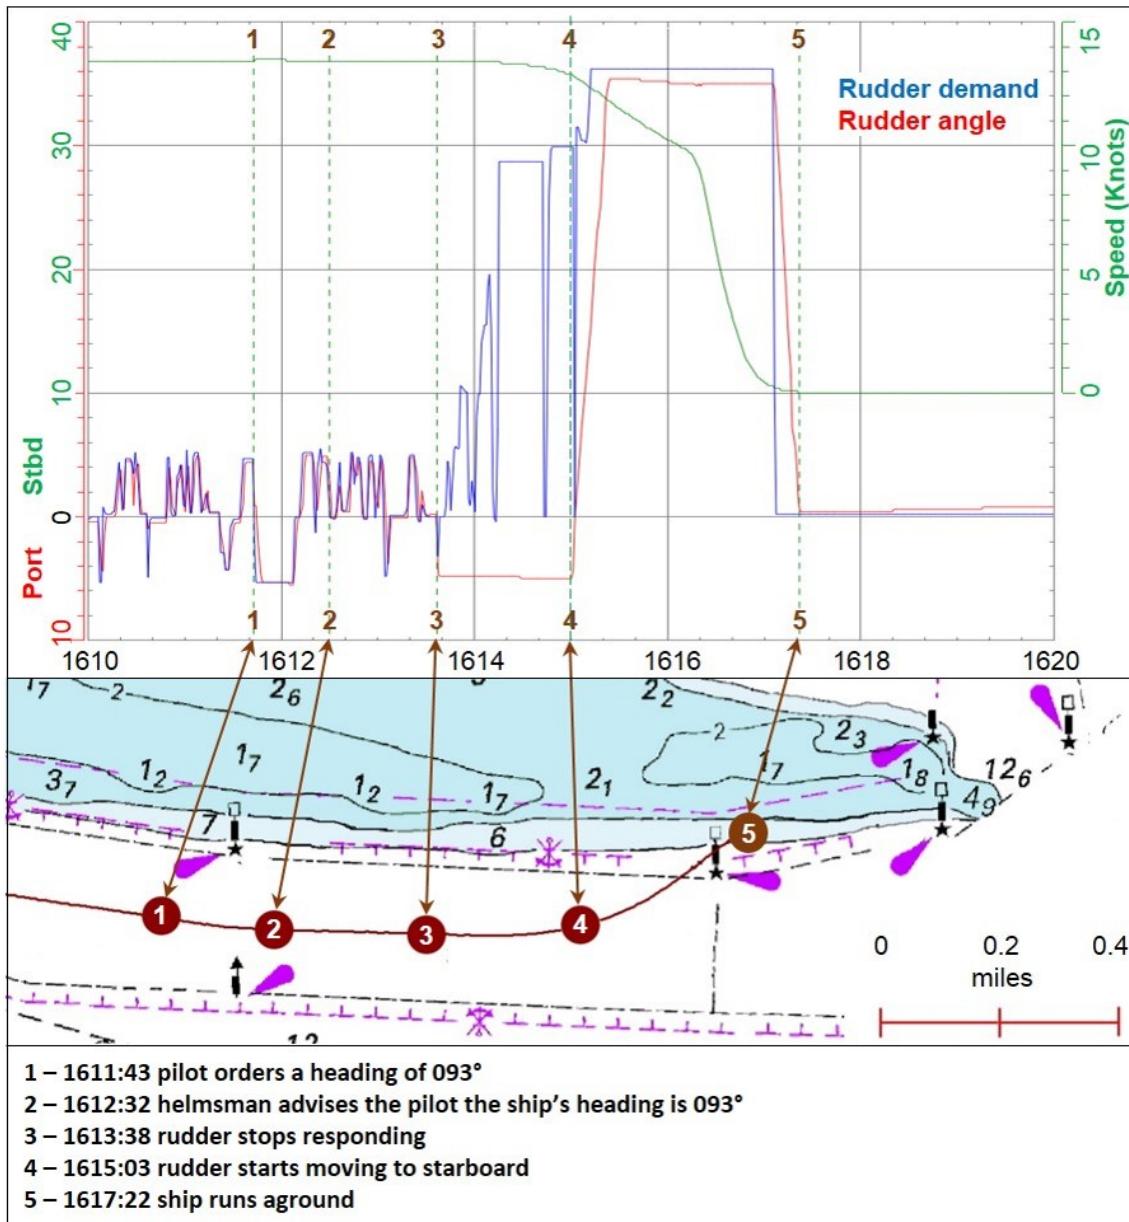
Figure 2: Bow Singapore's rudder movements, speed and position prior to grounding

At 1611:43, the pilot ordered a heading of 093° (Figure 2, point 1), an alteration of about 7° to port. The order was repeated back by the helmsman, and at 1612:32 he advised the pilot that the ship's heading was 093° (Figure 2, point 2). The helmsman then used the rudder, as needed, to maintain that heading.

By 1615:03, the master had changed the main steering pumps from number one to number two as requested by the pilot and the OOW had changed the steering (telemotor) system⁶ from number one to number two. The rudder then started to respond to the NFU starboard demand. A few seconds later the pilot observed that the rudder was moving to starboard (Figure 2, point 4).

At 1617:22, the pilot contacted Lonsdale VTS and reported the ship had grounded on the sandbank (Figure 2, point 5).

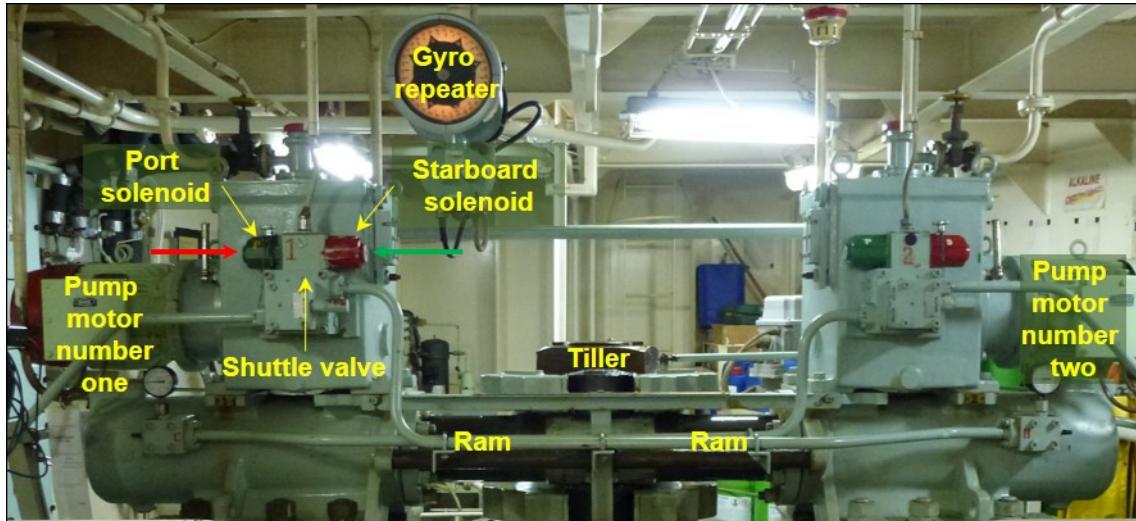
Figure 3: Bow Singapore's steering gear

Bow Singapore was fitted with a Kawasaki Precision Machinery RV21-022 steering gear (Figure 3). It was a two (simplex) ram Rapson slide system with two identical hydraulic systems. Each system included a hydraulic pump, directional control (shuttle) valve and electrical control systems.

In summary, from the evidence provided by the ship, the manufacturer's representative and the ATSB laboratory, no mechanical or electrical fault could be found to establish why the steering gear failed to respond to starboard telemotor signals.

Odfjell Management, the ship's managers, arranged for a manufacturer's representative of the steering gear to attend the ship when it arrived in Singapore. The solenoids and shuttle valves for both steering systems were replaced, the relief valves were opened and examined and the oil was changed. No faults that could cause the failure were found.

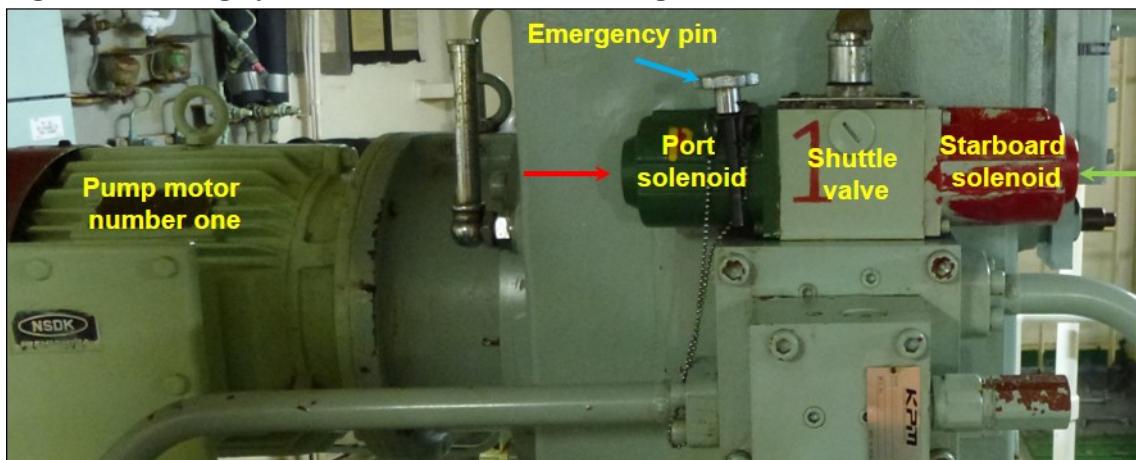
Figure 4: Steering system one solenoid valve arrangement

Manual (emergency) operation can be performed locally by inserting a pin (Figure 4, blue arrow) into the back of the required solenoid and pushing the shuttle valve across (red arrow – rudder to port, green arrow – rudder to starboard).

The manual testing showed that the solenoid, shuttle valve and pump were operating as expected. Therefore, the fault was unlikely to be mechanical and more likely to be an electrical fault associated with the starboard solenoid. The engineers then changed the solenoid and the steering gear resumed normal operation.

- An intermittent fault. Although an intermittent fault is possible, it is unlikely as this condition has not reoccurred and there is no history of this fault having previously occurred.
- A high-resistance contact. The solenoid's electrical pins were clean and showed no signs of mechanical damage. There was also no sign of arcing and/or heat discoloration that can sometimes be found with a poor electrical connection. However, this does not rule out the possibility of a high-resistance (dry) joint having developed. As the steering gear returned to normal operation, after fitting another solenoid, it is possible that if there was a poor connection, it was restored during the solenoid changeover.

Therefore, this could create confusion when crewmembers operating the solenoids locally receive a rudder order from the bridge. For example, receiving an order for port 5 could be interpreted as either operating the port solenoid or the red starboard solenoid. Although the colouring of the solenoids did not contribute to this occurrence, in an emergency situation, the risk of a helm order being incorrectly applied would increase. The added complexity of steering a ship from the steering gear room and the likelihood of an error occurring would be further increased due to the colouring found on the solenoids.

The ship managers have now included a 6-monthly job entry into their planned maintenance system for the opening and inspection of the steering gear's solenoids. In addition, the telemotor solenoids have been repainted so that the colours now match the direction of rudder movement, rather than the side of the ship on which they are mounted.

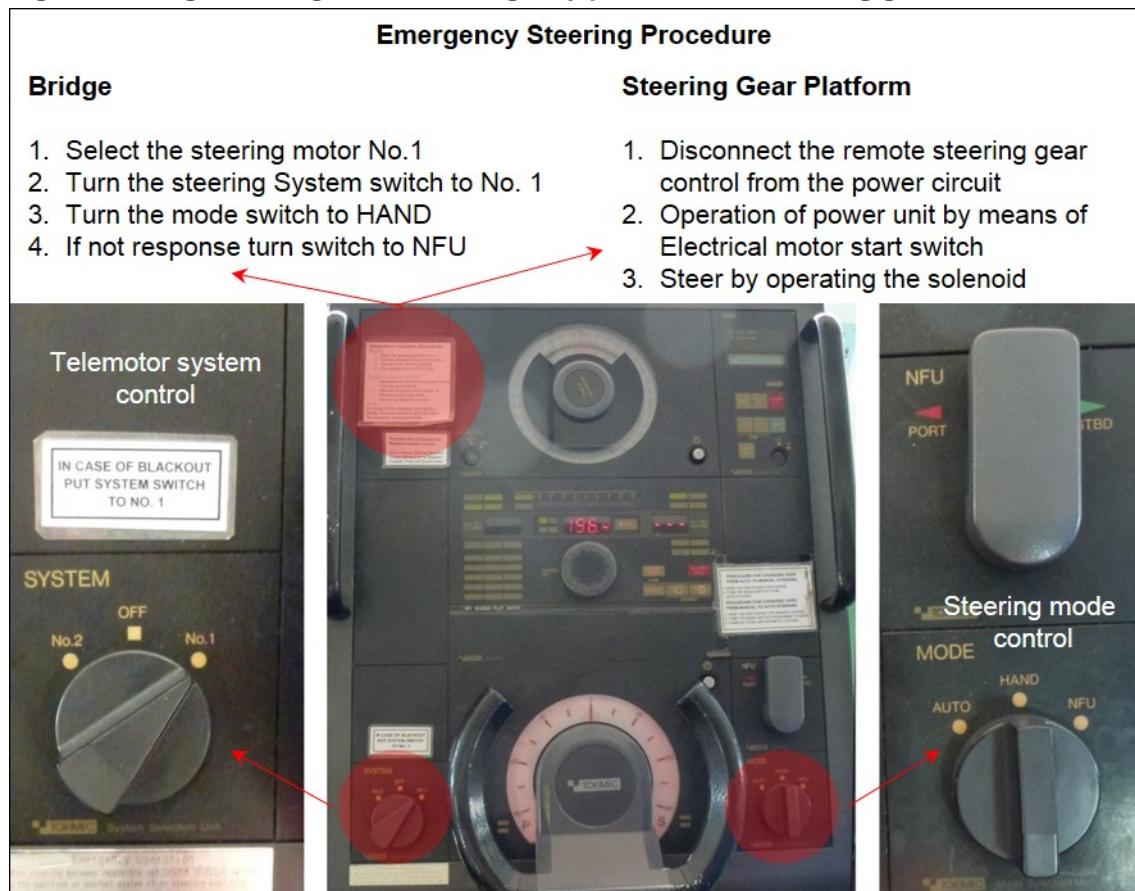
Figure 5: Bridge steering console emergency procedure for steering gear failure

However, the crewmembers had made an on board procedure stating the above (Figure 5) and affixed it to the bridge steering console. The ship's bridge team followed the steps in the on board procedure after the helmsman reported the issue with the steering gear.

Therefore, there was an inconsistency between the company-controlled documented procedure and the procedure affixed to the steering console. The company procedure would have resolved a loss of steering control from the bridge but required local operation to work. However, during pilotage in restricted waters, there is a limited time available to respond. Hence, the time required for crewmembers to proceed to the steering gear room and operate locally would not be the most expedient way to respond to a steering failure.

The ship's bridge team initially responded to the steering failure by changing over to NFU mode. When the rudder did not respond, they changed over from steering pump number one to two and steering (telemotor) system number one to two, the reverse order of the procedure affixed to the steering console (Figure 5).

Further, the fleet wide safety management system procedure for 'steering gear failure' has been amended to include reference to ship specific emergency change over procedures.
