Final report MO-2016-201: Restricted-limits passenger vessel the *PeeJay V*,
Fire and sinking , 18 January 2016

Marine inquiry MO-2016-201

Restricted-limits passenger vessel the *PeeJay V*
Fire and sinking

18 January 2016

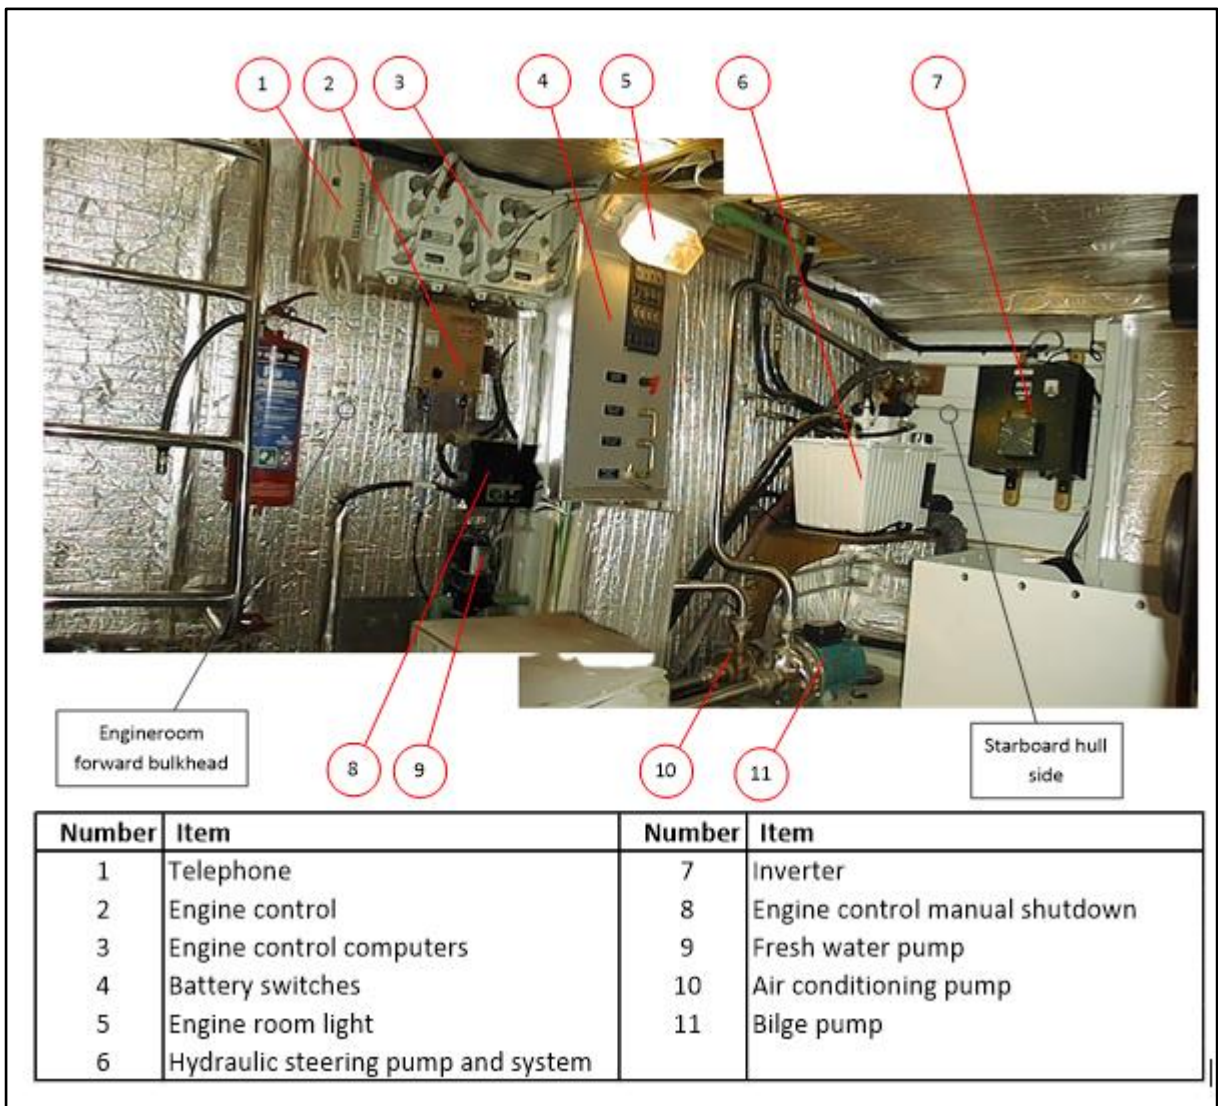
Figure 4
 Composite image of the forward starboard area of the *PeeJay V* engine room (from survey records)

- 4.2.3. The underwater survey of the wreck showed the charring in the timber hull was deepest in the forward starboard area of the engine room. Depth of charring is one indicator of how long a fire has burnt for. However, it can also be an indicator of the intensity of the fire in that area. Factors affecting the intensity of a fire include the supply of air to the space and the combustibility of materials in the area.

- 4.2.4. Most of the electrical installations and systems were located in the starboard forward area of the engine room, but so too was the hydraulic tank for the steering system. Electrical systems are a common cause of fires on small vessels. However, once ignited, hydraulic oil is known to burn with intensity, which could be one explanation for the deeper charring in the area. The deeper charring in that area was therefore not necessarily proof that the fire originated in that area.

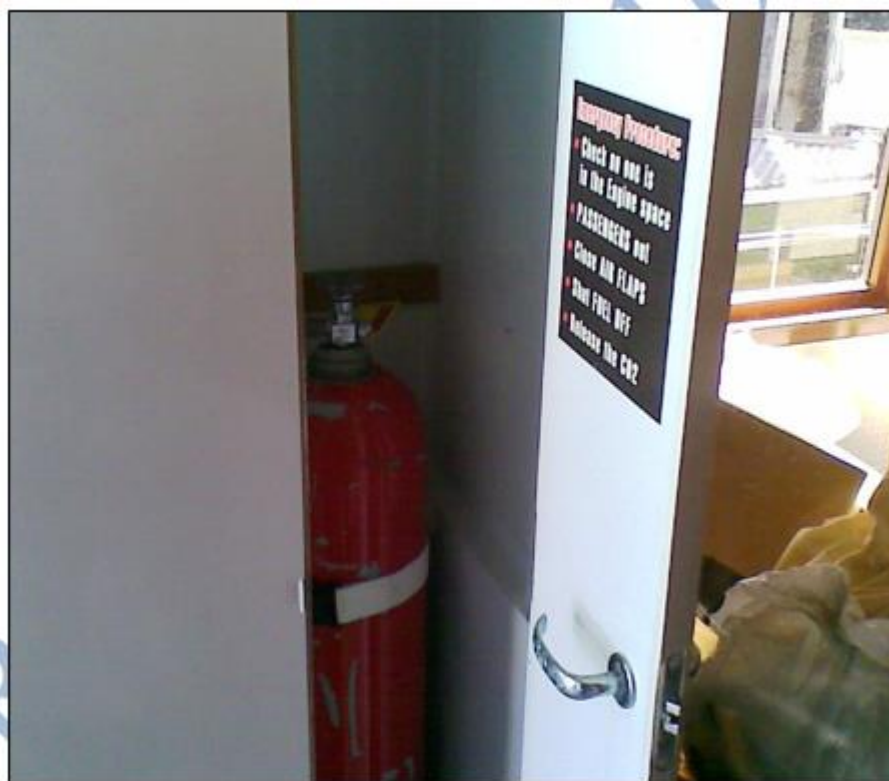
Figure 5
CO₂ locker showing the CO₂ bottle and its instructions for use

4.6.3. The emergency procedure for a fire in the engine room, which the crew followed, was described in the *Boat Work Manual*. It was basically the same procedure as that given in the cupboard of the triggering mechanism.

4.6.4. The *PeeJay V*'s operator and crew training included fire drills on board the vessel, and they attended the local fire station to receive training and gain experience using fire extinguishers. However, the training on the CO₂ flooding system was limited. Consequently, the principles underlying how the CO₂ system worked were not well understood. Had they had a better appreciation for the principles of the CO₂ system it is more likely they would have understood the critical need for the compartment to be fully closed down.
