Fire on board *BBC Xingang*

Newcastle, New South Wales, 11 December 2017

ATSB Transport Safety Report
Marine Occurrence Investigation
337-MO-2017-011
Final – 25 May 2018

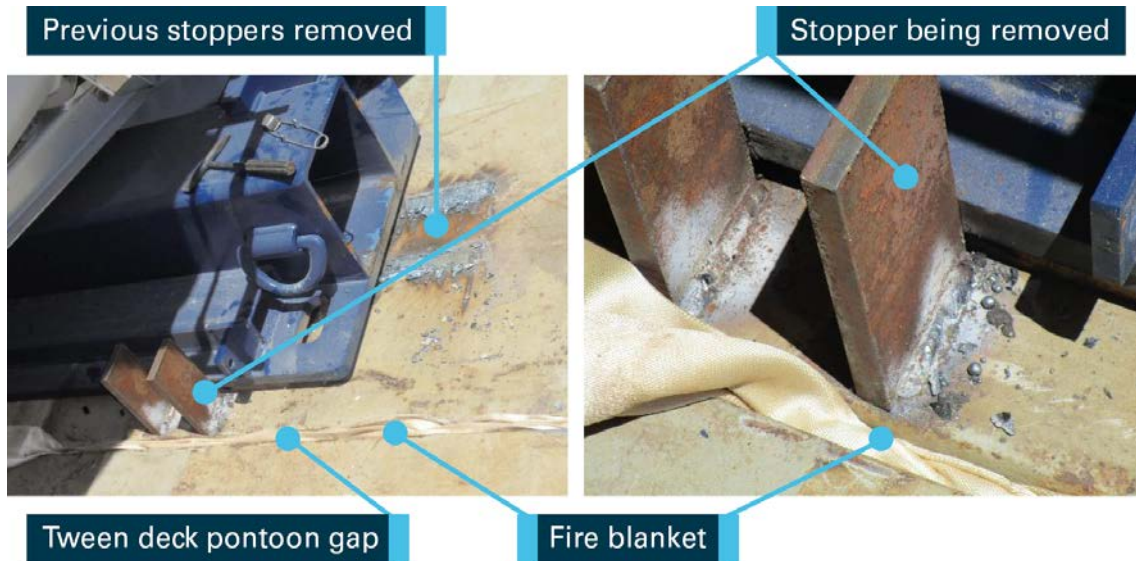
The work commenced in the number two cargo hold tween deck.² In preparation for the hot work, gaps between the tween deck pontoons were filled and covered with fire blankets (made from woven fibre and leather) to stop sparks from falling onto the cloth-covered cargo in the lower hold (Figure 2).

Figure 2: Worksite showing stoppers, after the incident

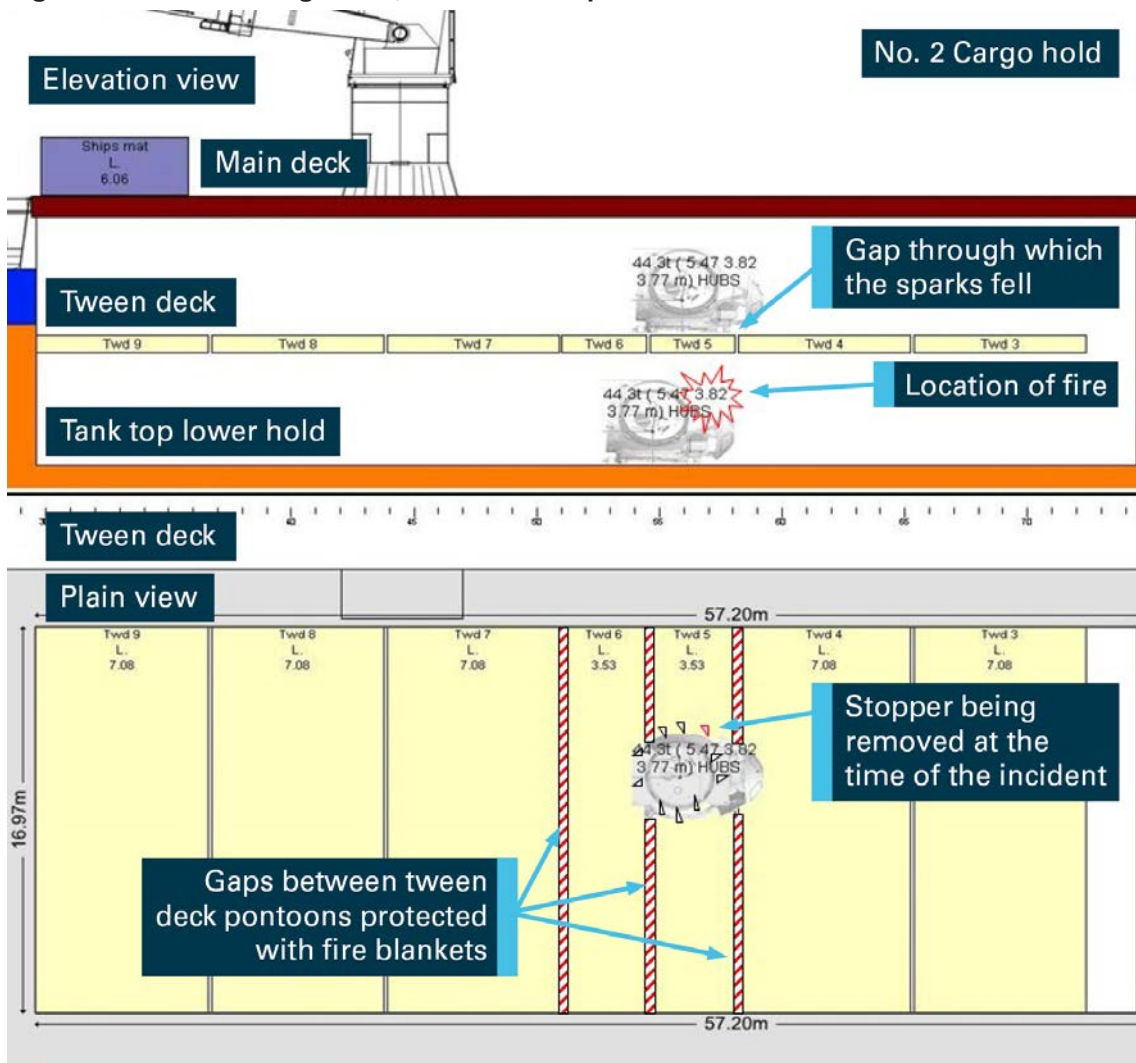
The work continued as expected and, at 1100, the boilermaker stopped to relocate to the next stoppers on the tween deck. As part of checking the new work area, he lifted a fire blanket and could see small flames and smoke in the lower hold through the gap in the tween deck pontoons. He immediately raised the alarm. The lower hold fire watch was notified on the radio. At the time he was notified he was not near the area directly under where the work was being conducted. After moving to the relevant area, he quickly extinguished the fire using the water hose and water spray. Figure 3 shows the location of the work site and the fire in the ship's hold (elevation view and plan view).

Figure 3: Number 2 cargo hold, elevation and plan views of worksite

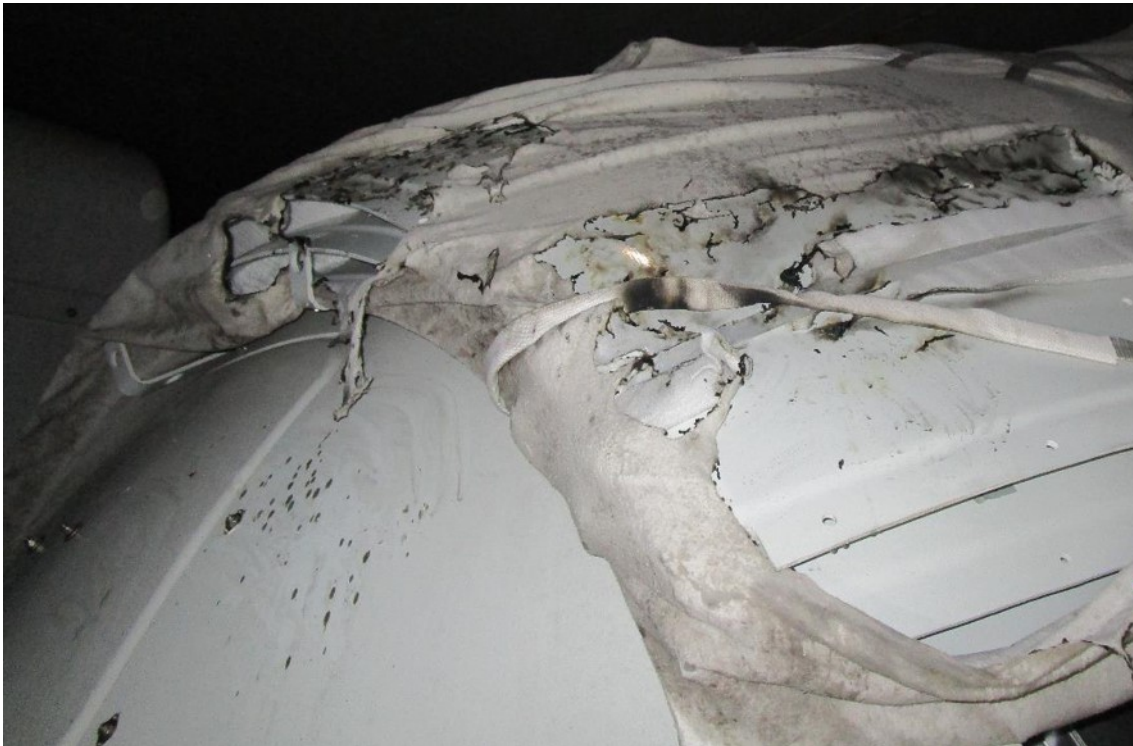
An inspection of the work site following the fire identified that molten metal and other hot material produced by the hot work had burned through the fire blankets. This hot material fell onto the material covering the cargo in the lower hold, resulting in the fire. As a result of the fire, the material covering the cargo was damaged and some surface blemishes were apparent on the cargo itself (Figure 4). No other damage was reported. Subsequent inspection of the cargo covering material found it to be 100 per cent polyester transport cloth with a maximum rated temperature of 200 °C.

Figure 4: Cargo covering material and cargo surface damage

The work area and the gaps/holes in the pontoons were protected by fire blankets. However, the molten metal produced was of sufficient size and intensity to burn through the protective fire blankets and fall onto the cargo stowed in the deck below. This cargo was covered with transport cloth to protect it during transport but was not protected from the hot debris by covering with fire blankets. Transport cloth is made of 100 per cent polyester and will ignite if directly exposed to fire. As a consequence, when the hot material fell onto the unprotected transport cloth it resulted in the fire.

Following the fire, all work to remove the stoppers was suspended and the incident was reviewed. Procedures and safety measures were reassessed during a meeting of ship's crew and the shore contract team. The cutting procedure was amended to direct the sparks away from deck openings and containment of sparks around the work area was improved. Further, additional filling material was added to holes in the tween decks used for removable hand rails, and the lower hold fire watch was directed to monitor the area directly below the work rather than the general vicinity. Work resumed at 1315 and continued to completion without further incident.

- improve coordination and communication between vessel management and third party contractors regarding expectations of fire watchers and firefighting equipment prior to starting work
- ensure inspections are conducted on all cargo and materials in lower holds, prior to starting any hot work in the tween decks
- ensure that if suspect items are found in the lower hold that communications with work teams and site management include focus on safety expectations and hot work controls
- include using heat proof tape to cover gaps in the tween decks with fire blankets added on top
- use fire blankets to protect items in the lower hold.

- gaps/holes in the tween decks will be covered by fire resistant tape in addition to other measures such as using fire blankets to protect areas below hot work.
