# National Transportation Safety Board

## Marine Accident Brief

### Fire aboard Sailing Vessel *Best Revenge 5*

| <b>Accident no.</b> | DCA17FM021 |

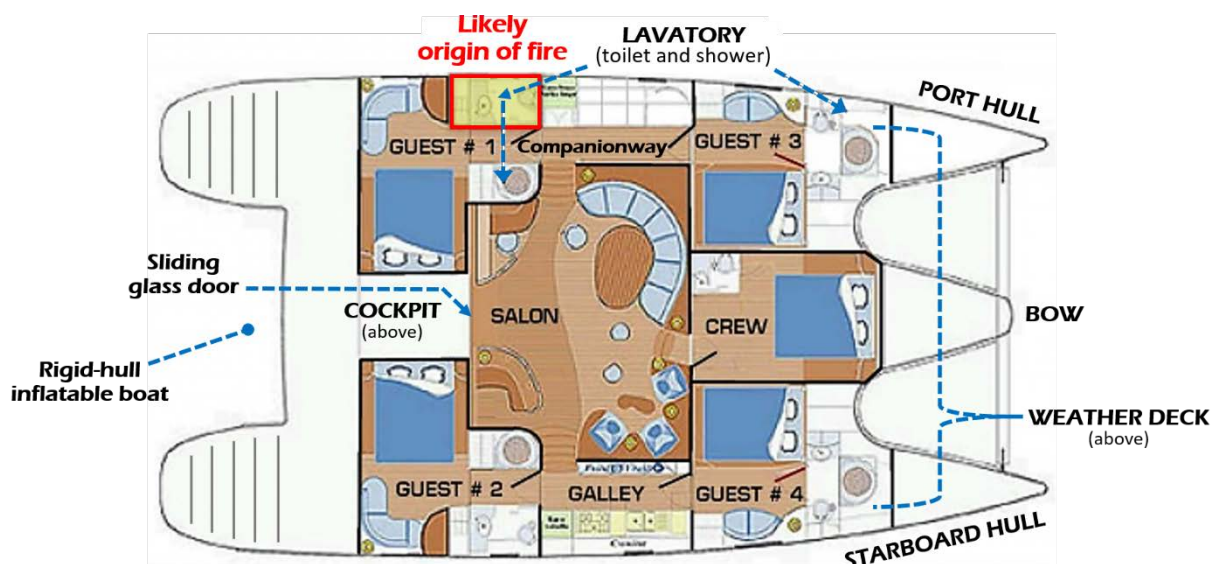
An annotated schematic of the *Best Revenge 5* identifies various accommodation spaces and where the fire likely originated in the lavatory on the port side. (Image courtesy of Sailing Directions®)

The captain of the *Best Revenge 5* told investigators that he was initially awakened by the smell of smoke in the crew stateroom, not from an installed smoke alarm. He also stated that he saw the glow of a fire by the stairs below the salon in the port hull, in an area known as the companionway. From his viewing position forward on the vessel's centerline, his line-of-sight indicated that the glow could have been emanating from the guest aft lavatory. However, he did not view what was burning and could not provide the ignition source.

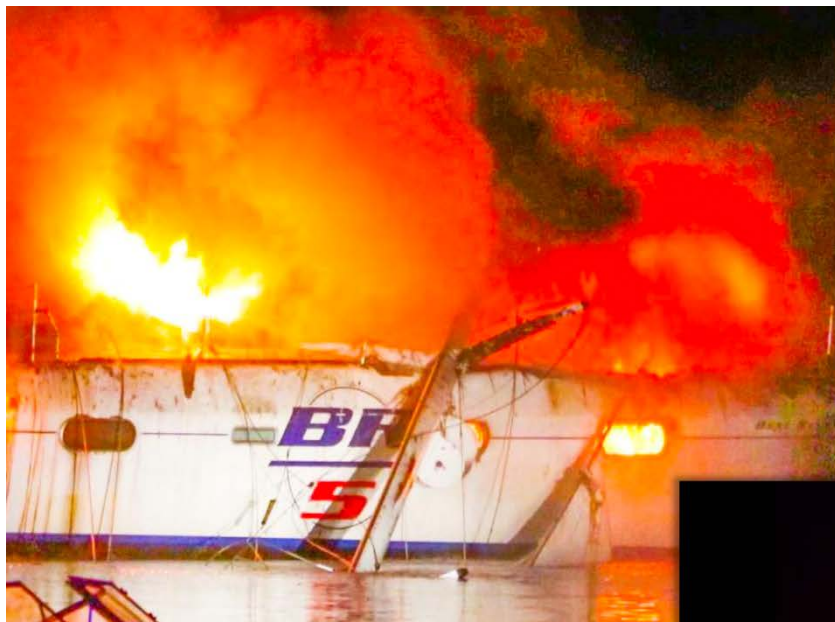
The first mate told investigators that, as she approached the catamaran, she could see that the exterior of the boat was burning near the electrical power pedestal on the pier. The pedestal itself, she said, was also “smoldering, burning, and charred.” At that point she grabbed a garden hose from further down the dock and began spraying fresh water on the fire; however, the flames continued to spread towards the stern. About this time, a portlight that was above the area of the flames fell inward into the fire and the hole in the port side of the *Best Revenge 5* began to widen.

While the first mate was attempting to fight the fire, the captain had been assisting the owner of the nearby boat in moving his vessel away from the area. Once the boat was moved, the captain joined the first mate near the *Best Revenge 5* in fighting the fire using the garden hose. He stated that the fire was around the aft guest lavatory located on the lower interior level of the port hull. At some point during the next several minutes, they heard a “whoosh” and then witnessed flames “[shooting] forcefully out” from the salon into the cockpit (through the sliding glass door) and from the hole in the side of the vessel.

*Best Revenge 5* on fire at the dock. (Photo courtesy of Satellite News Service; screen shot from video courtesy of Gayle Kiley via Cape Cod Times)

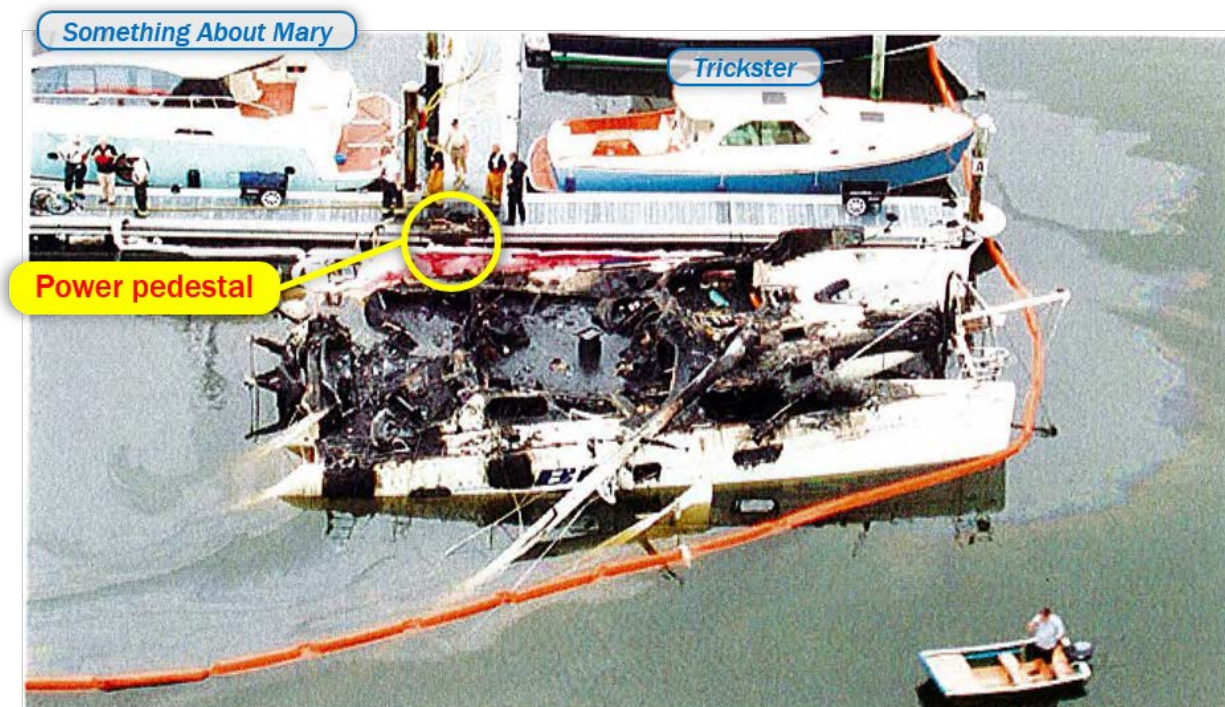
The *Best Revenge 5* was declared a constructive total loss, the dock was damaged in the area of the fire, and exterior equipment on the two adjacent docked vessels sustained some melting and warping damage, according to the fire department report. The following day, on July 12, the *Best Revenge 5* was dewatered, lifted onto a barge, and towed to the Port of New Bedford, Massachusetts. The total damage was estimated at \$1,385,000 for the *Best Revenge 5*; \$48,000 for the adjacent vessel *Something About Mary*; and \$75,000 for the dock.

***Best Revenge 5* partially submerged at dock postaccident. (Photo courtesy of Coast Guard)**

An examination of the vessel was first conducted on July 14, 2017, by fire investigators representing various interested parties. Because the vessel was partially submerged from firefighting efforts, the fire department could not complete a fire origin and cause investigation. A second multiparty examination of the vessel was conducted on August 9 and 10, 2017, by fire investigators, representatives of involved vessels and the marina, the Coast Guard, and the National Transportation Safety Board.

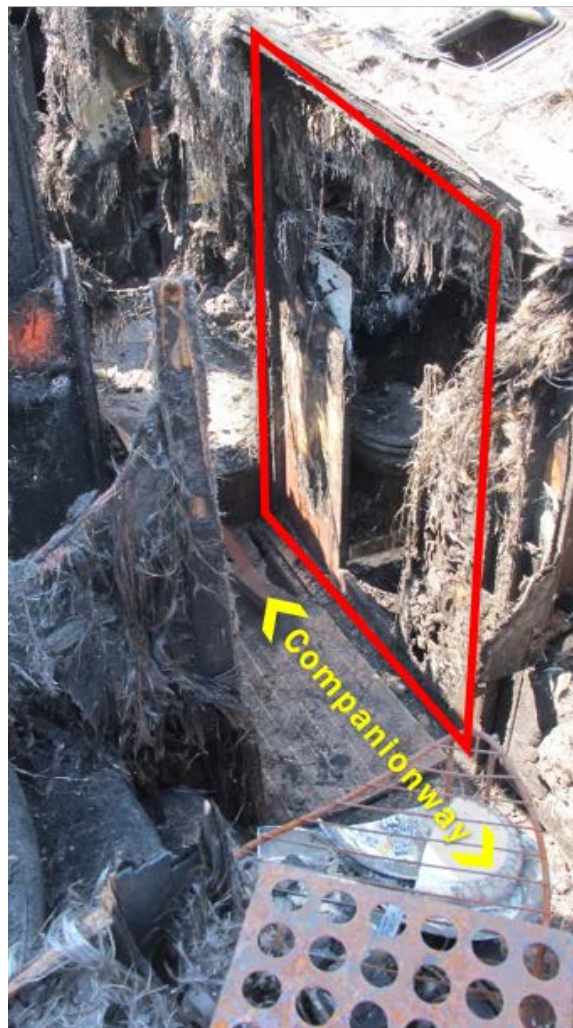
... the fire originated on the port side of the vessel; specifically, in the area between the port side lavatory, aft stateroom closet, and port side hull, in the area of the shore power pedestal. The only potential ignition sources identified within the area of origin were the shore power pedestal, electrical conductors/components in the lavatory, aft-port stateroom closet, and area above the aft port lavatory/shower area. The only fuels identified were the fiberglass hull, insulation, and ordinary combustibles within the area of origin.

Lavatory where fire likely originated next to portside companionway between guest staterooms while looking aft to stateroom.

The National Transportation Safety Board determines that the probable cause of the fire aboard the uninspected sailing vessel *Best Revenge 5* and on its pier was an electrical fault in an accommodation space on the vessel.

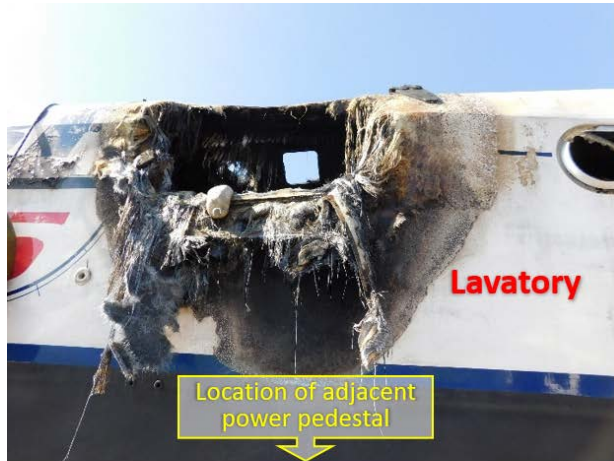
At top, the hole resulting from the fire on the port side at the aft guest lavatory. At bottom, the shore power pedestal, cable, and portions of the dock planking where the pedestal caught fire, which was re-created for examination.

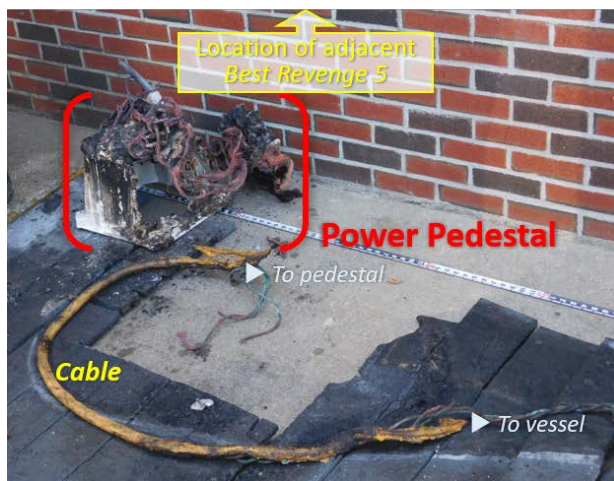
electrical evaluation with an x-ray image of the shore power pedestal remains, which showed arcing and shorting. The evaluation noted that, after the fire, marina personnel reported that the circuit breaker powering the dock pedestal from shore was in the “tripped” position (electrically disconnected as a protection measure) and that the two shore power circuit breakers on board the *Best Revenge 5* (fed by cables from the pedestal) were undamaged and tripped to the “off” position as well. They concluded that the vessel “may have been [electrically] powered at the time of the fire.”

If the shore power pedestal was the source of the fire, it would have had to first have an electrical fault resulting in ignition of the pedestal's wire insulation and plastic casing. The ensuing pedestal fire would have had to reach a sufficient intensity to ignite the vessel's paint, fiberglass, and resin on the portside hull through direct flame impingement or radiant heat. Burn marks on the dock around the power pedestal, however, did not indicate that the pedestal was fully engulfed in fire on all sides. Additionally, the damaged remnants of the power pedestal indicated an uneven burn with the areas farthest away from the boat less affected by the fire. Therefore, considering the size of the fire that would have been required to ignite the adjacent vessel, the burn pattern around the pedestal, and the asymmetric pedestal remains, along with witness statements, it is less likely that the fire damage to the dock and pedestal was the result of a fire originating within the pedestal but rather more likely from the radiant heat from a fire located on the vessel.
