Isle of Man Ship Registry

Casualty Investigation Report No. CA 128

M/V Cheshire

Ammonium nitrate fertiliser cargo decomposition

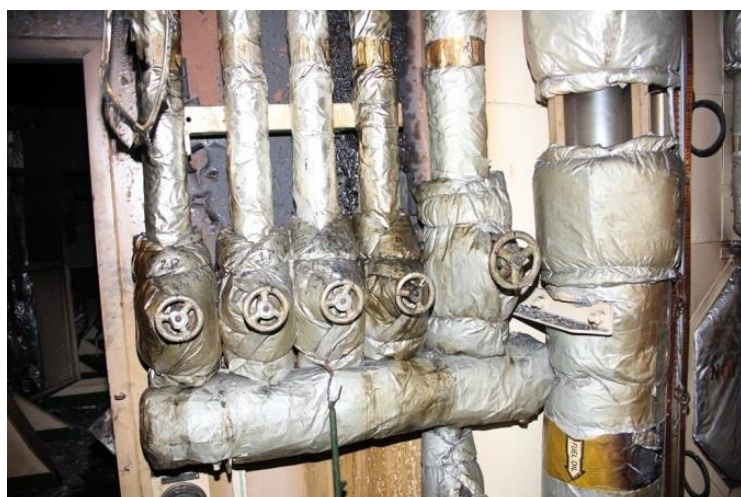
HFO heating coil steam valves (confirmed as being closed in the managers initial access to the vessel) ^[2]

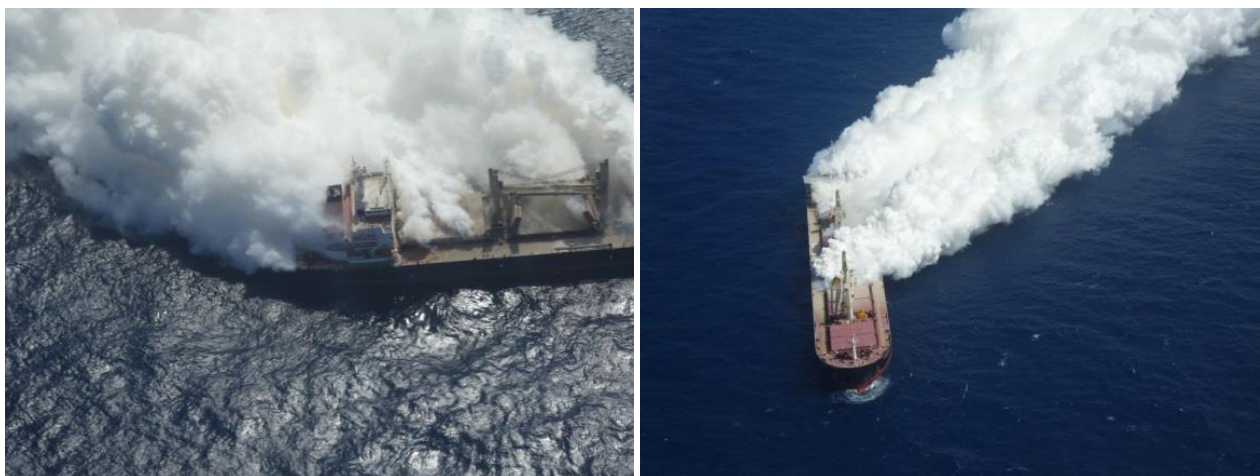
Examples of the conditions described by the crew on the 13/14th August (toxic gas enveloping the accommodation and being drawn into the engine-room ventilation system) these pictures taken after the vessel was evacuated with CH#3, # 4 & #5 decomposing and toxic gas plume visible from 14nm away. ^[1]

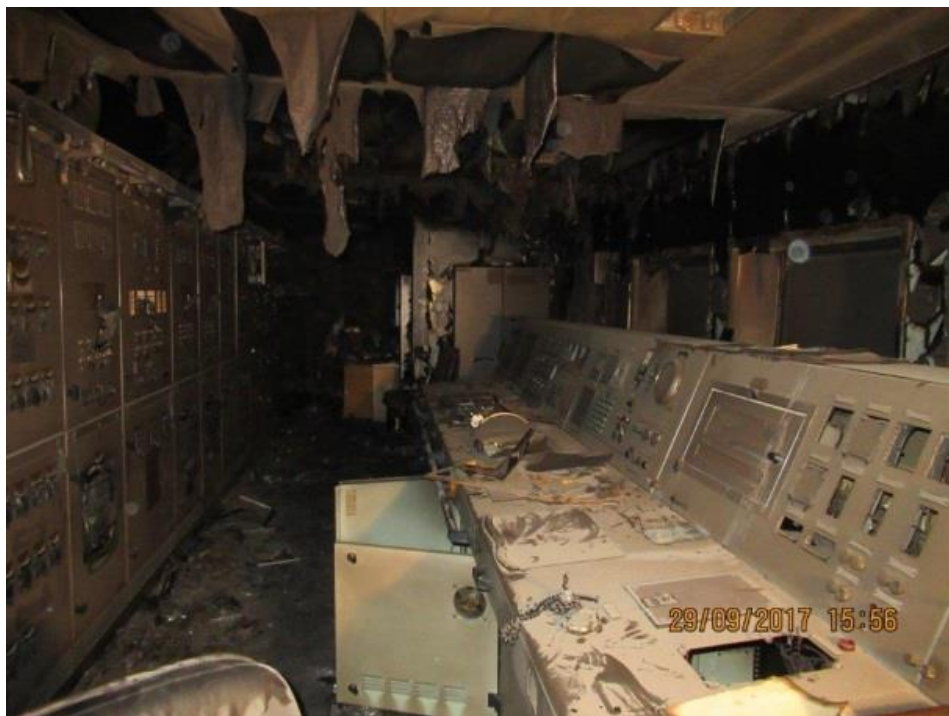
Post salvage photograph of the engine control room giving some indication of cargo decomposition particulates that were drawn into the engine-room by the ventilation and blocking the turbocharger filters (approx. ½ ton of dust was removed from the ER) – note that structural fire insulation is designed to offer protection for hours, not days and why fire damage was also evident in the engine-room. ^[3]

The blocking filters and high deviation temperatures caused by the particulates, prevented the vessel from going fast enough astern to gain sufficient steerage to clear the gas cloud, this meant that the situation was going to continue until the wind outside the vessel picked up enough for the vessel to finally clear the significantly sized cloud evolving from CH#4 and completely surrounding the vessel, since there was little or no wind to disperse it.

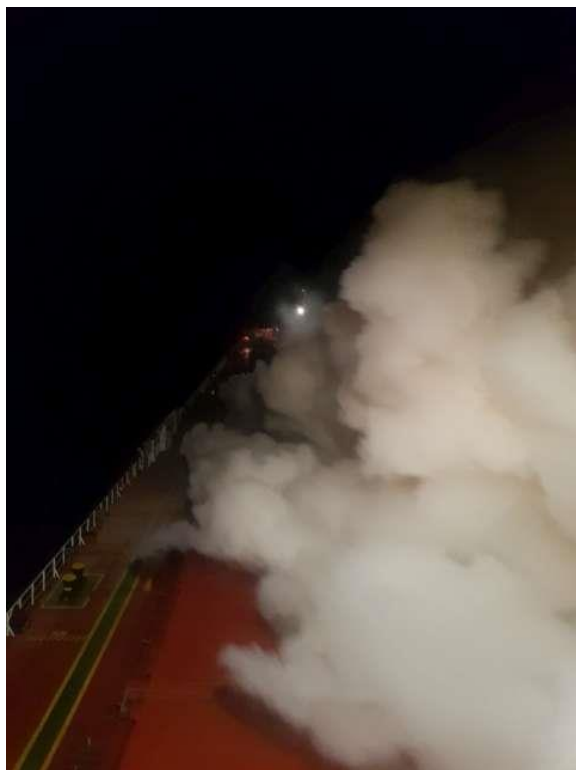
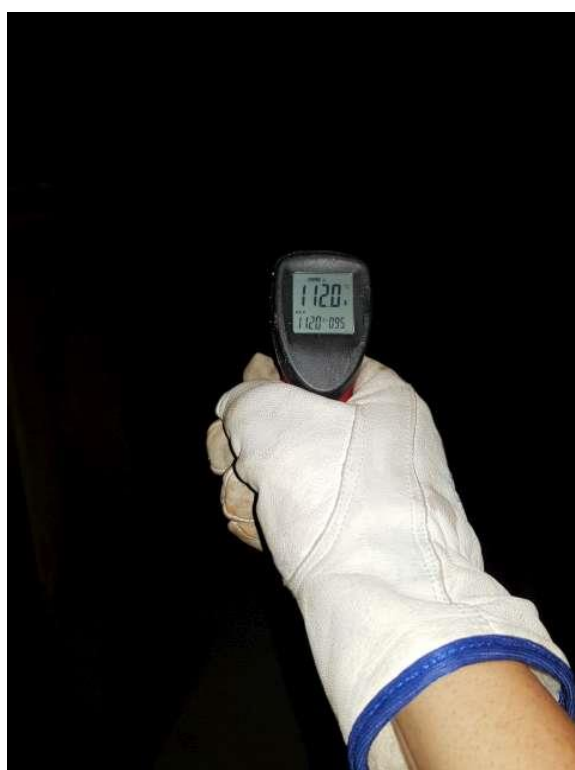
Photographs taken by the surveyor soon after boarding ^[4]

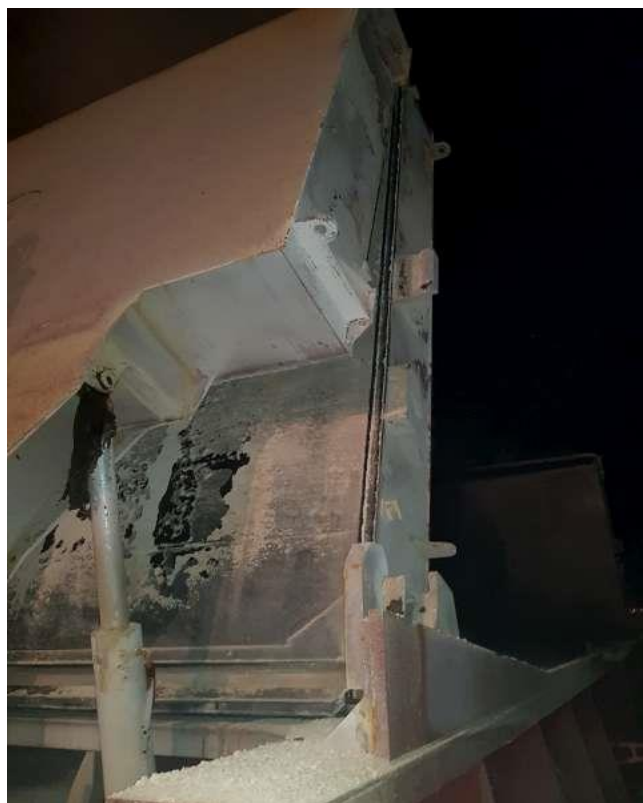
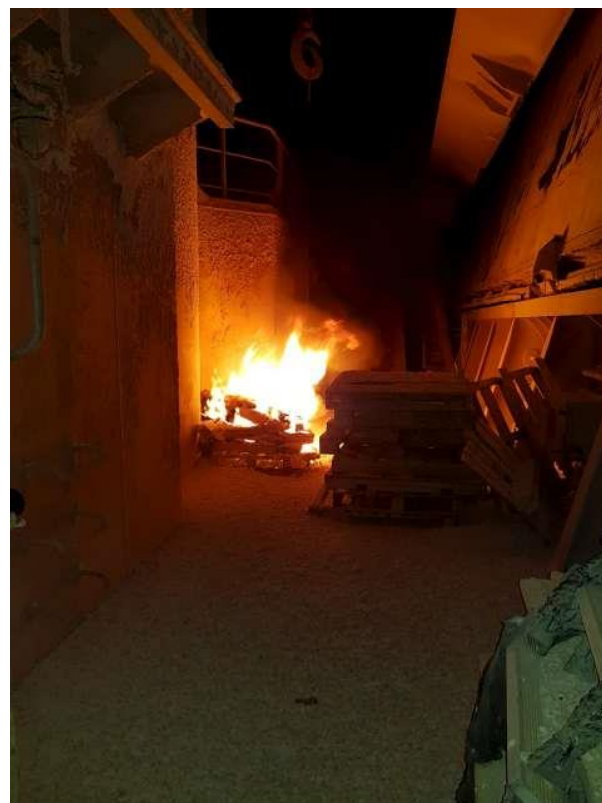
CH#4 hatch cover following the initial “explosion” and burning wood pallets ignited from hot cargo. ^[4]

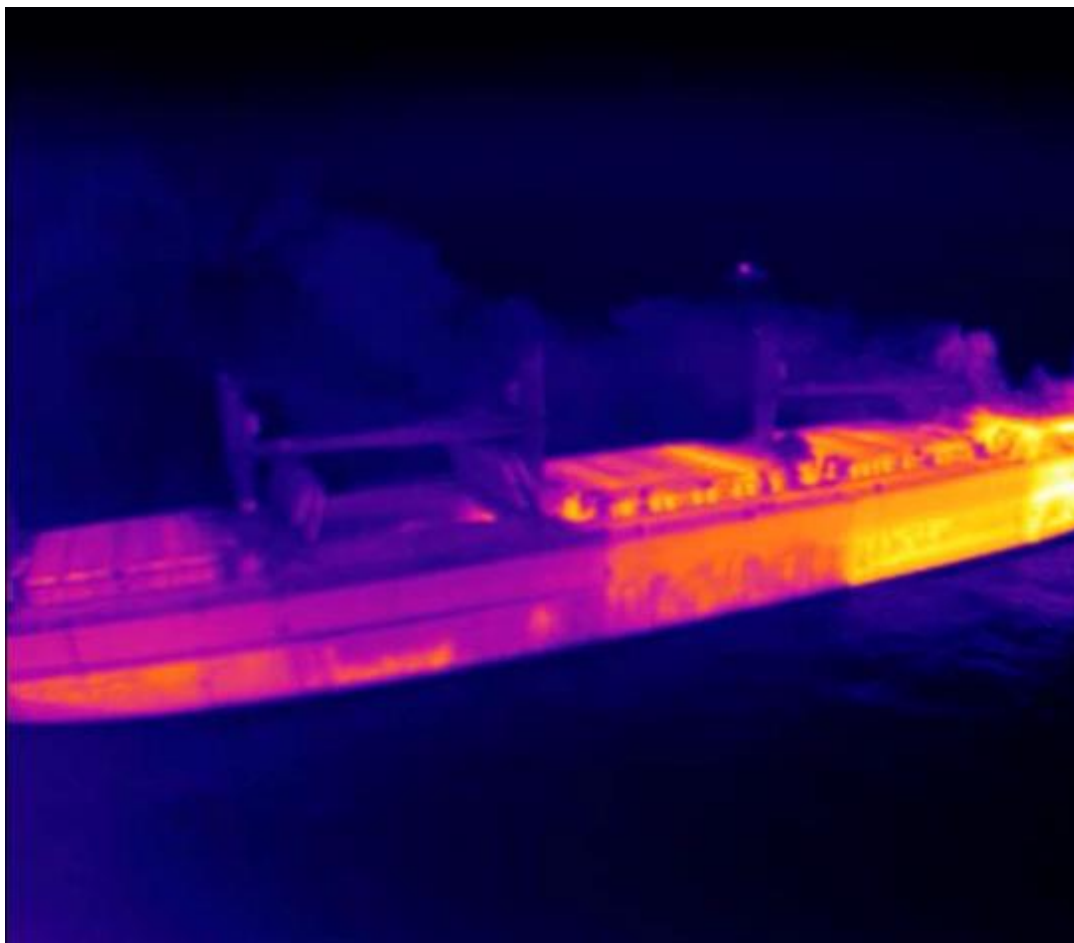
Thermographic and visible images of CH#5, #4, #3, #2, and #1 left to right (CH#1 hottest, CH# 4 coolest) ^[1]

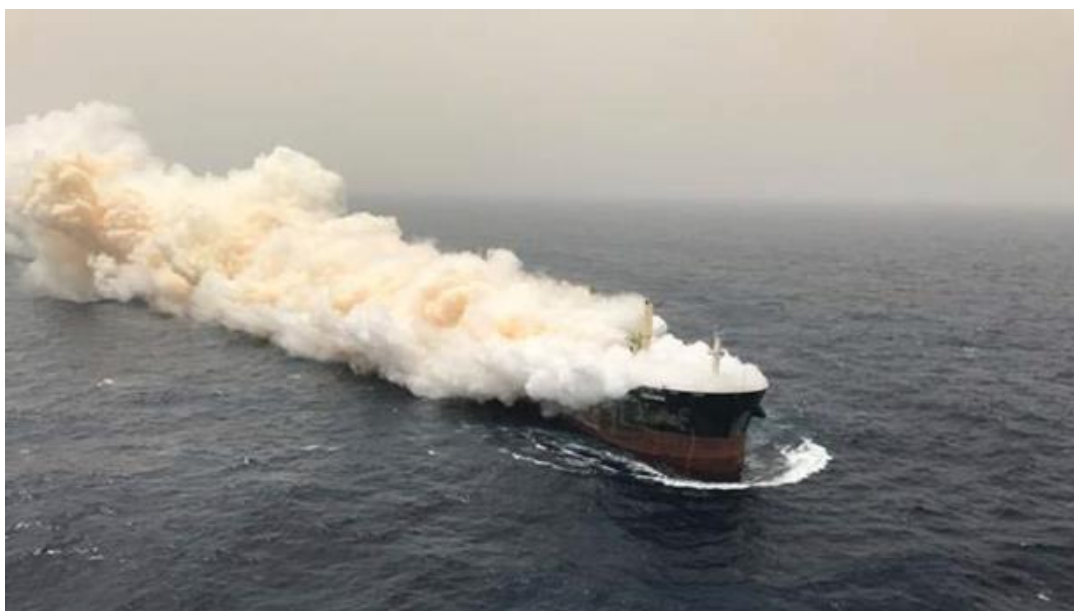
Although damaged in its entirety by the decomposition, approximately 23,183 tons (54%) of the cargo was consumed by the reaction and by toxic decomposition products being released to the atmosphere, only 19,471 tons (46%) remained on board after the event. ^[1]

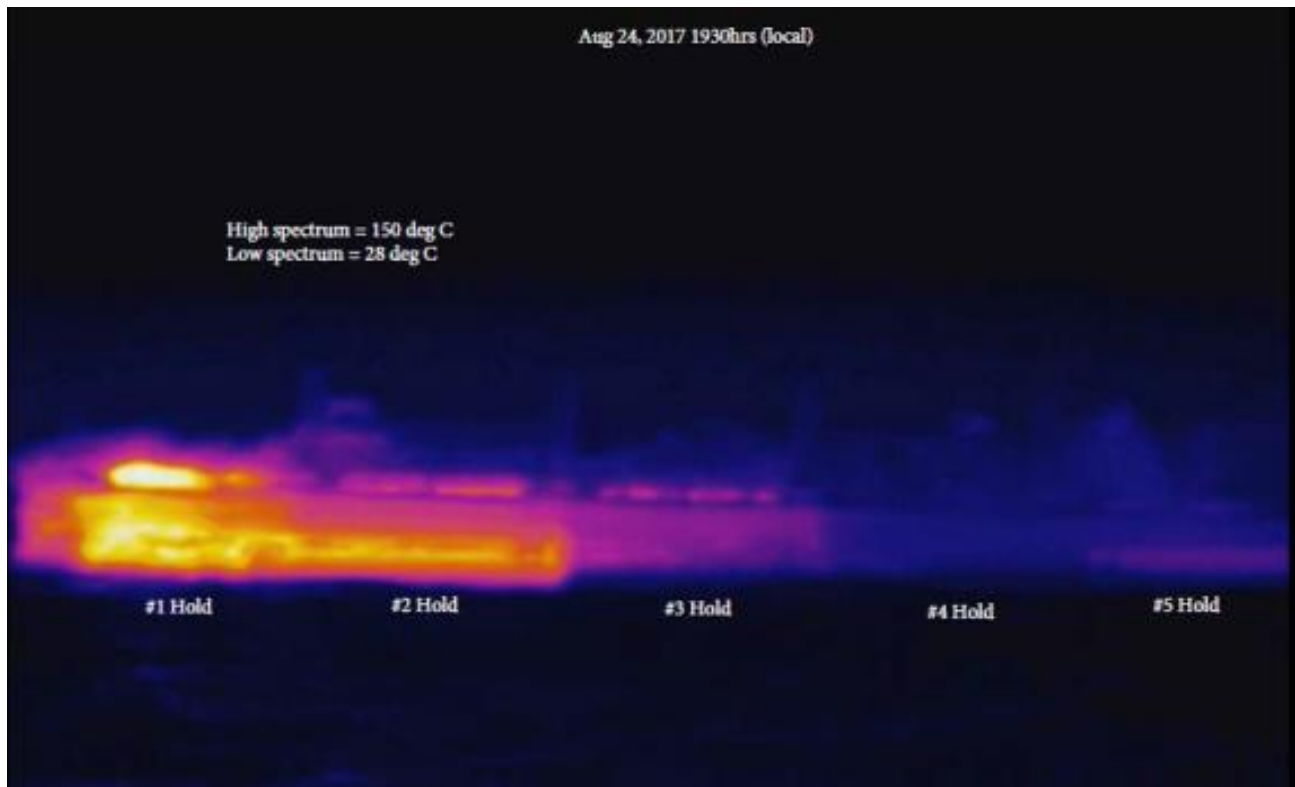
Thermographic and visible images of CH#1, #2, #3, #4, and #5 left to right, prior to initial salvage access. CH#1 is hottest followed by #2,(CH# 3, #4 and #5 reactions have largely run their course and CH#4 is now the coolest hold) ^[1]

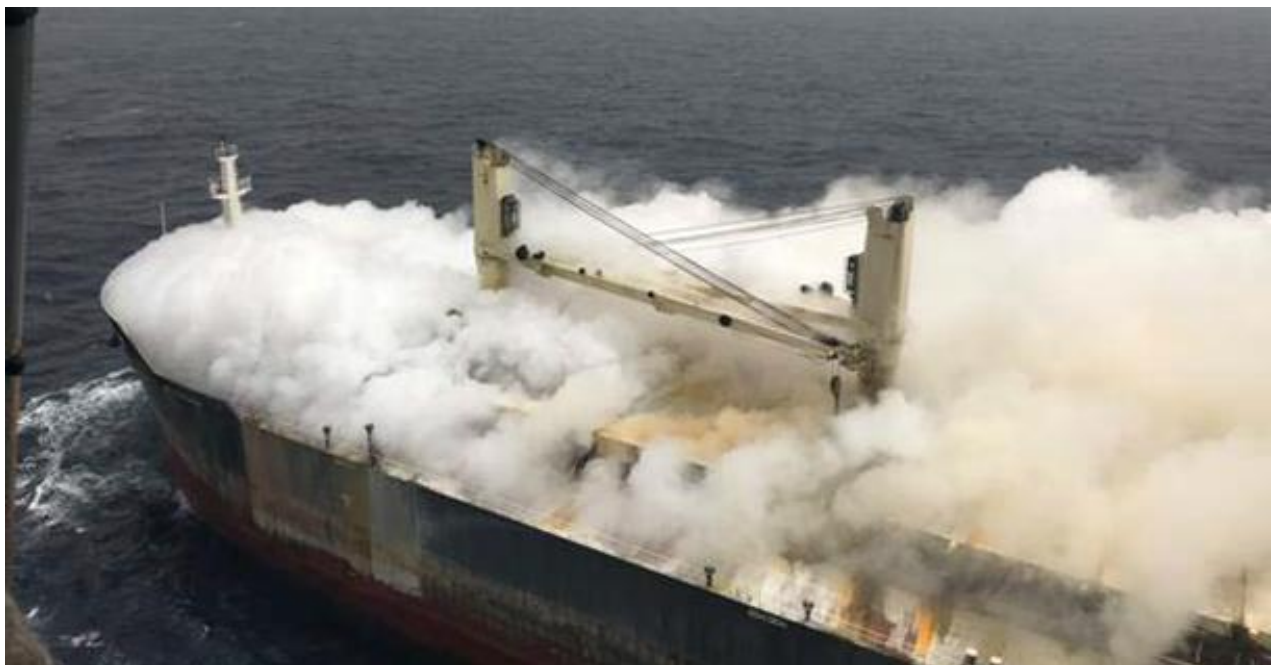
Not smoke but toxic gas that is harmful to life ^[1]

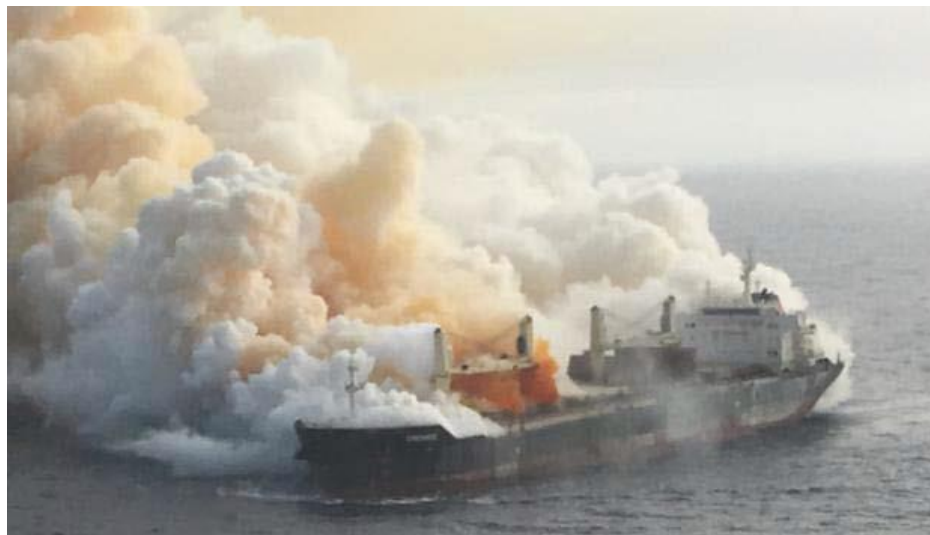
Initial salvage access to vessel, by gas colour CH#2 is seen to be at a more advanced stage of decomposition than CH#1^[1]

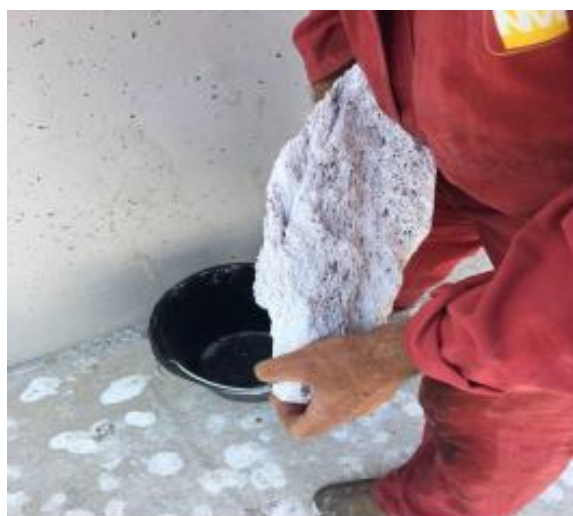
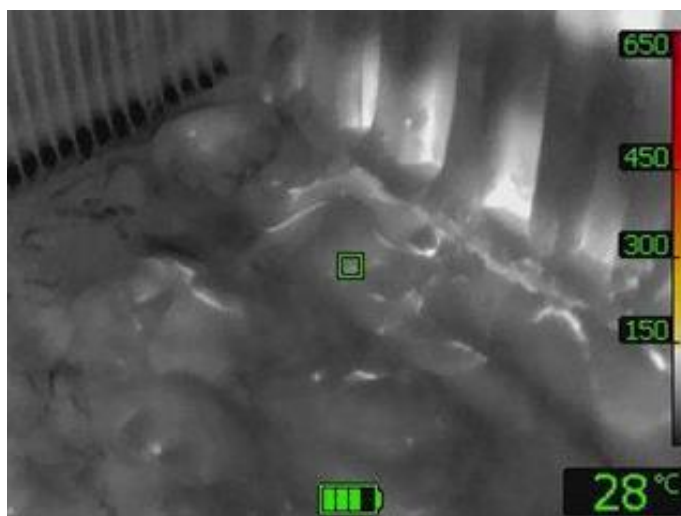
Although the fertiliser mass itself acts as an insulator, manufacturers advised Matrix formation could assist a decomposition reaction by retaining heat at the reaction front. It was observed that a Matrix had in fact formed over the decomposed cargo and had retained heat. One of the conditions placed on the vessel for safe discharge of cargo by Motril port authorities, was that any decomposed cargo landed on the quayside must be less than 50°C – this was to prove difficult due to the Matrix retaining heat and being hard, requiring it to be broken up to enable access to the hot cargo below it. As a result the unloading was expected to take a long time.

Insulating Matrix formed over the cargo retaining heat ^[1]

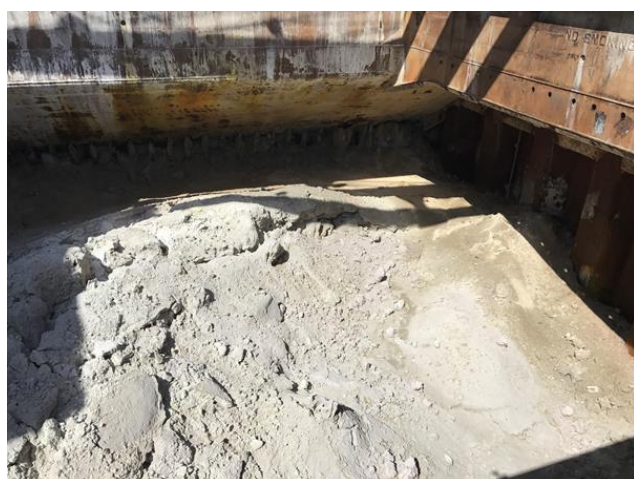
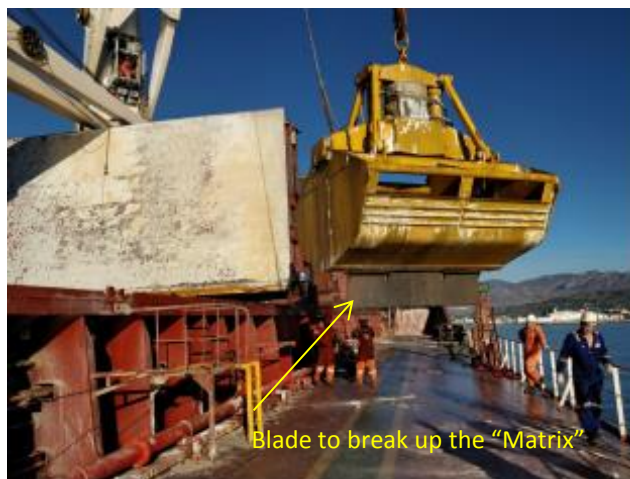
Matrix formed over cargo and blades welded to cargo grabs to help break it up ^[2]

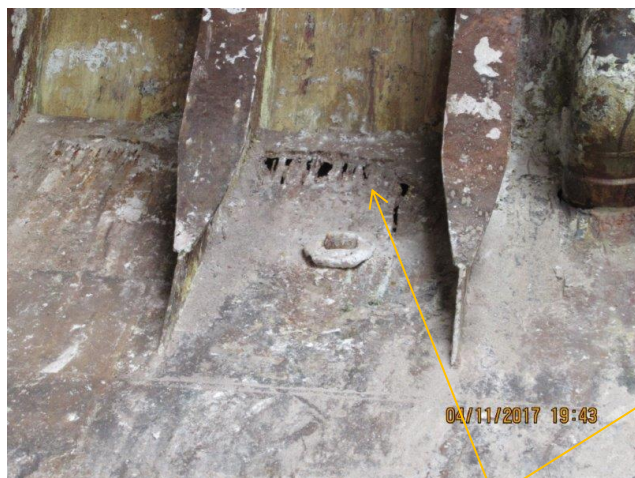
It was becoming more and more clear that significant structural deformation had occurred in addition to the visibly obvious structural damage and on 4th December 2017 under the vessel’s hull and machinery policy, the underwriters declared the vessel a Constructive Total Loss (CTL).

Cargo hold no.2 structural damage. [3]

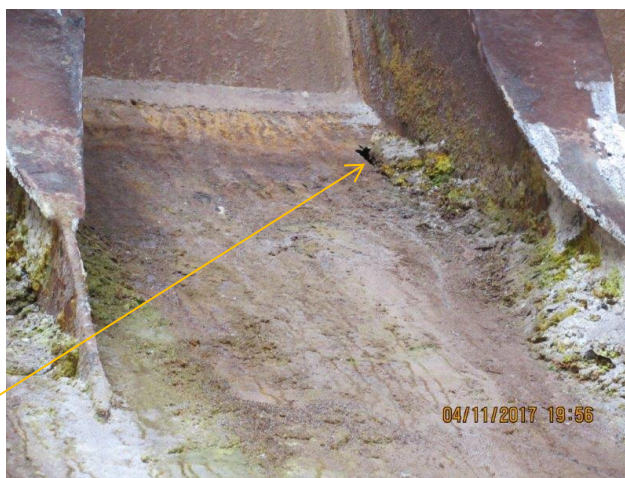
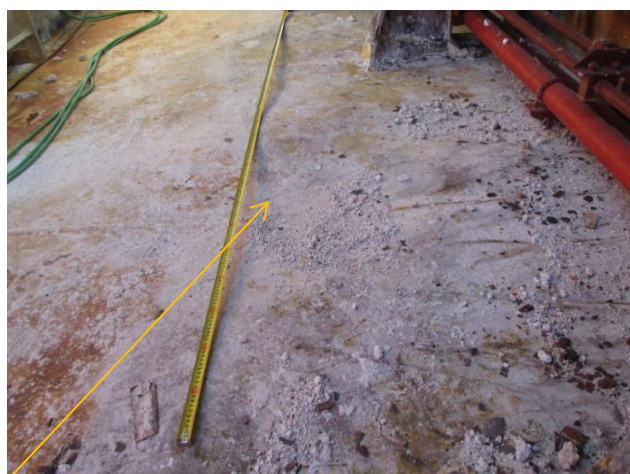
Deformed/rippled cross decks. [1]

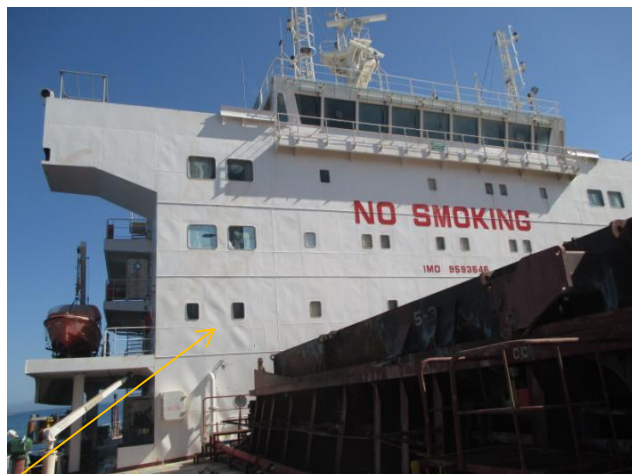
Deformed/rippled superstructure [1]

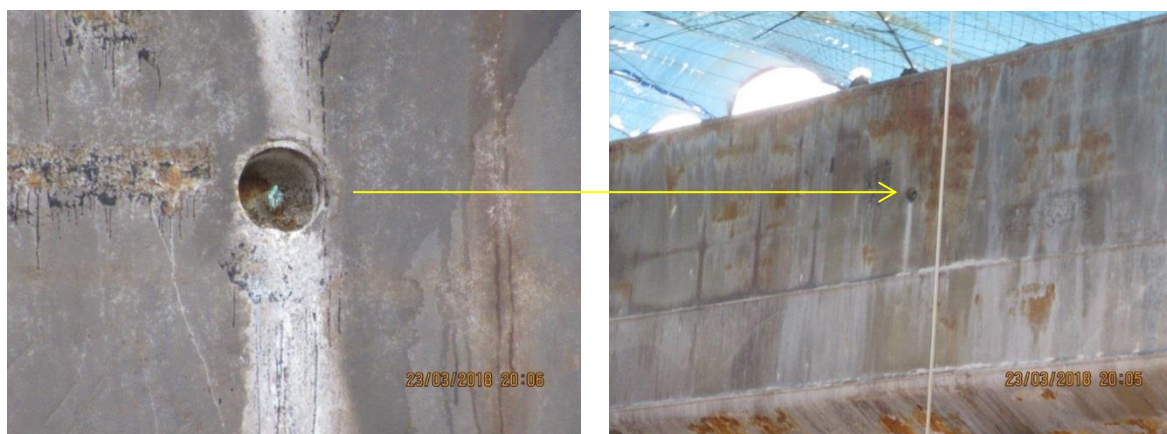
Analysis – In the days prior to the obvious signs of a decomposition and “smoke” being evident coming from CH#4 drains and openings, for some reason a cargo hold fire detection alarm was not listed in the alarm history and the deck area fire detection zone is not recorded as having been isolated. There is an open system fault (16.55hrs 23.05.17 onwards) on the log maintained on the bridge by ship’s staff recovered after the incident ([link](#)) – but the description does not make it clear how the fault might have affected the system.

Comment – Specific maintenance records have not been located, no spare parts were ordered and an explanation of a simple failure to close the record once power was restored to the system has since been offered by the C/O. Photographs taken following the incident show what may be a blockage on the sampling line/cargo hold connection points and may possibly explain this failure to alarm, but this blockage is most likely a result of the cargo activity (sampling points were higher than the cargo and would not be expected to have been blocked), accordingly at this time the Author is unable to explain why an alarm is not shown in the alarm logs pertaining the cargo area and therefore did not raise awareness of a problem, in the period since departure.

CH#4 smoke detection sampling points (the cargo surface lay below the sloping surface at the bottom of the second picture, upon completion of loading). ^[3]

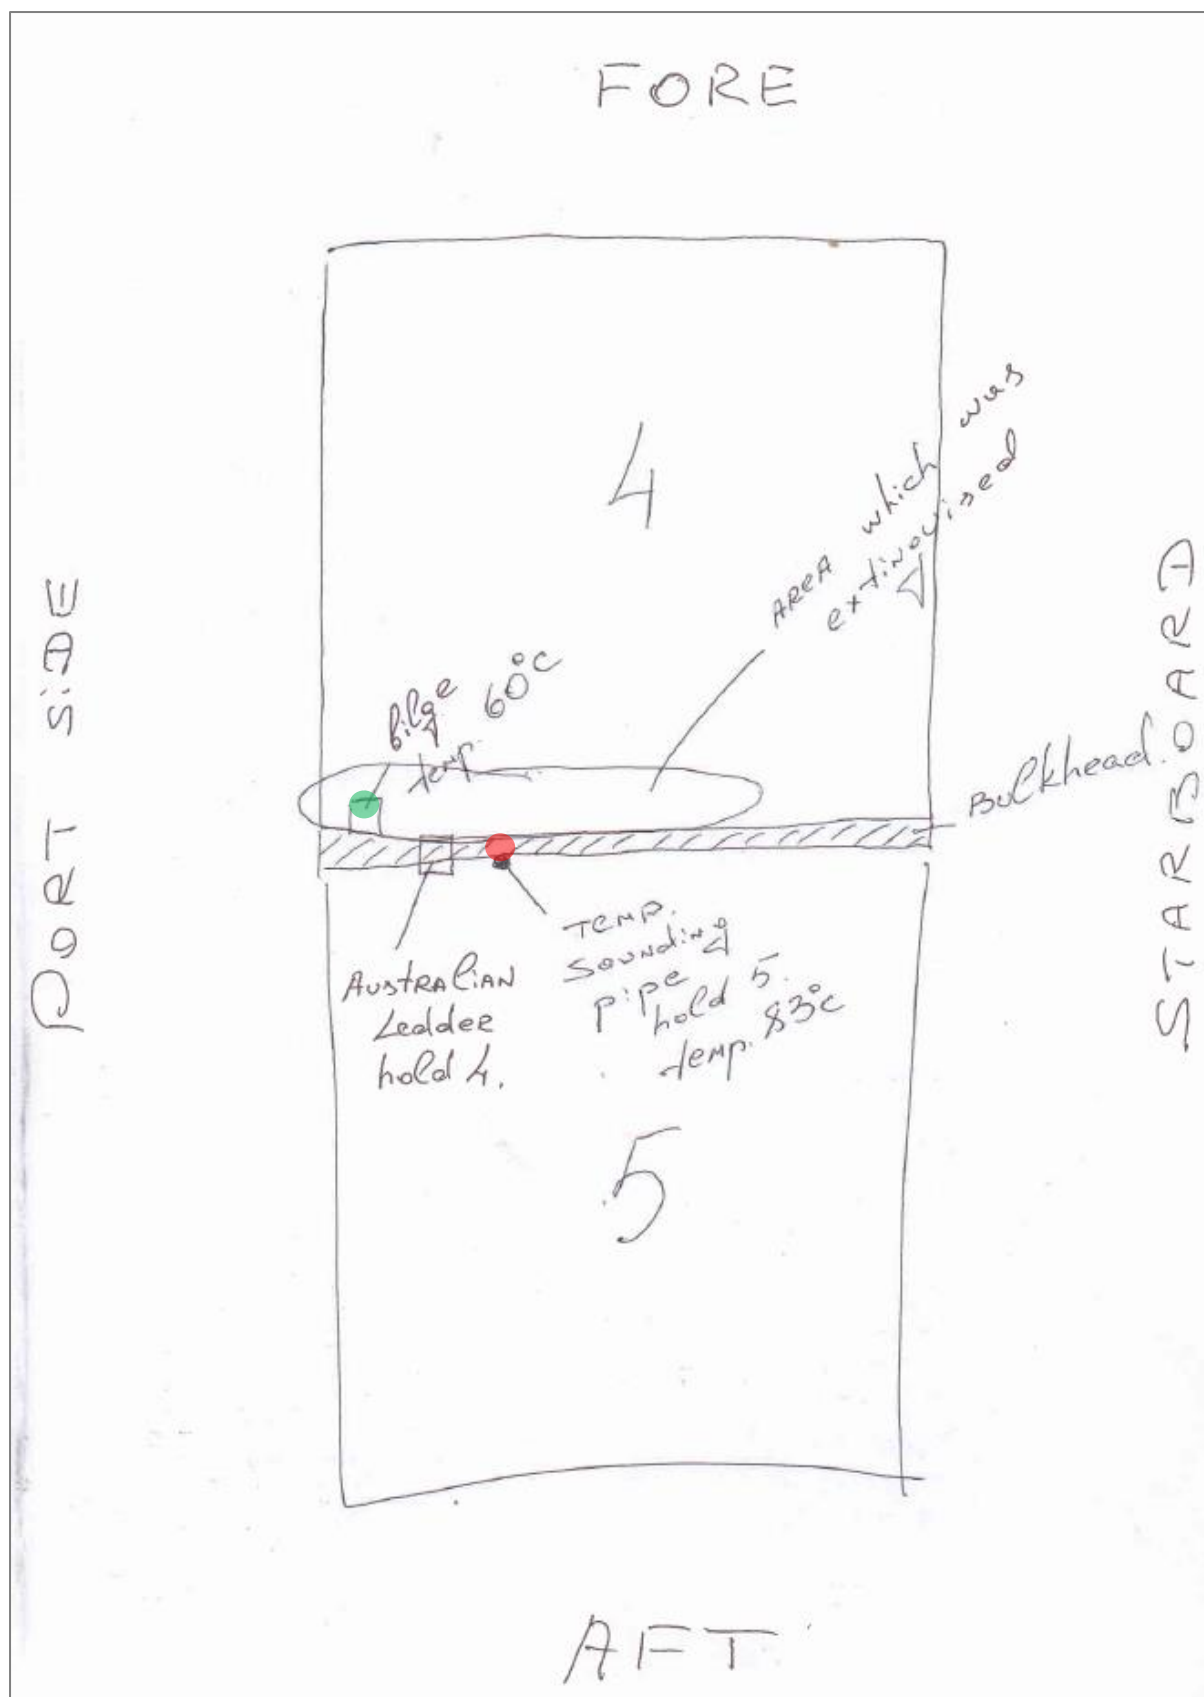
Sketch of initial hot-spot location and cooled area. ^[3]

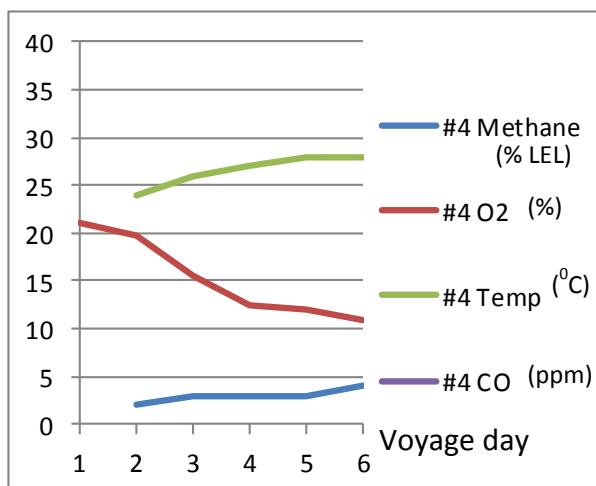
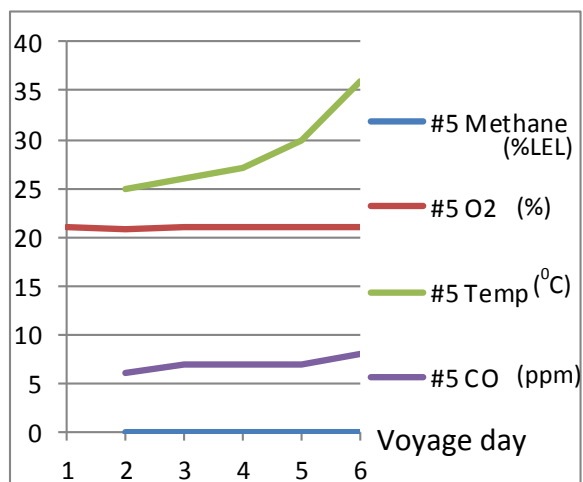
#4 Carbon Monoxide ppm off scale when measured (all days)

Quickly rising temperature in #5 from 9th Aug (voyage day 4)

Hold atmosphere conditions trended from information obtained during the investigation.

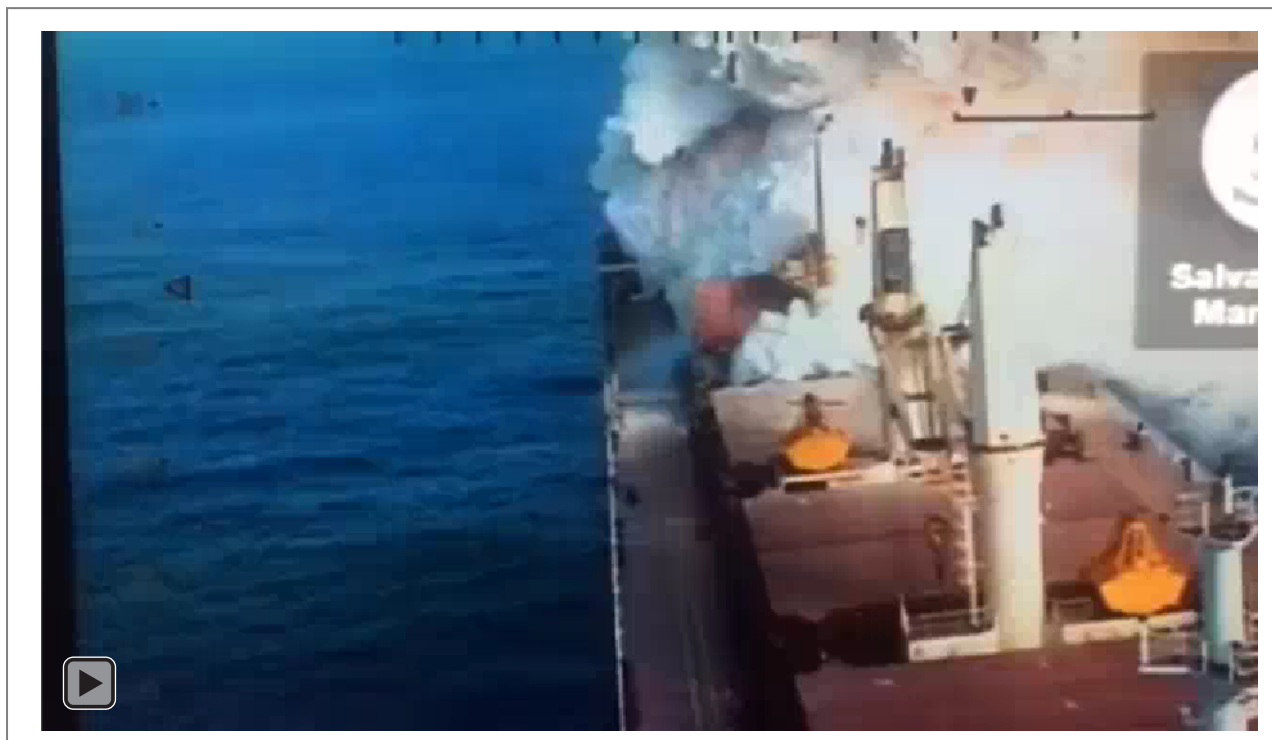
Deflagration ^[5]
