NTSB | National
Transportation
Safety Board

SAFER SEAS DIGEST

Lessons Learned from Marine Accident Investigations | **2017**

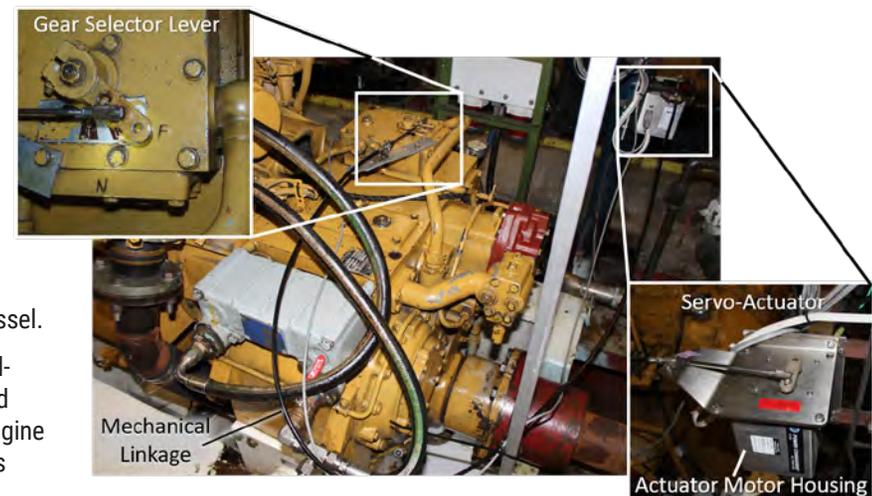
Investigators learned that, since November 2015, the vessel's port main engine transmission had been leaking hydraulic oil, requiring replenishment of 1.5–2 gallons of oil each day. A new gasket kit to correct the leak was received in January 2016 but had not yet been installed when the accident occurred. In February 2016, pans were placed under the equipment to collect the leaking oil. Although this was a widely known maintenance issue, it was not regularly noted in the daily engineering checklists, including the checklist left for the captain to review on the morning of the accident.

Investigators also learned that the *Adventure Hornblower's* transmissions had not received longterm maintenance every 5 years, or 4,000-6,000 hours, as recommended by the manufacturer. When the accident occurred, the port and starboard transmissions had more than 66,000 operating hours each, yet the owner provided no evidence that the longterm maintenance had been conducted in the life of the vessel.

■ The NTSB determined that the probable cause of the allision of the *Adventure Hornblower* with the Navy Pier and the downtown San Diego seawall was a failure of the port transmission to disengage from the forward propulsion position due to the operating company's lack of adherence to the transmission manufacturer's recommended periodic maintenance schedule and the lack of routine maintenance and upkeep of the propulsion system's equipment. Contributing to the accident was the lack of instrumentation to provide positive indication of thrust direction or an alarm to indicate the propulsion control system was not responding properly to the captain's commands.

Figure 3: Port ZF marine transmission with close-up of the gear selector lever for the mechanical control unit in the forward position as found immediately after the accident. Also shown is a close-up of the Twin Disc control system servo-actuator.

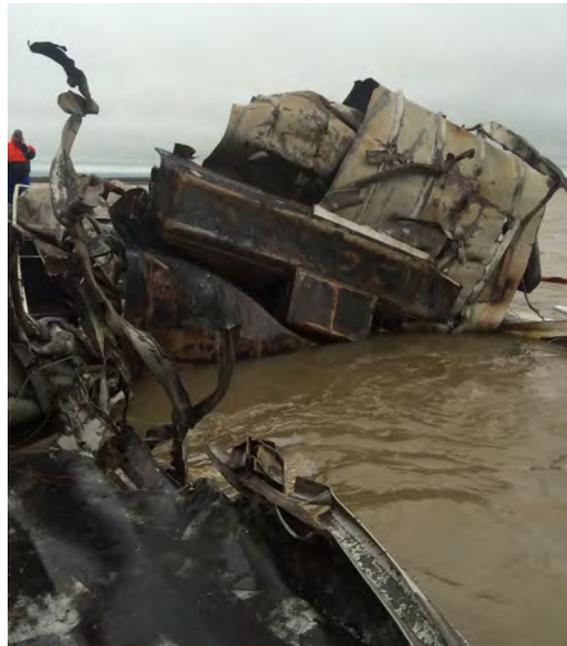
Figure 5: Close-up of damage to barge *MM-46*.

■ The NTSB determined that the probable cause of the allision of the *Amy Frances* tow with the Natchez–Vidalia Highway 84 Bridge was the pilot's failure to properly compensate for the current in the vicinity of the bridge while proceeding downbound under high-water conditions, and the captain's failure to recognize the pilot's inexperience with these conditions and assist the pilot with the maneuver.

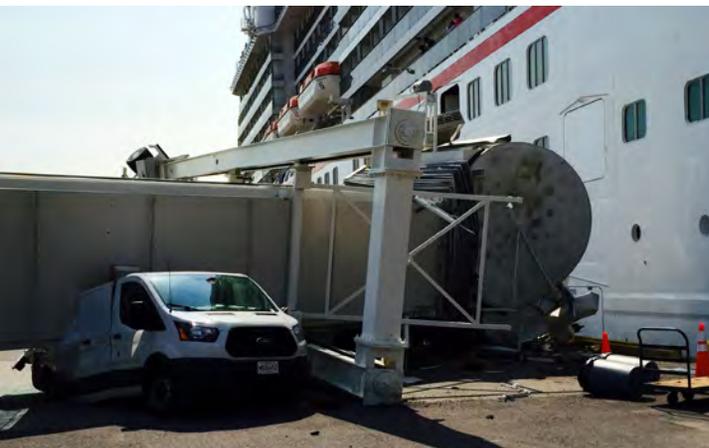
Figure 9: Below, elevated passenger embarkation walkway lying on its side on top of dockyard vehicles following the allision. At right, *Carnival Pride's* damaged retractable observation and mooring platform. PHOTOS BY COAST GUARD

The staff captain allowed the *Carnival Pride* to approach the pier too fast and at an angle too steep because he misjudged the power available in the joystick mode for correcting maneuvers. In the seconds it took him to realize that the joystick control would not be enough to slow the ship, he lost valuable time in shifting to manual control. In his haste to shift control, he was unable to assume manual control at the starboard console, an event the staff captain could not explain. The vessel's operating company was not able to replicate the failed transfer of control from the joystick mode to the manual mode during testing on subsequent voyages. Thus, the company was unable to determine a cause other than possible human error.

■ The NTSB determined that the probable cause of the *Carnival Pride's* allision with the pier and elevated passenger embarkation walkway was the staff captain's errors during the docking maneuver—approaching the pier with excessive speed and at too steep of an angle—and the master's insufficient oversight during the maneuver.

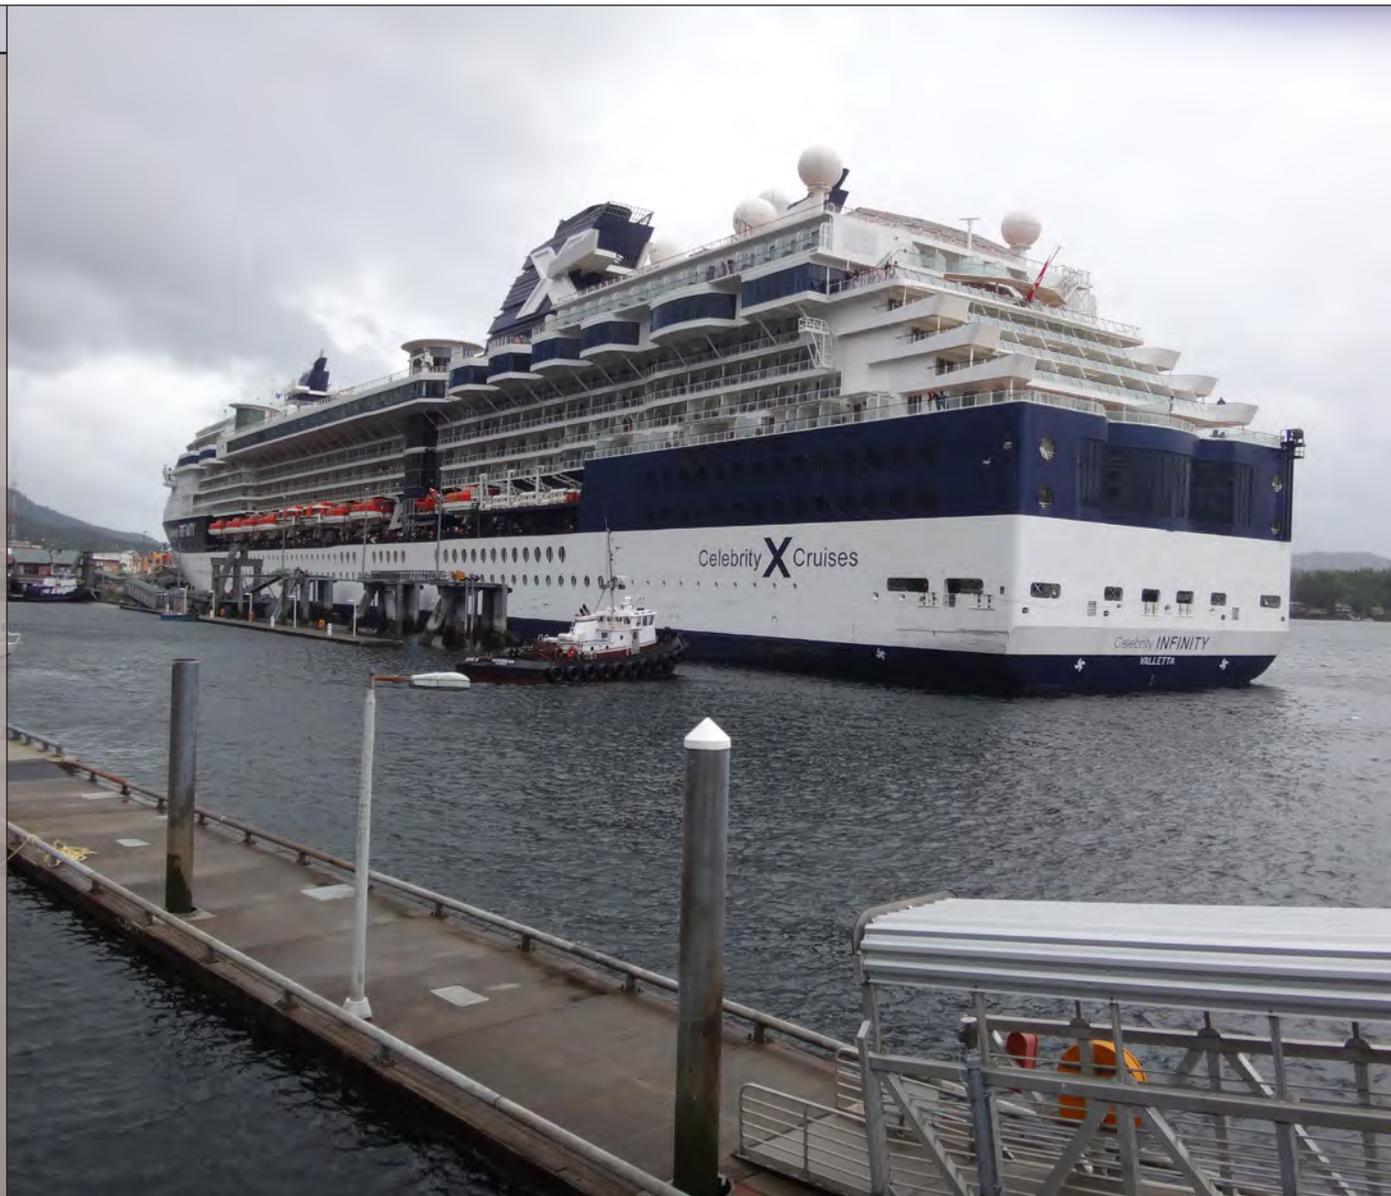
Figure 10: Postaccident photo of *Celebrity Infinity* docked at damaged berth 3, Ketchikan, Alaska.

The berth sustained extensive damage to catwalks and structural members. Recorded wind speeds from the vessel's VDR showed gusts around 40 knots.

■ The NTSB determined that the probable cause of the *Celebrity Infinity*'s allision with the dock was the master's failure to plan, monitor, and execute a safe docking evolution.

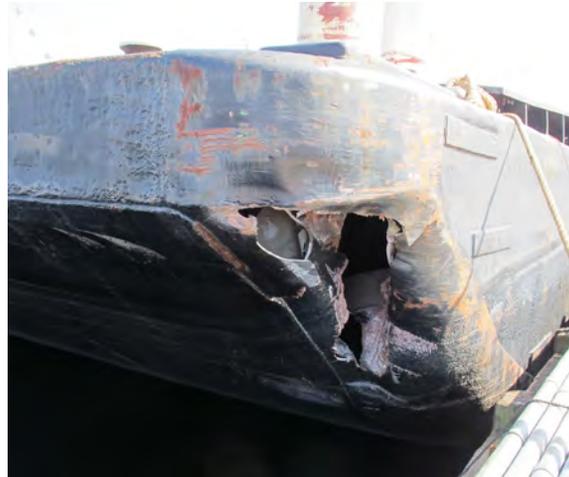
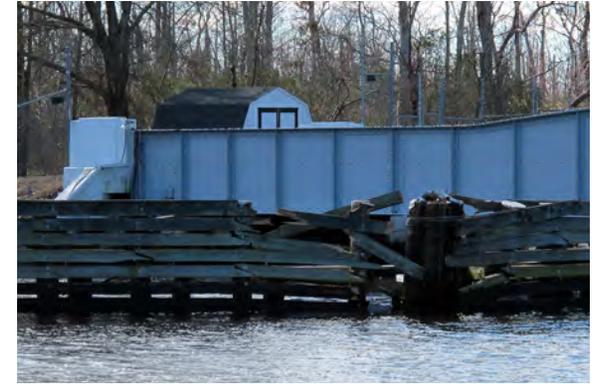
Figure 14: Damage to the southside fender of the North Landing Bridge.

■ The NTSB determined that the probable cause of the allision of the *Kodiak* tow with the North Landing Bridge was the mate's inability to safely navigate the vessel due to his inexperience in conning tows through narrow waterways.

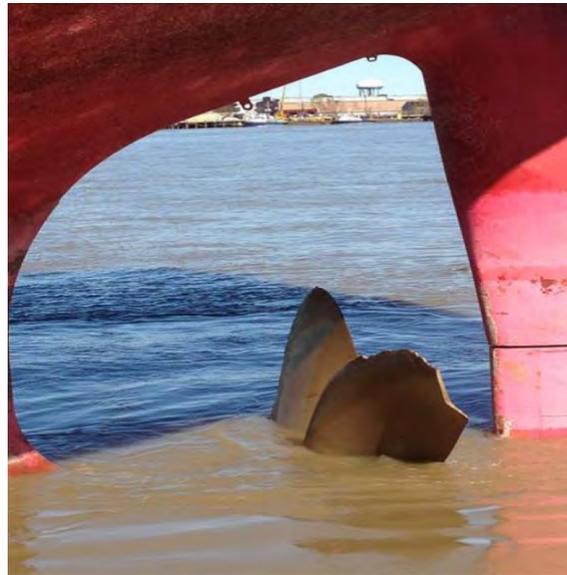
■ The NTSB determined that the probable cause of the *Nordbay*’s allisions with water intakes and docks was the pilot and the master not adequately assessing the risks of handling the ballasted vessel during high-river conditions with strong following currents while turning into the wind. Contributing was the bridge team’s poor situational awareness of the vessel’s position in the waterway. Contributing to the second allision was the master’s distraction from his duties while making a phone call.

Figure 18: *Nordbay*’s damaged propeller.

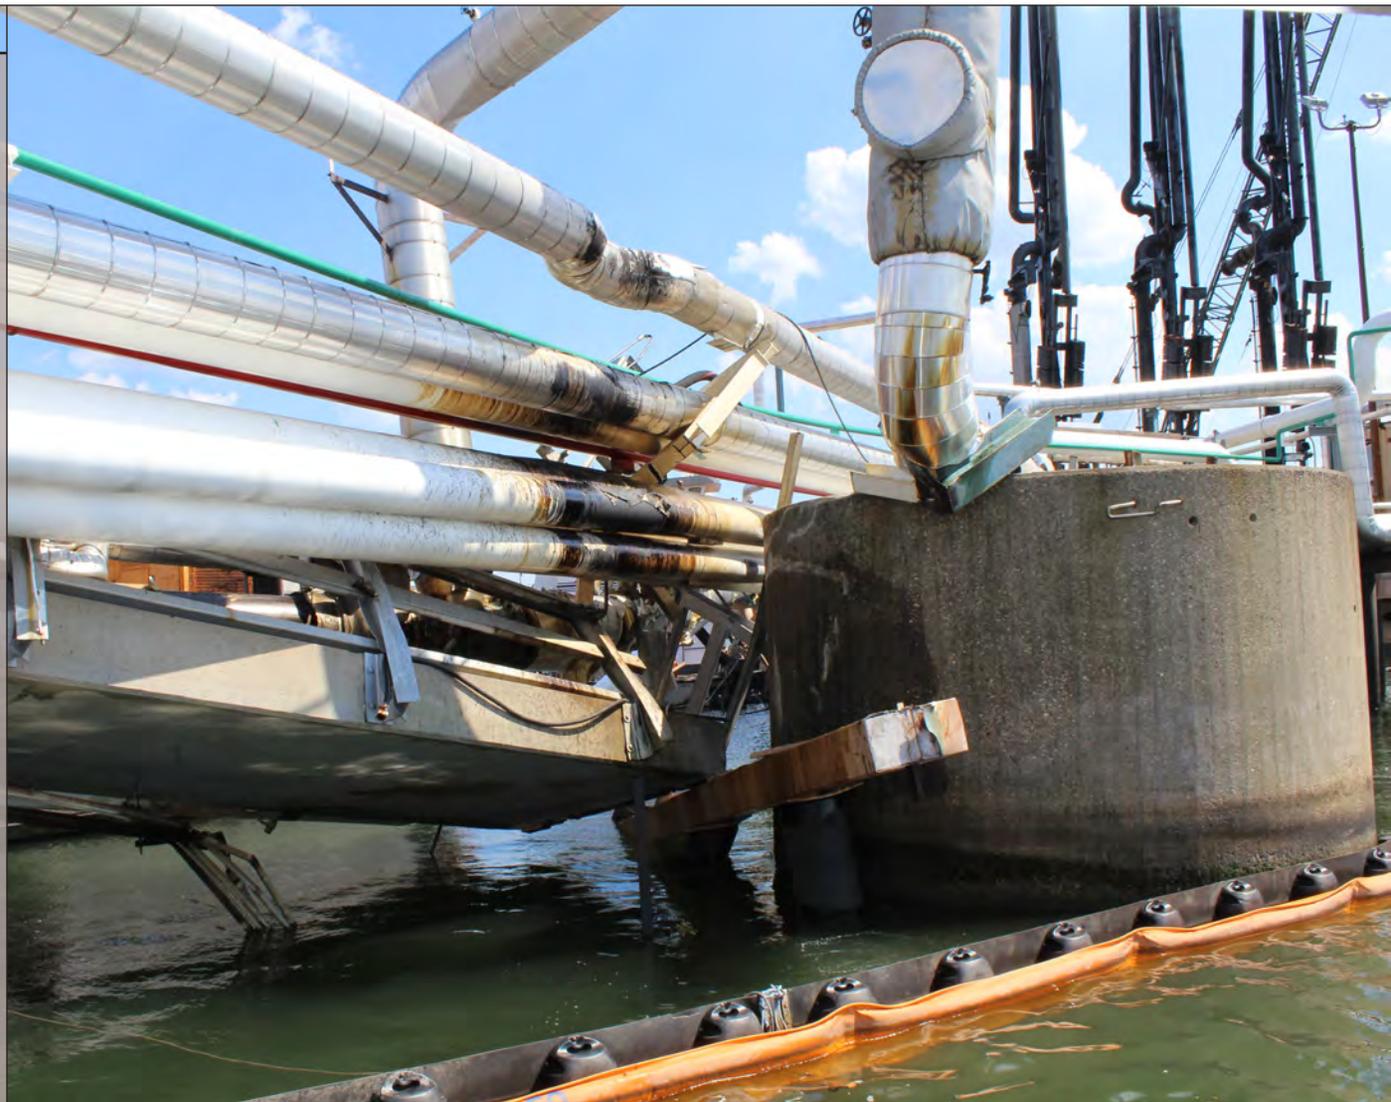
Figure 19: Damaged pipelines leading to loading arms on IMTT Bayonne Pier A.

■ The NTSB determined that the probable cause of the allision of the *Peter F Gellatly* tow with IMTT Bayonne Pier A was the captain and the engineer’s poor communication, their inadequate assessment of the hazardous condition posed by the starboard engine control malfunction, and the captain’s decision to continue operations without ensuring that the malfunction had been adequately corrected. Contributing to the accident was the crew’s unfamiliarity with the provisions of the company’s SMS that addressed actions in response to hazardous conditions.

After the accident, technicians examined the *Peter F Gellatly*’s control systems and found loose wires on the electronic selector valve solenoid on the starboard marine gear unit. The company concluded that the loose wires caused a mechanical failure of the shift solenoid.

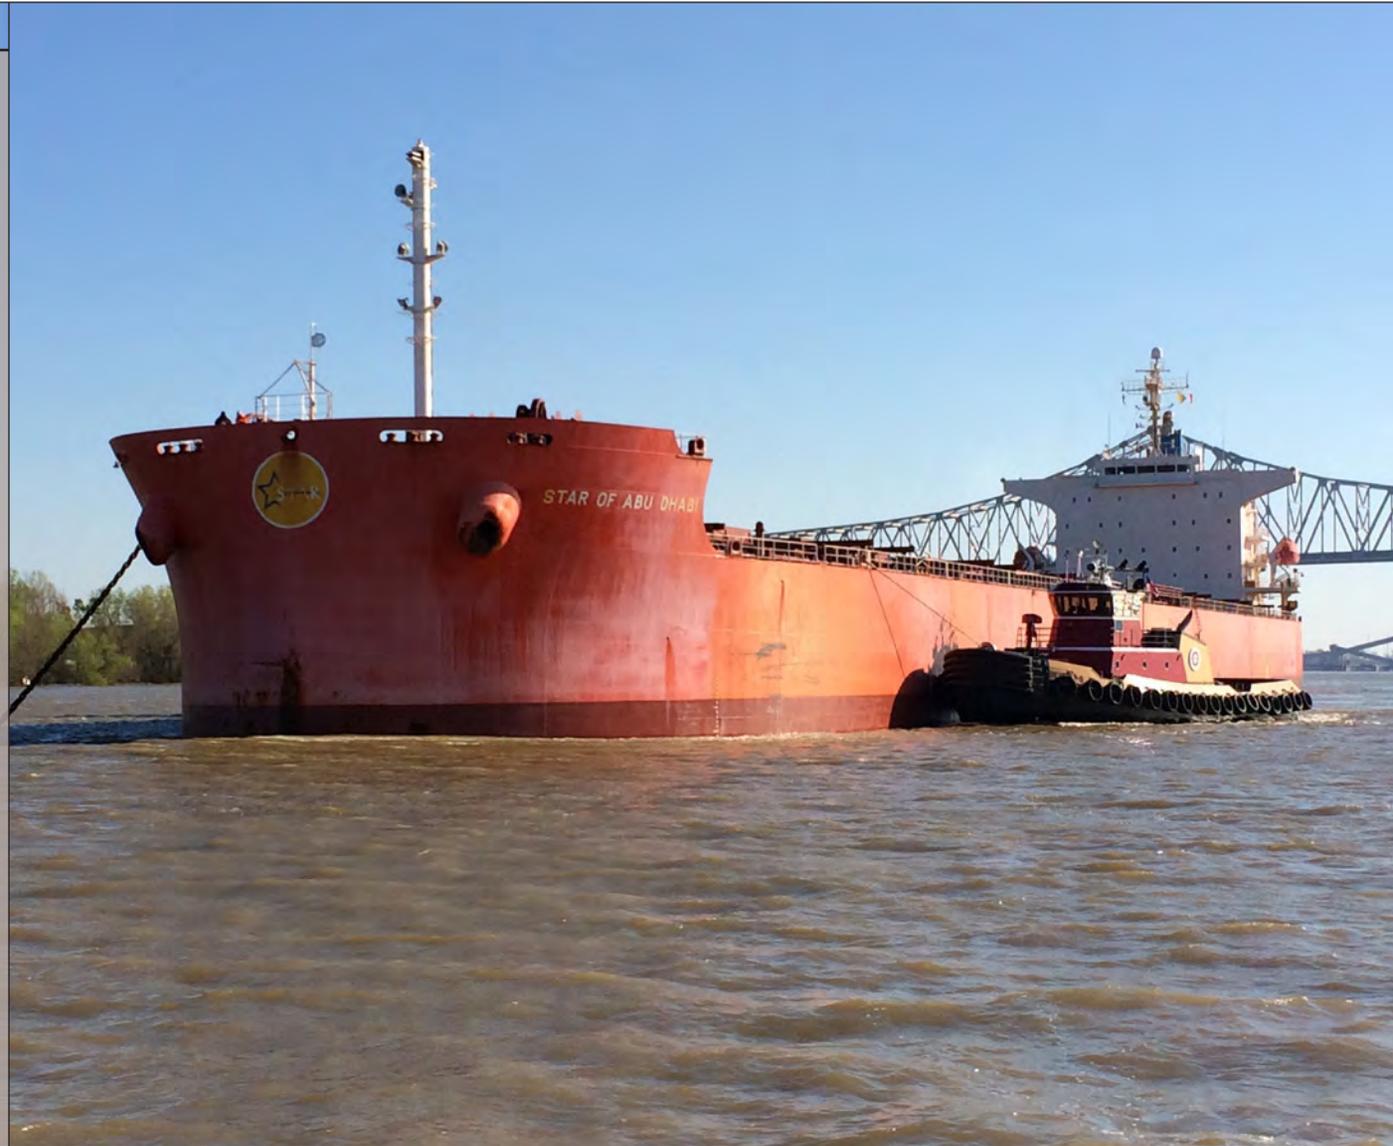
Figure 21: *Star of Abu Dhabi* after the accident, with missing port anchor. PHOTO BY COAST GUARD

When the vessel had anchored on March 24, the pilot had directed that each anchor be dropped with four shots of chain (about 385 feet) in the water. The crew correctly did so, but then dropped the starboard anchor with four shots *on deck* (about 345 feet). The scope of the port anchor chain was therefore longer than the starboard chain. Use of a second anchor was intended to minimize the back and forth motion of the bow, and the scope should have been adjusted to equalize tension on both anchors. A jerking motion or shock load can break a chain, whereas a constant load is less likely to cause a break. Given the longer scope of chain and the current's effect on the port bow, the port anchor chain was likely taking the majority of the strain.

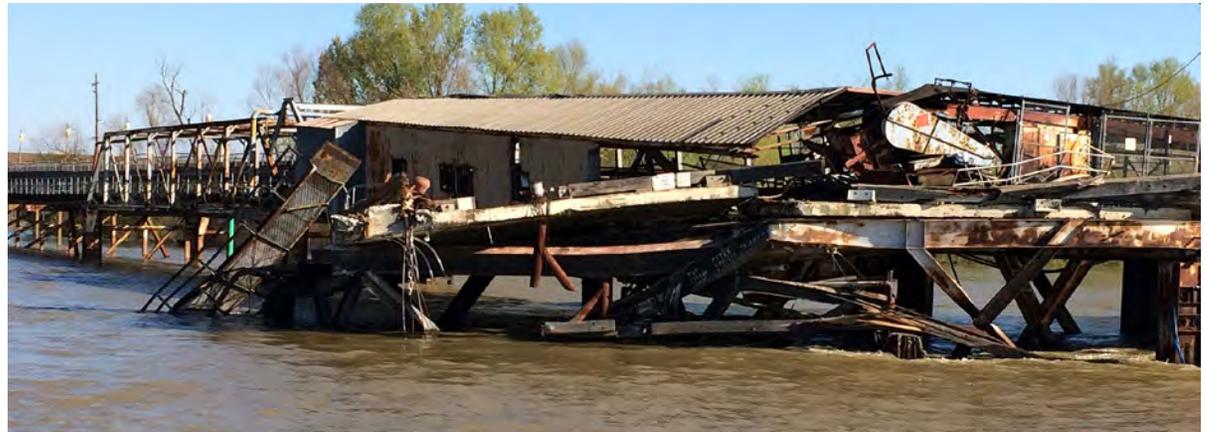
Figure 22: Damaged sugar unloading dock. PHOTO BY COAST GUARD

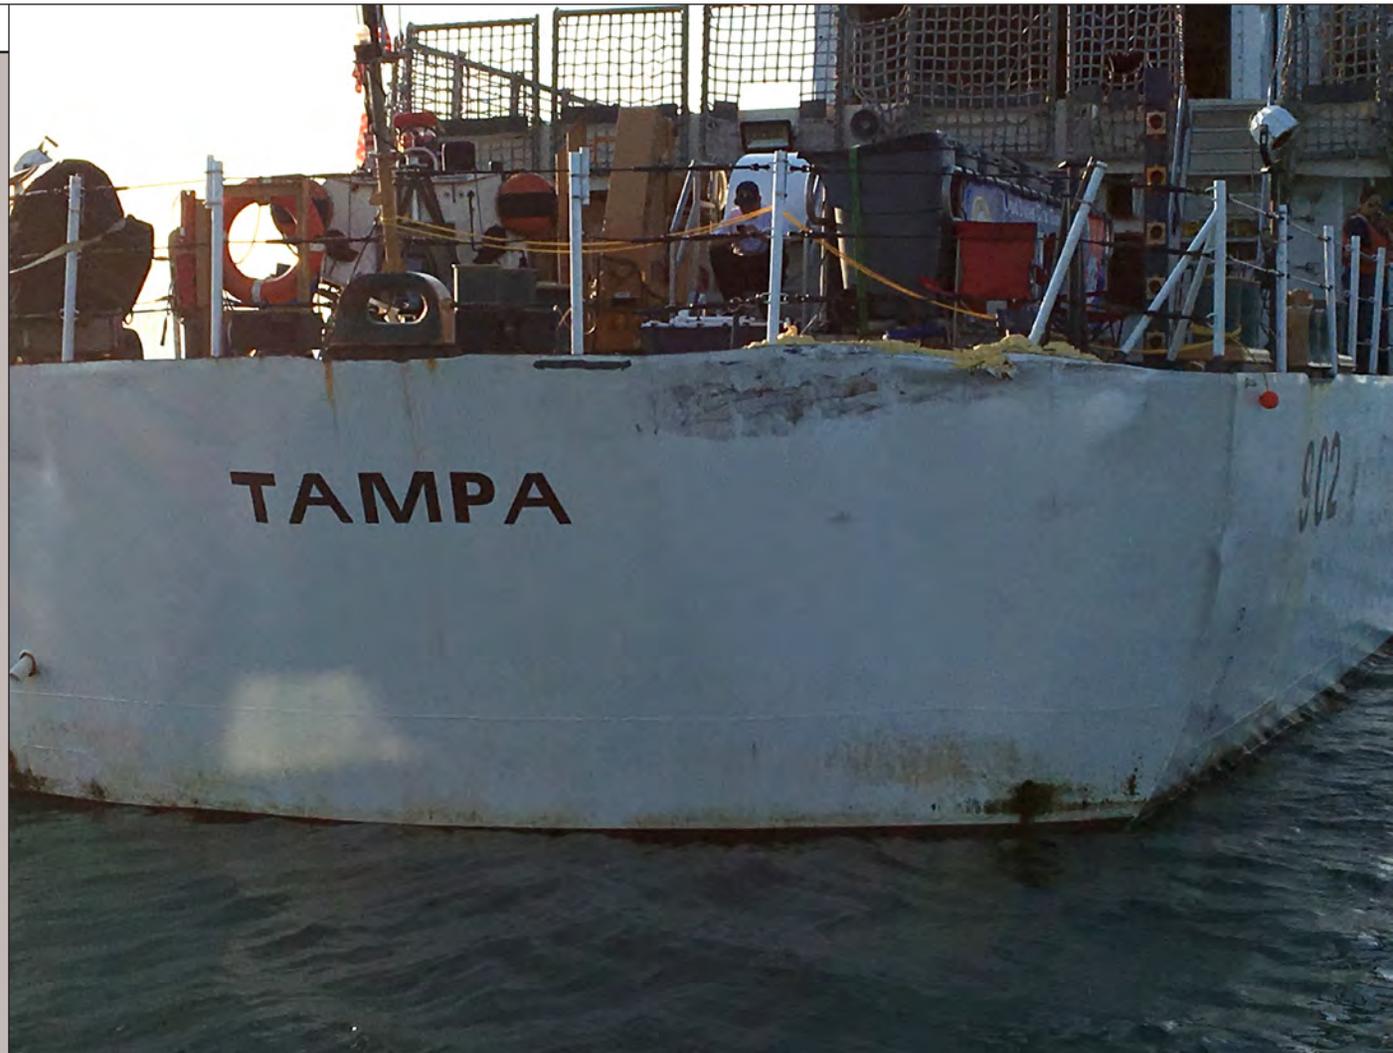
Figure 27: Damaged stern on cutter *Tampa*.

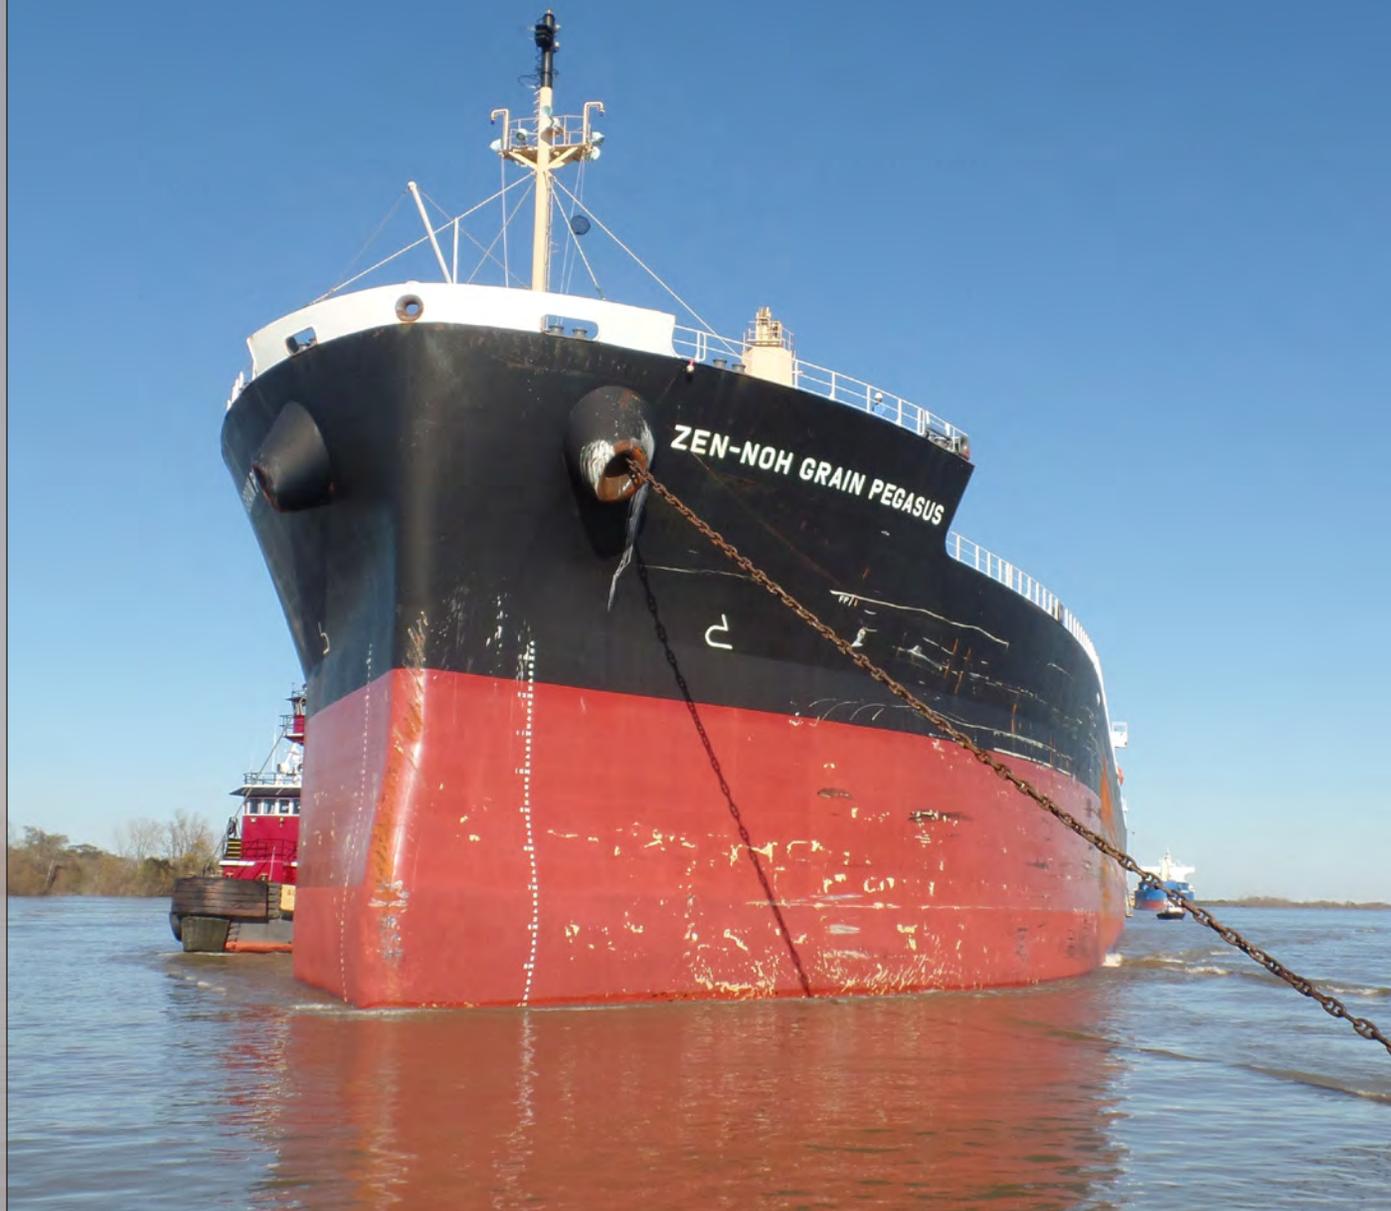
Figure 30: Zen-Noh Grain Pegasus bow with missing anchor.

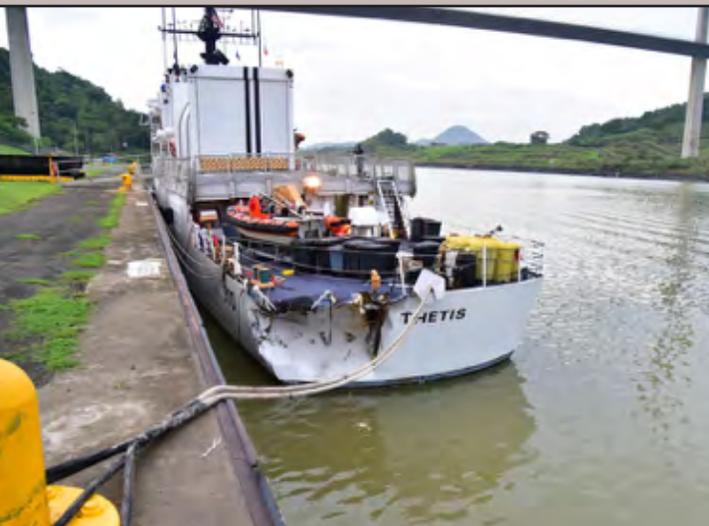
Figure 32: The damaged stern of cutter *Thetis*.

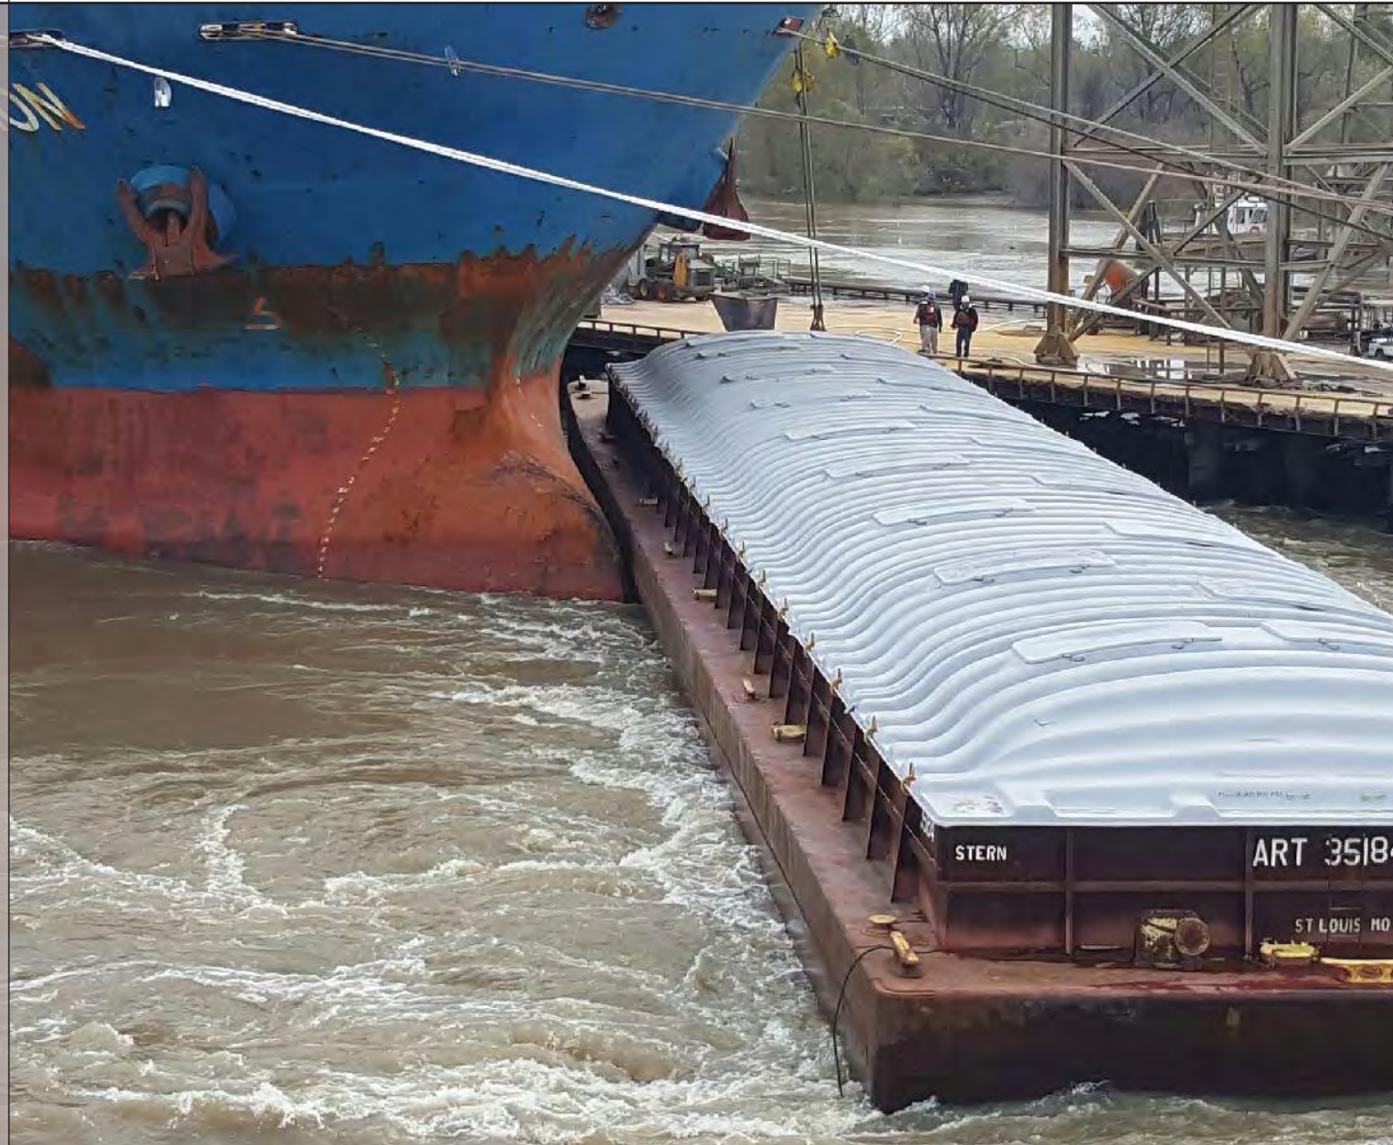
Figure 38: Barge ART 35184 wedged under the dock after the *Crimson Gem* tow collided with the bulk carrier *Yangtze Ambition*. PHOTO BY COAST GUARD

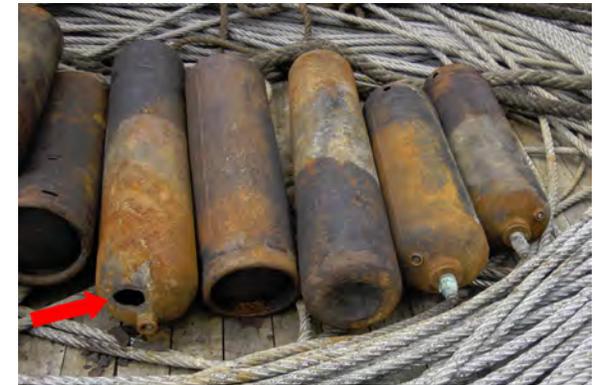
Figure 44: Oxygen and acetylene bottles on deck post-fire. Arrow shows a hole at the melted pressure-relief fusible plug location on one of the bottles. PHOTO BY COAST GUARD

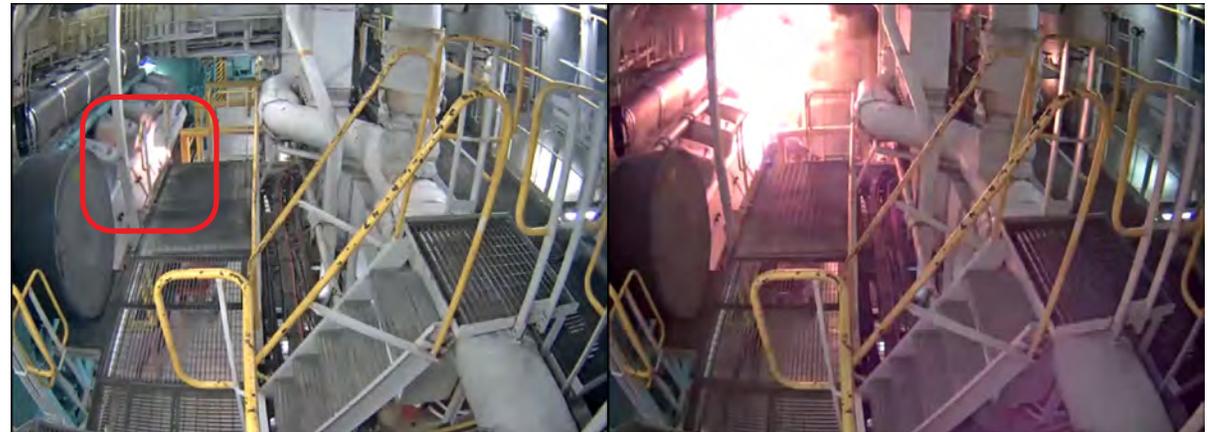
Figure 46: Images from the ship's closed-circuit television of DG 4 from forward looking aft. The red box on the left image highlights the first visual sign of open flame. The right image shows the same area less than 1 second later.

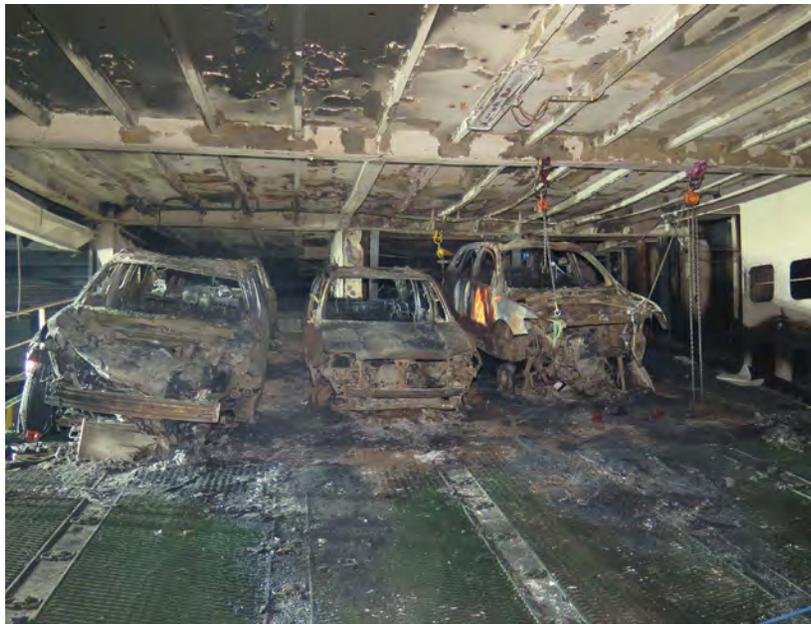
Figure 48: Damaged ramp and destroyed vehicles near the origin of the fire.
PHOTO BY COAST GUARD

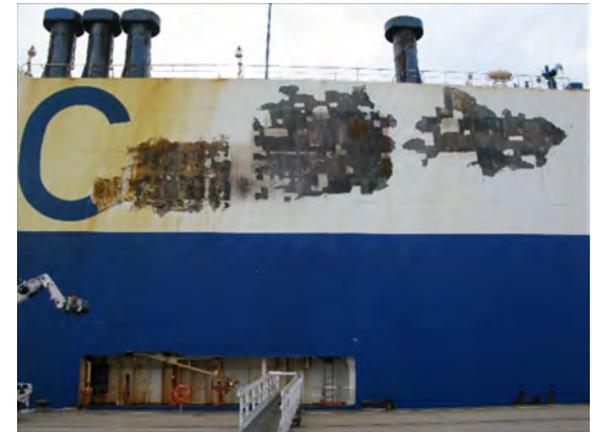
Figure 49: Exterior damage to *Courage* starboard side in the vicinity of the fire. PHOTO BY COAST GUARD

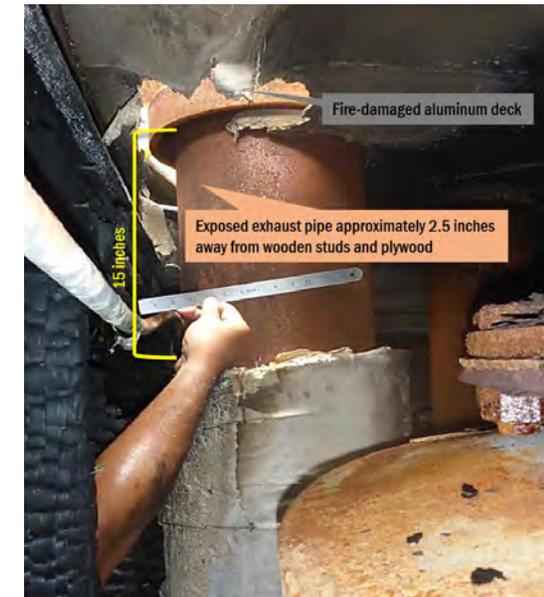
Figure 53: An investigator measures the distance between the wooden studs and the exhaust pipe of Raffaello's starboard generator, on which a 15-inch section of insulation is missing at the top. PHOTO BY COAST GUARD

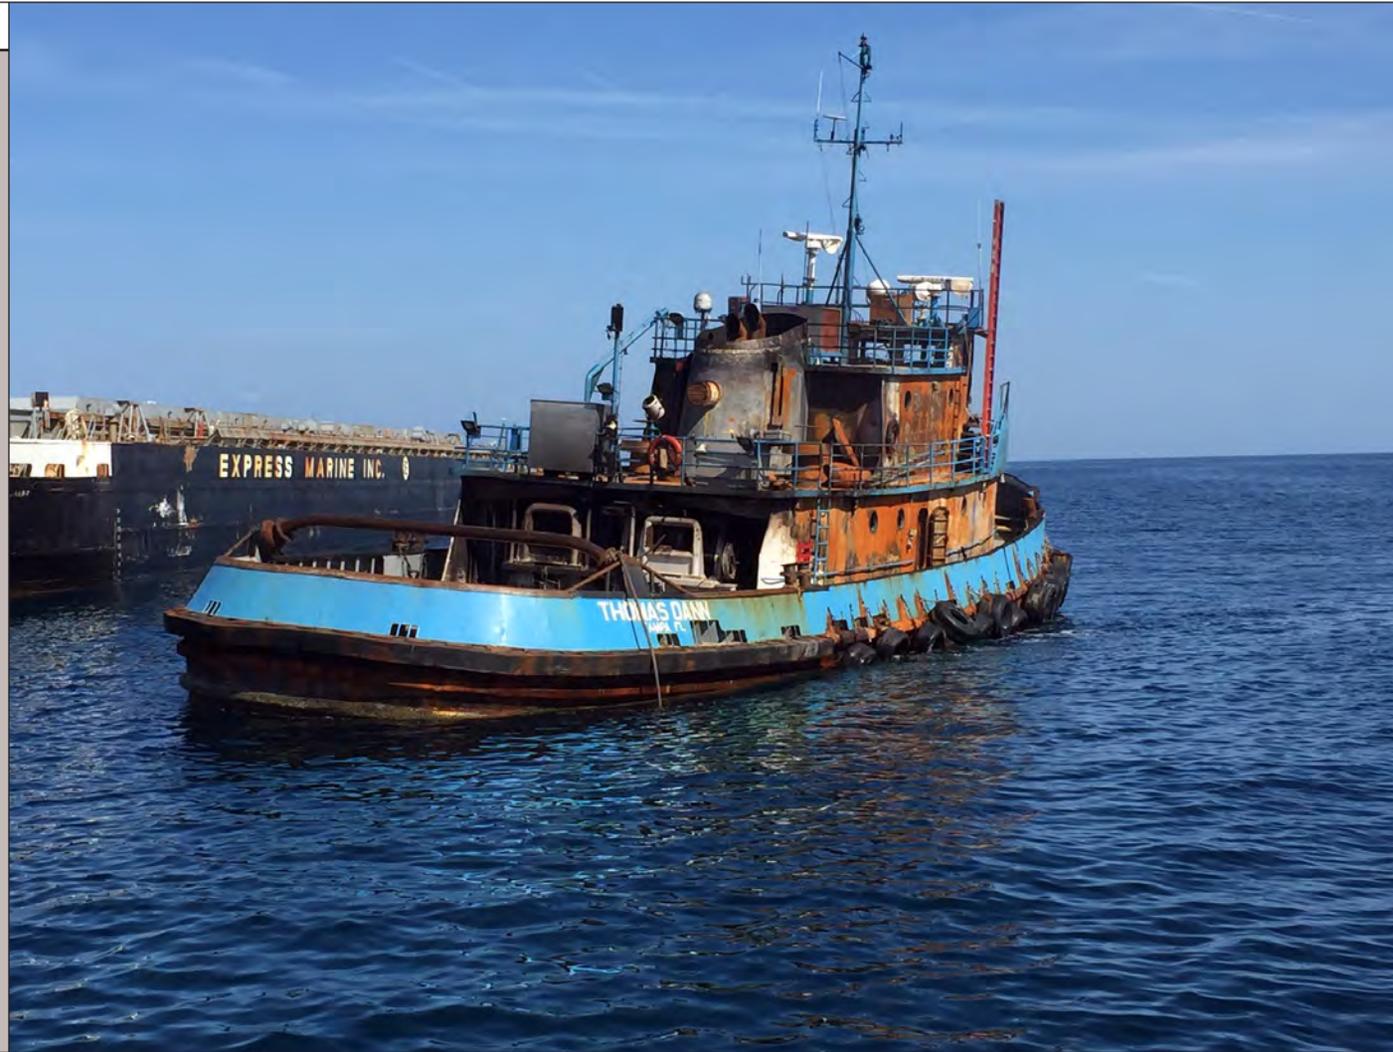
Figure 56: The fire-damaged *Thomas Dann*.

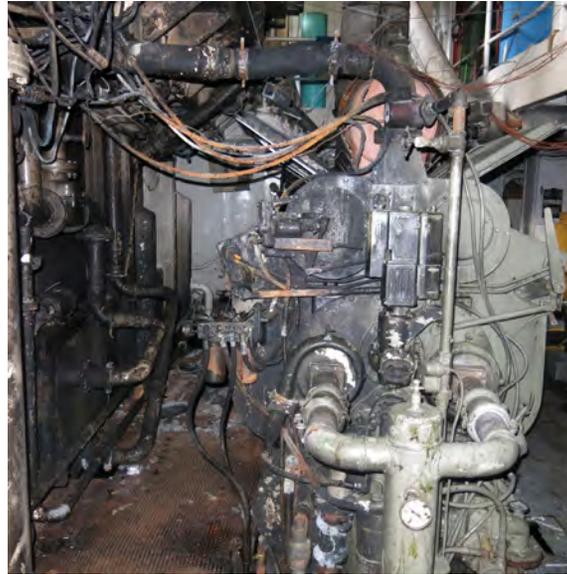
Figure 59: Damaged starboard engine aboard *The Admiral* after the fire.

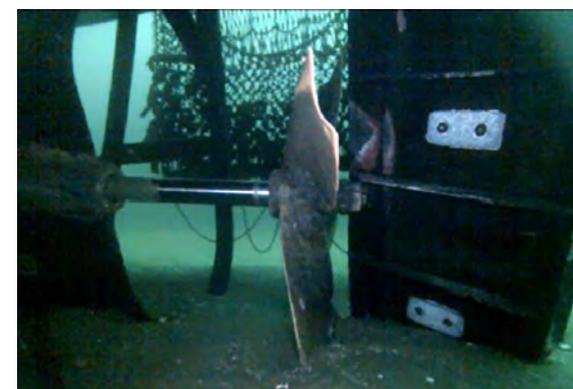
Figure 77: *Lady Gertrude* on the ocean floor. The propeller shaft has backed out of the stern tube and the shaft locking nut is jammed against the balanced rudder. PHOTO BY DEPTH CHARGE MARINE

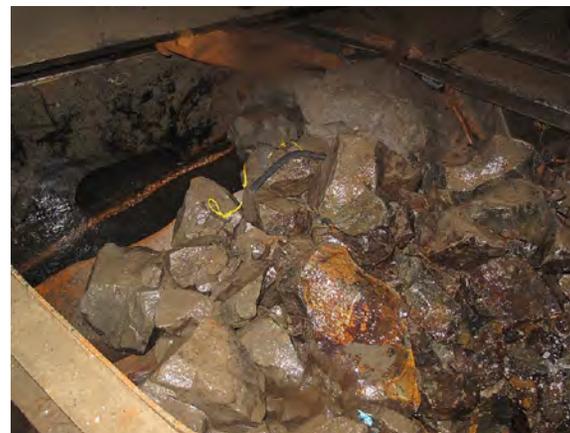
Figure 94: Rocks inside one of the ballast tanks.

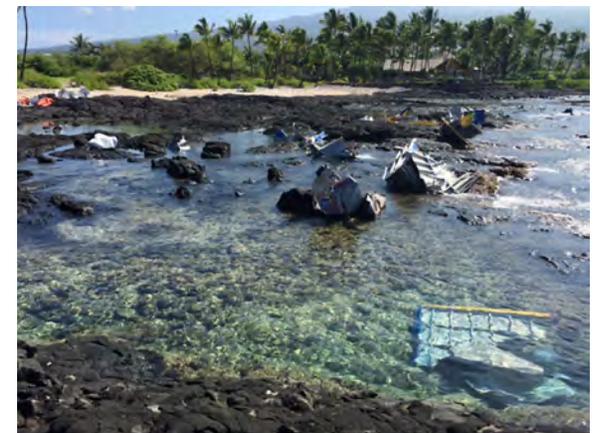
Figure 96: Wreckage of the *Spirit of Kona*.
