Marine 2018/06

REPORT ON WORK ACCIDENT ON BOARD THE NORMAND MAXIMUS OFF THE COAST OF BRAZIL ON 21 FEBRUARY 2017

BRAZILIAN NAVY
Directorate of Ports and Coasts
Marine Safety Superintendence
Department of Inquiries and Investigations of Navigation Accidents
ACCIDENT WITH PEOPLES ON BOARD THE MARITIME SUPPORT VESSEL "NORMAN MAXIMUS"
Maritime Safety Investigation Report

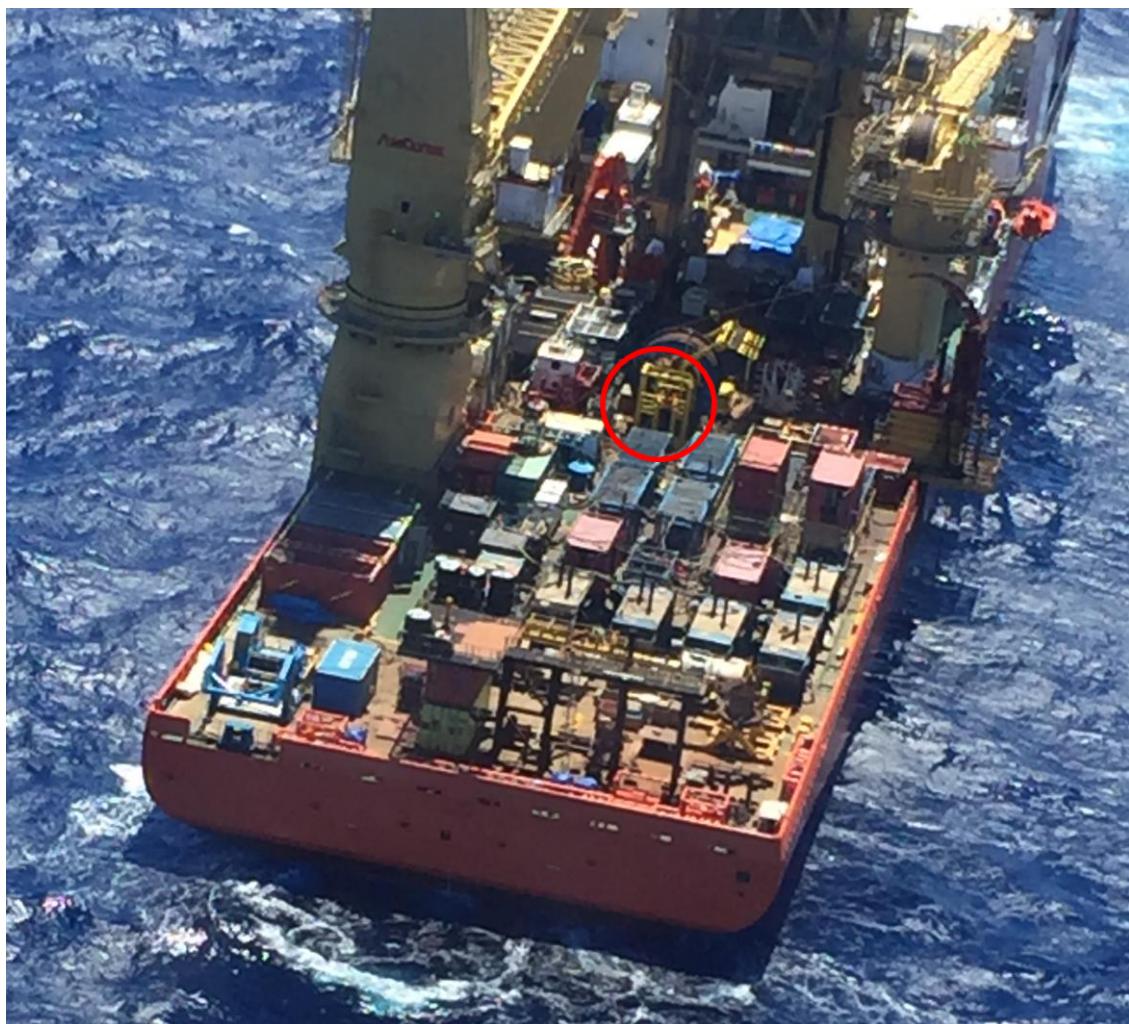
Figure 3: The system installed for use in the pre-commissioning assignment consisted of a number of components placed on the open aft deck of the CSV Normand Maximus. The accident site is marked with a red circle. Photo: The Brazilian Navy

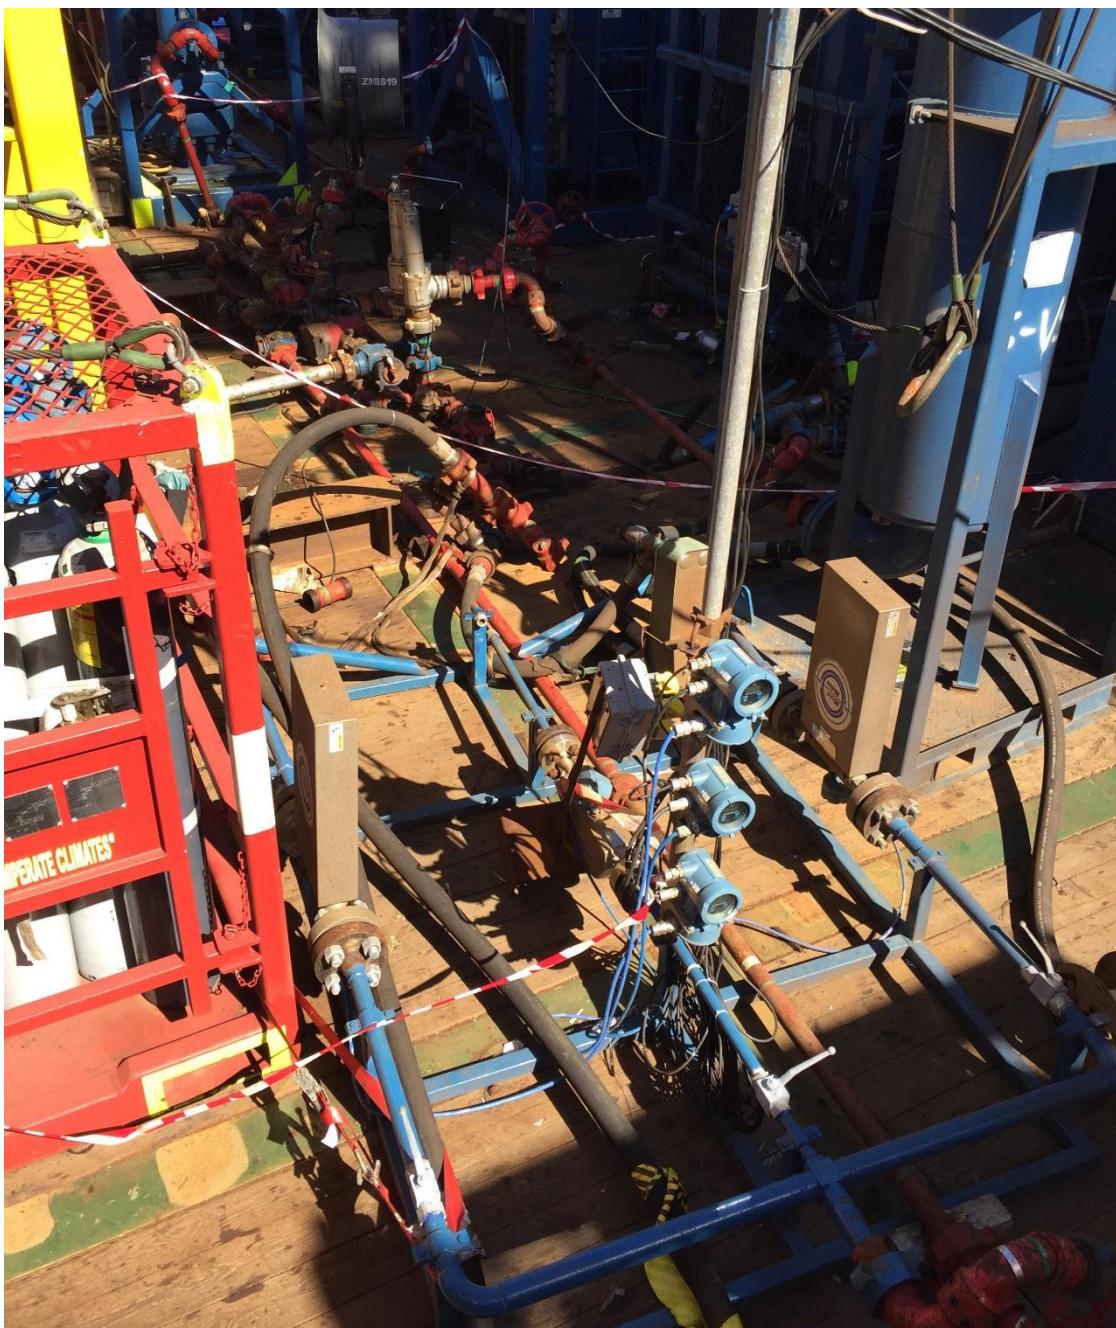
Figure 4: Pipes, hoses and valves placed between components on the open deck. Photo: The Brazilian Navy

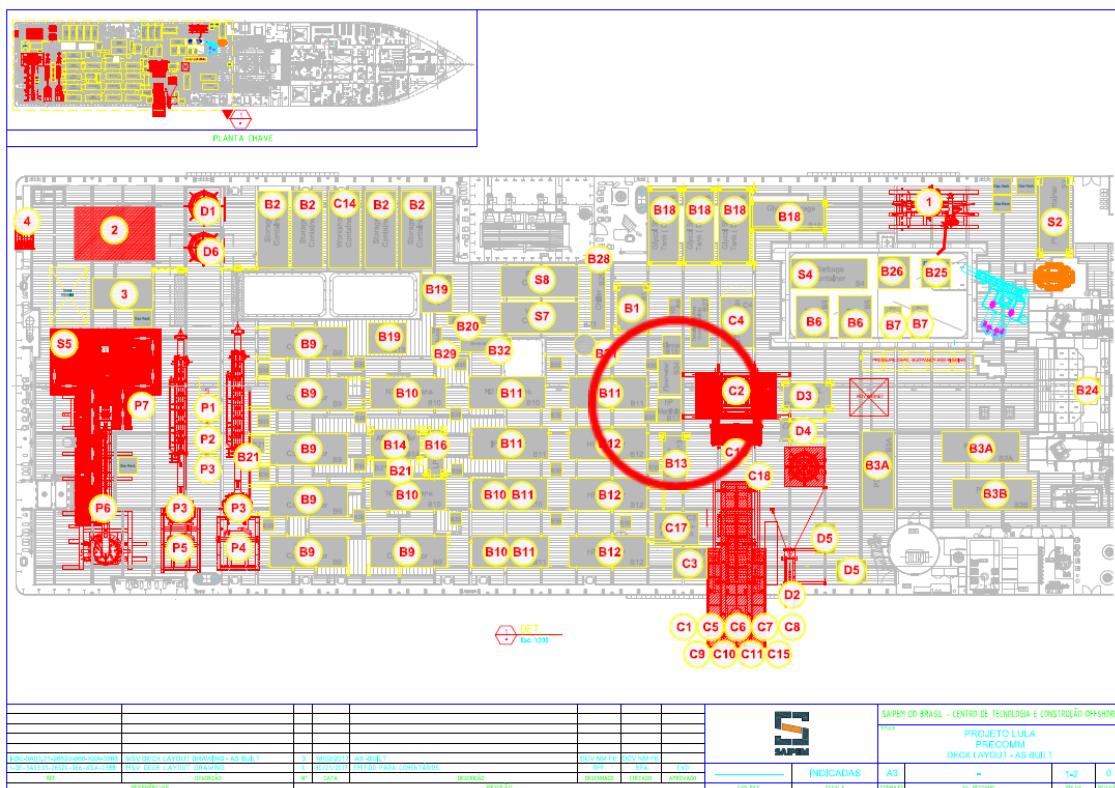
Figure 6: The layout of the main deck with all the components used during the operation. The accident site is marked with a red circle. Source: Solstad Offshore AS

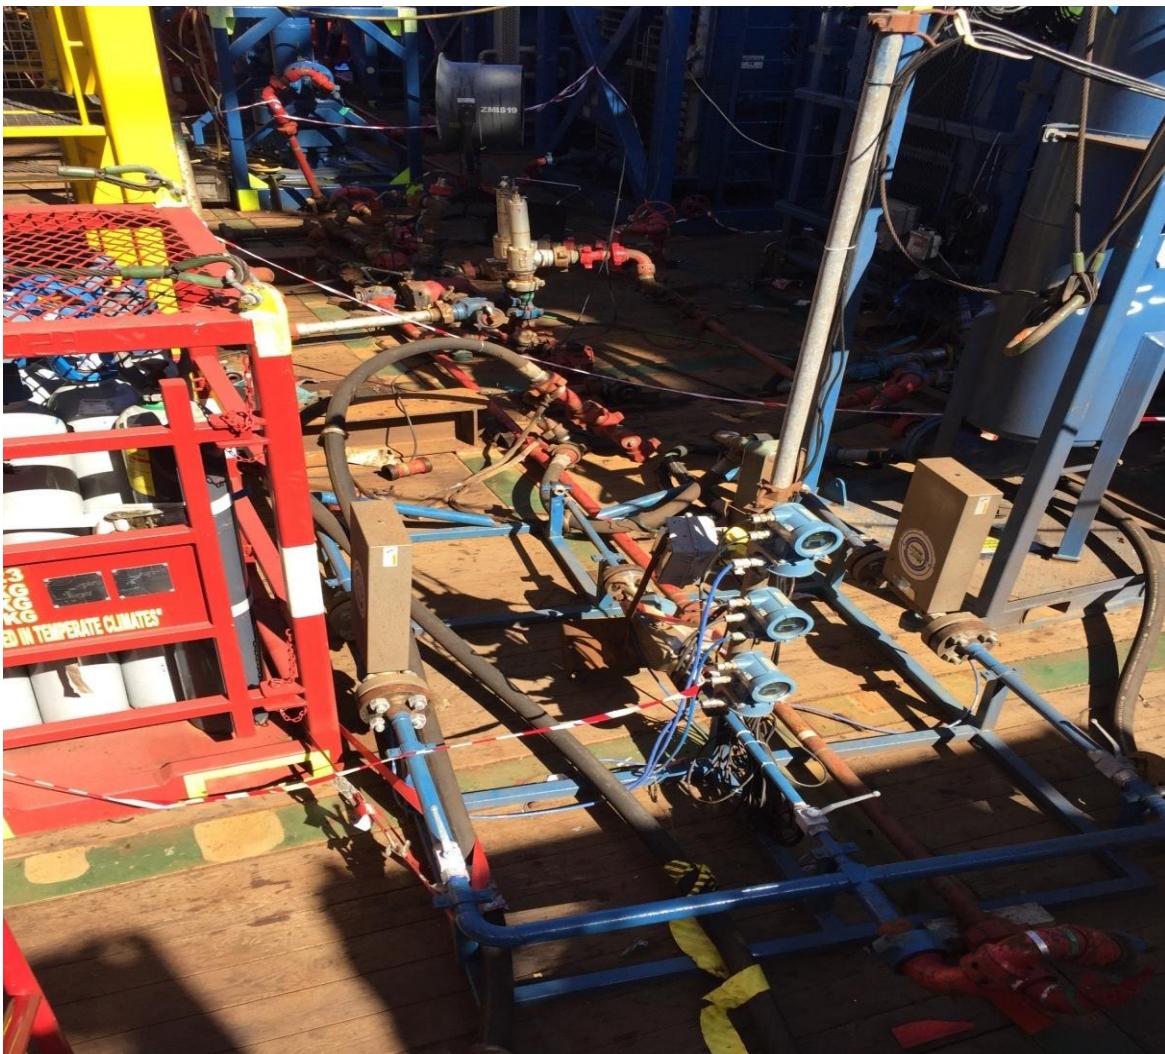
At 6:15 p.m. on February 21, 2017, during the MEG recovery process and pressure reduction of the underwater system, an accident occurred at the pre-commissioning facility positioned on the main deck of the vessel, causing one fatality and four injured. The pre-commissioning facility positioned on the main deck of the vessel is a temporary and independent installation.

Photo 2: Installation overview

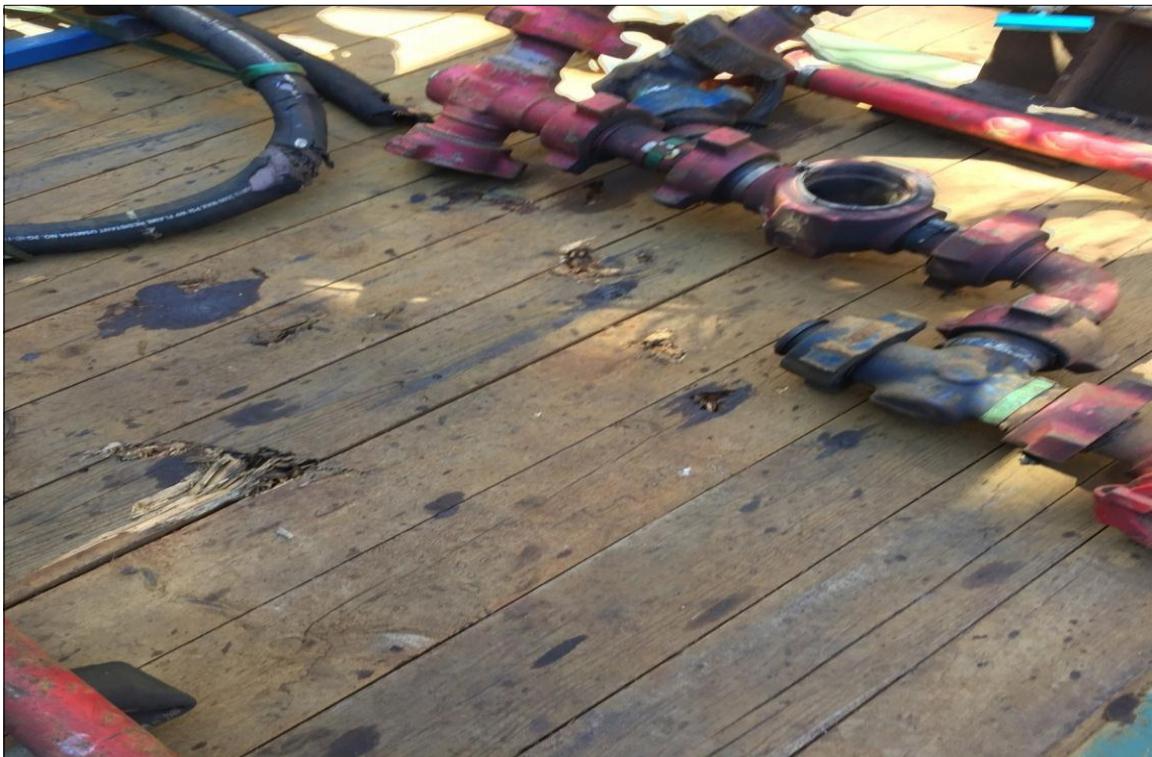
- Several material broken and broken steel pipes; faulty locking and relief valves; high pressure hoses (2,500 psi capacity), belonging to the pre-commissioning system, were torn and with broken steel mesh;

Photo 3: Pre-commissioning system equipment

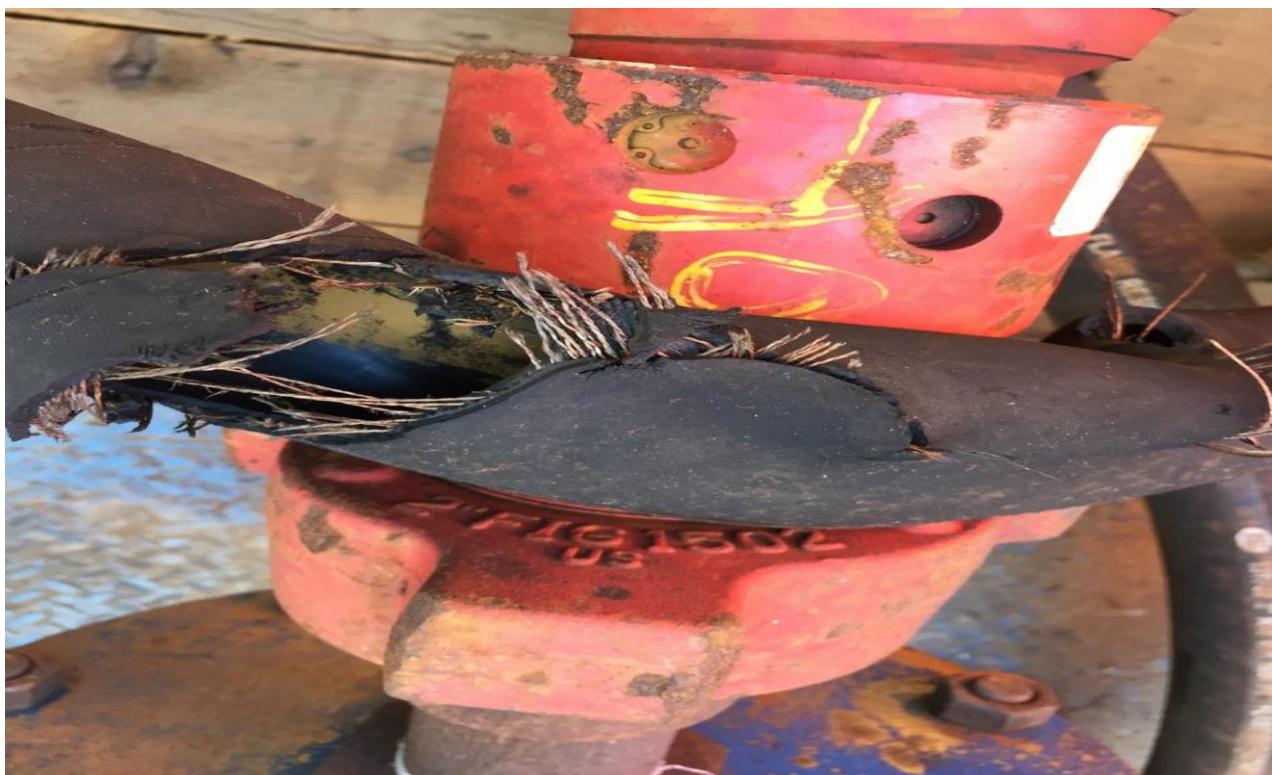
Photo 4: Faulty pre-commissioning system hoses

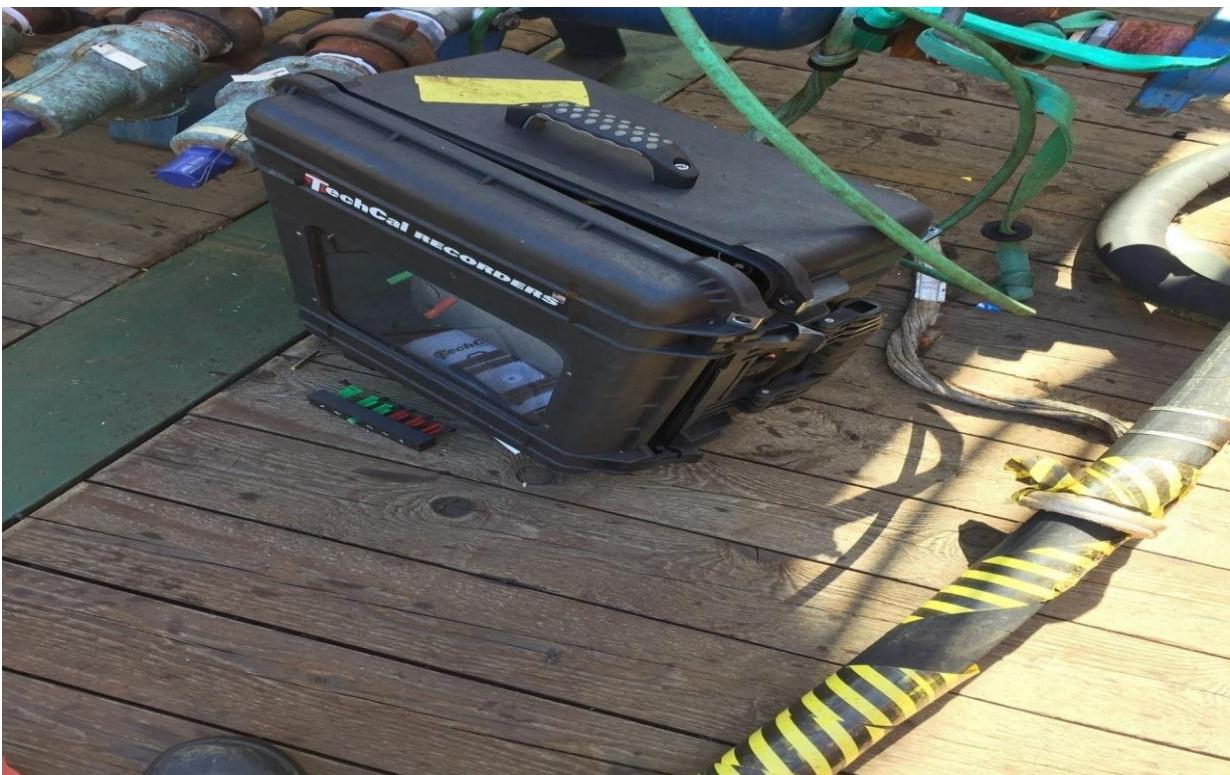
Photo 5: Pressure and temperature recorders not installed

Due to the decharacterization of the area, it was not possible to determine the monitoring points of the pressure and temperature values predicted in the procedure used in the pre-commissioning of the well line. From the information gathered in the interviews with Baker Hughes employees, only the pressure and flow elements in the system were monitored during the process, although MEG suppliers warned in the FISQ about the risk of explosion of this gas when subjected to the special conditions of sources of heat and static electricity.

Thus, the critical monitoring element to be monitored in terms of safety would become the temperature rise, which may occur depending on the process conditions. However, the control of temperature elevation during the process was not evidenced, although the FISQ contained this orientation.

- Valve commands and monitoring of local flow, temperature and pressure variables should be done remotely, in scanned and automatic form, to increase the individual protection of the equipment.
- It is essential that there are safety valves in the pre-commissioning installation, thus avoiding the occurrence of an accident caused by an excessive increase of pressure above the permitted limits.

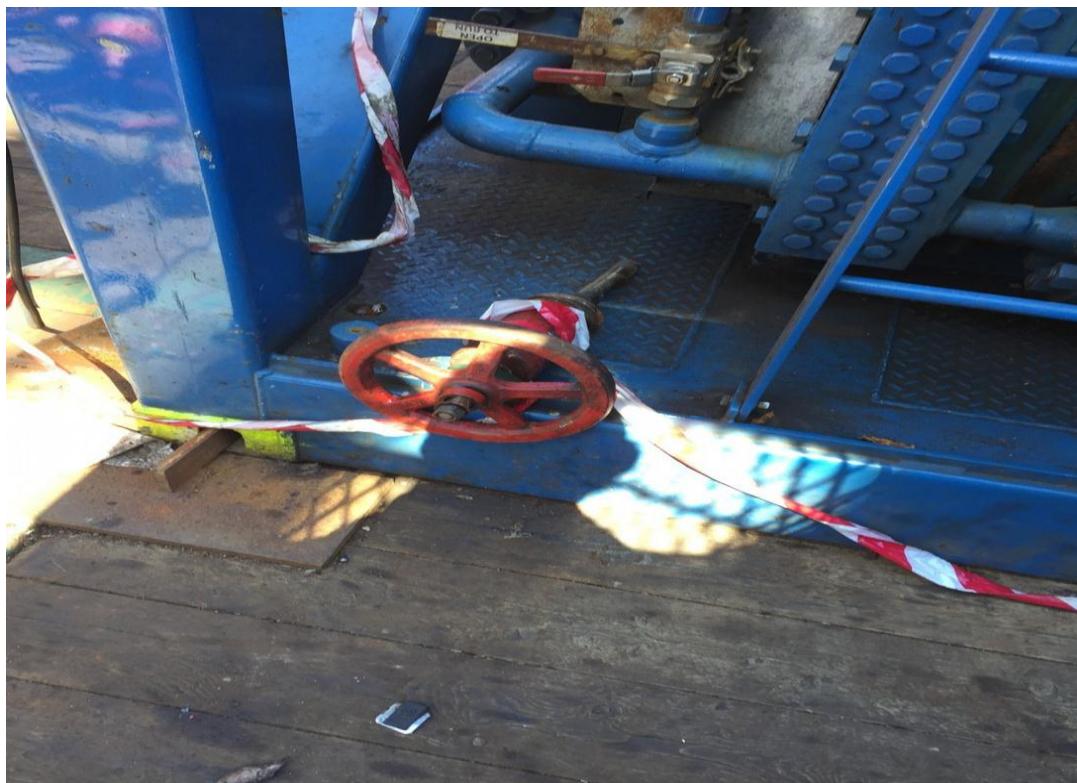
At the time of the accident, at 06:15 hours, the General Supervisor was positioned in front of the flow control valve and depressurising (choke valve), controlling the flow rate.

Photo 9: "Choke valve" failed

- The use of a manually actuated flow control and depressurising valve was the determining factor for the death of the General Supervisor, since his positioning in the operation was frontal to the valve and, when it was exploded, it was directly hit by the steering wheel of equipment, so was shown to be inadequate and fatal. For this type of system, equipment with remote actuation must be used in order to increase the individual protection of the operators.

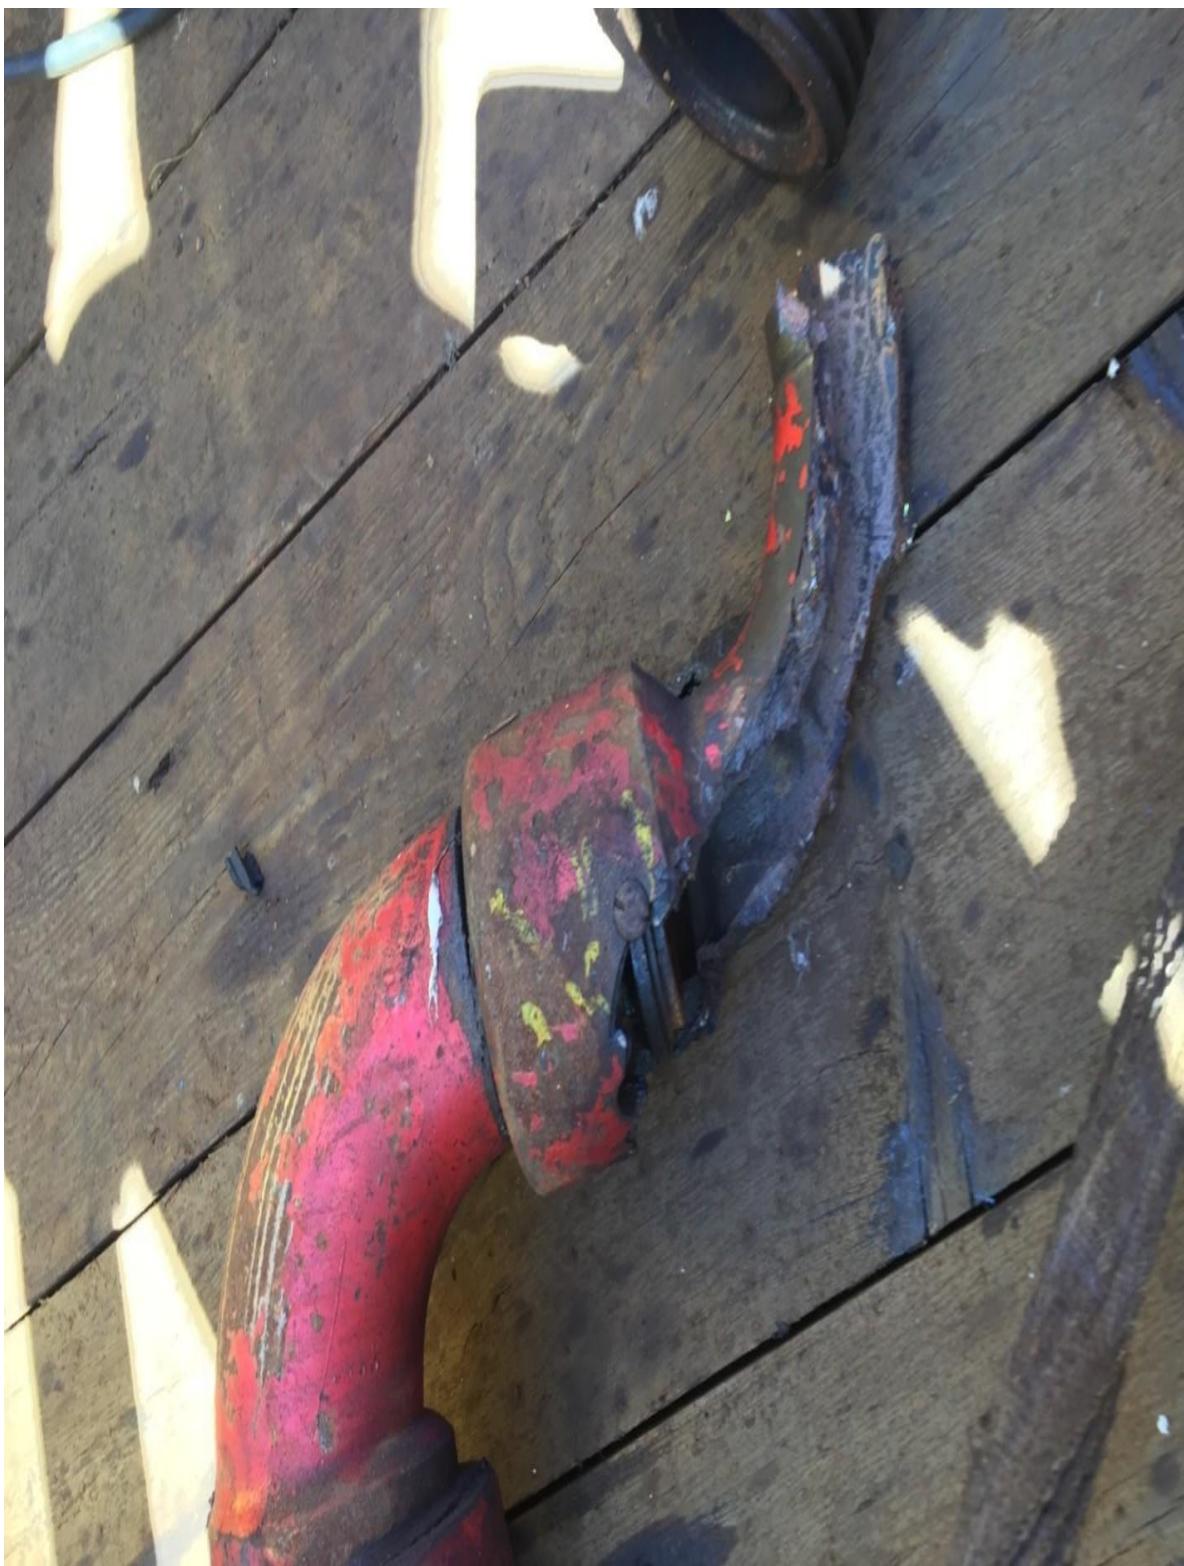
- b) installation was without supports; the structures had no fixation and were loose, as well as pipes, valves and connections belonging to the system presented corrosion on their surfaces; two pressure and temperature loggers, members of the project scope (according to the approved procedure), were positioned on the main deck and not installed;
- c) lack of grounding protection, existing recommendation in the Chemical Safety Data Sheets (FISQ) of the suppliers of chemical products to Baker Hughes;
- d) lack of traceability of documents or certificates of high pressure piping, fittings and hoses, as well as affixed location identifiers (TAGs);
- e) absence of remote control for activation of the system flow control valve; and
- f) the existence of residues of oily product already absorbed by the wooden deck, close to the damaged valves.

Photo 10: Faulty installation (1)

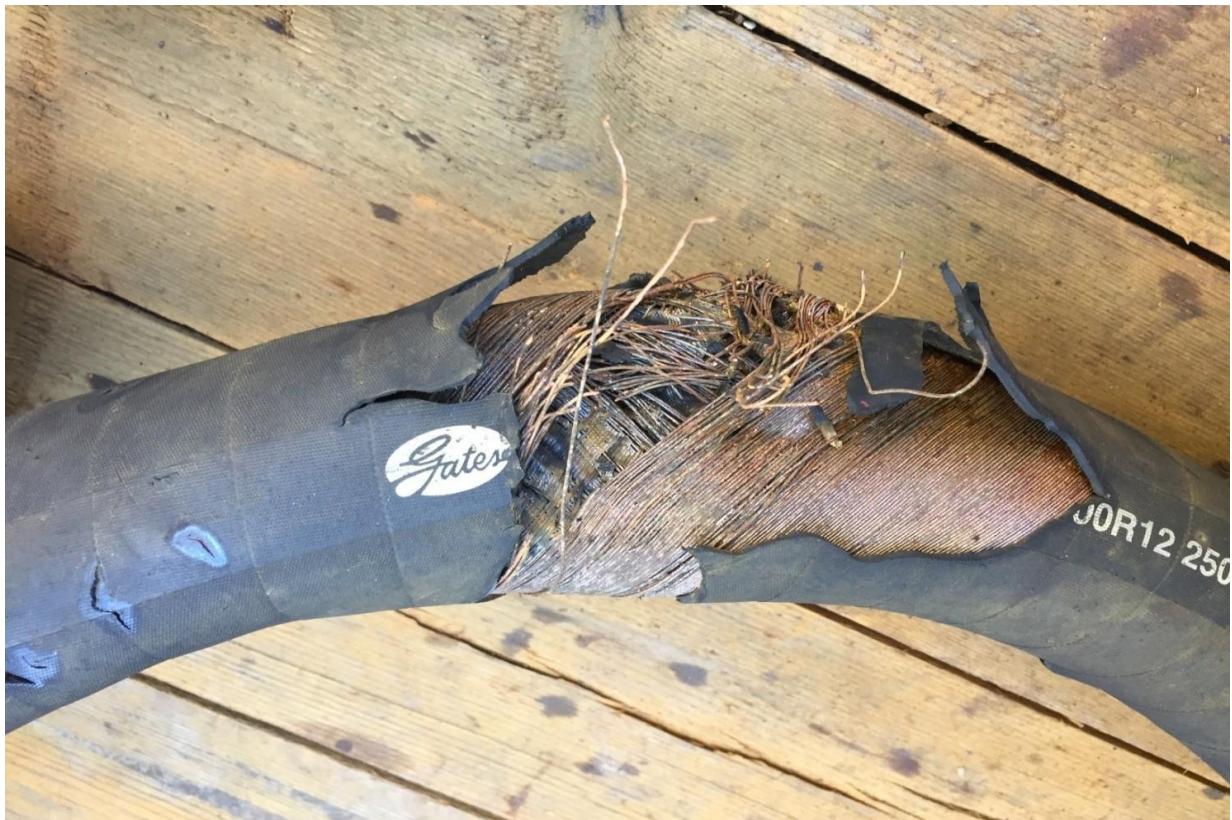
Photo 11: Faulty installation (2)
