## MARINE SAFETY INVESTIGATION REPORT

**Investigation into the partial flooding of the  
engine-room on board the Bulk Carrier**

***CAPRI***

**MARINE SAFETY INVESTIGATION REPORT NO. 24/2018**

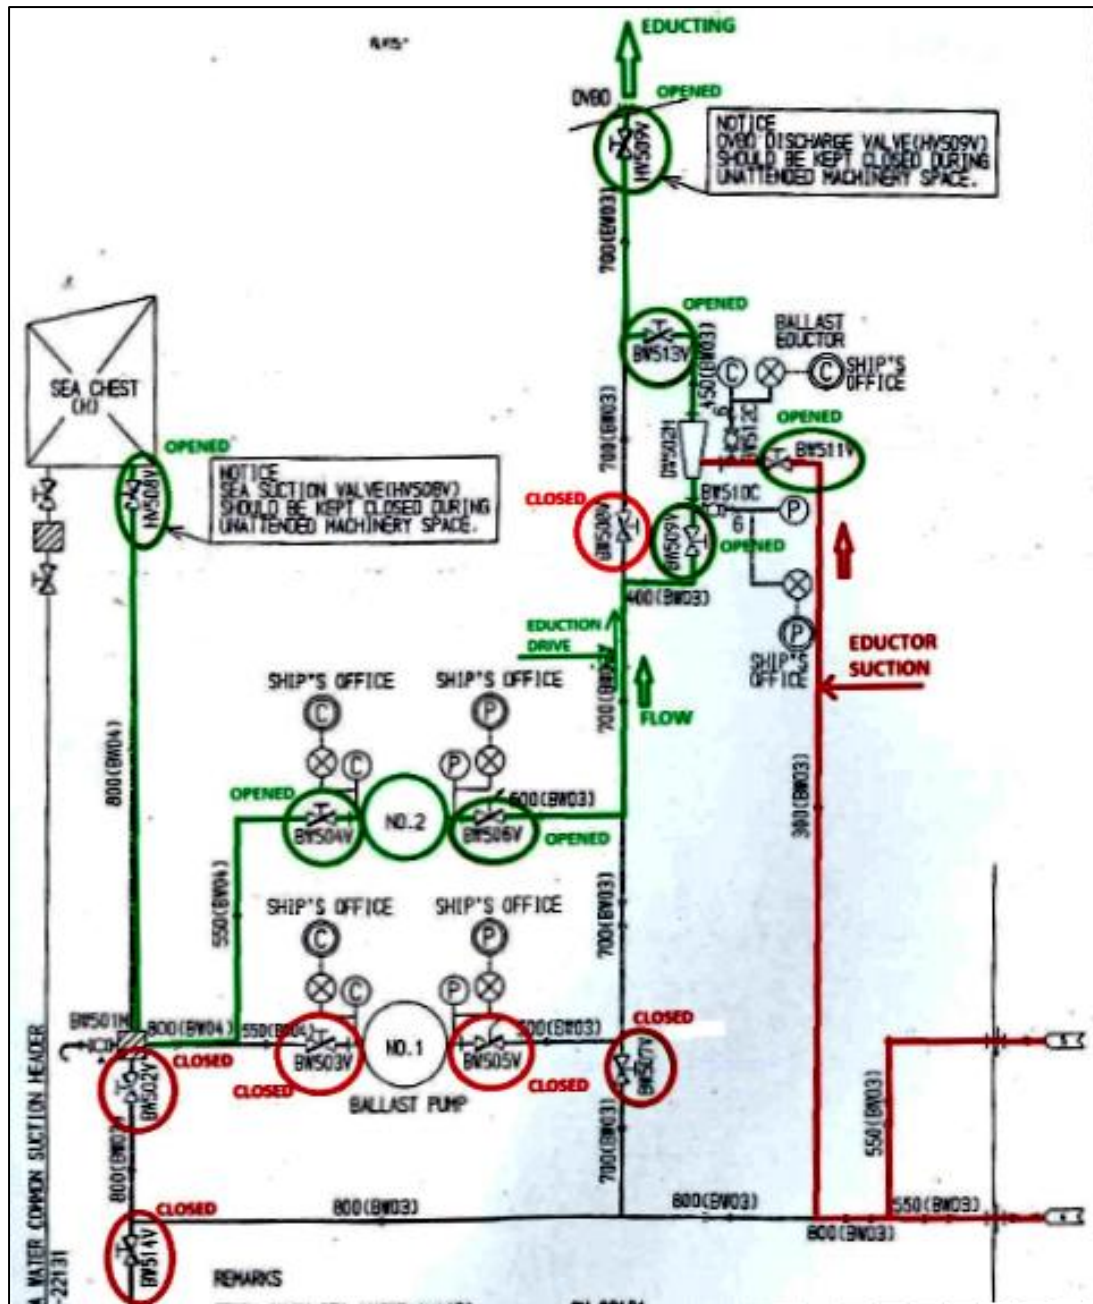
Figure 3: Ballast piping diagram

At 1936 on 25 December, the vessel came alongside berth no. 5 at Parker Point. Her drafts were noted to be forward 7.10 m and aft 8.90 m. Soon afterwards, at 2000, ballast tanks nos. 1 and 4 port and starboard were stripped using ballast pump no. 2 and the ballast eductor (Figure 3).

- engine-room operated valves open: BW508V, BW502V and HV509V;
- engine-room operated valves closed: BW509V, BW507V, BW514V, HV508V, BW503V, BW504V, BW511V and BW513V;
- ballast control mimic board (ship's office) remotely operated valves closed BW506V, BW505V (Figure 3).
