National Transportation Safety Board

Marine Accident Brief

Fire and Subsequent Sinking of Commercial Fishing Vessel *Hit List*

Accident type	Fire/Explosion	No. DCA18FM035
Vessel name	<i>Hit List</i>	
Location	Merrimack River at the Harbormaster's Dock: Newburyport, Massachusetts 42°48.75'N; 70°52.04'W	
Date	August 24, 2018	
Time	1730 eastern daylight time (coordinated universal time – 5 hours)	
Injuries	None	
Property damage	\$550,000 est.	
Environmental damage	Approx. 100 gallons of diesel fuel in water	
Weather	Light southerly winds, air temperature 79°F	
Waterway information	The Merrimack River flows south through parts of New Hampshire and then northeast through parts of Massachusetts before entering the Atlantic Ocean.

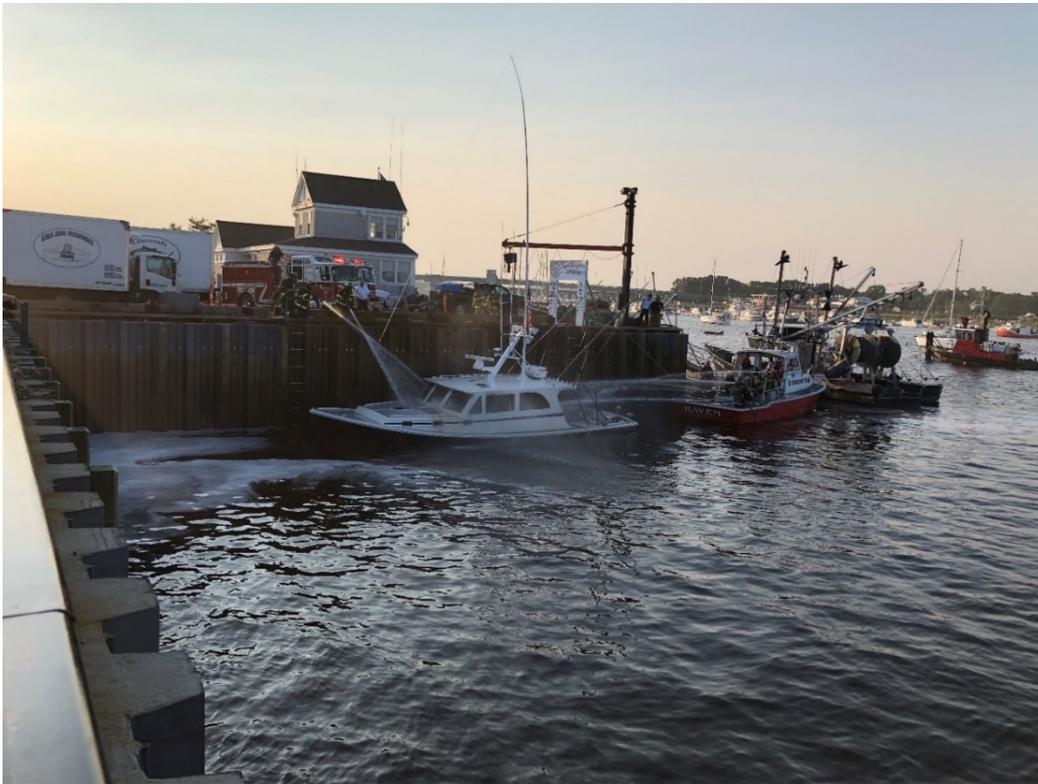
Fire department fighting the *Hit List* fire from the pier and a fire boat. (Photo by witness)

About 1830, firefighting water applied to the vessel as well as river water flooding through holes burned in the port exhaust pipe caused the *Hit List* to partially sink, which extinguished the fire, leaving only the top of the cabin exposed. As the vessel sank, about 100 gallons of diesel fuel spilled from the vessel's fuel tanks into the Merrimack River. A containment boom and sorbent pads were deployed around the vessel to contain the fuel spill. A salvage company arrived on scene later that evening to refloat the vessel and transport it to a local marina.

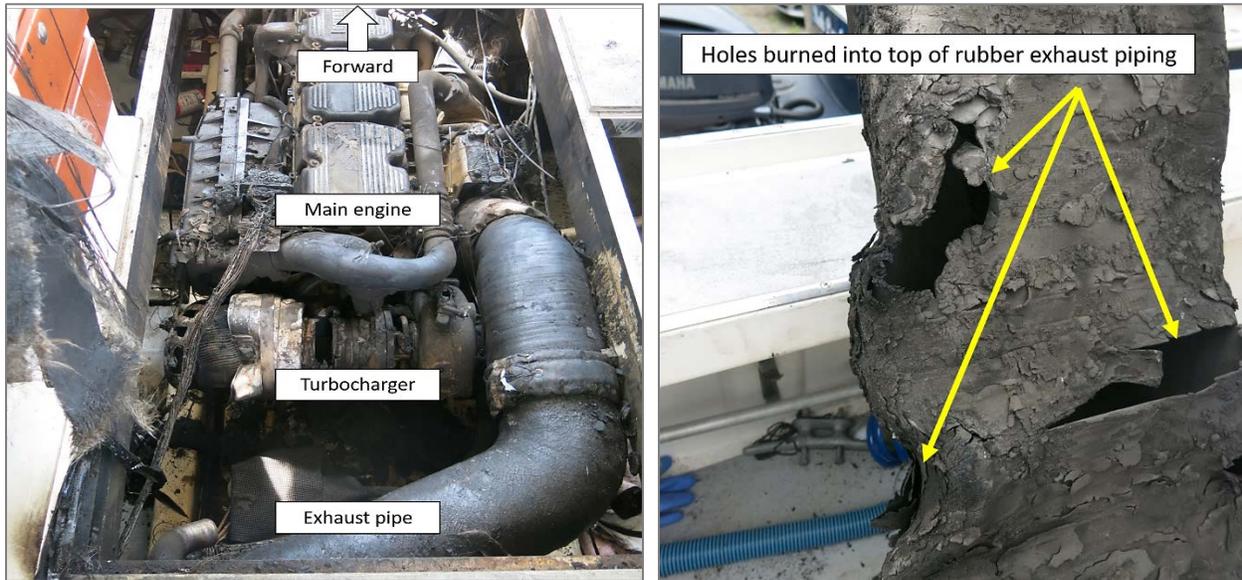
The greatest amount of fire damage occurred in the aft section of the engine compartment. Additional water damage occurred from the flooding and subsequent sinking of the vessel. About 2 weeks after the fire, a fire and explosion investigator inspected the vessel on behalf of the owners' insurance company. He determined that due to the extensive time taken to extinguish the fire, it spread to areas inconsistent with the origin of the fire. He reported that extensive heat damage occurred along the port side of the engine compartment, damaging the upper half of the wet-exhaust rubber pipe. Based on this finding, a failure of the raw-water cooling pump was considered, and its rubber impeller was inspected.² The fire investigator determined that the pump was in good condition and eliminated it as a cause. The electrical system was also inspected with no evidence of arcing or shorting.

Left: Damage to the engine as seen from above. Right: Damaged exhaust tubing after removal from engine room.

Flooding occurred on the *Hit List* because of water used in suppression efforts and because of holes burned through the wet-exhaust hose from the heat of the fire, which allowed seawater to flood the engine compartment from the exhaust outlet on the port side of the vessel. Eventually, the *Hit List* sank alongside the pier.

The National Transportation Safety Board determines that the probable cause of the fire aboard fishing vessel *Hit List* was the failure of a hydraulic hose fitting that sprayed pressurized hydraulic oil onto the engine, eventually causing the oil to ignite. Contributing to the sinking was water applied during firefighting efforts and flooding through the rubber engine exhaust tubing, which the fire burned through.

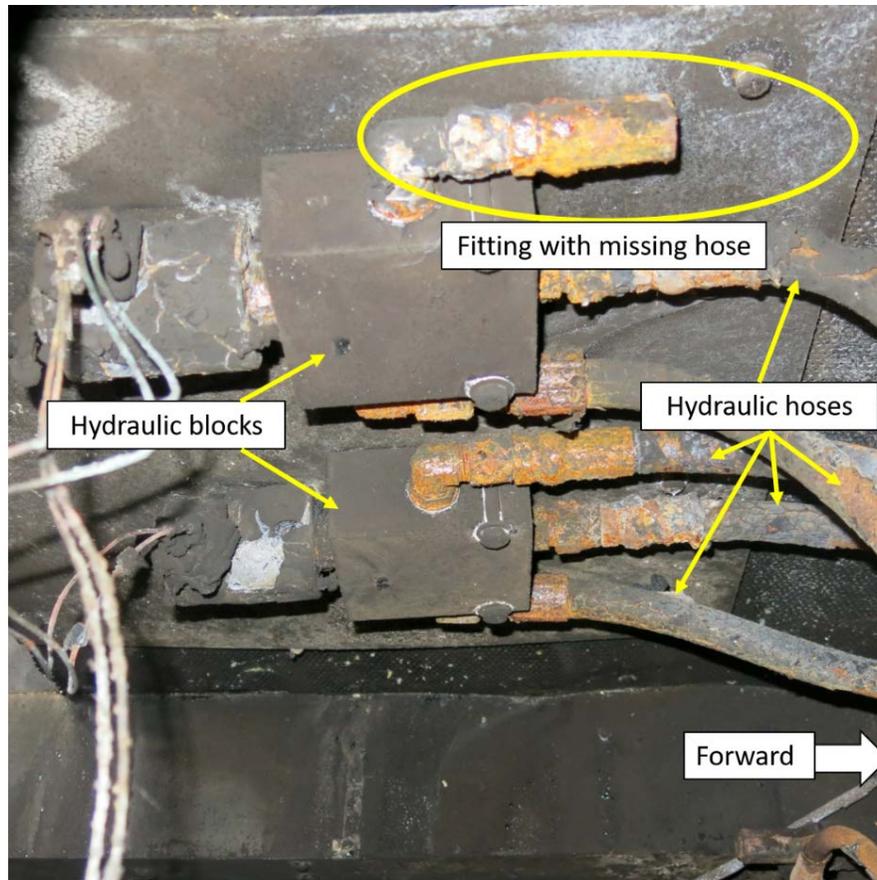
The hydraulic system in the aft section of the engine compartment was examined, and a hydraulic hose was found broken off at a fitting on a control block mounted in the overhead about 4 feet aft and 1 foot above the main engine turbocharger. According to the fire investigator, this finding corresponded to burn patterns around the turbocharger, indicating that hydraulic fluid likely sprayed on the turbocharger and ignited. A typical petroleum-based hydraulic fluid has a flash point ranging from 300°F to 600°F and an auto-ignition temperature of 500°F to 750°F. Parts of a diesel engine's exhaust system around the turbocharger can reach over 800°F when operating.

According to the owners, the hydraulic hose was original to the vessel and did not have any inspection or maintenance records associated with it. The hydraulic hose that was found disconnected after the fire was associated with the pot hauler winch system. Although the pot hauler was not in use at the time of docking, it had been used to raise the anchor at the conclusion of fishing activities about 4 hours earlier.

Hydraulic block with parted hose fitting, circled in yellow.

Investigators determined that the initiating event for the fire aboard the *Hit List* was a failure of a hydraulic hose fitting connected to a distribution block in the overhead of the aft part of the engine compartment for the pot hauler system. After the fire, the fitting was found to be broken off from the hydraulic block, and it most likely sprayed hydraulic fluid when pressurized onto the surface of the main engine turbocharger and ignited when the exterior surface heated up while the vessel was underway. The fire eventually spread to other areas of the engine compartment and filled the cabin with smoke.
