## **Collision of the rigid inflatable boat *Tiger One* with a mooring buoy, River Thames, London, England 17 January 2019**

### **SUMMARY**

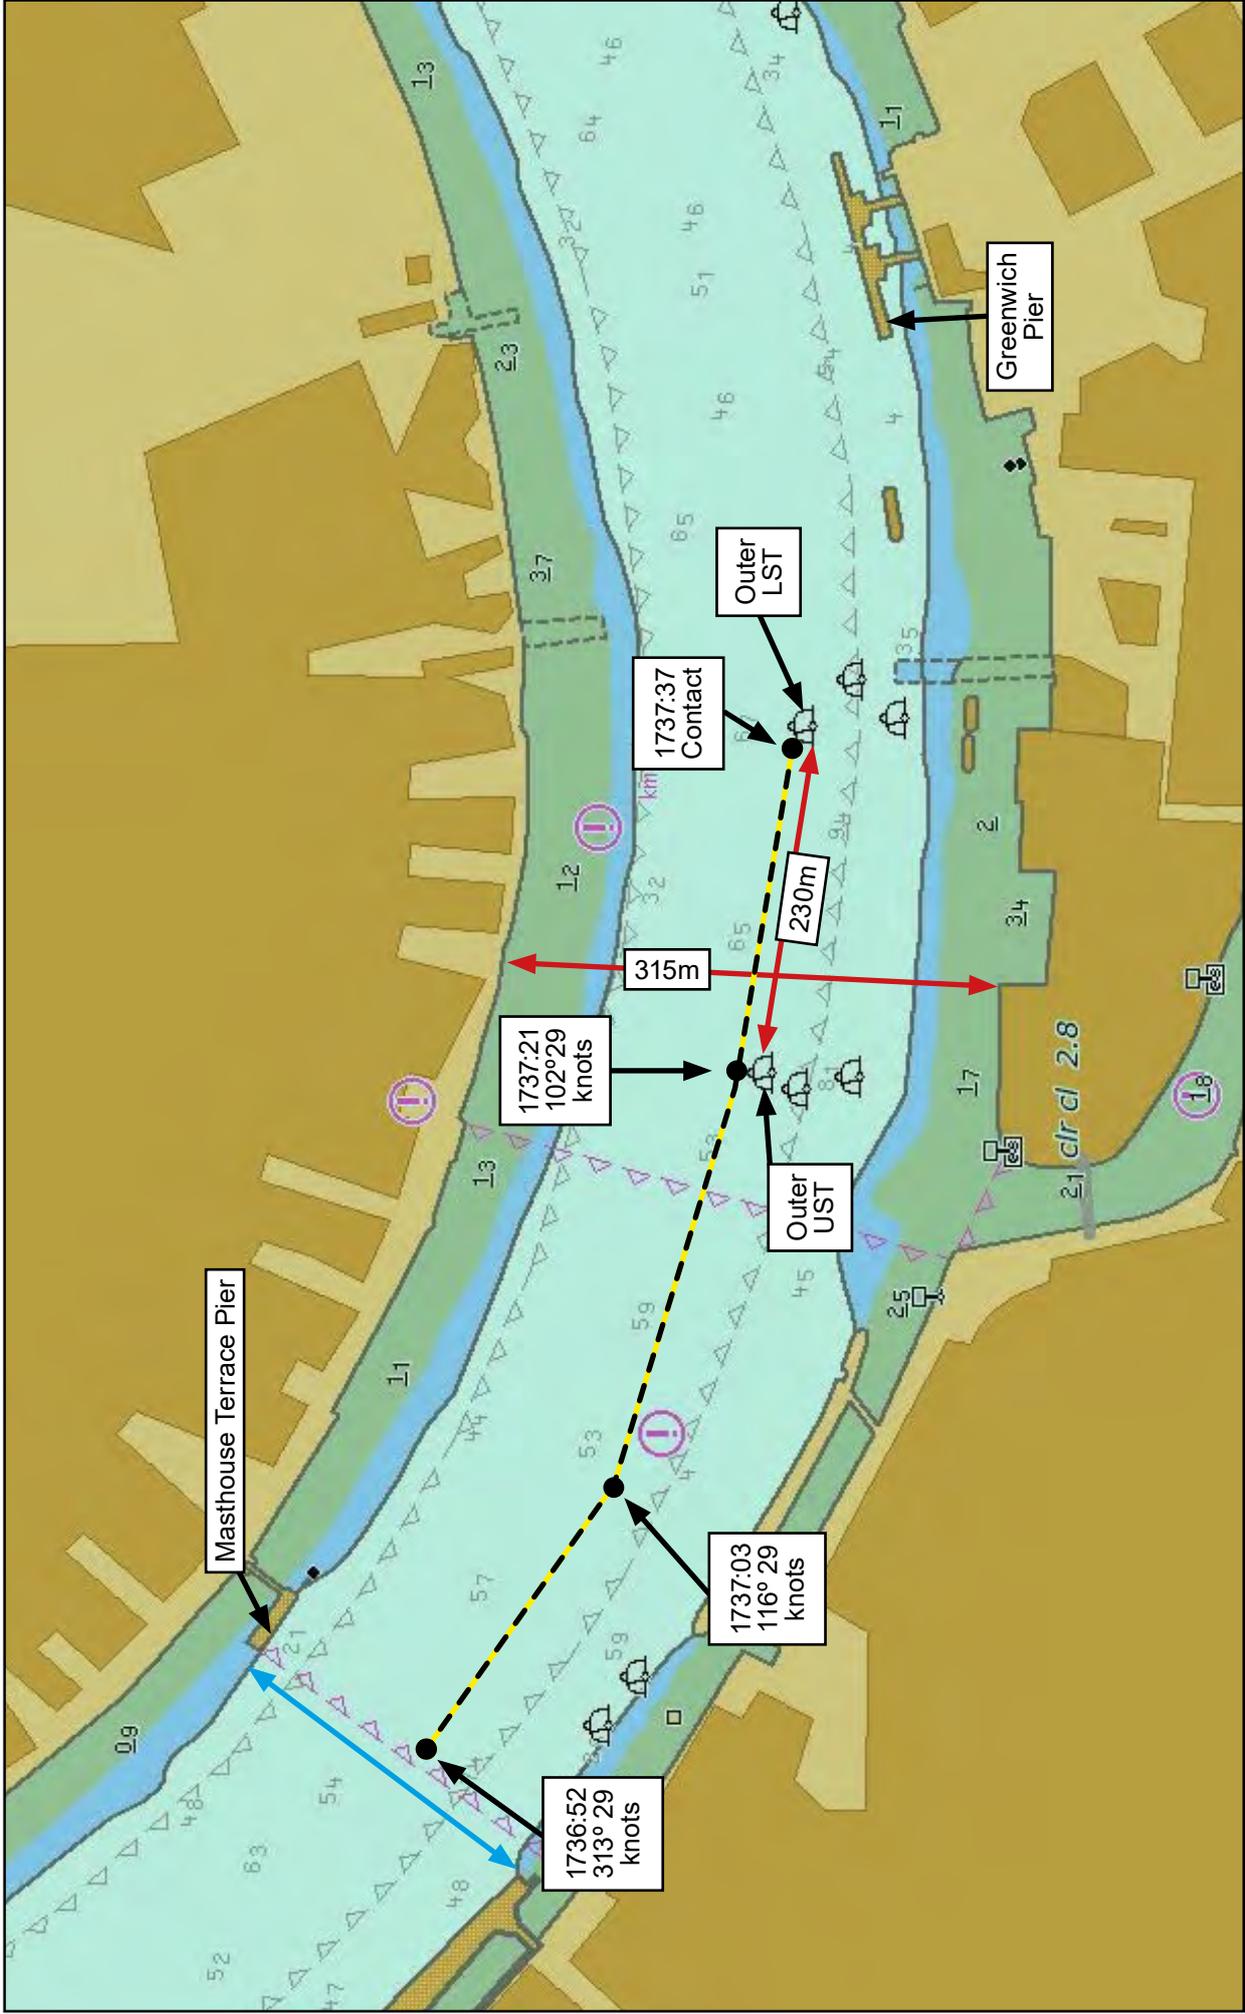
Figure 3: Extract of electronic chart GB503337 showing Greenwich Reach with Tiger One's track

As *Tiger One* transited Greenwich Reach, the RIB was making good 29 knots, and the skipper was making small alterations to port to follow the main channel (**Figure 3**). That the RIB passed 15m from the outer UST buoy, the light of which was on and visible, but the skipper did not recollect seeing it, and that the skipper was not concerned that he could not see the outer LST buoy, which was only 230m ahead, indicates that he thought the RIB was in the navigable channel and clear of hazards. However, it is also possible that he had forgotten that the outer Ship Tier buoys were located in the main channel.

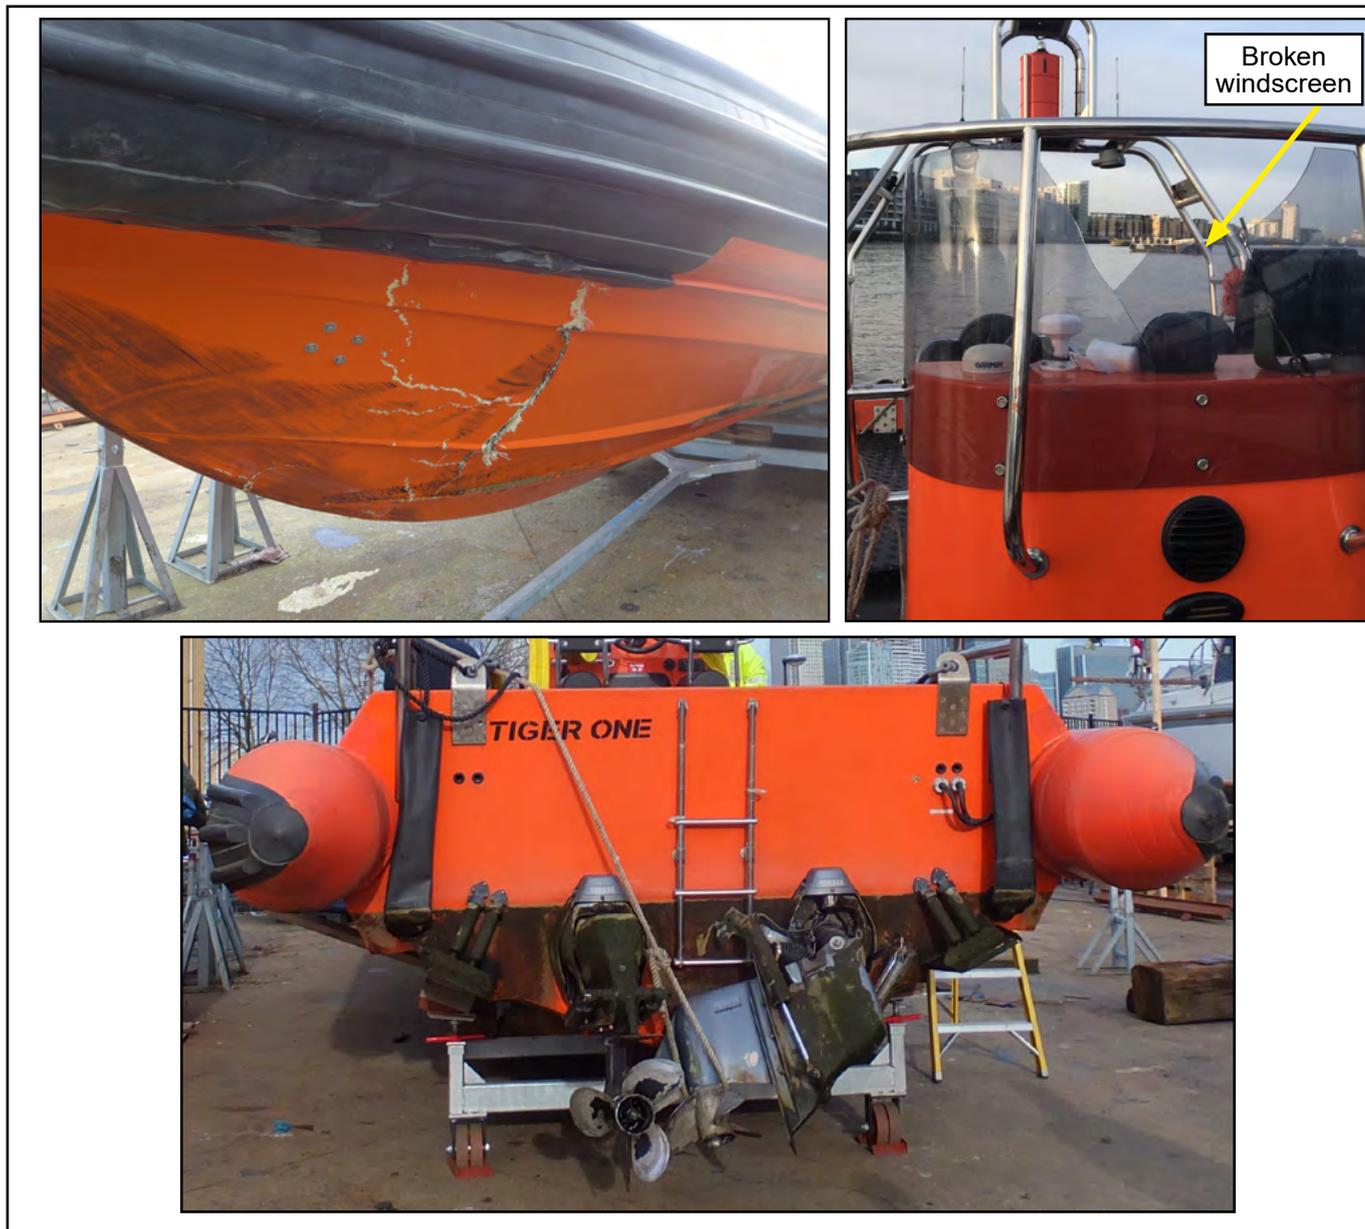
*Tiger One's* skipper checked the RIB and confirmed that it was not sinking. He then drove the RIB alongside Greenwich Pier, where the passengers and crew disembarked and were treated by the Tower lifeboat crew. Police breathalysed the skipper and deckhand; the results were negative. Both crew and two of the passengers were taken to hospital with facial injuries. Both crew also suffered bruising to the upper body. *Tiger One's* bow and starboard propulsion drive unit were badly damaged (**Figure 4**). There was no damage to the LST buoy.

**Figure 4:** Damage to bow, windscreen and stern drive

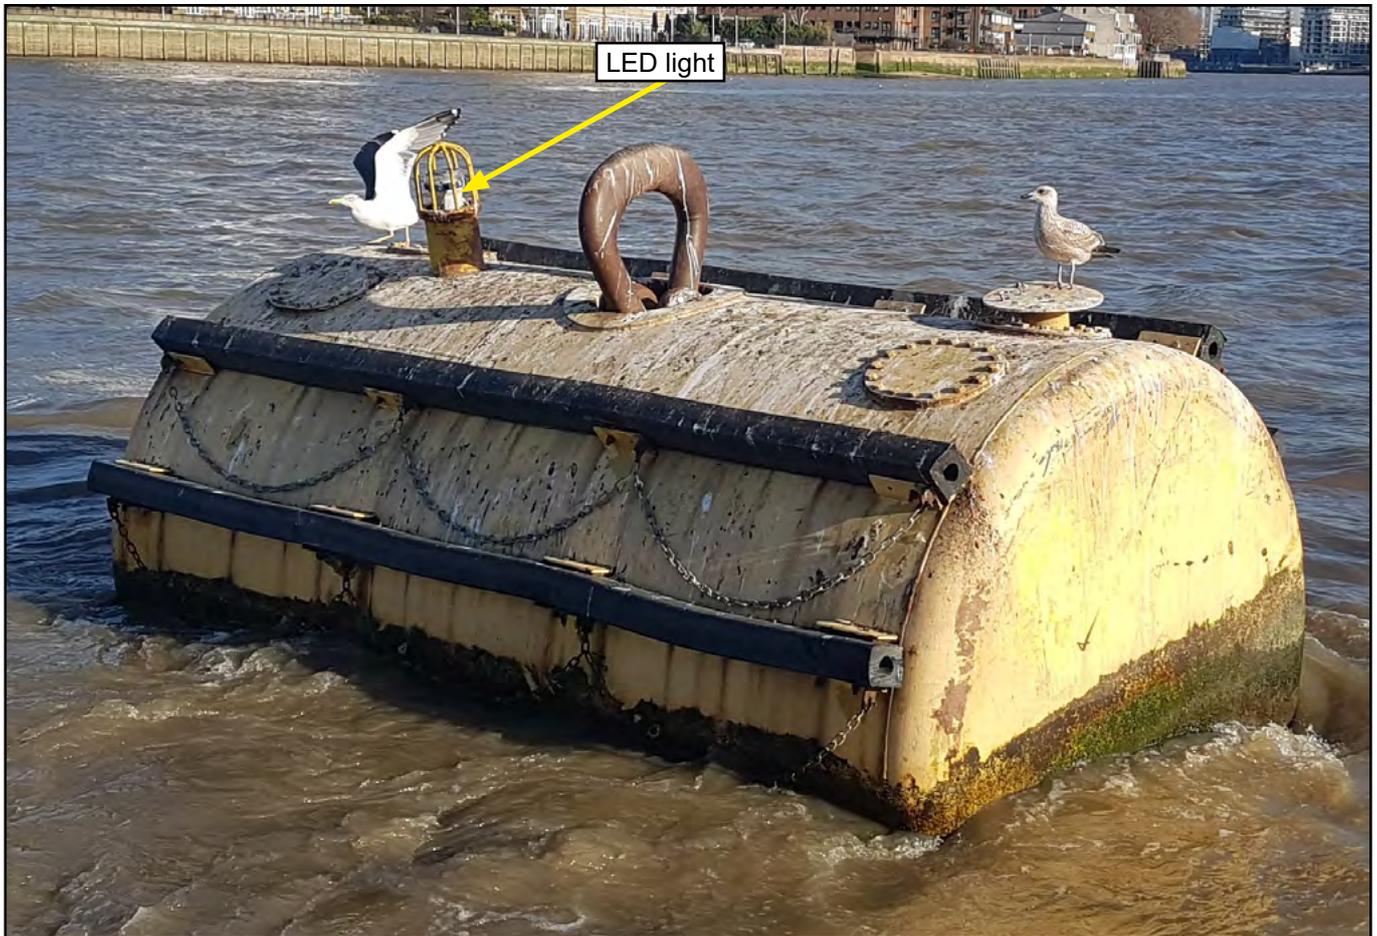
**Figure 5:** Outer lower Ship Tier buoy

It was evident from the amount of guano present on the surface of the outer LST buoy (**Figure 5**) that birds regularly perched on the river's mooring buoys. As birds were seen flying close to *Tiger One* immediately before impact, the likelihood that the buoy's LED light was obscured or partially obscured by birds cannot be discounted. Without a light, the silhouette of the outer LST buoy alone would have been very difficult to see.

- Trialled the use of isophase lights on the Greenwich Ship Tier buoys. The trial was unsuccessful due to a loss of light intensity, and research into the use of alternative lights and light characteristics is ongoing.

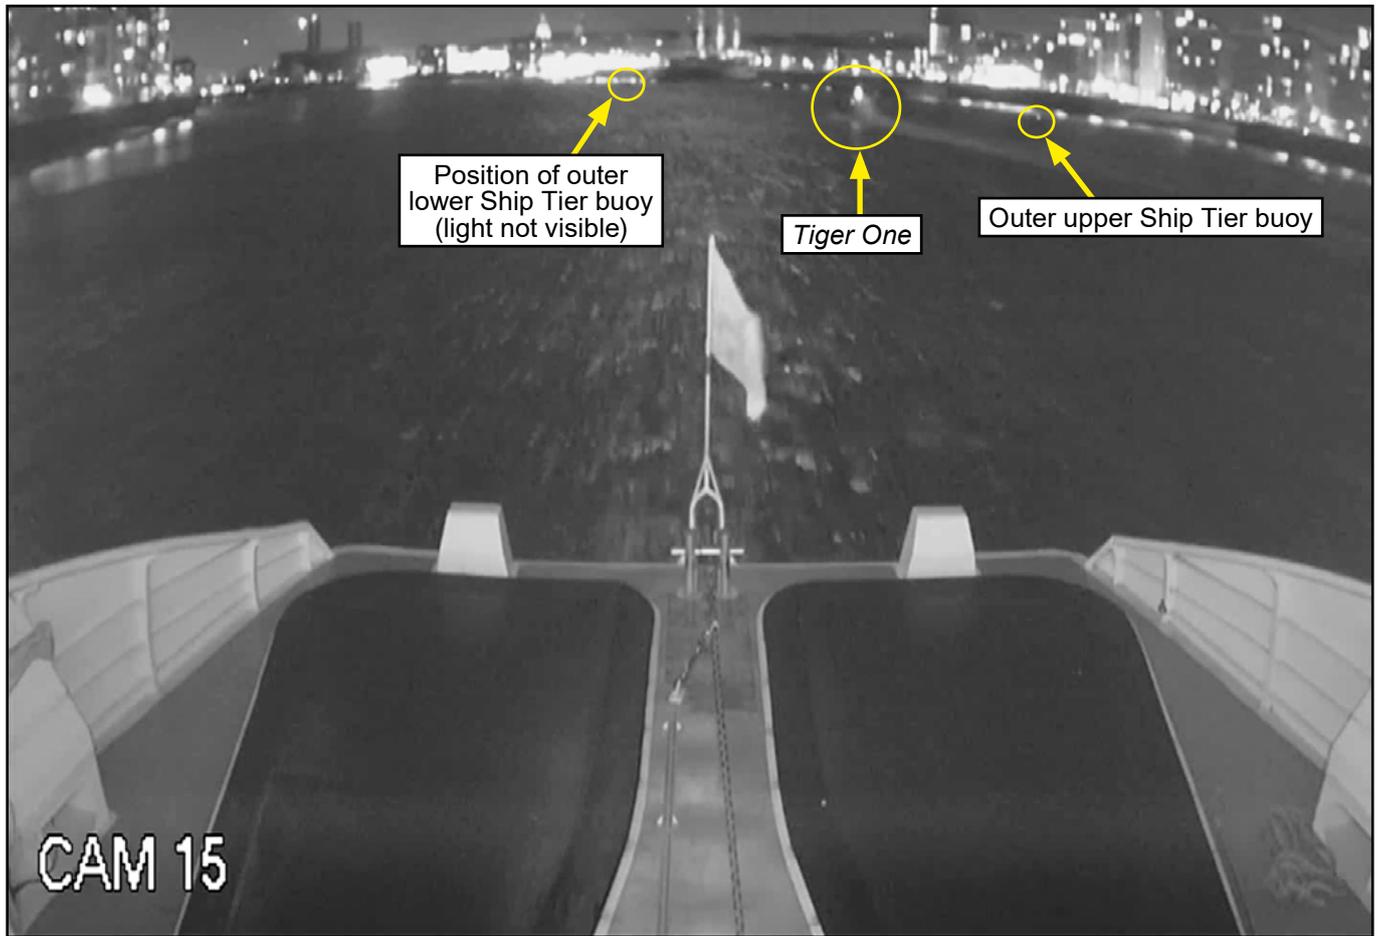
According to its data logger, the outer LST buoy's LED light was illuminated continuously between 1619 on 17 January 2019 and 0654 the following morning, but it became visible on *Cyclone Clipper's* CCTV recordings (**Figure 6**) only a split second before the impact. It remained visible thereafter. The outer UST buoy's LED light was illuminated and visible on *Cyclone Clipper's* CCTV recordings when *Tiger One* passed it.

**Figure 6:** *Cyclone Clipper* CCTV still at 1737:25 showing *Tiger One*
