SAFETY INVESTIGATION REPORT

REPORT NO.: 16/2019

MY KANGA

Fire in the garage of yacht, in position 42° 46.1' N, 017° 45.9' E 07 September 2018

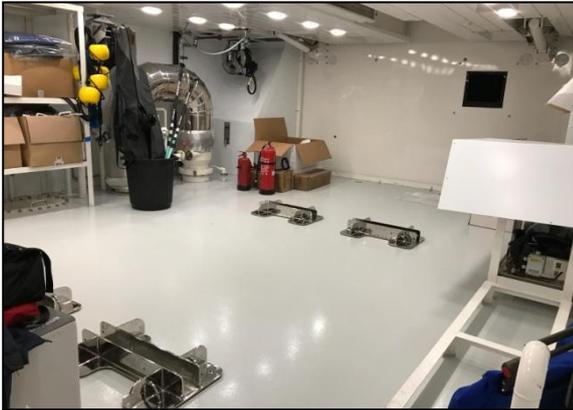
Figure 1: Internal view of the garage – facing the door through which the Tender RIB is launched

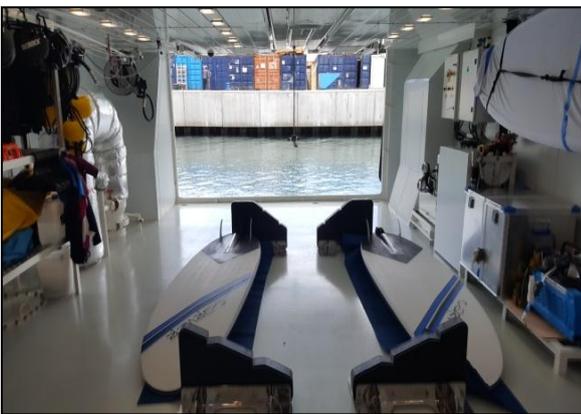
Figure 2: Internal view of the garage – with electric surfboards in their stowed position

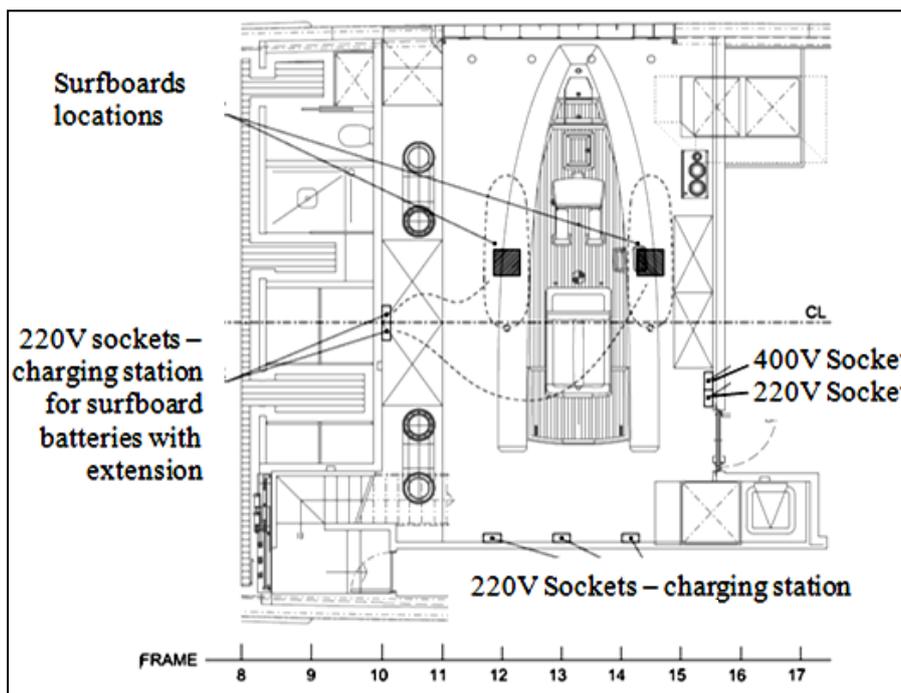
The garage had a total of six 220V power sockets and one 400V power socket. Two of the 220V sockets were used to recharge the battery packs of the electric surfboards, while three of these sockets were used to recharge the underwater scooters, shown in Figure 3.

According to the crew, none of the equipment / batteries were being recharged at the time of the occurrence, and the garage extraction fan was running. The only fuel stored in the garage was diesel, located in the tender's fuel tank. There were also empty jerry cans, which had previously contained diesel.

Figure 3: Plan of the garage showing the power outlets

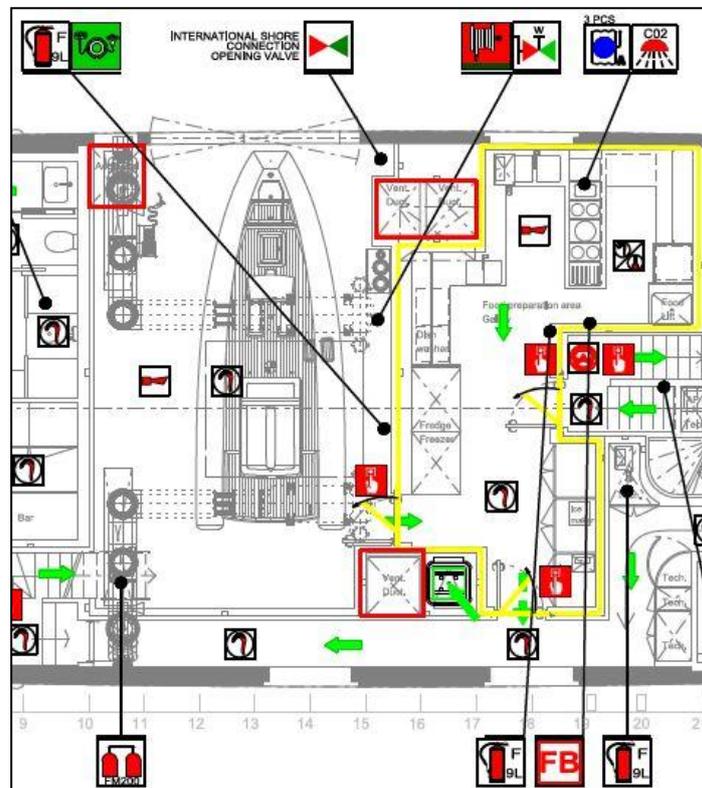
However, as the forward bulkhead of the garage separated it from the galley, this bulkhead was a B-15 Class division³, as can be seen in Figure 4.

Figure 4: Extract of fire and safety plan depicting the garage and galley

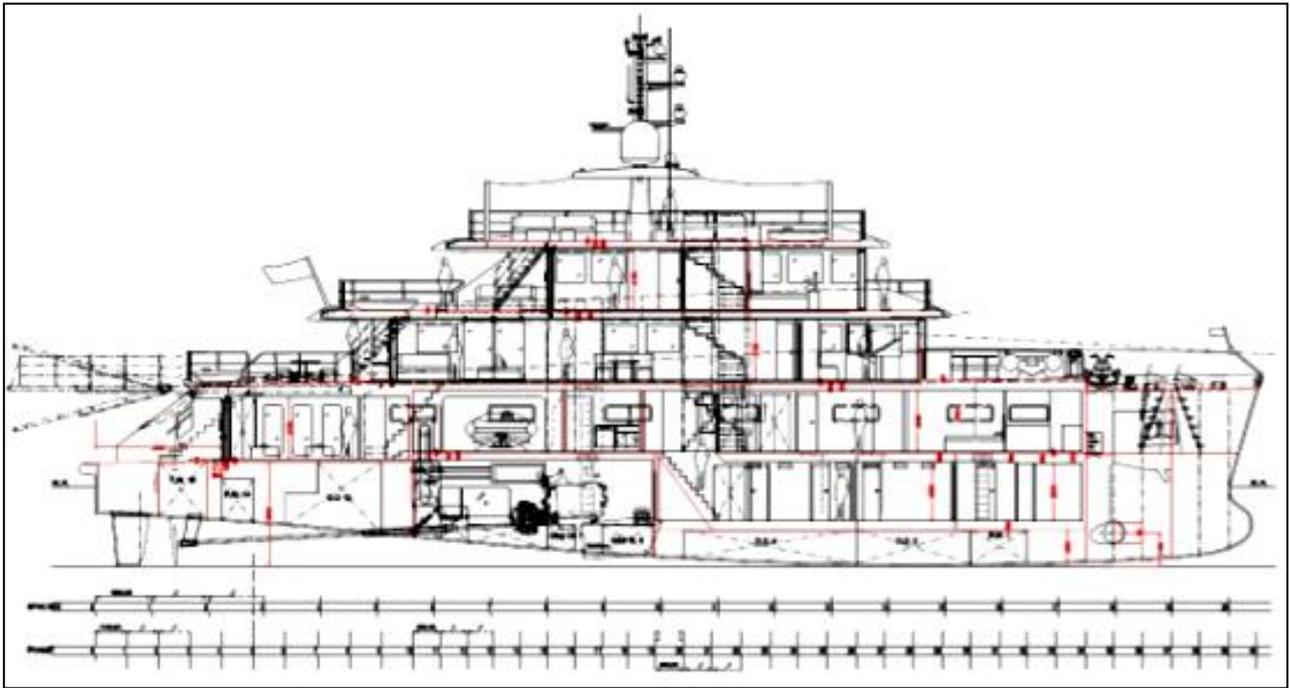
Evidence has indicated that the fire had spread from the garage to the sun deck, which was the uppermost deck (Figure 6), in less than 15 minutes.

Figure 6: Side Profile of *Kanga*

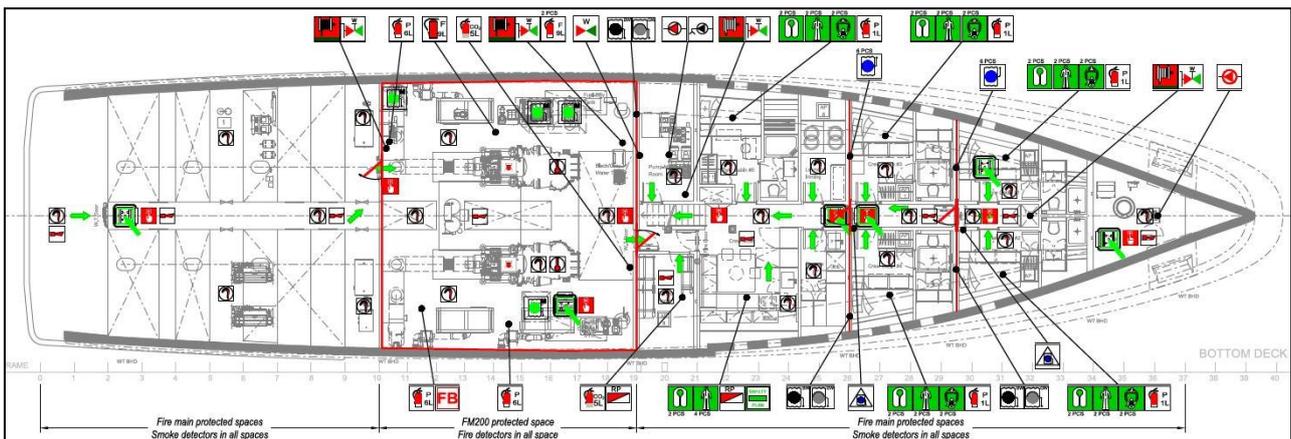
The entire engine-room (located just below the garage) and the first two bulkheads, forward of the engine room, had A-30 class fire-resistant divisions (Figure 7). Besides these spaces, only the galley, which was located just forward of the garage, had B-15 class fire-resistant divisions (Figure 4).

Figure 7: Extract of Fire and Safety Plan – Bottom Deck

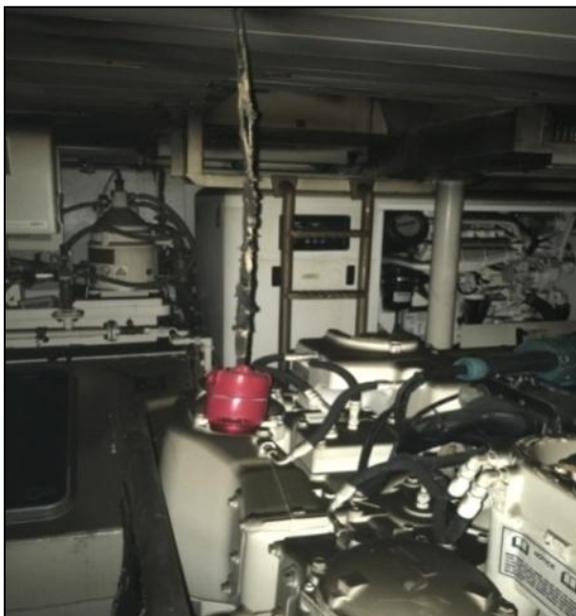
As it can be seen in Figures 8, 9 and 10, the engine-room sustained minimal damages due to the fire, with mainly some electrical wirings and fittings on the engine room deck-head being subjected to excessive heat.

Figure 8: Heat Detector located above the starboard side engine

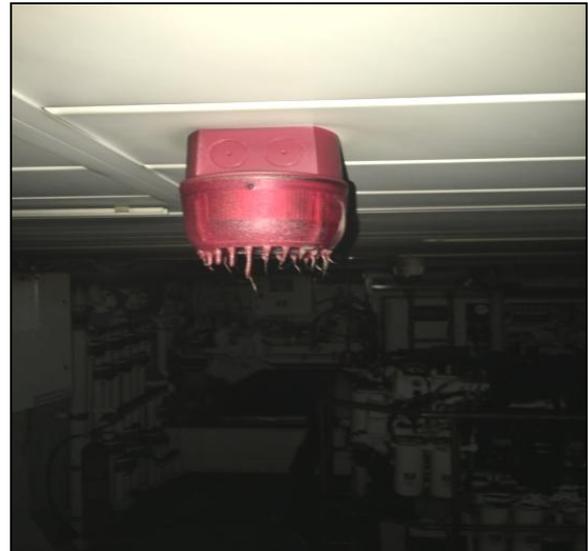
Figure 9: Heat detector, located above the port side engine

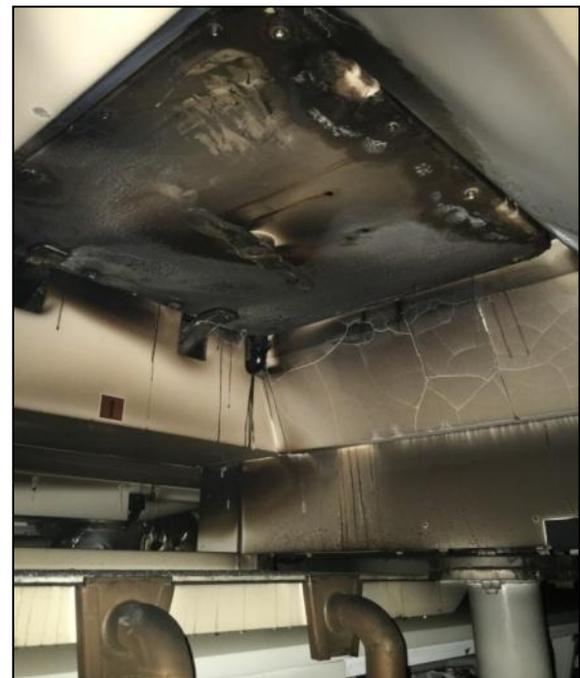
Figure 10: Engine-room emergency escape hatch – located on the starboard side
