## MARINE TRANSPORTATION SAFETY INVESTIGATION REPORT M18P0230

### GIRDING AND CAPSIZING

Tug *George H Ledcor*

13 August 2018

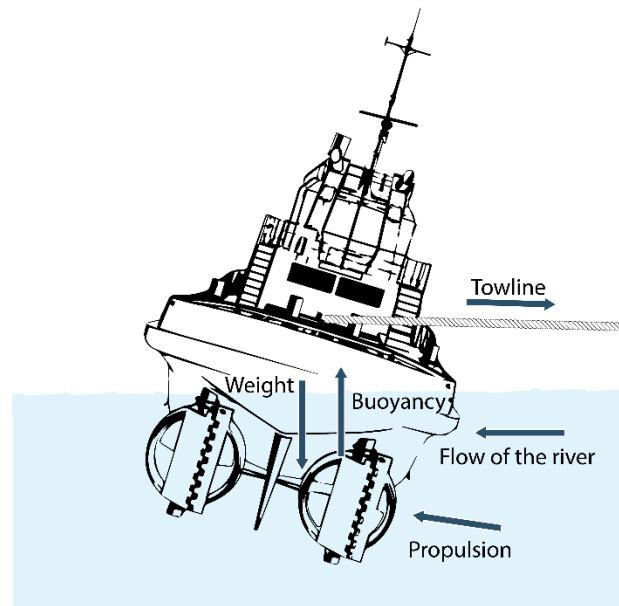
In this occurrence, the assist tug was used to push the barge up the river. The assist tug was positioned on the centre of the barge's stern and was being used to push only; it was not helping guide the barge. The assist tug applied a longer turning lever and had more influence on the direction and momentum of the barge (in a straight line) than the lead tug with the shorter turning lever (Figure 7). As a result, the lead tug, with its shorter turning lever, was unable to turn the barge.

Figure 6. Forces that can contribute to a girding situation (Source: TSB)

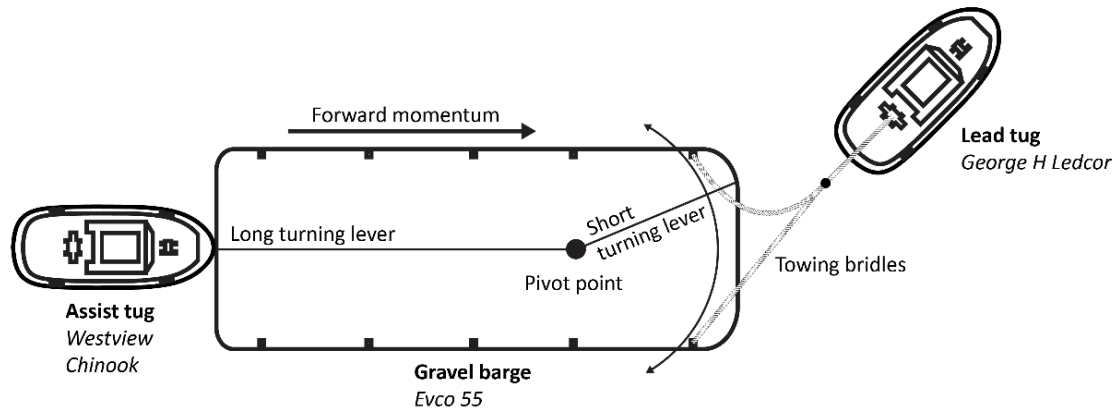
Figure 7. Comparison of turning levers for the George H Ledcor and the Westview Chinook (Source: TSB)

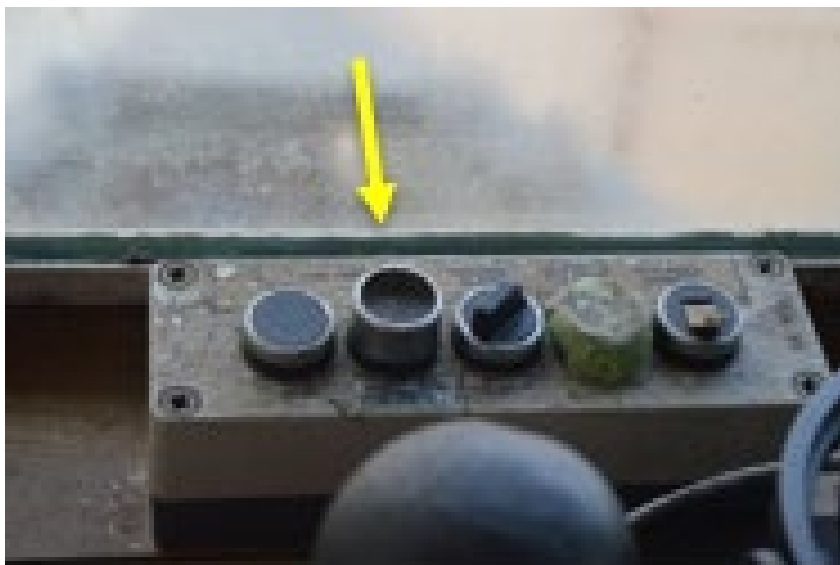
The *George H Ledcor* had abort mechanisms located at each of the 3 conning stations. The TSB examined the abort mechanisms on the *George H Ledcor* and observed that the location, orientation, and colour of the buttons for the abort mechanisms on the 3 control panels were different. The 3 buttons were labelled, but the labels were obscured by the position of other controls and switches. The 3 mechanisms had guards to prevent inadvertent activation, but each of the guards was of a different design. Table 2 summarizes the observations made about each of the mechanisms.

| Labelling | Both the abort button and the reset button labelled<br>Labels not visible | Only the abort button labelled<br>Label not visible | Both the abort button and the reset button labelled<br>Labels not visible |

Figure 8. Abort mechanism at the wheelhouse conning station, with the abort button indicated by a yellow arrow (Source: TSB)

Following the occurrence, the company installed additional abort mechanisms of a standard design in a common location on all of its tugs (Figure 11).

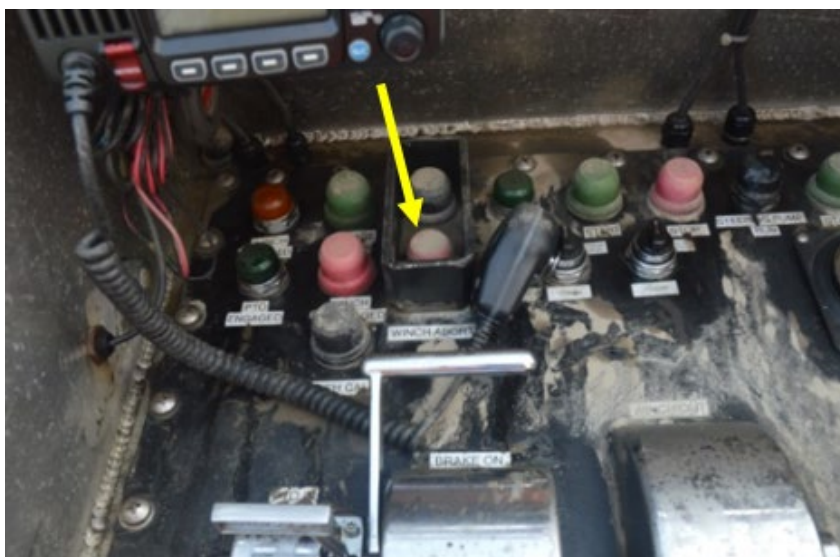
Figure 9. Abort mechanism at the conning station on the upper aft deck, with the abort button indicated by a yellow arrow (Source: TSB)

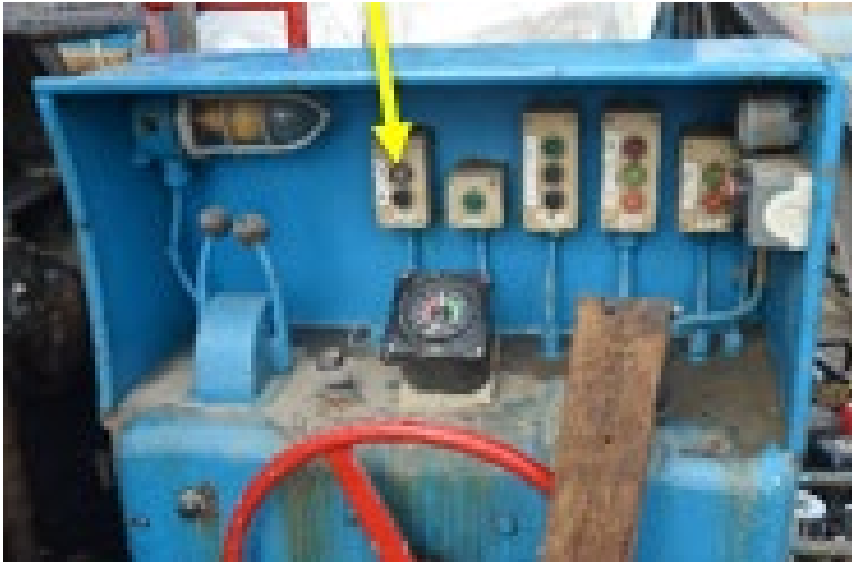
Figure 10. Abort mechanism at the conning station on the main deck, with the abort button indicated by a yellow arrow (Source: TSB)

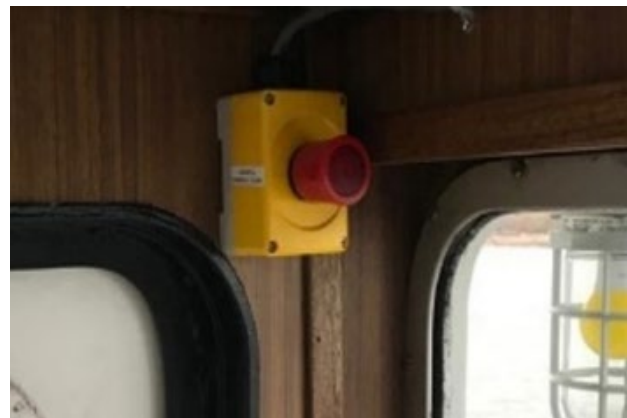
Figure 11. Newly added standardized button for abort mechanism (Source: Ledcor Resources and Transportation Inc.)

Ledcor also installed additional abort mechanisms of a standard design in common locations throughout its fleet of tugs. The abort mechanisms are more visible, are illuminated, and have an audible alarm when activated. Ledcor is also in the process of ensuring that liferaft painter lines are of the recommended length for its vessels and operations.

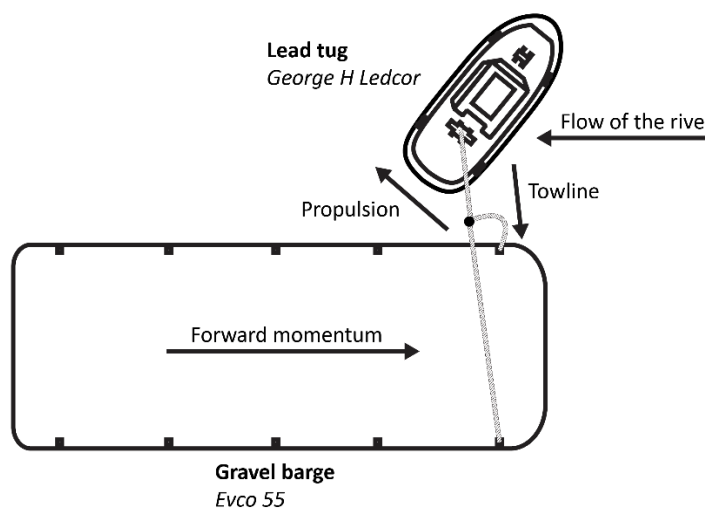
Once the master recognized that the barge had not responded to the course alteration, he called off the assist tug and applied more port rudder. However, the barge continued on a straight course and began to overtake the tug, at which point the short towline, which was not secured by hold-down gear, began to exert a broadside force on the tug, placing it in a girded position. When the barge began to pass off the stern of the tug's starboard side, the master applied full starboard rudder and full throttle. However, given the forces acting on the vessel's stability, such as thrust from the propellers, flow of river against the hull, and increasing force from the towline, this action increased the tug's heel (Figure 12). As this progressed, the master did not have sufficient time to initiate corrective action.

Figure 12. Forces acting on the stability of the *George H Ledcor* as it is overtaken by the barge *Evco 55* (Source: TSB)

Within seconds, the tug's deck edge and bulwarks were submerged, creating a dragging force that heeled the tug further to starboard. At this point, the crew attempted to abort the tow, but they were unsuccessful and the tug rapidly capsized. Neither the master nor the deckhand was able to alert the mate and second deckhand in the accommodation space, communicate with the *Westview Chinook*, transmit a distress call, or don life jackets. The
