National Transportation Safety Board
Washington, DC 20594

Safety Recommendation Report

**Improving Vessel Survivability and Passenger Emergency Egress of
DUKW Amphibious Passenger Vessels**

Accident No.	DCA18MM028
Location	Table Rock Lake, near Branson, Missouri
Date	July 19, 2018
Recommendation Nos.	M-19-15 and -16
Adopted	November 6, 2019

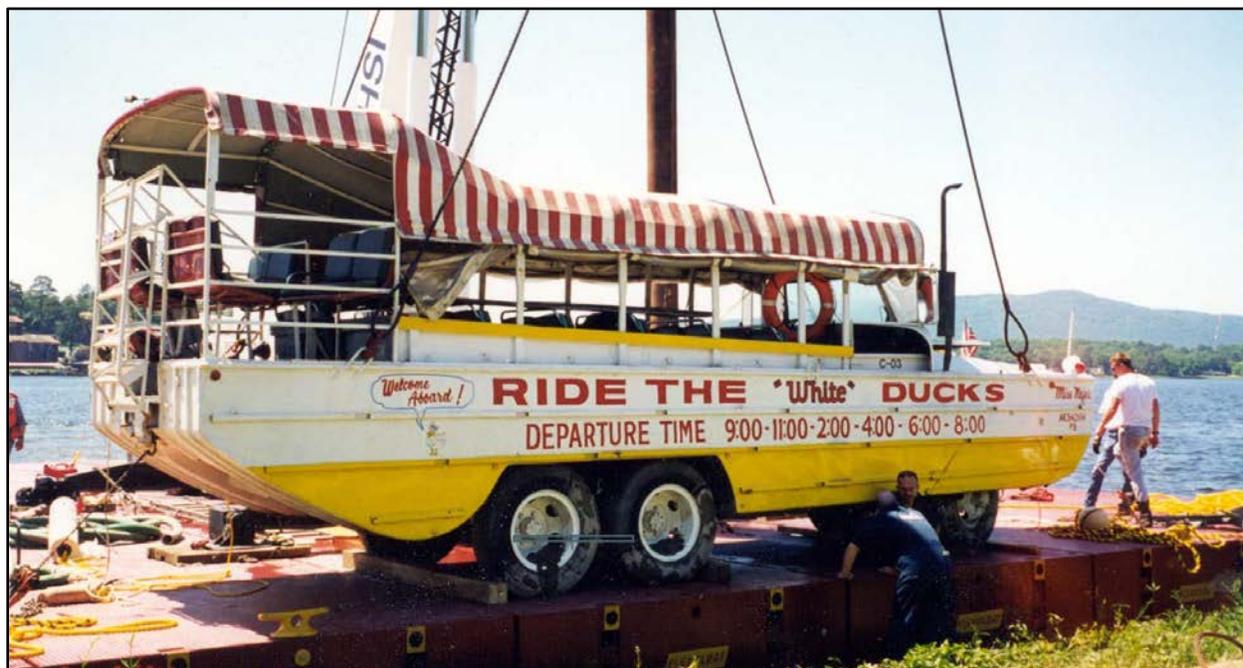
Figure 2. *Miss Majestic* post-salvage, 1999.

initially entered the *Miss Majestic* through the gap between the driveshaft and its housing via an unsecured clamp for the watertight rubber boot. Once the weight of floodwater in the aft portion of the hull reduced the freeboard at the stern to zero, water poured over the immersed transom and into the interior of the *Miss Majestic*, causing it to sink rapidly by the stern.⁵

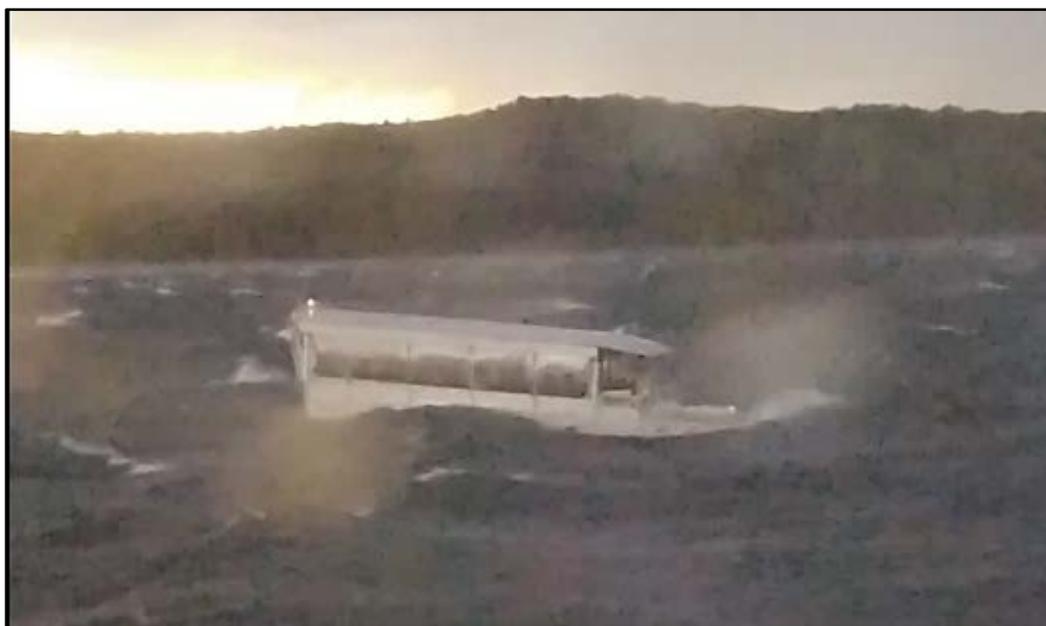
During the waterborne portion of its final voyage, the *Stretch Duck 7* was exposed to high winds and waves estimated at 3 to 5 feet. The video recorder on board captured bilge alarms sounding 4 minutes after the vessel encountered severe weather, signaling an ingress of water. About 4 minutes later, the *Stretch Duck 7* sank. Witness videos showed the vessel pitching in the storm with white-capped waves covering the bow several times (see **figure 4**). In the forward section of the vessel, the ventilation openings that supplied combustion and cooling air to and from the engine most likely permitted water to enter the engine compartment, from where it would have flowed freely throughout the rest of the hull. The additional water weight would have further lowered the vessel's freeboard and thereby subjected it to more rapid flooding.

Figure 4. *Stretch Duck 7* moments before sinking. (Source: Jennie Carr)

Surviving passengers who were interviewed after the accident recalled water quickly rising from under the floorboards of the *Stretch Duck 7*. They described how waves pushed in the starboard-side curtain and water entered from the bottom rail of the curtain where it met the gunwale. Once the water started filling the vessel, it quickly flooded and sank within seconds after covering the passengers' feet. Most passengers recalled the *Stretch Duck 7* had a starboard list in the final moments of the voyage and rapidly sank by the stern. If the *Stretch Duck 7* had been modified to include several subdivided compartments—one approach to a passive safety system—the flooding could have been contained to individual sections of the vessel, thus increasing the vessel's ability to remain afloat. The vessel could have remained afloat and upright indefinitely had it been fitted with built-in flotation or watertight compartmentalization, which can be designed and sized to provide a boat with sufficient reserve buoyancy even when the hull is fully flooded.

Require DUKW amphibious passenger vessels (commonly referred to as original and/or “stretch” DUKWs) to have sufficient reserve buoyancy through passive means, so that they remain upright and afloat with a full complement of passengers and crewmembers in the event of damage or flooding. (M-19-15)

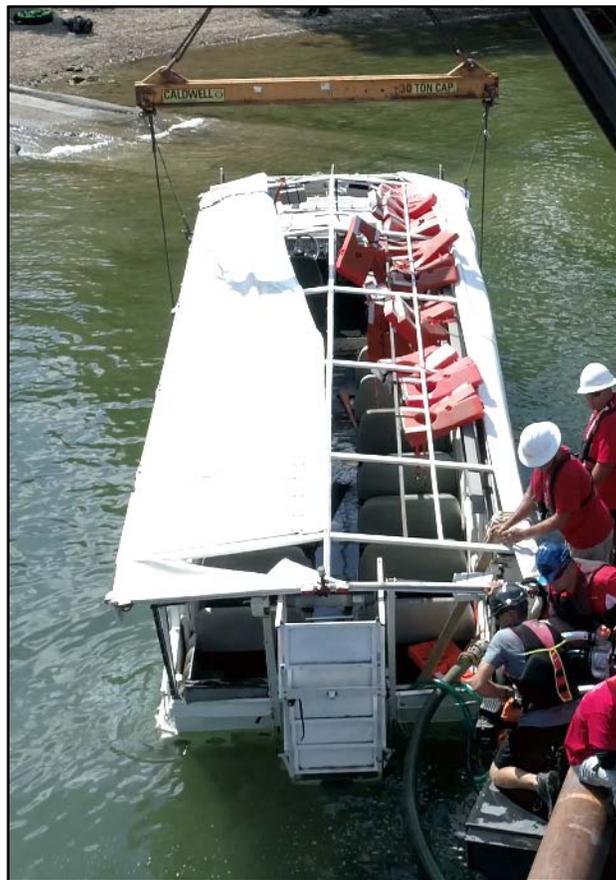
The entire passenger and crew space of the *Stretch Duck 7* had been covered by a fixed canopy. Upon recovery of the vessel, the canopy was found torn from front to back (see **figure 5**). It was peeled back over the starboard side but largely remained intact on the port side. The canopy was constructed of vinyl measuring .032 inches thick and pressed into a seam along the horizontal support at the center of the vessel. Underneath the canopy, the *Stretch Duck 7*'s personal flotation devices (PFDs, commonly called lifejackets) were stored above the seating compartment. All of the PFDs on the port side were found in their stowed position, as well as all but three of the PFDs on the starboard side. With the PFDs in their storage locations above the passengers, vertical egress was blocked during the sinking, despite the canopy being peeled back over the starboard side.

Figure 5. Torn canopy of the *Stretch Duck 7* found during recovery operations.

The canopy framing also created obstructions for clear egress from the vessel. Several surviving passengers recalled hitting various impediments and being pinned against the canopy before they could break through it to escape upward from the submerged vessel. The NTSB believes that some of the fatalities likely resulted from the presence of the canopy and its associated framing.

For DUKW amphibious passenger vessels without sufficient reserve buoyancy (commonly referred to as original and/or “stretch” DUKWs), require the removal of canopies, side curtains, and their associated framing during waterborne operations to improve emergency egress in the event of sinking. (M-19-16)
