REPUBLIC OF THE MARSHALL ISLANDS

STI WINNIE CASUALTY INVESTIGATION REPORT

Fatal Electrocution of the Electrician

Arabian Gulf | 2 May 2019

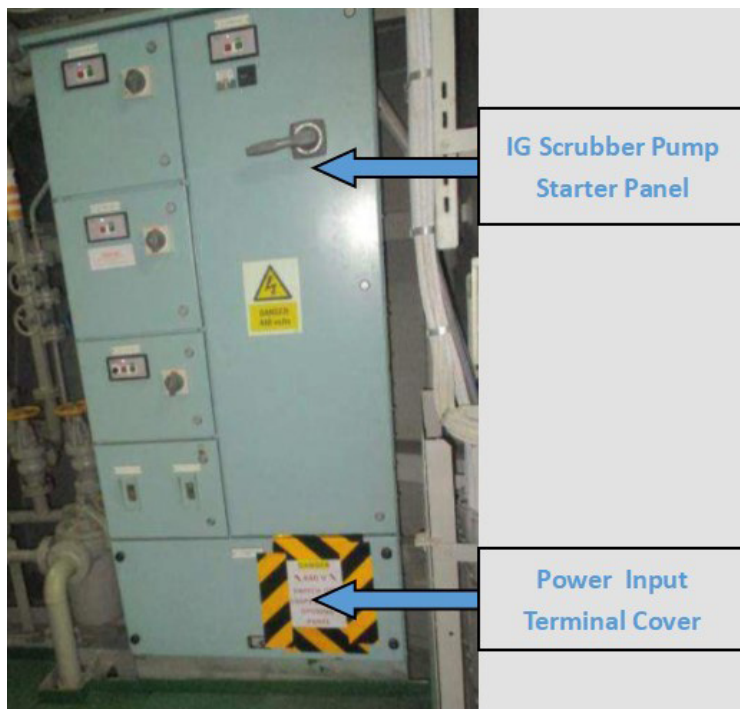
6. The IG scrubber pump starter panel was inside a LGSP cabinet located on the Engine Room's bottom platform.
7. The LGSP cabinet has several sections. The upper parts are starter controls for various machinery and the lower part contains the 440 V power terminals (*see Figure 1*).

Figure 1: LGSP cabinet with all covers in place. The warning label on the lower panel was added after the incident.

The panel's upper door had a warning sign about the 440 V shock hazard. The lower panel cover had no attached notice warning of the exposed 440 V power terminals. A warning label on the lower panel cover may have prevented the Electrician from opening the cabinet without de-energizing the power.

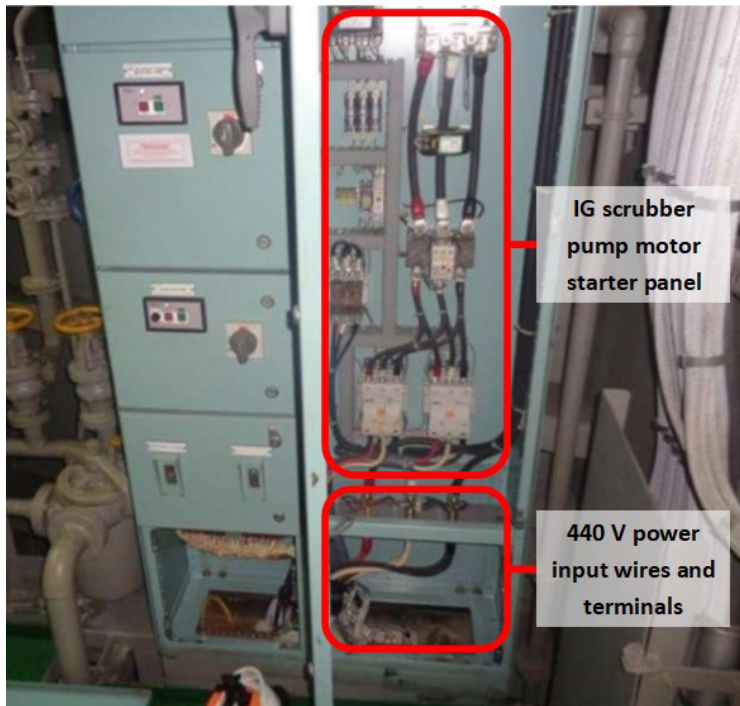
8. The door covering the panel opens outward with hinges on the left side. The cover over the power terminals is fully removable (*see Figure 2*).

Figure 2: LGSP cabinet with IG scrubber pump starter panel open and power input terminal cover removed.

9. Inside the LGSP cabinet, there was no divider between the upper section, containing the contactors, and the lower section, with the 440 V power terminals. Inside the lower panel, the three power cable terminals did not have guarding.²

The LGSP cabinet was divided into two sections. The upper has various contactors and the lower encloses the 440 V power terminals. The design of the LGSP cabinet that the Electrician was working in did not have a physical barrier between the two sections, nor was one installed at the time of the incident.

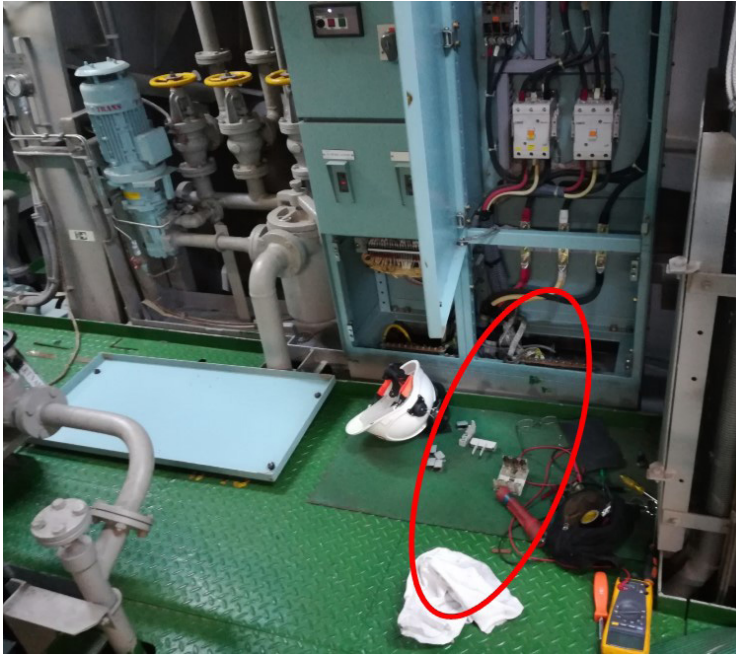
10. At 1144, the Engine Control Room (ECR) received a “Main Switch Board Abnormal” alarm, indicating “440 V Low Insulation”. At the time of the alarm, the 1AE, Third Assistant Engineer (3AE), and TME were in the ECR. The alarm was immediately acknowledged, and the cause investigated. The Engineers could not identify the cause of the alarm.³
11. At about 1150, the 1AE told the TME to tell the Electrician to investigate the alarm’s cause. The TME went to the Engine Room’s bottom platform, where he had last seen the Electrician.
12. On arriving at the LGSP cabinet, the TME saw the Electrician lying on the deck with his head and hands inside the lower section. He stated that he called the Electrician’s name and received no response (see Figure 3).

Figure 3: Location of the Electrician when found by the TME.

When the TME found the Electrician lying on the deck with his hands and head inside the LGSP cabinet, he immediately pulled him out by grabbing his boots. However, he did not ensure that the power was secured or that the Electrician's body was not energized due to contact with the live terminals. In this specific incident, the TME did not receive an electrical shock when removing the Electrician, however, there was a potential that he could have also been electrocuted while pulling him out of the cabinet.

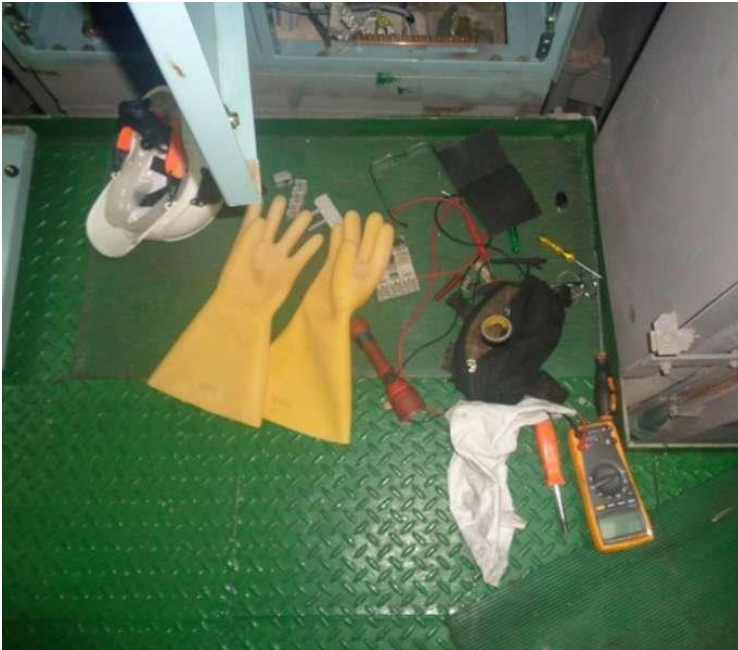
21. When the Electrician was found, the door for the IG scrubber pump starter panel was fully open. Also, the lower panel (covering the 440 V power terminals) had been removed and placed to the left of the LGSP cabinet (*see Figure 3*).
22. The Electrician's tool bag, various tools, safety helmet, and rubber gloves were spread on the deck in front of the LGSP cabinet (*see Figure 4*).

Figure 4: Tools and safety helmet, on deck, where Electrician was found.

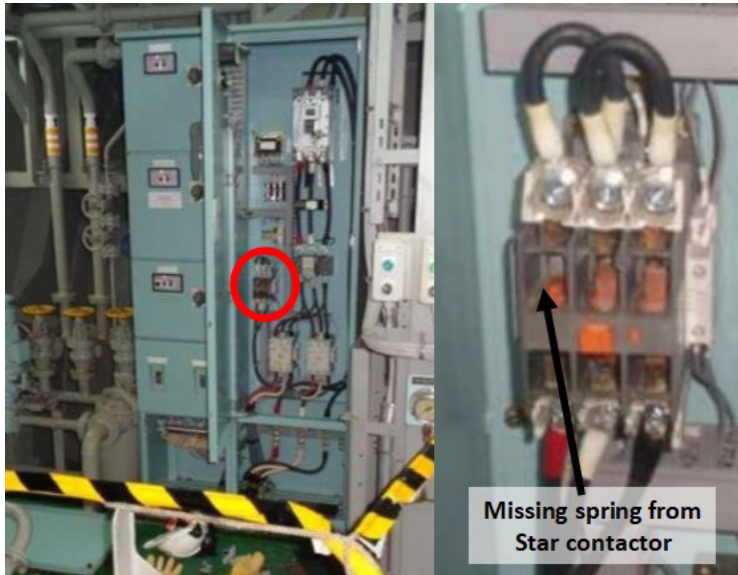
23. After the incident, the main circuit breaker supplying power to the pump starter was found in the off (open) position. This breaker is inside the IG scrubber pump starter panel.
24. The star contactor for the pump starter was missing a spring and cover locking pin when examined after the incident (*see Figure 5*).

Figure 5: IG scrubber pump starter contacts and the missing star contactor spring.

After the incident, the star contactor for the IG scrubber pump starter was missing a spring. This contactor is in the upper part of the LGSP cabinet. The missing spring was found resting on a ground buss bar in the cabinet's lower section.

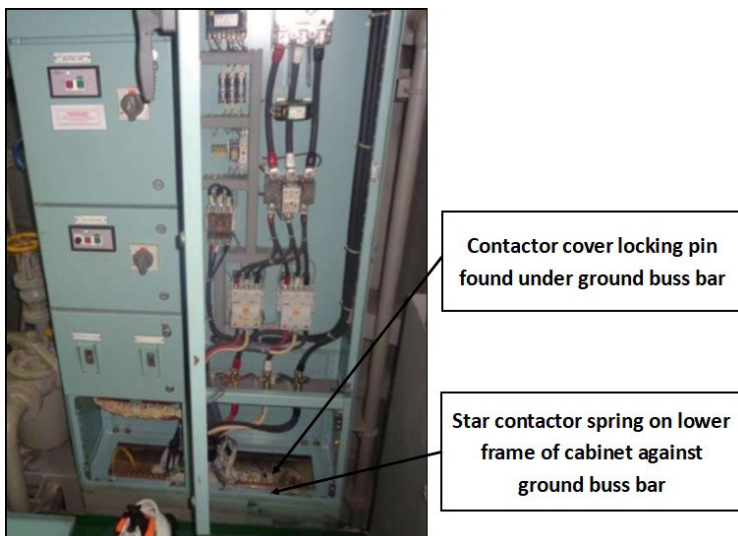
25. The missing star contactor spring was found on the LGSP cabinet's lower framing, resting against a ground buss bar. The star contactor cover locking pin was on the deck, under the buss bar (see Figure 6).

Figure 6: Location where the star contactor spring and contactor cover locking pin were found.

The cover locking pin for the star contactor was found on the deck, behind the ground buss bar (within the cabinet's lower section). This indicates that the Electrician was likely working on the star contactor before the incident. While attempting to retrieve the spring and cover locking pin, it is likely he removed the lower panel's cover, which covered the 440 V power terminals.
